Seismic Walkdown Checklist (SWC)Equipment ID No. 2-1805-53-BBC Equip. Class¹² Motor Control Centers & Wall-Mounted ControllersEquipment Description 480V MOT Control CTR 2BBCLocation: Bldg. Control Floor El. 180'-0" Room, Area R/B18

Seismic Walkdown Checklist (SWC)Equipment ID No. 2-1806-S3-DCC Equip. Class¹² 1-Motor Control Centres and Wall-mounted ControllersEquipment Description 125 VDC MCC 2C D1MLocation: Bldg. Control Floor El. 180'-0" Room, Area RB85

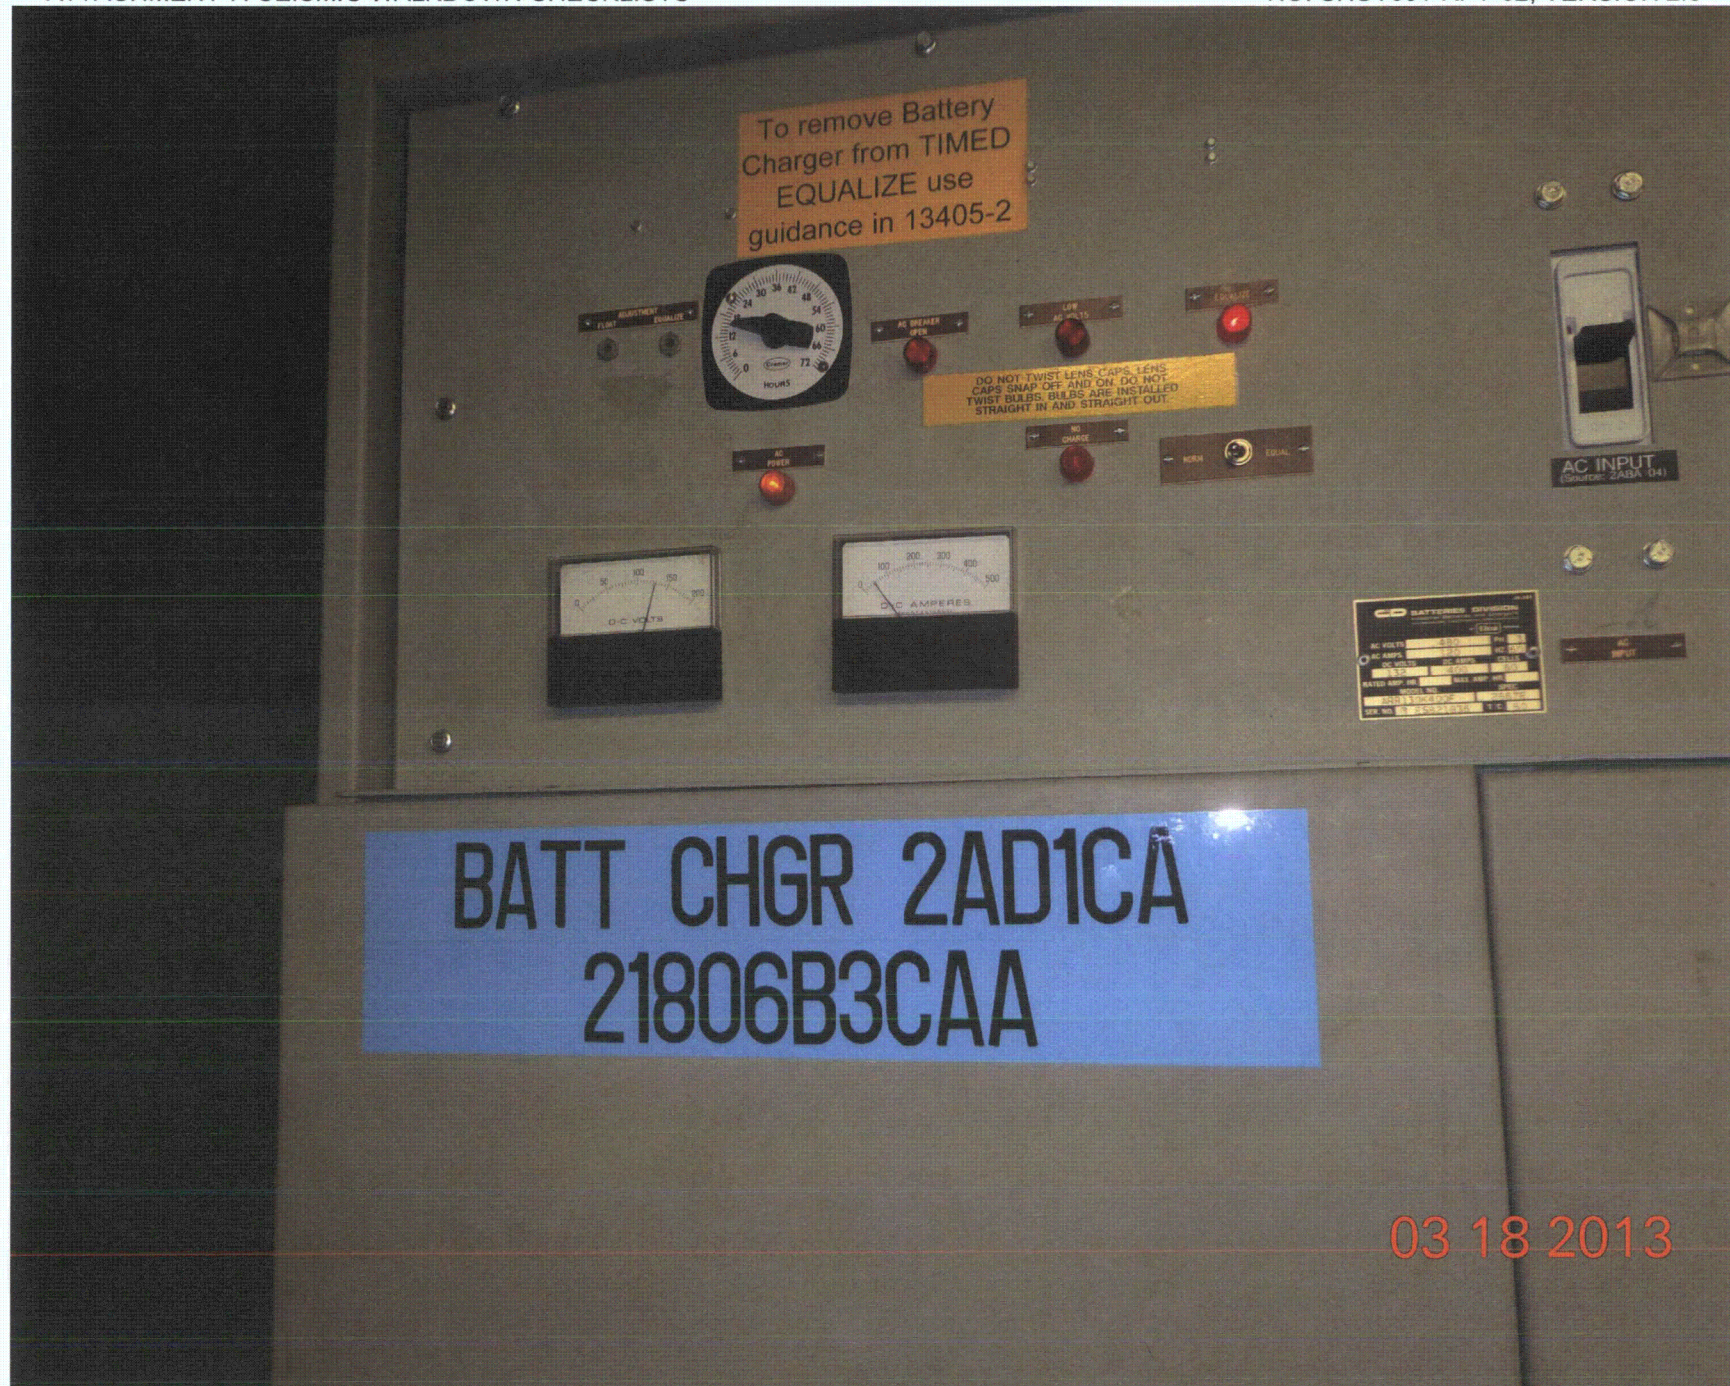
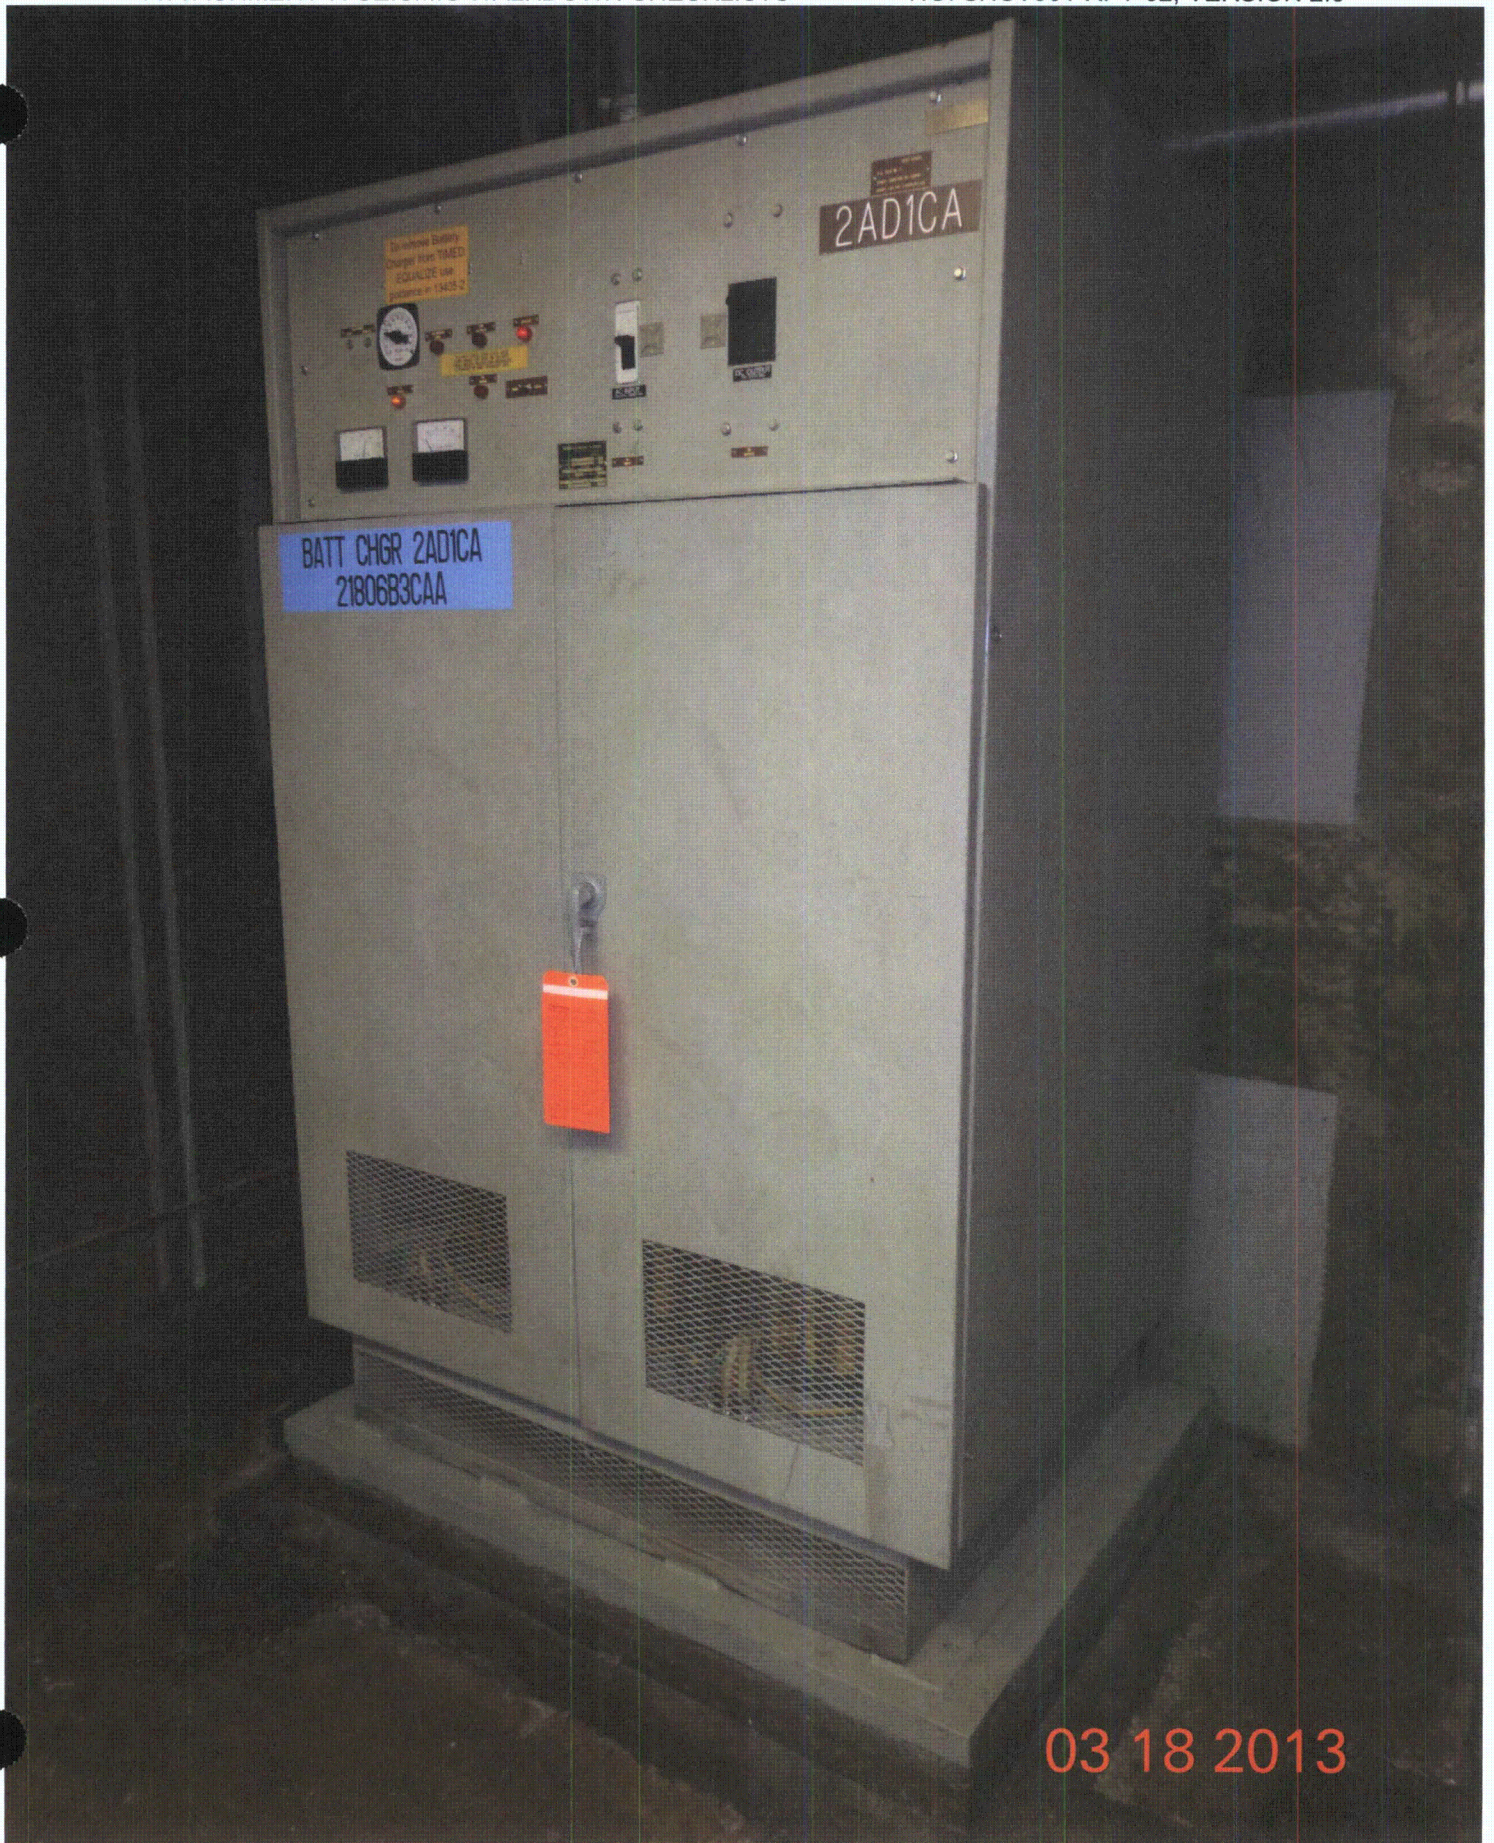
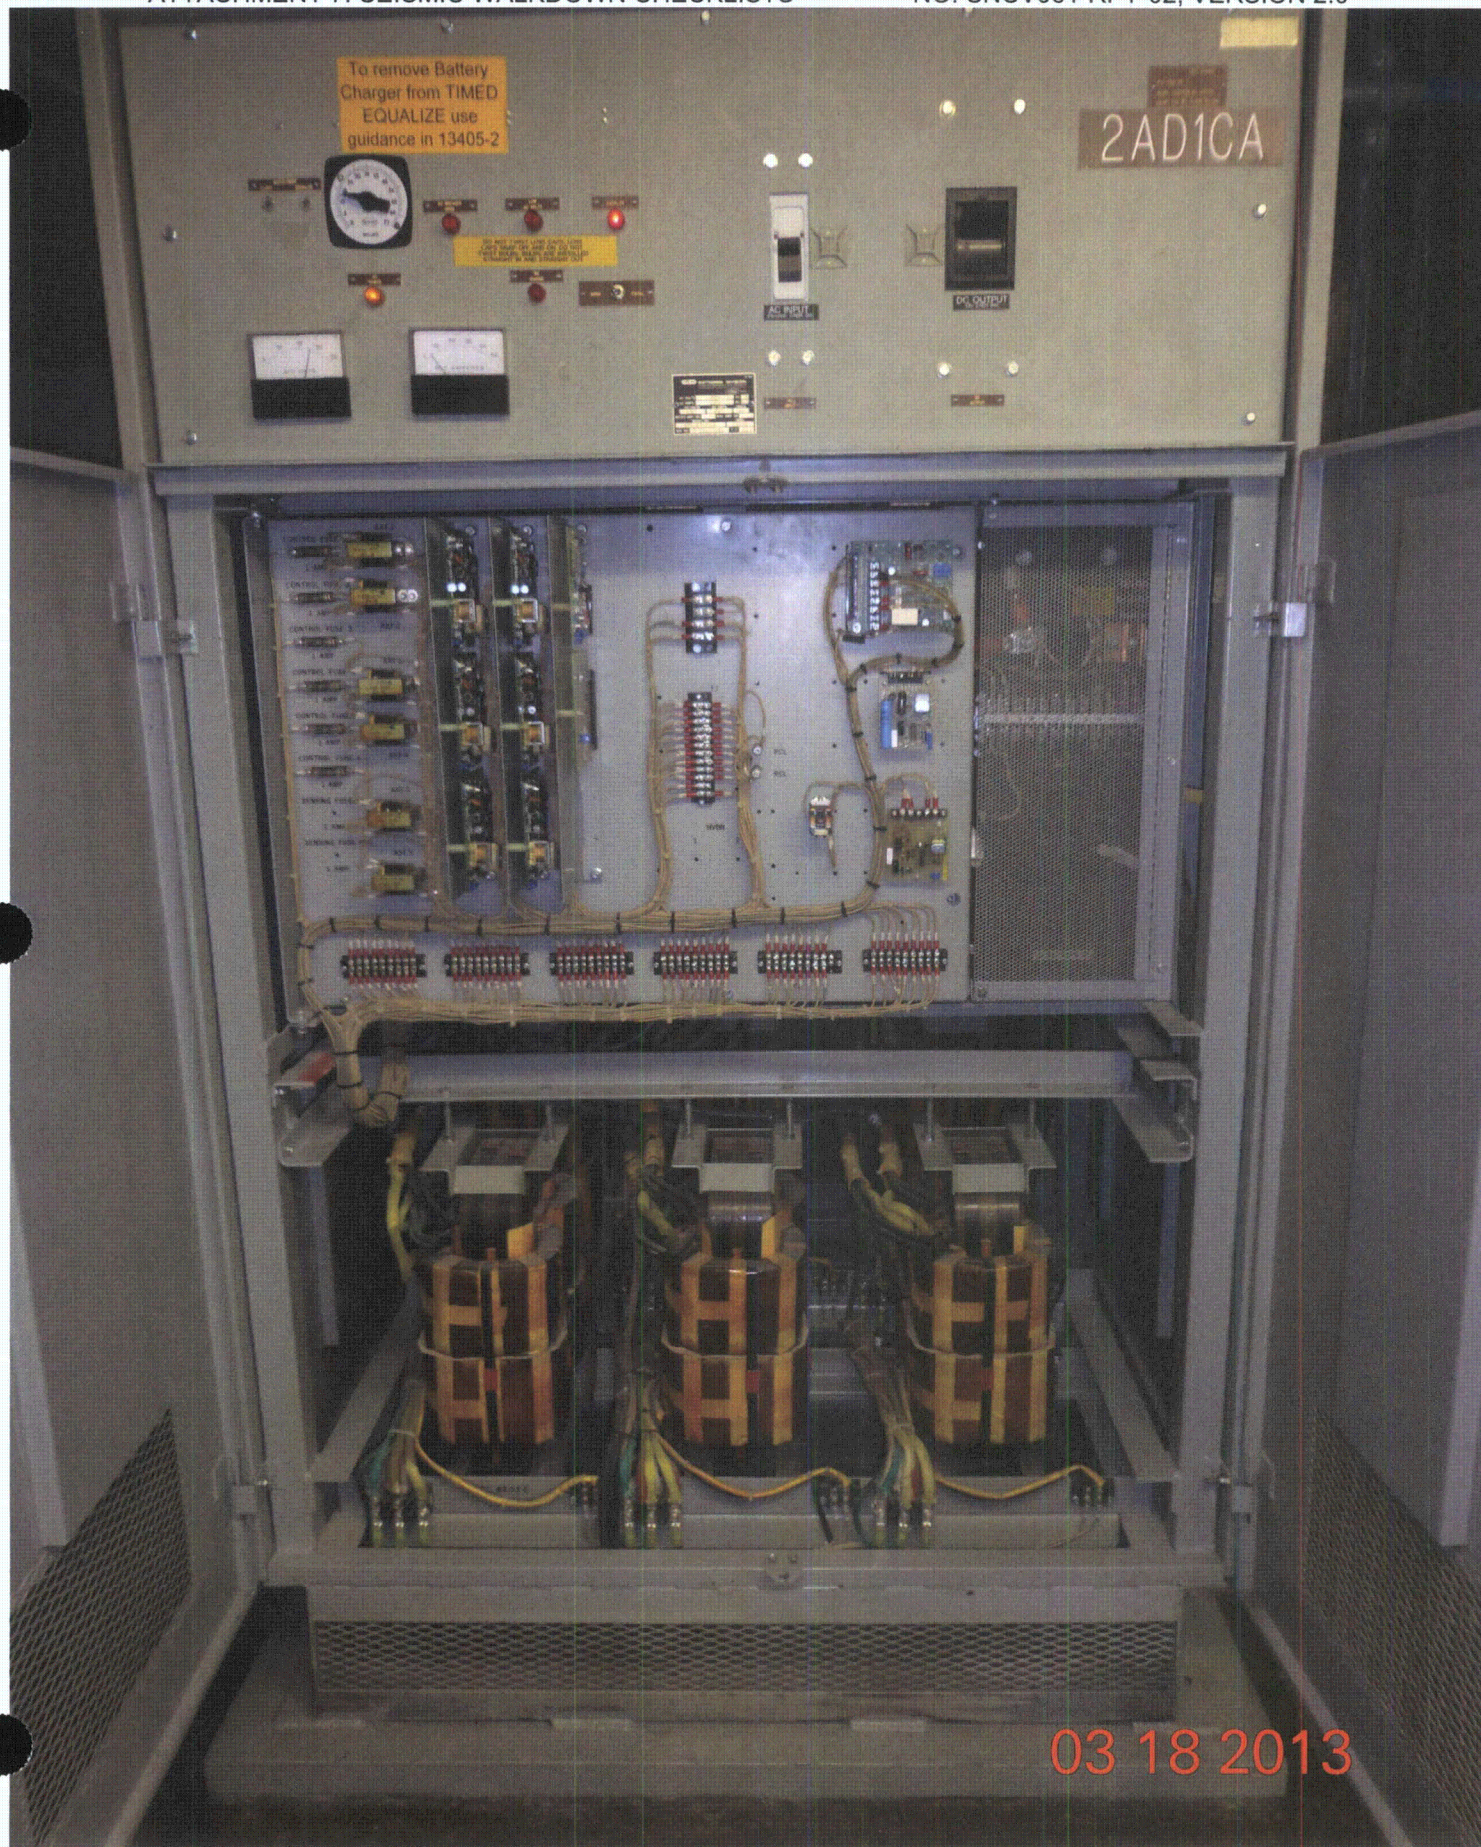
For an old cabinet it is very well maintained.
