Duke Energy Florida  
**Levy Nuclear Plant  
Units 1 and 2  
Part 2, Final Safety Analysis Report**

Postulated Faults and Fractures (Lineaments)  
within the LNP Site Area Shown on Hillshade  
Relief Map Derived from LIDAR Data  
FIGURE 2.5.3-214 Rev 6

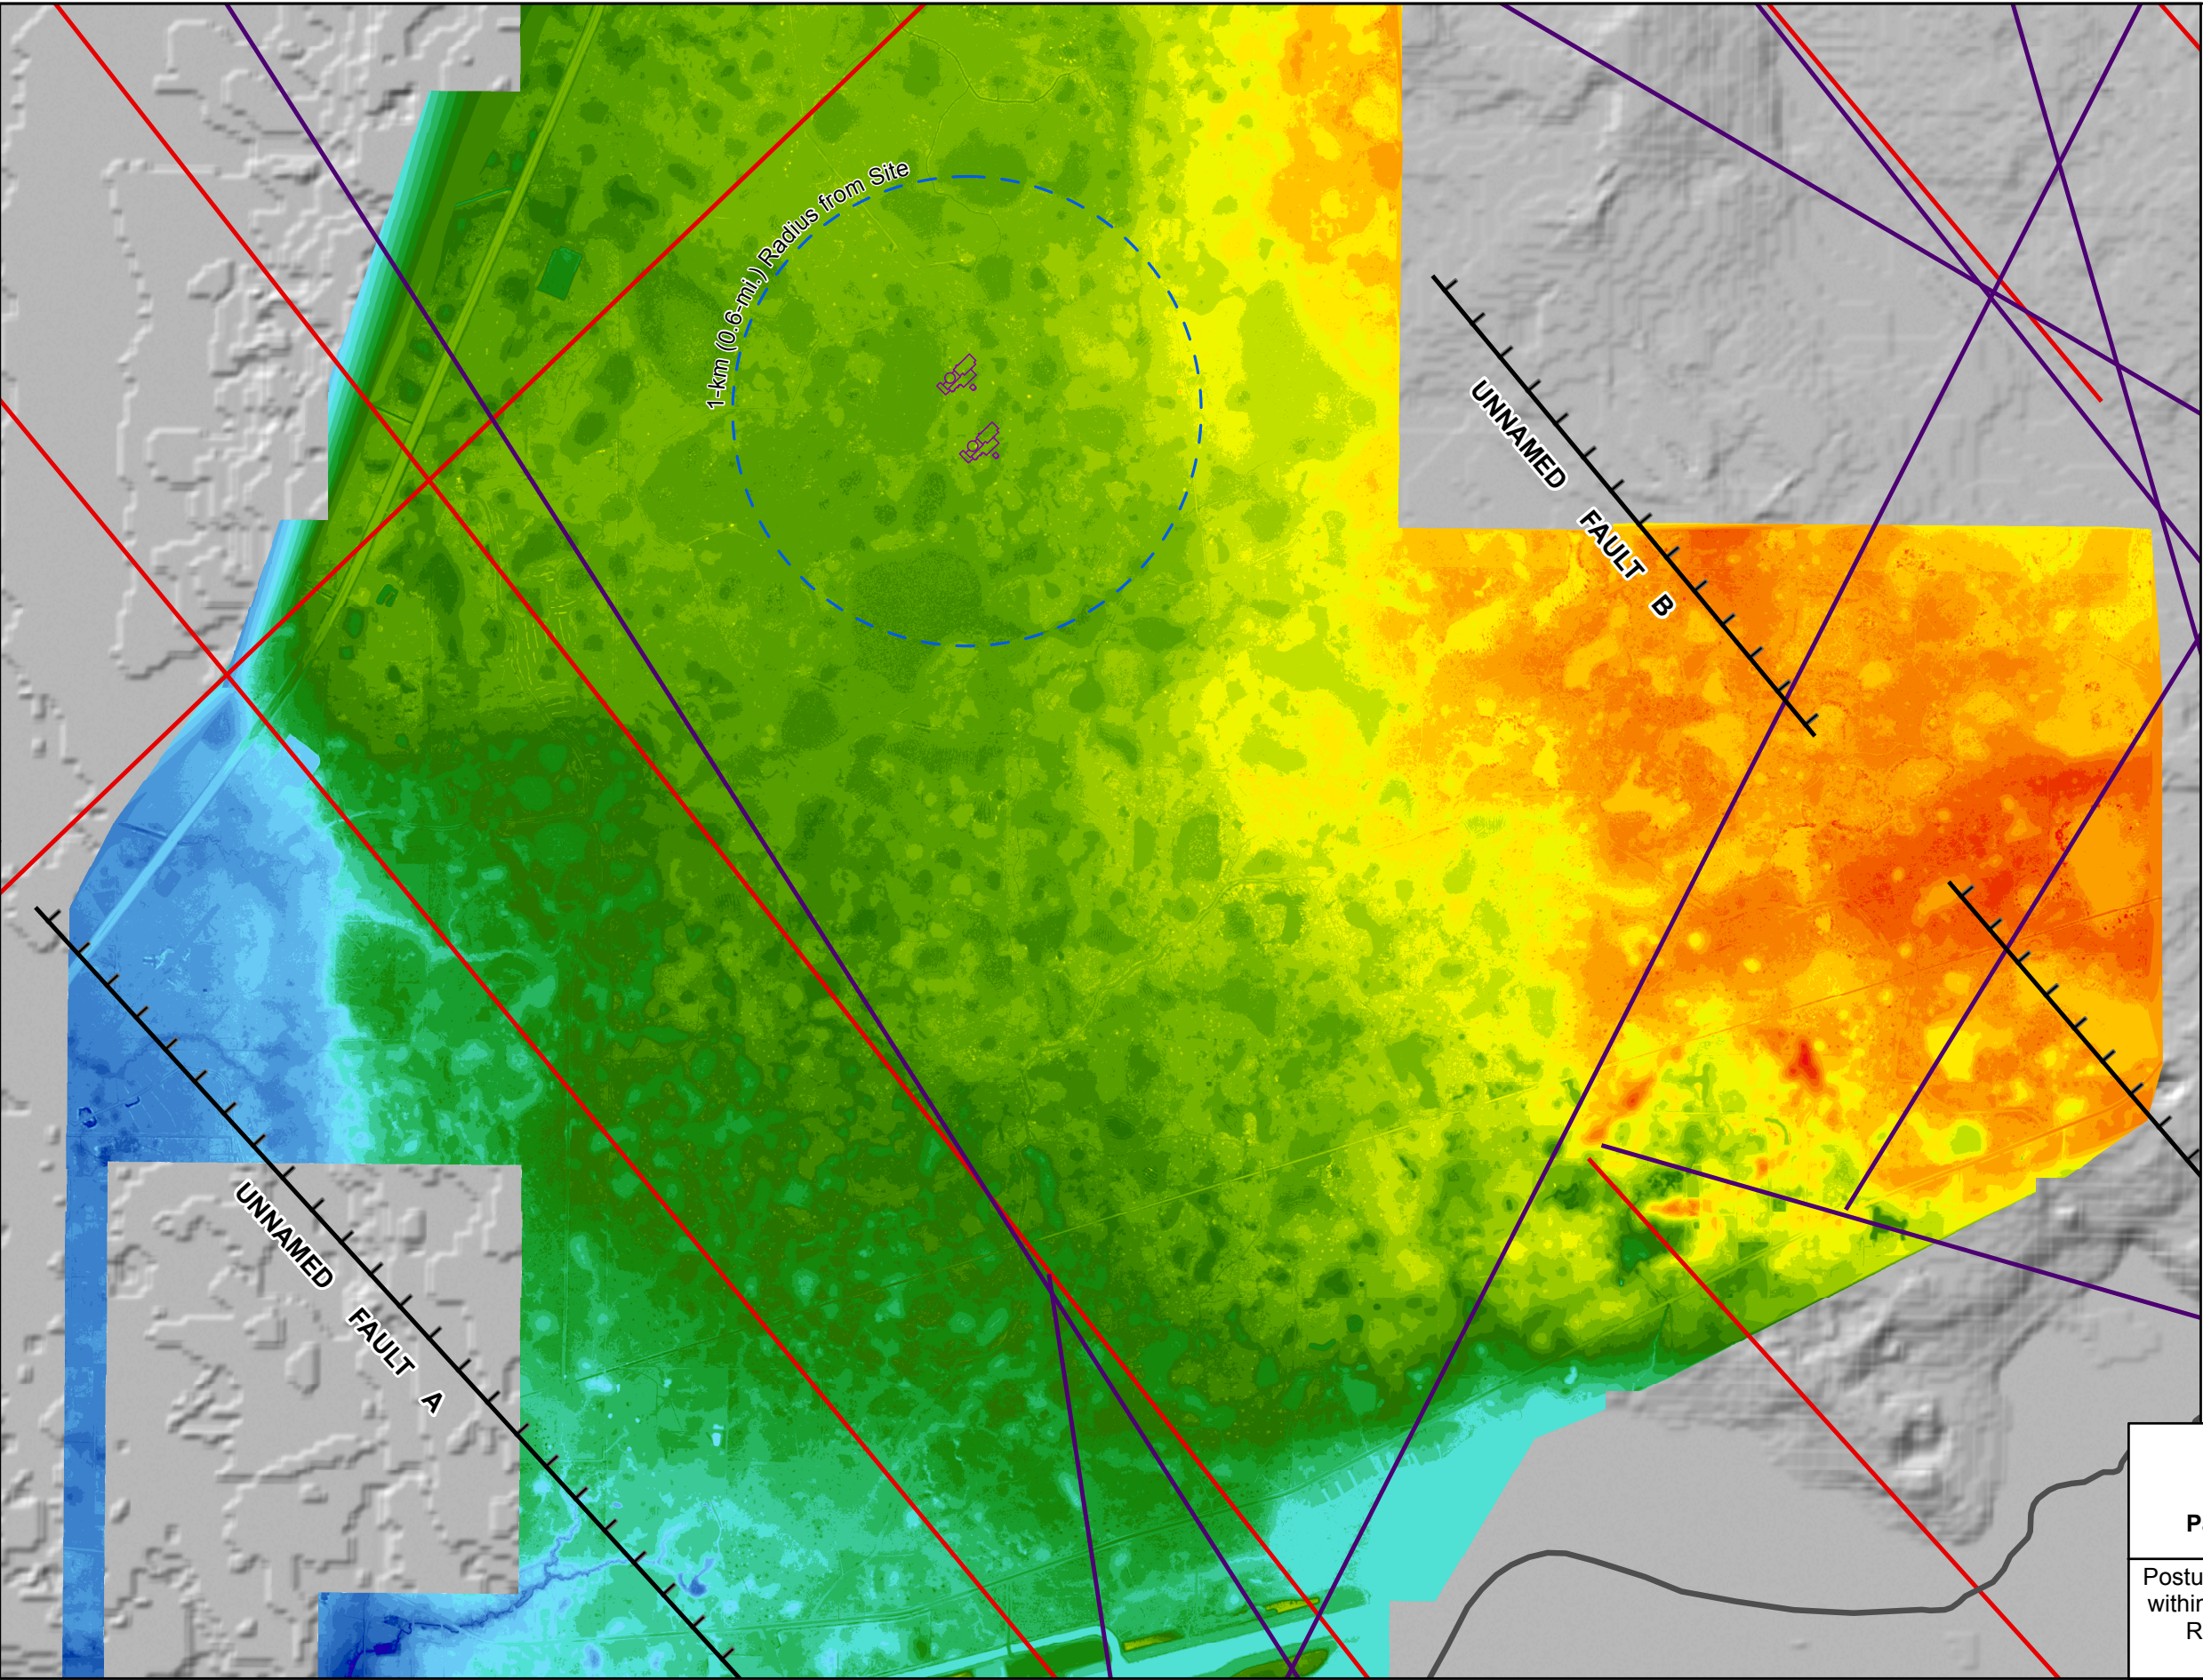
- 1-km (0.6-mi.) Radius from Site
- AP1000 Structures
- Postulated Faults  
Ticks indicate downthrown side.  
(Source: Vernon, 1951)
- Regional Fractures  
(Source: Vernon, 1951)
- Lineaments  
(Source: Florida DOT, 1973)
