Primary Water Stress Corrosion Cracking Tests and Metallurgical Analyses of Davis-Besse Control Rod Drive Mechanism Nozzle #4

D.S. Dunn¹, J. Collins¹, D. Alley¹, B. Alexandreanu²,
S.M. Bruemmer³, M.B. Toloczko³

¹ United States Nuclear Regulatory Commission, Washington DC

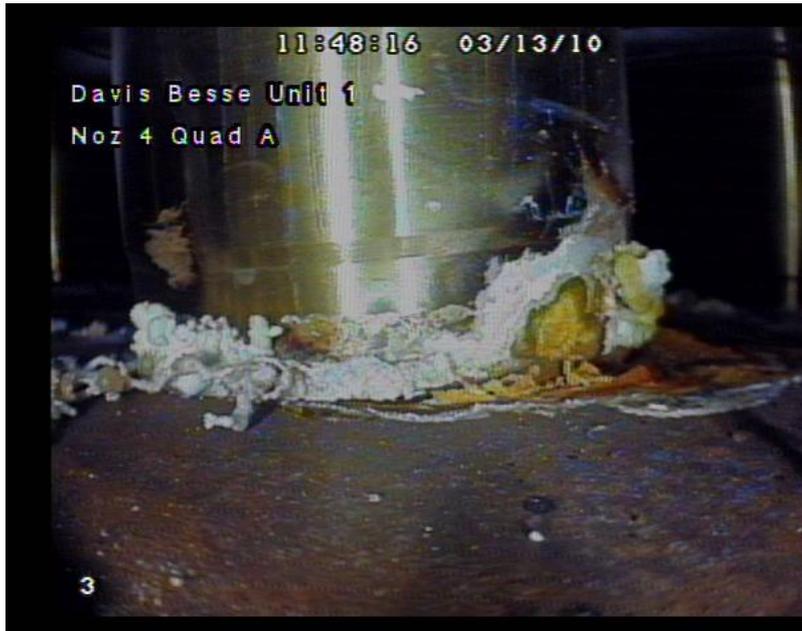
2010 Inspection Results

- 2002 PWSCC indication
 - Through wall PWSCC in Nozzle #3
 - Significant corrosion of the low alloy steel reactor pressure vessel head (RPVH)
 - Replaced with RPVH from the cancelled Midland, MI PWR
 - Operation resumed in 2004
- 2010 PWSCC indication
 - Observed after 5.5 effective full power years of operation
 - Bare metal visual: 13 potential leaking nozzles, Nozzle #4 confirmed leaker
 - Volumetric: 11 axial indications, 1 small circumferential indications, and 2 leak paths Nozzles #4 & #67
 - Surface: 12 indications; 6 were potential leakers

- Licensee performed ½ nozzle repairs on 24 nozzles
- Sample of Nozzle #4 provided to the NRC for testing and analyses
- On June 18, 2010, the licensee informed NRC that Davis-Besse would shut down on October 1, 2011 to replace the head

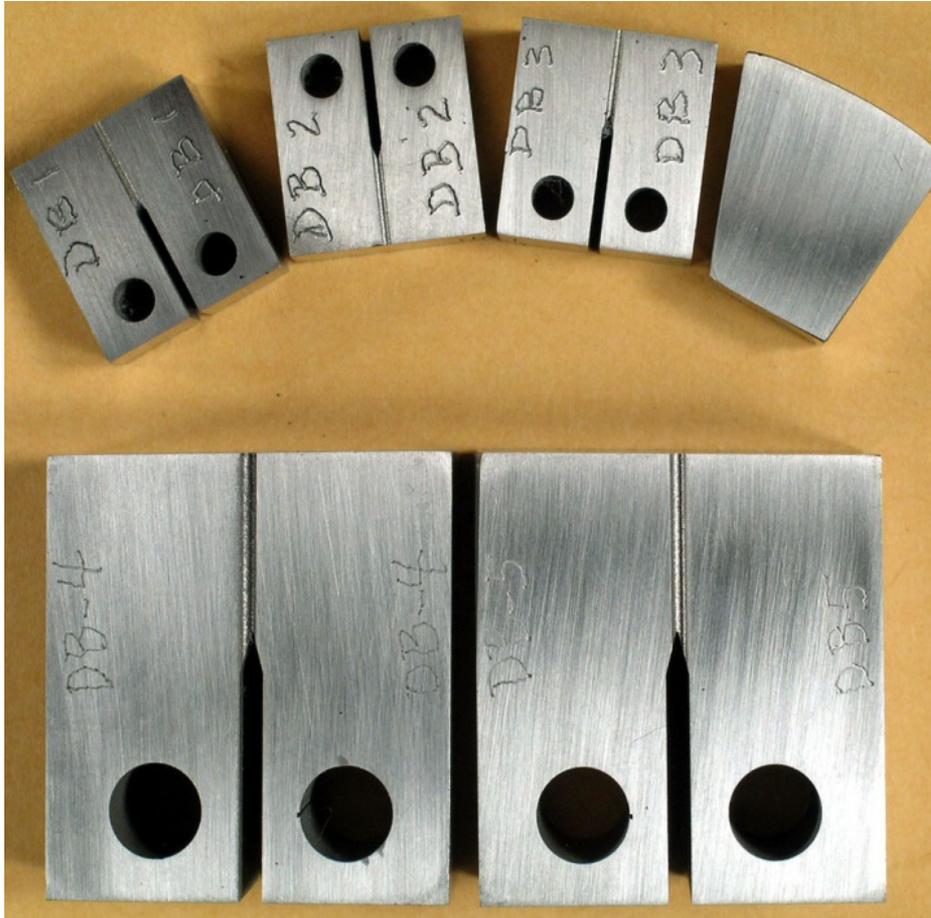
Test Specimens

- 2 - $\frac{1}{2}$ thickness (T)-compact tension (CT) specimens
 - Tested at Argonne National Laboratory (ANL)
- 3 - $\frac{1}{4}$ T-CT specimens
 - 1 tested at ANL
 - 2 tested at Pacific Northwest National Laboratory (PNNL)
