Re: **Lost Creek ISR LLC, Permit 788, Class 3 UIC Well Acceptance for Mine Unit 1 Header House 3 (HH 1-3)**

Wyoming Department of Environmental Quality (WDEQ)- Land Quality Division (LQD)
Inspection Memorandum

Subject: Inspection of UIC Class 3 Wells – Mine Unit 1, Header House 3

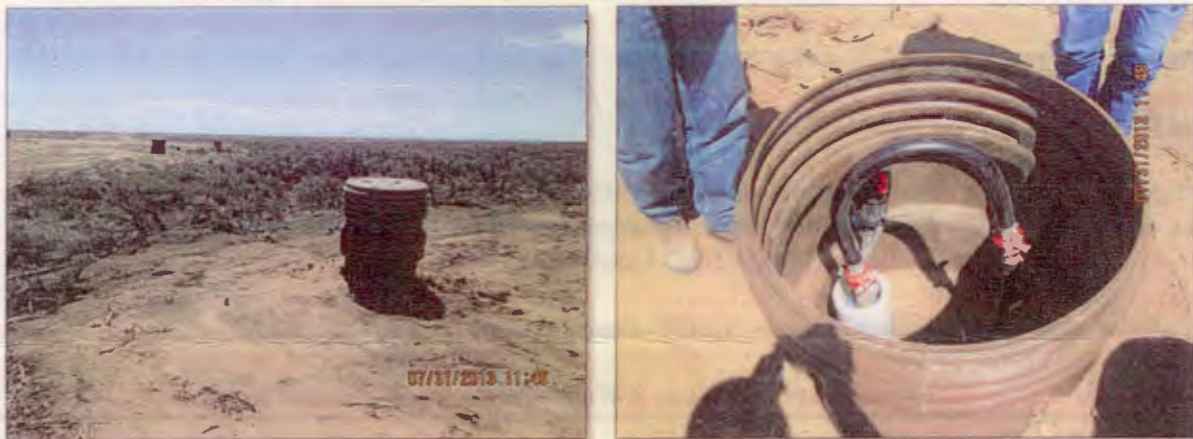
Photo Number 1: The photo on the left depicts the well cover for one of the HH 1-3 well inspected today. It is on the west edge of HH 1-3, west of a prominent drainage (which is behind this well). The wells in HH 1-3 are at least 20 feet away from the drainage. The photo on the right depicts the inside of the well depicted on the left. It is currently set up with injection well hardware.

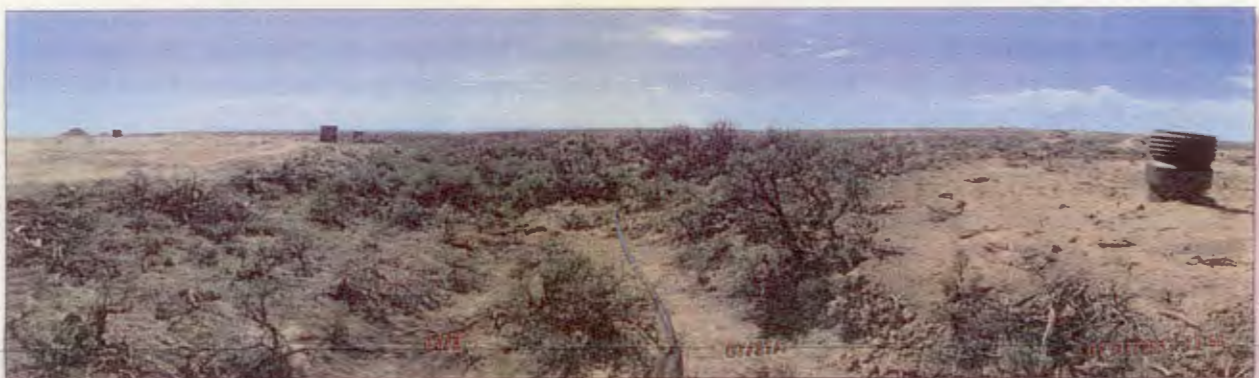
Photo Number 2: This is a panoramic view looking generally to the south along the drainage depicted above. LCI's efforts to keep away from this drainage appear to be working well. There is no evidence of sediment from the well field entering this drainage.
