Fukushima -  
Flooding Hazard Reevaluation  
Upstream Dam Failure Analysis

**NCR  
Technical  
Presentation**

**March 25, 2013**

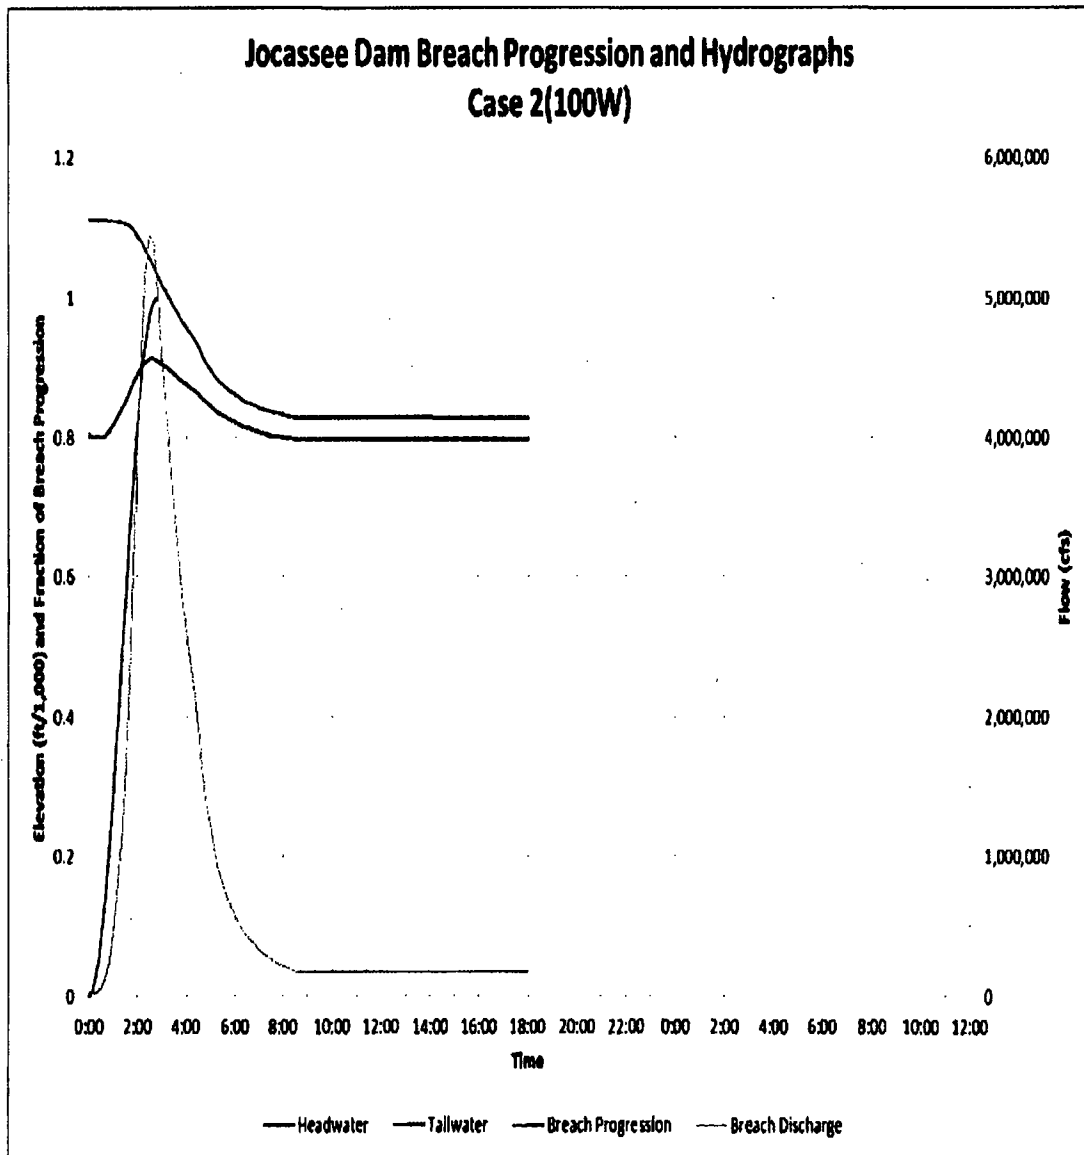
# 2011 SE Jocassee Dam Breach Progression and Stage-Discharge Hydrographs

- ❖ Initial breach derived primarily from Froehlich regression equations.
- ❖ Breach dimensions were adjusted based on physical constraints of natural valley
- ❖ Jocassee breach parameters:
  - Top Width - 1156 (64% of overall crest)
  - Bottom Width – 431 feet
  - Bottom Elevation – 800 msl
  - Breach Formation Time - 2.8 hrs,
  - Peak outflow 5,400,000 cfs

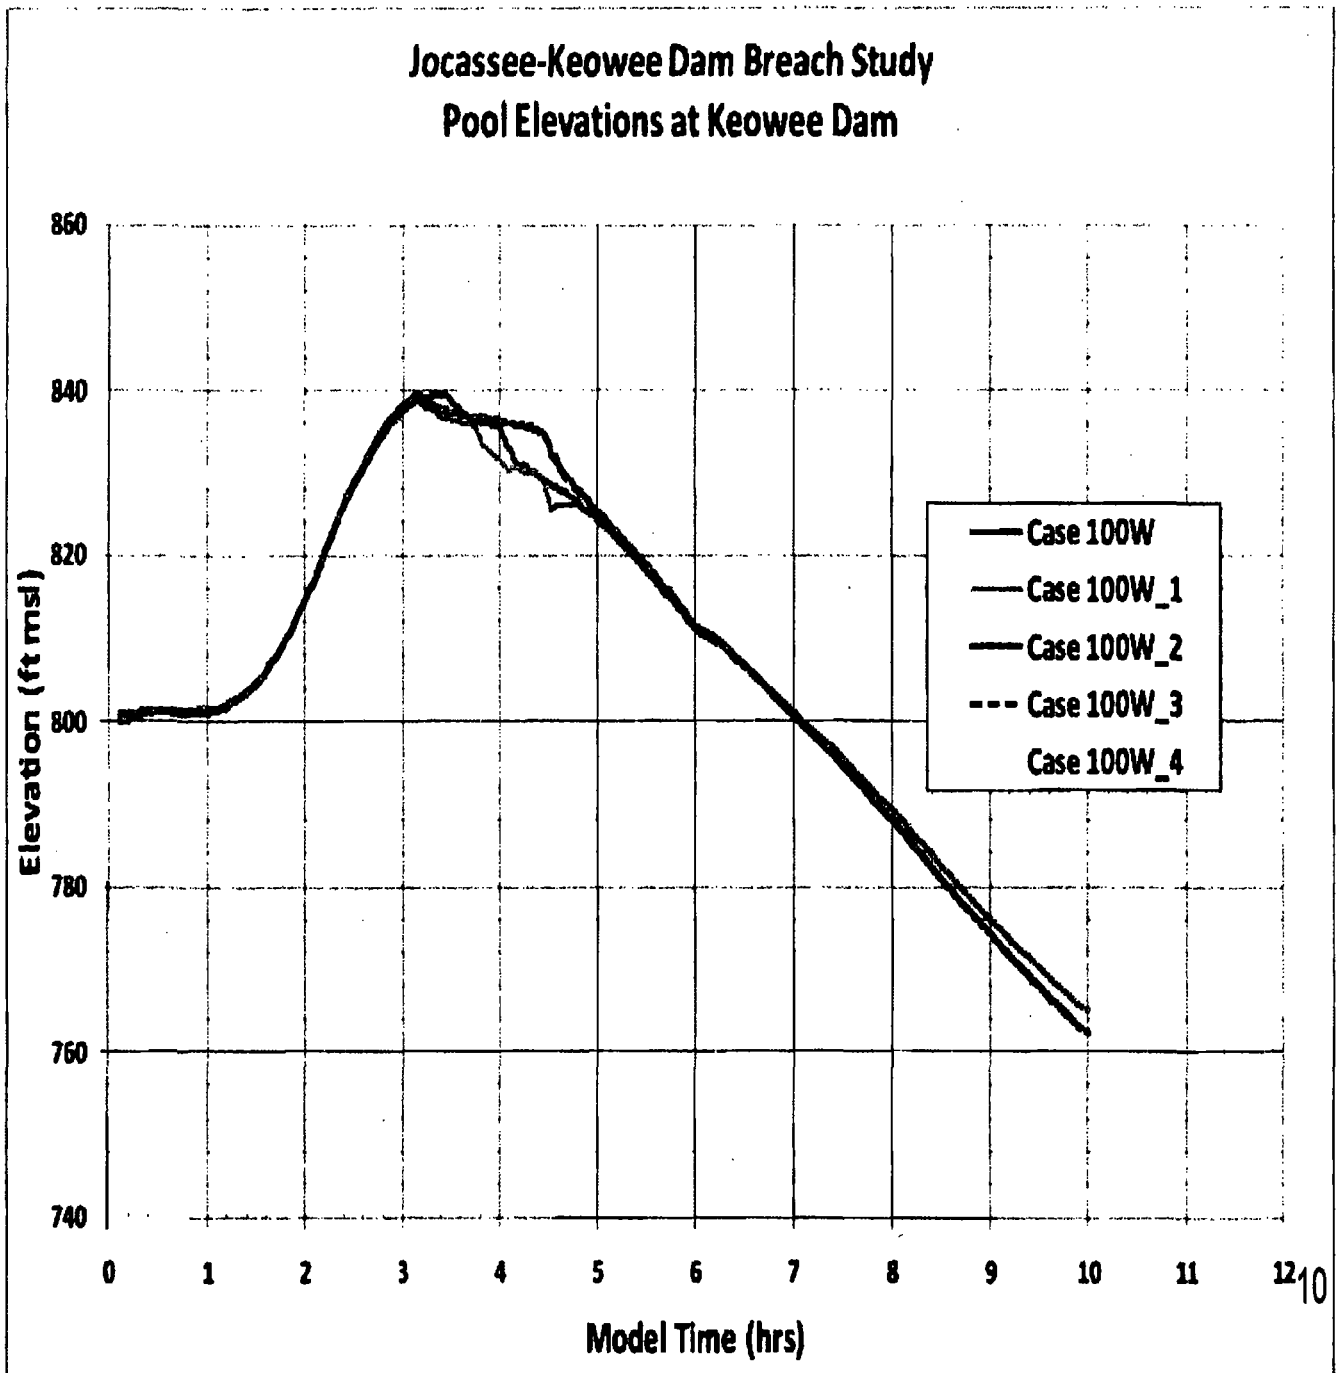
### WATER SURFACE ELEVATIONS AT KEOWEE DAM

## 2D Model
