Review of Key Aspects of the FAVOR Model Relevant to Small Surface Breaking Flaws

Mark Kirk, Josh Kusnick, and Mike Benson
*United States Nuclear Regulatory Commission
Office of Nuclear Regulatory Research
Division of Engineering, Component Integrity Branch
mark.kirk@nrc.gov*

Appendix G Periodic Meeting
NRC Headquarters
June 24th 2013

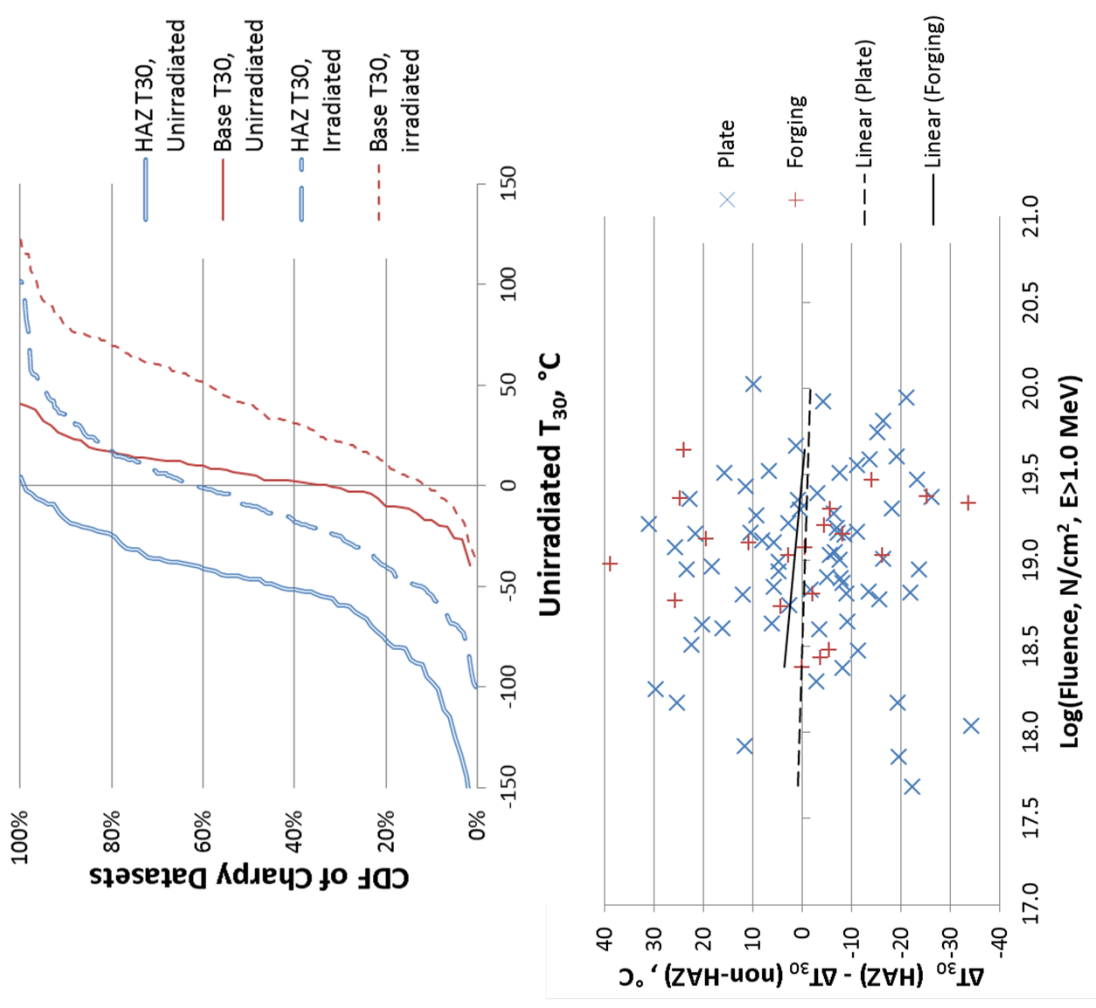
Troyer & Erickson, 2013

- Comprehensive summary based on USA surveillance testing
 - Data from PR-EDB
- HAZ T_{30} values compared with T_{30} values for companion plate or forging
- Key findings
 - T_{30} of HAZ < T_{30} of plate or forging in virtually all cases
 - Embrittlement behavior (ΔT_{30}) of HAZ, plates, and forgings very similar
