**CLOSURE OF HLW TANKS – PHASE 2
FULL SCALE COOLING COILS GROUT FILL
DEMONSTRATIONS**

E. K. Hansen and A. D. Cozzi

Savannah River National Laboratory

June 2008

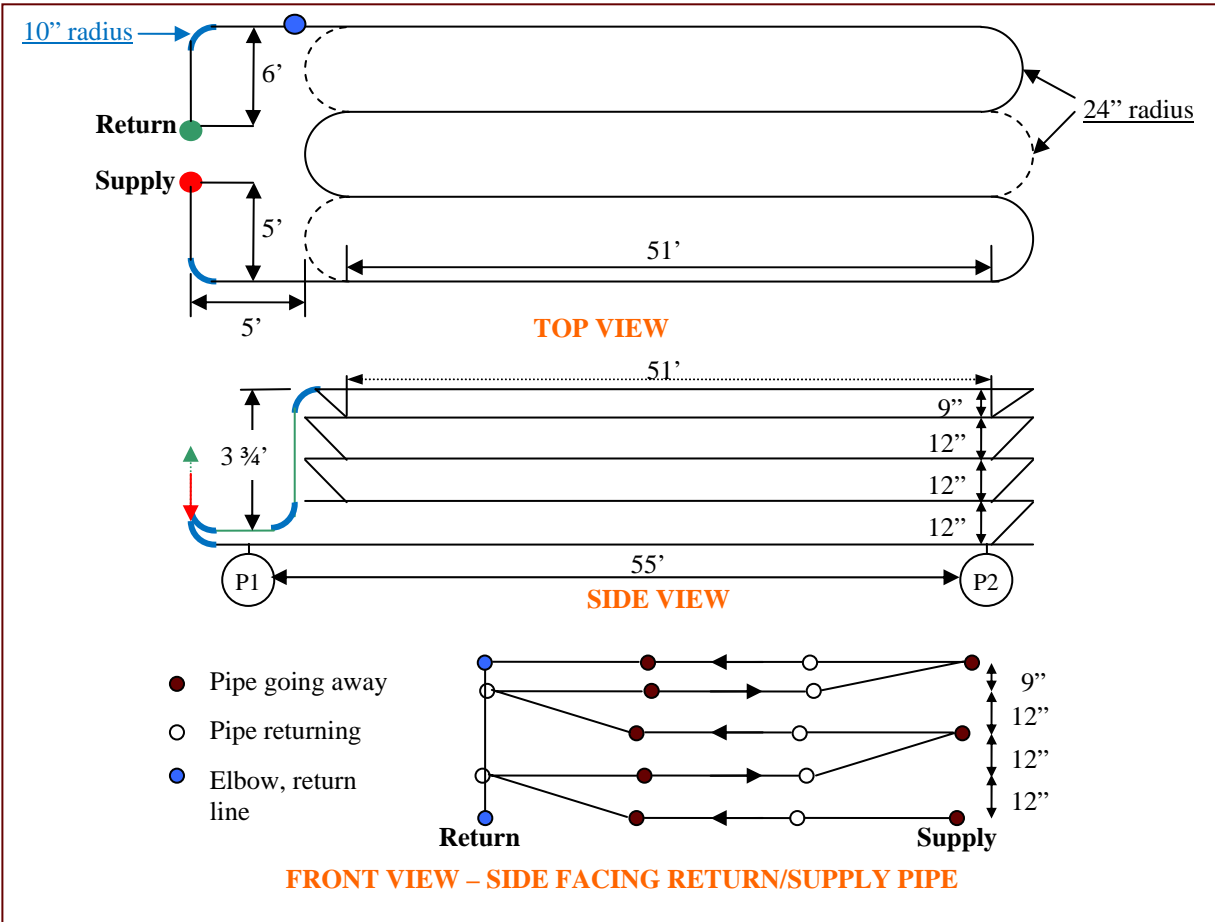
Figure 2-4 Horizontal Cooling Coil Assembly Located Outside on Ground Level

The supply/return piping runs were located indoors and were in the same area used by the vertical cooling coil assembly supply/return piping. The full scale mockup was approximately five feet shorter in height than that of the SRS Type I horizontal cooling coil assemblies, as previously discussed in section 2.2.1.1. There was an additional 113 feet of horizontal piping required in the mockup to connect the supply/return connection on the 3rd floor to the horizontal cooling coil assembly located outdoors. Sixteen 90° 10-inch radius bends were used in the supply/return connection to the horizontal assembly. The Type I tanks have two 90° 2-foot radius bends to connect the vertical supply/return lines to the horizontal runs and four 90° 10-inch radius bends for the piping between the pump house and tank per assembly. A 0.5 inch vent line was also installed at the high point in the system. The horizontal cooling coil assembly used the same sampling location as that of the vertical cooling coil assembly.

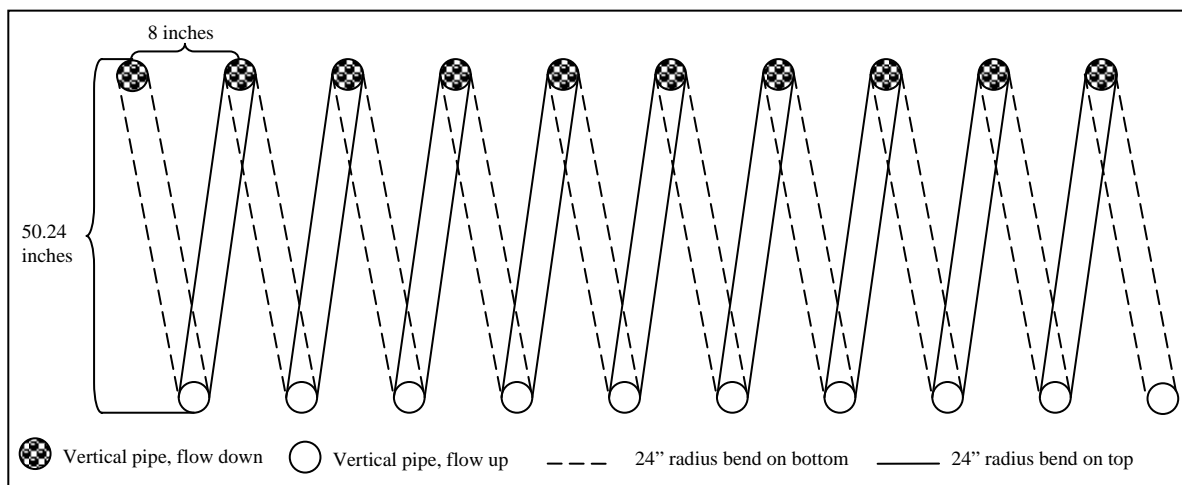
Figure 2-6 Layout of Vertical Cooling Coil Assembly in Support Frame

The vertical cooling coil assembly was supported using Unistrut™ materials. A top view of how the nineteen 180° 2-foot radius bends and piping run were installed is shown in Figure 2-6. The support assemblies between the first and second floors were set using a plumb bob. The vertical cooling coil assembly is shown in Figure 2-7, Figure 2-8 and Figure 2-9. Figure 2-9 partially shows the piping on the third level, which also includes the horizontal cooling coil connections. The horizontal cooling coil assembly is shown in Figure 2-10, Figure 2-11, Figure 2-12, and Figure 2-13. The horizontal pipe support frames for the cooling coil assembly located outside are shown Figure 2-10 and Figure 2-11 and the support frames were leveled prior to installing the piping. Figure 2-12 and Figure 2-13 show the piping connecting the horizontal cooling coil assembly on the first floor and the run of horizontal piping on the second floor, respectively.

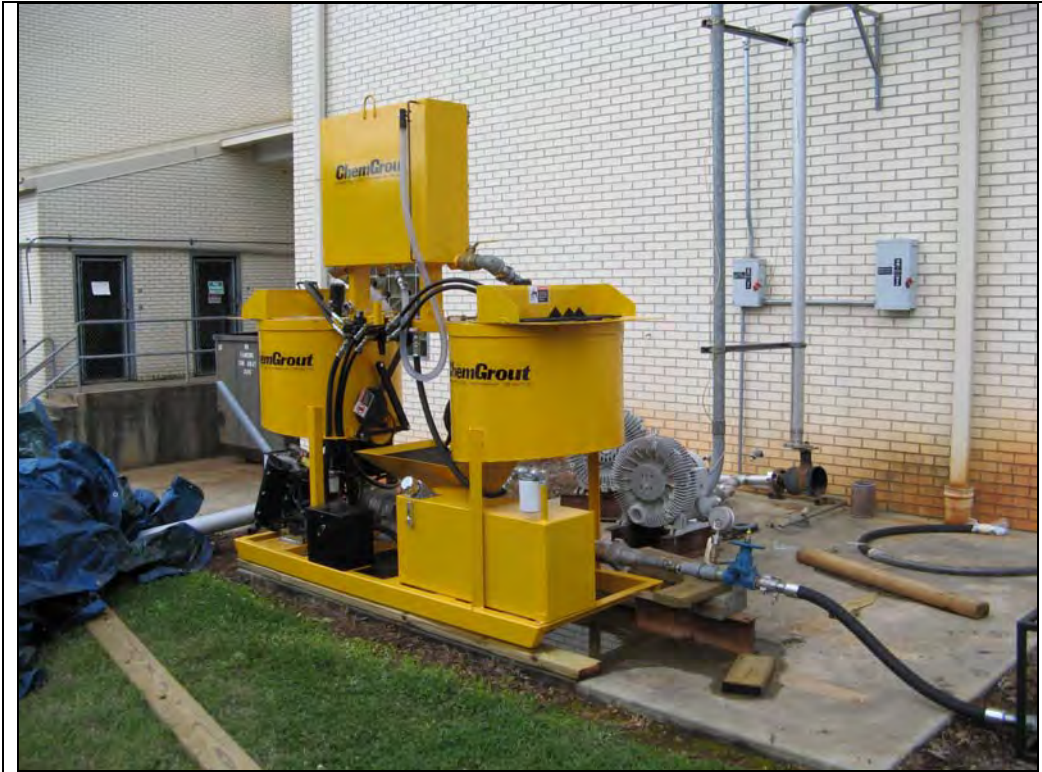
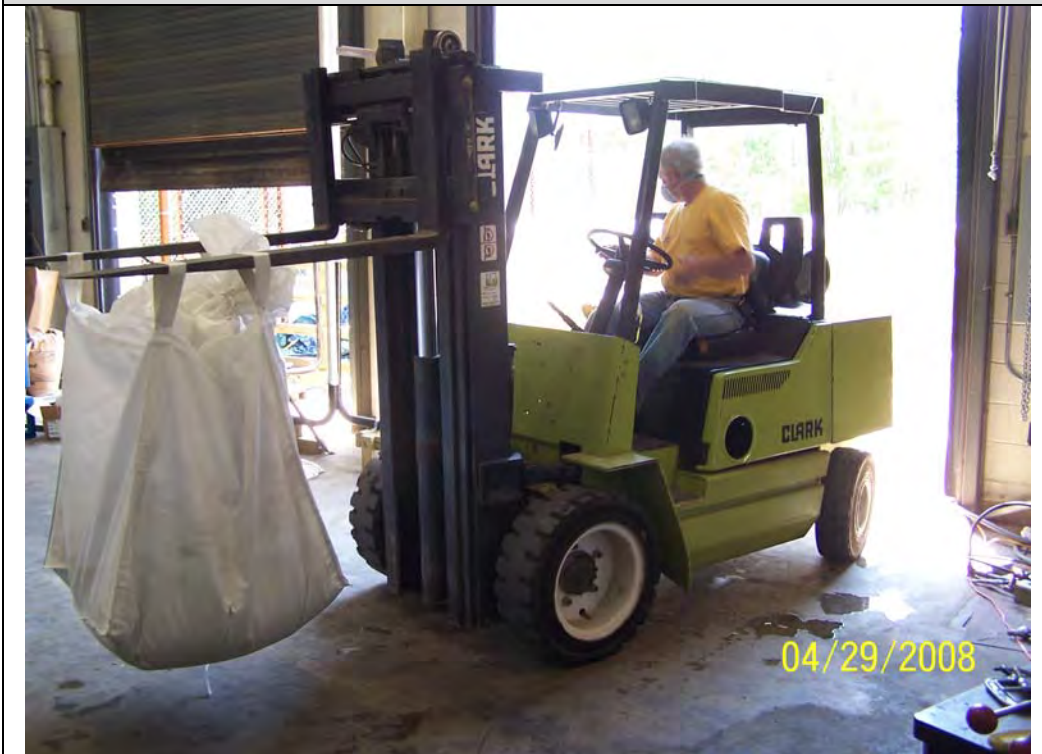
Figure 2-14 ChemGrout GC-500-DH and Supersack

To assist in the addition of dry solids (MF 816 and slag) into the mixing tanks, the solids were pre-batched into supersacks that contained enough solids to make a 38 gallon batch of grout. Each supersack contained eight 55 pound bags of MF 816 and 48.89 pounds of Slag. Figure 2-14 shows a supersack being transported to the mixer.

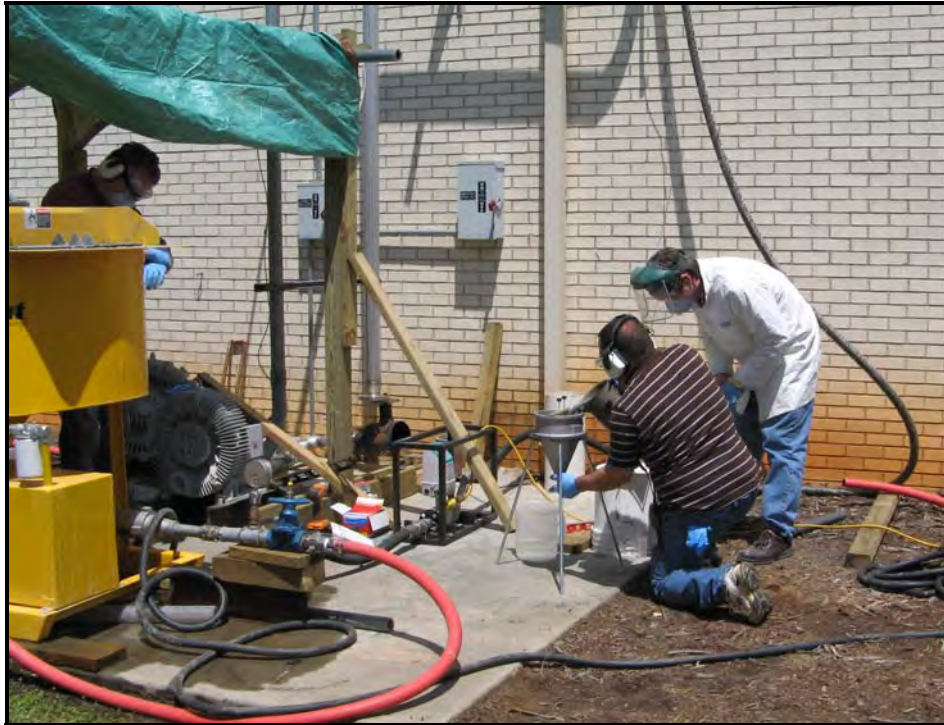
Figure 2-17 ASTM C939 Flow Cone Measurement

During actual operations, flow cone (see Figure 2-17) measurements were performed to determine the flowability of the grout during pumping operations. The flow cone measurement was performed based on ASTM C939 [7]. The flow cone was leveled, a predetermined volume of water was placed in the cone, allowed to stabilize, and the level indicators were set. The water was then allowed to discharge the cone and the time measured until the first break in the continuous flow was observed. The water must flow out of the cone within 8 ± 0.2 seconds. Prior to the grout flow measurements, water was added to the predetermined level to wet the internal surfaces of the cone. The grout was added, allowed to equalize (within a minute), the discharge was opened and the time (T_{flow}) was recorded when the first break in the continuous flow was observed. When a batch was measured for flow, only one measurement was performed. The allowable flow time for this grout is provided in Table 2-1.

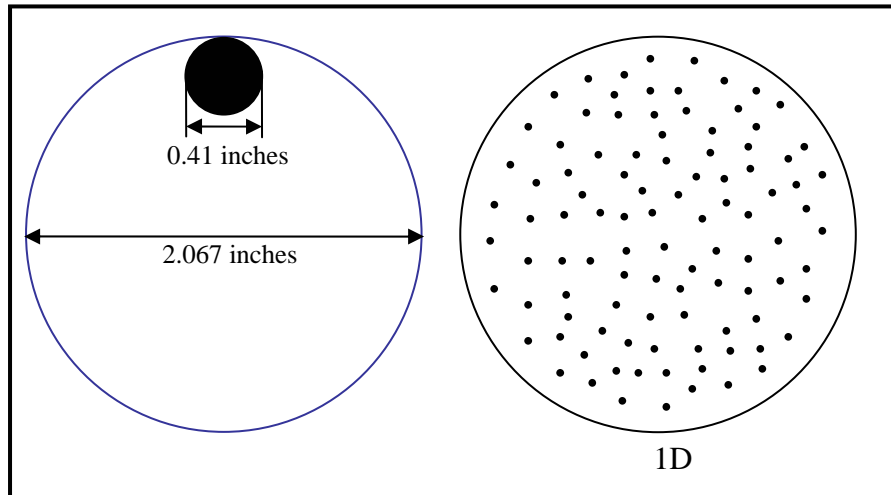
Figure 2-18 Four Volume Percent Void in 2 inch Piping

A criterion in the TT&QAP [2] states that the void fraction should be less than four volume percent. Figure 2-18 shows a cross-section of what four volume percent would look like, assuming that the voids can be treated as infinite cylinders. One circle contains a single void and the other circle contains 100 voids that equate to four volume percent. This figure provides a reference to which the cured grout from the sectioned piping can be compared.

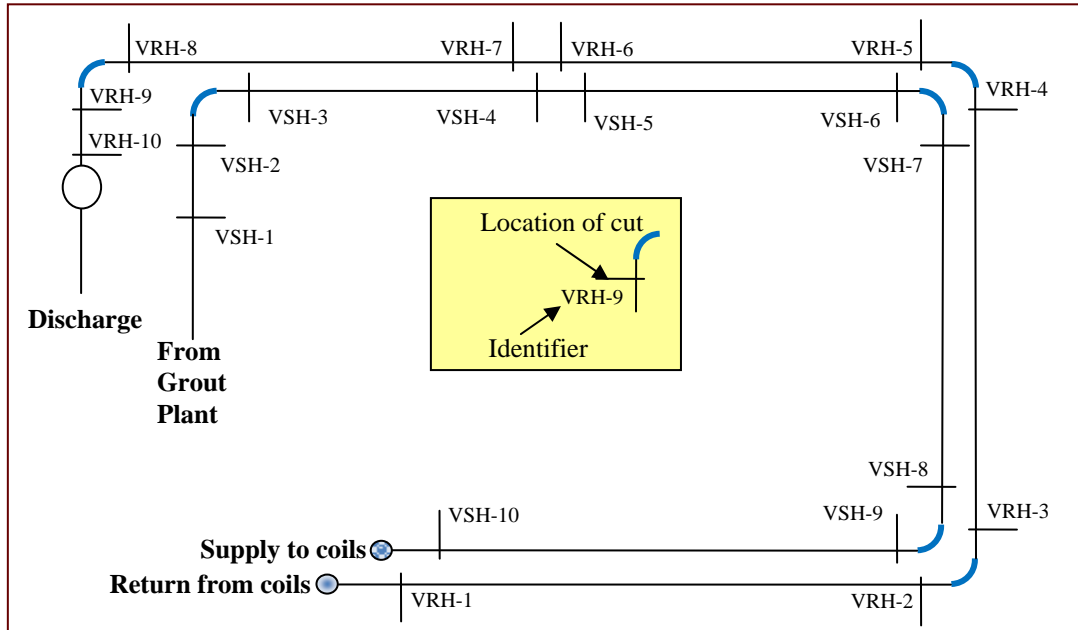
The sectioning of the vertical cooling coil assembly after the grout has cured is shown in Figure 2-19 and Figure 2-20. These figures show where the cuts in the vertical and horizontal piping were made. A majority of the sections of piping were photographed after the sections were cut flush using a chop saw. Sections of piping between the cuts were also photographed.

Figure 2-19 Vertical Cooling Coil Assembly - Section Marks

Figure 2-20 Horizontal Piping Run for the Vertical Cooling Coil Assembly on the 3rd floor – Section Marks

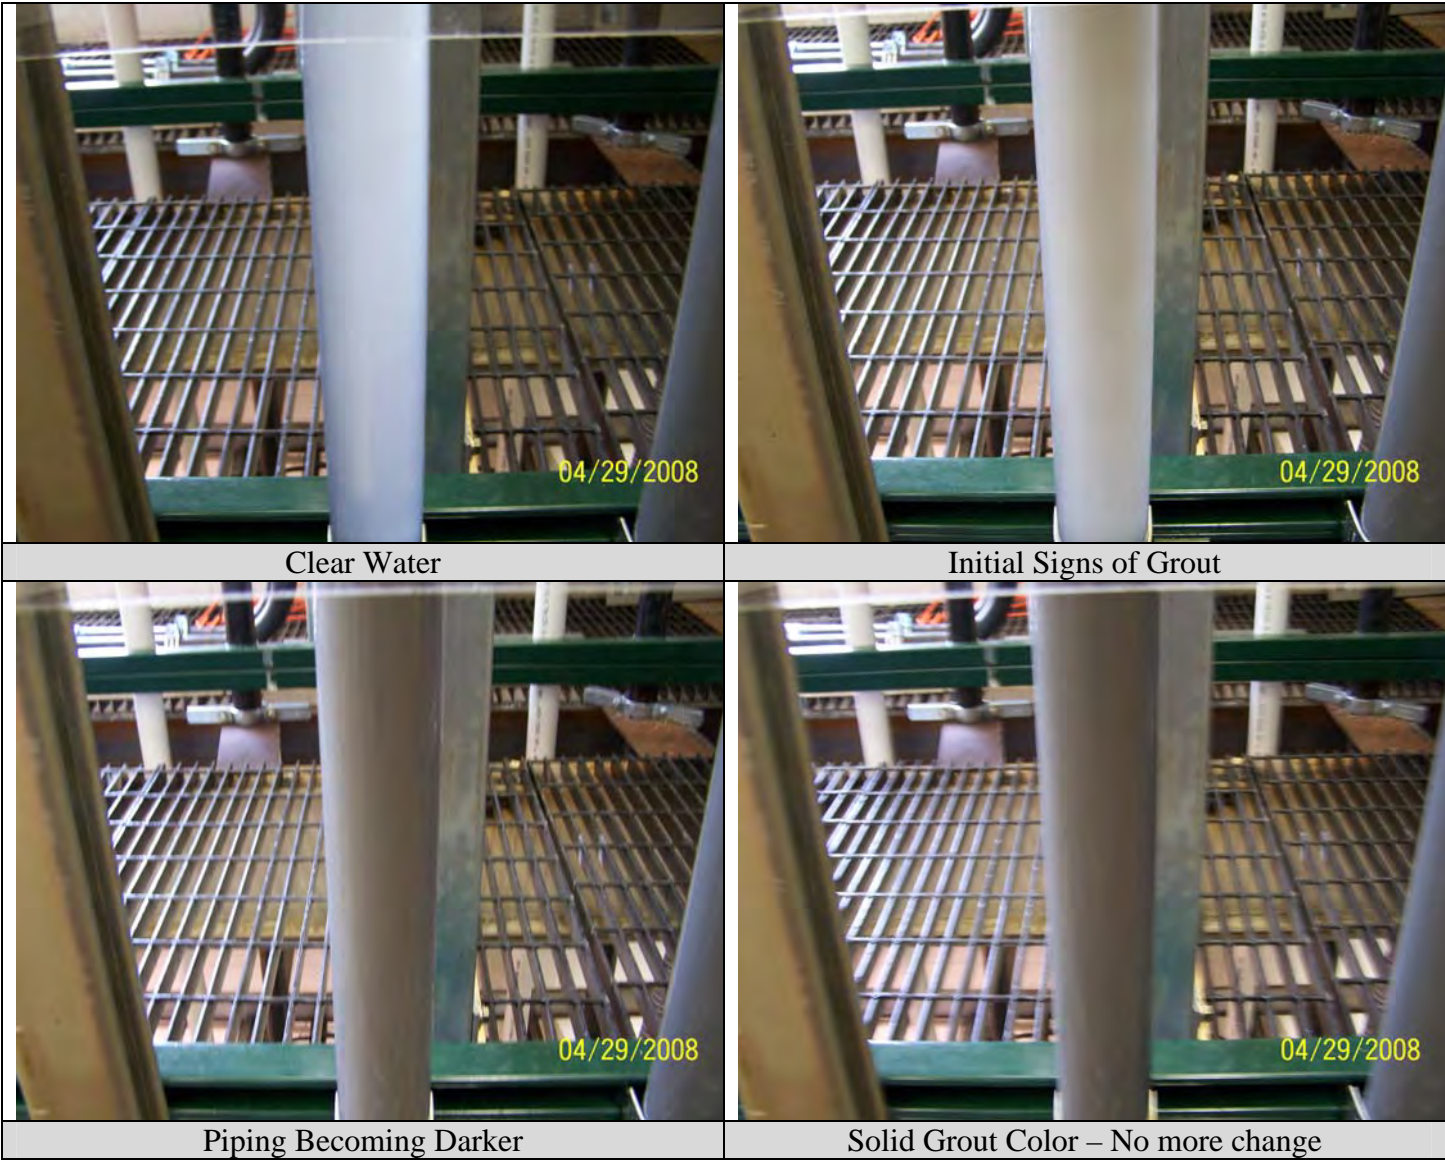
Figure 3-1 Water to Grout Transition in Vertical Cooling Coil Assembly

The water in the coils was displaced with the grout as shown in Figure 3-1 and the transition between the water to the grout took less than ten seconds, at which point there was no visual difference of the grout that followed. The pressure and flow data taken during the filling of the assembly are shown in Figure 3-2. The flow rate was initially targeted for five gpm during the run, but due to the initial visual observations of the grout entering the cooling coil supply header on the third floor, the flow was quickly increased to eight gpm and remained above six gpm for the remainder of the test. The decrease from eight to just above six gpm is due to the power demands for mixing and transporting the grout. The diesel motor, for a specified diesel speed, supplies a given quantity of power, which is shared by the two agitators and pump. As conditions change, such as mixing speed and hydraulic resistance due to filling the cooling coils, the flow rate will change. The flow rate was initially increased due to the grout undercutting the water at five gpm. This decision did cause some operational stress on the batching of the material in the GC-500-DH given that the batching time decreased from approximately 7.6 to 5.5 minutes. A reduction in mixing time yields a more viscous grout. The maximum flow rate was limited to two variables, the manual batching time and the required time for all of the grout to mix and become fluid. Miscellaneous pictures taken before, during and after the vertical cooling coil assembly run are provided in Reference 17.

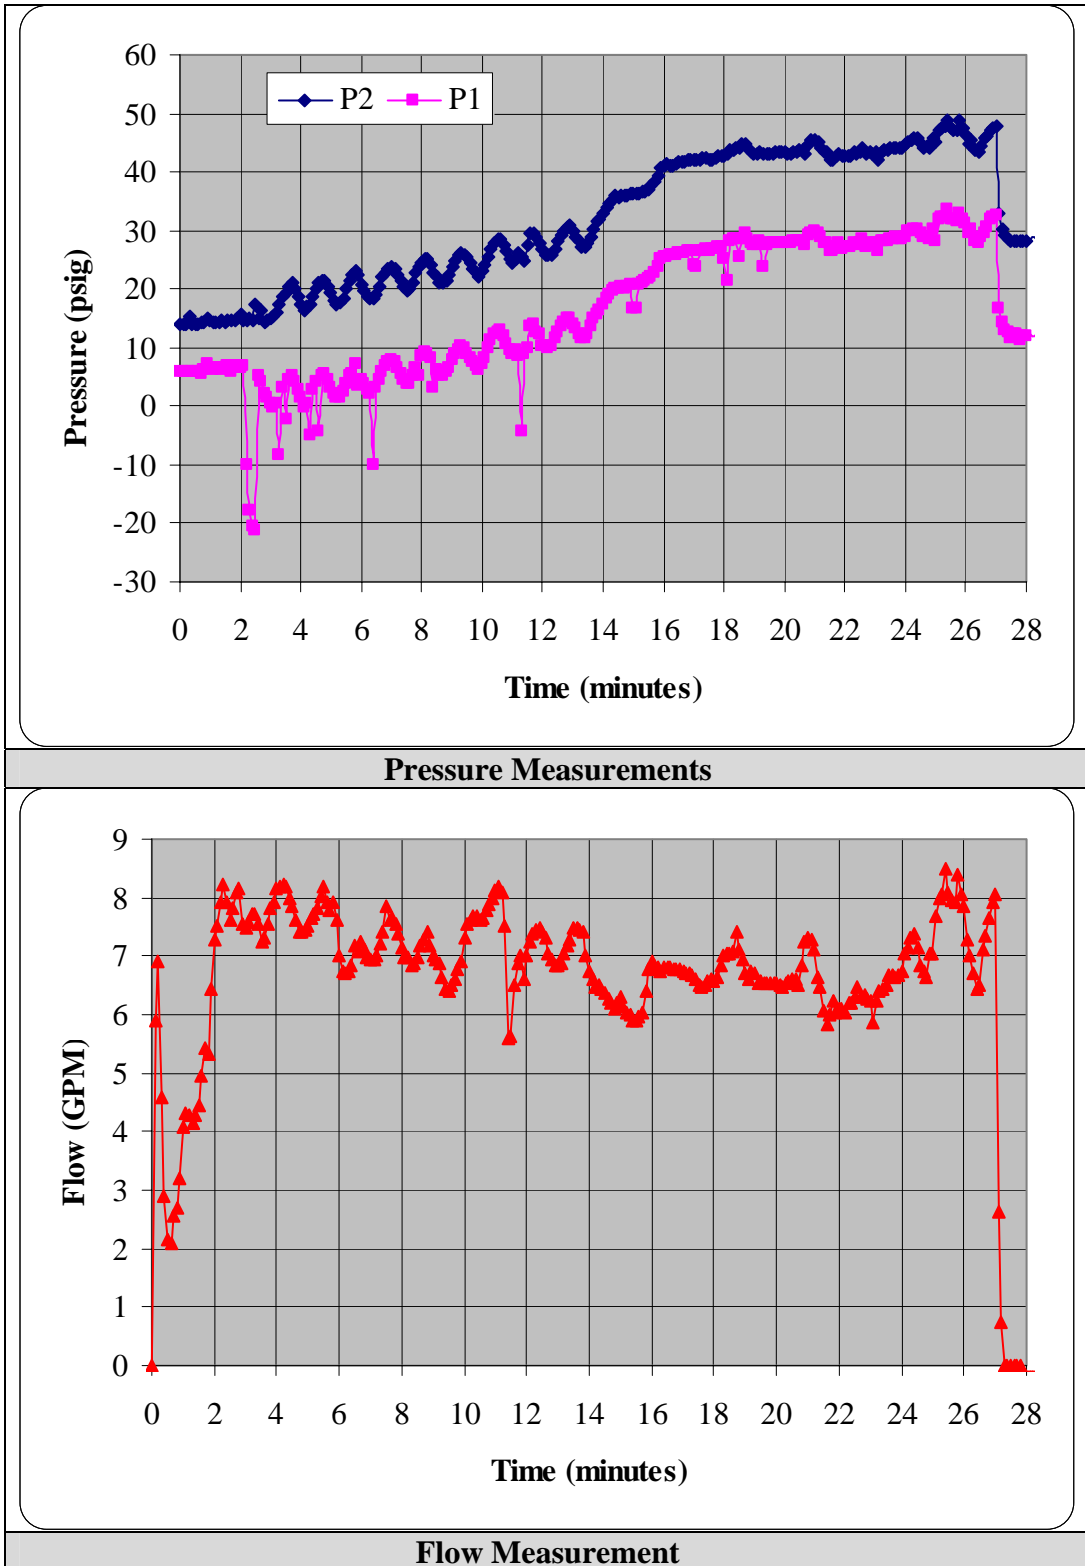
Figure 3-2 Vertical Cooling Coil Process Parameters

Review of the pressure data indicates that the pressure started to stabilize at around 19 minutes into the run, indicating that the cooling coils were filled with the batched grout. Flow cone measurements were made from the first and fifth batch. For the first batch, the sample was pulled after six minutes of mixing and the flow time was 26 seconds, which was within the acceptable range. The fifth batch had a flow time of 42 seconds, which was outside of the acceptable range; however, this sample was pulled too early from the batch (i.e., after only 1.5 minutes of mixing). Because this sample was pulled only 1.5 minutes after the solids were added to the mixing tank rather than after five minutes of mixing, clumps had not had sufficient time to break apart, which impacted the flow measurement. The contents in the tank were allowed to mix for approximately five minutes prior to being pumped to the assembly. The temperature of the grout being pumped into the assembly was 35°C.

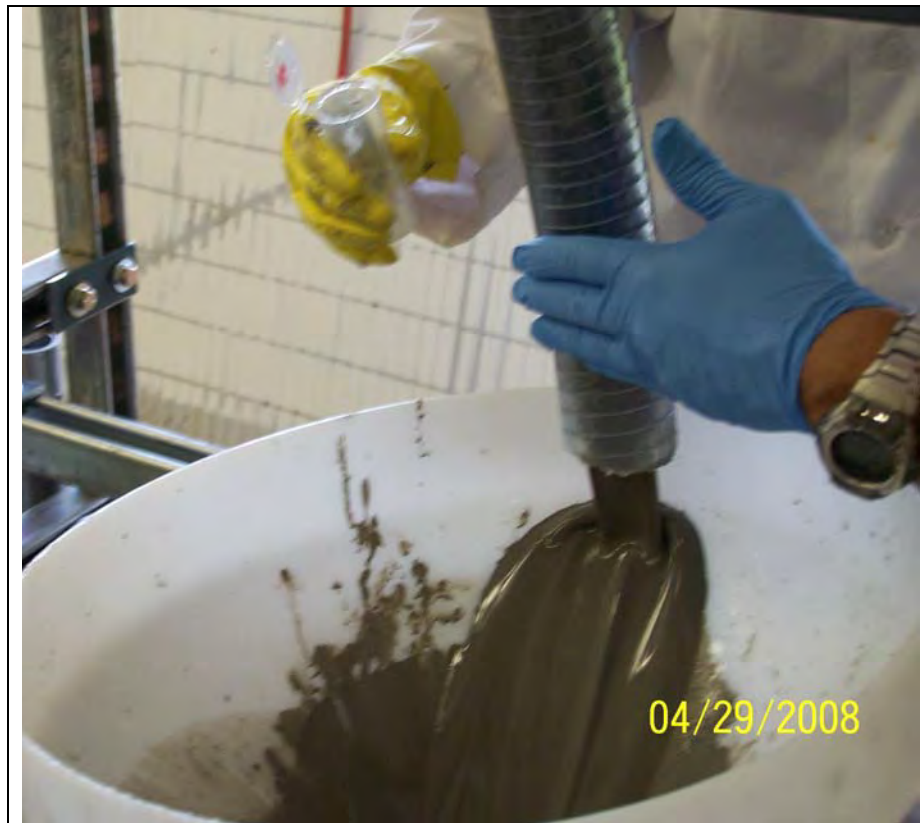
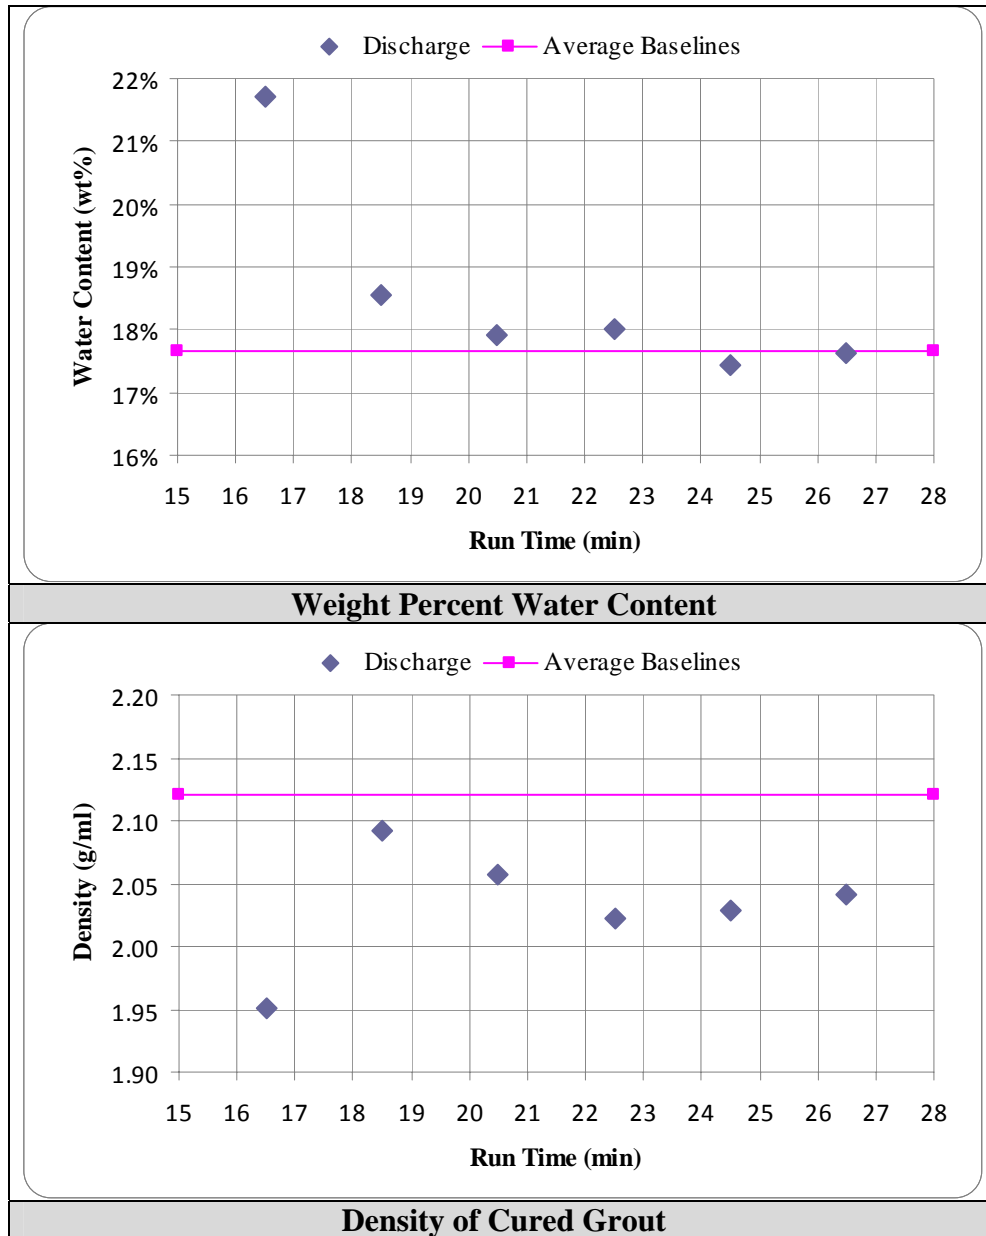
Sampling of the discharge occurred over a period of twelve minutes and resulted in thirteen samples being pulled. The grout discharging the cooling coil assembly is shown in Figure 3-3, just before a sample is about to be taken. Visually, the grout looked very smooth upon discharge. The water content and density of the cured grout samples are provided in Figure 3-4. The first sample ($t = 15.5$ minutes into the run) was not analyzed because it contained mostly water. The remaining discharge and baseline samples when cured did not have any bleed water. Based on the water content data, five minutes (total run time of 20.5 minutes) after the grout was first observed to be leaving the discharge of the assembly, the characteristics of the grout in the assembly matched those of the batched material. In essence, the mixing zone, given this pumping condition, required approximately 35 gallons of additional grout over that required to fill the cooling coil (cooling coil fill volume was approximately 125 gallons). This data compares well to that of the pressure data. The grout density data from bench scale testing is 2.07 g/ml [5]. The density data indicates that the samples, as well as the bench scale are similar, but all the discharge samples were lower in value than the baseline and bench samples, indicating that the discharge samples had slightly more entrained air or voids.

Figure 3-3 Typical Grout Discharging the Vertical Cooling Coil Assembly - Sampling

Figure 3-4 Physical Properties of Discharged Grout for the Vertical Cooling Coil Assembly

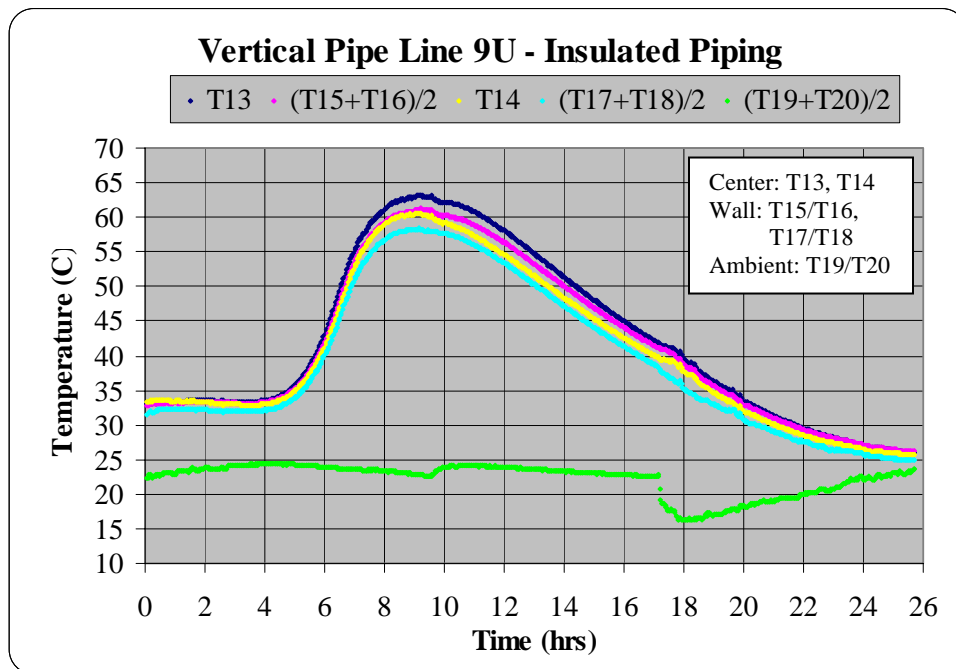
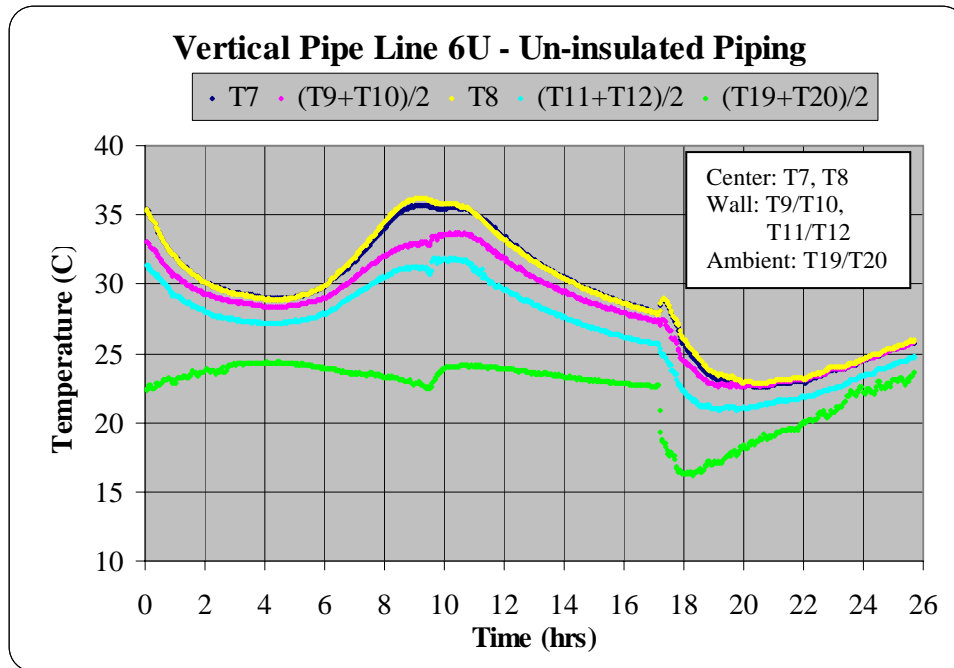
The temperatures of the curing grout, for the insulated piping sections are shown in Figure 3-5 and Figure 3-6 and the un-insulated piping sections are shown in Figure 3-7. These figures clearly show that if the piping is insulated (such as having cured grout around the pipe, although the heat transfer characteristics of the insulation is most likely not the same as the tank grout fill), then the heat of hydration will cause the temperature of the curing grout to be greater than that of an un-insulated pipe. The insulated pipe reached a maximum temperature of 65°C as compared to 35°C for the un-insulated pipe. The thermal properties of the curing grout, piping and final heat sink (grout or air) will determine the actual temperature increase. The maximum temperature for all conditions peaks around 9.5 hours after the cooling coil assembly was filled. This data compared well to the peak observed in the normalized heat flow [5]. At approximately

seventeen hours into the curing cycle, the ambient temperature dropped due to the opening of the high bay doors in the morning. There is active air motion in the location where the vertical cooling coil assembly was located. The ventilation system of the building maintains a fairly constant temperature at this location if the high bay doors are maintained closed.

- The maximum temperature of the curing grout peaked around 9.5 hours after the cooling coil assembly was filled. This data compared well to the peak observed in the normalized heat flow [5].

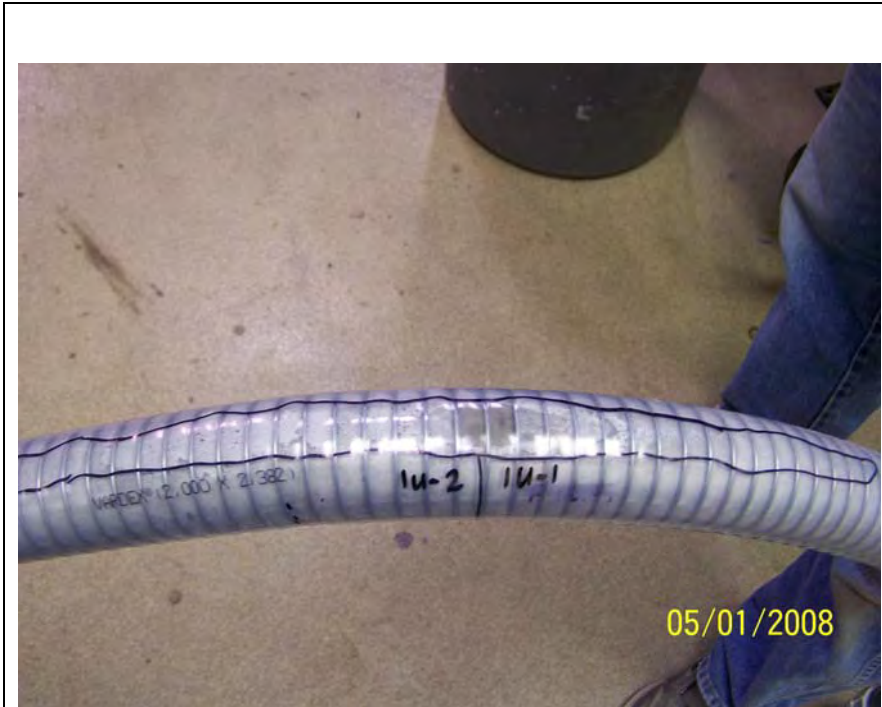
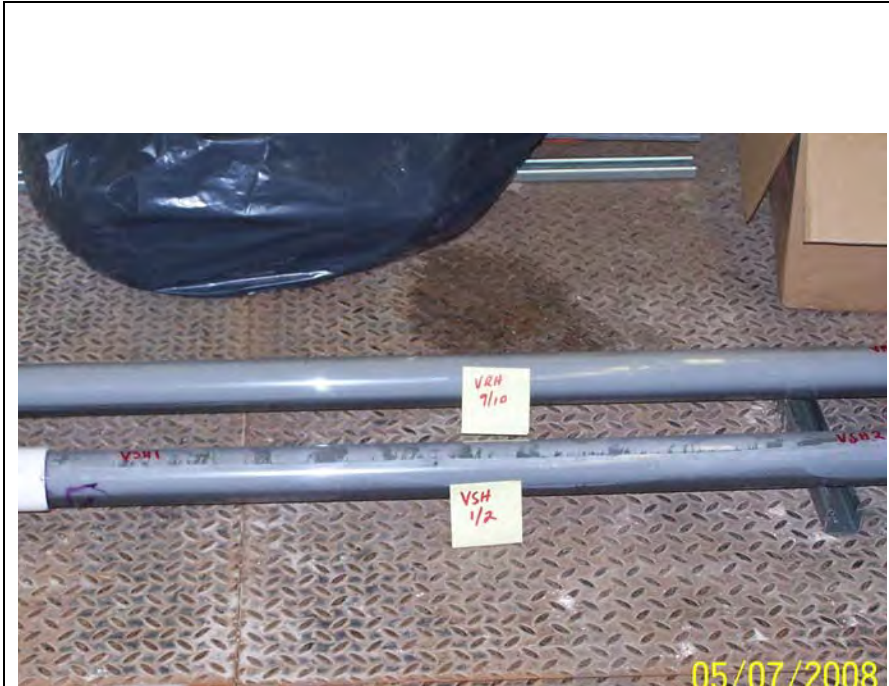
Air voids were present in all horizontal sections of piping. The voids were close to or exceeded the four volume percent in the horizontal supply line, see Figure 3-11. Voids were also present in the return headers and the 180° 2-foot radius bends at the top part of the cooling coils, see Figure 3-10 and Figure 3-11. In Figure 3-10 the 180° 2-foot radius bend is marked, showing a section where air bubbles were present, but the actual voided bubble length is approximately two to four inches of piping for this loop. The supply header seemed to contain a much larger upper void as compared to the other horizontal piping. The reason for this air is due to the mixing/pumping process employed and the supply header is the first section of horizontal piping, where large voids would displace themselves. The paths for air entrainment in this process (see Figure 3-12) are from air associated with the dry solids being mixed into a slurry, vigorous mixing in the mixing tank, discharging the grout onto the meshed grate at the hopper inlet, and the recirculation line returning a large fraction of the flow onto the meshed grate of the hopper inlet. Based on the experiences with the vertical cooling coil fill, the mixing/pumping process for the horizontal cooling coil assembly was changed to further minimize air entrainment. Additional pictures of the sectioned horizontal piping and 180° 2-foot radius bends for the vertical cooling coil assembly are provided in References 15 and 18.

Figure 3-10 Voids in the Upper Loops in the Vertical Cooling Coil Assembly

Figure 3-11 Voids in Horizontal Piping VSH1 in the Vertical Cooling Coil Assembly

- Filling of the vertical cooling coil assembly had all four of the air entrainment processing steps described above and this mode of operation is not recommended. Air gaps existed in the horizontally sections of piping that may have exceed four volume percent.

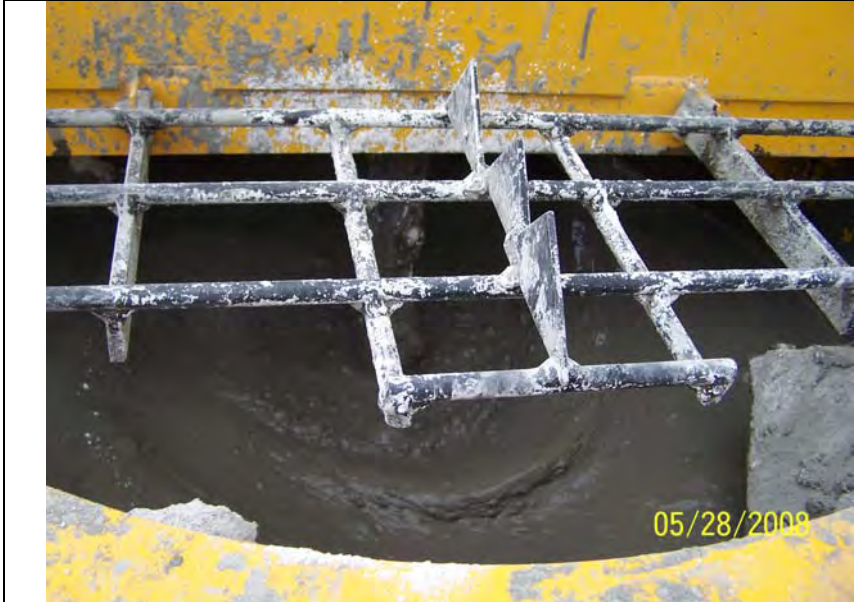
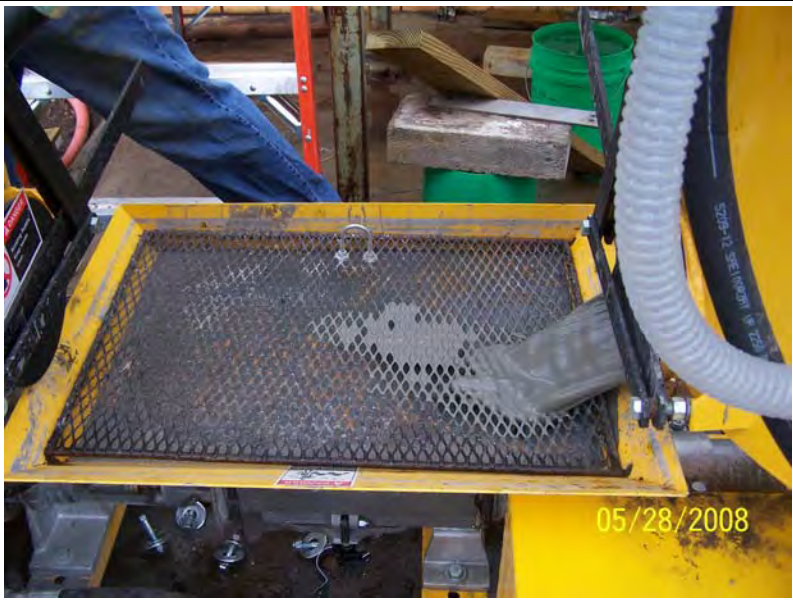
Figure 3-12 Process Locations that Lead to Air Entrainment

Mixer on GC-500-DH – Dry Solids to Slurry

Discharge of grout over pump section hopper grating

- A mixing system that can blend and process the quantity of material required to fill at least one or more assemblies should be considered. The mixing system should be designed to blend in the solids and to minimize air entrainment. To further remove entrained air in the grout, the tank could be placed under a vacuum. This would require additional testing to determine operating parameters. A minimum of six minutes of vigorous mixing is recommended for this grout to become flowable, after all the solids have been added. During pump down of this grout, recommend that the agitator be de-energized. If necessary, the tank could also be used to control the temperature of the batch.

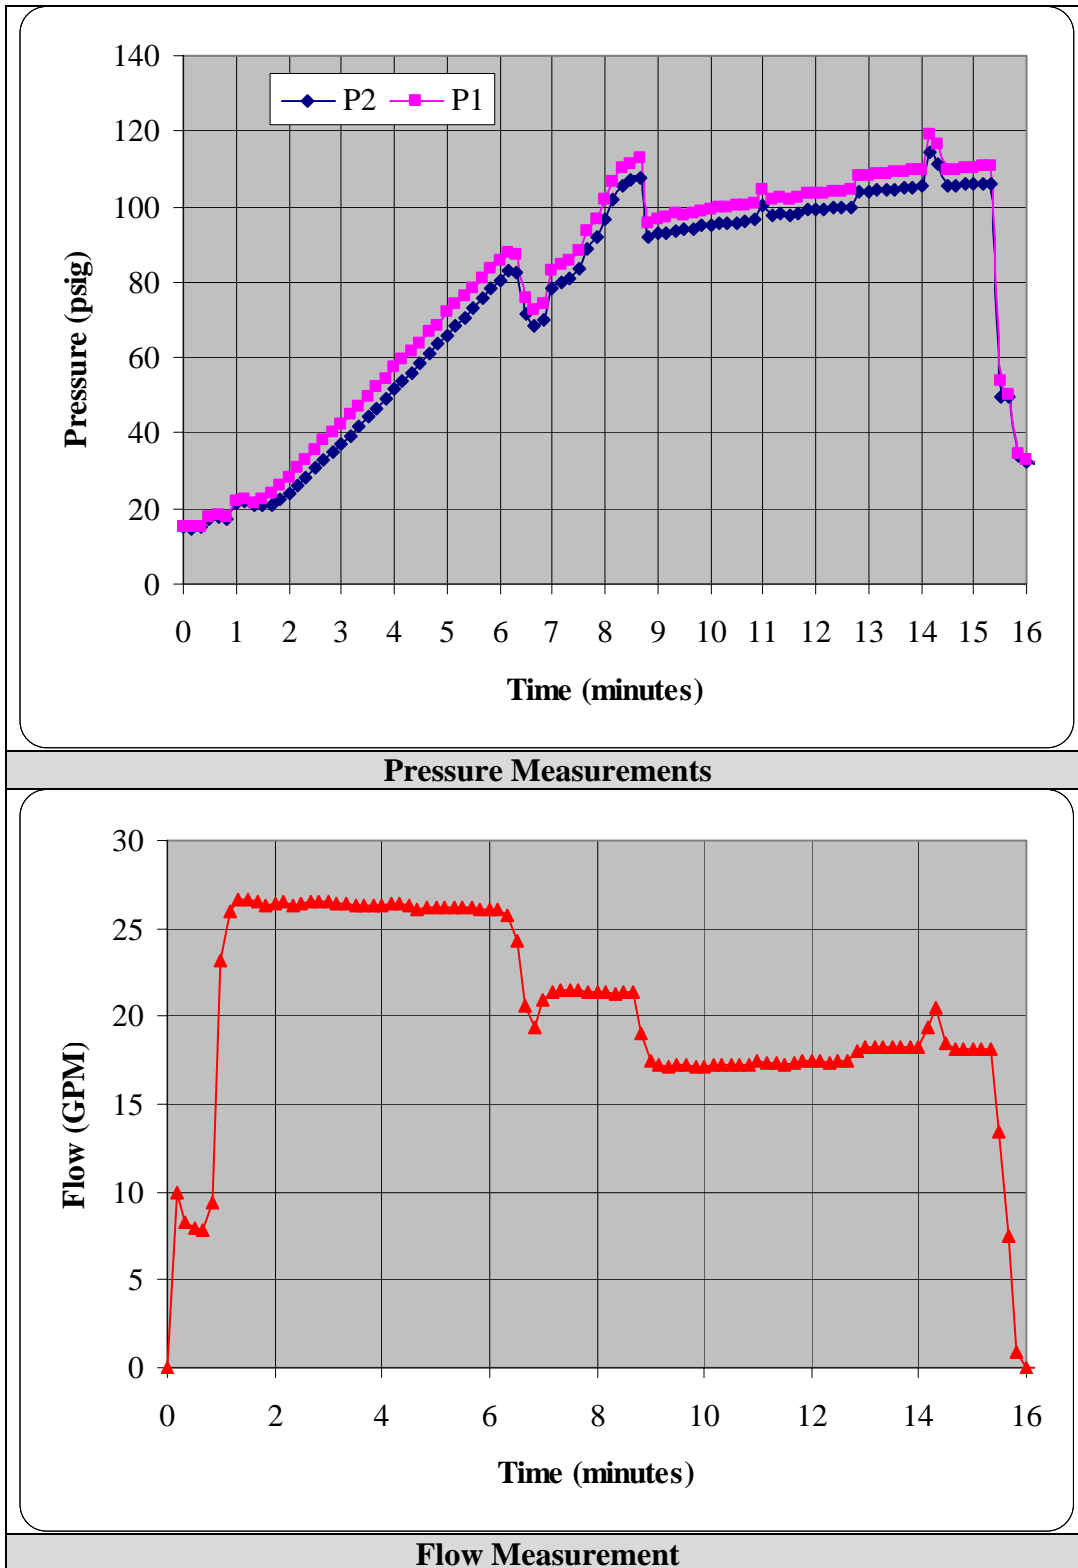
Figure 3-13 Horizontal Cooling Coil Assembly Process Parameters

The operational data, pressure and flow, during the filling of the assembly are shown in Figure 3-13. The flow rate was initially targeted for 20 gpm, but the operator ran the process at higher rate of approximately 26 gpm. A review of the pressure data indicates that it started to stabilize at between nine to eleven minutes into the run, indicating that the cooling coils were filled with the batched grout. The maximum pressure at the cooling coil assembly located outside was approximately 120 psig, which was below the design pressure of the Type I SRS cooling coils. The pump discharge pressure gage reached a maximum of 168 psig at approximately the same time the 120 psig was observed in the cooling coil assembly. The temperature of the grout being pumped into the assembly was 38°C. The flow measurement was taken seven minutes after the contents in the 500 gallon tank began to be pumped out and the flow time was 24 seconds, which was within the acceptable flow time for this grout.

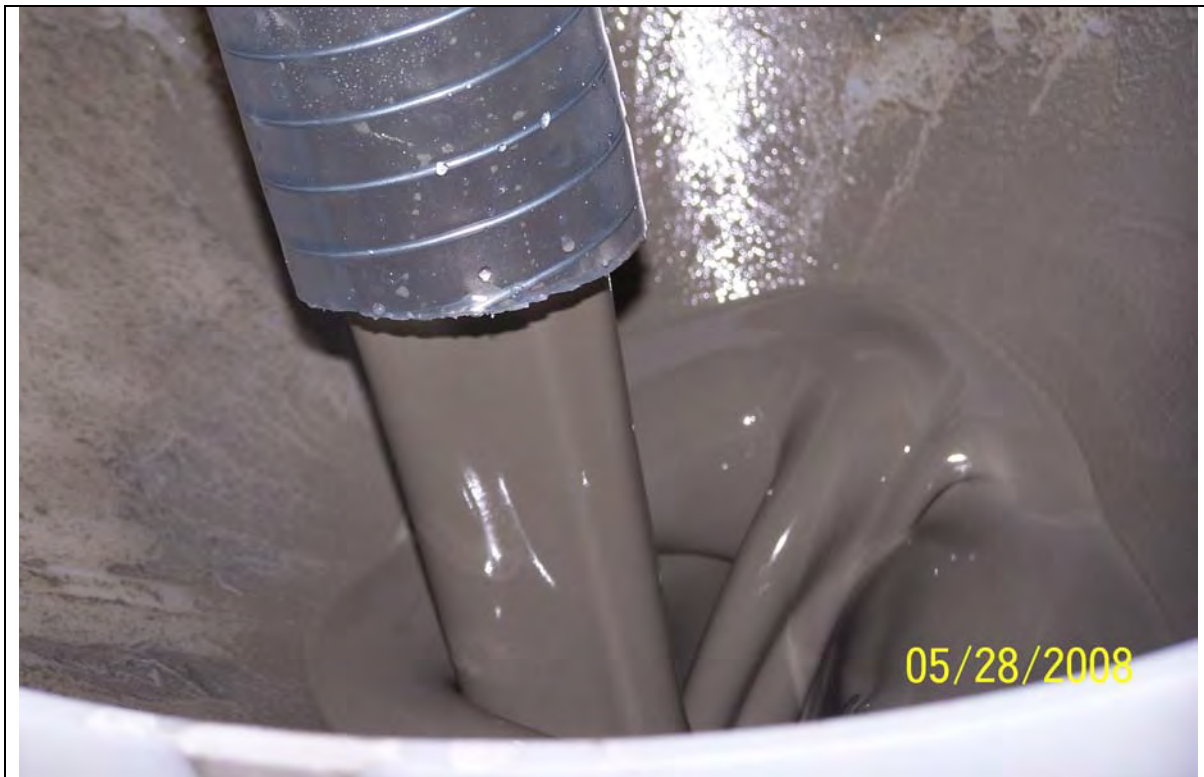
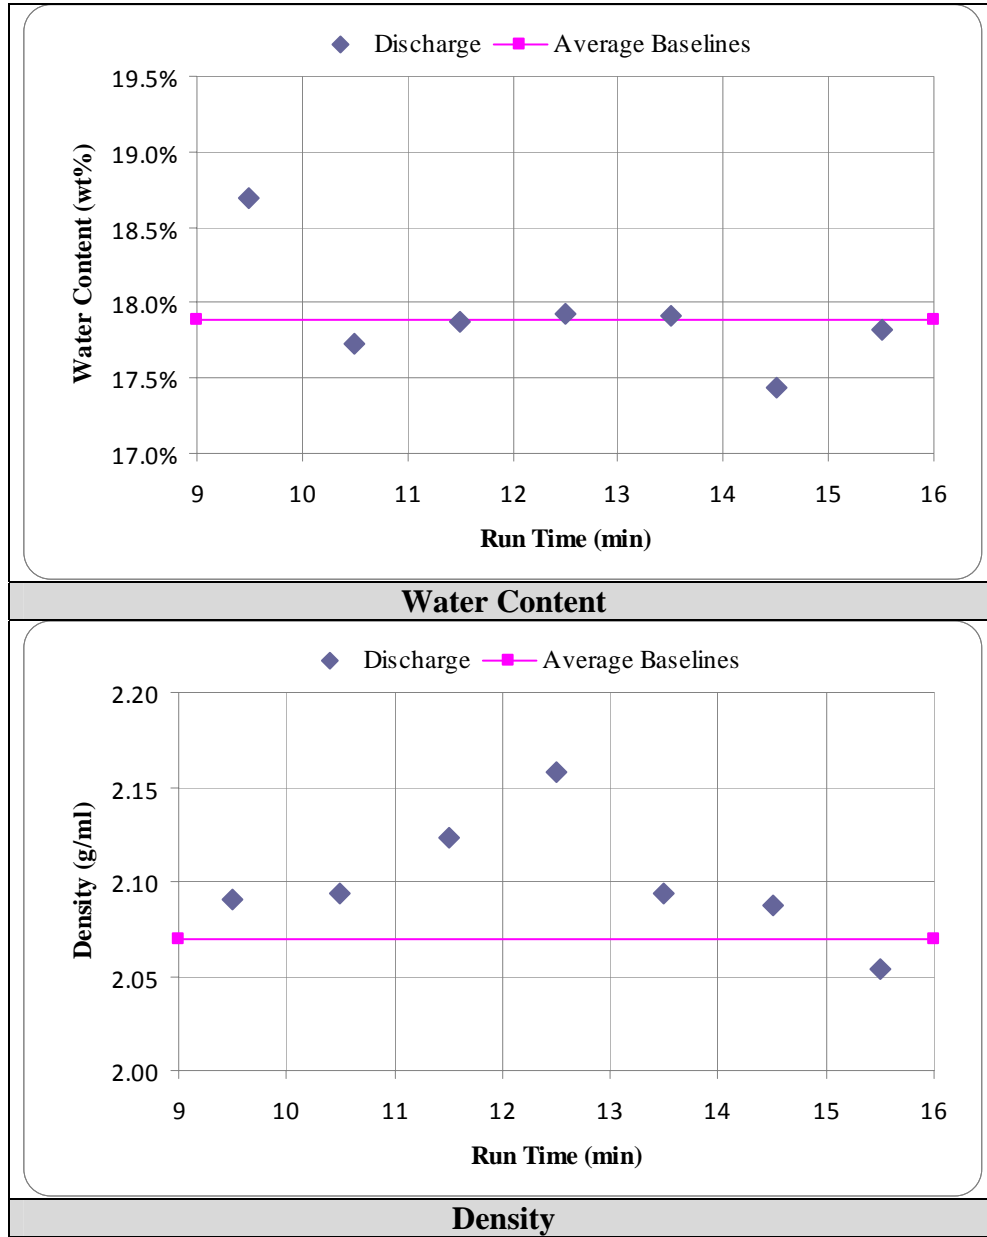
Sampling of the discharge occurred over a period of 7.5 minutes, resulting in sixteen samples. The grout discharging the cooling coil assembly is shown in Figure 3-14. Visually, the grout looked very smooth and consistent throughout the run, after the first sample had been pulled. The water content and density of the cured grout are provided in Figure 3-15. The first sample ($t =$ nine minutes into the run) was not analyzed because it contained mostly water. The remaining discharged and baseline samples when cured did not have any bleed water. Based on the water content data, 1.5 minutes (total run time of 10.5 minutes) after the grout was first observed to be leaving the discharge of the assembly, the grout in the assembly contained that of the batched material. In essence, the mixing zone, given this pumping condition, coincidentally required approximately 35 gallons of additional grout over that of the grout required to fill the cooling coil assembly (total assembly volume was approximately 200 gallons). This quantity of grout compares exactly to the vertical cooling coil assembly, though the flow rates and piping configurations are very different. The actual mixing zone for the horizontal cooling coil assembly is smaller than that of the vertical cooling coil assembly, since the volume of grout in the horizontal cooling assembly is much greater than that of the vertical cooling coil assembly. The velocity of the grout most likely had an influence on the mixing zone, but is not quantified in this report. All of the discharge sample densities, except for the last sample, were greater than the baseline density. All of the grout densities, except the last discharge sample, from this test exceeded the bench scale test density of 2.07 g/ml [5], which indicates that the discharge samples contained less air than either the bench scale or baseline densities.

Figure 3-14 Typical Grout Discharging the Horizontal Cooling Coil Assembly

Figure 3-15 Physical Properties of Discharged Grout for the Horizontal Cooling Coil Assembly
