**CLOSURE OF HLW TANKS – PHASE 2
FULL SCALE COOLING COILS GROUT FILL
DEMONSTRATIONS**

E. K. Hansen and A. D. Cozzi

Savannah River National Laboratory

June 2008

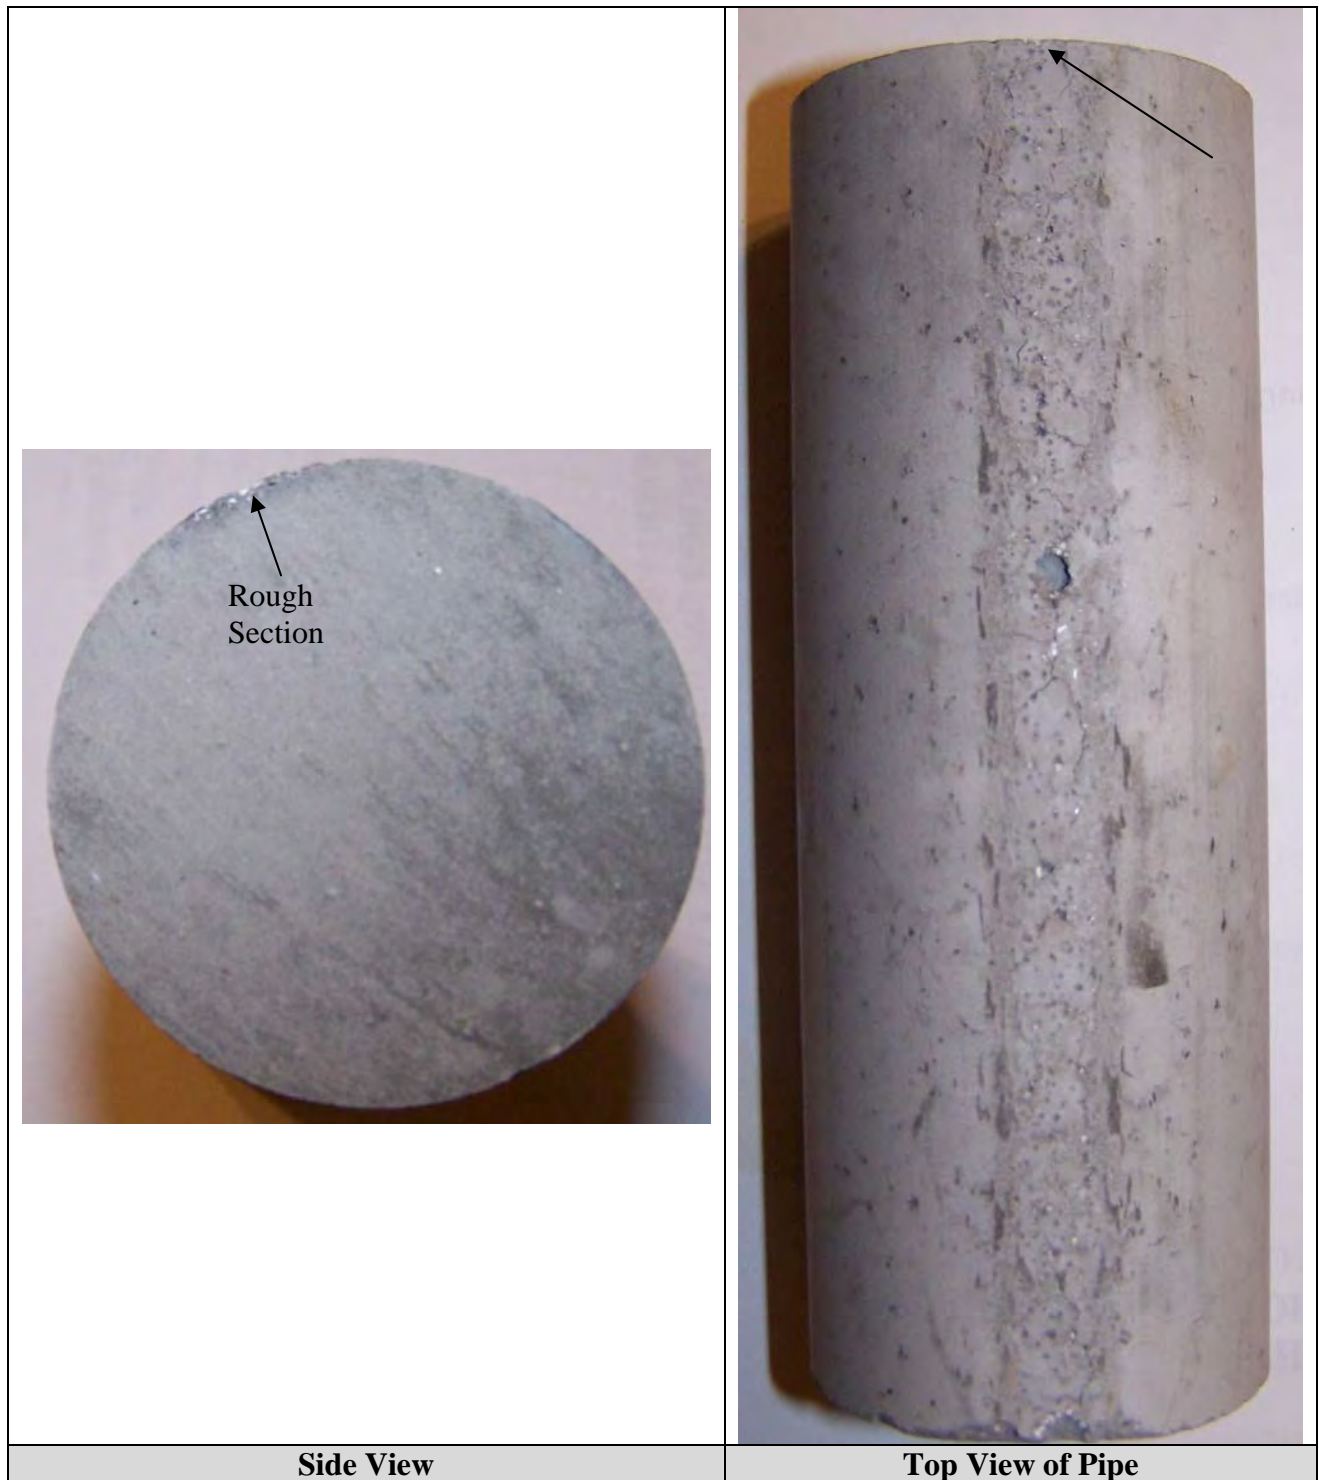
Sectioning of various locations in the vertical runs showed them to be filled completely with grout and with hardly any noticeable air voids. Examples of these vertical sections are shown in Figure 3-16 and Figure 3-17. Upon filling of the horizontal sections of piping, visual observations were made using the sections of transparent piping and there were no observable air voids on top of the lines. Visual observations were made the next morning and they showed that the air in the grout had traveled to the tops of the horizontal piping. The ability for the air to move upward leads one to conclude that this grout did not set immediately. For the horizontal runs in the outside assembly, over 99% of the sectioned locations were observed to be solid in nature, as shown in Figure 3-18 and Figure 3-19. Upon closer inspection, one can see a very

small rough area, much less than four volume percent in each of these photographs. The rough areas are located on the outer diameter and on the top of the pipe. Figure 3-20 is a piece of cured grout that was extruded from the pipe to expose the top surface of the grout and a cross section was cut to examine the rough area. This piece of grout also contained a visible void, that if cut, would have looked like what is in Figure 3-21. Figure 3-20 is typical of how the top surface of the grout looked in the horizontal sections of piping and is fairly uniform. In Figure 3-21, there is a large and small void. A walk down of the 380 feet of transparent piping yielded four large type voids approximately 1.25 inches long and 28 small voids 0.25 to 0.5 inches long. Assuming the voids have the longest lengths for their size, the length of the voids add up to 19 inches, which is less than 0.5% of the length of transparent piping. Additional photographs of the sectioned cured grout in the horizontal cooling coil assembly can be found in Reference 11.

- After filling the horizontal cooling coil assembly, there were no observable air voids in the horizontal sections of piping. Observations of the horizontal lines the day after filling showed air in the top sections of the horizontal piping, which indicated that the grout does not cure quickly during field conditions.

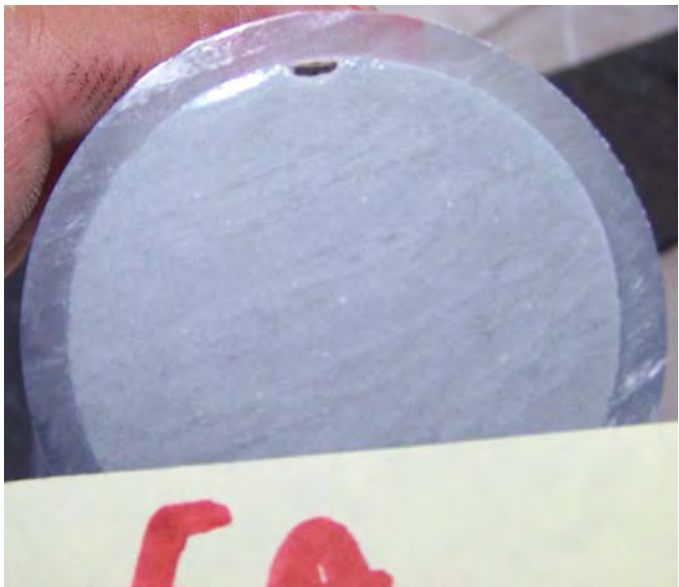
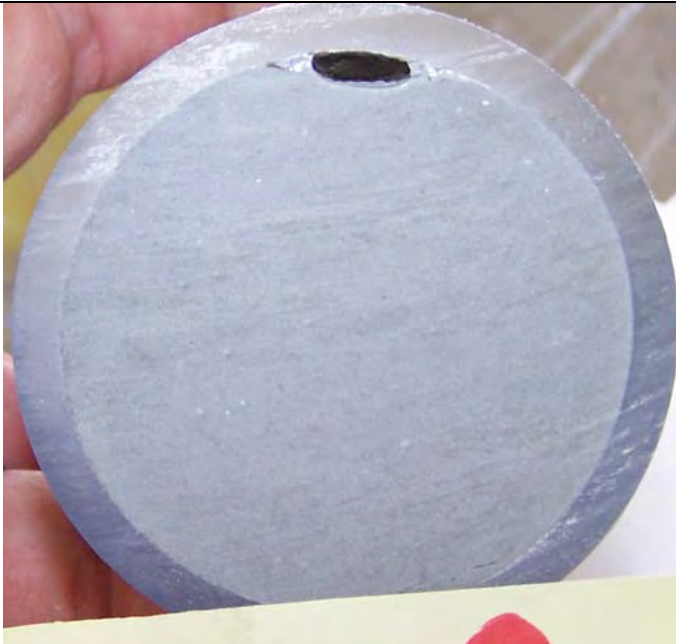
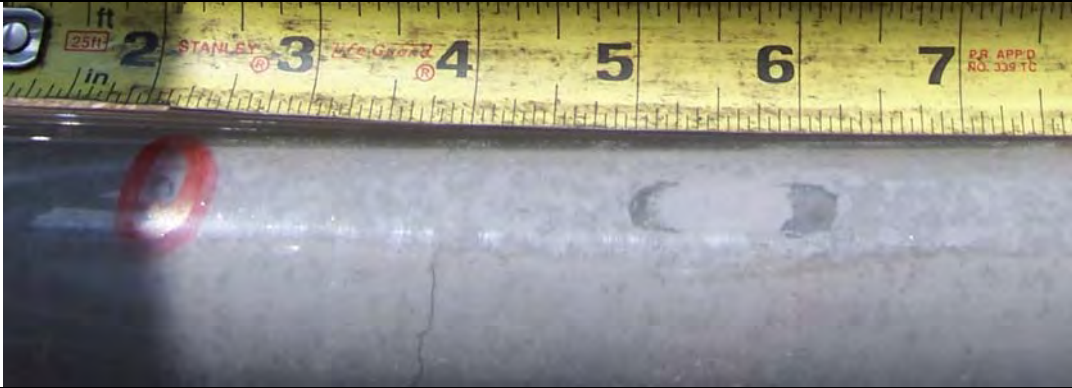
Figure 3-21 Sectioned 5A Horizontal Piping – Horizontal Cooling Coil Assembly

5A – Small Hole – Cut off center

5A – Large Hole – Cut off center

5A – Top View of Pipe, small hole on left, large hole on right
