SUBJECT: NRC OBSERVATIONAL SITE VISIT AT THE MAYBELL, COLORADO  
DISPOSAL SITE

Report: WM-00069/13-001

Facility: Maybell Disposal Site

## NRC Trip Report

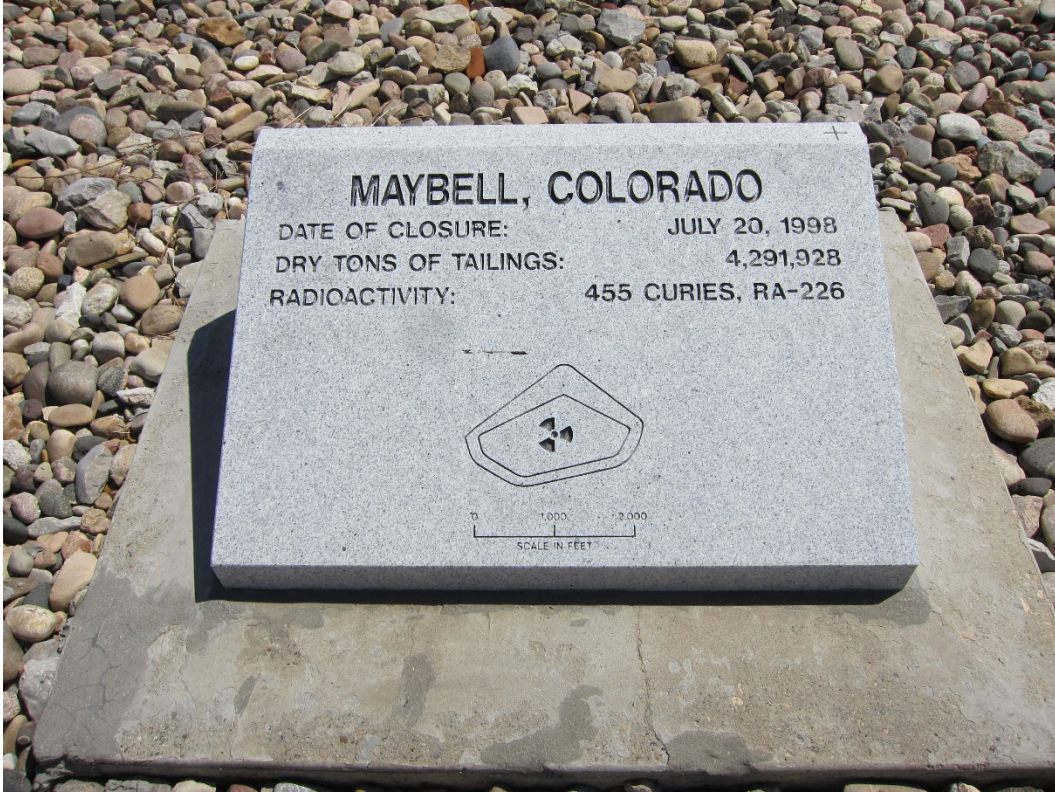
Figure 1: Site marker SMK-2 located at crest of the Maybell disposal cell

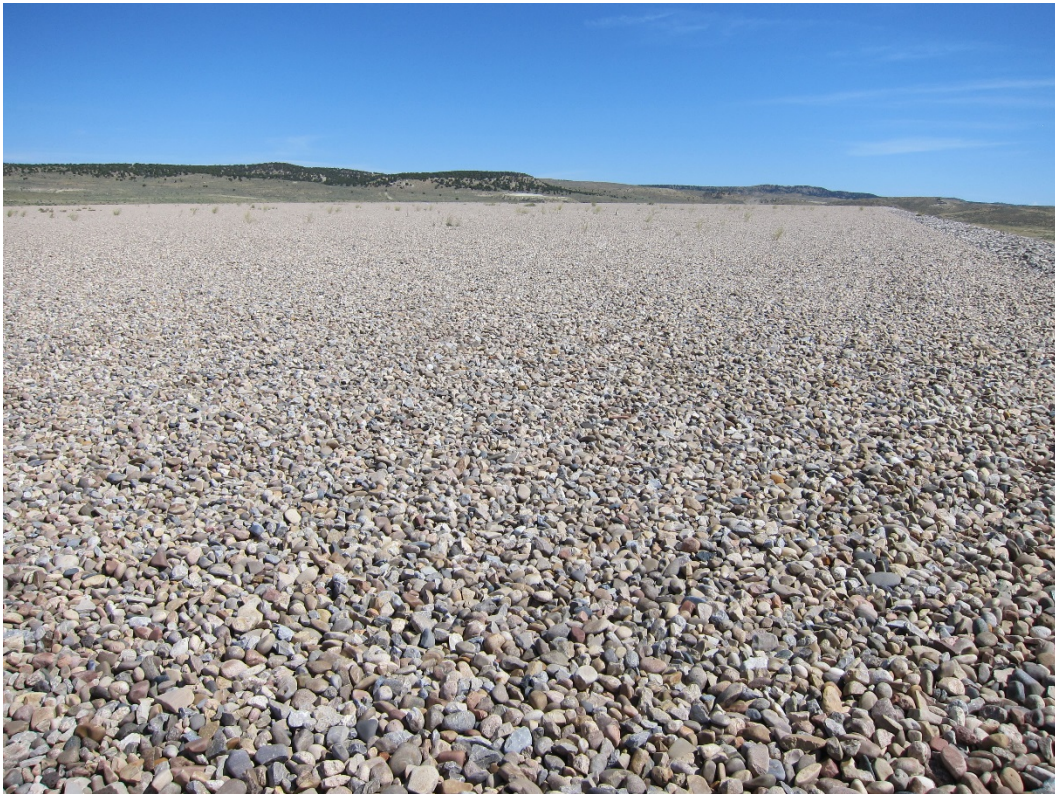
The DOE inspectors checked the disposal cell for evidence of erosion, settlement, slumping, displacement, and any other feature that would require maintenance or repair. The rock surfaces on the top and side slopes were found to be in excellent condition. Some minor vegetation was observed on the disposal cell, but this vegetation did not appear to impact the cell cover. No deep-rooted plants were observed on or around the disposal cell. Two slight depressions were noted on top of the cell during 2008, but these depressions have not been identified during subsequent site inspections. These depressions were attributed to inconsistencies in cell construction and not settlement.

Figure 2: Top of Maybell disposal cell (looking north)

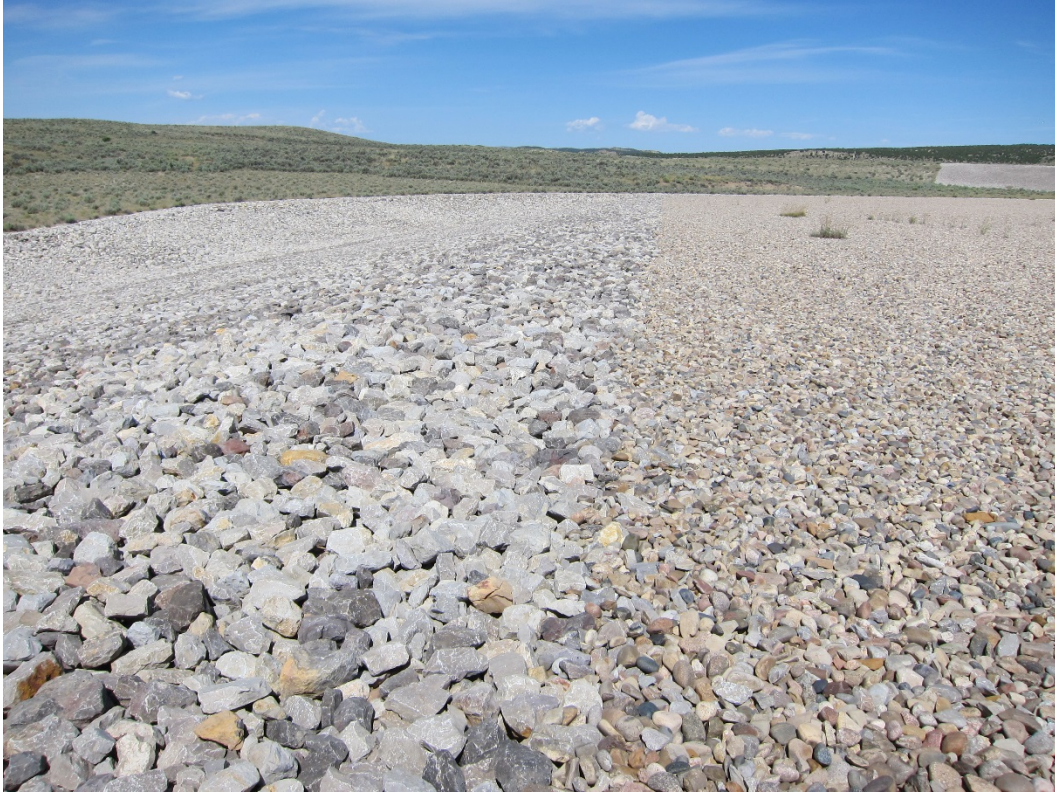
Figure 3: Diversion channel (left) and top of cell (right); southwest side of cell

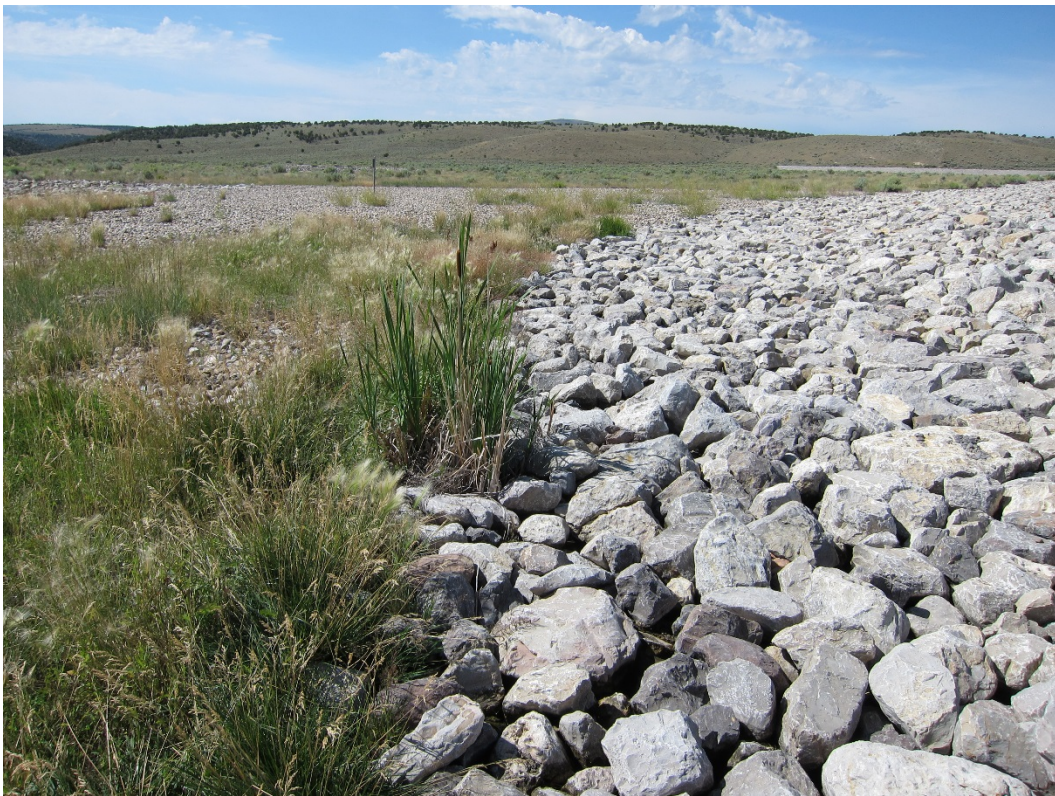
No seeps were identified in the eastern or southeastern portions of the disposal cell. Standing water was observed in the eastern apron of the disposal cell, but the DOE inspectors noted that the water appeared to be standing rainwater versus tailings seepage. As noted below, the NRC inspector conducted a radiological survey during the observational site visit. The ambient gamma radiation levels measured in the eastern and southeastern areas were indistinguishable from background levels, suggesting that the standing water appeared to be rainwater and not seepage from the cell.

Figure 4: Vegetation near standing water in apron at eastern tip of cell
