REPORT OF GEOLOGIC AND FAULT  
RECONNAISSANCE

VICINITY OF OCEANSIDE,  
CALIFORNIA

Project No. 70-054-EG  
April 6, 1972

FUGRO, Inc.

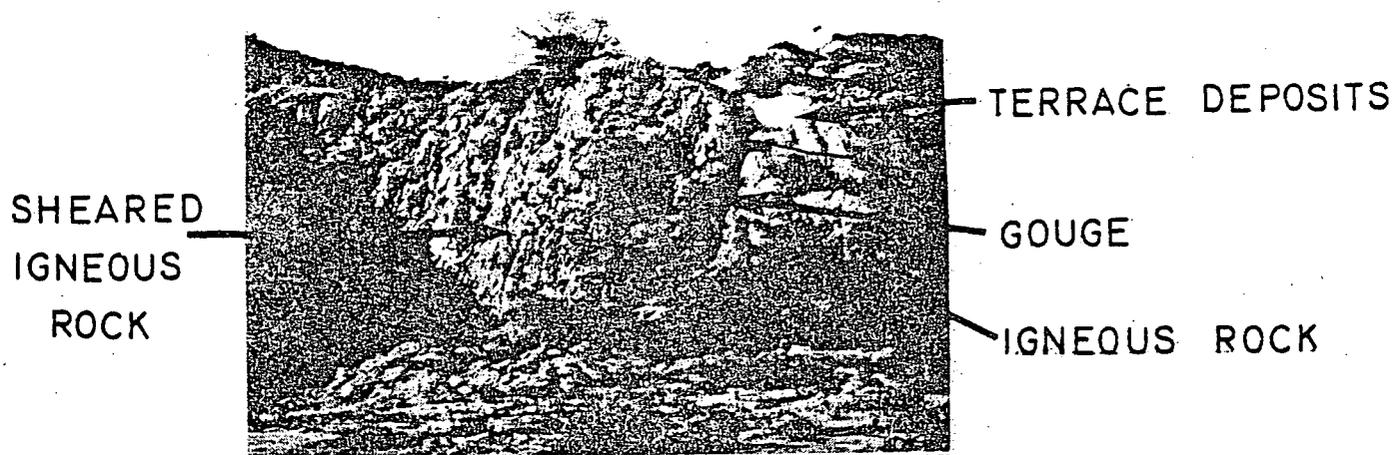
FIGURE 1

The northern exposure defines a 17-foot thick shear zone with gouge on the eastern portion of the zone, in the igneous rock. In the upper part of the exposure Quaternary river terrace sands and gravels are deposited over igneous rock and against the eastern limits of the sheared section (Plate 3, Fig. 1). Gouge is found between the lower portion of the terrace deposits and the fractured igneous rock (Plate 3,

Location 3 : North Side of Quarry

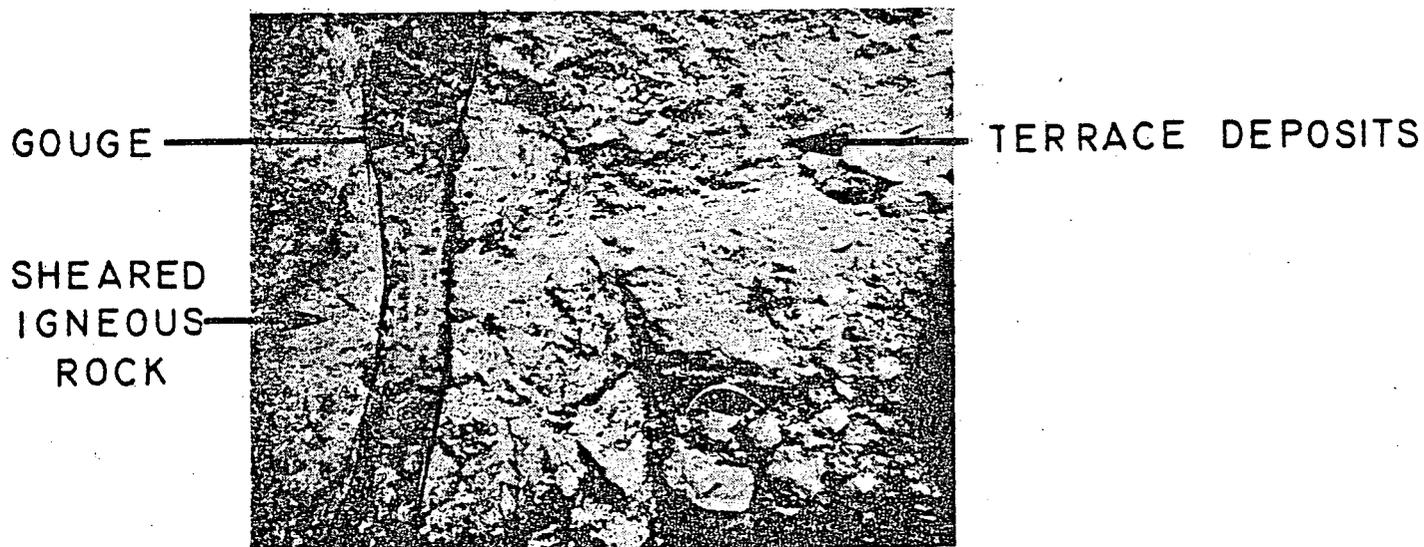
FIGURE 2

Fig. 2). The long axes of some of the gravels adjacent to the igneous/terrace contact and above the gouge, are found in a vertical rather than a horizontal orientation. In the southern exposure the sheared igneous rock and gouge material can be seen. However, no terrace deposits were found. The attitude of the shearing in both exposures is N 10° E, 84° W.

Location 3 : North Side of Quarry

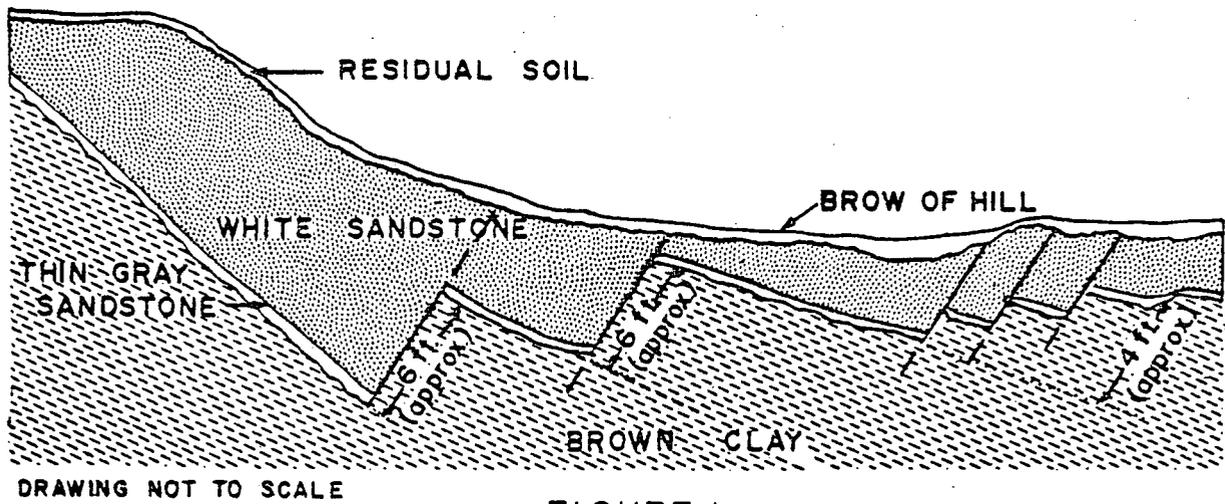
FIGURE 1

4. In this outcrop in the vicinity of the Supply Depot, sandstones and clays of the Eocene, La Jolla Formation are possibly faulted (Plate 4, Fig. 1). A thin gouge-like material was found along the supposed fault planes. The attitude of the fault planes is N 10° E, 85° W.

Location 4: Possible Faulted Sandstone and Clay of the La Jolla Formation.

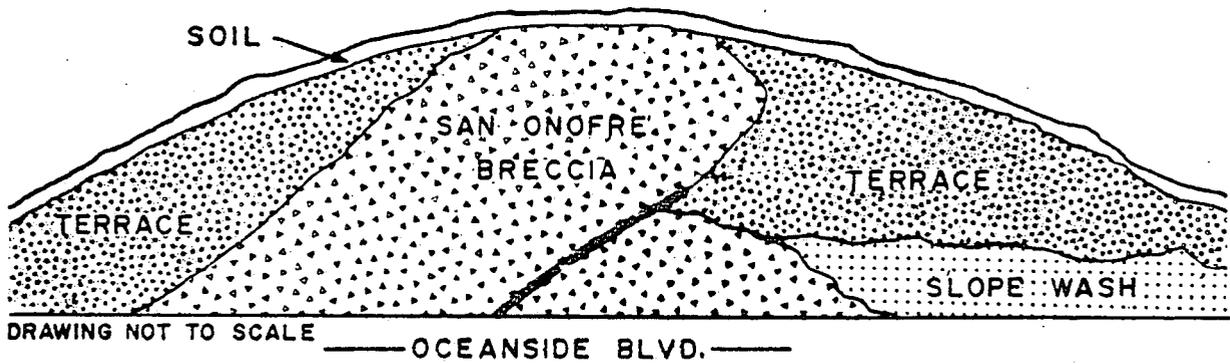
FIGURE 2

7. In a south-facing cut to develop the road alignment for Oceanside Boulevard, middle Miocene San Onofre Breccia is in contact with probable younger marine terrace deposits (Plate 4, Fig. 2). The strike of this contact plane is  $N 5^{\circ} E$  and dips moderately to the west. The geometry of this outcrop can be explained by a geologic interpretation; where the San Onofre Breccia was faulted before or during deposition of the probable younger marine terrace materials.

Location 7: Contact of San Onofre Breccia and Probable Terrace

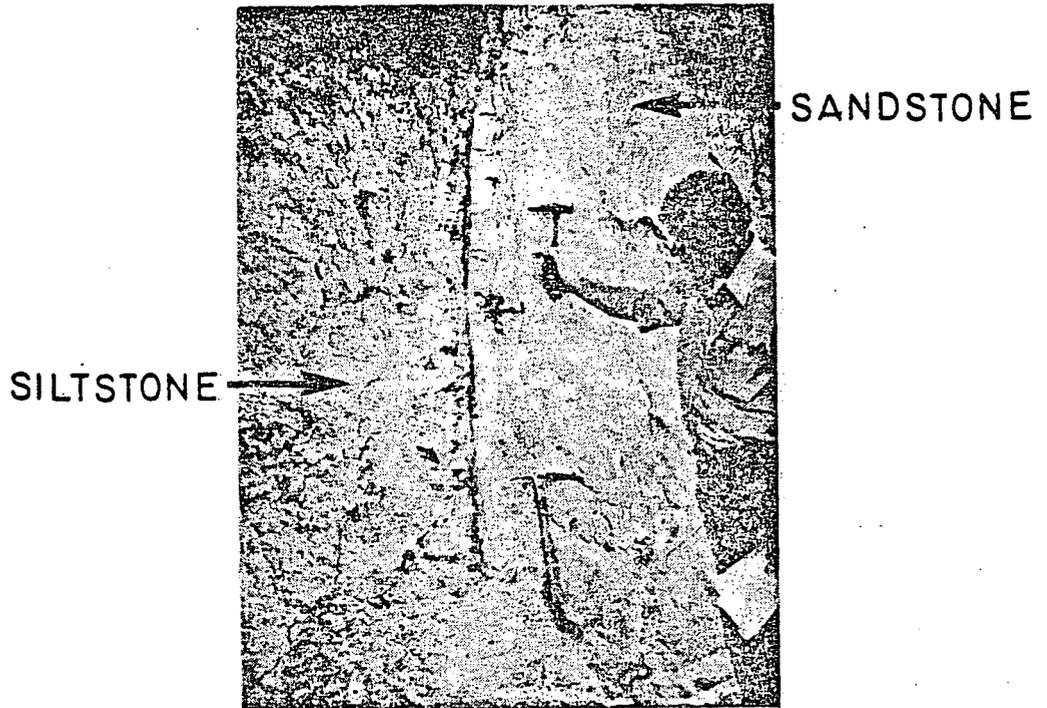
FIGURE 1

9. In a north facing outcrop in Rattlesnake Canyon a siltstone is in fault contact with a sandstone (Plate 5, Fig. 1). The faulted units are within the La Jolla Formation. Direction of movement and amount of displacement were not determined during this inspection.

Location 9 : Fault Contact of Siltstone  
and Sandstone

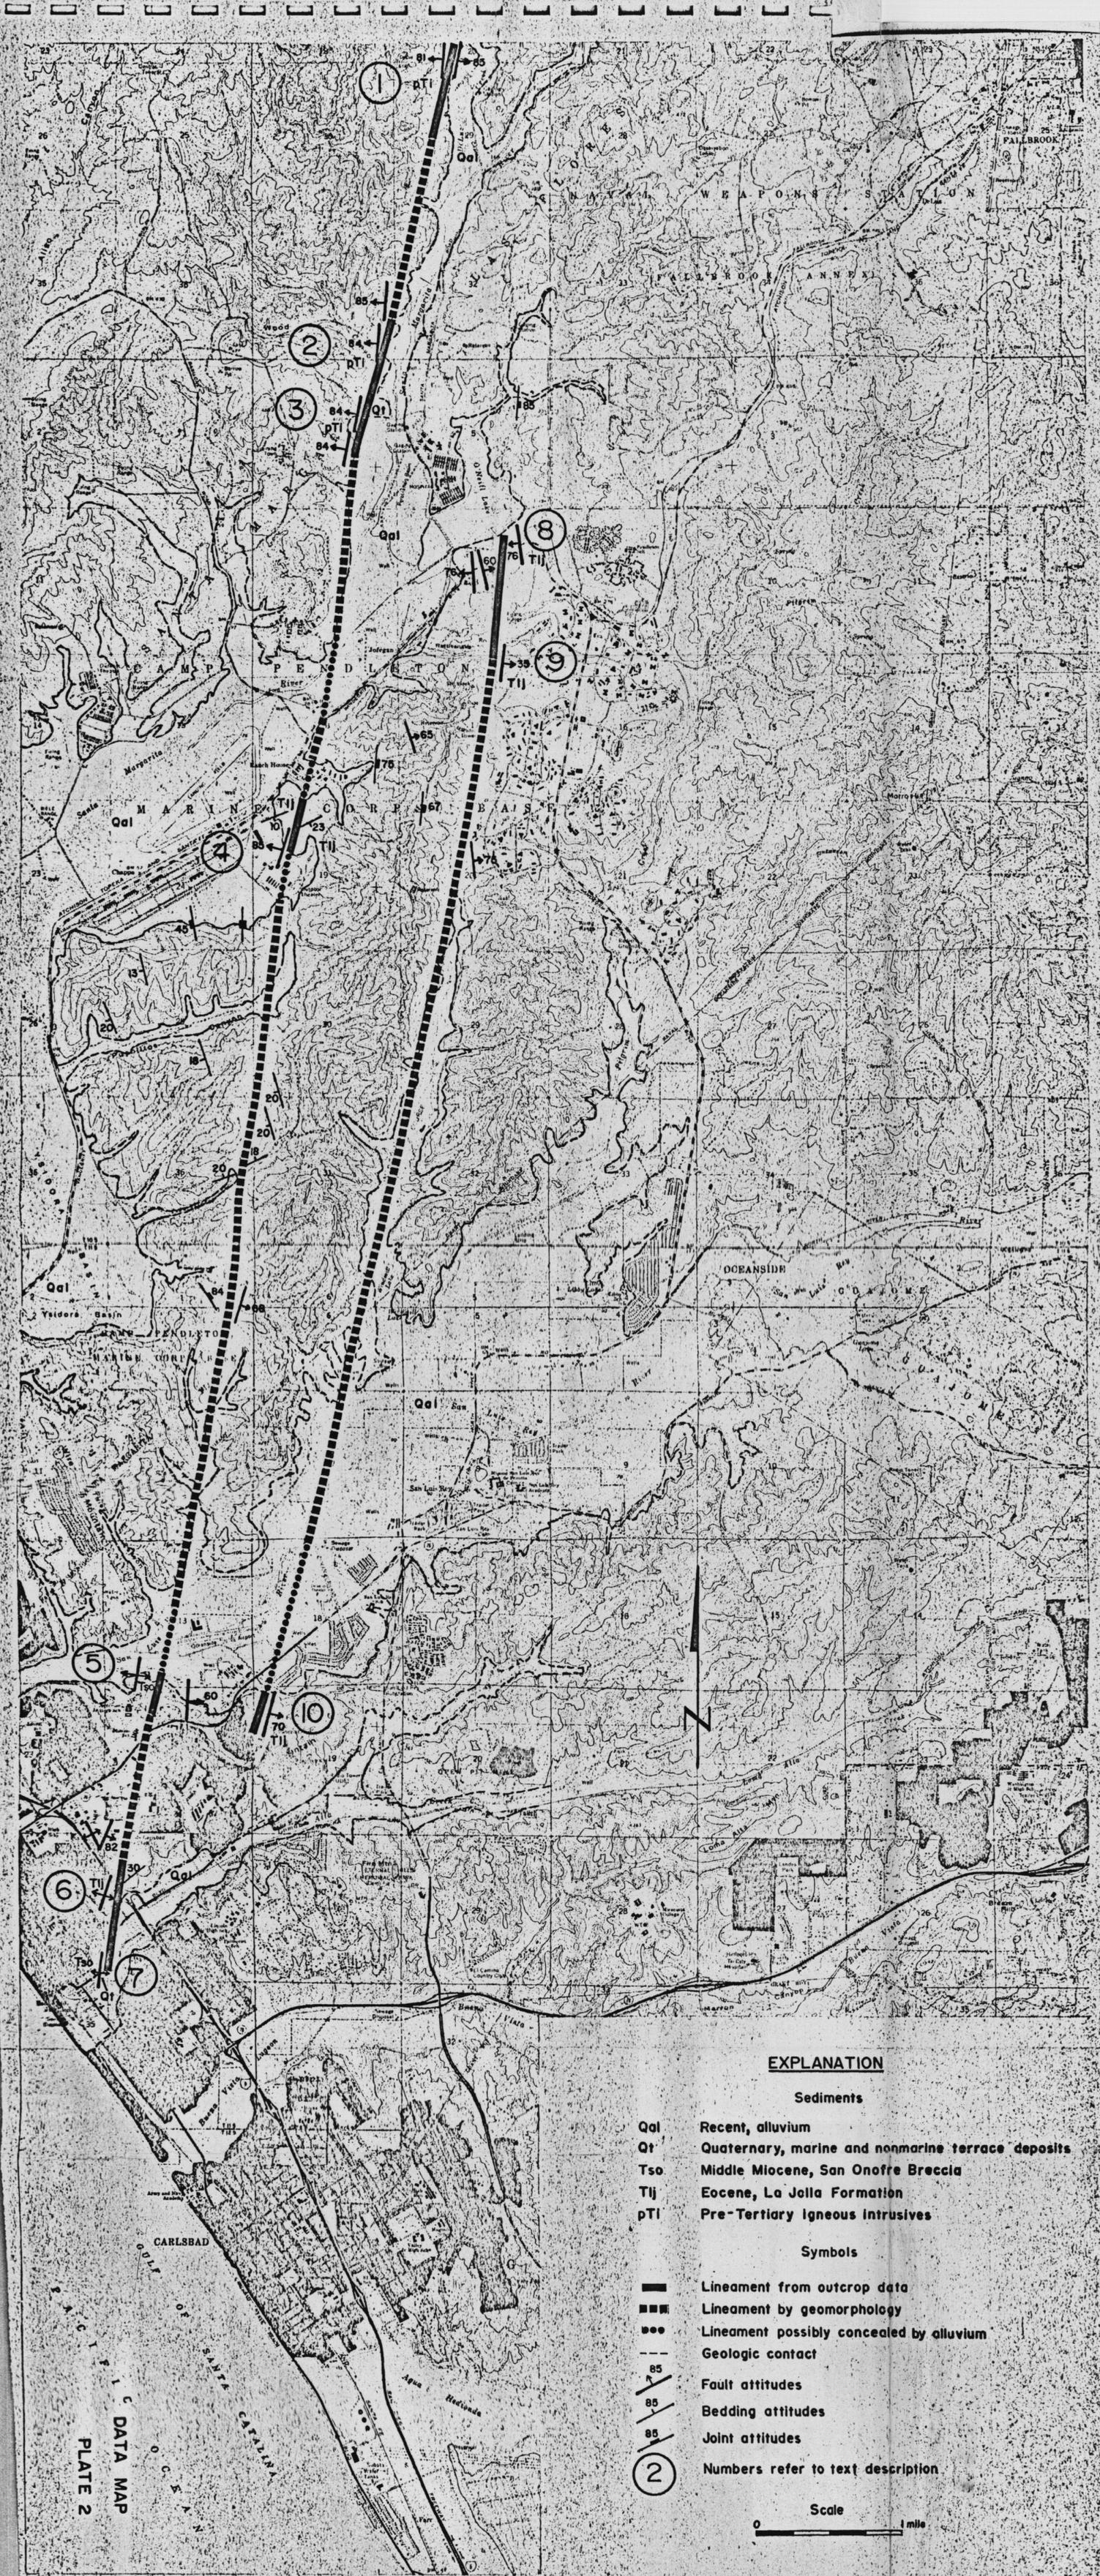
The following presents a description of some exposures inspected during the field work for this study. The numbers refer to locations which are indicated on the Data Map, Plate 2.

Based on data of the recent study the earlier, possible faults in the Camp Pendleton area can be traced southward to the vicinity of the coast at Oceanside, California. The faults strike east of north and dip vertically or steeply to the west and east (Trace of Possible Faults, Plate 6). However, at this time the magnitude of displacement or relative direction of movement of these structures has not been determined.
