8.4 Summary of Test Schedule

8.5 Compression Test (10 CFR 71.71(c)(9))

40 NORTH AVE, BURLINGTON, MA 01603		DESCRIPTIVE DRAWING	
TITLE 650L SOURCE CHANGER TEST UNITS			
SIZE	DWG. NO.	REV	
A	R-TP80	D	
SCALE: NONE		SHEET 1 OF 2

Test Plan 187 Model 880 Pipeliner, ISO 3999:2004(E) / ANSI N432 (1980), Endurance Test

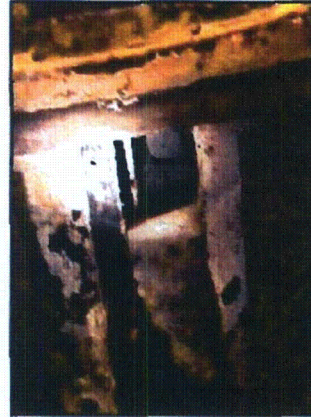
**TP80(B) Detail of
Cracked Shell**

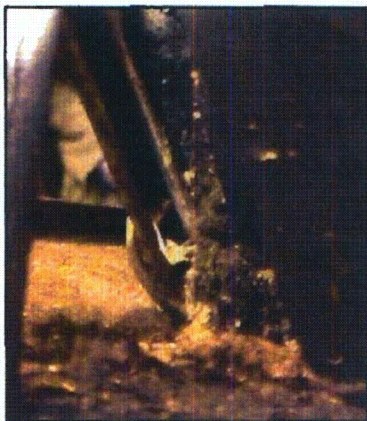
**TP80(B) Detail of
Uranium Oxide Residue**

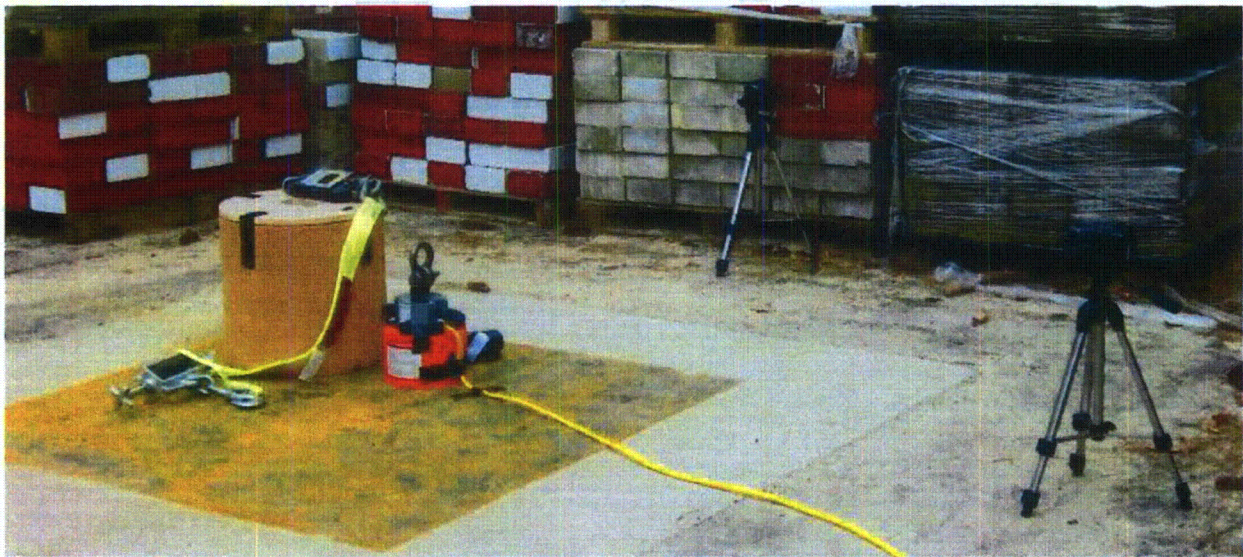
1 Test equipment and camera positions

1. The equipment used is shown in pictures 1 & 2.
2. The setup is shown in picture 3
3. The setup was the same for both configurations, Standard and Pipeliner.
4. The setup consisted of:
 - 4.1. A Walker Model CER.9 electro-magnet rated for 2400 lbs secured to the Drop Test Pad, T10740, S/N 001.
 - 4.2. The magnet was protected from damage by a cork enclosure topped with ½ plywood.
 - 4.3. The Pipeliner test device was secured to the magnet with a 2" wide ratchet strap.
 - 4.4. The load was applied by a fork-truck equipped with a lifting hook attachment.
 - 4.5. The load was measured by a Dillon Model Ed- Junior series digital crane scale rated for 2500 lbs
 - 4.6. The scale was attached to the device handle with a 2" wide lift strap.
 - 4.7. The device to be tested was cooled using dry ice to a temperature $\leq -40^{\circ}$ F prior to each test.

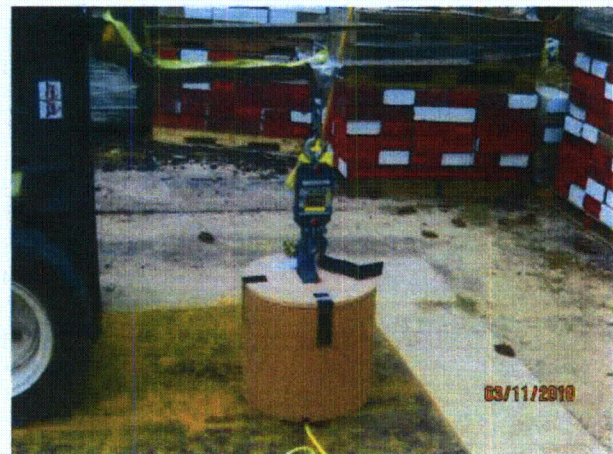
3 Test setup
