# **Assessment of Stress Corrosion Cracking Susceptibility for Austenitic Stainless Steels Exposed to Atmospheric Chloride and Non-Chloride Salts**

NUREG/CR-7170

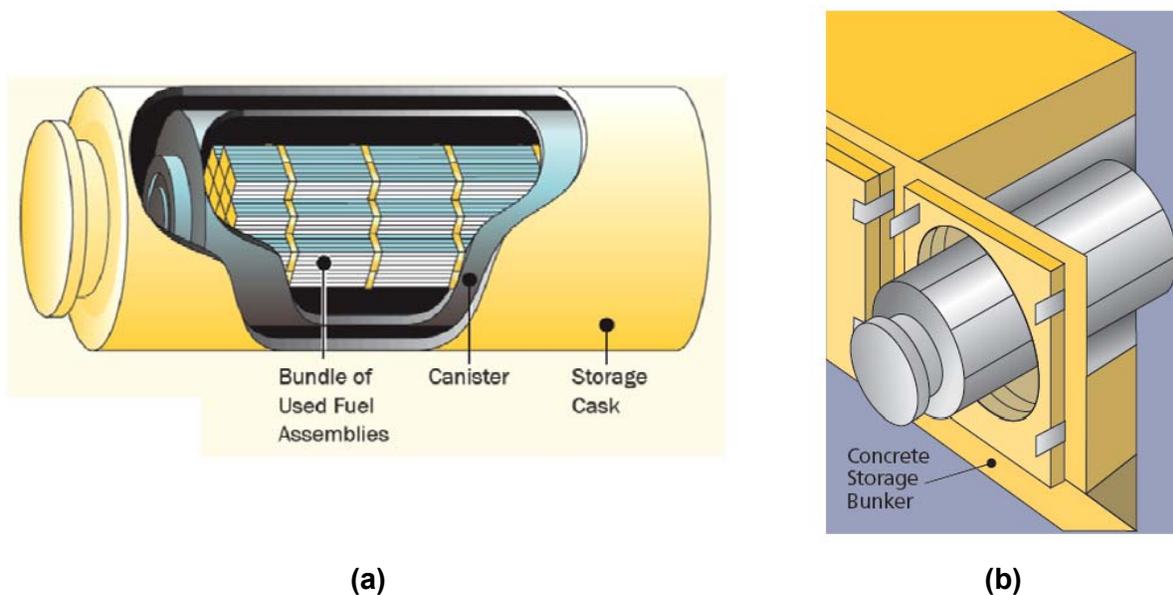
**Figure 1-1. Illustration of a Dry Storage Canister Within (a) a Metal Cask or (b) a Concrete Structure (NRC, 2012a)**

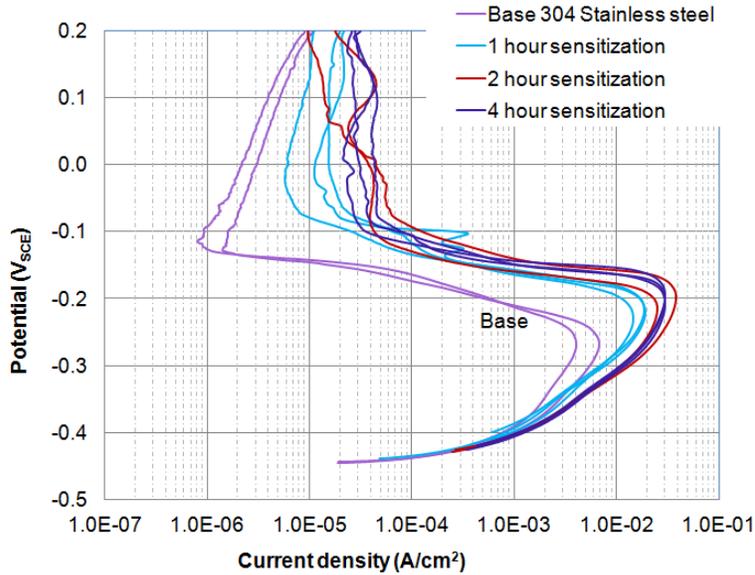
**Figure 2-1. Type 304 Stainless Steel Material Reactivation Curves Following ASTM G108–94 (ASTM International, 2010). Sensitization Was Conducted at 650 °C [1,202 °F] for 1, 2, and 4 Hours.**

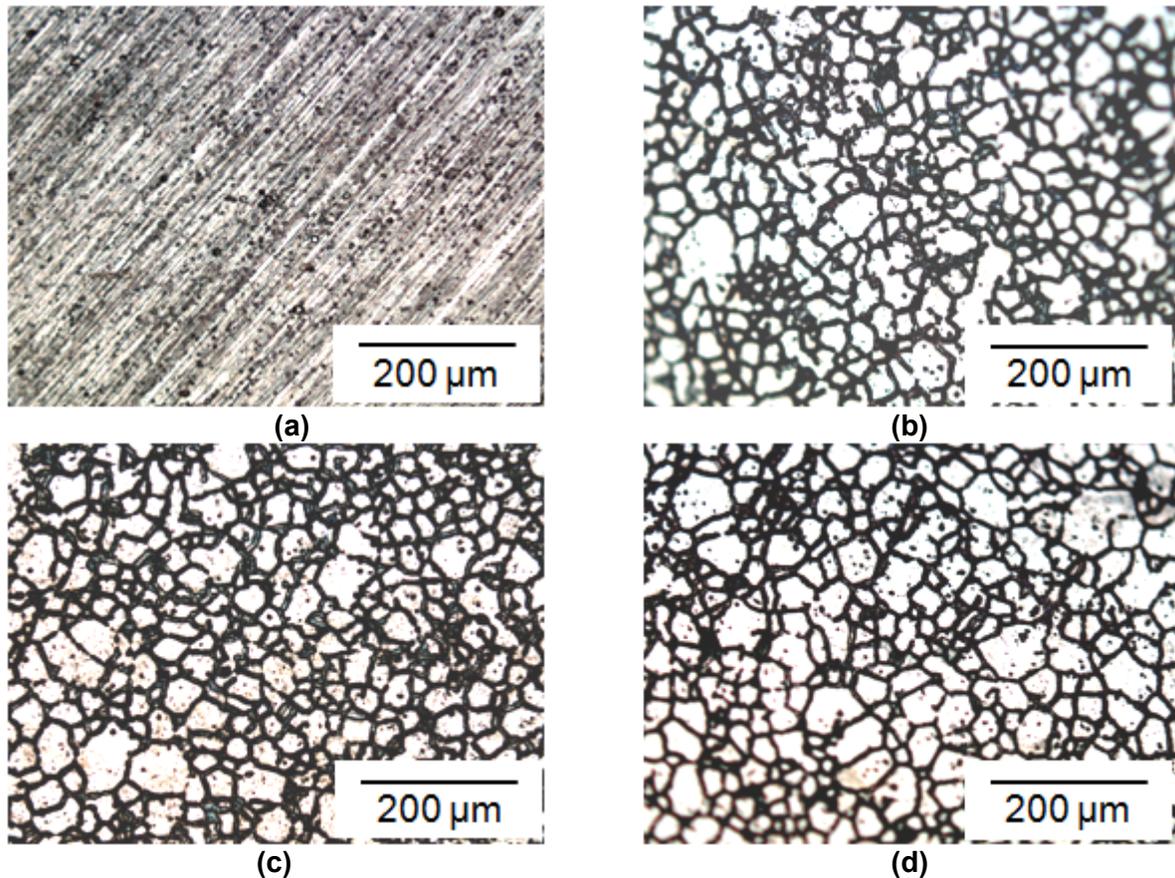
**Figure 2-2. Micrographs of Type 304 Stainless Steel Material After Electrochemical Reactivation Tests Following ASTM G108–94 (ASTM International, 2010). (a) Base Stainless Steel Without Sensitization, (b) 1-Hour, (c) 2-Hour, and (d) 4-Hour Sensitization at 650 °C [1,202 °F].**

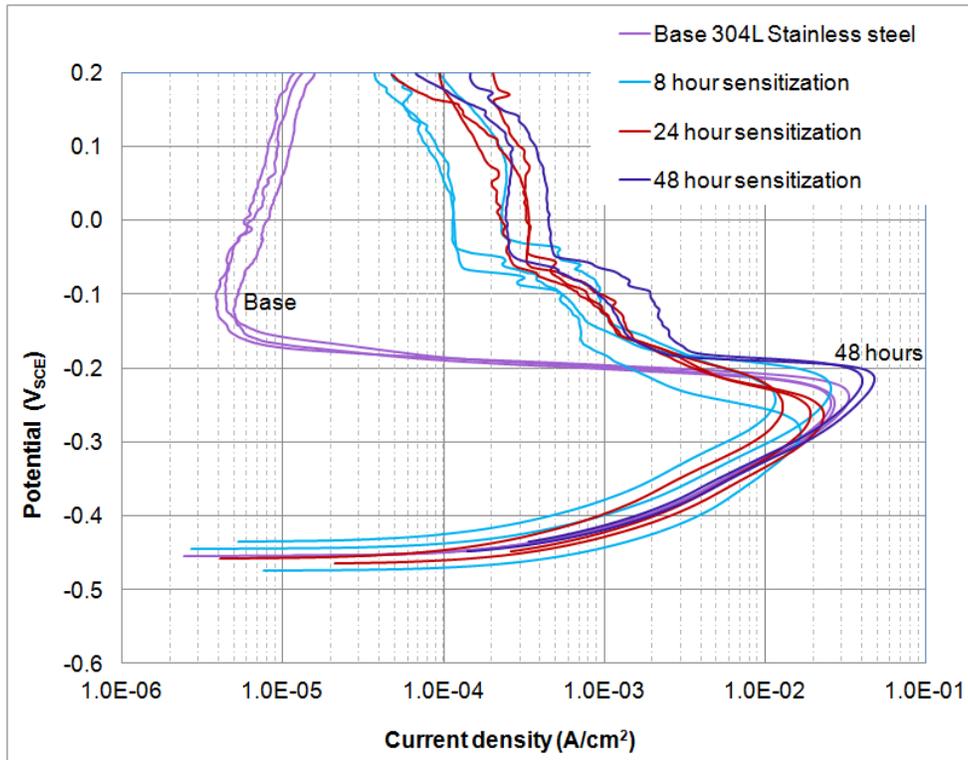
**Figure 2-4. Type 304L Stainless Steel Tube Material Reactivation Curves Following ASTM G108-94 (ASTM International, 2010). Sensitization Was Conducted at 600 °C [1,112 °F] for 8, 24, and 48 Hours.**

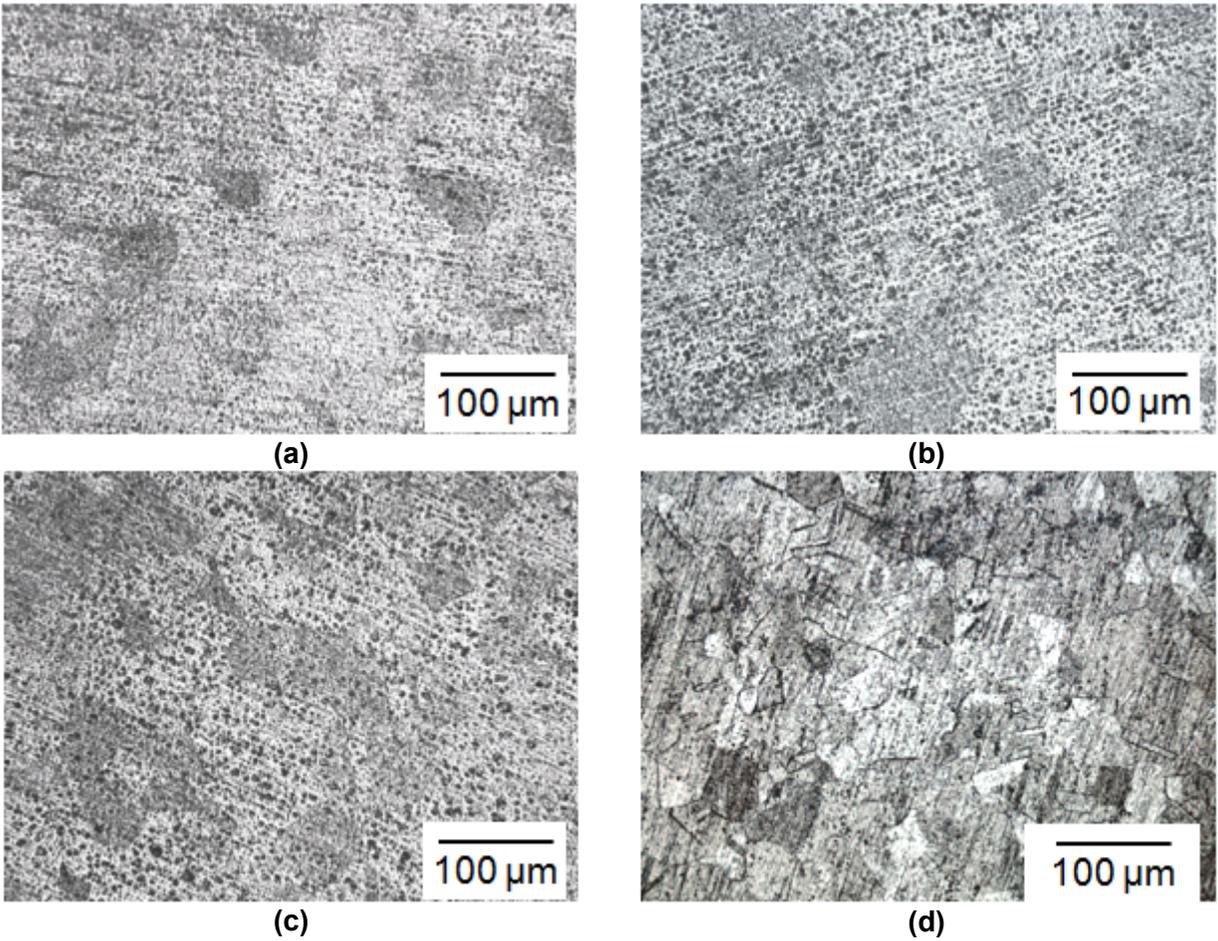
**Figure 2-5. Photos of Type 304L Stainless Steel Tube Material After Electrochemical Reactivation Tests Following ASTM G108–94 (ASTM International, 2010). (a) Base Stainless Steel Without Sensitization, (b) 8-Hour, (c) 24-Hour, and (d) 48-Hour Sensitization.**

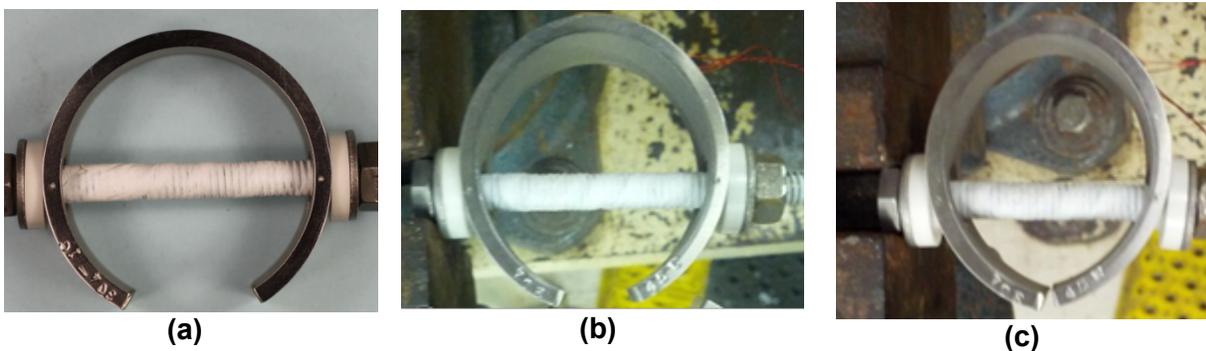
**Figure 2-8. C-Ring Specimens at Various Strain Levels: (a) Strain at Yield Strength, (b) 1.5 Percent Strain, and (c) 3.0 Percent Strain**

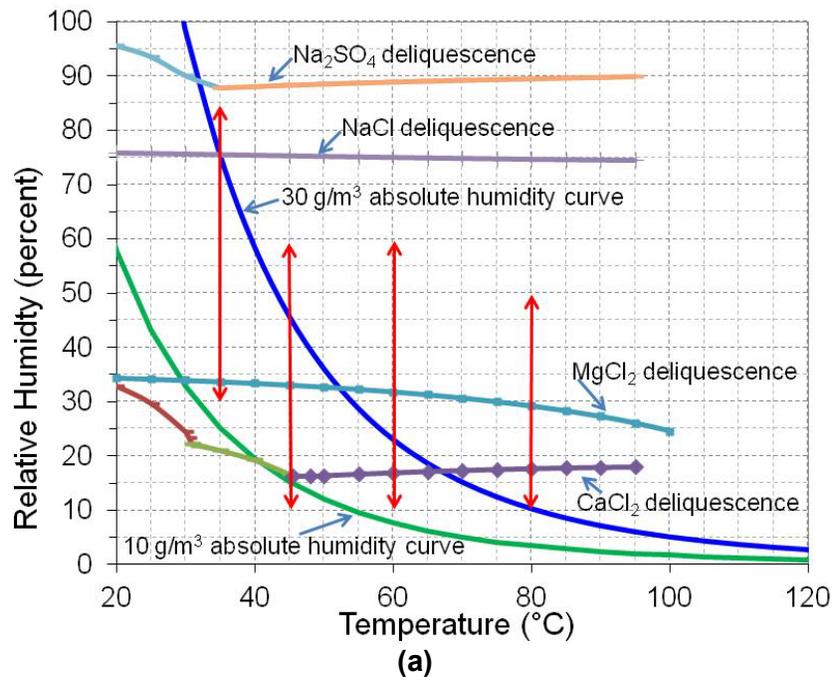
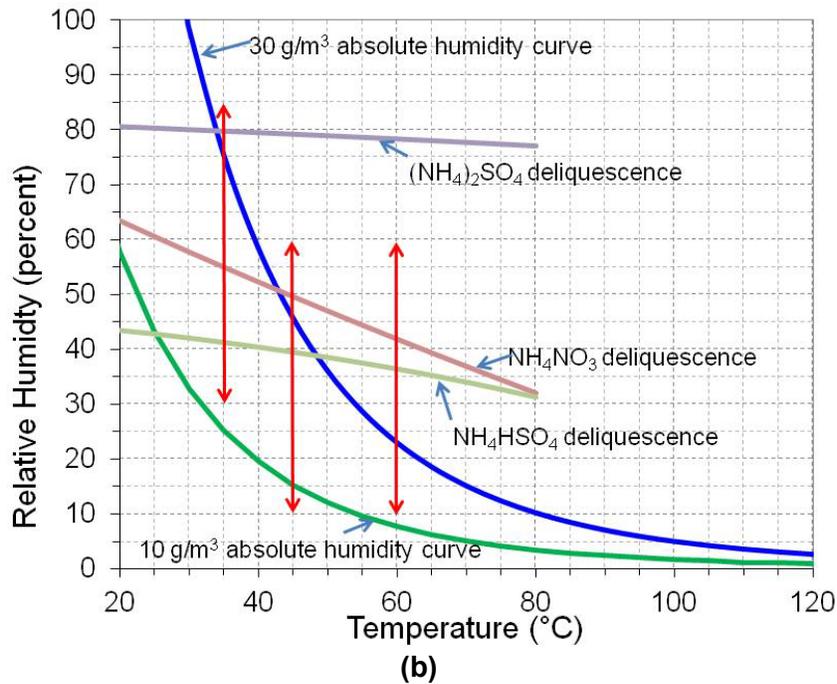
**Figure 2-11. Relative Humidity Chart Showing the Calculated Deliquescence Relative Humidity as a Function of Temperature for (a) Chloride-Rich Salts and (b) Non-Chloride Salts. The Red Arrows Indicate the Relative Humidity Ranges in the Deliquescence and Efflorescence Tests at 35, 45, 60, and 80 °C [95, 113, 140, and 176 °F]. Also Shown Are the Relative Humidity Versus Temperature Curves for Absolute Humidities of 10 and 30 g/m<sup>3</sup>.**

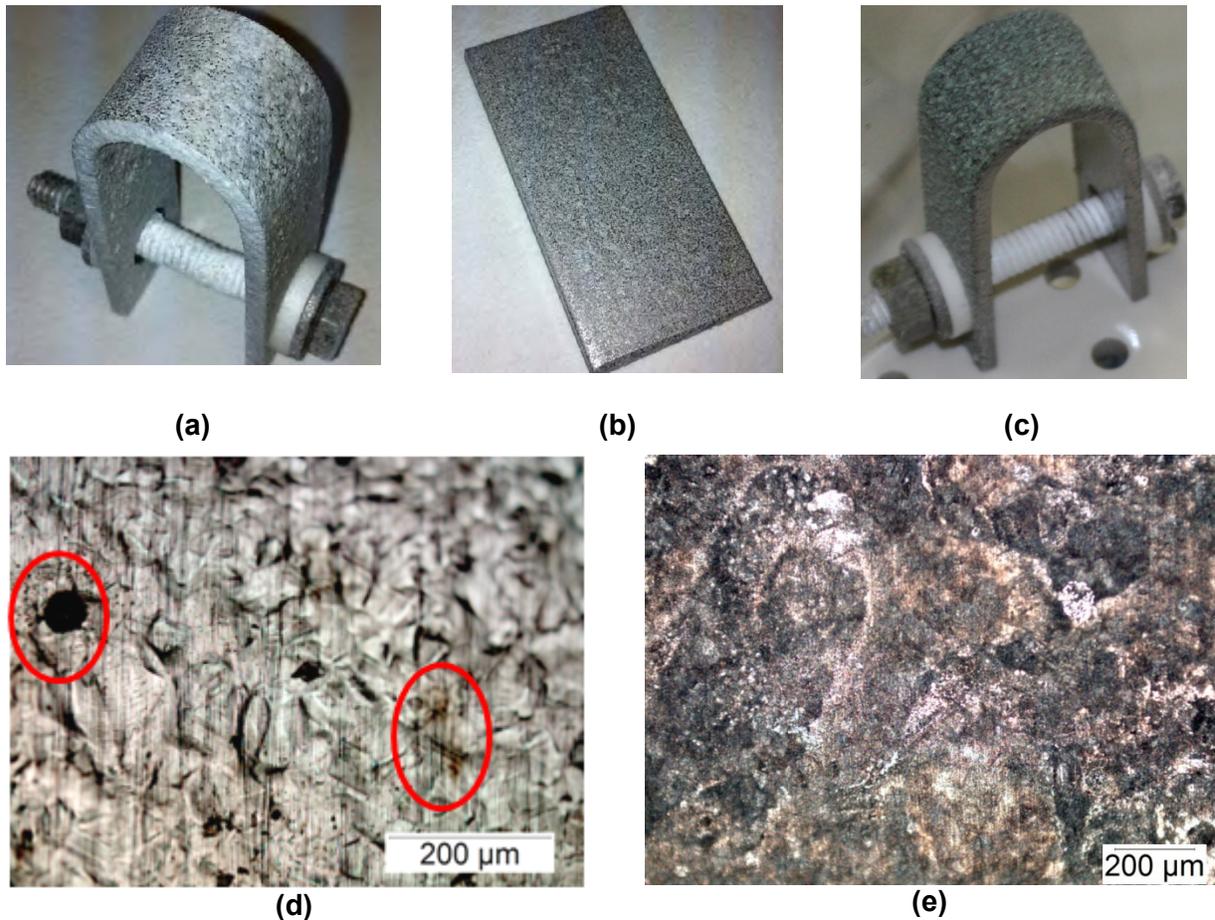
**Figure 2-16. Specimens Deposited With Non-Chloride-Rich Salts: (a) U-Bend, (b) Flat Specimen, (c) U-Bend Deposited With  $\text{NH}_4\text{HSO}_4$  and Optical Micrographs of Surface of Specimens Deposited With (d)  $\text{NH}_4\text{NO}_3$  and (e)  $\text{NH}_4\text{HSO}_4$  After Cleaning. The Red Circles Highlight the Pit and Etching.**

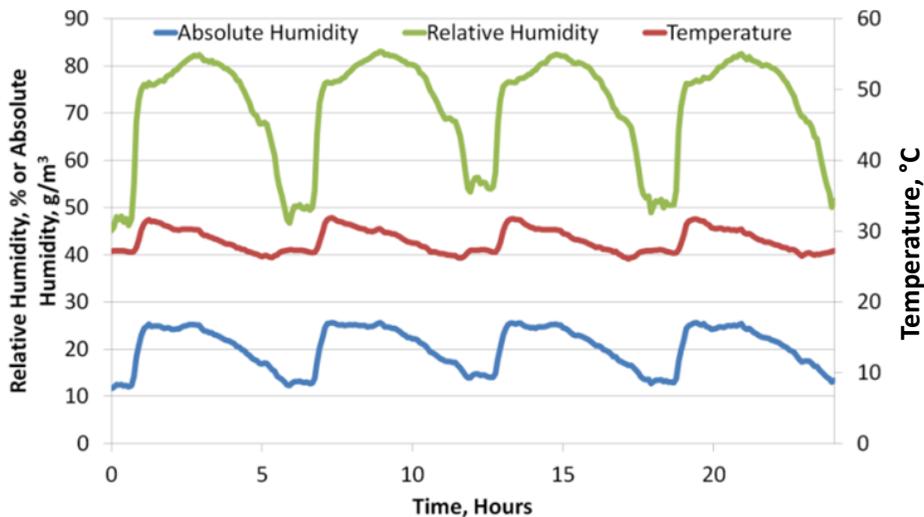
**Figure 2-17. Cycling Relative Humidity, Absolute Humidity, and Temperature in the Atmospheric Chamber During Some Stress Corrosion Cracking Tests With Cyclic Environmental Conditions**

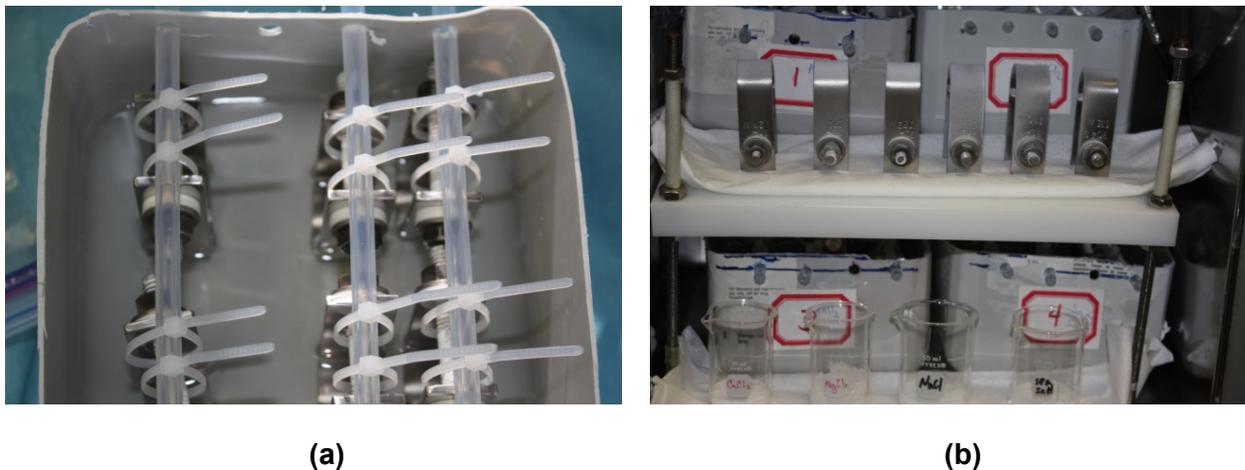
**Figure 2-18. Stress Corrosion Cracking Tests Exposed to 30 °C [86 °F] and 90 Percent Relative Humidity in Equilibrium With  $\text{CaCl}_2$ ,  $\text{MgCl}_2$ ,  $\text{NaCl}$ , and Sea Salt.  
 (a) U-Bend Specimens Hung Up in Solution With Crown Immersed and  
 (b) Deposited Specimens and Salt Beakers.**

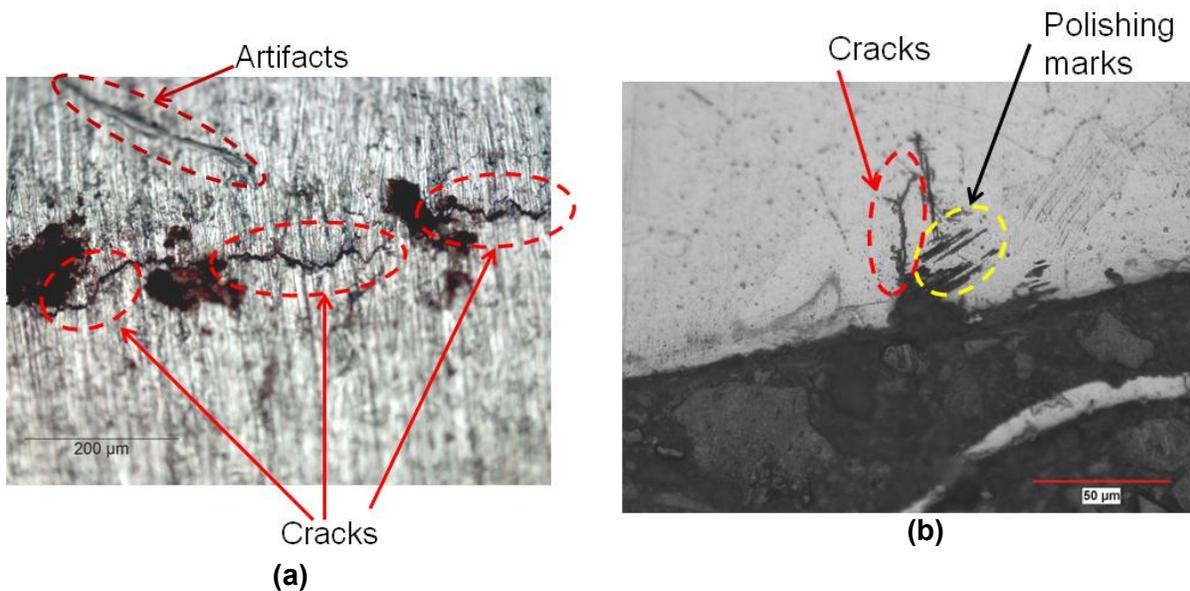
**Figure 2-20. Examples of Features Characterized as Stress Corrosion Cracks for (a) Surface Examination and (b) Cross Section**

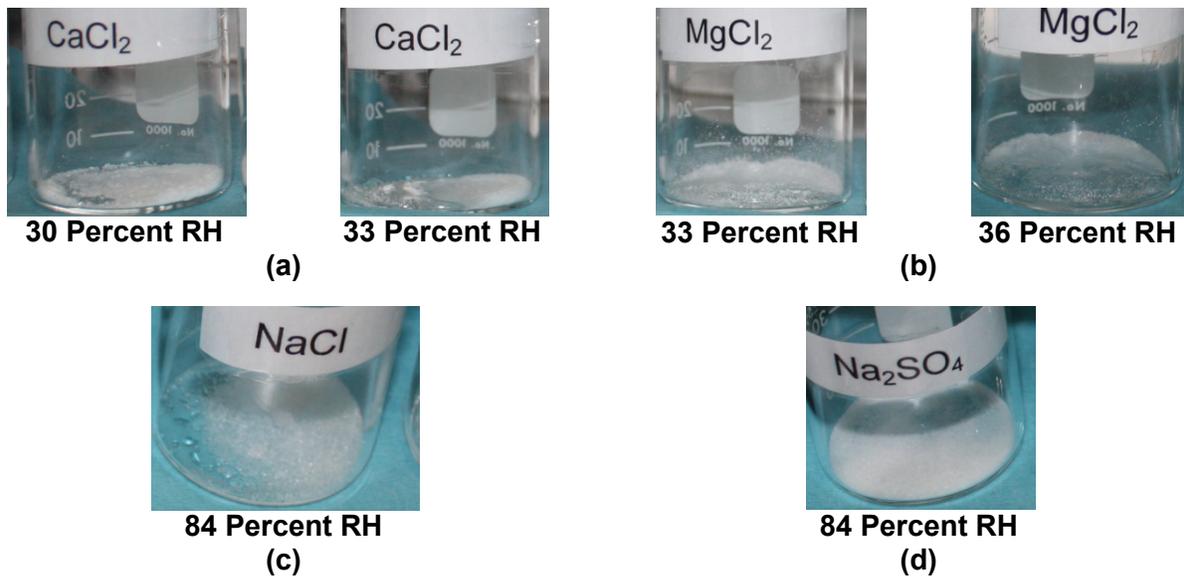
**Figure 3-1. Photographs of Salts in Beakers Showing the Deliquescence Behavior of (a) CaCl<sub>2</sub>, (b) MgCl<sub>2</sub>, (c) NaCl, and (d) Na<sub>2</sub>SO<sub>4</sub> at 35 °C [95 °F] at Various Relative Humidities**

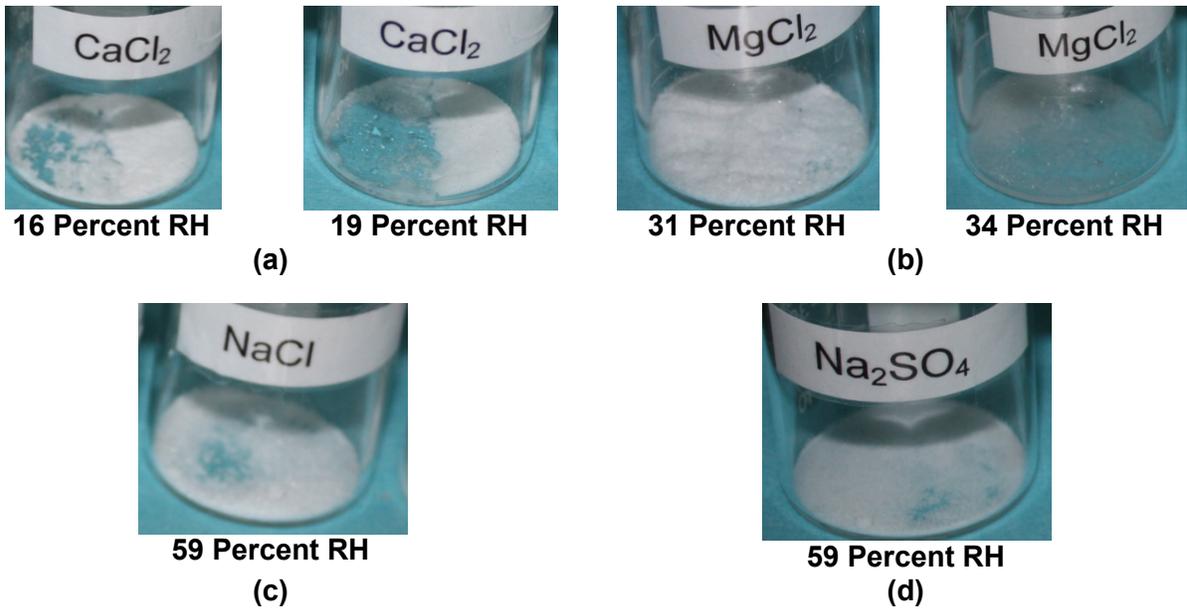
**Figure 3-2. Photographs of Salts in Beakers Showing the Deliquescence Behavior of (a)  $\text{CaCl}_2$ , (b)  $\text{MgCl}_2$ , (c)  $\text{NaCl}$ , and (d)  $\text{Na}_2\text{SO}_4$  at 45 °C [113 °F] at Various Relative Humidities**

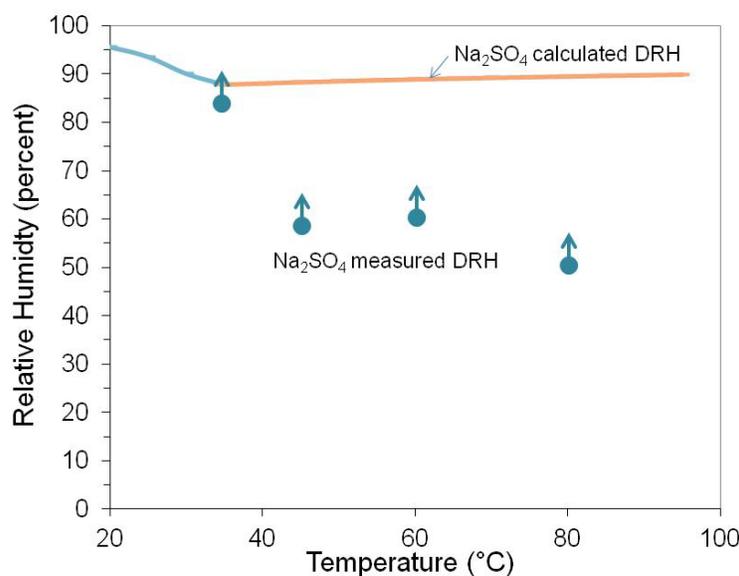
**Figure 3-5. Summary of Sodium Sulfate Deliquescence Behavior. Upward Arrows Mean Greater.**

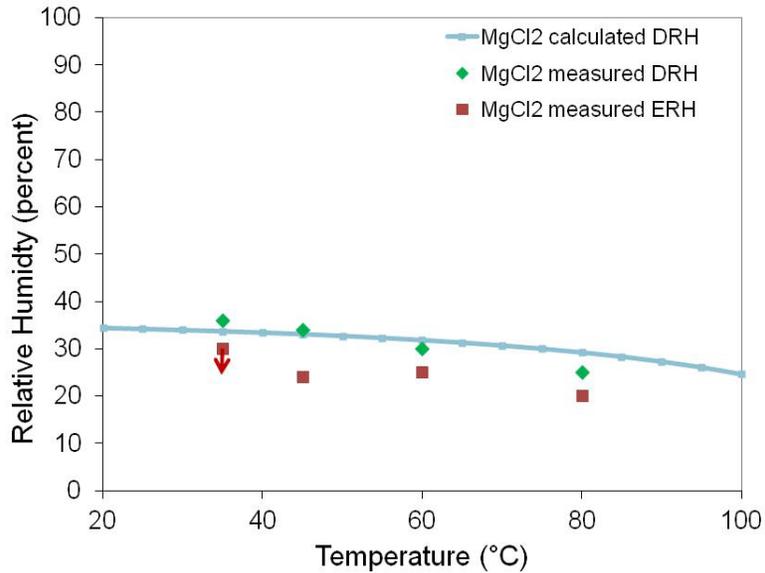
**Figure 3-7. Summary of Magnesium Chloride Deliquescence and Efflorescence Behavior. Downward Arrow Means Smaller.**

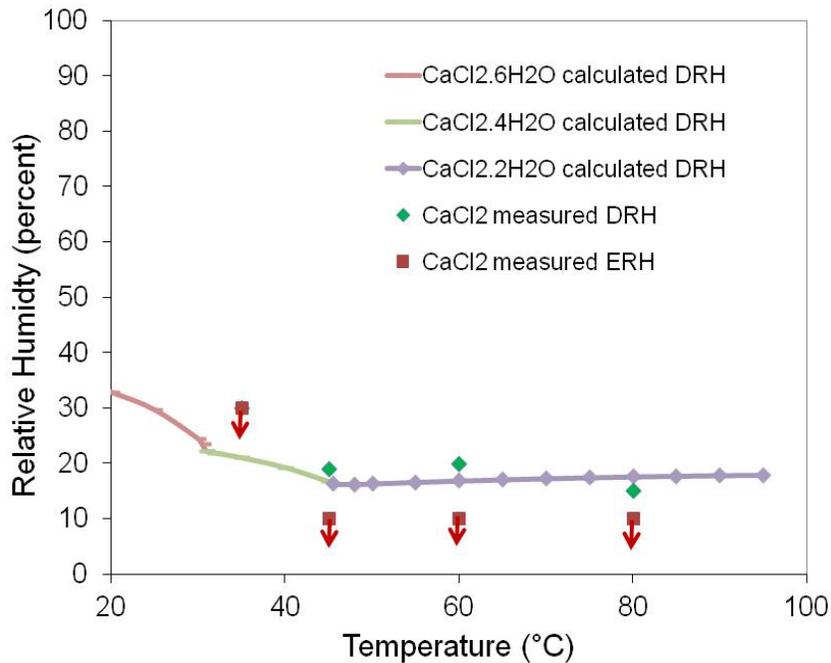
**Figure 3-8. Summary of Simulated Sea Salt and Calcium Chloride Deliquescence, and Efflorescence Behavior. Downward Arrows Mean Smaller.**

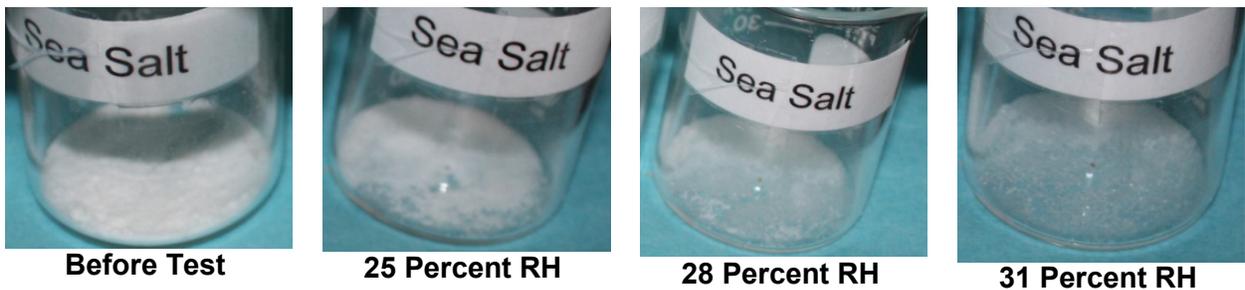
Figure 3-10. (a) Impedance Measured Using Conductivity Cell for Simulated Sea Salt and (b) Beaker Test Showing the Deliquescence Behavior at 45 °C [113 °F]

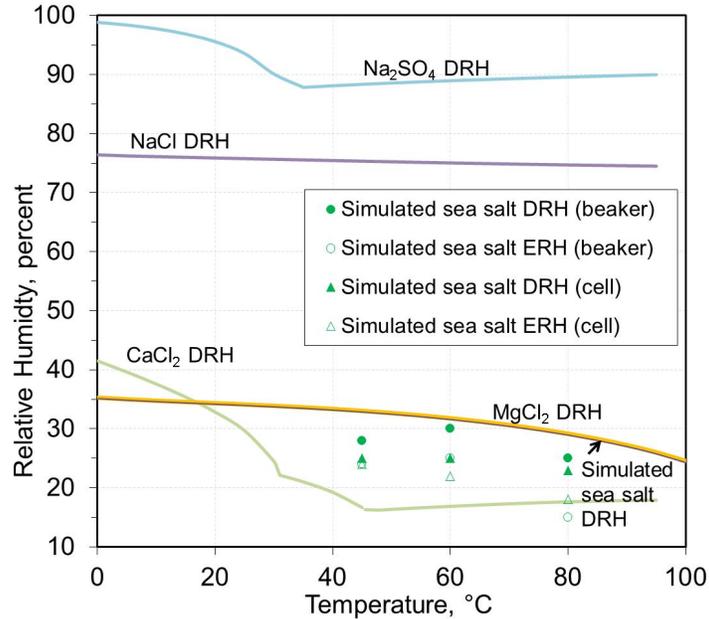
**Figure 3-13. Summary of Simulated Sea Salt Deliquescence and Efflorescence Behavior**

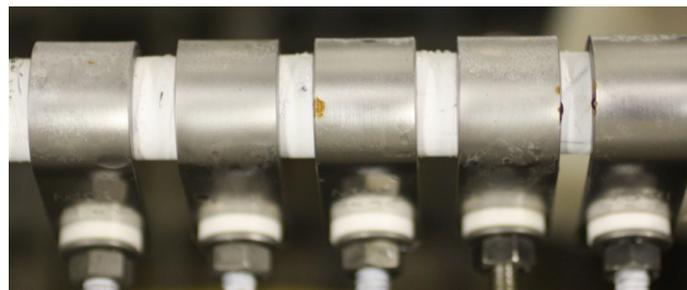
**Figure 3-14. Photograph of Type 304 U-Bend Specimens Deposited With 10 g/m<sup>2</sup> Salt Held at Chamber Temperature {27 °C [81 °F]} for 1 Month**

The temperature of 27 °C [81 °F] is the lowest that was evaluated in this program because this represents the bulk temperature in the test chamber. U-bend specimens in the as-received and sensitized conditions and deposited with 10 g/m<sup>2</sup> salt were placed in the chamber and exposed at this temperature, with some specimens removed after 1 month and others after 8 months. Figure 3-14 shows a photograph of some specimens after 1 month. The surfaces appeared shiny, suggesting that the salt had deliquesced and most of the solution drained off because of the high humidity, approaching 100 percent RH at the high end of the cycle. Minor pitting was observed, mainly on the edges of the specimens. Specimens exposed for 8 months were microscopically examined to determine whether cracking had occurred. As seen from the cross section and surface in Figure 3-15, some pits were observed, but no cracking. Because no SCC was observed for specimens with 10 g/m<sup>2</sup> of salt, no tests were performed at this temperature with salt quantities of 0.1 or 1 g/m<sup>2</sup>. Additional tests for SCC susceptibility in high humidity are discussed in Section 3.4.

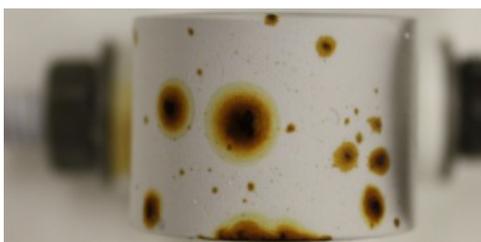
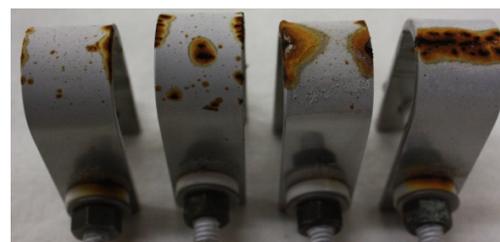
**Figure 3-16. Photographs of Sensitized Type 304 U-Bend Specimens Deposited With 10 g/m<sup>2</sup> Salt Held at 35 °C [95 °F] for (a) 1 Month and (b) 4 Months**

U-bend specimens in the as-received, sensitized, and welded conditions and deposited with 10 g/m<sup>2</sup> salt were exposed in the test chamber at 35 °C [95 °F], with some specimens removed after 1 month and the rest after 4 months. As shown in Figure 3-16(a), after 1 month, salt was still visible on the specimen surfaces, along with significant corrosion products. Corrosion was even more extensive after 4 months, especially on the arc of the U-bends, as shown in Figure 3-16(b). Figure 3-17 shows some optical micrographs of the specimen surfaces for sensitized, as-received, and welded specimens. The images appear to show SCC initiation in all material conditions, with crack lengths of up to several hundred microns. The cracks seem to grow from pit to pit on the surface of the specimens. For the welded specimen, the cracks were observed both in the weld material and in the base material. No cross-sectional micrographs were made because cracking was clearly visible on the surface images.

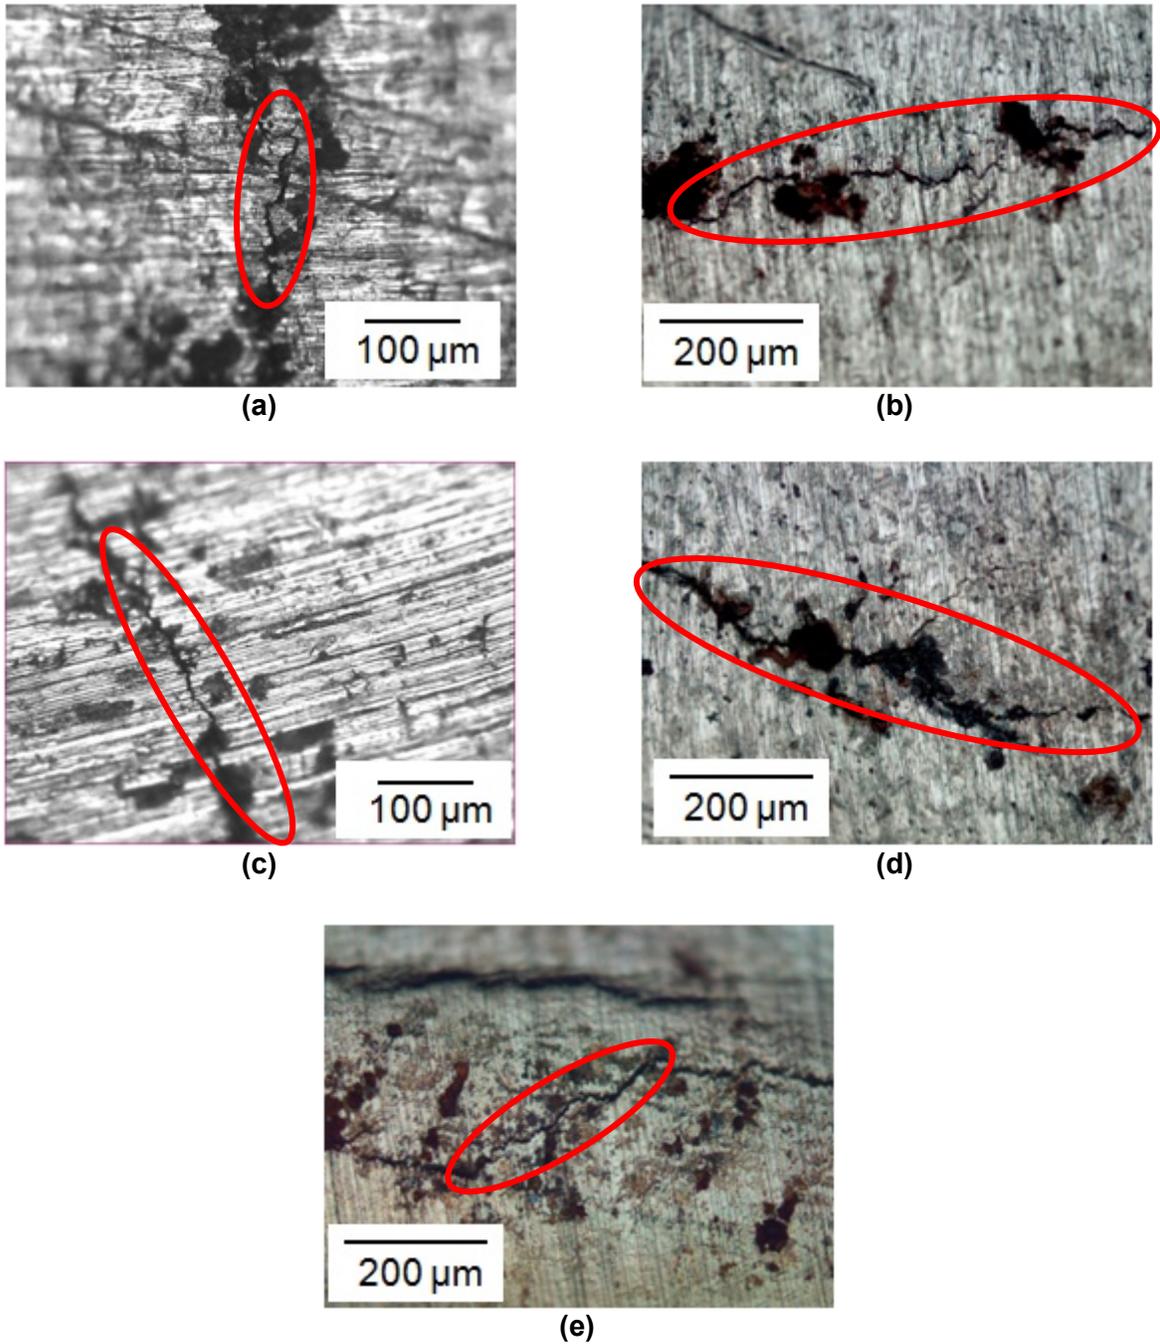
**Figure 3-17. Optical Micrographs of U-Bend Specimens Deposited With 10 g/m<sup>2</sup> Salt Held at 35 °C [95 °F]. Sensitized Type 304 Specimens Exposed for (a) 1 Month and (b) 4 Months. As-Received Specimens Exposed for (c) 1 Month and (d) 4 Months. Welded Specimen Exposed for (e) 4 Months. Red Circles Highlight the Cracks.**

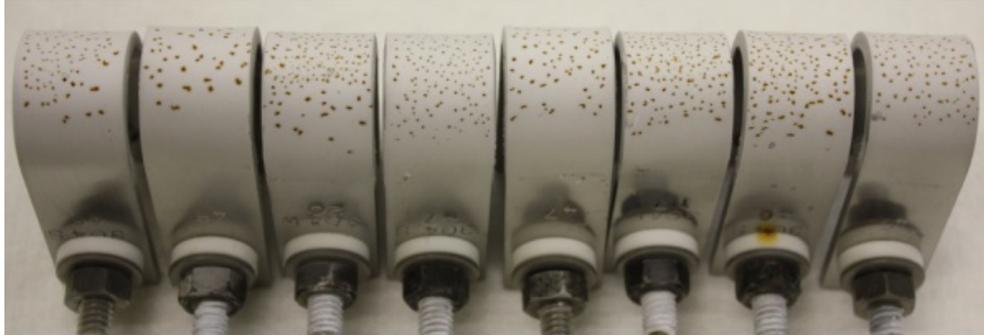
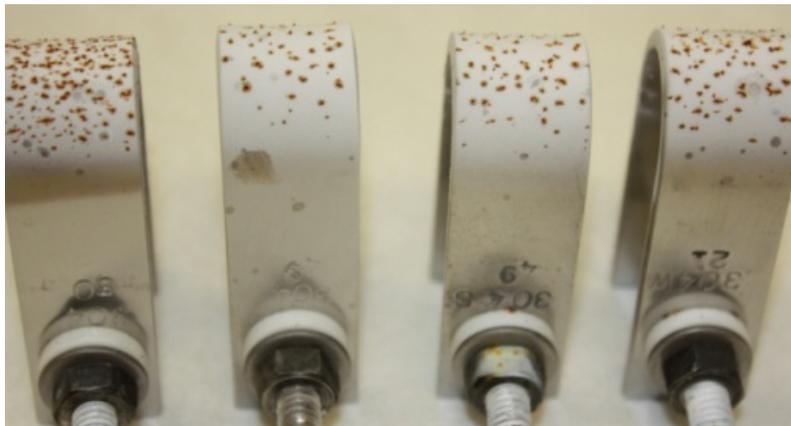
**Figure 3-18. Photographs of Type 304 U-Bend Specimens Deposited With  $10 \text{ g/m}^2$  Salt Held at  $45 \text{ }^\circ\text{C}$  [ $113 \text{ }^\circ\text{F}$ ] for (a) 1 Month and (b) 4 Months**

U-bend specimens in the as-received, sensitized, and welded conditions and deposited with 10 g/m<sup>2</sup> salt were exposed in the test chamber at 45 °C [113 °F], with some specimens removed after 1 month and the rest after 4 months. As shown in Figure 3-18, salt is still visible on the specimen surfaces after exposure, along with scattered pitting. The corrosion products were not as extensive as those observed at 35 °C [95 °F]. Surface and cross section micrographs

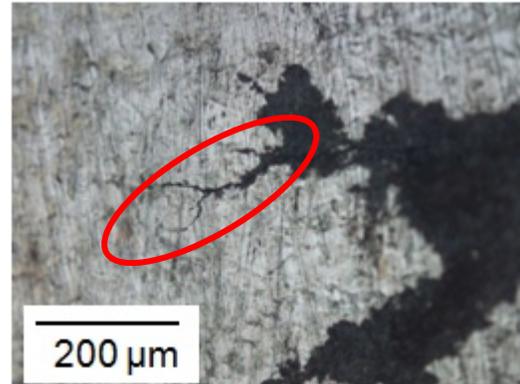
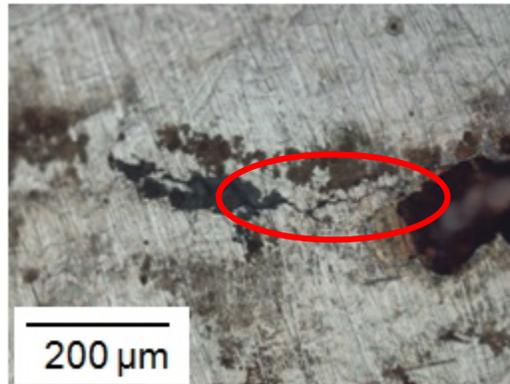
**Figure 3-19. Optical Micrographs of U-Bend Specimens Deposited With  $10 \text{ g/m}^2$  Salt Held at  $45 \text{ }^\circ\text{C}$  [ $113 \text{ }^\circ\text{F}$ ]. Sensitized Type 304 Specimens Exposed for (a) 1 Month From Cross Section and (b) 4 Months From Surface. As-Received Specimens Exposed for (c) 1 Month From Cross Section and (d) 4 Months From Surface. Welded Specimen Exposed for (e) 4 Months From surface. Red Circles Highlight the Cracks.**

from the as-received, sensitized, and welded specimens are shown in Figure 3-19. The images show SCC initiation in all material conditions, with crack lengths of up to several hundred microns. For the specimens exposed for 4 months, the cracks appear to grow from pit to pit on the surface. For the specimens only exposed for 1 month, the cracks appear at the bottom of the pits. For the welded specimens, the cracks were only observed to occur in the base material.

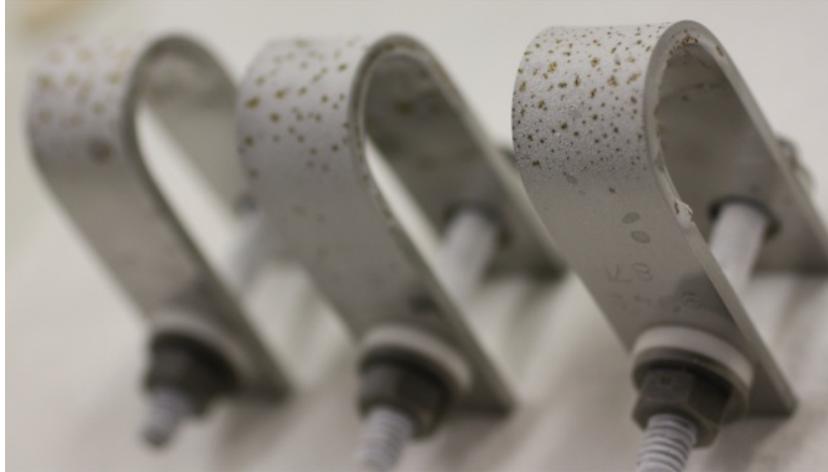
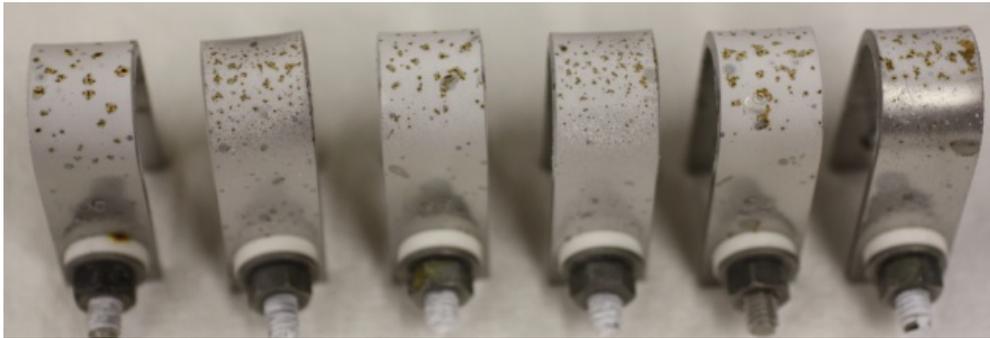
**Figure 3-20. Photos of Type 304 U-Bend Specimens Deposited With  $10 \text{ g/m}^2$  Salt Held at  $52 \text{ }^\circ\text{C}$  [ $136 \text{ }^\circ\text{F}$ ] for (a) 1 Month and (b) 2.5 Months**

U-bend specimens in the as-received and sensitized conditions and deposited with  $10 \text{ g/m}^2$  salt were exposed in the test chamber at  $52 \text{ }^\circ\text{C}$  [ $126 \text{ }^\circ\text{F}$ ], with some specimens removed after 1 month and the rest after 2.5 months. As shown in Figure 3-20, the specimens appear similar to those tested at  $45 \text{ }^\circ\text{C}$  [ $113 \text{ }^\circ\text{F}$ ]. Salt is still visible on the specimen surfaces after exposure, along with scattered pitting. Surface and cross section optical micrographs from as-received

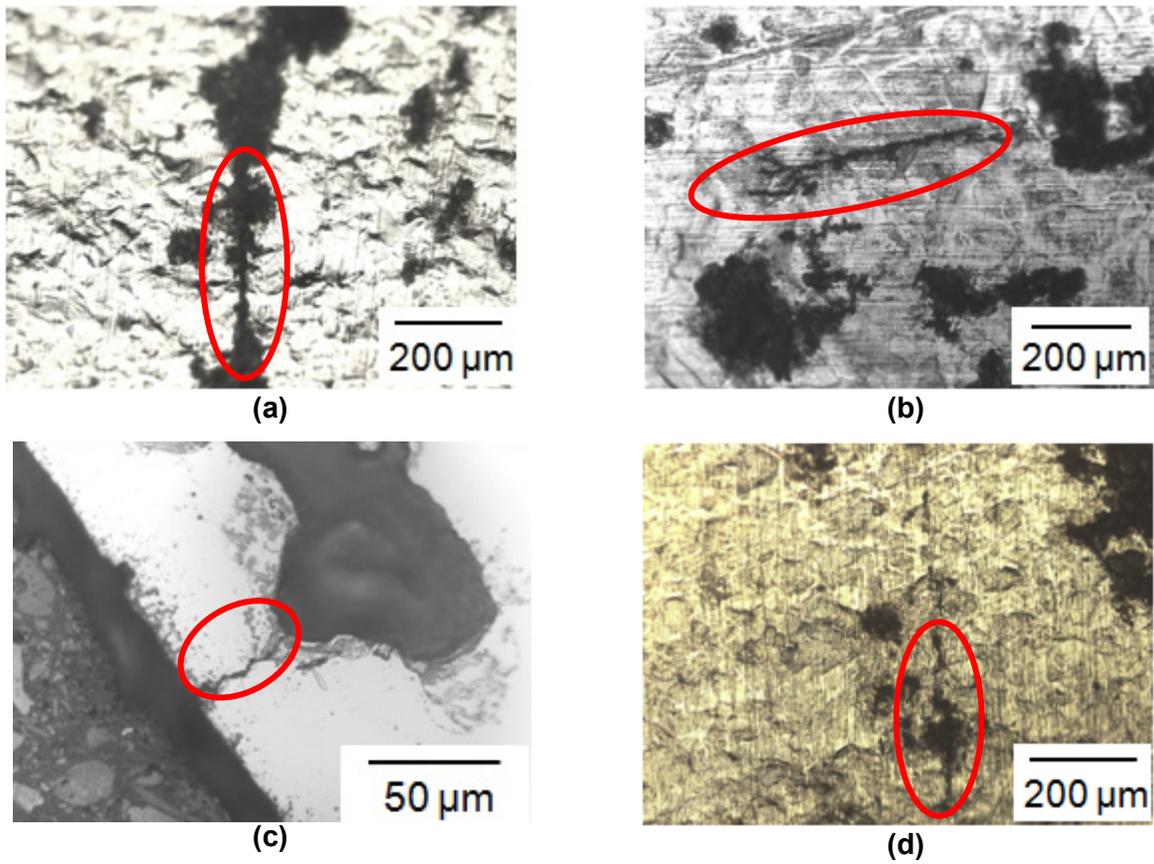
**Figure 3-21. Optical Micrographs of U-Bend Specimens Deposited With 10 g/m<sup>2</sup> Salt Held at 52 °C [136 °F]. Sensitized Type 304 Specimens Exposed for (a) 1 Month From Surface and (b) 2.5 Months From Surface. As-Received Specimens Exposed for (c) 1 Month From Cross Section and (d) 2.5 Months From Surface. Red Circles Highlight the Cracks.**

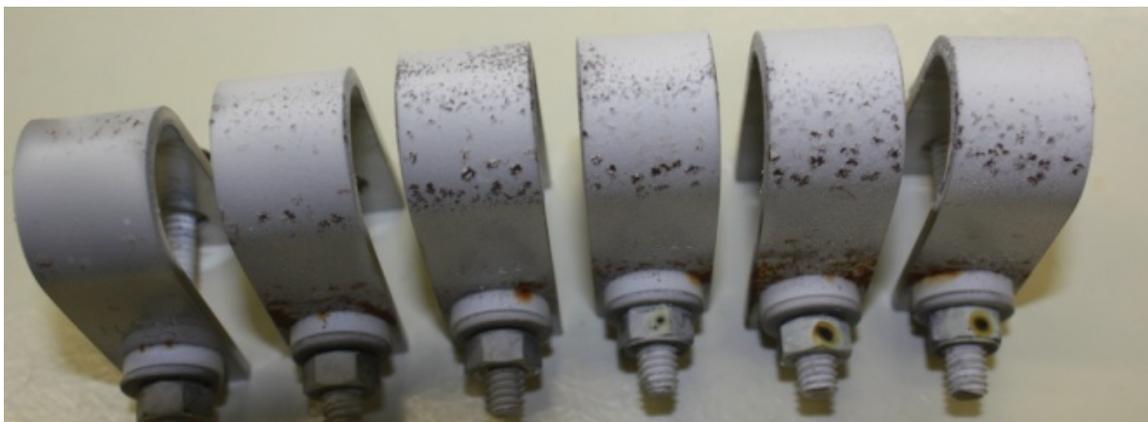
**Figure 3-22. Photograph of 10 g/m<sup>2</sup> Exposed Type 304 U-Bend Specimens Held at 60 °C [140 °F] for 6.5 Months**

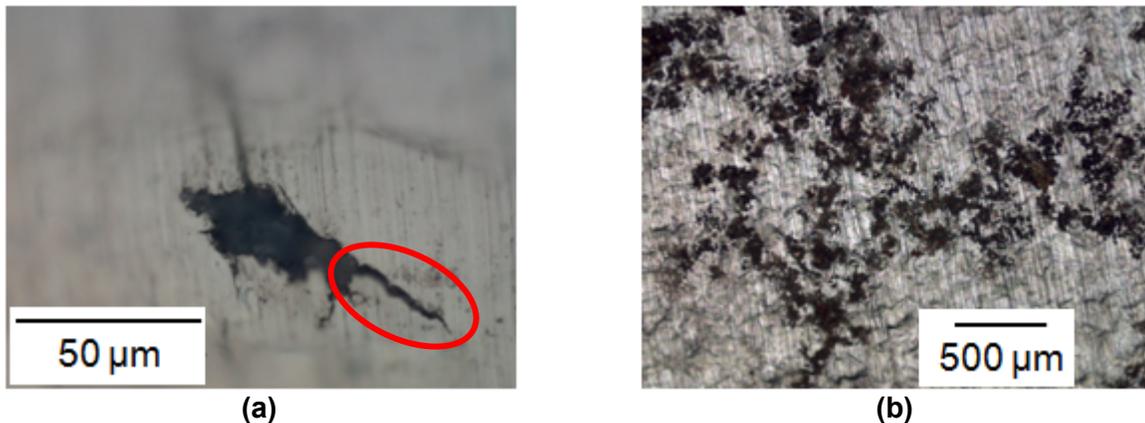
**Figure 3-23. Optical Micrographs of Type 304 U-Bend Specimens Deposited With 10 g/m<sup>2</sup> Salt Held at 60 °C [140 °F] and Exposed for 6.5 Months for (a) Sensitized From Surface, Red Circle Highlights the Crack. (b) As-Received Type 304 Specimens From Surface, No Cracking Observed.**

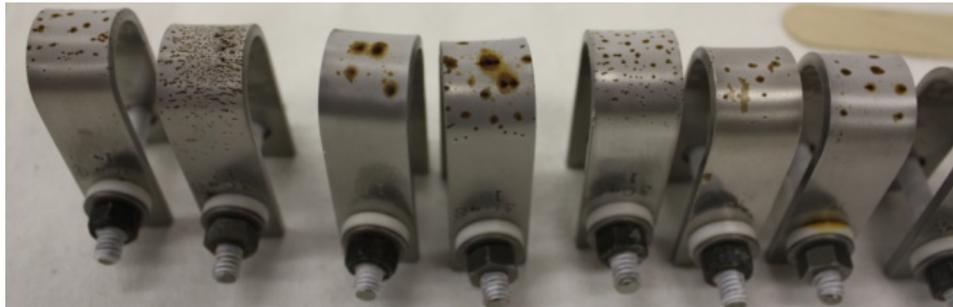
**Figure 3-24. Photographs of Type 304 U-Bend Specimens Deposited With 1 g/m<sup>2</sup> Salt Held at 35 °C [95 °F] for (a) 1 Month and (b) 4 Months**

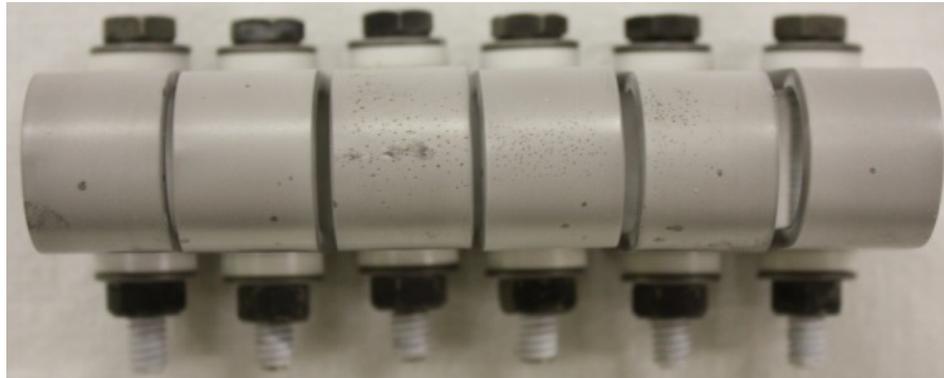
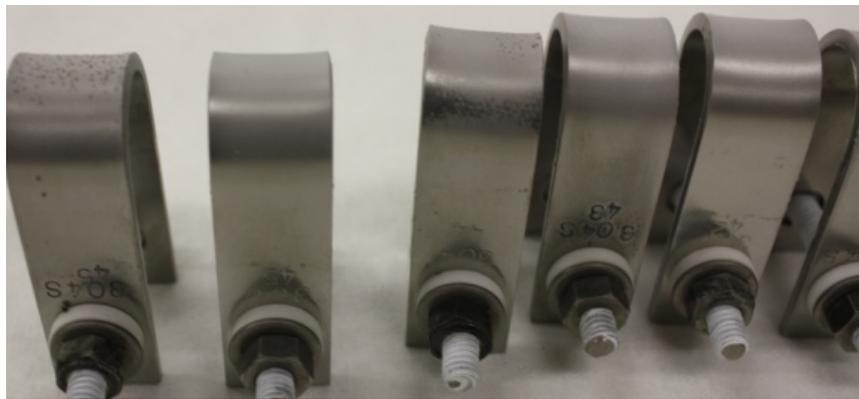
**Figure 3-26. Photographs of 1 g/m<sup>2</sup> Type 304 U-Bend Specimens Held at 45 °C [113 °F] for (a) 1 Month and (b) 4 Months**

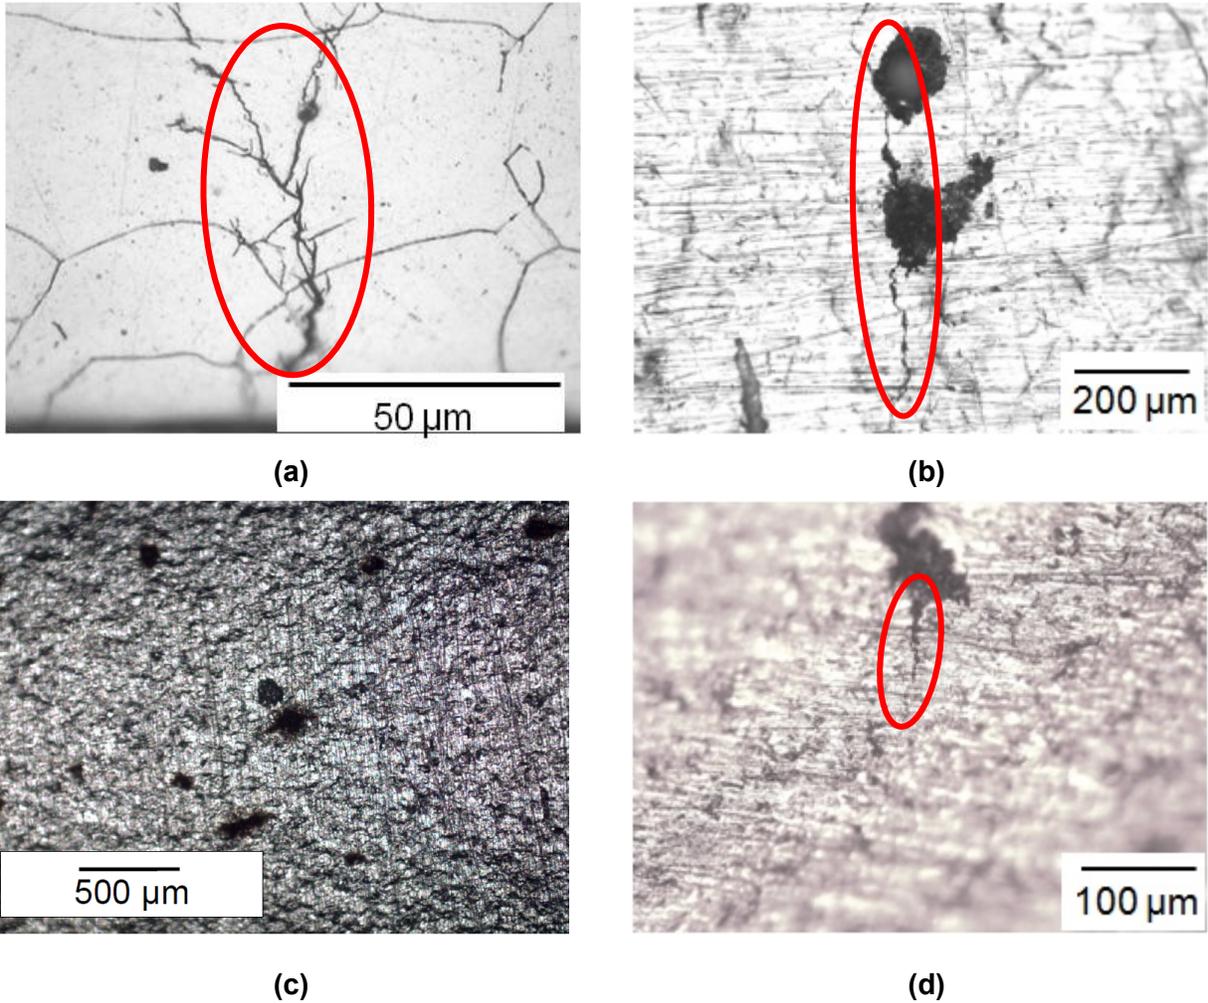
**Figure 3-27. Surface Optical Micrographs of 1 g/m<sup>2</sup> U-Bend Specimens Held at 45 °C [113 °F]. Sensitized Type 304 Specimens Exposed for (a) 1 Month and (b) 4 Months. As-Received Specimens Exposed for (c) 1 Month (No Cracking Observed) and (d) 4 Months. Red Circles Highlight the Cracks.**
