# **Assessment of Stress Corrosion Cracking Susceptibility for Austenitic Stainless Steels Exposed to Atmospheric Chloride and Non-Chloride Salts**

NUREG/CR-7170

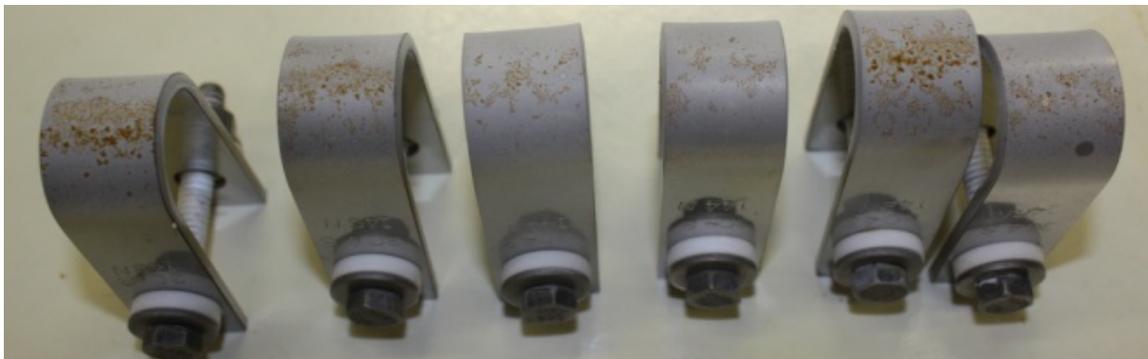
**Figure 3-28. Photograph of 1 g/m<sup>2</sup> Exposed Type 304 U-Bend Specimens Held at 52 °C [136 °F] for 8 Months**

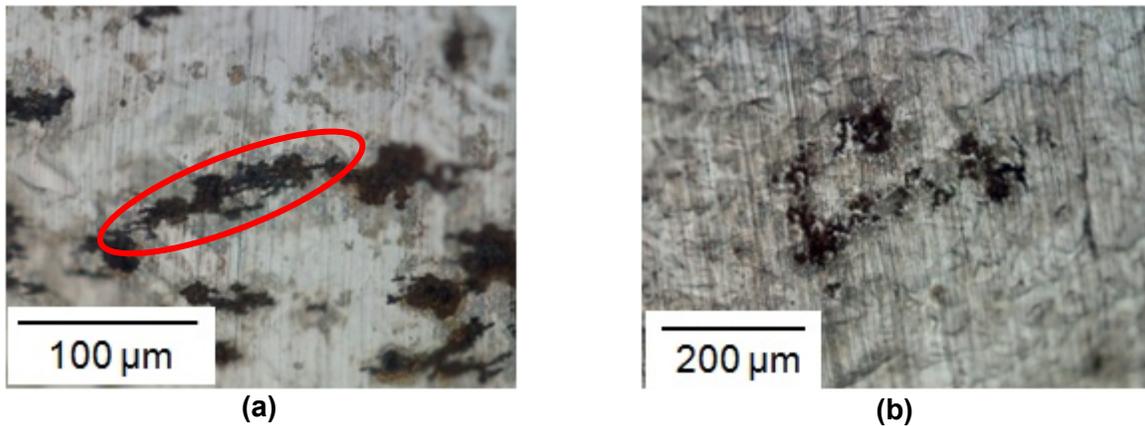
**Figure 3-29. Surface Optical Micrographs of 1 g/m<sup>2</sup> U-Bend Specimens Held at 52 °C [126 °F] for 8 Months for (a) Sensitized and (b) As-Received Type 304 Specimens. Red Circle Highlights the Crack on the Sensitized Specimen.**

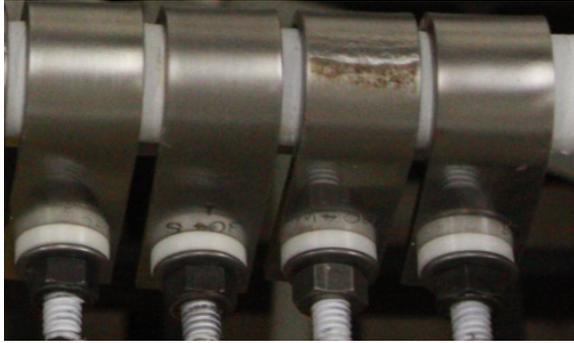
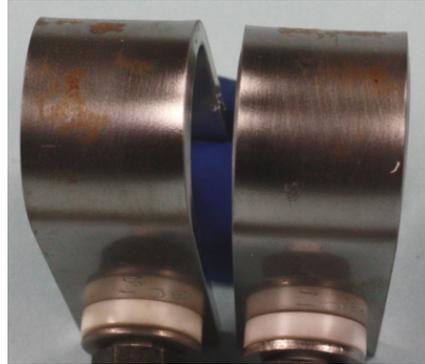
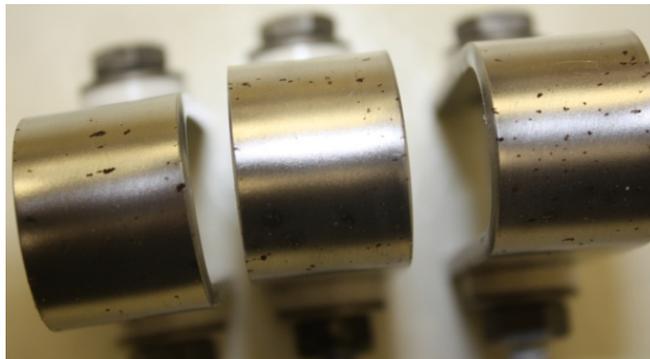
**Figure 3-30. Photographs of 0.1 g/m<sup>2</sup> Exposed Type 304 U-Bend Specimens Held at 35 °C [95 °F] for (a) 1 Month, (b) 4 Months, and (c) 12 Months**

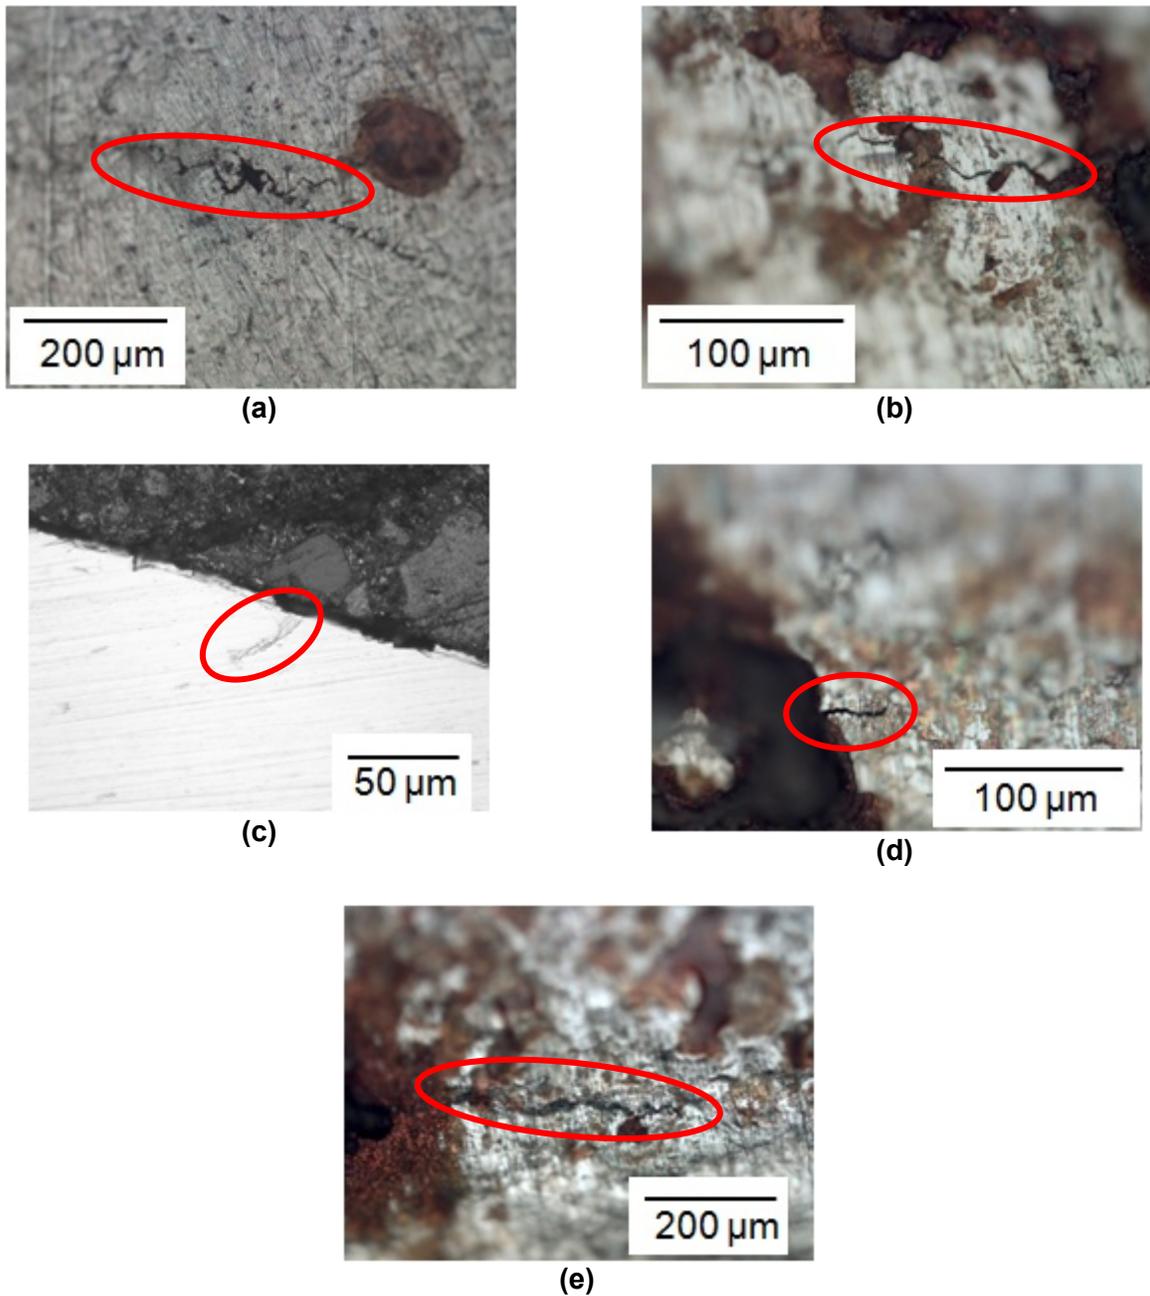
**Figure 3-31. Optical Micrographs of 0.1 g/m<sup>2</sup> U-Bend Specimens Held at 35 °C [95 °F]. Sensitized Type 304 Specimens Exposed for (a) 4 Months From Surface and (b) 12 Months From Surface. As-Received Specimens Exposed for (c) 4 Months From Cross Section and (d) 12 Months From Cross Section. Welded Specimens Exposed for (e) 12 Months From Surface. Red Circles Highlight the Cracks.**

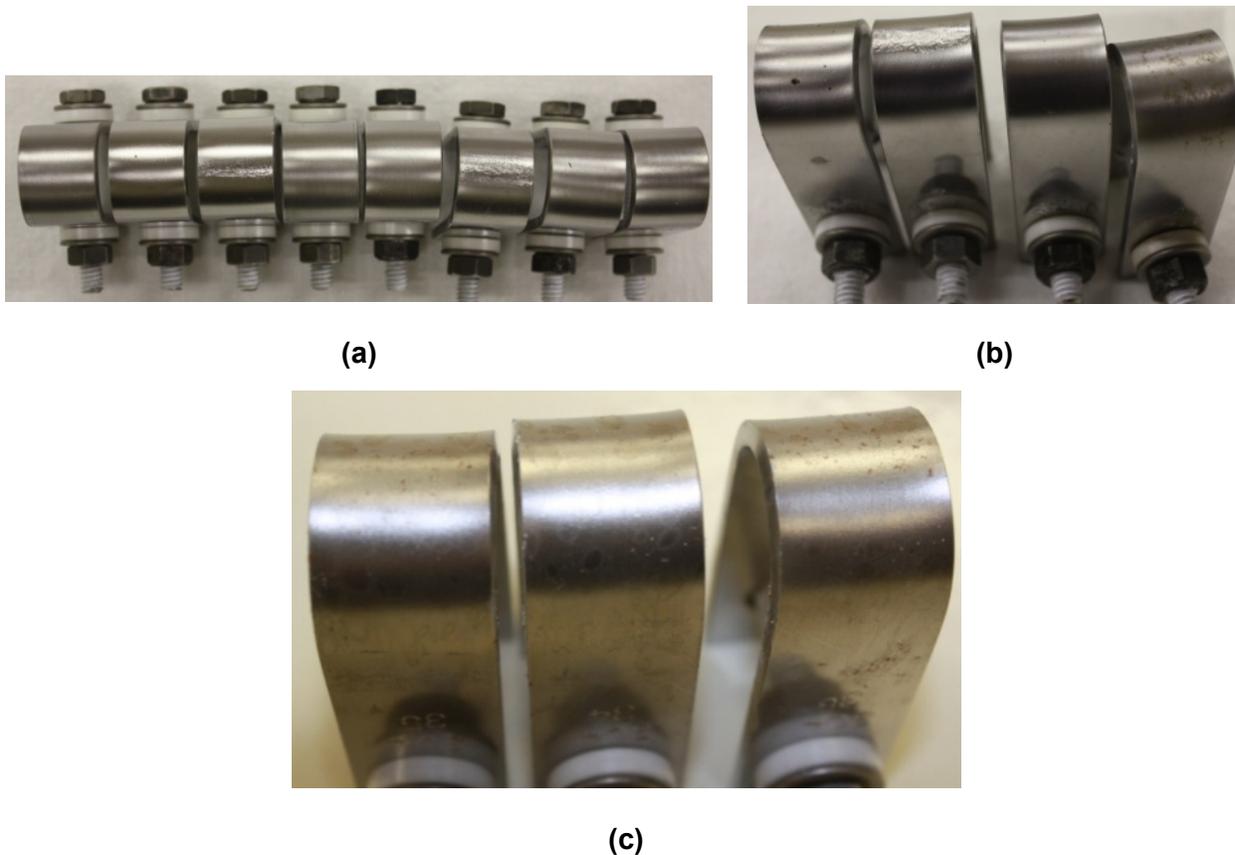
**Figure 3-32. Photographs of 0.1 g/m<sup>2</sup> Exposed Type 304 U-Bend Specimens Held at 45 °C [113 °F] for (a) 1 Month and (b) 4 Months**

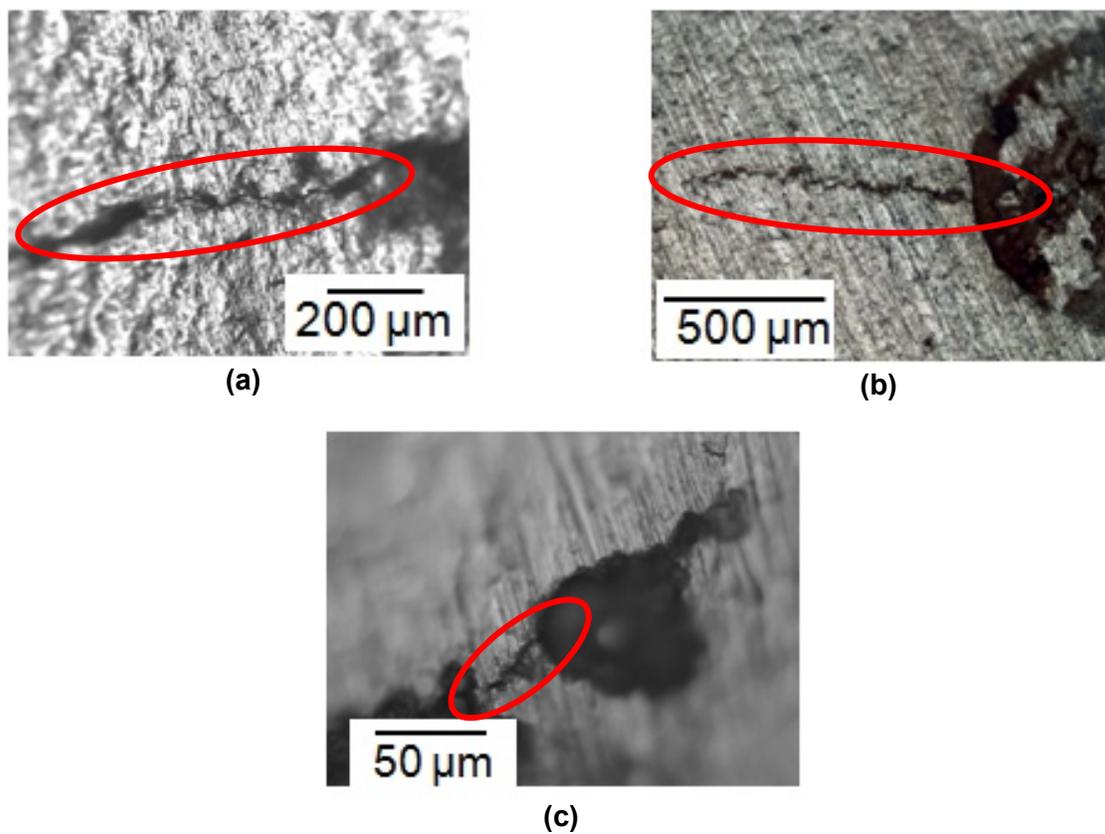
**Figure 3-33. Surface Optical Micrographs of 0.1 g/m<sup>2</sup> U-Bend Specimens Held at 45 °C [113 °F] Sensitized Type 304 Specimens Exposed for (a) 4 Months and (b) 12 Months. As-Received Specimen Exposed for (c) 4 Months. Red Circles Highlight the Cracks.**

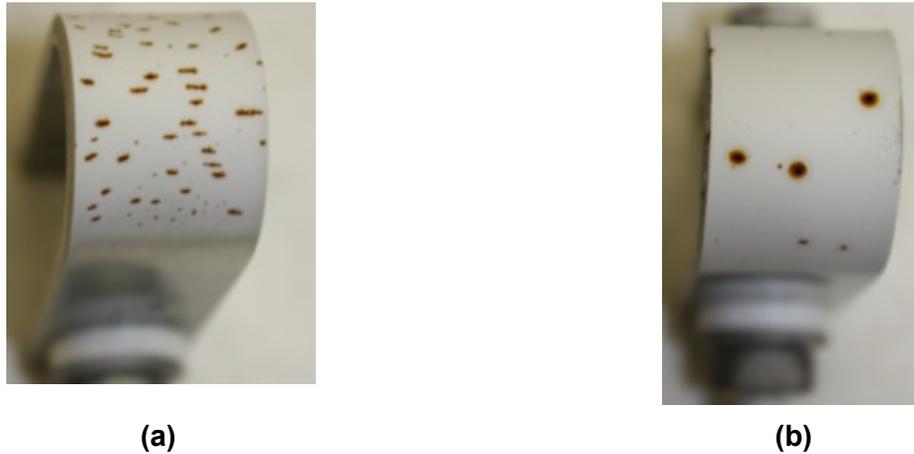
**Figure 3-34. Photographs of 10 g/m<sup>2</sup> Type 304 U-Bend Specimens Held at 45 °C [113 °F] and 44 Percent Relative Humidity for (a) Sensitized and (b) As-Received Conditions**

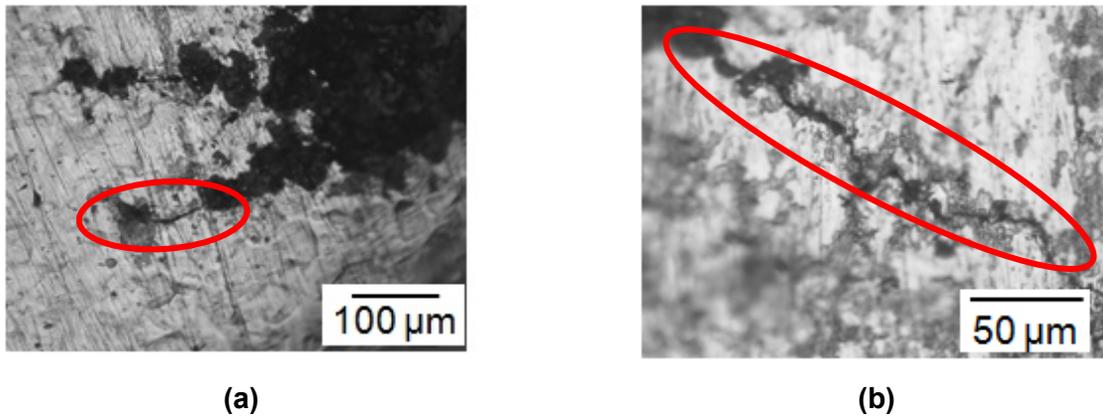
**Figure 3-35. Surface Optical Micrographs of 10 g/m<sup>2</sup> Type 304 U-Bend Specimens Held at 45 °C [113 °F] and 44 Percent Relative Humidity for (a) Sensitized and (b) As-Received Conditions. Red Circles Highlight the Cracks.**

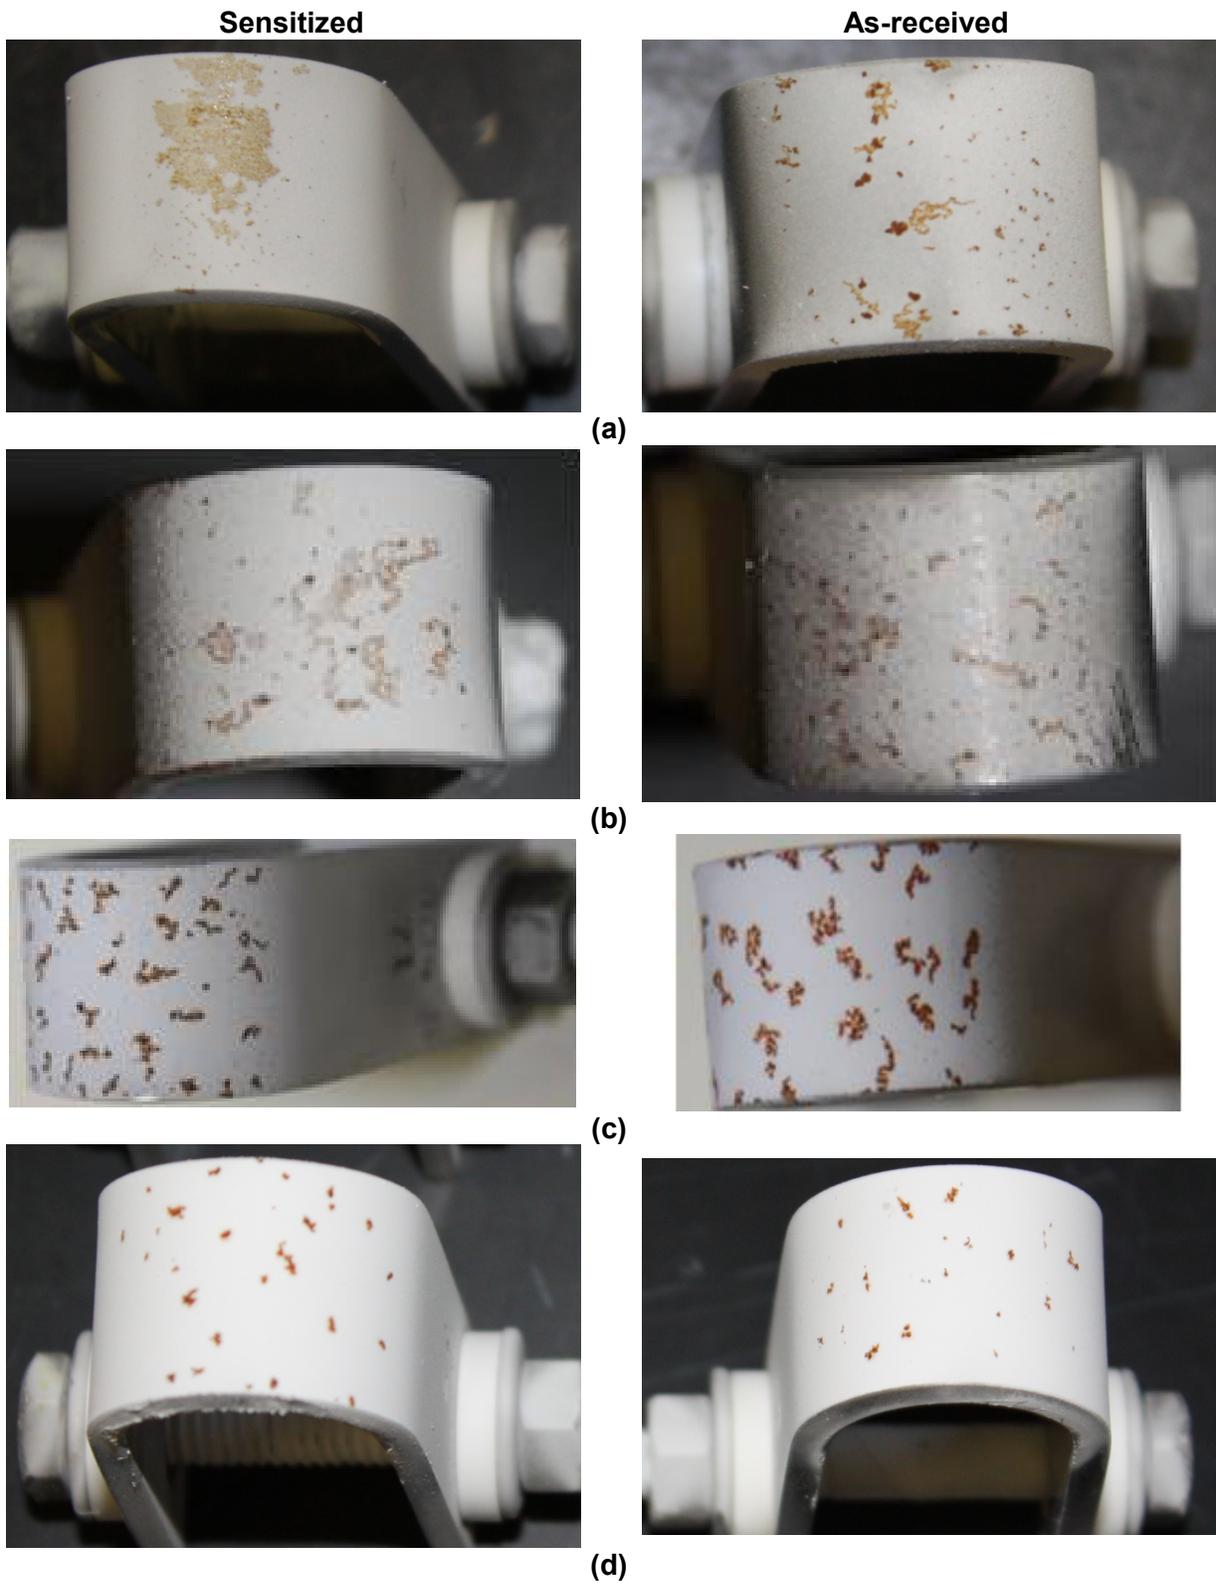
**Figure 3-36. Photographs of 10 g/m<sup>2</sup> Type 304 U-Bend Specimens Held at 60 °C [140 °F] and (a) 25, (b) 30, (c) 35, and (d) 40 Percent Relative Humidity**

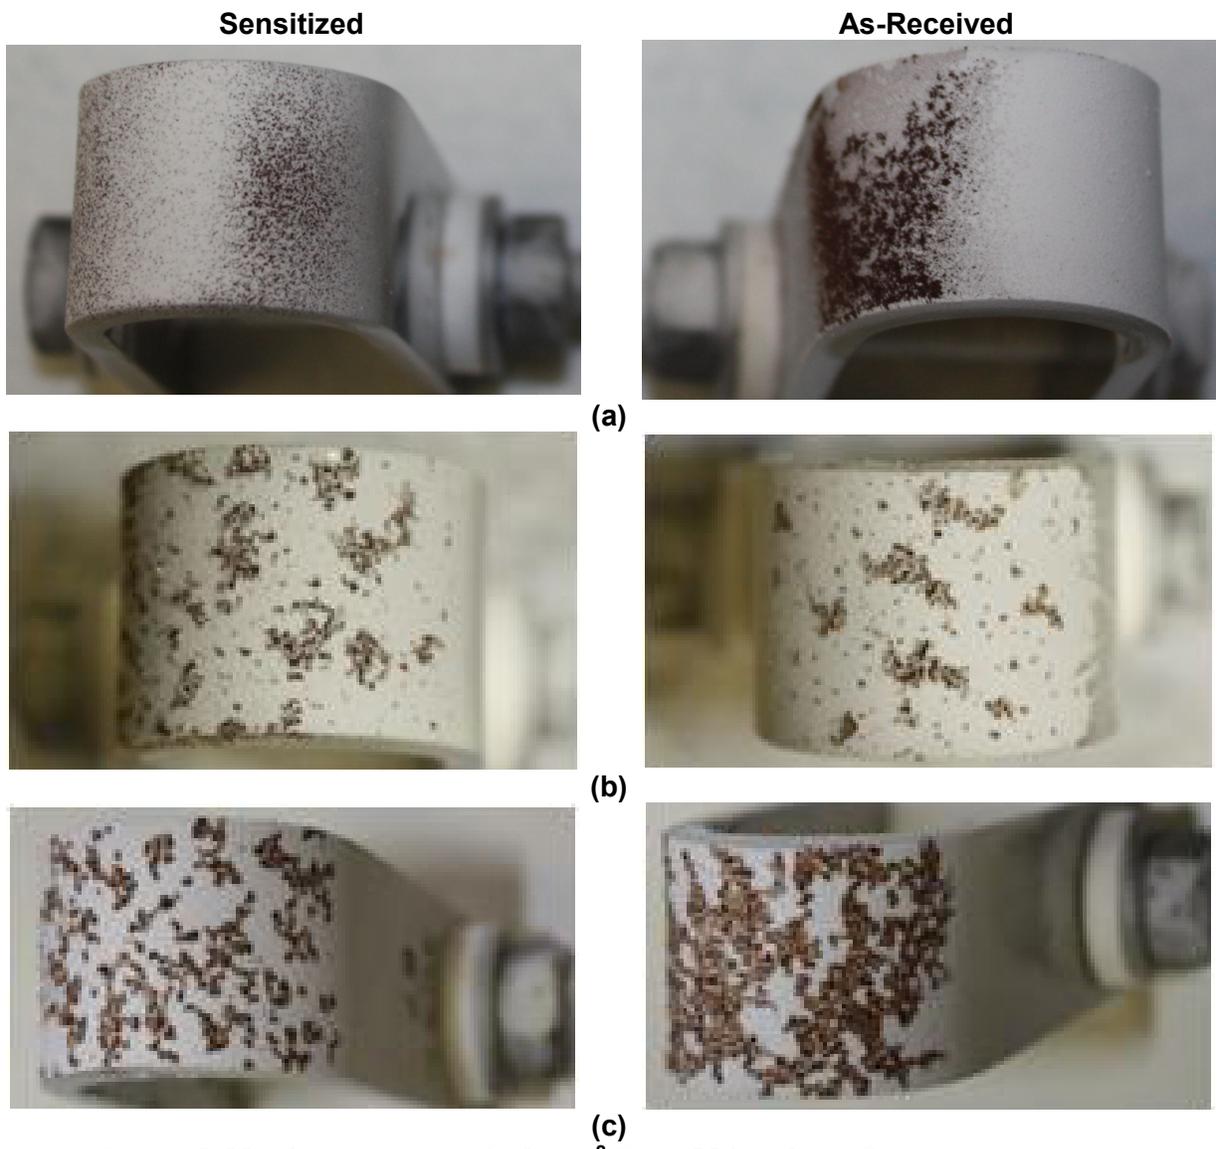
**Figure 3-38. Photographs of 10 g/m<sup>2</sup> Type 304 U-Bend Specimens Held at 80 °C [176 °F] and (a) 28, (b) 35, and (c) 40 Percent Relative Humidities**

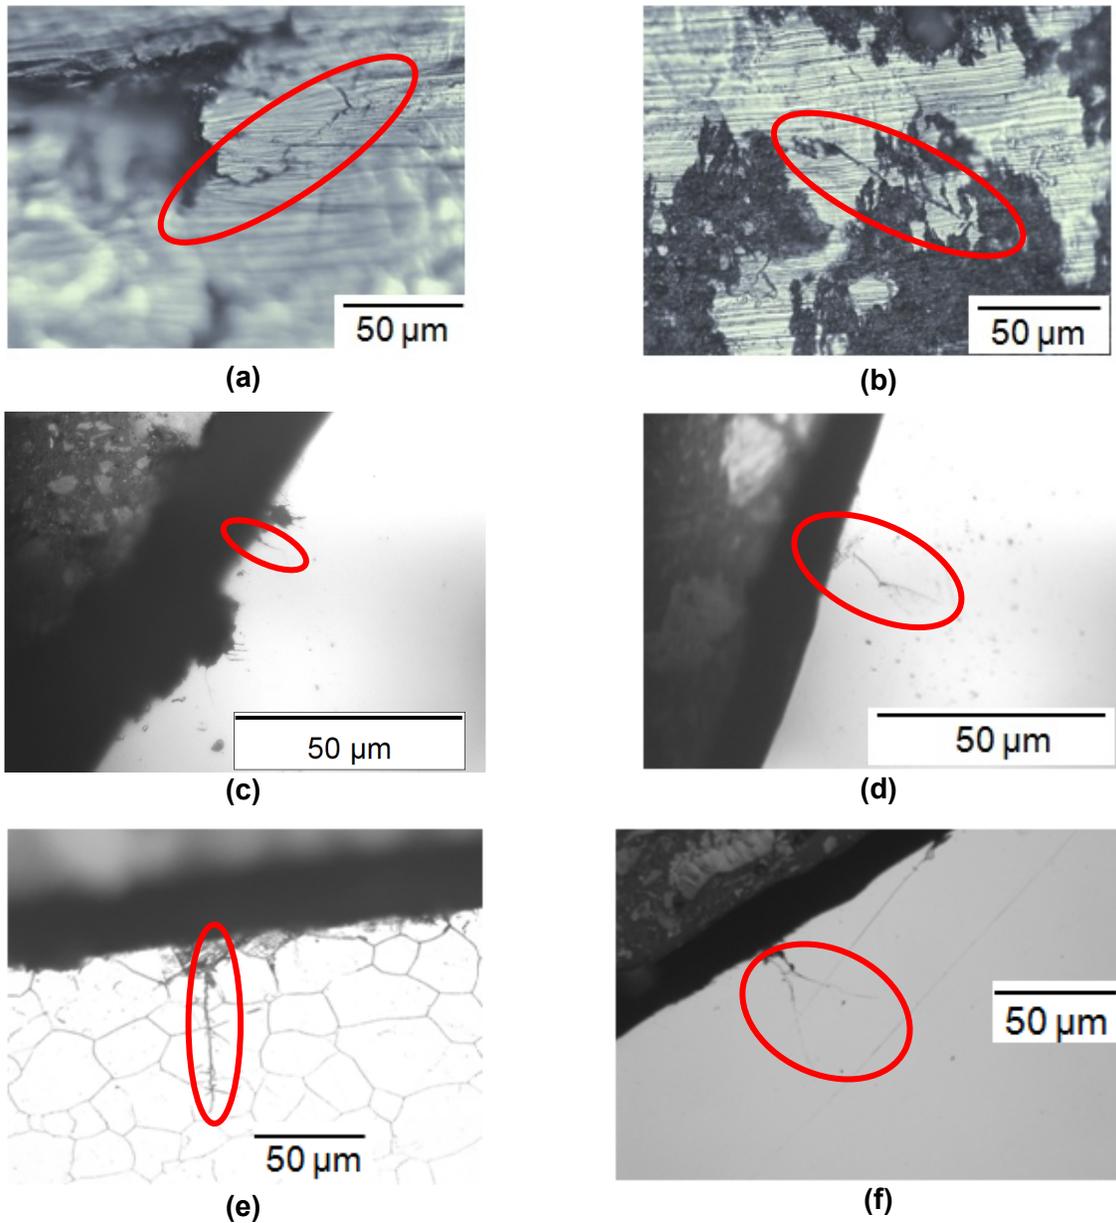
**Figure 3-39. Optical Micrographs of 10 g/m<sup>2</sup> Type 304 U-Bend Specimens Held at 80 °C [176 °F] and 28 Percent Relative Humidity for (a) Surface of Sensitized and (b) Surface of As-Received, 35 Percent Relative Humidity for (c) Cross Section of Sensitized and (d) Cross Section of As-Received Conditions, and 40 Percent Relative Humidity for (e) Cross Section of Sensitized and (f) Cross Section of As-Received Conditions. Red Circles Highlight the Cracks.**

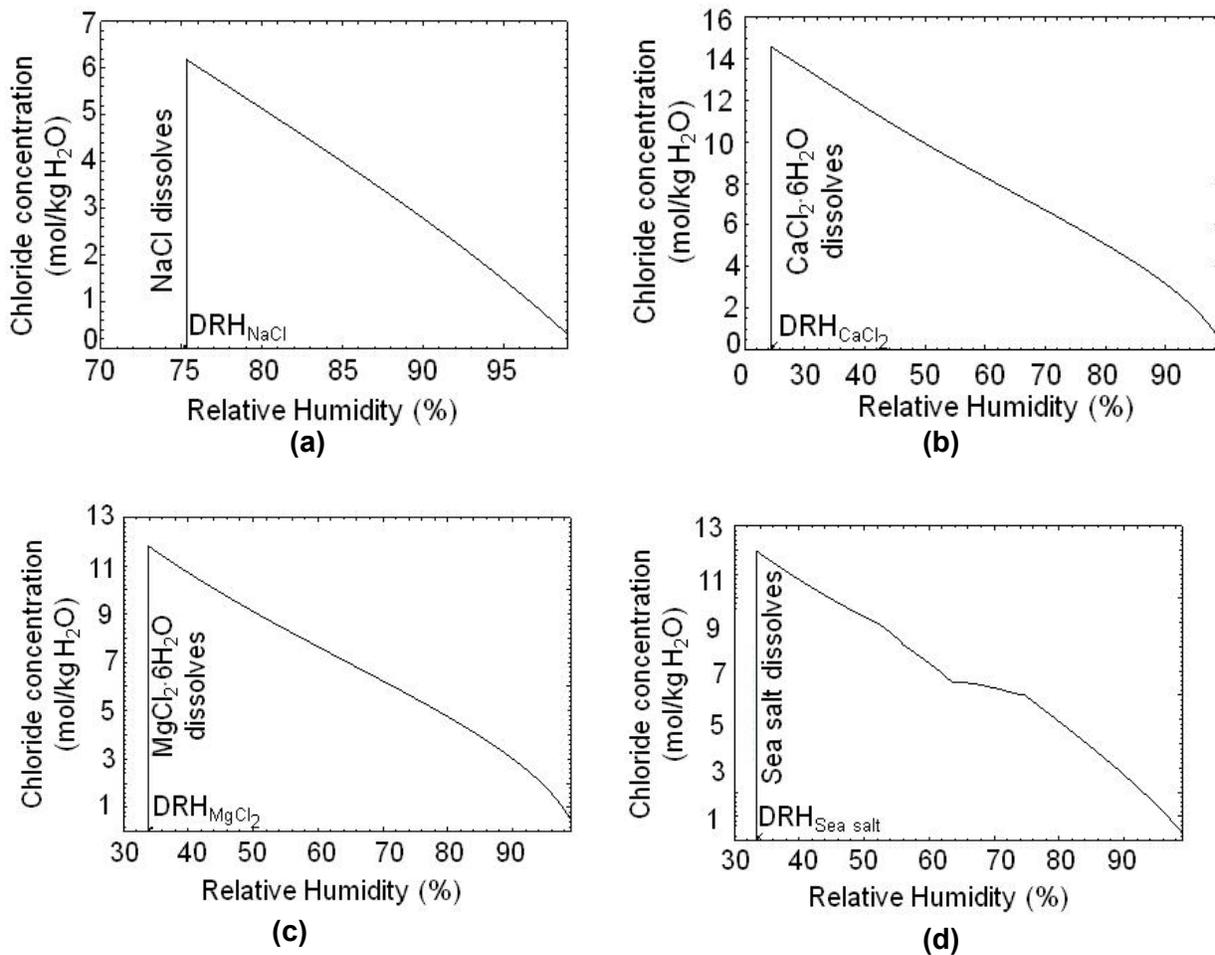
**Figure 3-40. Calculated Chloride Concentrations With Increasing Relative Humidity at 30 °C [86 °F] for (a) NaCl, (b) CaCl<sub>2</sub>, (c) MgCl<sub>2</sub>, and (d) Sea Salt**

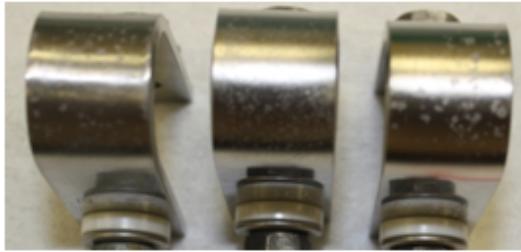
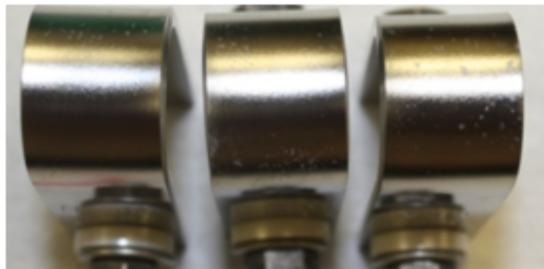
**Figure 3-41. Posttest Specimens Deposited With 10 g/m<sup>2</sup> Sea Salt Exposed to 30 °C [86 °F] and 90 Percent Relative Humidity for 5 Weeks: (a) As-Received and (b) Sensitized**

For the U-bend specimens deposited with sea salt, shown in Figure 3-41, the salt appeared to quickly deliquesce and drain off the side. The specimens were left shiny, with no visible corrosion products but with some white scales, which may be the undeliquesced constituents of the salt. This is similar to the appearance of the specimens used for cyclic humidity testing at 27 °C [81 °F]. The specimens were examined by optical microscopy at up to 500 times magnification. One magnified surface area covered with scale is shown in Figure 3-41(a). There is minor pitting on the surface of all as-received and sensitized specimens, such as the one shown in Figure 3-41(b), but the pits were shallow and small. No SCC initiation was observed.

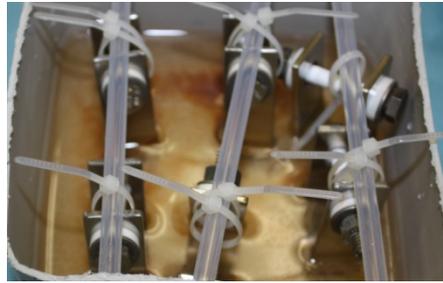
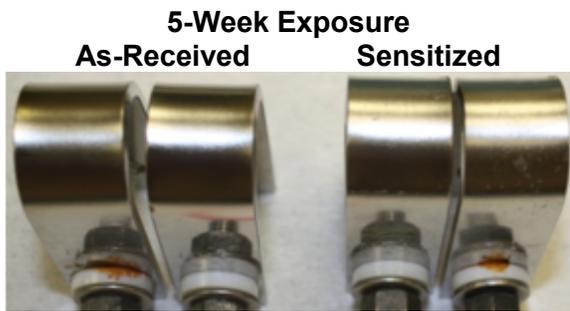
**Figure 3-43. (a) CaCl<sub>2</sub> Solution at 5 Weeks and (b) U-Bend Specimens After 5-Week and 4-Month Exposures. Cracks Observed on (c) As-Received and (d) Sensitized Specimens Immersed in CaCl<sub>2</sub> Solution Equilibrated at 30 °C [86 °F] and 90 Percent Relative Humidity for 5 Weeks. Red Circles Highlight the Cracks.**

For the specimens immersed in NaCl, MgCl<sub>2</sub>, and CaCl<sub>2</sub> solutions, Figures 3-42 through 3-44 show photographs of the test solutions and specimens after exposure, as well as optical micrographs. The solutions were yellowish in color from corrosion products. Pitting corrosion was observed on all specimens, mostly at the edges and sides. The extent of corrosion was similar after 5-week and 4-month exposures. SCC initiation was observed for specimens immersed in each solution. Cracks were found to grow outward from the pits, with a

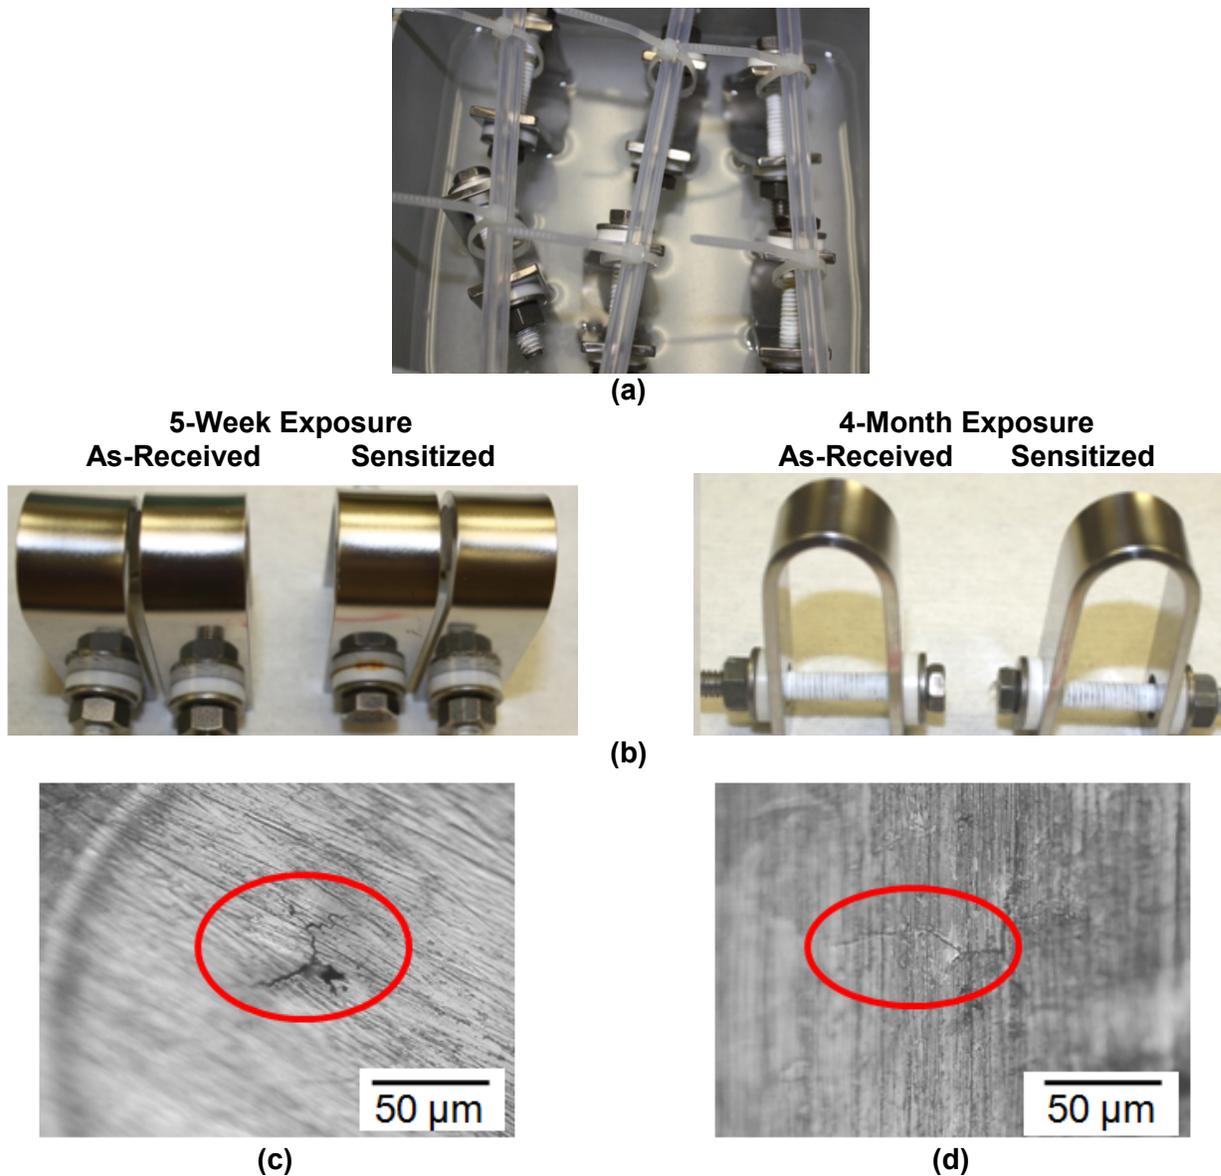
**Figure 3-45. (a) Sea Salt Solution at 5 Weeks and (b) U-Bend Specimens After 5-Week and 4-Month Exposures. Cracks Observed on (c) As-Received and (d) Sensitized Specimens Immersed in Sea Salt Solution Equilibrated at 30 °C [86 °F] and 90 Percent Relative Humidity for 5 Weeks. Red Circles Highlight the Cracks.**

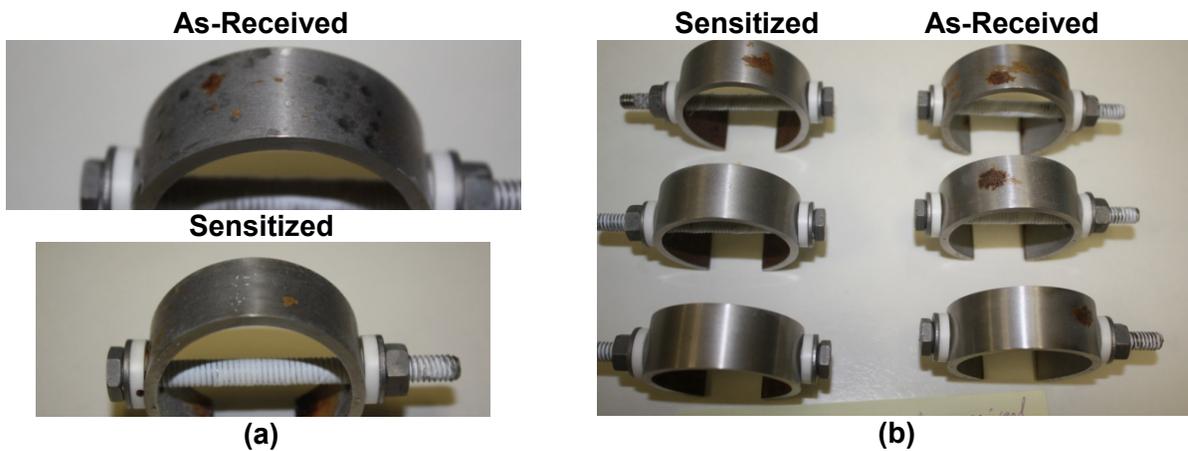
Figure 3-46. Photographs of Type 304L C-Ring Specimens Strained to 0.4 Percent Held at  $35 \text{ }^\circ\text{C}$  [ $95 \text{ }^\circ\text{F}$ ] and 72 Percent Relative Humidity for (a)  $10 \text{ g/m}^2$  After 3 Months and (b)  $1 \text{ g/m}^2$  After 2 Months

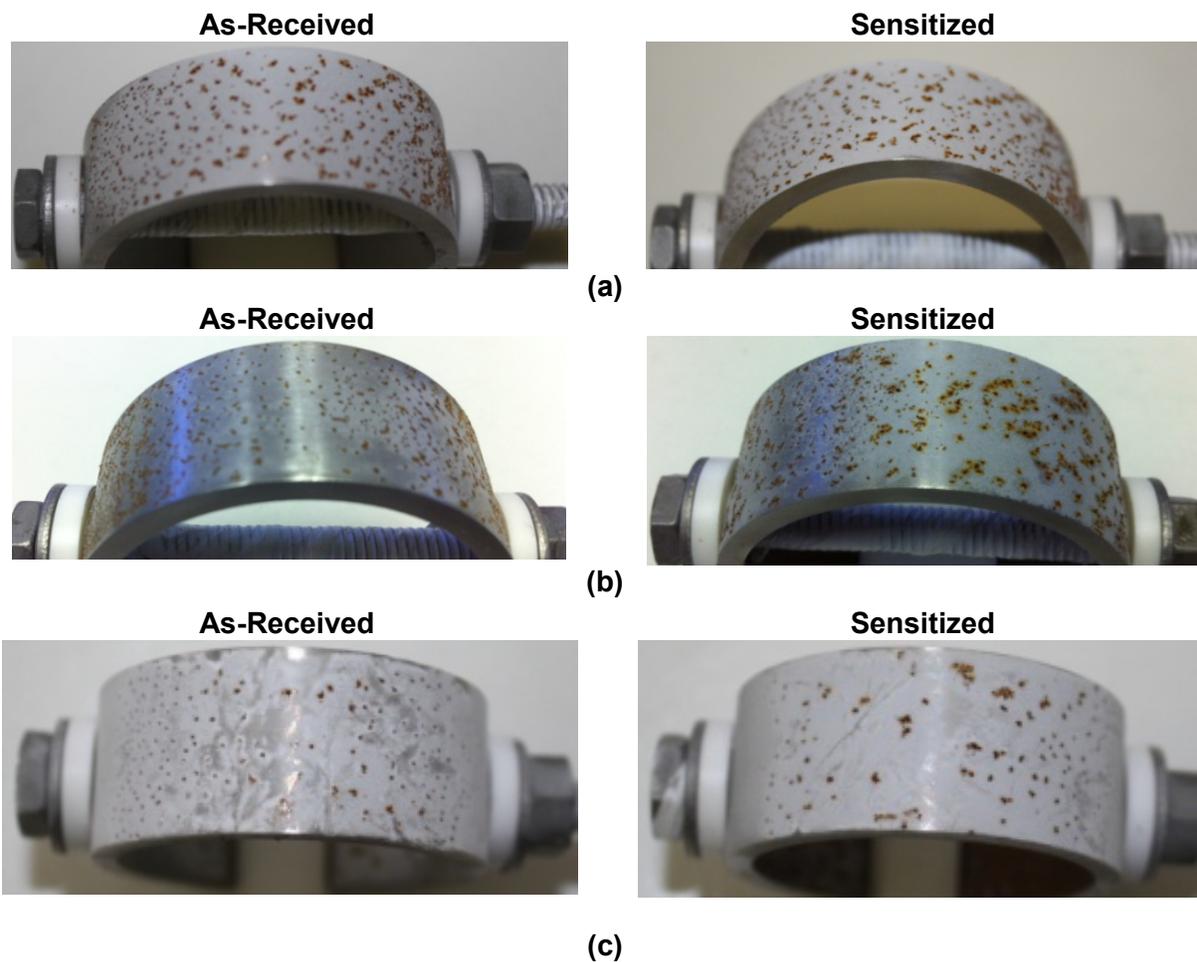
**Figure 3-48. Photographs of Type 304L C-Ring Specimens Held at 45 °C [113 °F] and 44 Percent Relative Humidity for 0.4 Percent Strain Specimens at (a) 10 g/m<sup>2</sup>, (b) 1 g/m<sup>2</sup>, and (c) 1.5 Percent Strain Specimens at 10 g/m<sup>2</sup>**

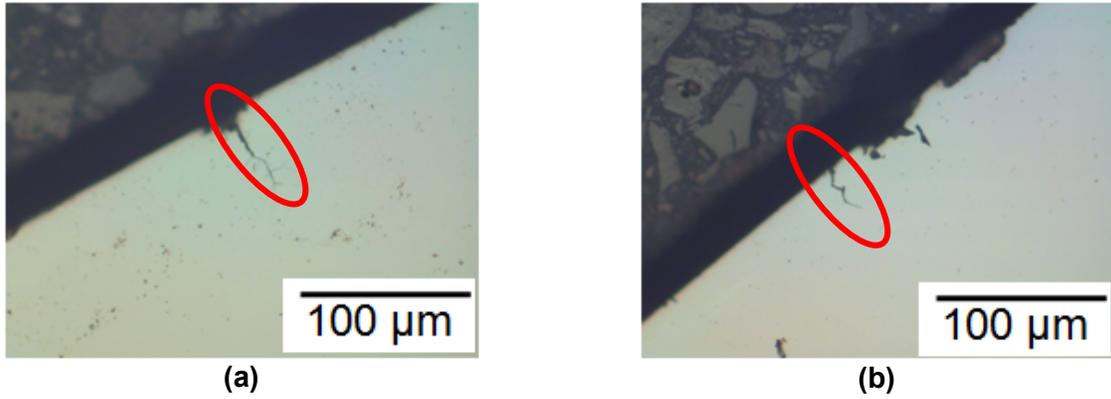
**Figure 3-49. Cross Section Optical Micrographs of 1.5 Percent Strained Type 304L C-Ring Specimens With  $10 \text{ g/m}^2$  Held at  $45 \text{ }^\circ\text{C}$  [ $113 \text{ }^\circ\text{F}$ ] and 44 Percent Relative Humidity in the (a) Sensitized and (b) As-Received Condition. Red Circles Highlight the Cracks.**

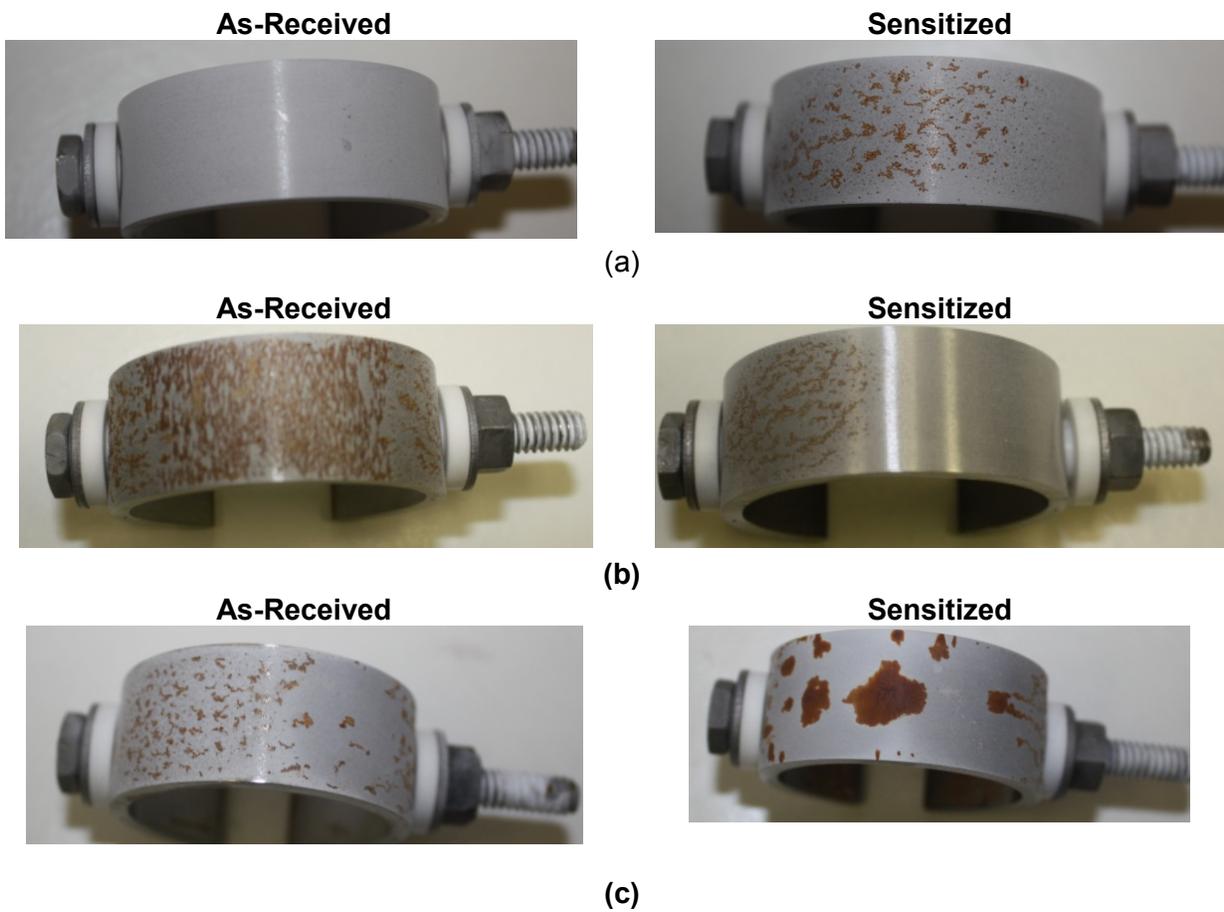
**Figure 3-50. Photographs of Type 304L C-Ring Specimens Held at  $52 \text{ }^\circ\text{C}$  [ $126 \text{ }^\circ\text{F}$ ] and 32 Percent Relative Humidity for 0.4 Percent Strain Specimens at (a)  $10 \text{ g/m}^2$ , (b)  $1 \text{ g/m}^2$ , and (c) 1.5 Percent Strain Specimens at  $10 \text{ g/m}^2$**

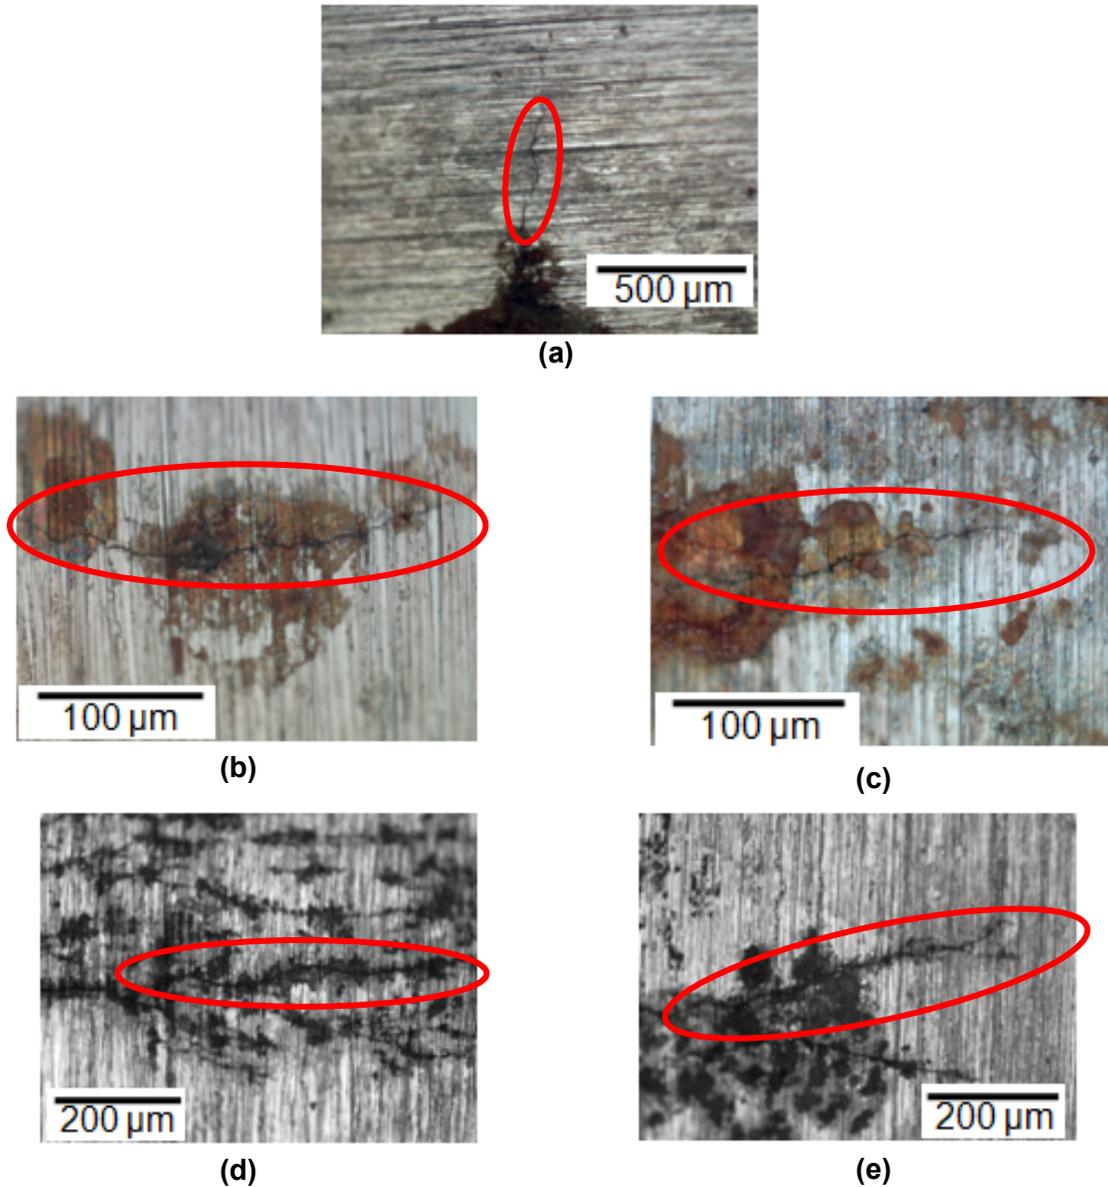
**Figure 3-51. Optical Micrographs of Type 304L C-Ring Specimens Held at 52 °C [126 °F] and 32 Percent Relative Humidity. Cracks Were Observed in (a) Sensitized Specimens Held at 0.4 Percent Strain With 10 g/m<sup>2</sup>. Cracks Were Also Seen in (b) Sensitized and (c) As-Received C-Rings Held at 0.4 Percent Strain With 1 g/m<sup>2</sup>. Finally, Cracks Were Observed in (d) Sensitized and (e) As-Received C-Rings Held at 1.5 Percent Strain With 10 g/m<sup>2</sup>. Red Circles Highlight the Cracks.**

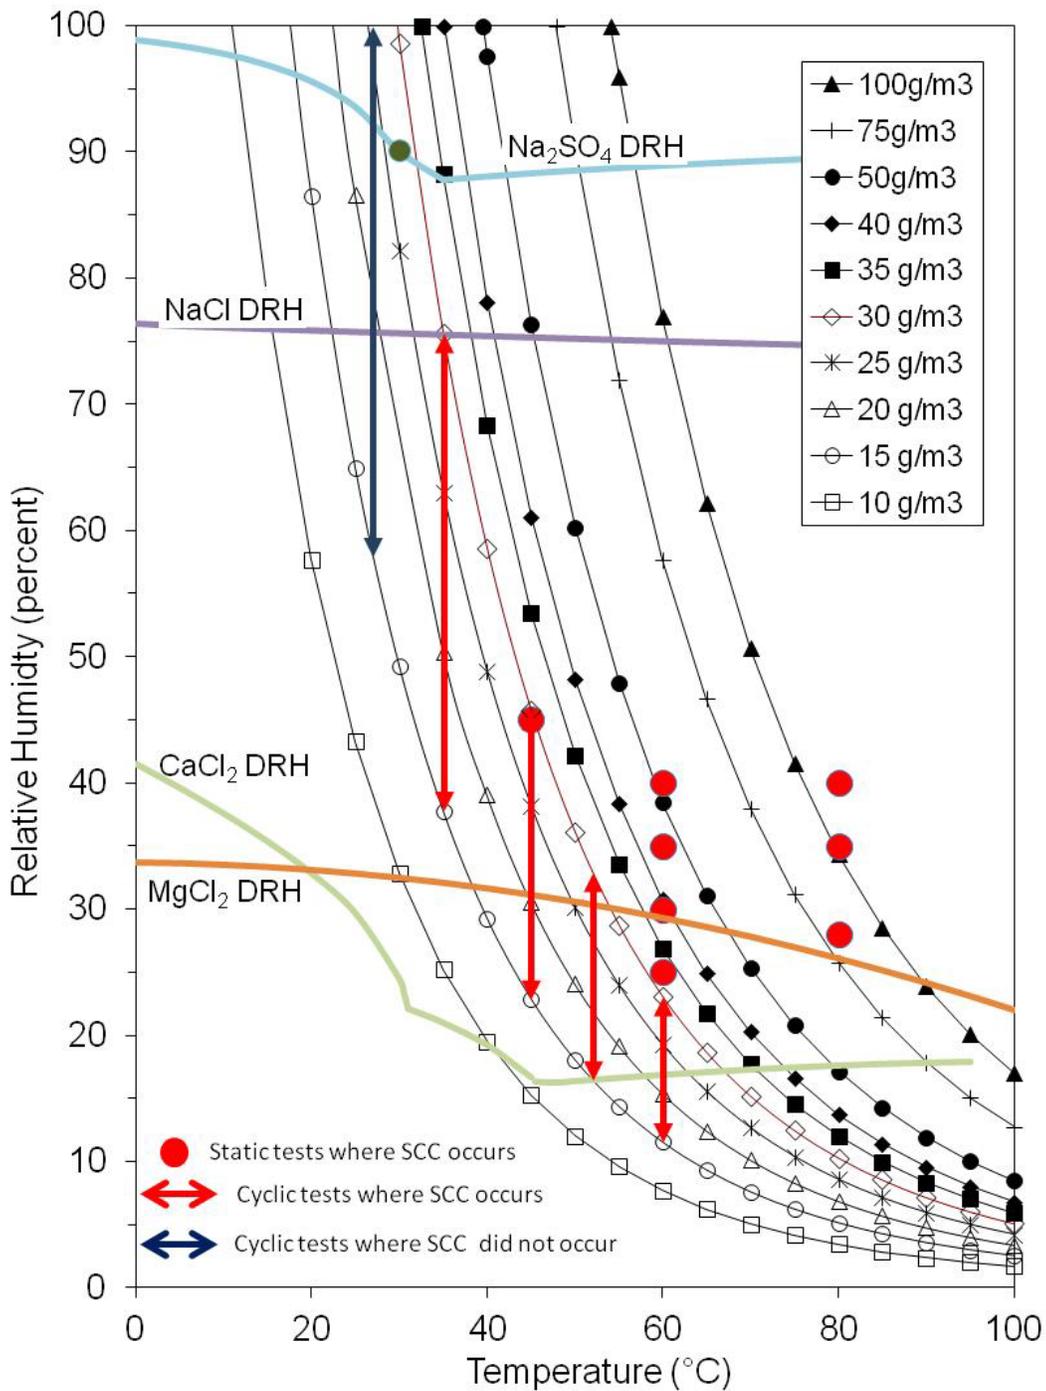
**Figure 3-52. Stress Corrosion Cracking Susceptibility Map From Both Cyclic and Static U-Bend Tests**

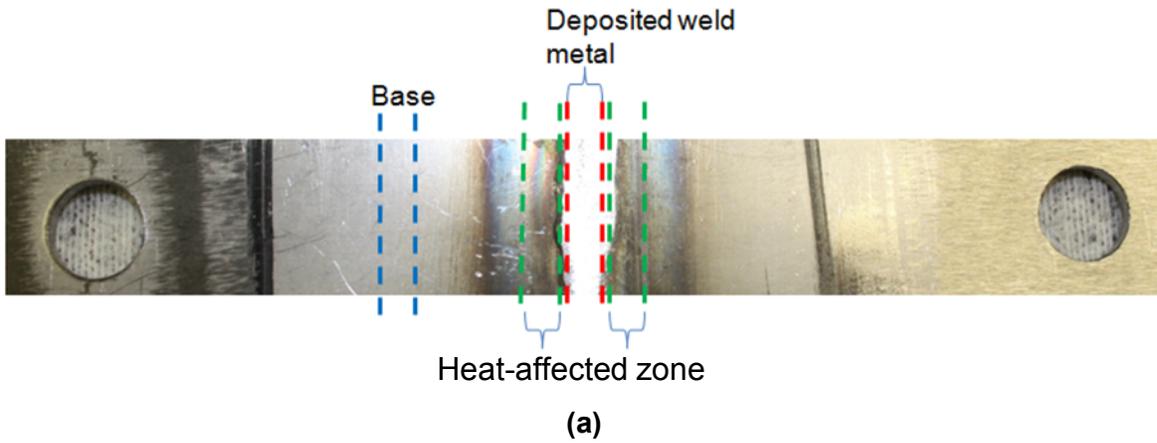
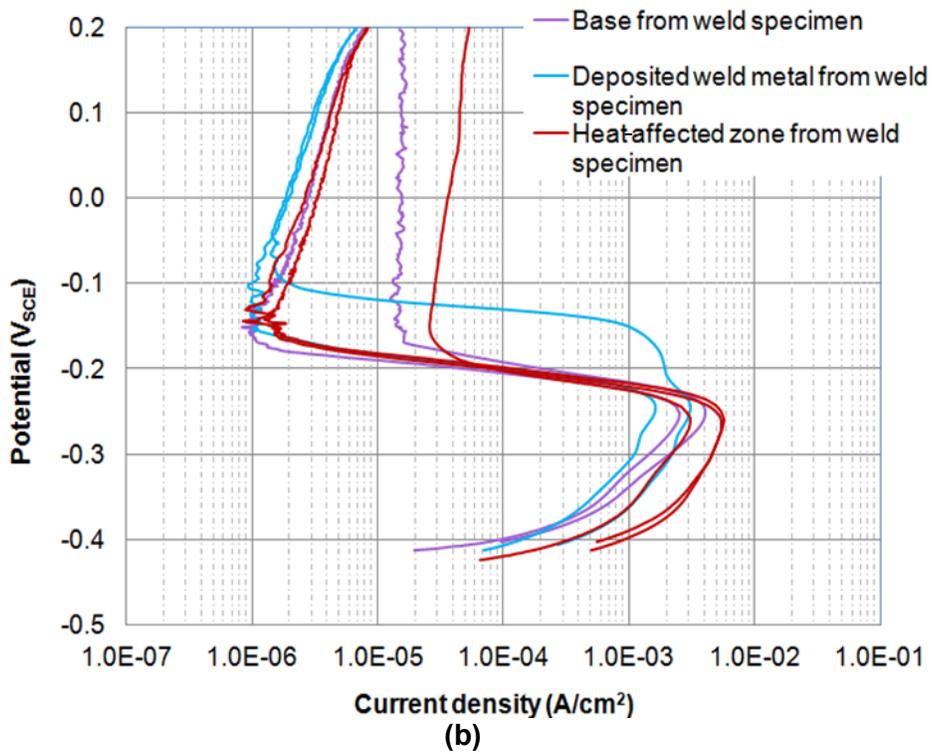
**Figure 3-53. (a) Weld Specimen and (b) Electrochemical Reactivation Curves Following ASTM G108–94 (ASTM International, 2010) for Type 304 Stainless Steel Base, Heat-Affected Zone Sections, and Type 308 Stainless Steel Cut From Weld-Deposited Weld Metal**
