# **Assessment of Stress Corrosion Cracking Susceptibility for Austenitic Stainless Steels Exposed to Atmospheric Chloride and Non-Chloride Salts**

NUREG/CR-7170

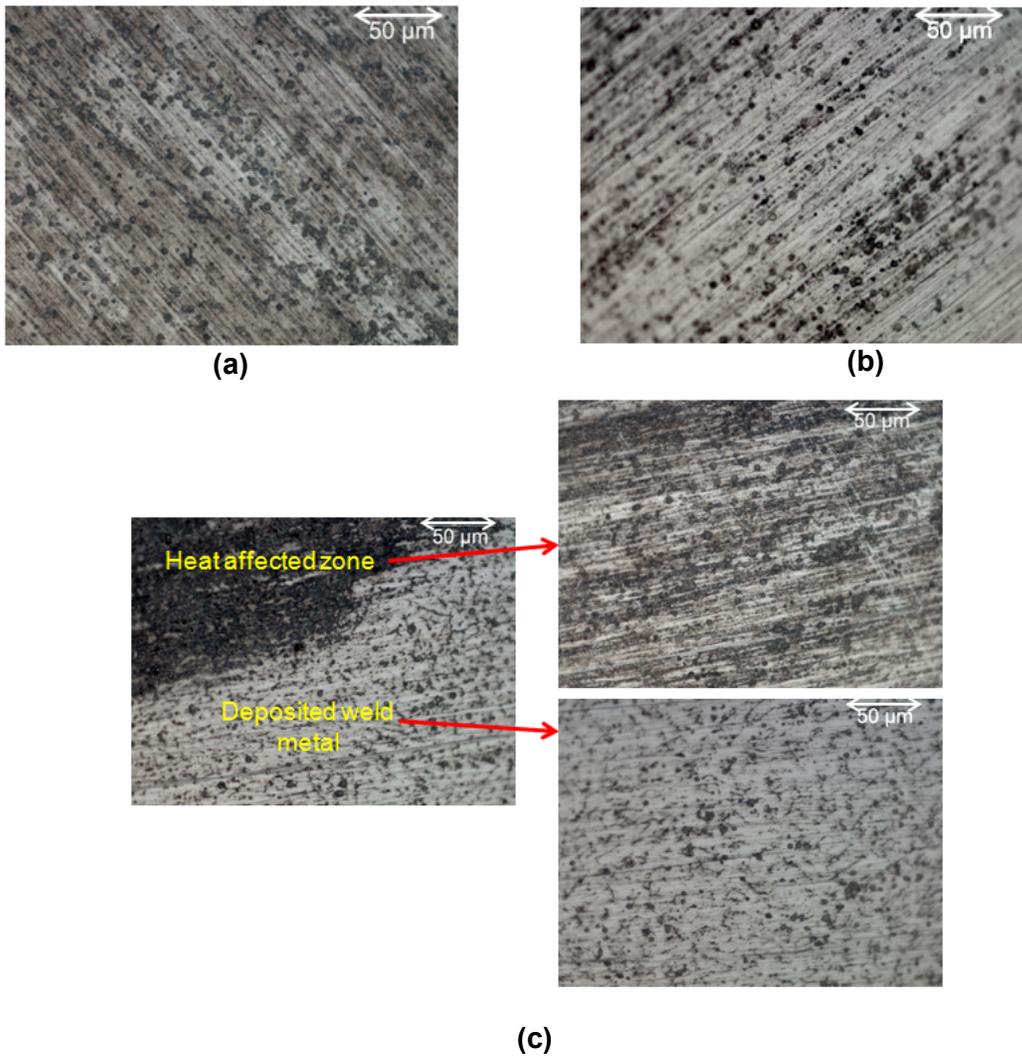
**Figure 3-54. Micrographs of Type 304 Stainless Steel Weld Specimen After Electrochemical Reactivation Tests Following ASTM G108–94 (ASTM International, 2010): (a) Base, (b) Heat-Affected Zone, and (c) Mainly Deposited Weld Metal**

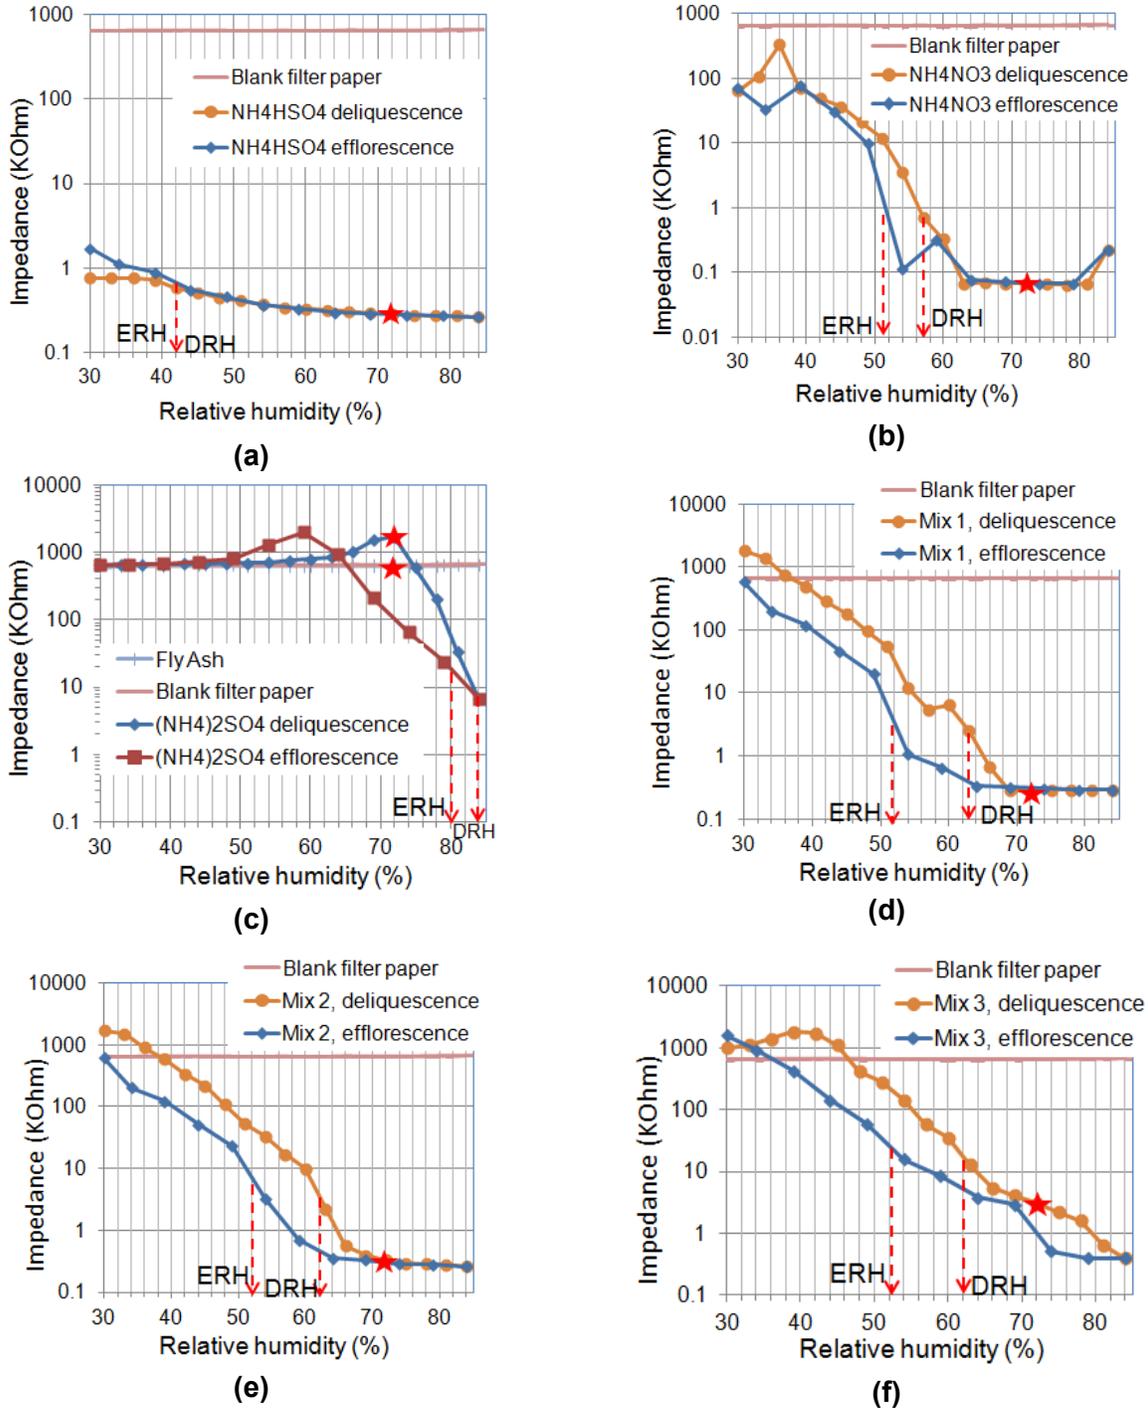
**Figure 4-3. Impedance Measured Using Conductivity Cells at 35 °C [95 °F] for Systems Containing (a)  $\text{NH}_4\text{HSO}_4$ , (b)  $\text{NH}_4\text{NO}_3$ , (c)  $(\text{NH}_4)_2\text{SO}_4$  and Fly Ash, (d) Mixture 1:  $(\text{NH}_4)_2\text{SO}_4/\text{NH}_4\text{NO}_3 = 0.5$ , (e) Mixture 2:  $(\text{NH}_4)_2\text{SO}_4/\text{NH}_4\text{NO}_3 = 1.0$ , and (f) Mixture 3:  $(\text{NH}_4)_2\text{SO}_4/\text{NH}_4\text{NO}_3 = 3.0$ . The Red Star Indicates 72 Percent Relative Humidity (Absolute Humidity of 30  $\text{g}/\text{m}^3$ ). Also Shown Is the Measured Impedance for the Blank Filter Paper With No Salt Present. [Note in Figure Legend:  $\text{NH}_4\text{HSO}_4 = \text{NH}_4\text{HSO}_4$ ,  $\text{NH}_4\text{NO}_3 = \text{NH}_4\text{NO}_3$ ,  $(\text{NH}_4)_2\text{SO}_4 = (\text{NH}_4)_2\text{SO}_4$ .]**

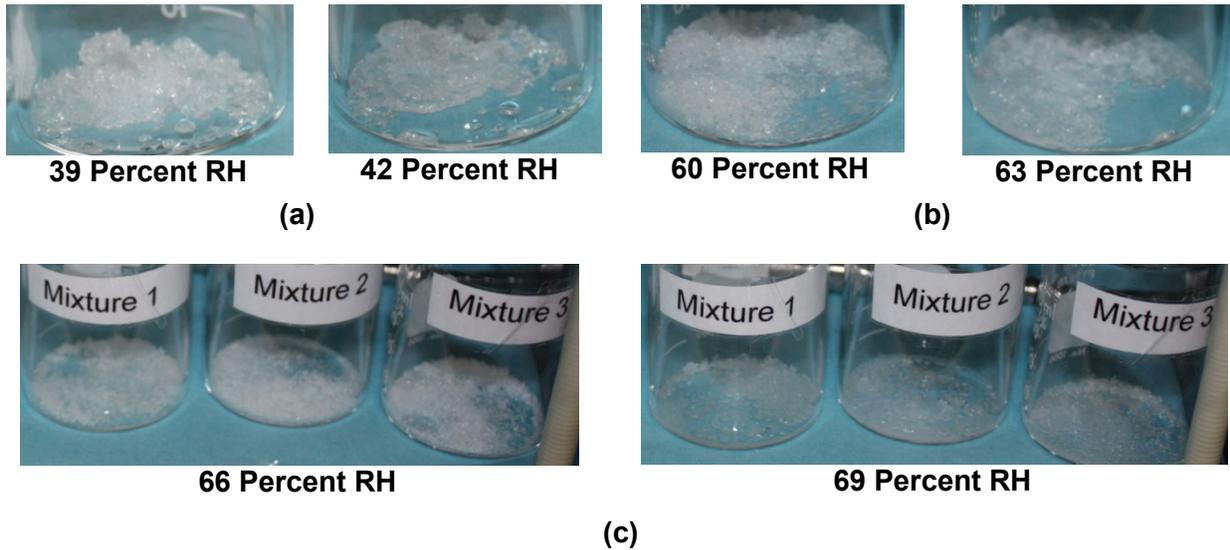
**Figure 4-4. Observation From Beakers at 35 °C [95 °F] for Deliquescence Tests at Increasing Relative Humidity: (a)  $\text{NH}_4\text{HSO}_4$ , (b)  $\text{NH}_4\text{NO}_3$ , and (c) Mixture 1:  $(\text{NH}_4)_2\text{SO}_4/\text{NH}_4\text{NO}_3 = 0.5$ , Mixture 2:  $(\text{NH}_4)_2\text{SO}_4/\text{NH}_4\text{NO}_3 = 1.0$ , and Mixture 3:  $(\text{NH}_4)_2\text{SO}_4/\text{NH}_4\text{NO}_3 = 3.0$**

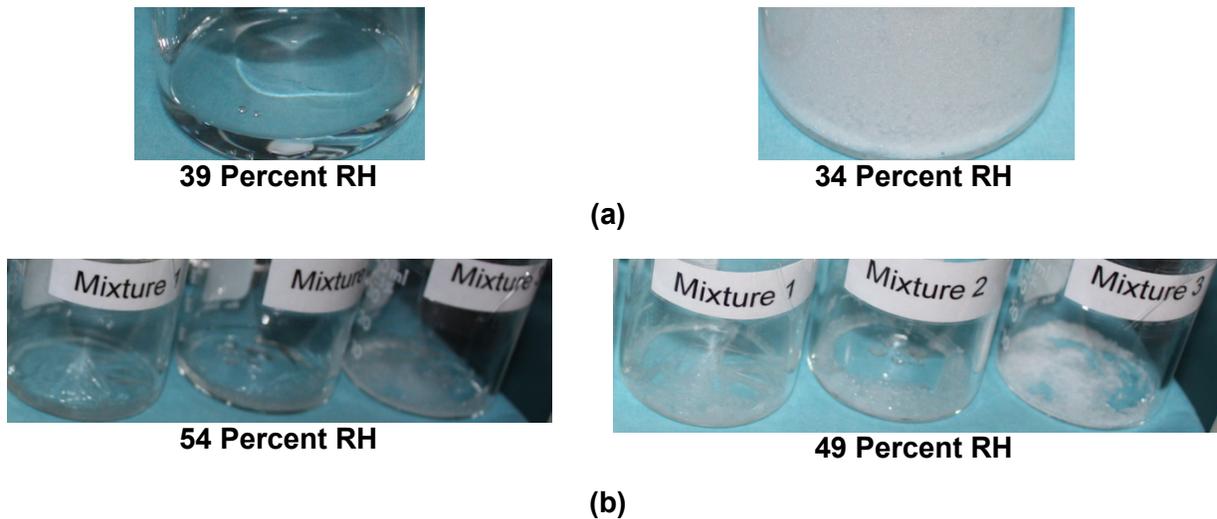
**Figure 4-5. Observation From Beakers at 35 °C [95 °F] for Efflorescence Tests at Decreasing Relative Humidity: (a)  $\text{NH}_4\text{NO}_3$  and (b) Mixture 1:  $(\text{NH}_4)_2\text{SO}_4/\text{NH}_4\text{NO}_3 = 0.5$ , Mixture 2:  $(\text{NH}_4)_2\text{SO}_4/\text{NH}_4\text{NO}_3 = 1.0$ , and Mixture 3:  $(\text{NH}_4)_2\text{SO}_4/\text{NH}_4\text{NO}_3 = 3.0$**

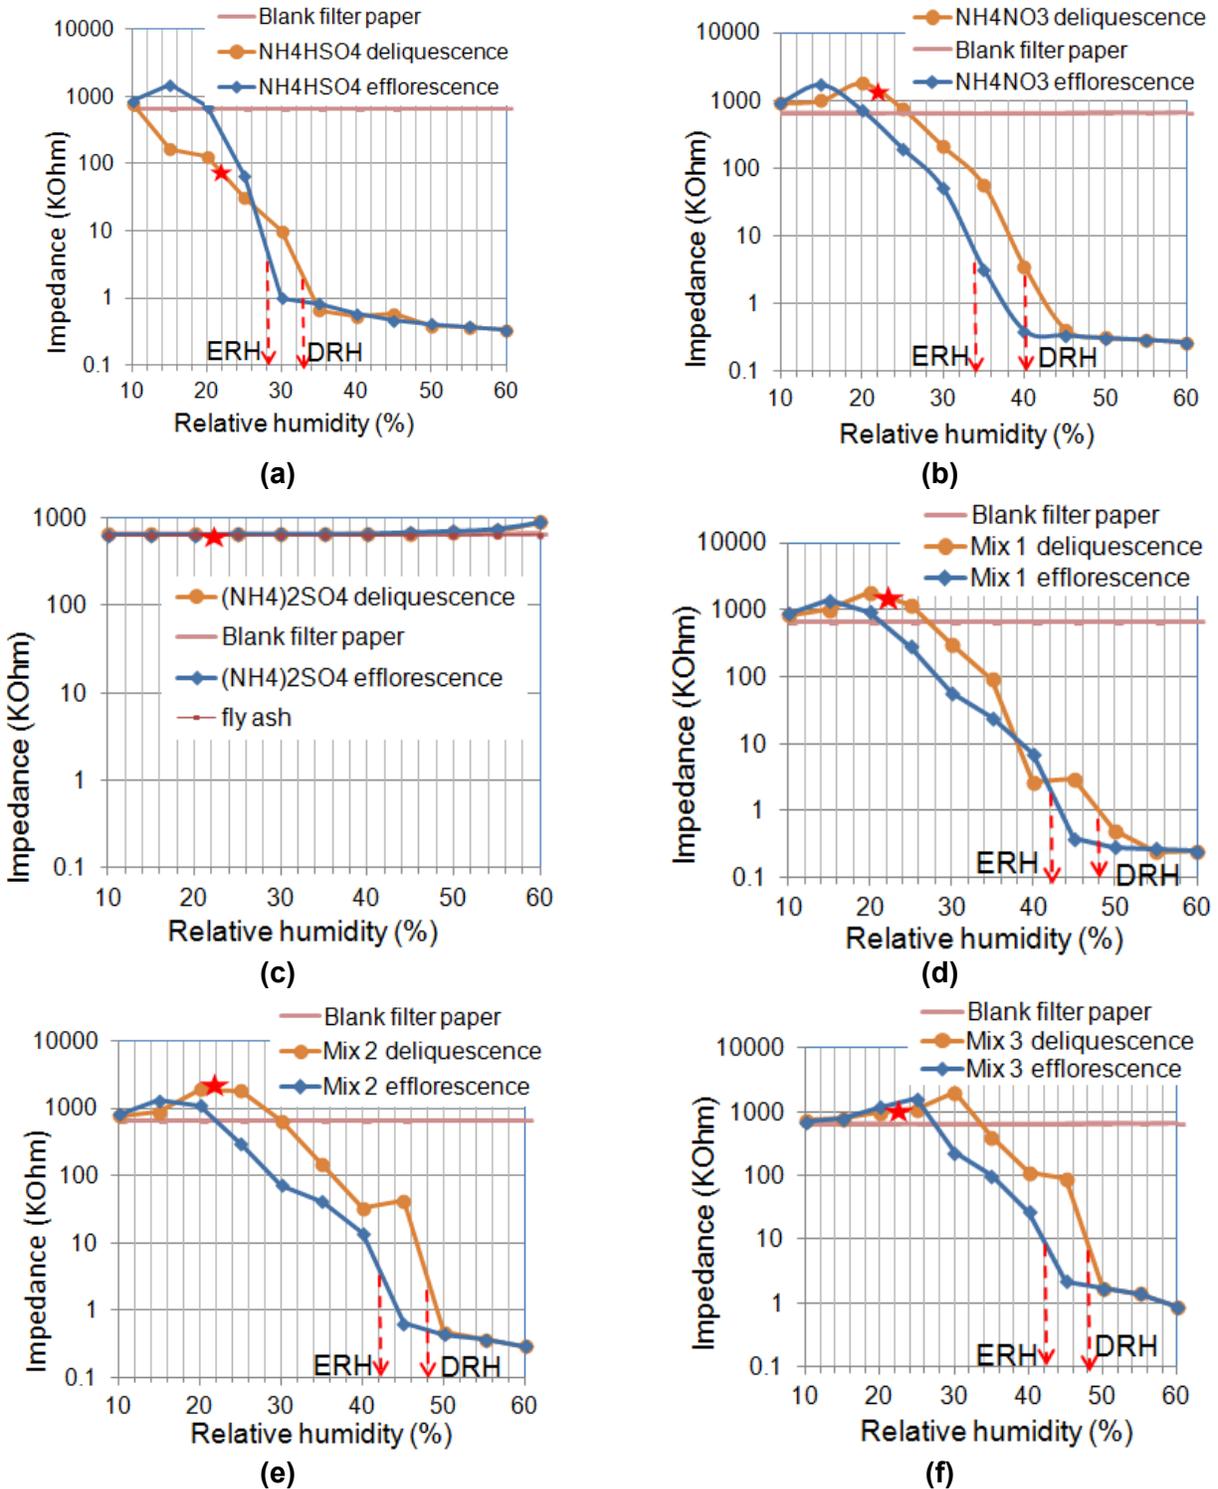
**Figure 4-9. Impedance Measured Using Conductivity Cells at 60 °C [140 °F] for Systems Containing (a) NH<sub>4</sub>HSO<sub>4</sub>, (b) NH<sub>4</sub>NO<sub>3</sub>, (c) (NH<sub>4</sub>)<sub>2</sub>SO<sub>4</sub> and Fly Ash, (d) Mixture 1: (NH<sub>4</sub>)<sub>2</sub>SO<sub>4</sub>/NH<sub>4</sub>NO<sub>3</sub> = 0.5, (e) Mixture 2: (NH<sub>4</sub>)<sub>2</sub>SO<sub>4</sub>/NH<sub>4</sub>NO<sub>3</sub> = 1.0, and (f) Mixture 3: (NH<sub>4</sub>)<sub>2</sub>SO<sub>4</sub>/NH<sub>4</sub>NO<sub>3</sub> = 3.0. The Red Star Indicates 22 Percent Relative Humidity (Absolute Humidity of 30 g/m<sup>3</sup>). [Note in Figure Legend: NH<sub>4</sub>HSO<sub>4</sub> = NH<sub>4</sub>HSO<sub>4</sub>, NH<sub>4</sub>NO<sub>3</sub> = NH<sub>4</sub>NO<sub>3</sub>, (NH<sub>4</sub>)<sub>2</sub>SO<sub>4</sub> = (NH<sub>4</sub>)<sub>2</sub>SO<sub>4</sub>.]**

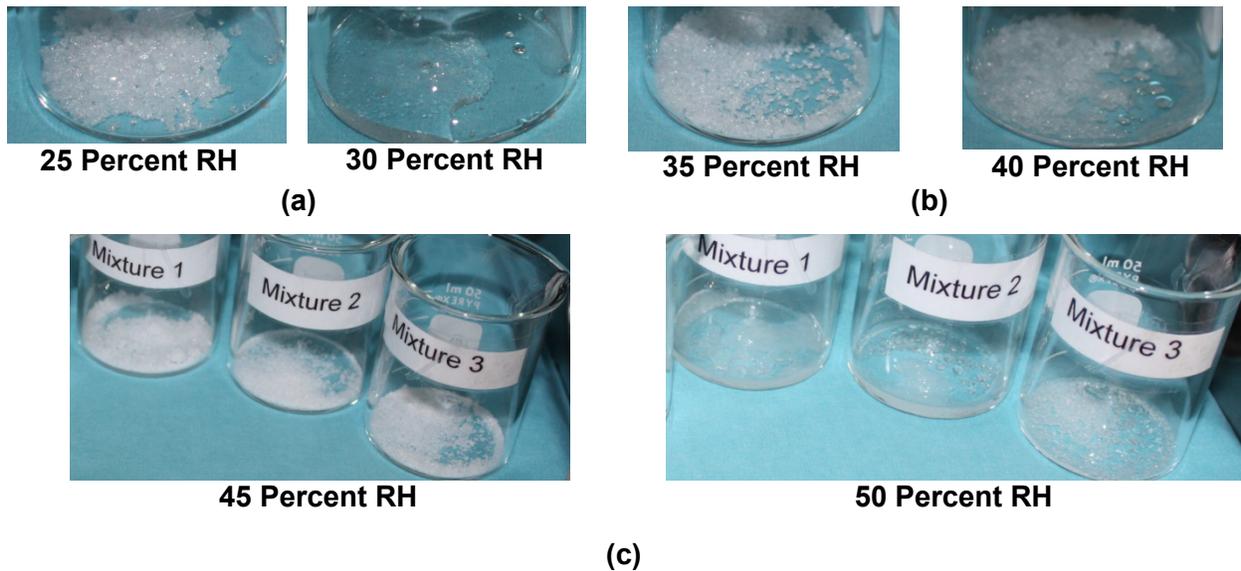
**Figure 4-10. Observation From Beakers at 60 °C [140 °F] for Deliquescence Tests at Increasing Relative Humidity: (a)  $\text{NH}_4\text{HSO}_4$ , (b)  $\text{NH}_4\text{NO}_3$ , and (c) Three  $(\text{NH}_4)_2\text{SO}_4$  and  $\text{NH}_4\text{NO}_3$  Mixtures**

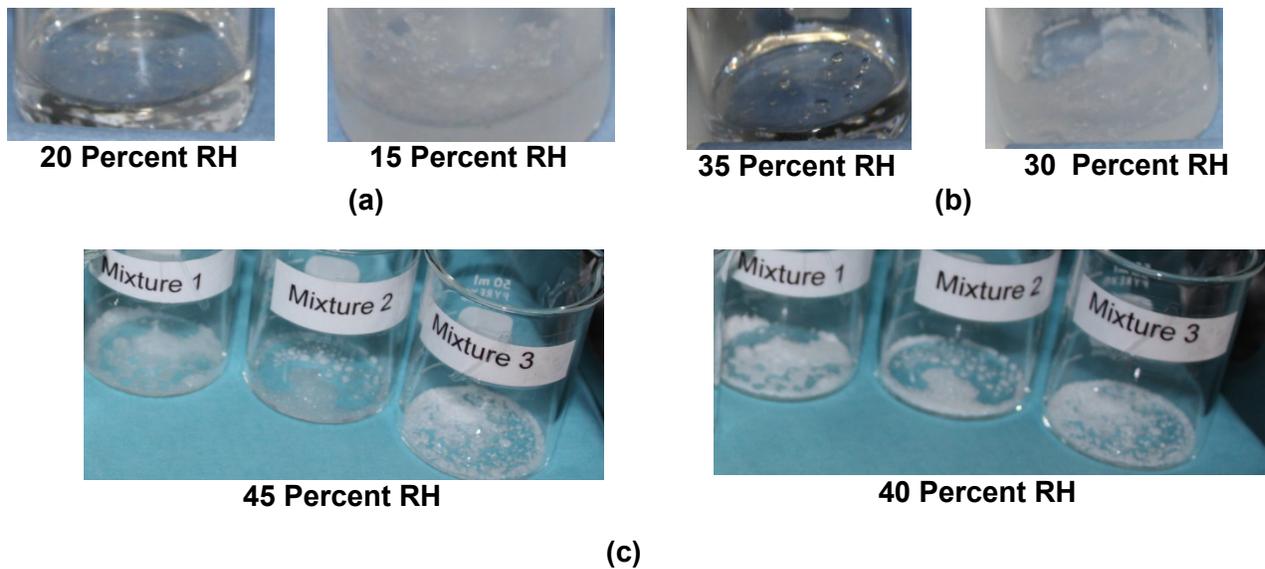
**Figure 4-11. Observation From Beakers at 60 °C [140 °F] for Efflorescence Tests at Decreasing Relative Humidity: (a)  $\text{NH}_4\text{HSO}_4$ , (b)  $\text{NH}_4\text{NO}_3$ , and (c) Three  $(\text{NH}_4)_2\text{SO}_4$  and  $\text{NH}_4\text{NO}_3$  Mixtures**

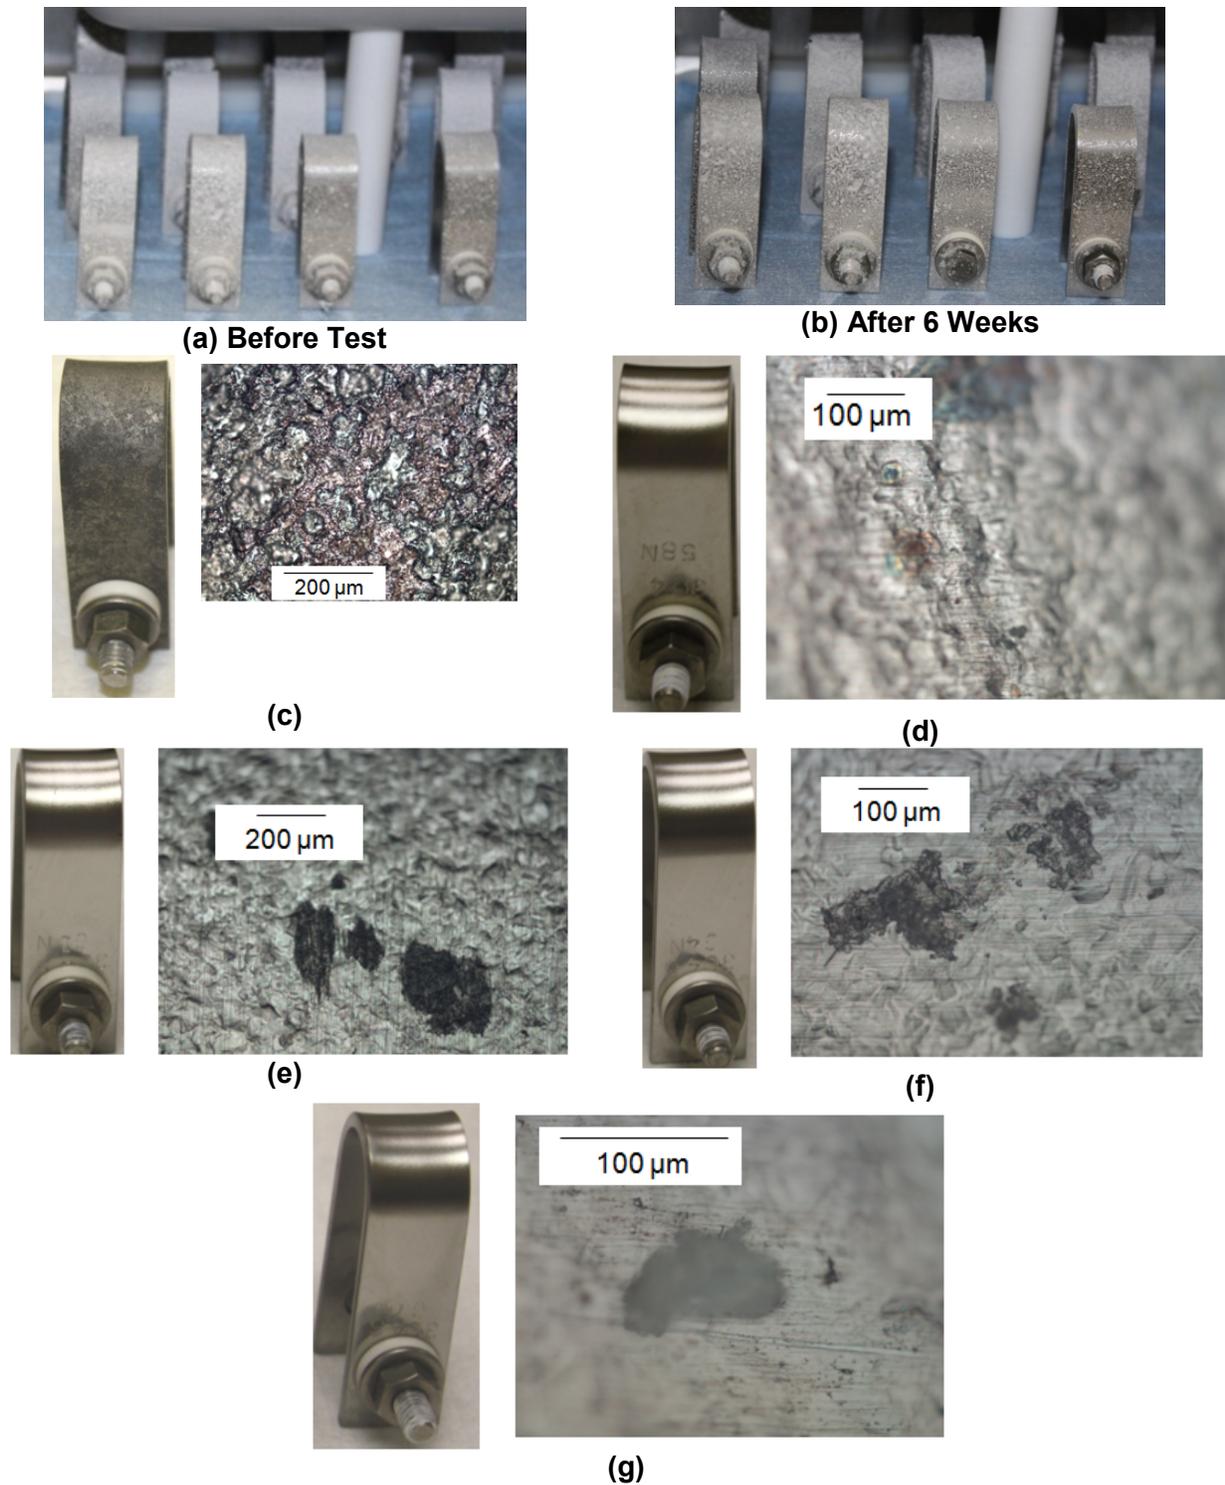
**Figure 4-12. Photographs of Specimens (a) Deposited With Salts Before the Test and (b) After the 6-Week Test Period at 45 °C [113 °F] and 44 Percent Relative Humidity. Photographs and Optical Micrographs of Specimens After Cleaning That Were Previously Deposited With (c)  $\text{NH}_4\text{HSO}_4$  Salt, (d)  $\text{NH}_4\text{NO}_3$ , (e)  $(\text{NH}_4)_2\text{SO}_4 + \text{NH}_4\text{NO}_3$  Mixture ( $\text{SO}_4^{2-}/\text{NO}_3^- = 0.5$ ), (f)  $(\text{NH}_4)_2\text{SO}_4 + \text{NH}_4\text{NO}_3$  Mixture ( $\text{SO}_4^{2-}/\text{NO}_3^- = 1$ ), and (g)  $(\text{NH}_4)_2\text{SO}_4 + \text{NH}_4\text{NO}_3$  Mixture ( $\text{SO}_4^{2-}/\text{NO}_3^- = 3$ ).**

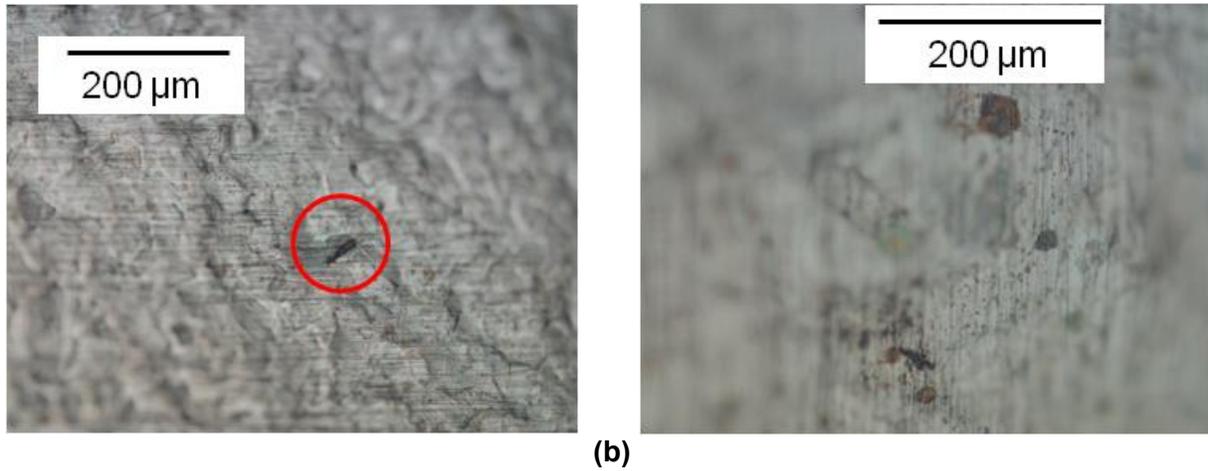
**Figure 4-13. Photographs and Optical Micrographs of (a) Posttest Specimens Exposed at 45 °C [113 °F] and 44 Percent Relative Humidity for 6 Weeks, Then at 35 °C [95 °F] and 72 Percent Relative Humidity to  $\text{NH}_4\text{NO}_3$  for 1 Month and (b) Magnified Surface Showing Minor Pitting. Red Circle Highlights Shallow Corrosion Feature on Surface.**

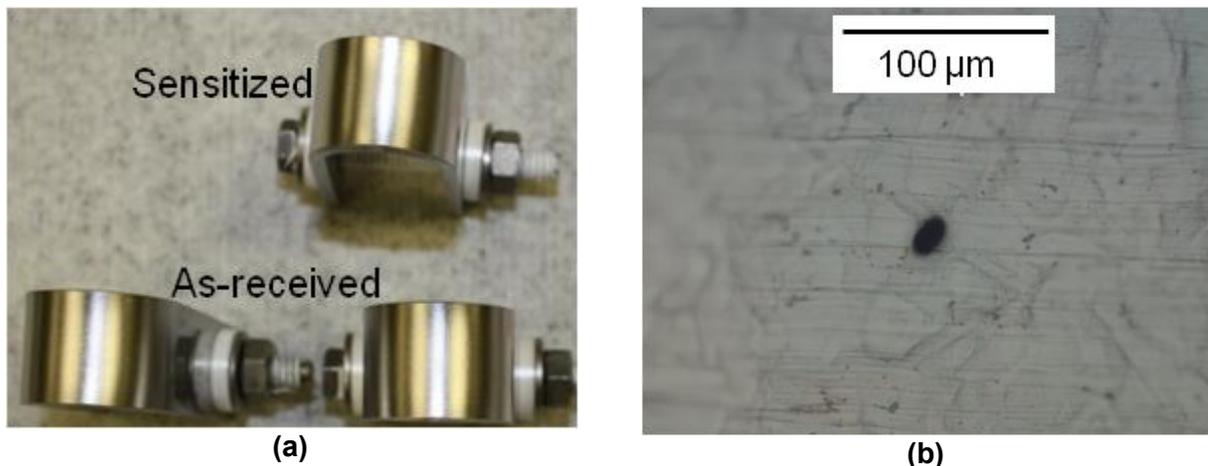
**Figure 4-14. Photograph and Optical Micrograph of (a) Posttest Specimens Exposed at 45 °C [113 °F] and 44 Percent Relative Humidity for 6 Weeks, Then at 35 °C [95 °F] and 72 Percent Relative Humidity to Mixture 1 for 1 Month and (b) Magnified Surface Showing Minor Pitting**

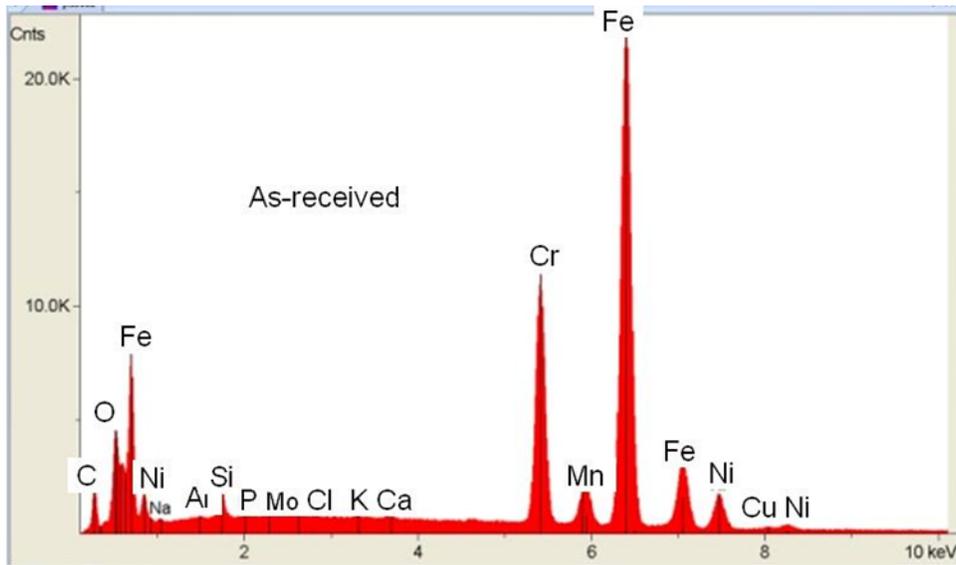
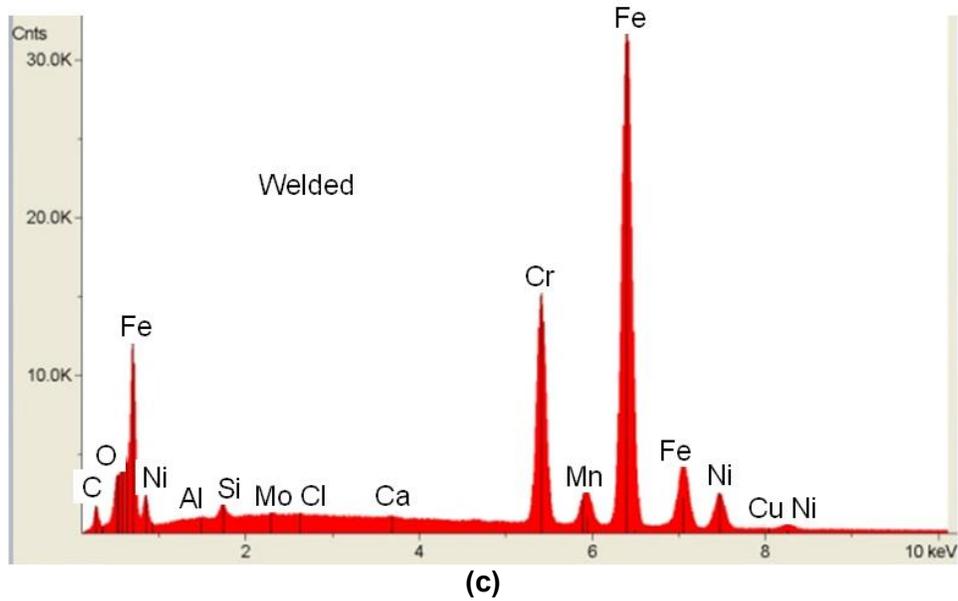
**Figure 4-18. (a) Photographs, (b) SEM, and (c) EDX of Posttest As-Received, Sensitized, and Welded Specimens Exposed at 45 °C [113 °F] and 44 Percent Relative Humidity for 6 Weeks, Then at 35 °C [95 °F] and 72 Percent Relative Humidity to  $\text{NH}_4\text{HSO}_4$  for 1 Month**

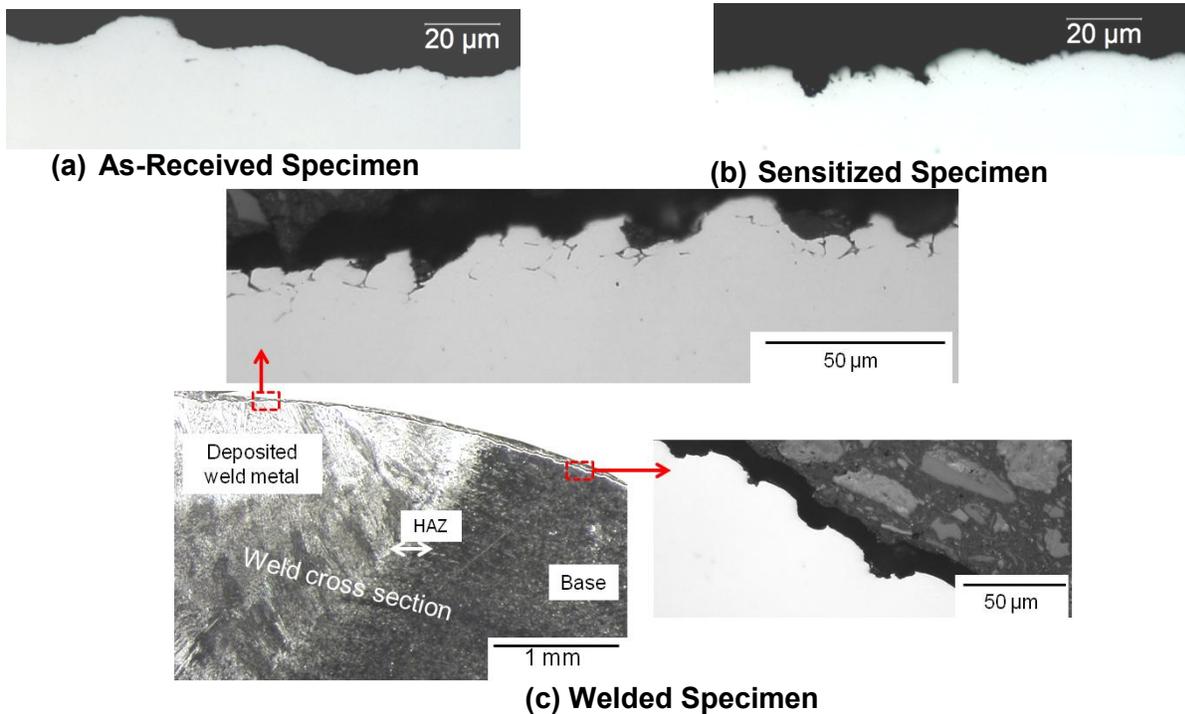
**Figure 4-19. Cross Section of (a) As-Received, (b) Sensitized, and (c) Welded Specimens Exposed to  $\text{NH}_4\text{HSO}_4$  at 45 °C [113 °F] and 44 Percent Relative Humidity for 6 Weeks, Then at 35 °C [95 °F] and 72 Percent Relative Humidity for 1 Month**

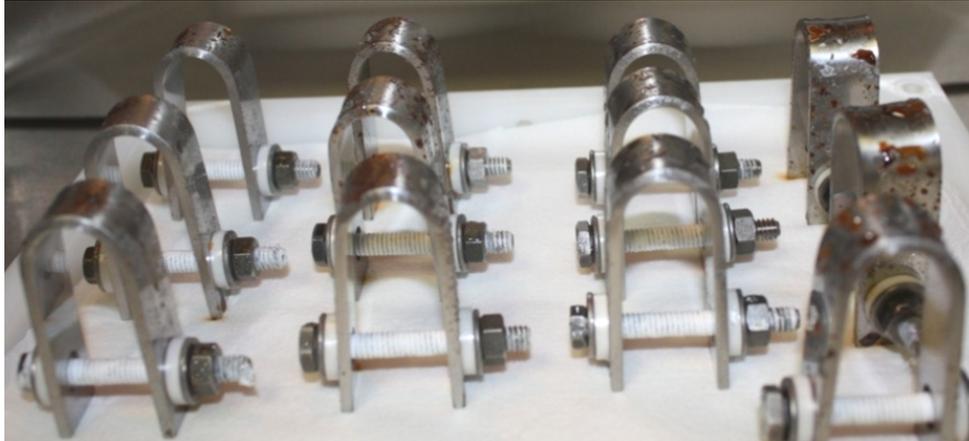
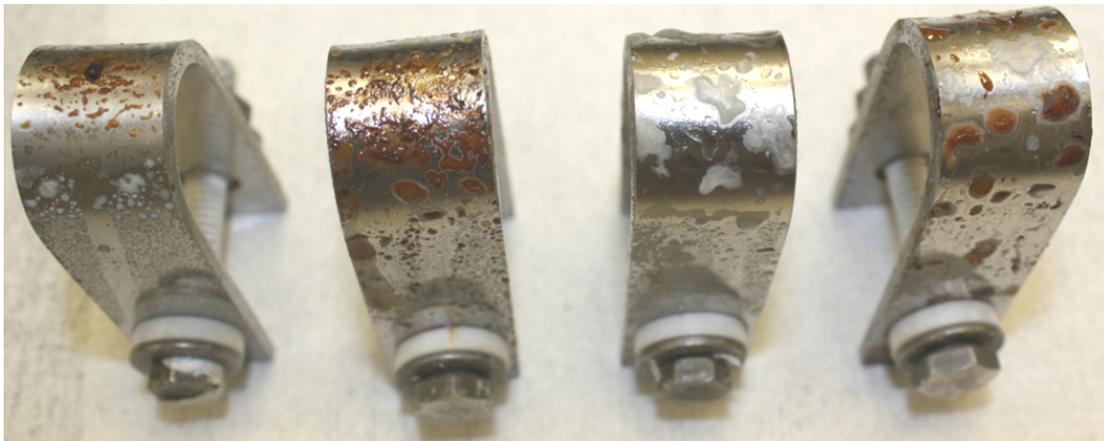
**Figure 4-20. (a) Photographs of Type 304 Stainless Steel U-Bend Specimens Deposited With  $\text{NH}_4\text{NO}_3$ , NaCl Mixture ( $\text{NO}_3^-/\text{Cl}^- = 3.0$ ),  $\text{NH}_4\text{NO}_3$ , and NaCl Mixture ( $\text{NO}_3^-/\text{Cl}^- = 6.0$ ) and (b) Four Specimens Removed After Exposure at 45 °C [113 °F] and 44 Percent Relative Humidity for 47 Days**

After 47 days of exposure at 45 °C [113 °F] and 44 percent RH, one as-received and one sensitized specimen were removed from each salt mixture. Figure 4-20(a) shows a photograph of all the specimens after 47 days, and Figure 4-20(b) shows a larger view of the removed specimens. Significant pitting corrosion was observed on all of the specimens, though more notably on the sensitized material. As shown in Figure 4-21, microscopic examination indicated SCC initiation in surface and cross section images of the sensitized material. No SCC was visible in the as-received material. Because the sensitized material already showed SCC initiation, the remaining sensitized specimens were removed from the chamber after 8 weeks of exposure. The remaining as-received specimens were left in the chamber for a total of 4 months.

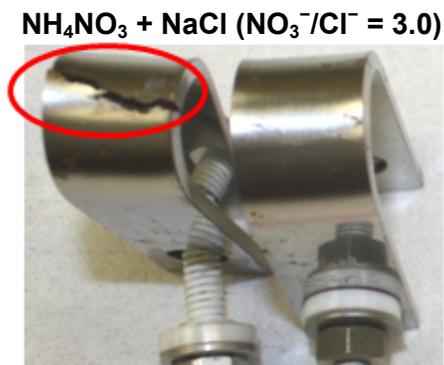
**Figure 4-22. Photographs of Sensitized Specimens Deposited With  $\text{NH}_4\text{NO}_3$ , NaCl Mixture ( $\text{NO}_3^-/\text{Cl}^- = 3.0$ ),  $\text{NH}_4\text{NO}_3$ , and NaCl Mixture ( $\text{NO}_3^-/\text{Cl}^- = 6.0$ ) Exposed at 45 °C [113 °F] and 44 Percent Relative Humidity for eight Weeks. Red Circles Indicate Cracks.**

Photographs of the sensitized specimens exposed for 8 weeks are shown in Figure 4-22. SCC is clearly evident from the surface, with one specimen with a NO<sub>3</sub><sup>-</sup>/Cl<sup>-</sup> mole ratio of 3.0 having a complete through-going crack. Photographs and optical micrographs of the as-received specimens exposed for 4 months are shown in Figure 4-23. Pitting corrosion occurred on all of the specimens, but to a greater extent on specimens with a NO<sub>3</sub><sup>-</sup>/Cl<sup>-</sup> mole ratio of 3.0. The microscopic examination showed SCC initiation from pits on the specimens with a NO<sub>3</sub><sup>-</sup>/Cl<sup>-</sup> mole ratio of 3.0. Cracking was less obvious on specimens with a NO<sub>3</sub><sup>-</sup>/Cl<sup>-</sup> mole ratio of 6.0, but the crack features were located away from the apex and near the arc-to-leg transition area of the U-bend. The specimens were not cross sectioned for further examination, because the pitting on the specimens was very small and it would be very difficult to capture the small pits with a cross section.
