37	Sheet 1 of g / 5
	Status: Y N U
Seismic Walkdown Checklist (SWC)	
Equipment ID No. <u>Q1R17B002</u> Equip. Class ¹ 1	
Equipment Description MCC 1B	
Location: Bldg. AUXILIARY Floor El. <u>121</u> Room, Area <u>209</u>	
Manufacturer, Model, Etc. (optional but recommended)	
Instructions for Completing Checklist This checklist may be used to document the results of the Seismic Walkdown of	
SWEL. The space below each of the following questions may be used to record findings. Additional space is provided at the end of this checklist for documenting the space is provided at the end of the space space.	
Anchorage

NO. SNCF164-RPT-01, VERSION 2.0

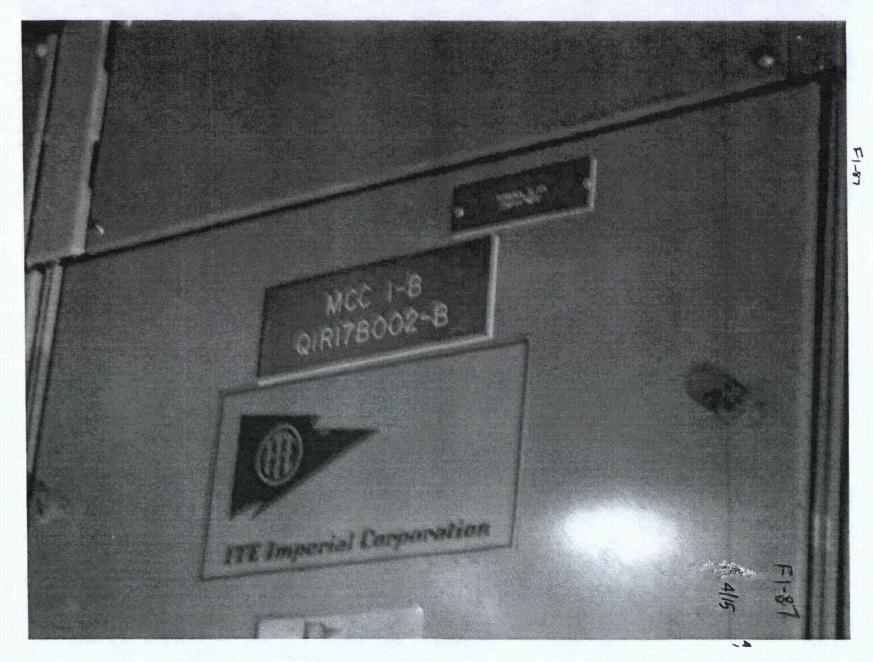
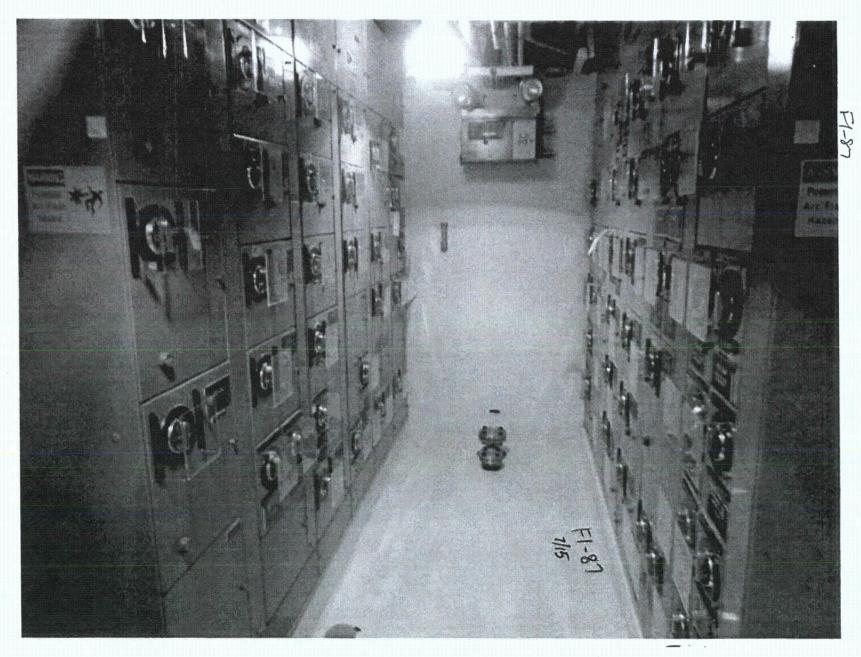
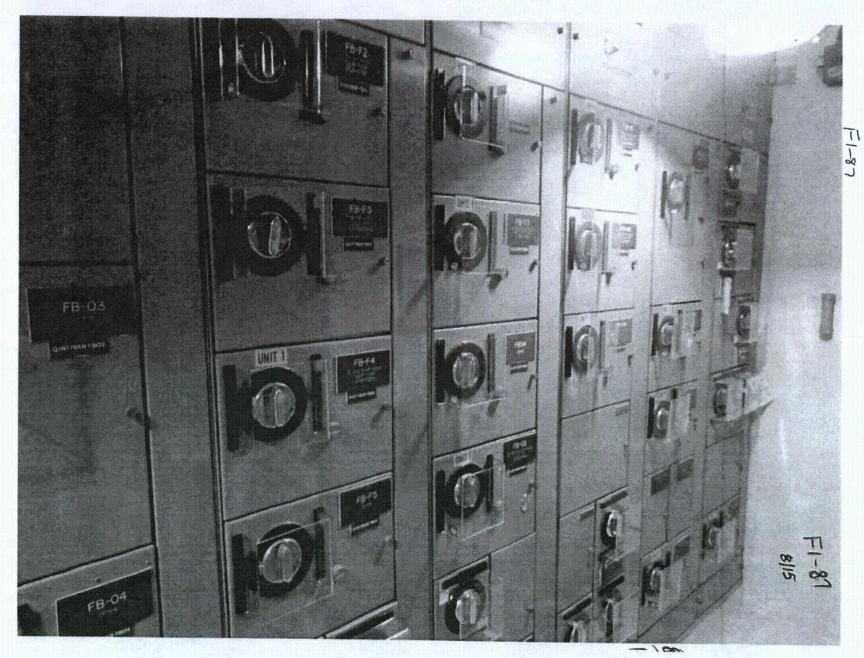
11. Have you looked for and found no other seismic conditions that could adversely affect the safety functions of the equipment?	YU NO VO
TO CHE COMMENT VERIFICATION.	
New New to VRV to Obumettion of panels	mi this Location
· LIxformer (IN Xformer connected to made	CONT'D NEXT
Evaluated by: 3.YVAN Stephen Jum	Date: _ 9/10/12
P.MIKRUS Paul Comilitation	9/10/12

Seismic Walkdown Checklist (SWC)	Sheet 3 of 3^{15} Status: $Y \square U \square 3^{15}$
Equipment ID No. <u>Q1R17B002</u> Equip	p. Class ⁴
Equipment Description <u>MCC 1B</u>	
Photographs COMMENTS (CONT'D)	
L CLIPS NOTED TO EXIST NEA TO PREVENT E-W MOVE MEN TRANSFORMER NIRITEOOI W. DUE TO THE MCC LOCATION I COULD NOT VERIFY CONNEC	AS FOUND BOLTED TO MCC, OK IN A CONFIGURATION CONTROL ANEM TIDN OF EAST AND WEST MCC GES 10 111. A BAR EXISTS THAT REGID TIE, BUT BOLTS ON THE TO
Note:	Note:
CONNECTION AT TOP O	F MCC IS CONFIRMED.
CONNECTION AT TOP O	
CONNECTION AT TOP O A BAR IS WELD TO THE	F MCC IS CONFIRMED.
CONNECTION AT TOP OF A BAR IS WELD TO THE	F MICC IS CONFIRMED.
CONNECTION AT TOP O A BAR IS WELD TO THE	F MICC IS CONFIRMED.
CONNECTION AT TOP O A BAR IS WELD TO THE	F MICC IS CONFIRMED.
A BAR IS WELD TO THE	F MICC IS CONFIRMED.
CONNECTION AT TOP ON A BAR IS WELD TO THE	F MICC IS CONFIRMED.
CONNECTION AT TOP O A BAR IS WELD TO THE	F MCC IS CONFIRMED.

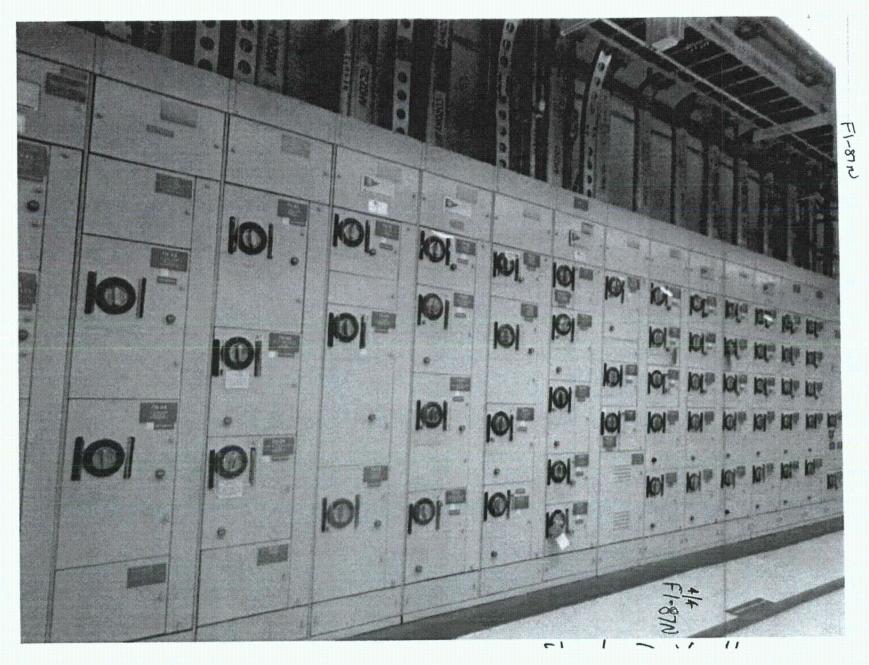
Seis	mic Walkdown Checklist (SWC)	Status: Y N
	pment ID No. <u>Q1R18B029</u> Equip. Class ¹ 2	
	oment Description POWER DISCONNECT SWITCH	
Locat	ion: Bldg. AUXILIARY Floor El. 127 139 Room, Area	32
Manu	facturer, Model, Etc. (optional but recommended)	
This of SWE	uctions for Completing Checklist checklist may be used to document the results of the Seismic Walkdown of L. The space below each of the following questions may be used to record gs. Additional space is provided at the end of this checklist for documenti	the results of judgments a
Anch	orage	1
1	Is the anchorage configuration verification required (i.e., is the item one of the 50% of SWEL items requiring such verification)?	YD NO

9. Do attached lines have adequate flexibility to avoid damage?	
Conduit AHDOSI is not a Jex conduit have	IT is attached
Conduit AHDOSI is not a flex conduit, house to cable Tray supports attached to the same wal firmly attached to. There is there fore no seismi 10. Based on the above seismic interaction evaluations, is equipment free of potentially adverse seismic interaction effects? Since the Two would act rogether dowing a seismic	vinteraction issue, view u
Other Adverse Conditions
