**Seismic Walkdown Checklist (SWC)**

Equipment Description DIESEL GENERATOR 1B STARTING AIR RECIEVER TANK

Equipment Description AUXILIARY BLDG B TRAIN BATTERY ROOM EXHAUST FAN

Equipment Description DIESEL GEN 1B FUEL OIL STORAGE TRANSFER PUMP

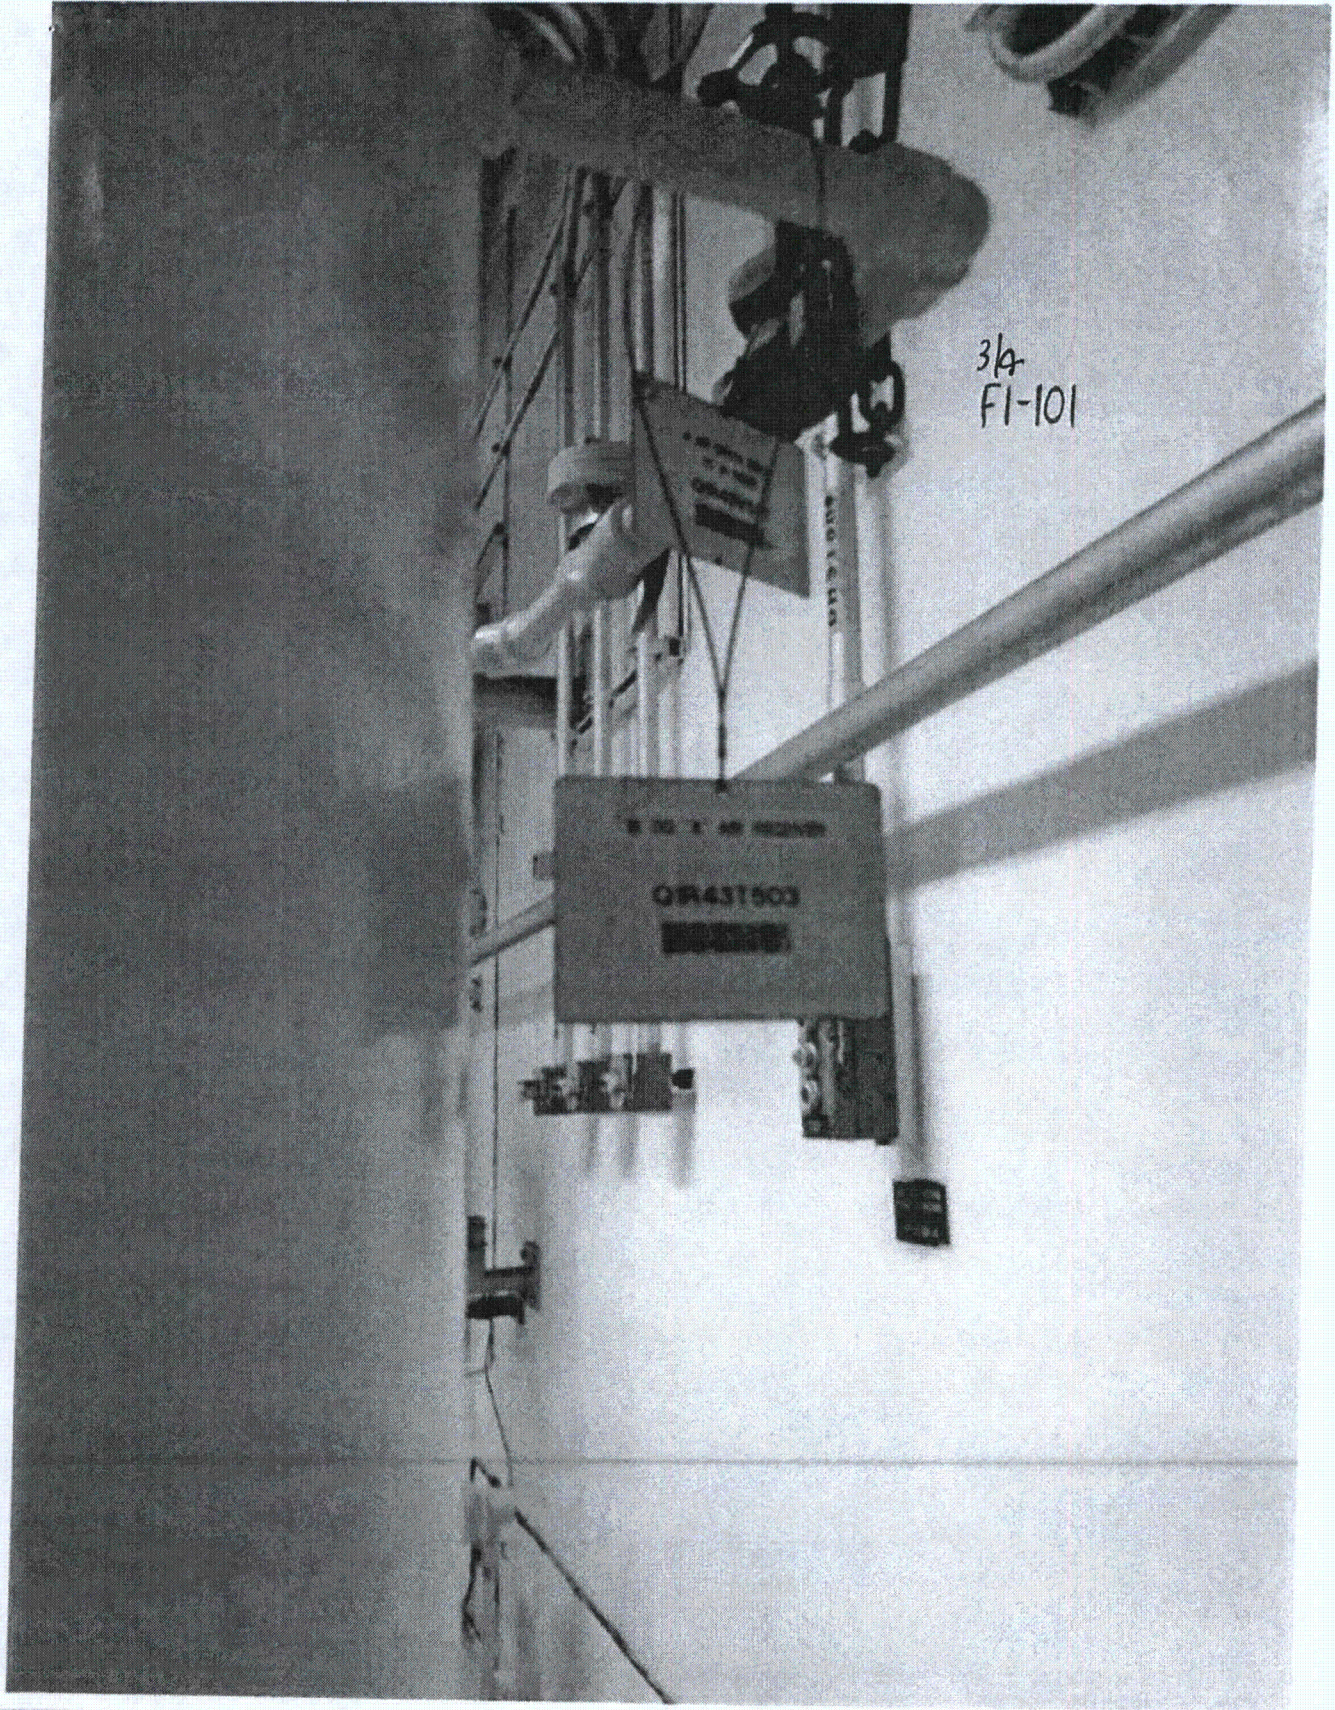
F1-101

- 7. Are soft targets free from impact by nearby equipment or structures? Y  N  U  N/A   
*Small gap was noted between tank and cantilevered unistrut. This was previously noted in A-46 walkdowns and determined to be acceptable.*

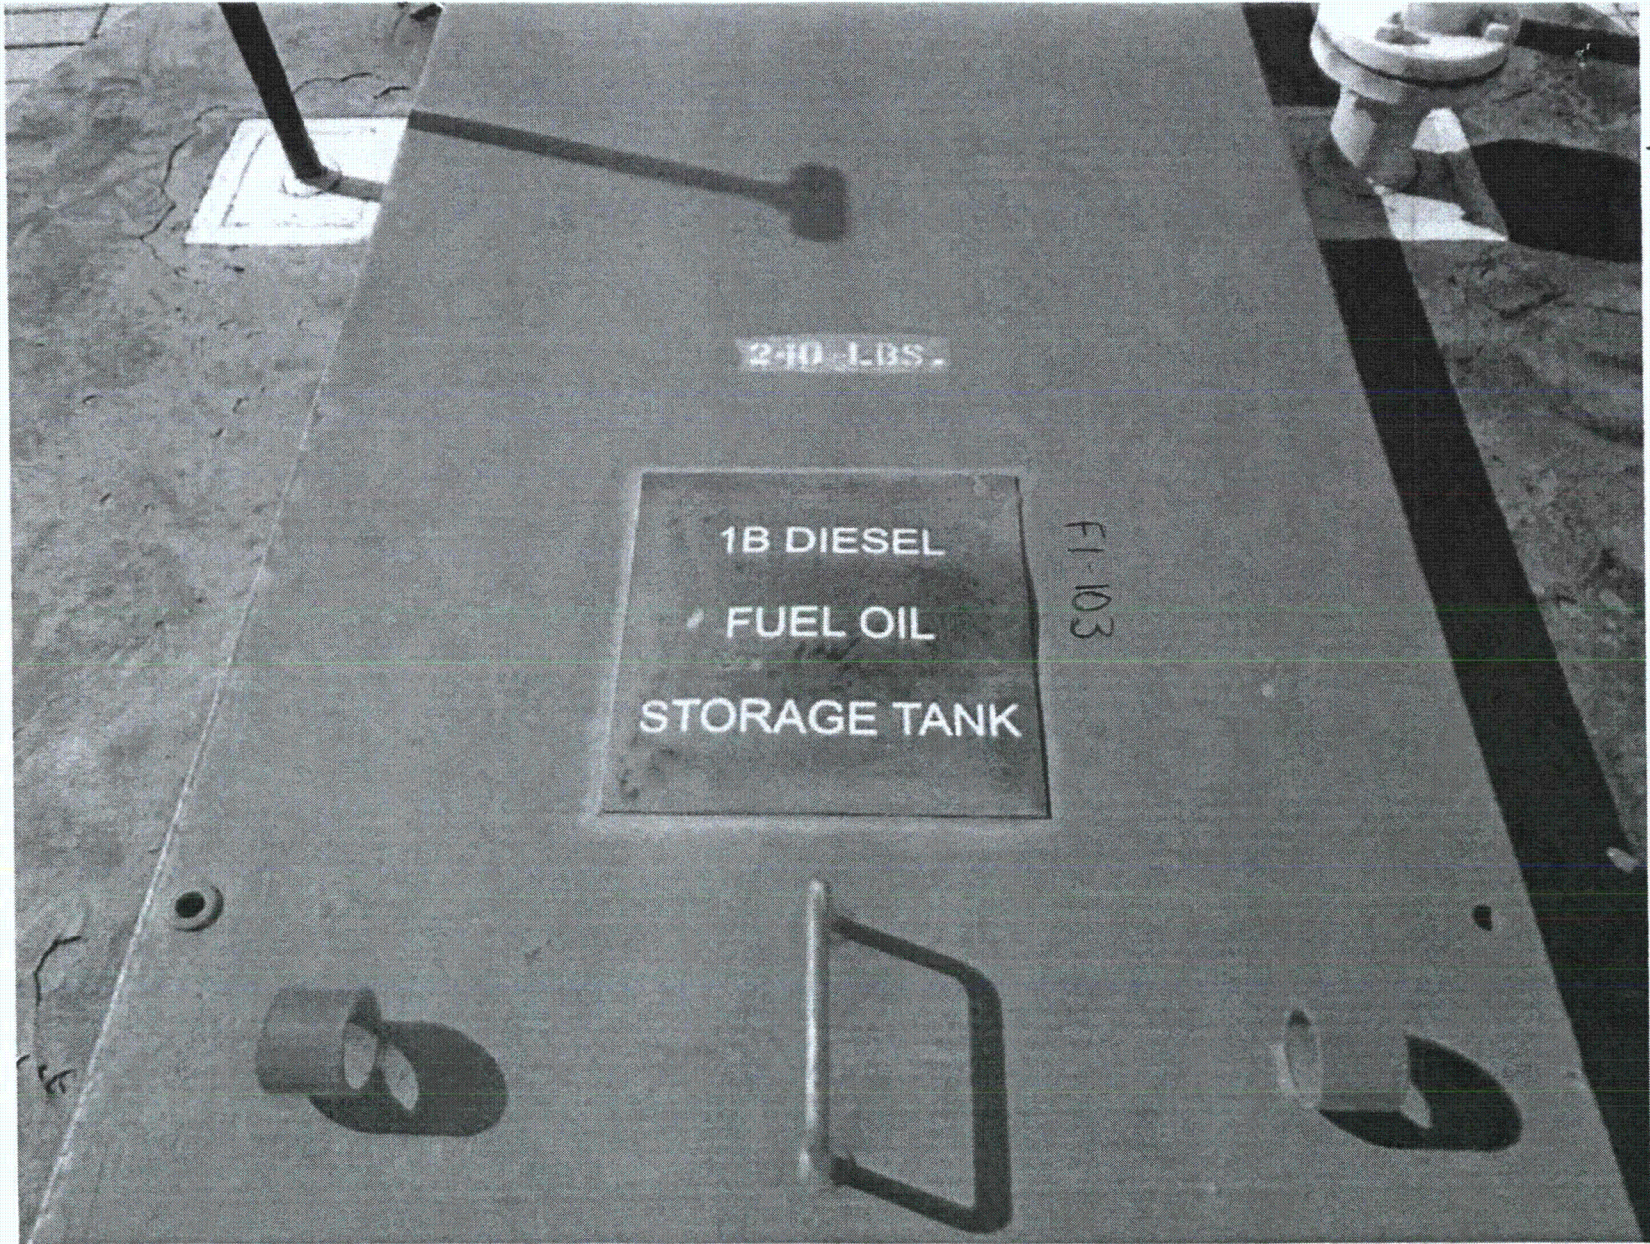
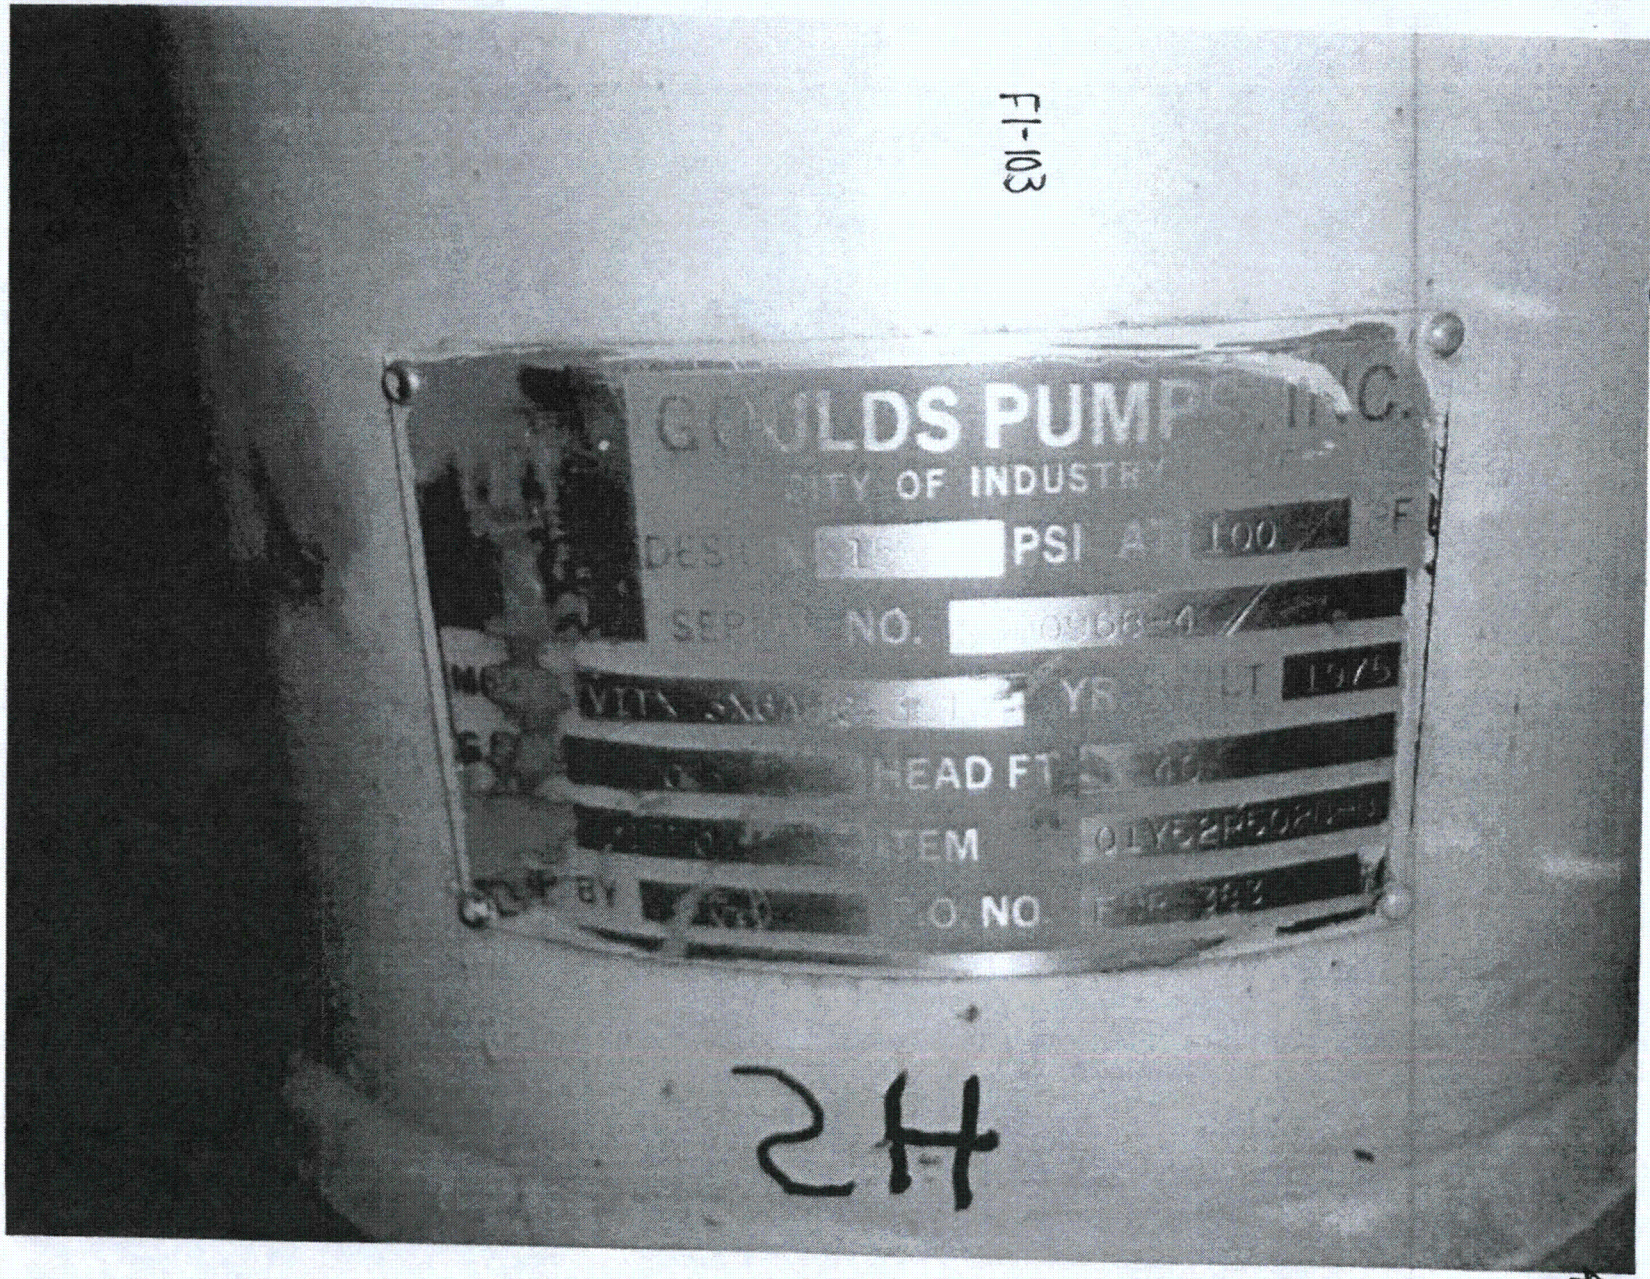
F1-103

Mass added to pump to attenuate vibrations per MDC S484537901 and the effect on the pump/motor is evaluated for in S484537901C405.

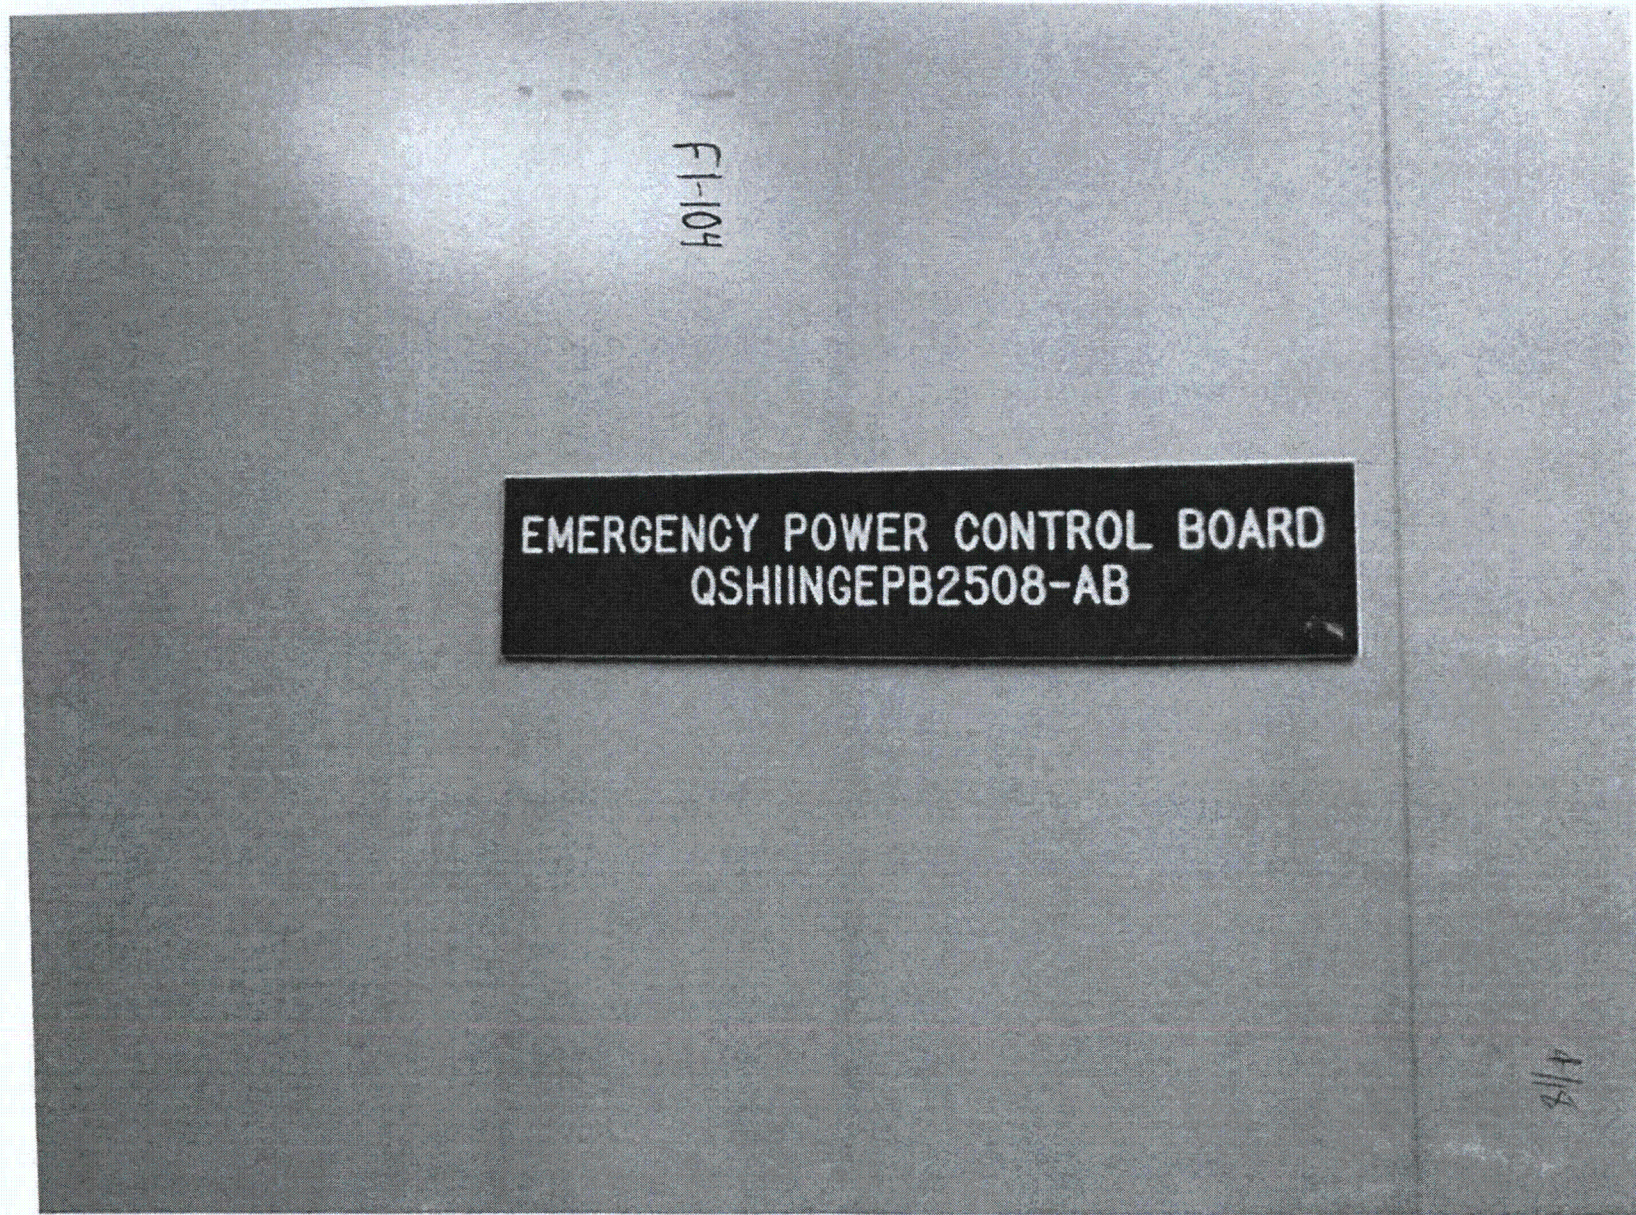
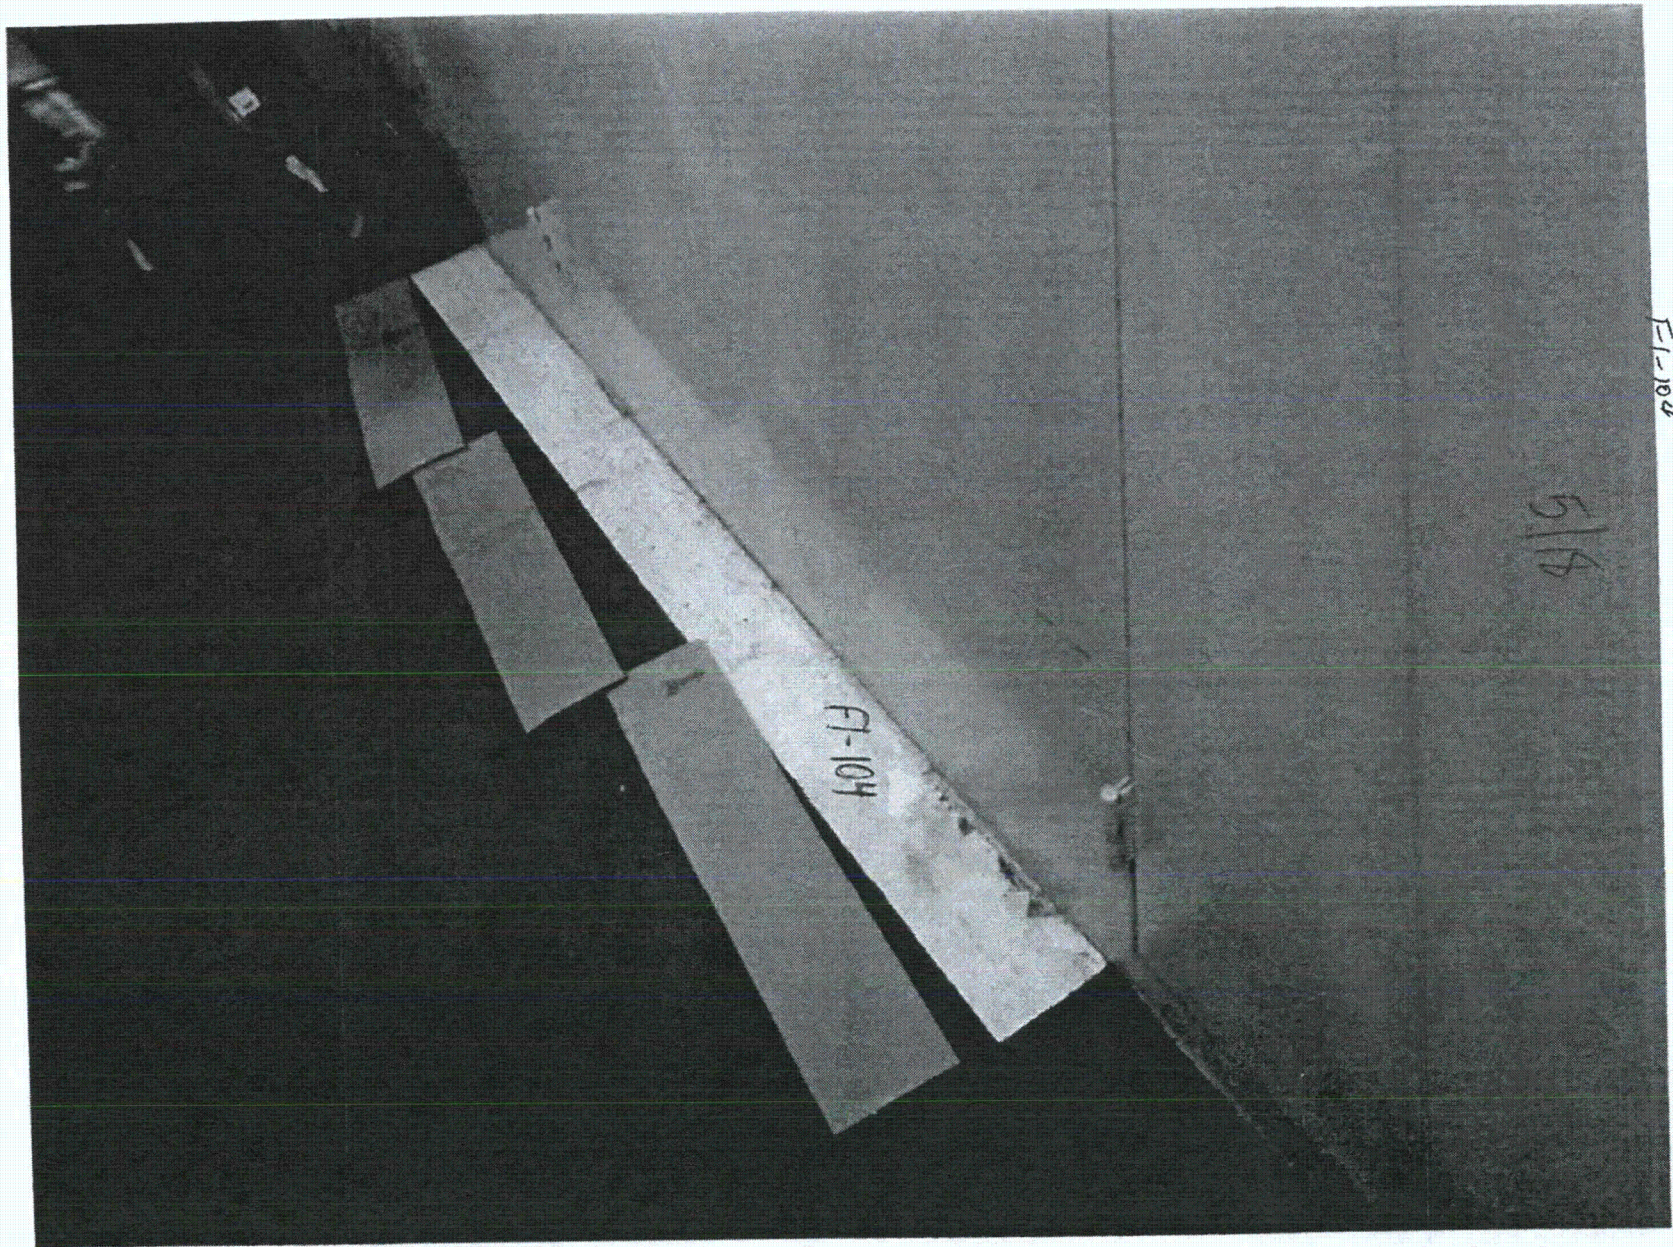
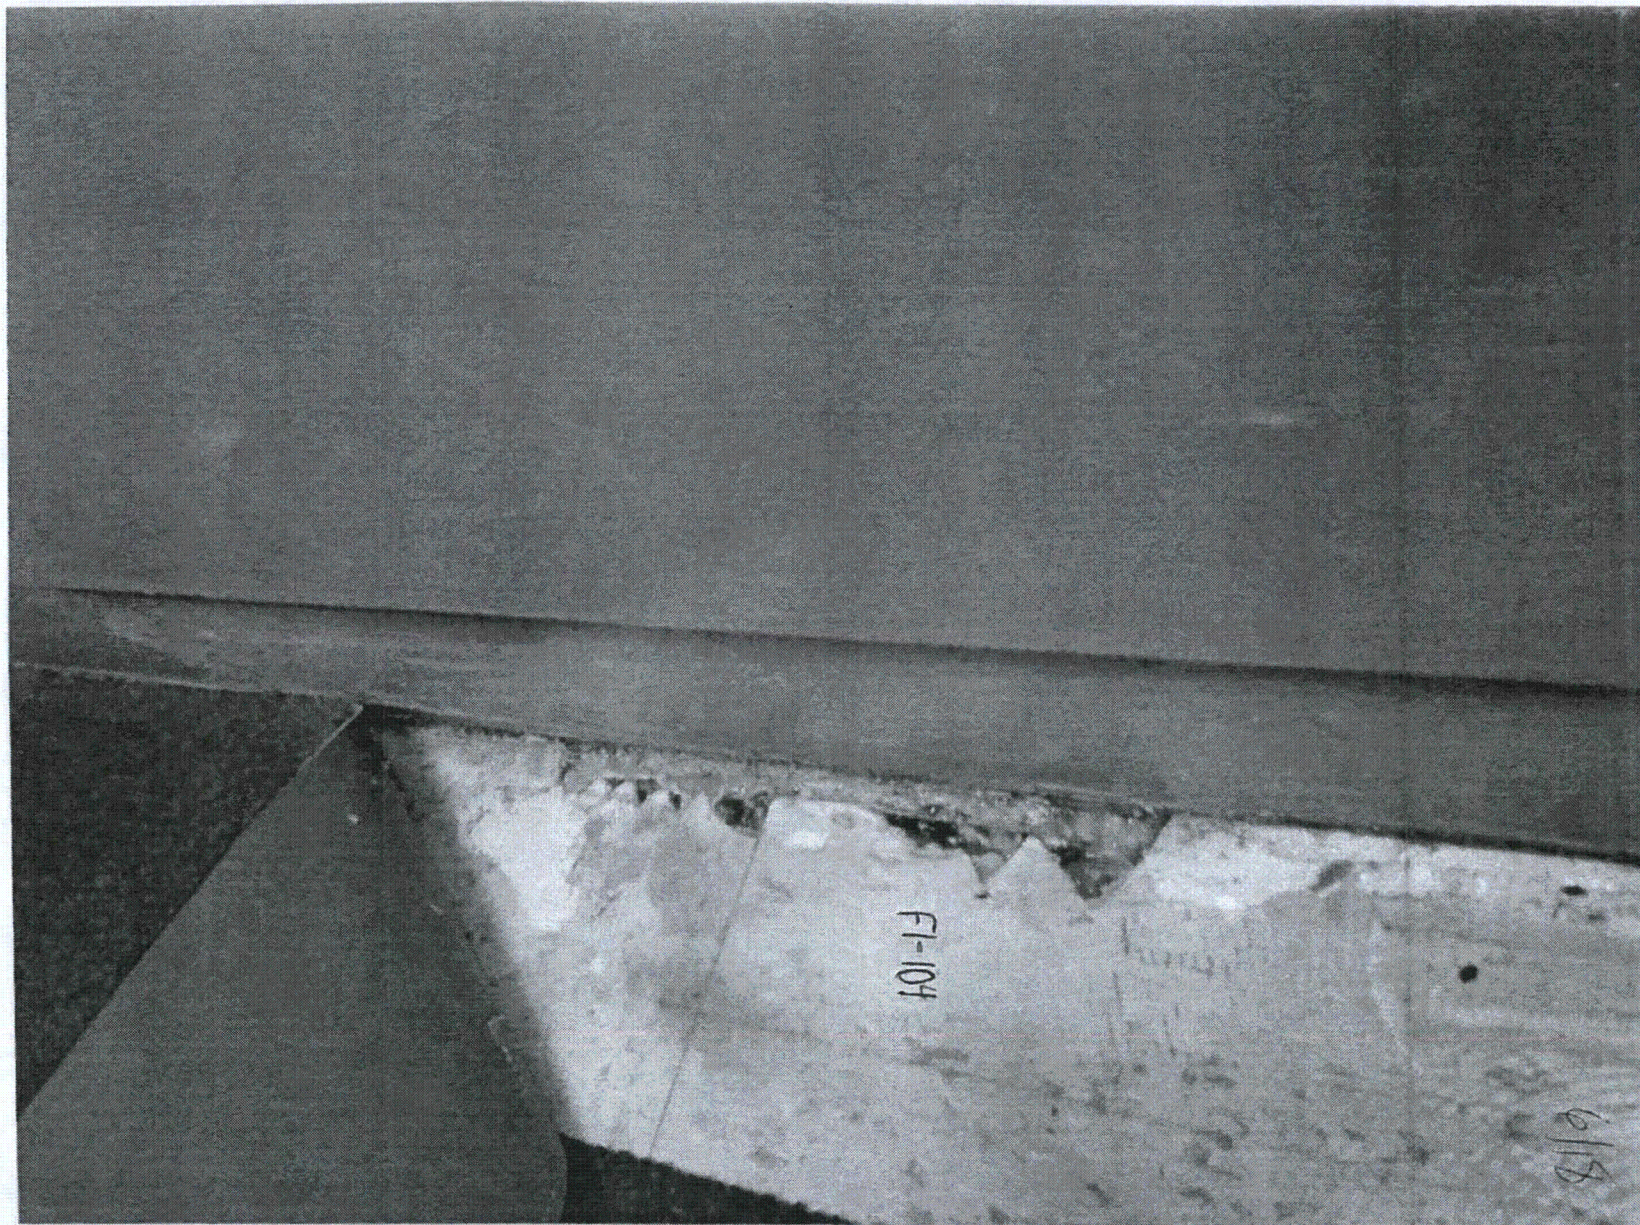
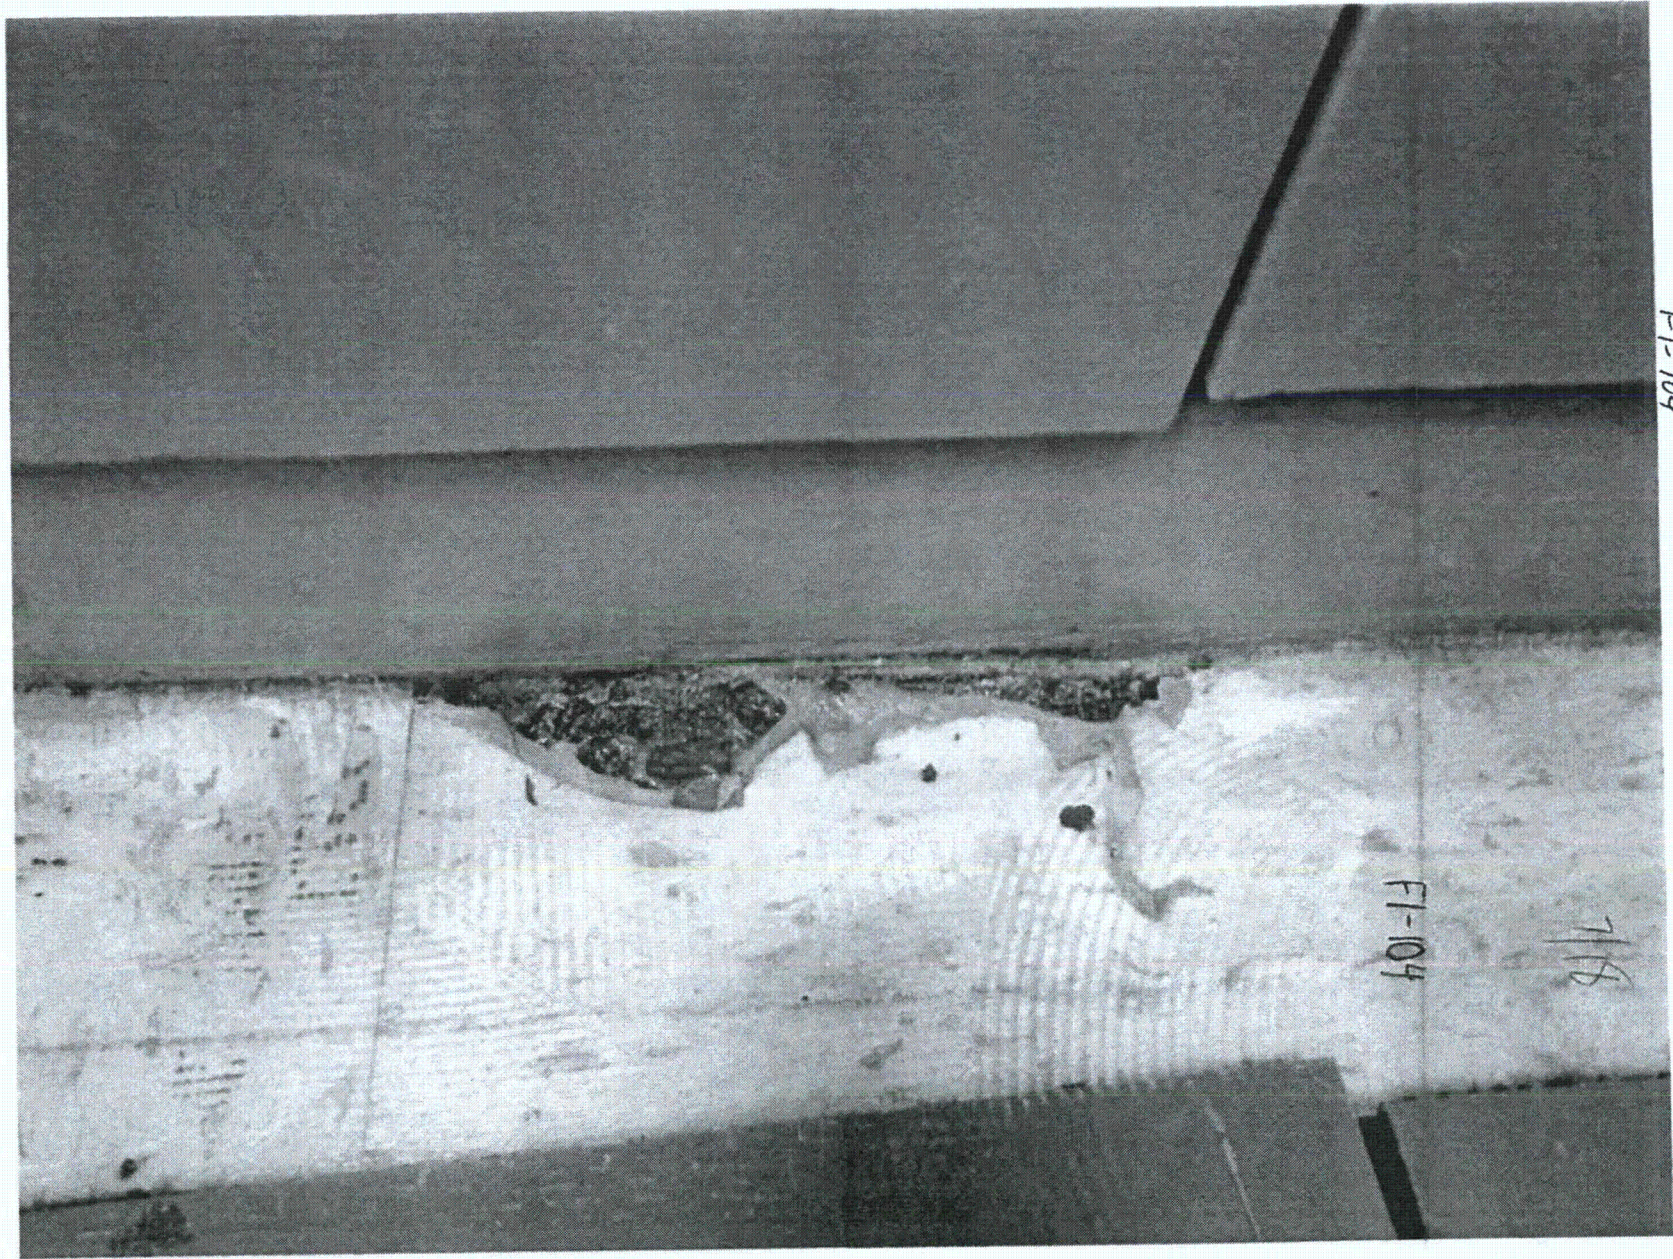
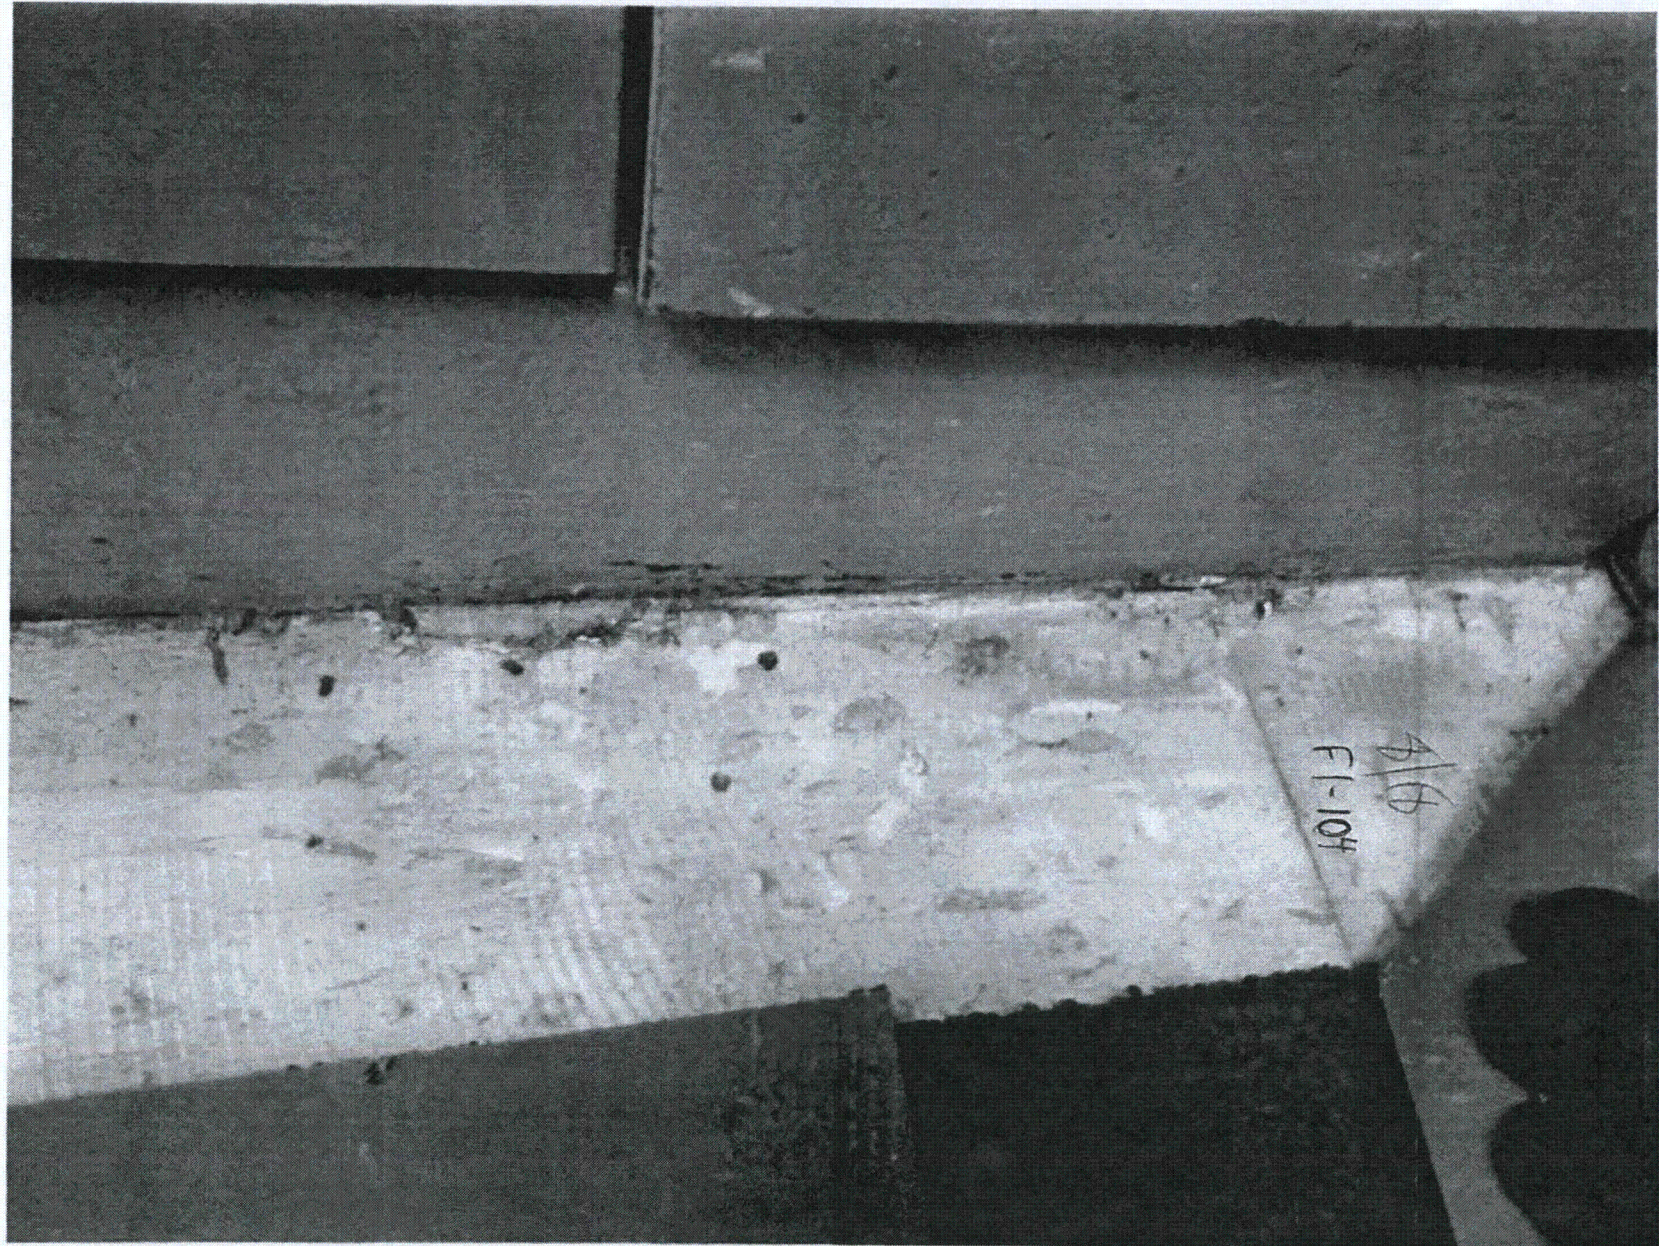
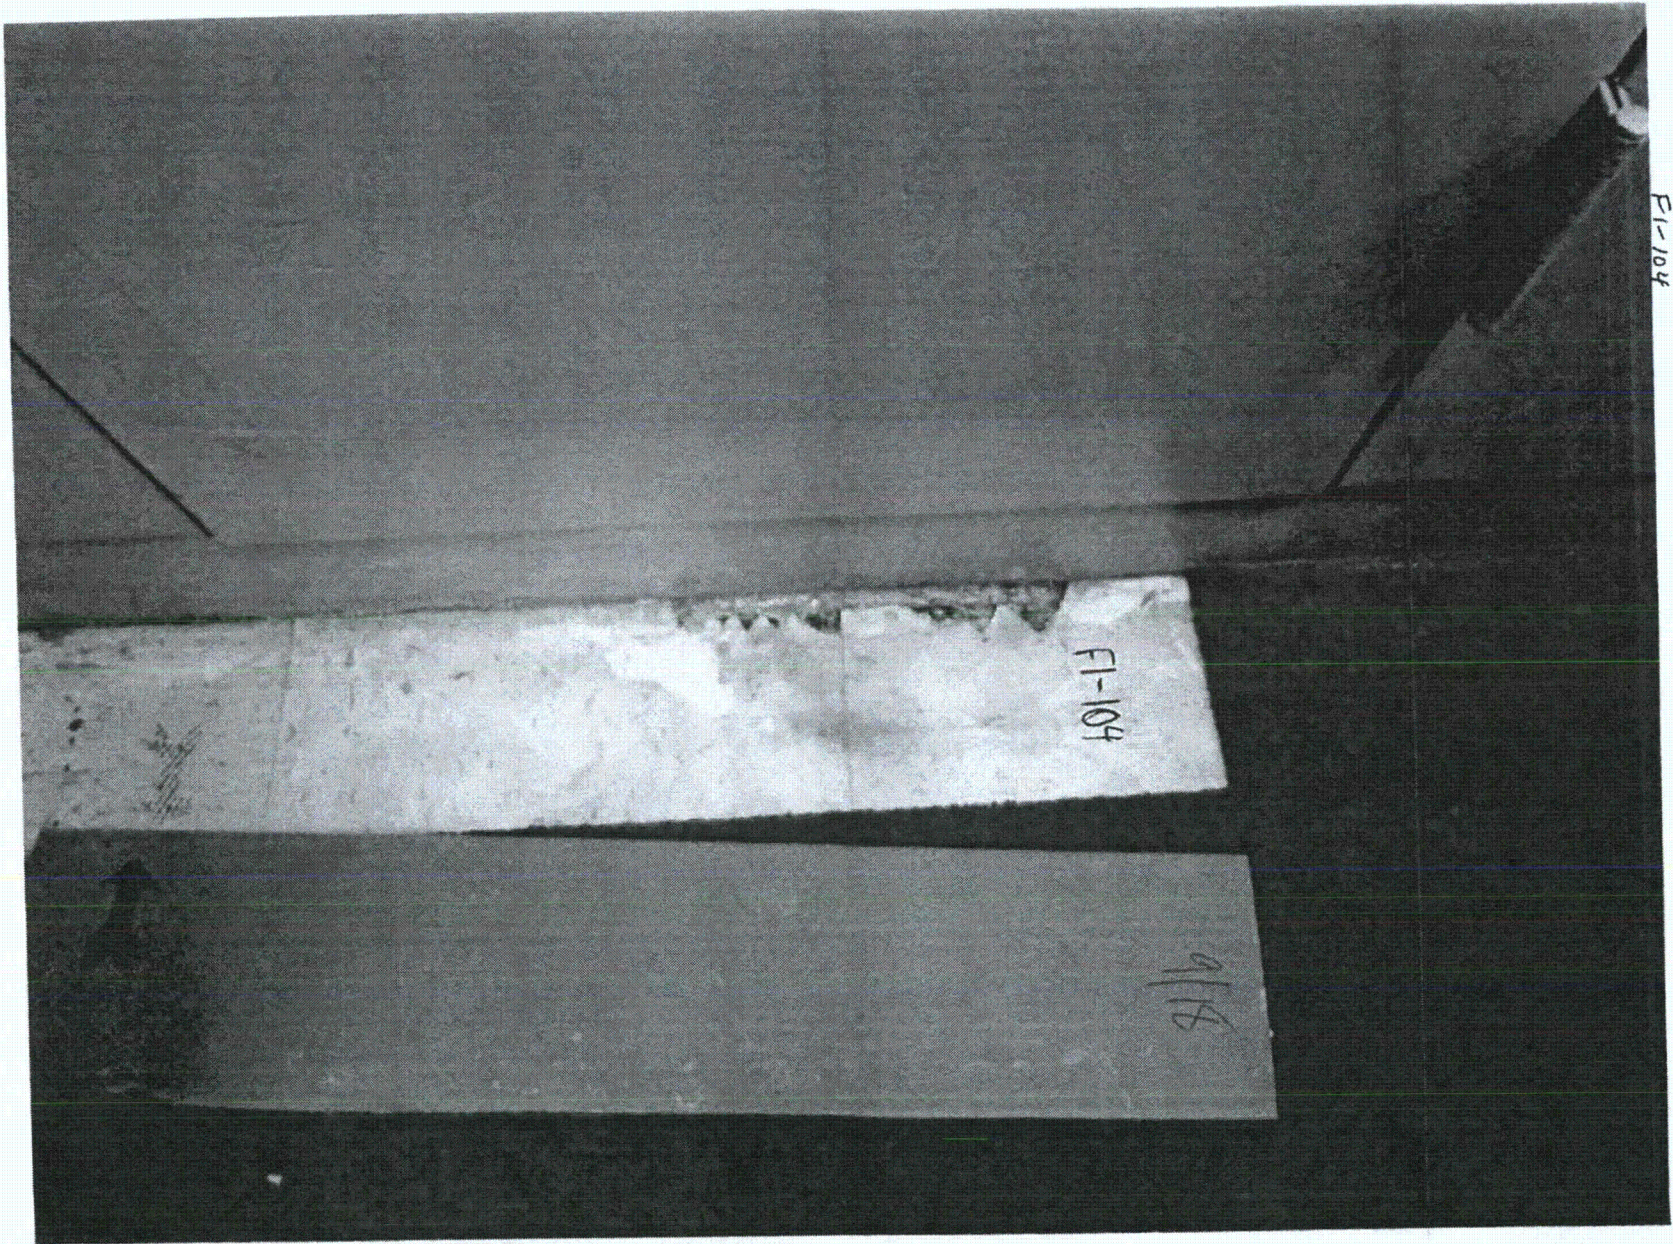
INSPECTION OF ANCHORAGES (WELDS) ON THE FRONT SIDE, I.P. THE MAIN CONTROL ROOM SIDE, OF THIS PANEL REQUIRED THE REMOVAL OF A 3" VINYL KICK PLATE. THE PLANT OPERATIONS SHIFT SUPERVISOR WOULD NOT ALLOW REMOVAL OF THIS KICK PLATE TO COMPLETE THE INSPECTION.

INSPECTIONS FROM THE REAR DOORS FOUND THE BOTTOM 4" OF EACH PANEL SEGMENT TO BE FILLED WITH A <sup>BLACK</sup> SUBSTANCE THAT APPEARED SIMILAR TO PENETRATION SEAL MATERIAL

BASED ON REVIEWS/INSPECTIONS OF MORE THAN 10 FLOOR MOUNTED CONTROL ROOM PANELS AND CABINETS THAT CONCLUDED THE EXISTING WELDS ARE CONFIGURED AS PER SEWS PACKAGES; AND BASED ON VERIFICATION OF EXISTING WELDS ON THE BACK SIDE OF THIS PANEL, IT IS JUDGED THAT THE ANCHORAGE FOR THIS PANEL IS IN ACCORDANCE WITH EXISTING CONFIGURATION CONTROL DOCUMENTATION.

AN IPEEE VULNERABILITY FOR THIS COMPONENT WAS A POTENTIAL SEISMIC INTERACTION WITH LOOSE LIGHTS IN THE OVERHEAD. ALTHOUGH NOT SPECIFICALLY

Note: ADDRESSED IN THE 8-28-12 WRITE UP OF THIS SWC, BASED ON A TEL-CON DISCUSSION WITH S.YUAN ON 01-17-14, AND BASED ON THE ORIGINAL RESPONSES

TO QUESTIONS 7, 10 & 11 ON PAGE 2, IT IS CONCLUDED THAT THE IPEEE VULNERABILITY HAS BEEN ADDRESSED BY THE PLANT AND NO LONGER EXISTS
