# Fukushima Water Update

September 17, 2013

## Briefing Sheet to Support Inter-Agency Discussions

### Contaminated Water at Fukushima Daiichi Nuclear Facility

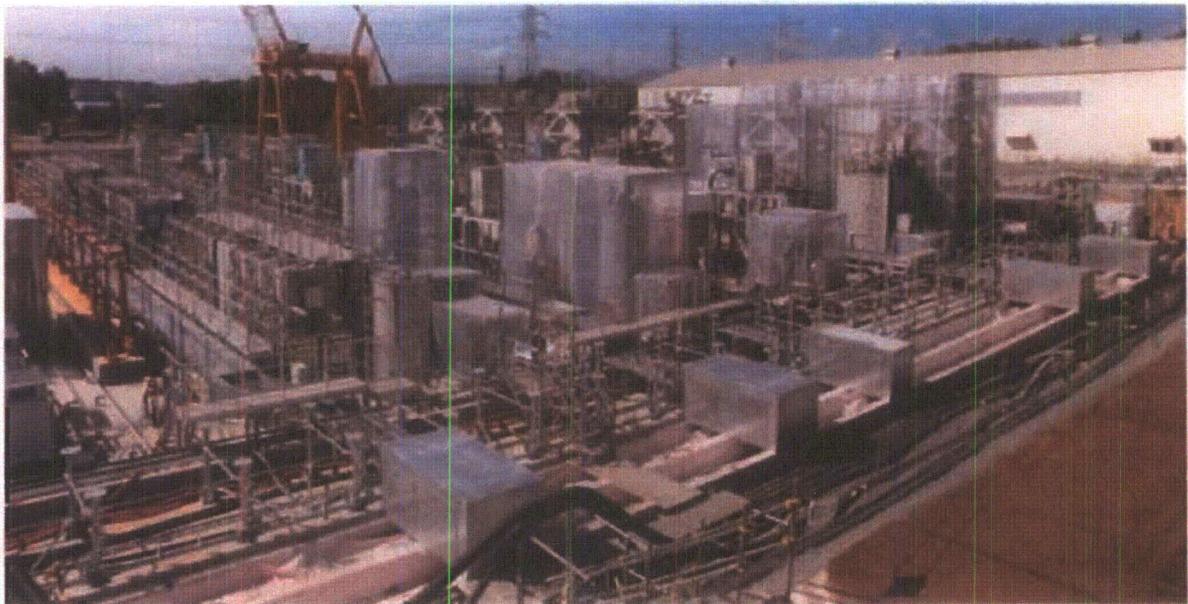
ALPS under construction

↑  
Advanced Liquid Processing System -  
over 1 year behind schedule

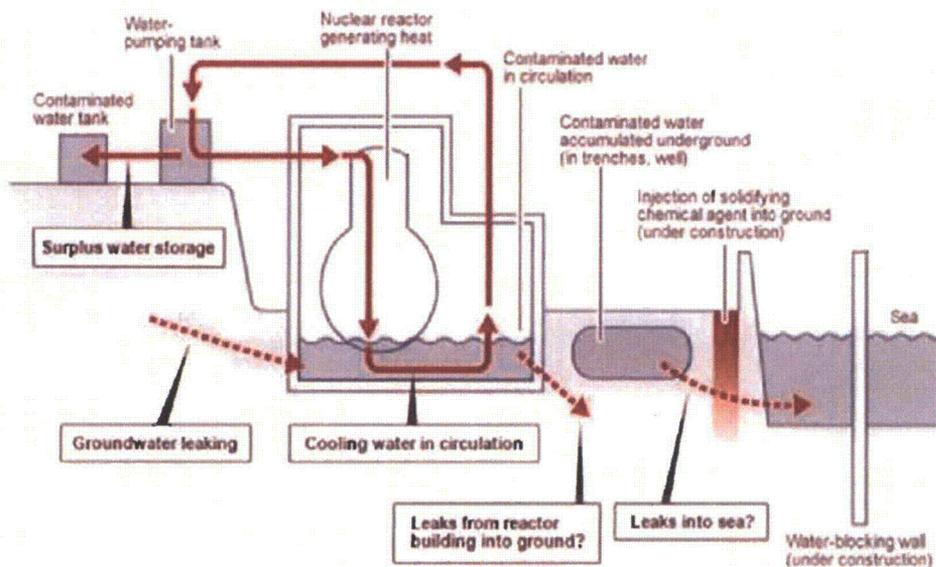
Flow Of Contaminated Water At Fukushima Daiichi Nuclear Power Plant

TEPCO pumps approximately 800 tons/day of highly contaminated waste water out of the reactor building/turbine building basements. This water is desalinated and run through a filtering system to remove radioactive cesium. About 400 tons/day is pumped back to cool the reactors, becoming contaminated again as it flows through reactor core debris, before flowing back to the reactor

building/turbine building basements. The rest of the water, 400 tons/day, containing high concentrations of Sr-90 and tritium, is pumped to the ever growing storage tank farm.

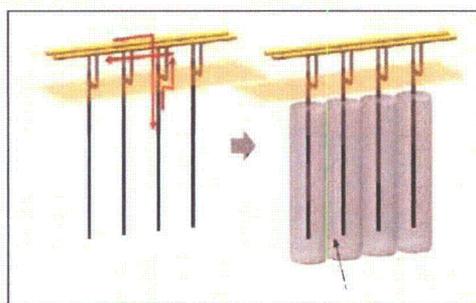
Groundwater Bypass and Sub-drain Systems

The water level in the reactor building/turbine building basements is maintained lower than the water table on the uphill side of the plant so that ground water flows into the basement. This leads to an estimated 400 tons/day of ground water leaking into the basements where it mixes with contaminated water. Some water may leak from the basements to the soil and groundwater underneath. The movement of radioactive cesium in the groundwater will be slowed as it absorbs on the soil but radioactive strontium and tritium remain with the ground water as it flows towards the harbor.

TEPCO is trying to limit the flow of water to the ocean. They are completing a steel wall at the edge of the harbor to block ground water. They are also injecting sodium silicate (liquid glass) into the soil, making a low permeability wall that also blocks flow of groundwater. Water trapped behind these walls will be pumped out and treated to limit the amount of radioactive contamination reaching the ocean. TEPCO plans to start operation of a ground water bypass system to pump up ground water before it reaches the reactor buildings/turbine buildings and pump it directly to the ocean. TEPCO plans to restart a sub drain system to pump and treat ground water from directly below the turbine buildings. There are also plans to construct, with Japanese Government support, a subterranean frozen soil wall around Units 1 through 4 to prevent ground water from mixing with highly contaminated water in the reactor building/turbine building basements.

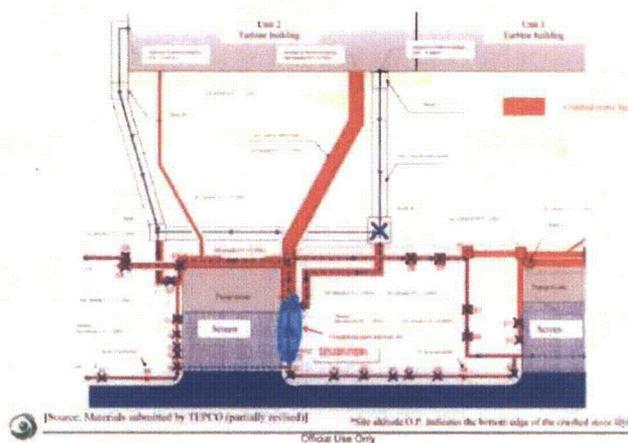
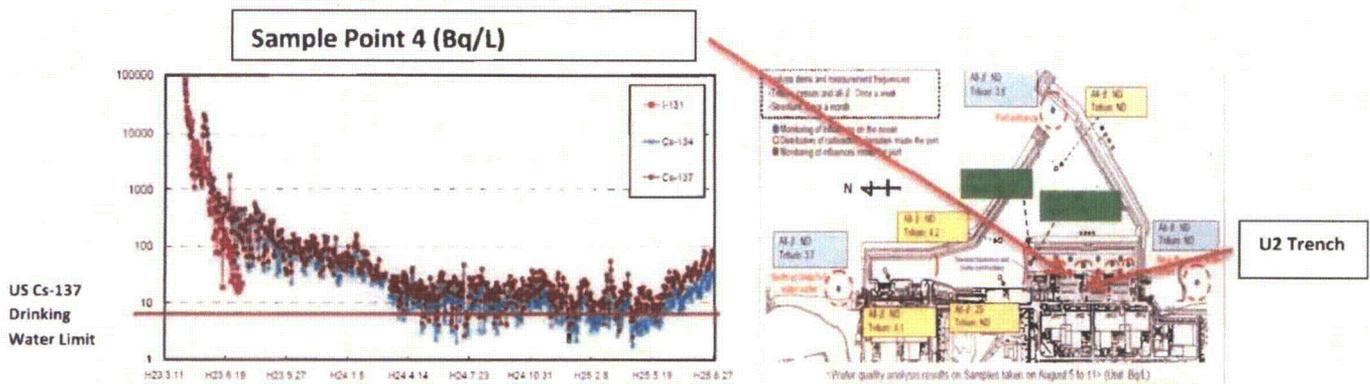
A second source of ocean contamination may be the trenches, U shaped concrete tunnels, that house the pipes and electrical cable runs between the sea water pumps and the turbine buildings. These trenches flooded during the accident on March 11, 2011. The unit one trench was flooded with tsunami water and contains very little radioactivity. The unit 2 trench however, was flooded with highly contaminated accident water. TEPCO believed the water in the unit 2 trench was contained and so left it until a recent radioactivity uptick was observed at a harbor sample point near the trench. (See below) On Friday August 30, 2013 TEPCO pumped the unit 2 trench water to the turbine building basement and will continue monitoring to determine if this arrests the increasing release of radioactive materials to the Fukushima harbor.

Official Use Only  
Layer of crushed stone below the seaward side pipe trench, power cable trench, and power cable conduit

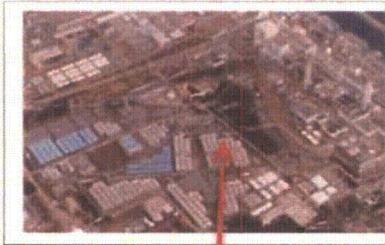
**No. 5 Tank**

Another concern at the Fukushima Daiichi site is the roughly 300 tons of highly contaminated water that leaked from Tank No. 5 in the storage tank farm and passed through open berm drain valve to the surrounding soil in August 2013. TEPCO is digging up soil to determine the extent of water migration

and inspecting other tanks to determine if there are other leaks. The Japanese Nuclear Regulatory Authority (JNRA) declared this event a level 3, serious incident, on the International Nuclear and Radiological Event Scale based on the amount of radioactive material released from the storage tank. The Japan Nuclear Regulation Authority released a public report on September 5, 2013, in which they describe the current situation of contaminated water leakage and possible issues with the storage tanks.

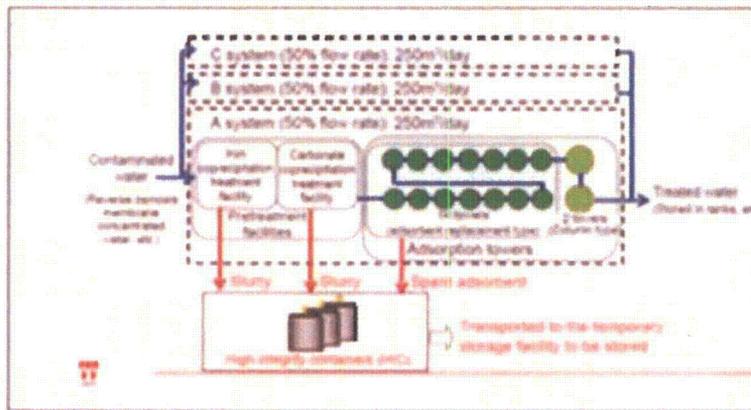
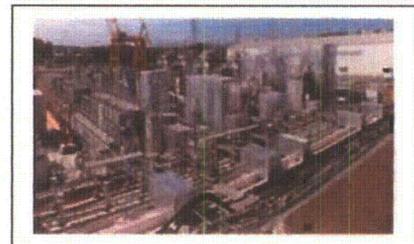
**Advanced Liquid Processing System**

The amount of radioactive strontium stored in the tank farm, if not contained, has the potential to release more radioactivity to the ocean than was released in the days initially following the March 2011 accident. Removing the radioactivity from this stored water is considered by many to be a priority. However, the Advanced Liquid Processing System (ALPS) designed to remove all radioactivity with the exception of tritium is over a year behind schedule. When operational, ALPS can process up to 750T/day of the highly contaminated water. TEPCO hopes to receive permission to pump this tritium contaminated water to the ocean.

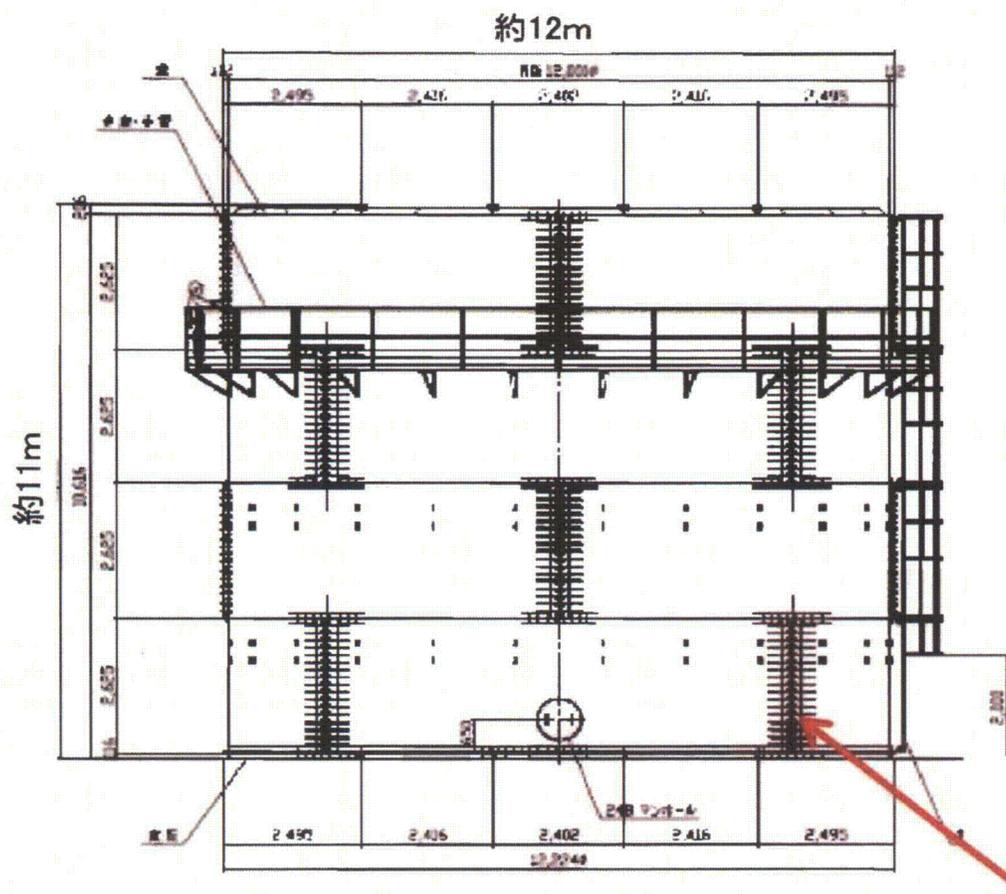
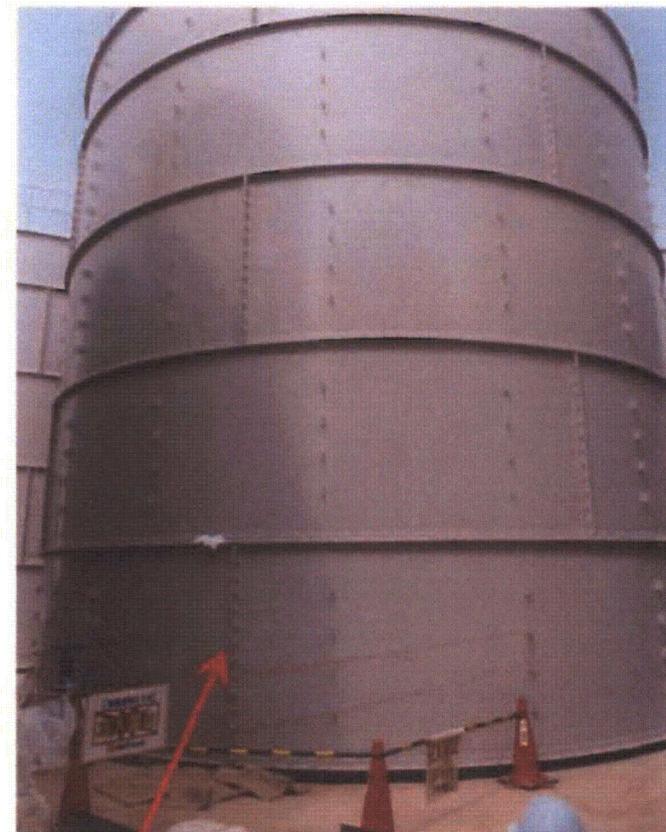
<Attachment 1>

**Bolted-joint storage tank**  
cf. Weld-bonding storage tank

There are 305 bolted-joint storage tanks for contaminated water at the Fukushima Daiichi Nuclear Power Station. According to the TEPCO's reports to the NRA, one of 305 bolted-joint storage tanks had an incident of water leakage, four storage tanks have the high possibility of water leakage, and one connection pipe between bolted-joint storage tanks had an incident of water leakage. **[Attachments 1 and 2]**

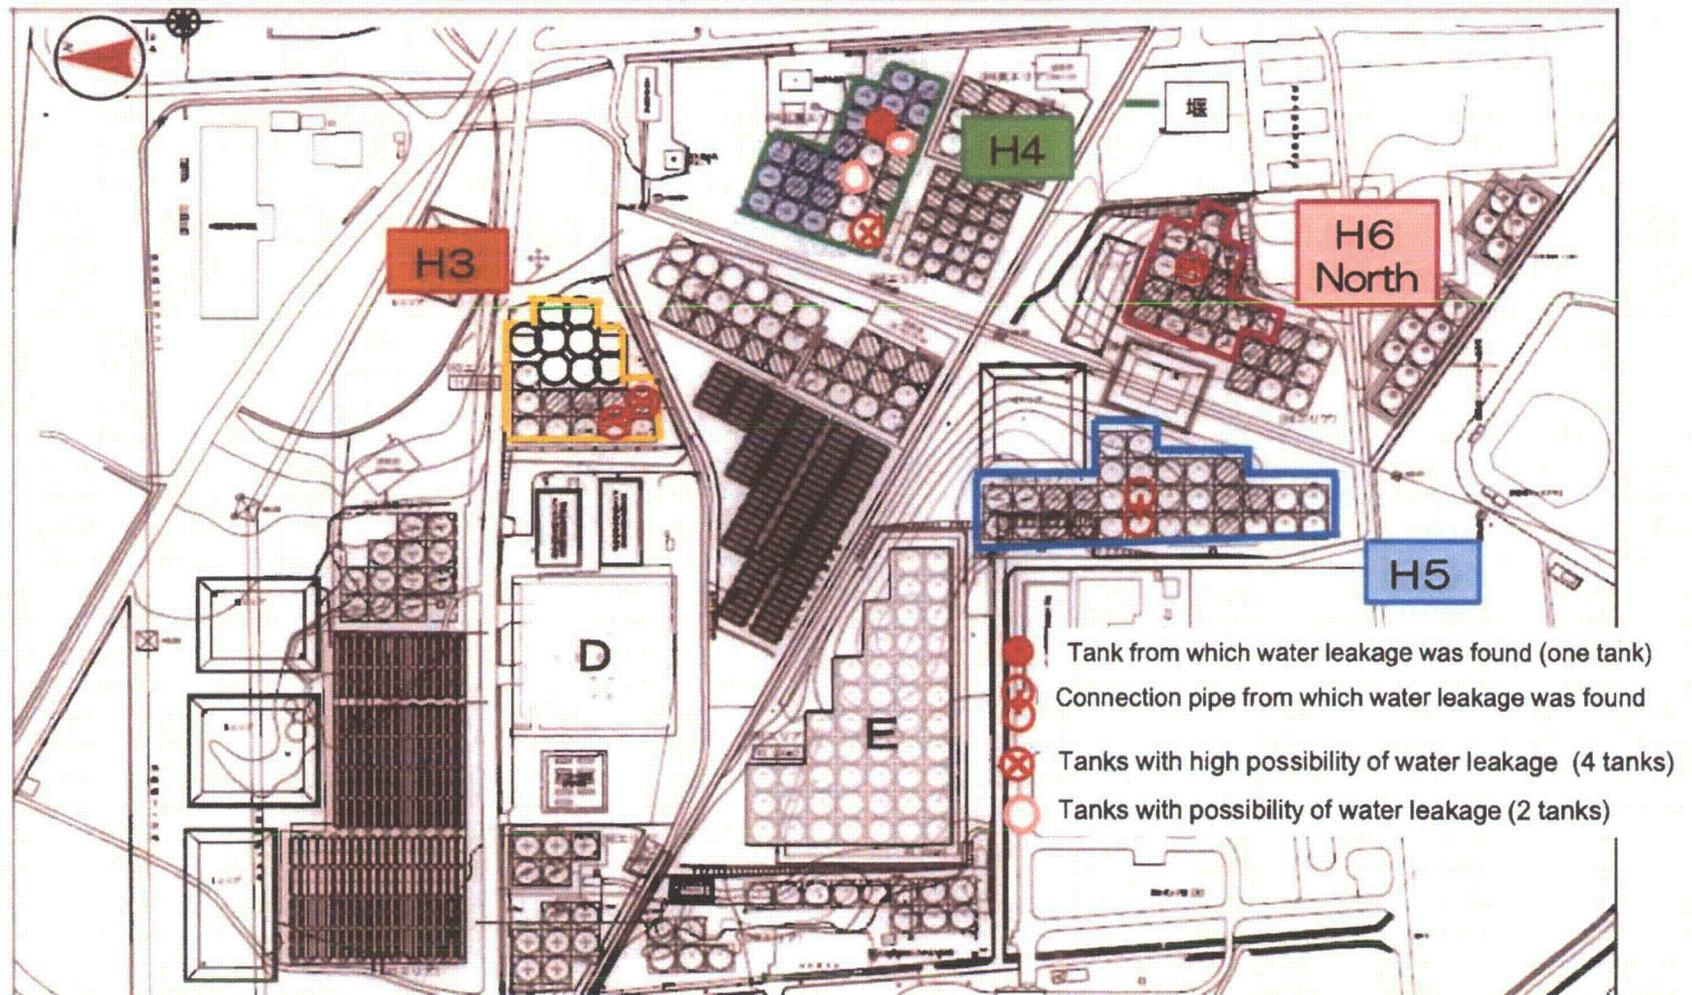
## Location of Storage Tanks

Modified by the NRA, Original illustrated by TEPCO

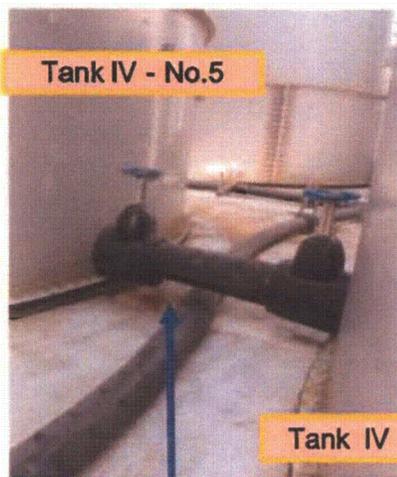
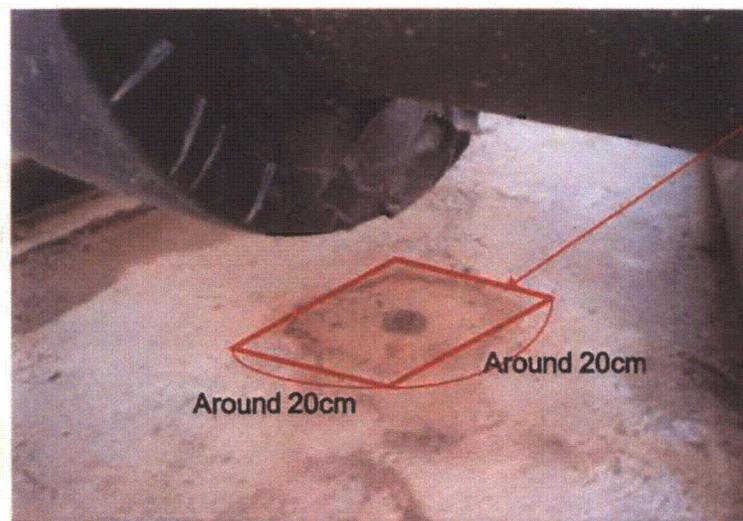
## Water Leakage from Connection Pipe between Storage Tanks (H5 Tank Area)

The photo taken by TEPCO on 31 August

Puddle trace (20 cm x 20 cm)

At the point 5cm from the surface of the puddle trace 230 mSv/h \* of  $\beta$  rays was detected by TEPCO on 31 August.

It was found by TEPCO that one drop of contaminated water fell every 90 seconds after the cover stuff of the flange was removed, and then this water drop has stopped by TEPCO's tightening up the bolts of flange on 1 September.

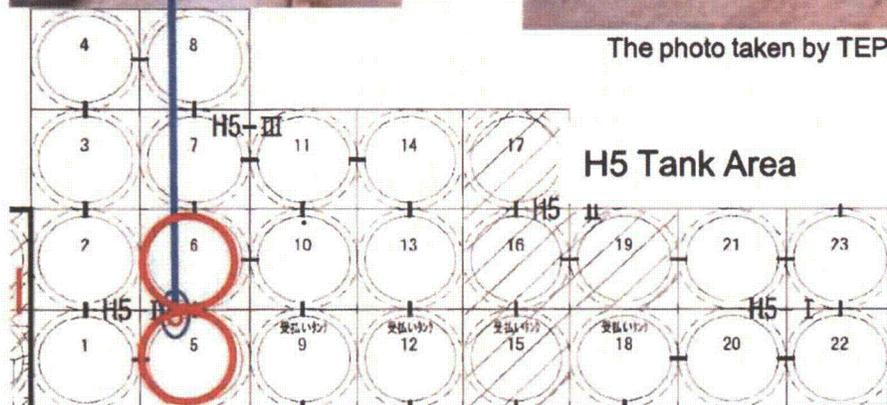
Radioactivity (Sampling date: 31 August 2013)

Nuclide	Concentration (Bq/cm <sup>3</sup> )
Cs-134	25
Cs-137	61
Total Beta	3.0×10 <sup>5</sup>

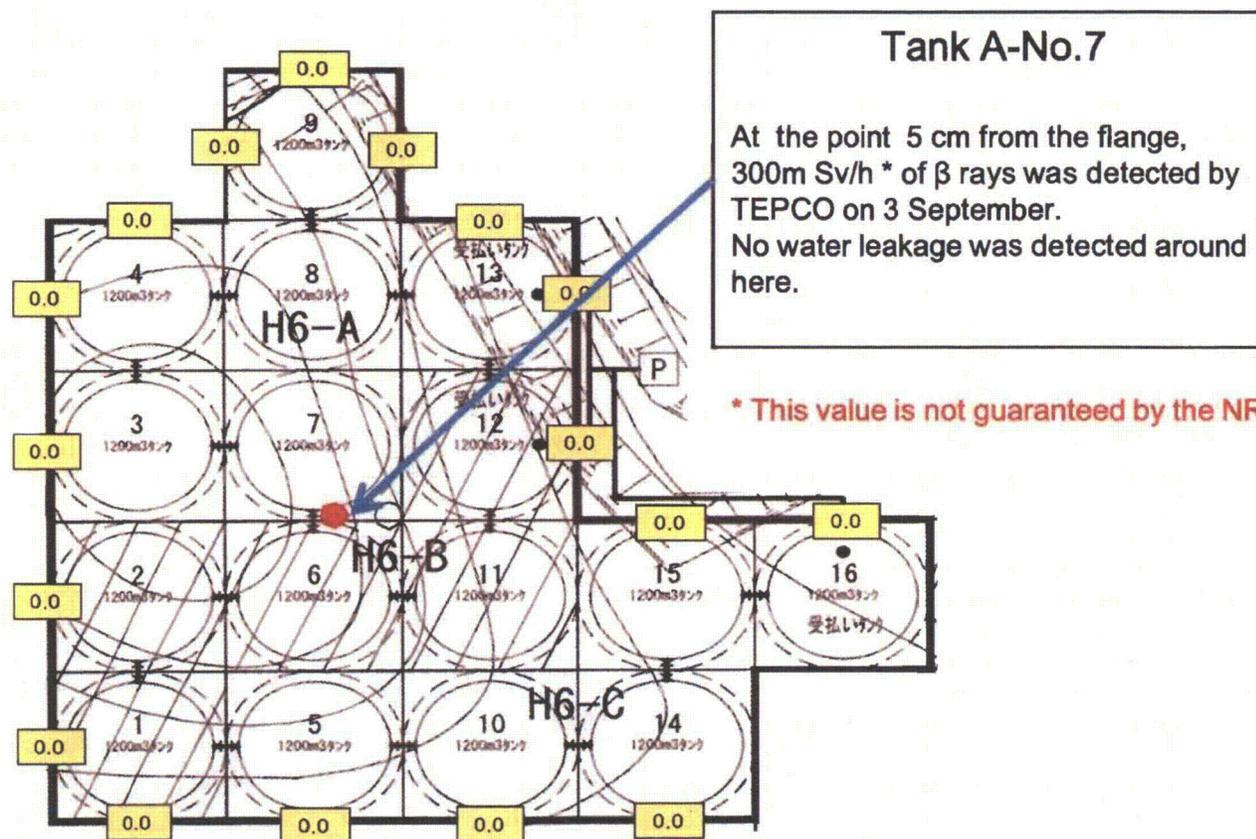
# H 6 North Tank Area

Modified by the NRA, Original illustrated by TEPCO

Four storage tanks (two tanks in H3 Tank Area **[Attachment 4]**, one tank in H6 Tank Area **[Attachment 5]** and one tank in H4 Tank Area **[Attachment 6]**) have the high possibility of water leakage. In addition, other two storage tanks in H4 Tank Area have the possibility of contaminated water leakage. **[Attachment 6]**

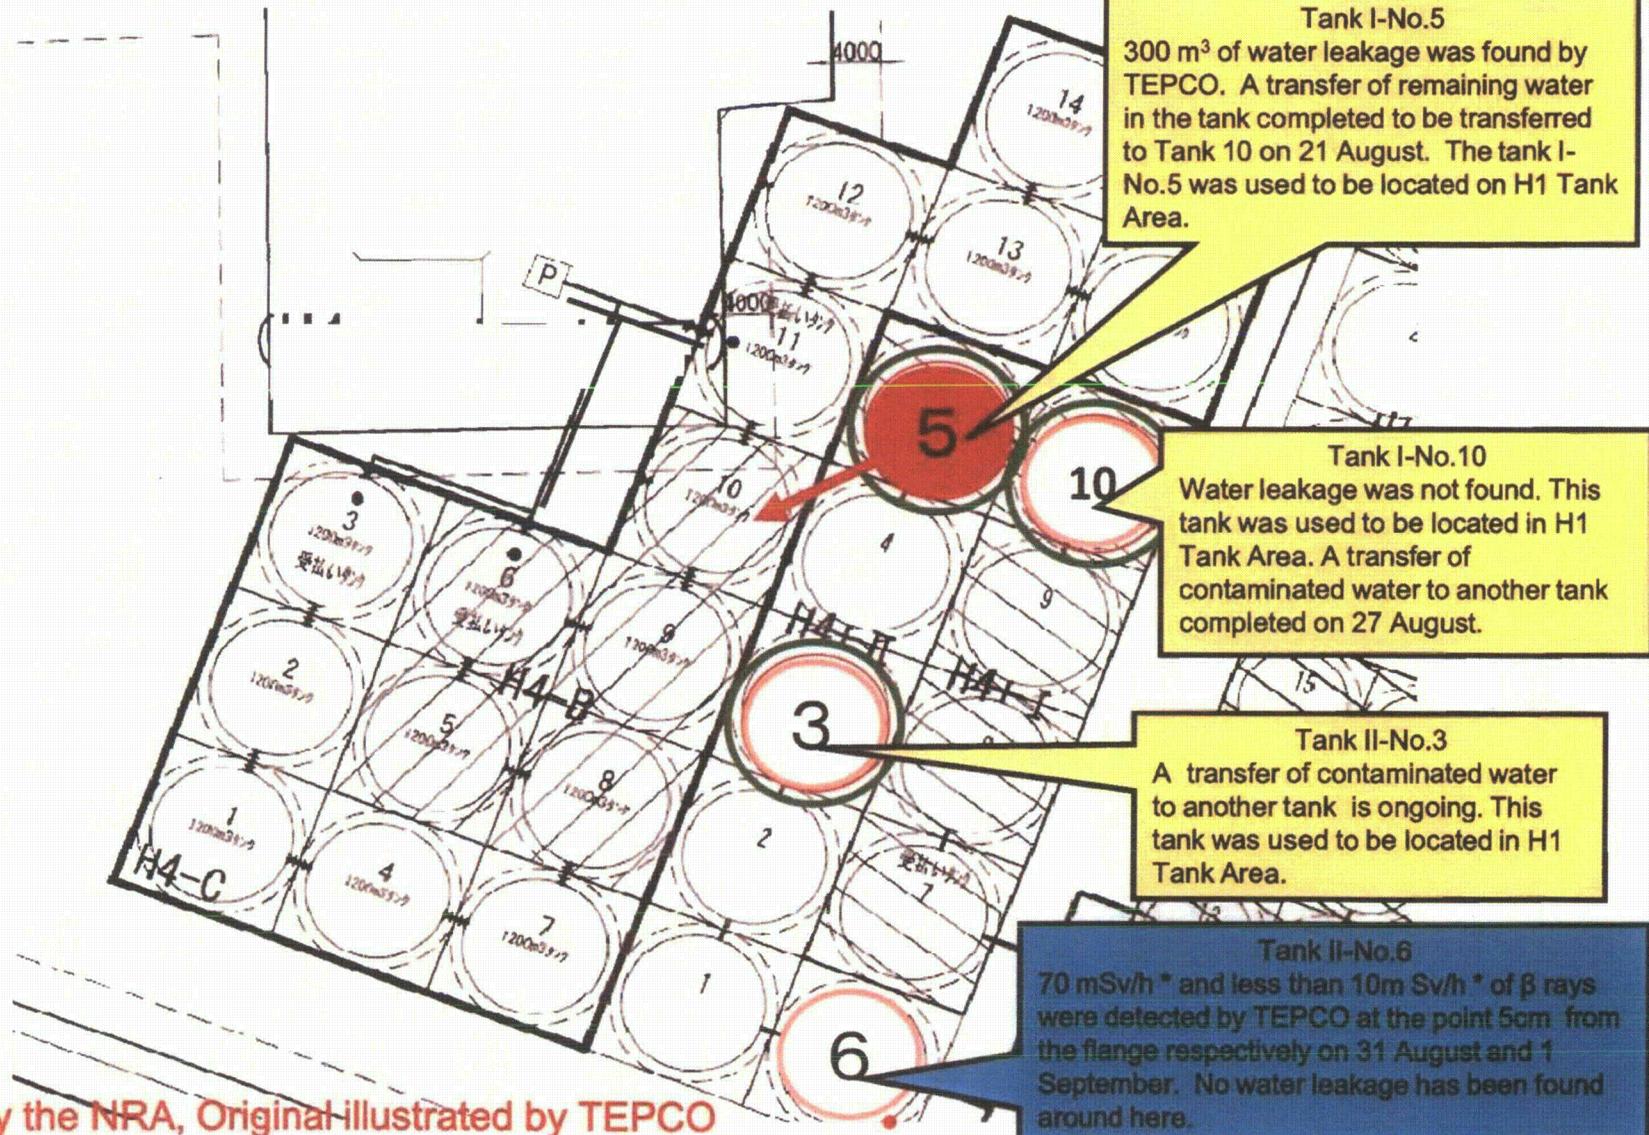
### H 4 Tank Area

**Tank I-No.5**  
300 m<sup>3</sup> of water leakage was found by TEPCO. A transfer of remaining water in the tank completed to be transferred to Tank 10 on 21 August. The tank I-No.5 was used to be located on H1 Tank Area.

**Tank I-No.10**  
Water leakage was not found. This tank was used to be located in H1 Tank Area. A transfer of contaminated water to another tank completed on 27 August.

**Tank II-No.3**  
A transfer of contaminated water to another tank is ongoing. This tank was used to be located in H1 Tank Area.

**Tank II-No.6**  
70 mSv/h\* and less than 10m Sv/h\* of β rays were detected by TEPCO at the point 5cm from the flange respectively on 31 August and 1 September. No water leakage has been found around here.

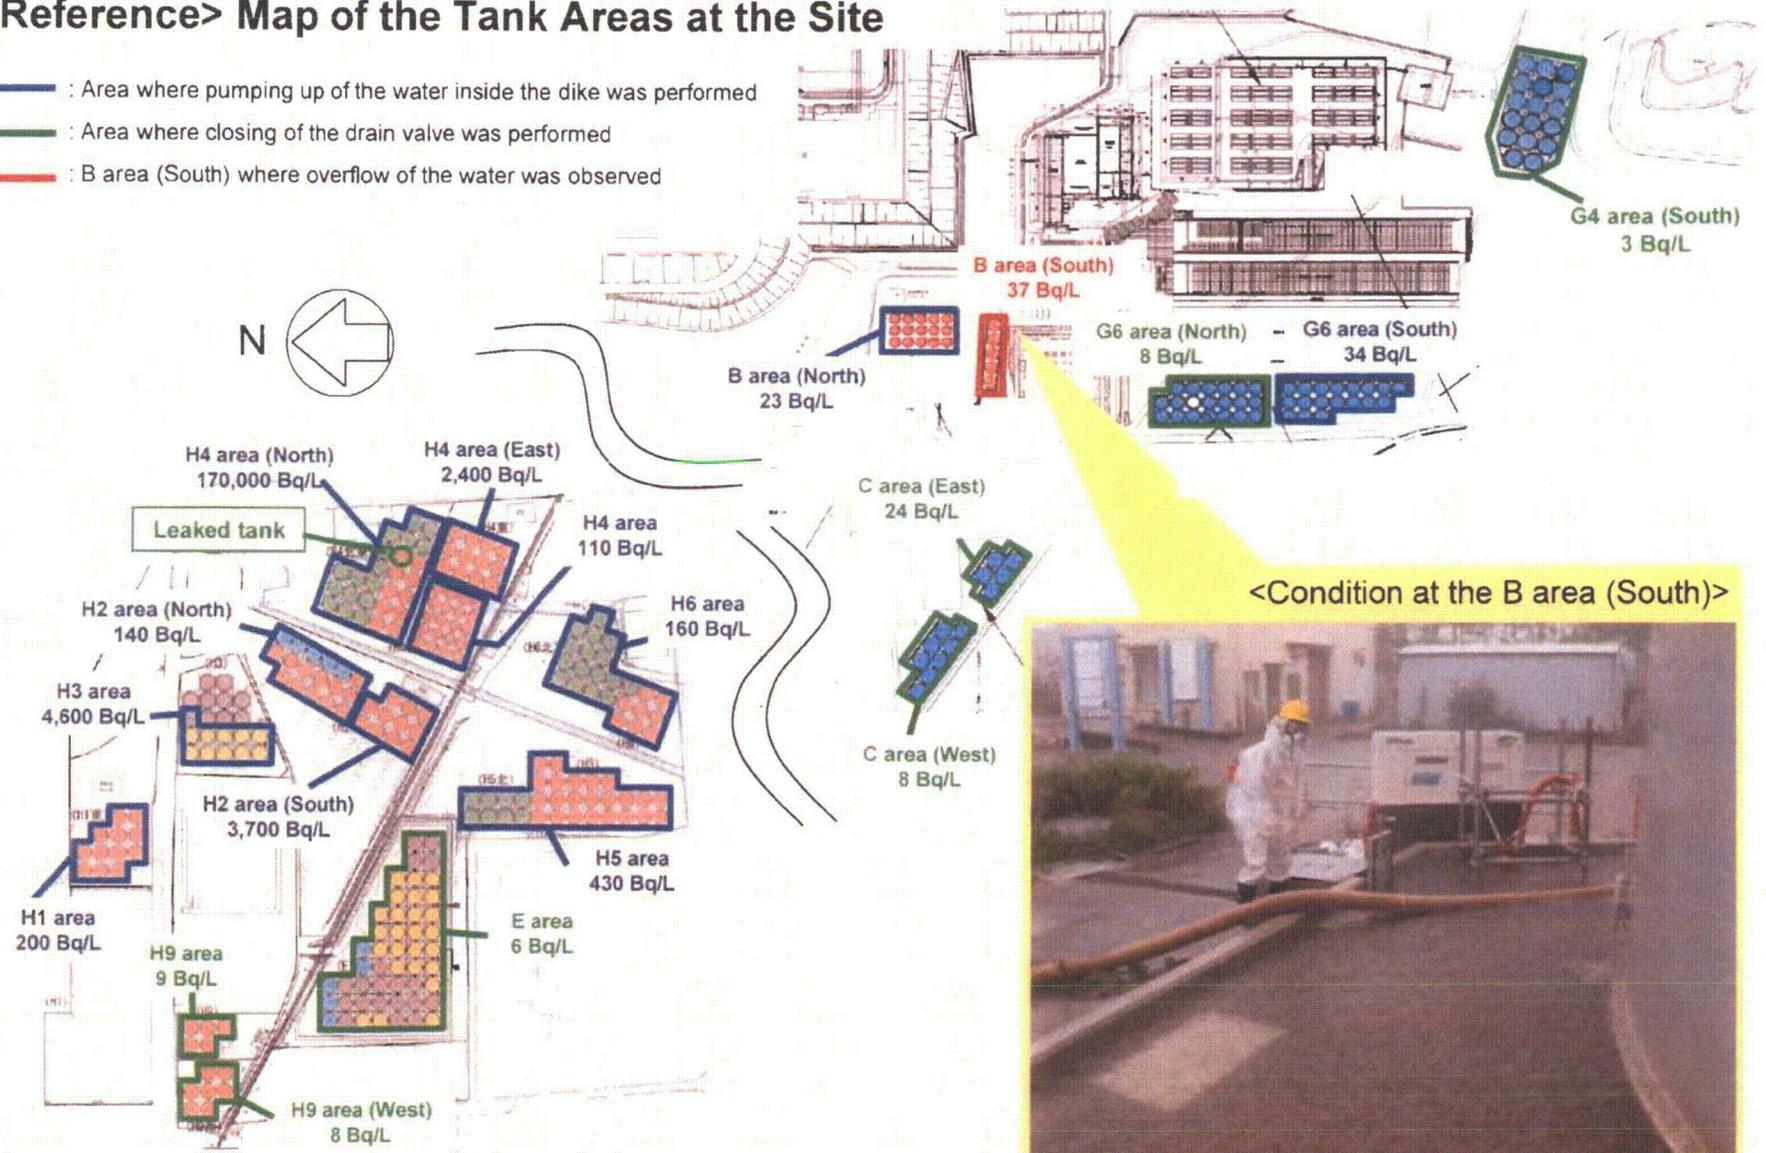
## <Reference> Map of the Tank Areas at the Site

- : Area where pumping up of the water inside the dike was performed
- : Area where closing of the drain valve was performed
- : B area (South) where overflow of the water was observed

(Photo taken by TEPCO on September 15, 2013)

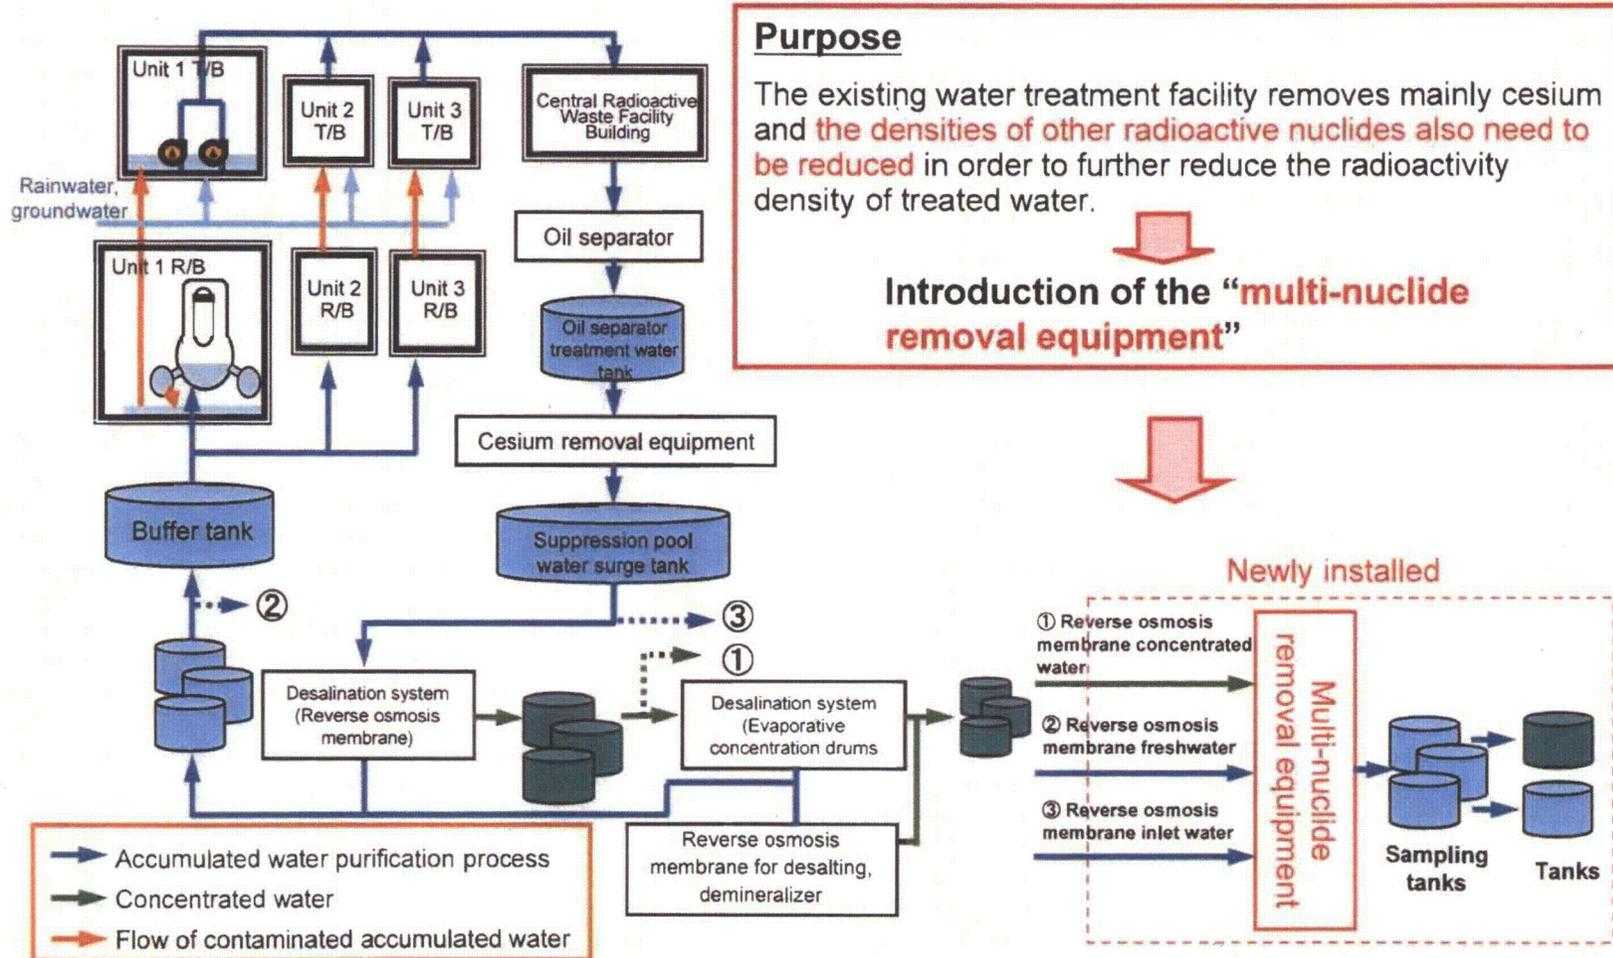
# Purpose of Installing the Multi-nuclide Removal Equipment

## Installation of the multi-nuclide removal equipment

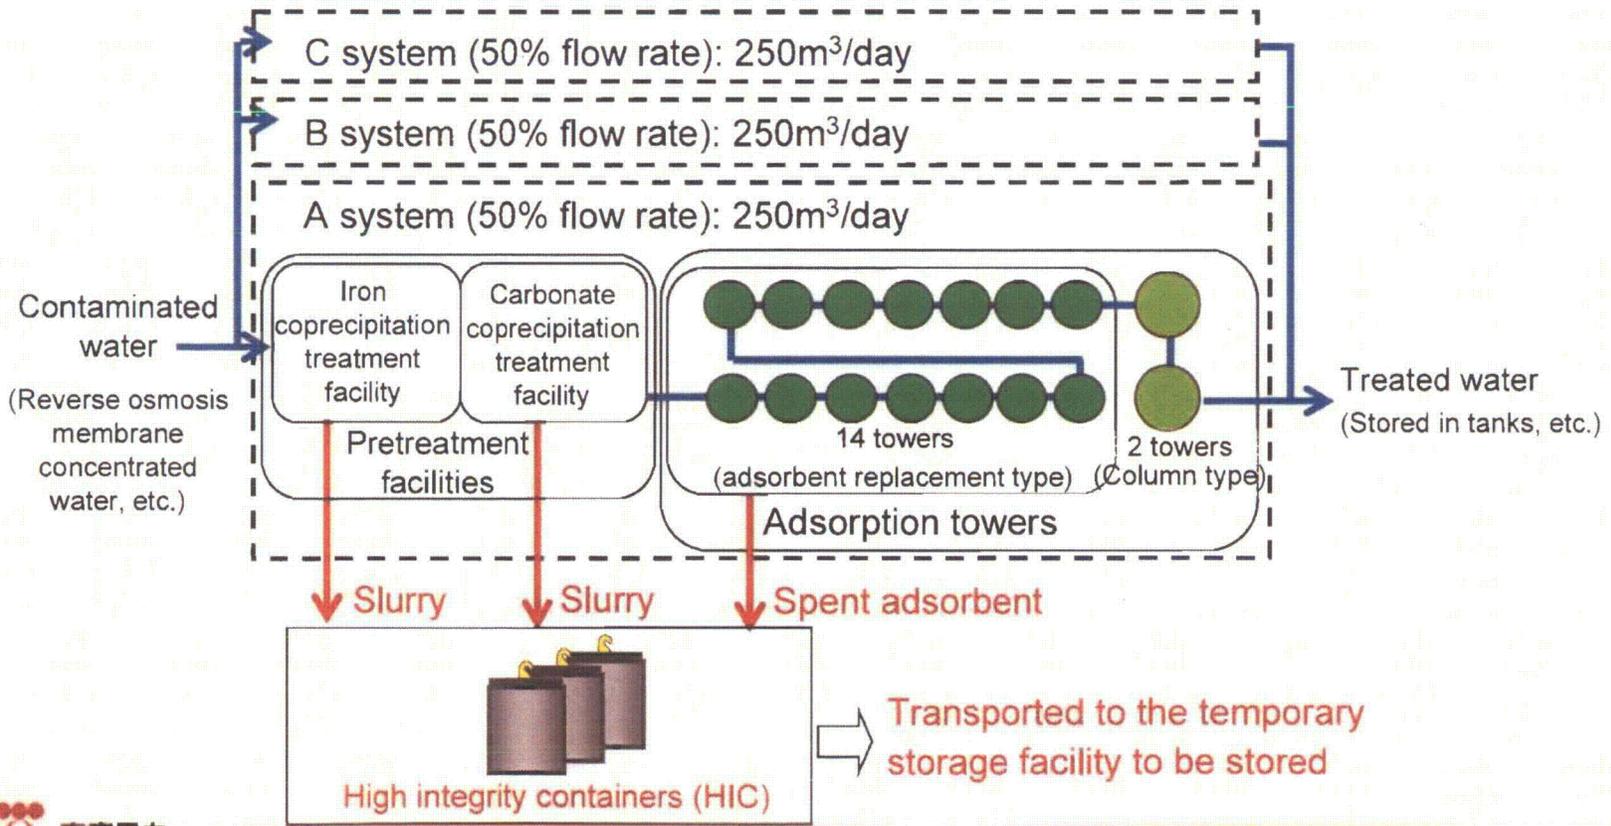
# Overview of the Multi-nuclide Removal Equipment

- Radioactive materials are removed by passing radioactive contaminated water through the pretreatment facilities and adsorption towers.
- The waste materials (slurry, spent adsorbent) are transferred into high integrity containers (HIC). HICs which store a specified amount of waste are transported to the temporary storage facility to be stored.

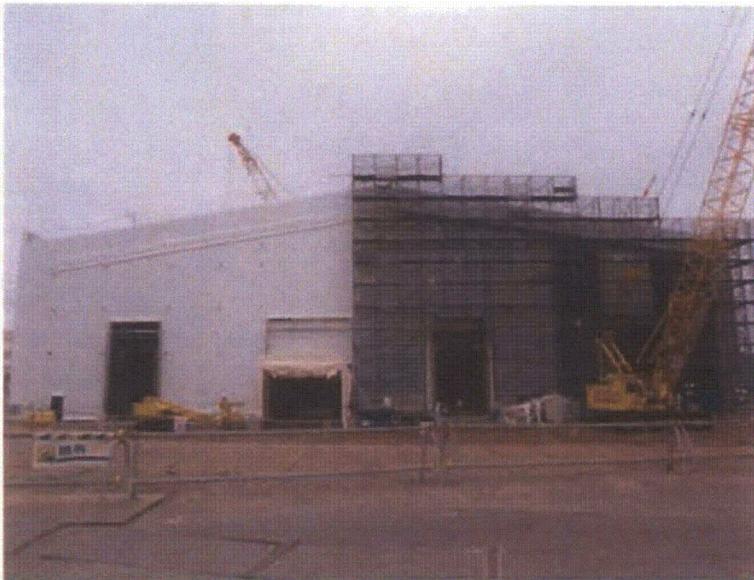
Progress of building construction for the  
multi-nuclide removal equipment  
(Photos taken on March 27, 2013)

Photo taken from the south side

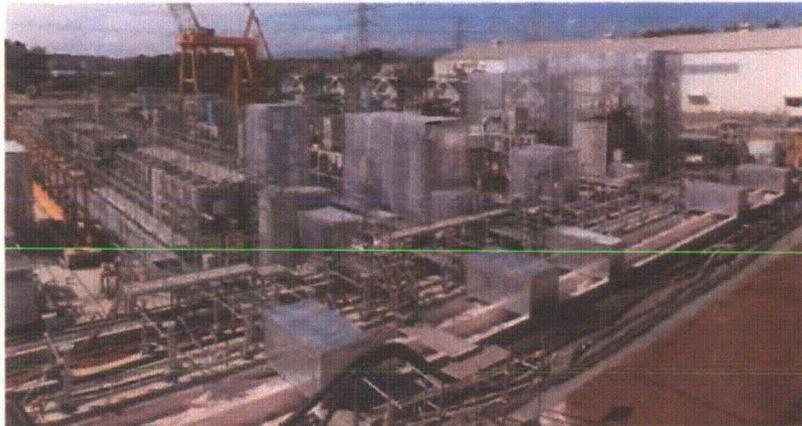
Progress of multi-nuclide removal equipment installation  
(Photo taken on September 16, 2012)

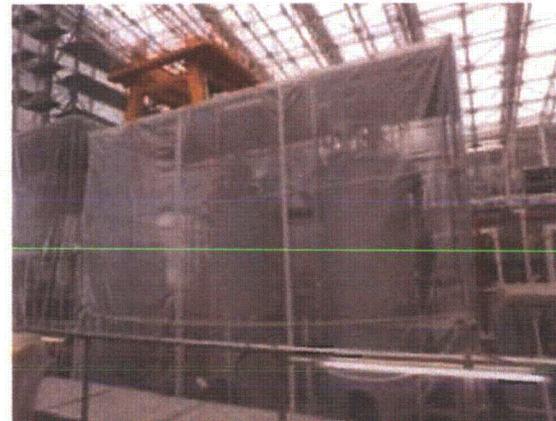
Adsorption tower (Treatment column)  
(Photo taken on March 27, 2013)

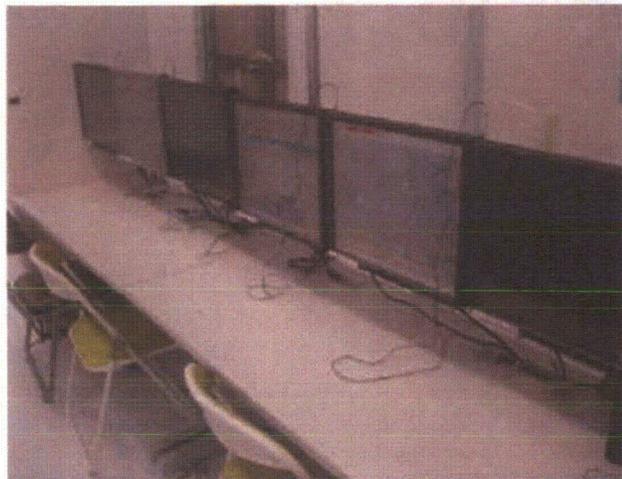
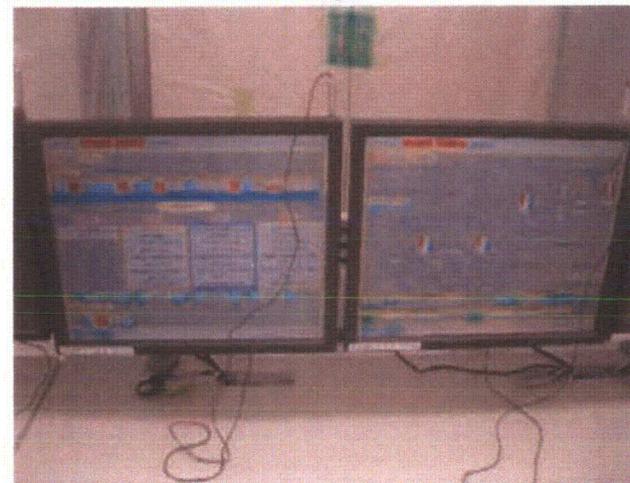
Control panels (Photos taken on March 27, 2013)

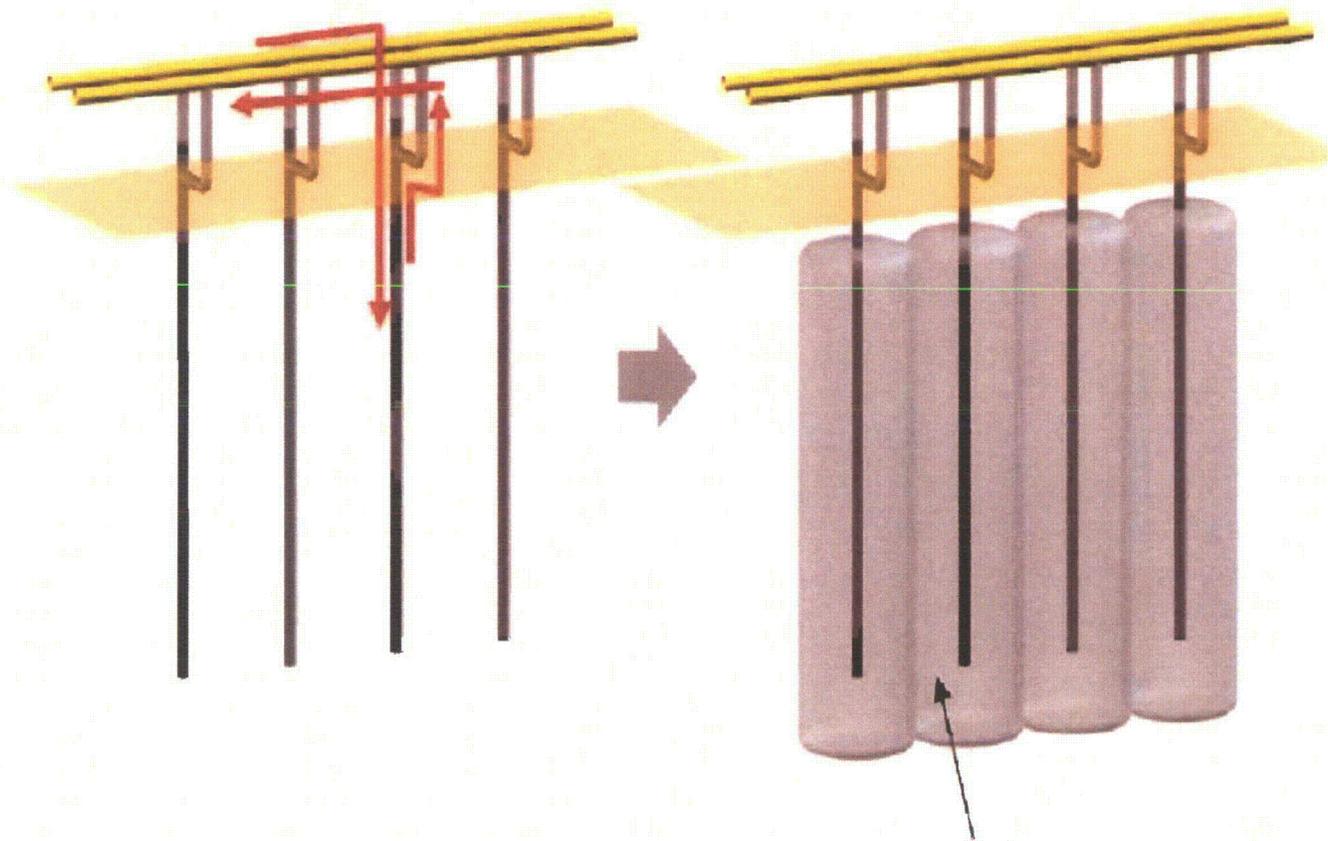
# Frozen Wall

Impermeable Barrier

Fukushima plan: 1.4 km in length; as deep as 30 m, vertical pipes, 1 m apart, anticipate 6-8 weeks for ice columns to merge. The ice-wall is not the only means of relieving water flow to basements; upgradient pumps and subdrain pumps may be used.

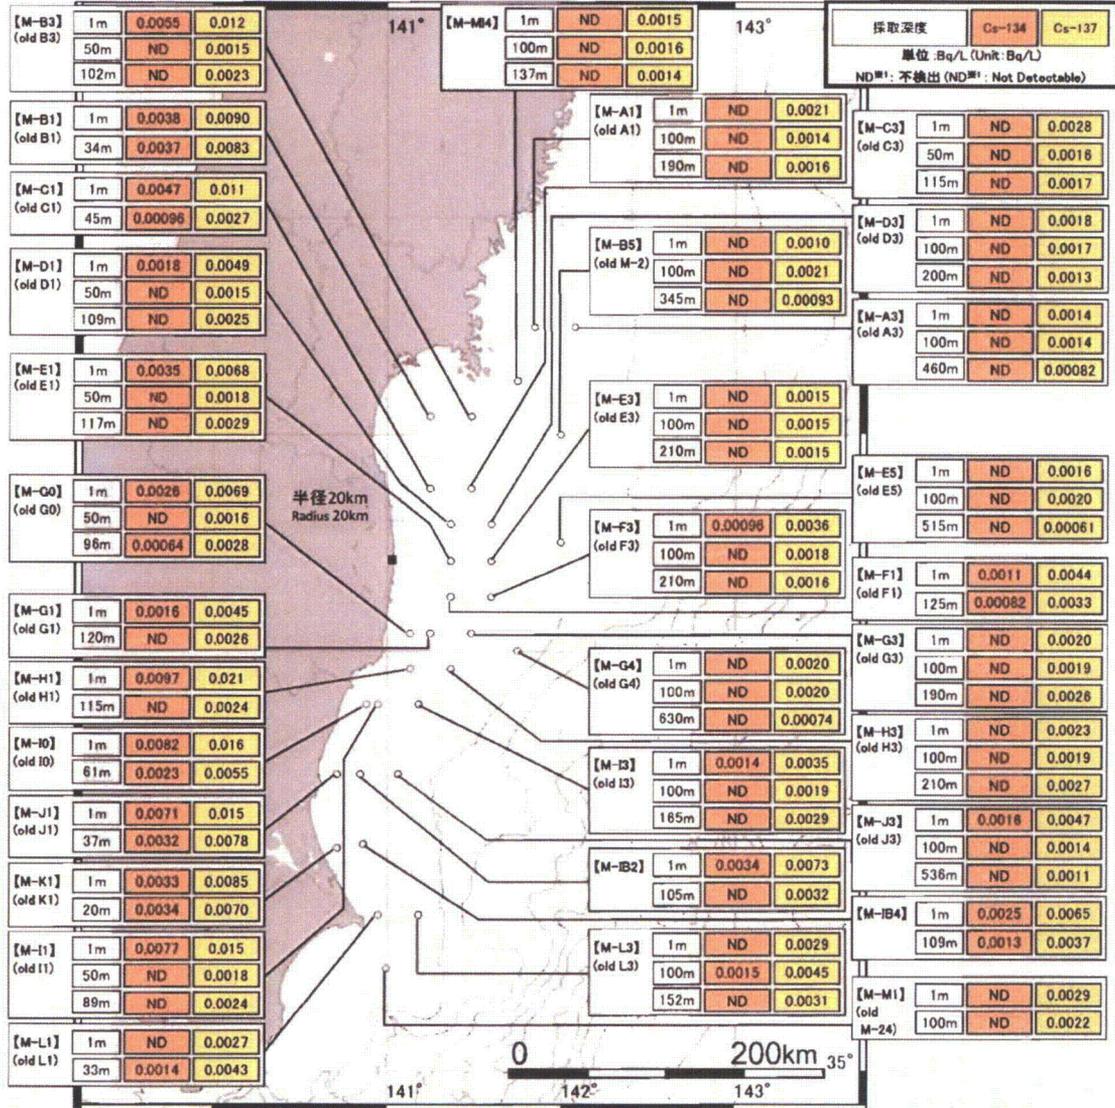
Readings of Sea Area Monitoring at offshore of Miyagi, Fukushima, Ibaraki and Chiba Prefecture (Seawater)

試料採取日: 平成25年5月16日~6月2日  
(Sampling Date: May 16~Jun 2, 2013)

※1 ND indicates the case that the detected radioactivity concentration in seawater was lower than the minimum detectable activity 0.001Bq/L.

Activity in Pacific more recently; Cs-137 distributions in coastal ocean **see NRA Map of May 16 – June 2, 2013**; surface activities about 50 km offshore range from 0.0010 – 0.0023 Bq/L. Closer to shore (20 km) concentrations are higher, 0.004 to 0.016 Bq/L, even when more than 200 km from Fukushima. This suggests to me effects of runoff from land. Further offshore, about 200 km, Cs-137 concentrations are essentially at background.

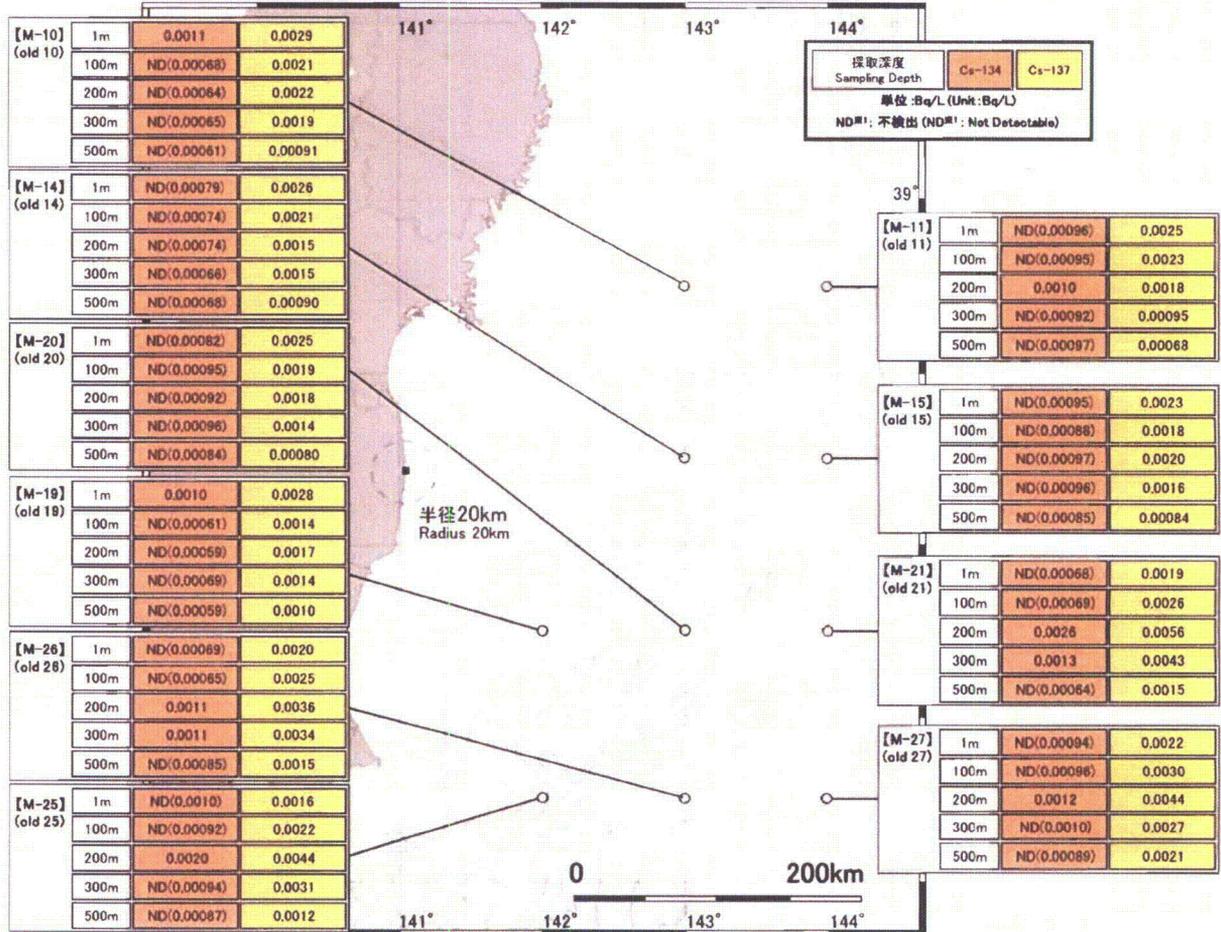
(Sampling Date: May 14-19, 2013)

※1 ND indicates the case that the detected radioactivity concentration in seawater was lower than the detection limits.
