# Fukushima Water Update

September 17, 2013

## Briefing Sheet to Support Inter-Agency Discussions

### Contaminated Water at Fukushima Daiichi Nuclear Facility

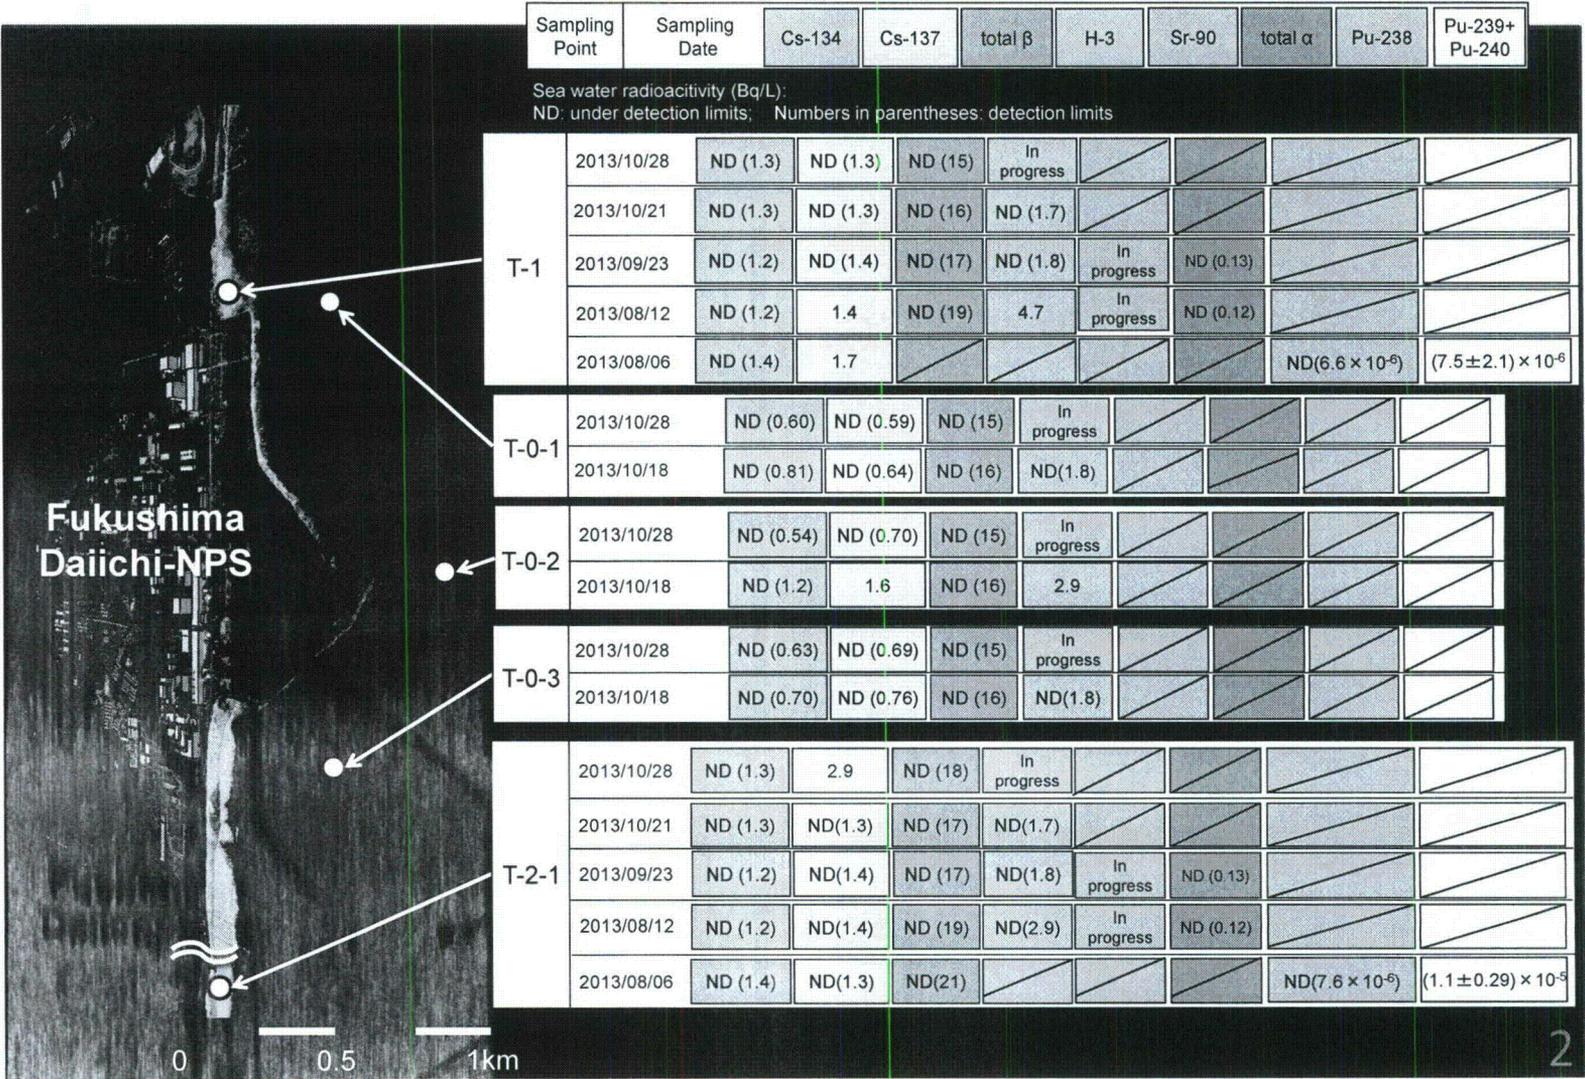
# Sea area within 2km radius from the NPS

Sea water radioactivity (Bq/L):  
 ND: under detection limits; Numbers in parentheses: detection limits

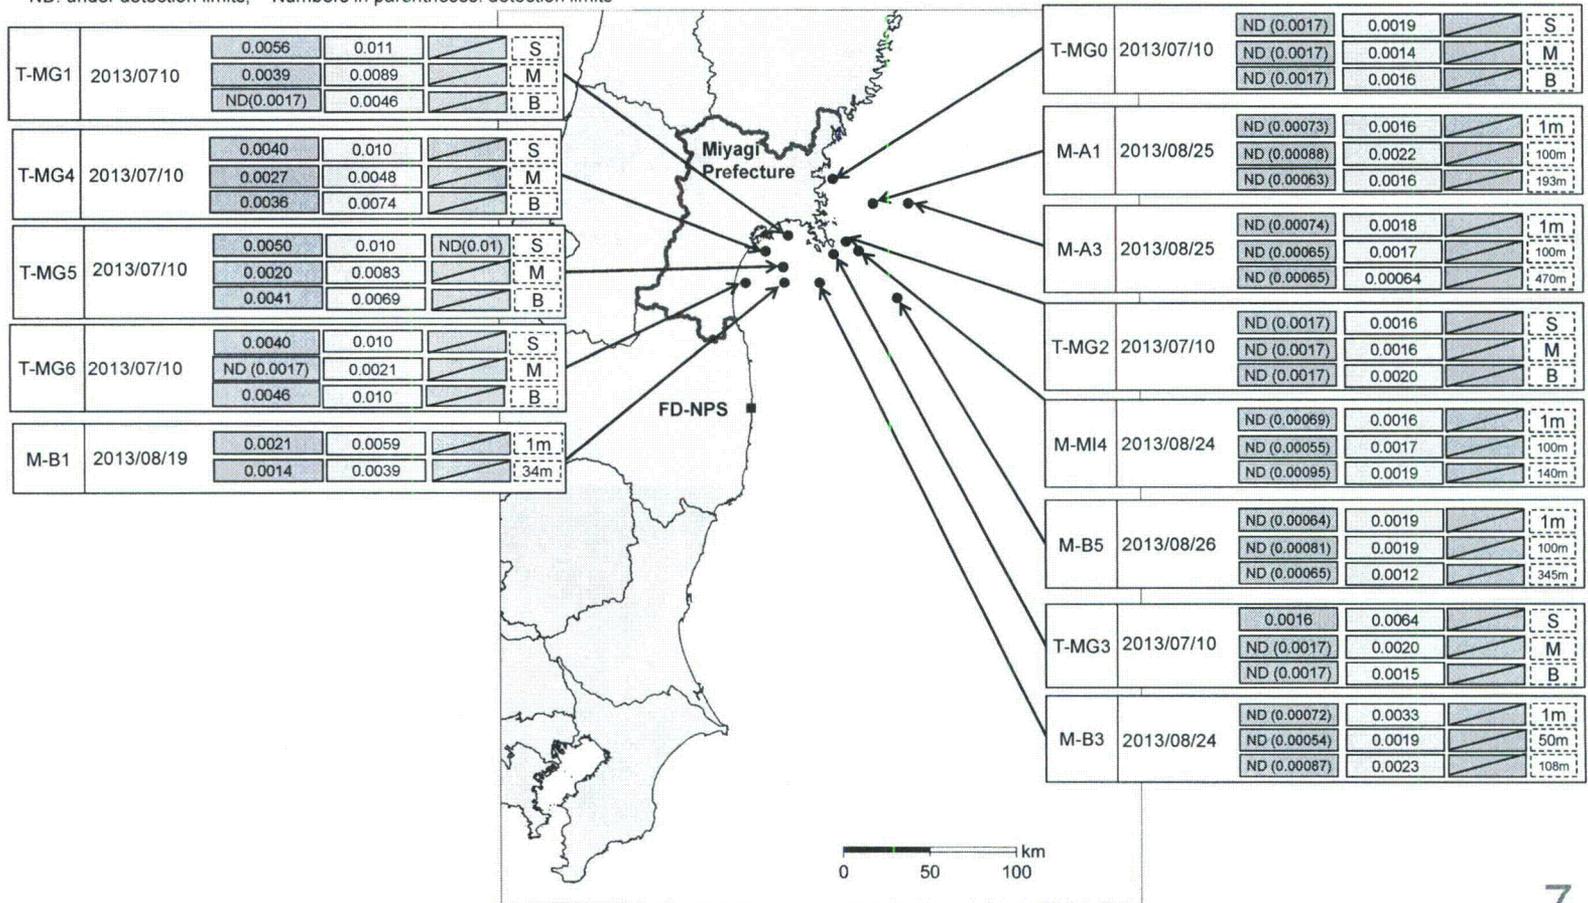
# Sea area along and off the coast of Miyagi Prefecture

S: 2m below sea level  
M: between 2m below sea level and 2-3m above sea bottom  
B: 2-3m above sea bottom

Sea water radioactivity (Bq/L):  
ND: under detection limits; Numbers in parentheses: detection limits

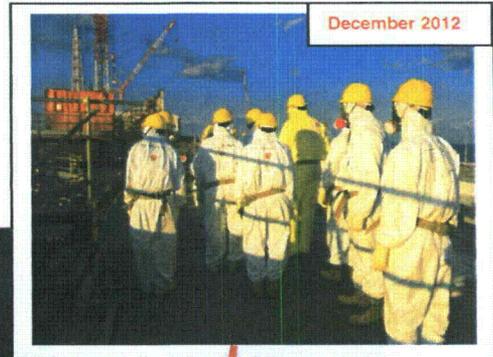
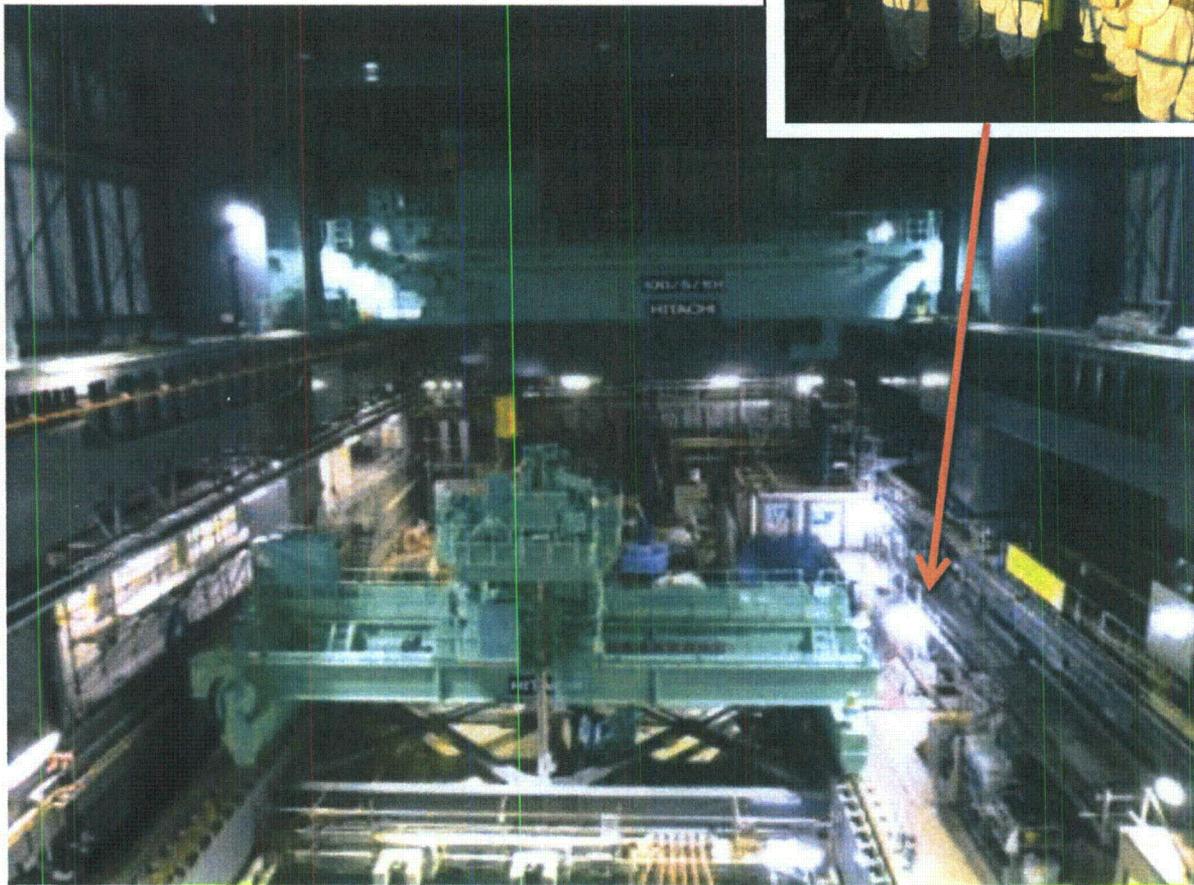
Ready for Fukushima fuel move: Unit 4 at Fukushima Daiichi is nearly ready for used reactor fuel removal. The main crane and the fuel handling machine are in place.

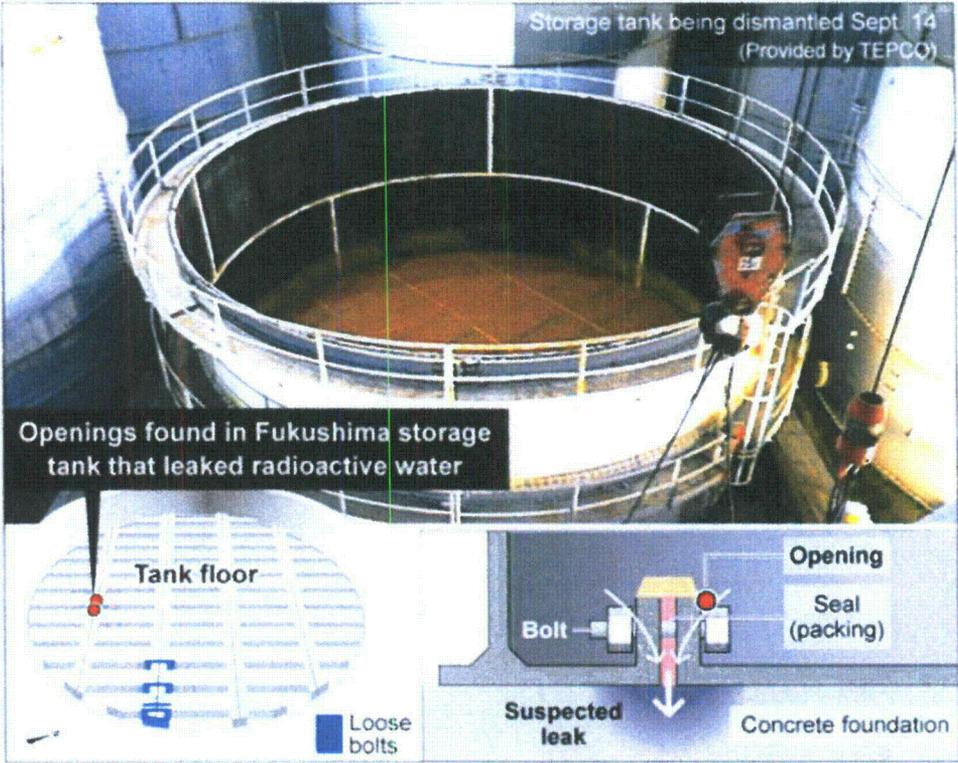
**TEPCO pinpoints breaches in leaky water storage tank:** Engineers found two openings along a joint in the Area 5 tank H4 that leaked 300 tons of highly radioactive water.

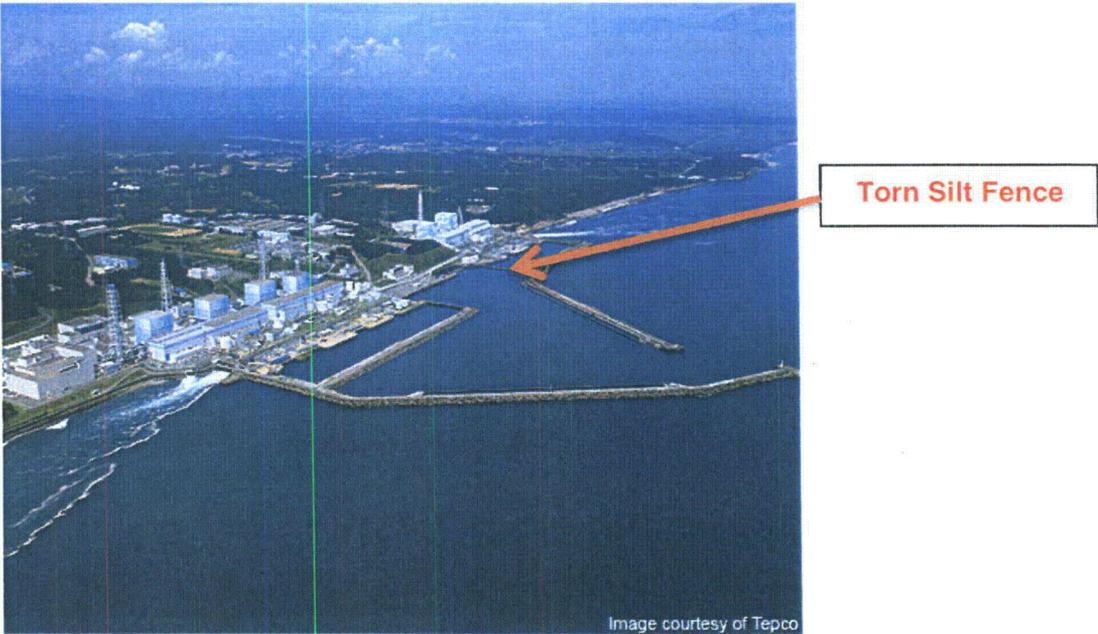
**TEPCO Finds Hole in Anti-Radiation Silt Fence:** Fukushima plant workers spotted a hole in the barrier intended to keep radioactive particles contained on the egress of reactors 5-6.

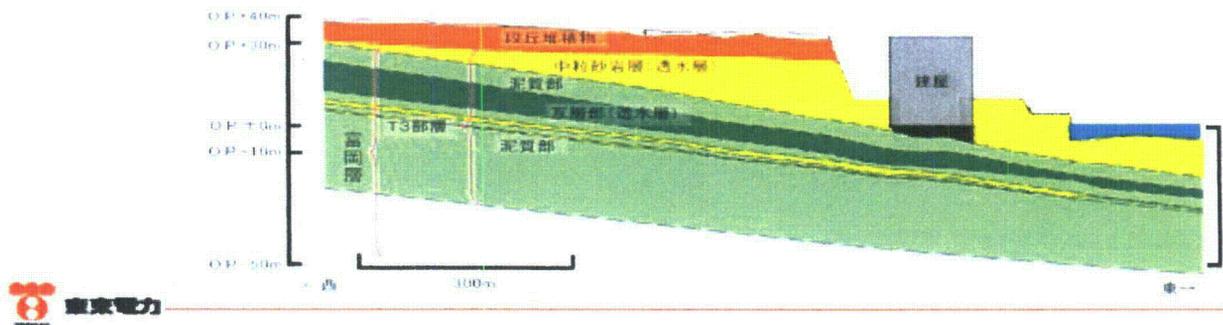
*The memo, USNRC TT5310, recommended building an uphill ground water barrier. The umbrella effect would limit the flow of ground water into the site. TEPCO rejected the proposal in order to maintain ground water level higher than the reactor/turbine building basement water level so that water would leak into the buildings rather than out and directly to the sea.*

Orange-surface deposits  
 Yellow-sandstone (permeable)  
 Light green-mudstone (impermeable)  
 Dark green-mudstone mixture (permeable)
