Alloy 690/52/152 PWSCC Testing

Technical Exchange Meeting on Materials, NRC

June 3-5, 2014

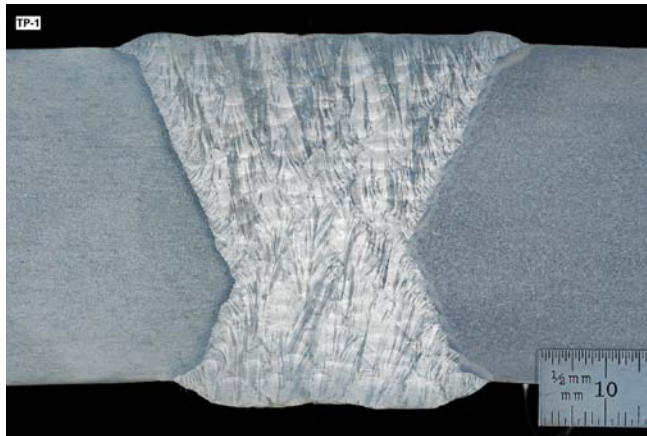
Low Residual Strains and CGR in 50% Repair Mockup

Repair Weld 1

Alloy 152M Repair Weld
50% of wall thickness

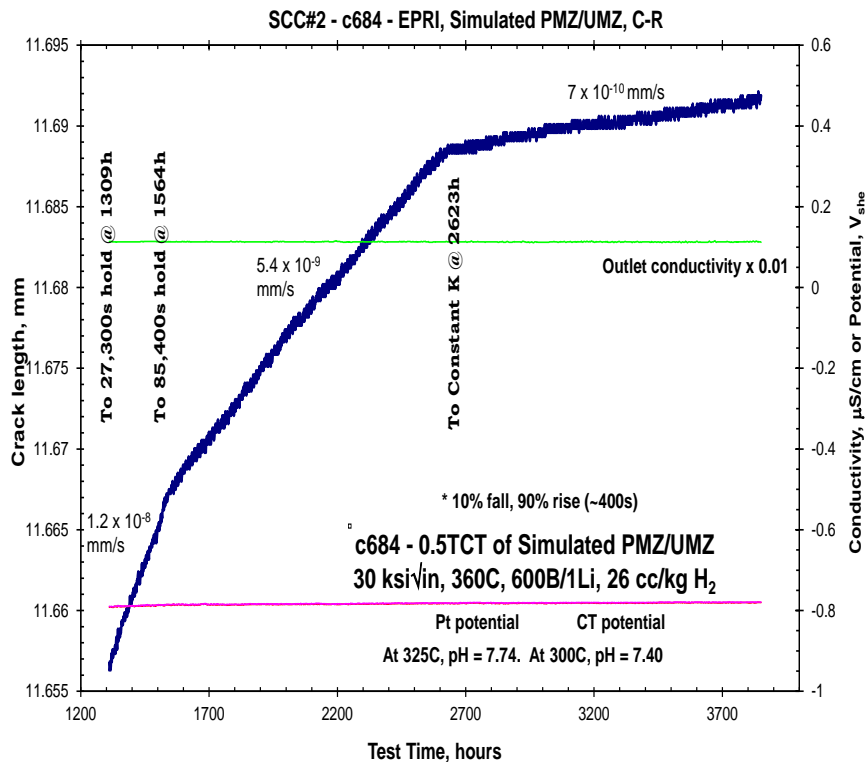
PMZ/UMZ CGR Testing: C-R Orientation

Very low CGRs

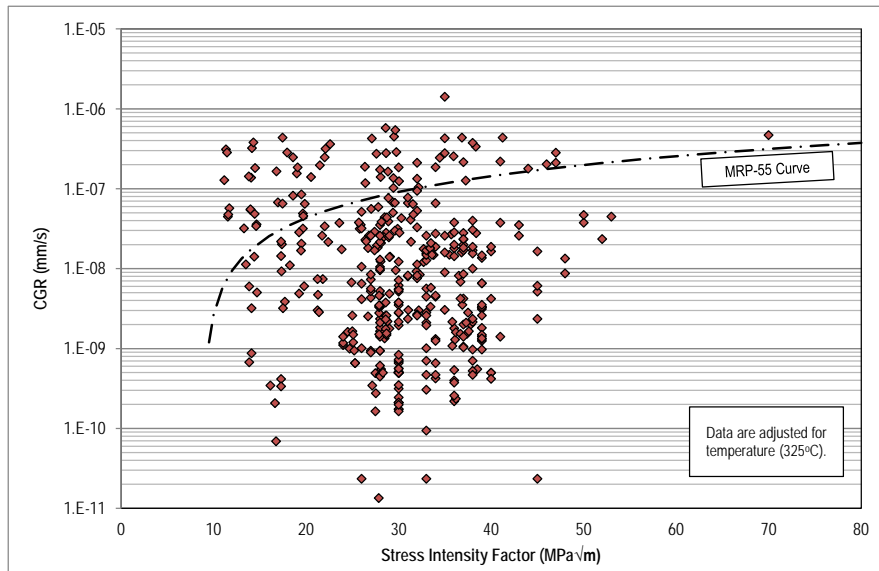
Alloy 690: 6 laboratories, 450+ data points
