# Near-term Task Force Recommendation 2.1 Seismic Hazard Evaluation

# **NTTF Recommendation 2.1- Summary of Preliminary Seismic Hazard Analysis: Indian Point Units 2 and 3**

# Indian Point 2

# Indian Point 3

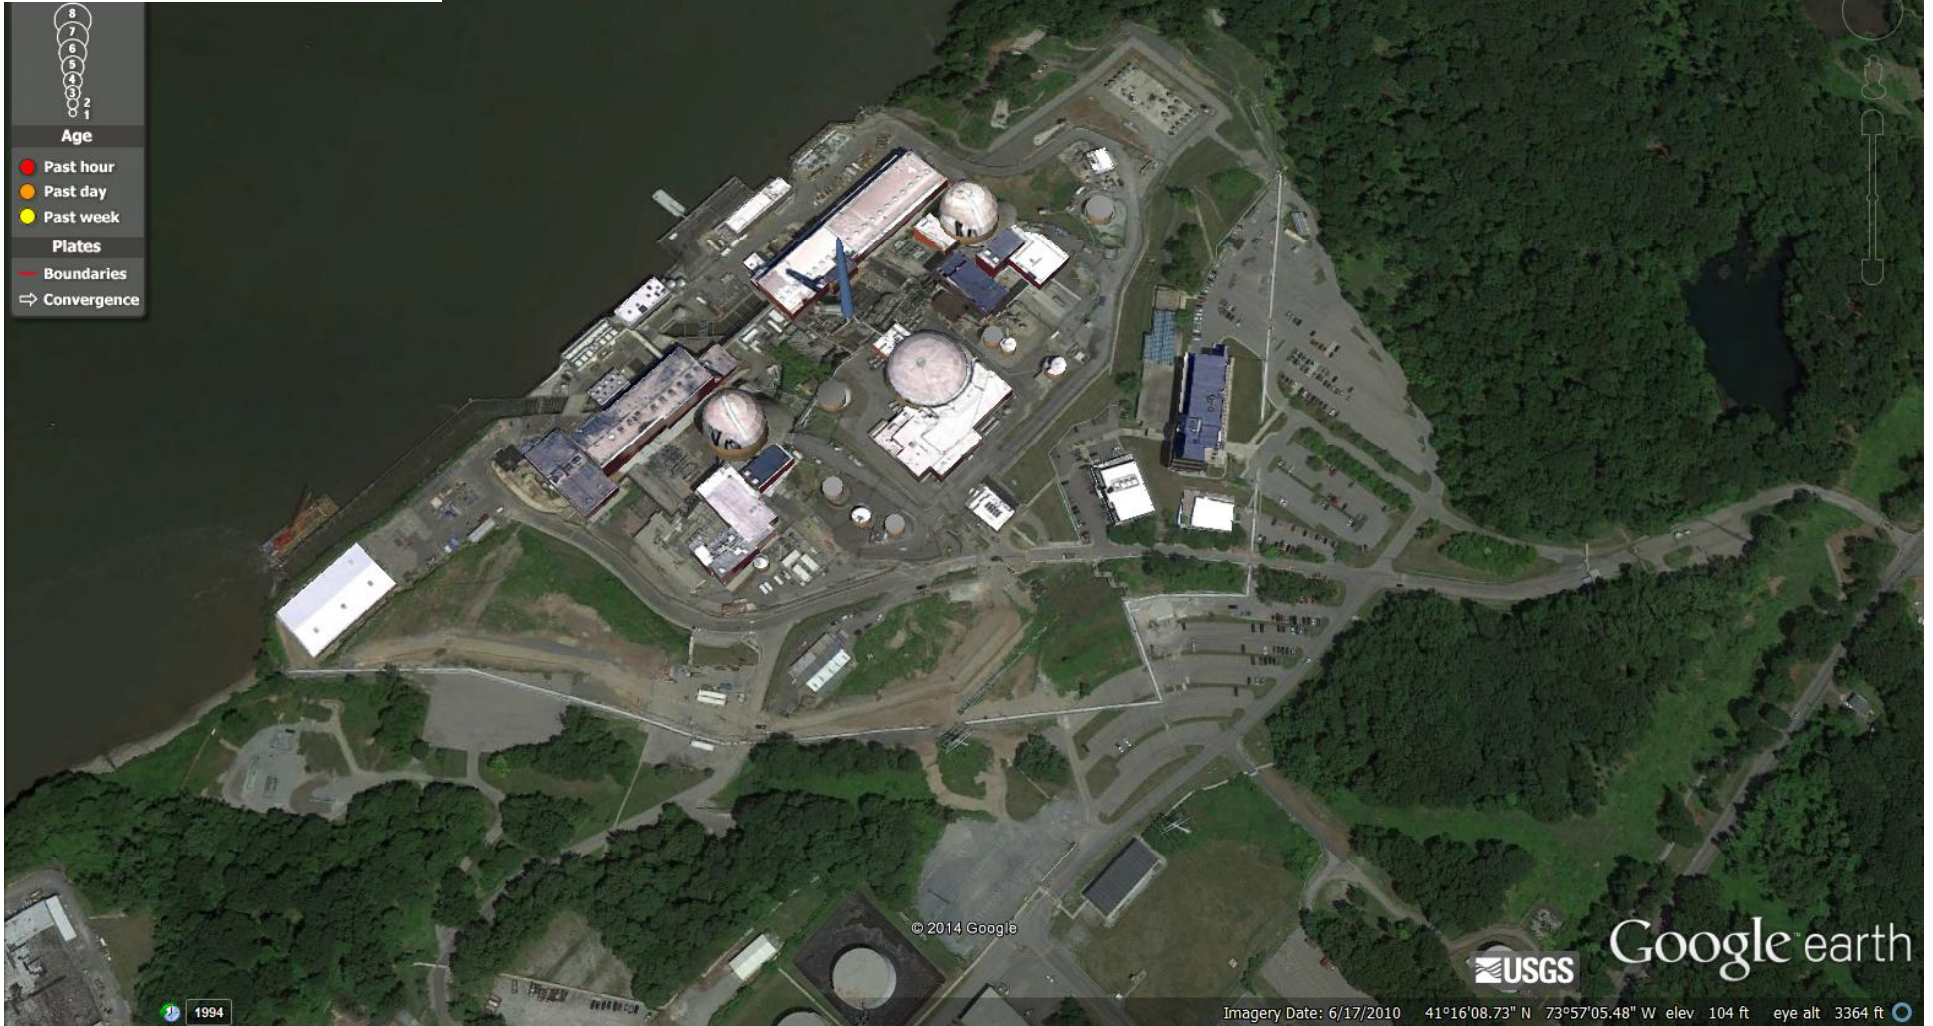
Bedrock: Inwood Marble w/Manhattan schist present in northeastern portion of site

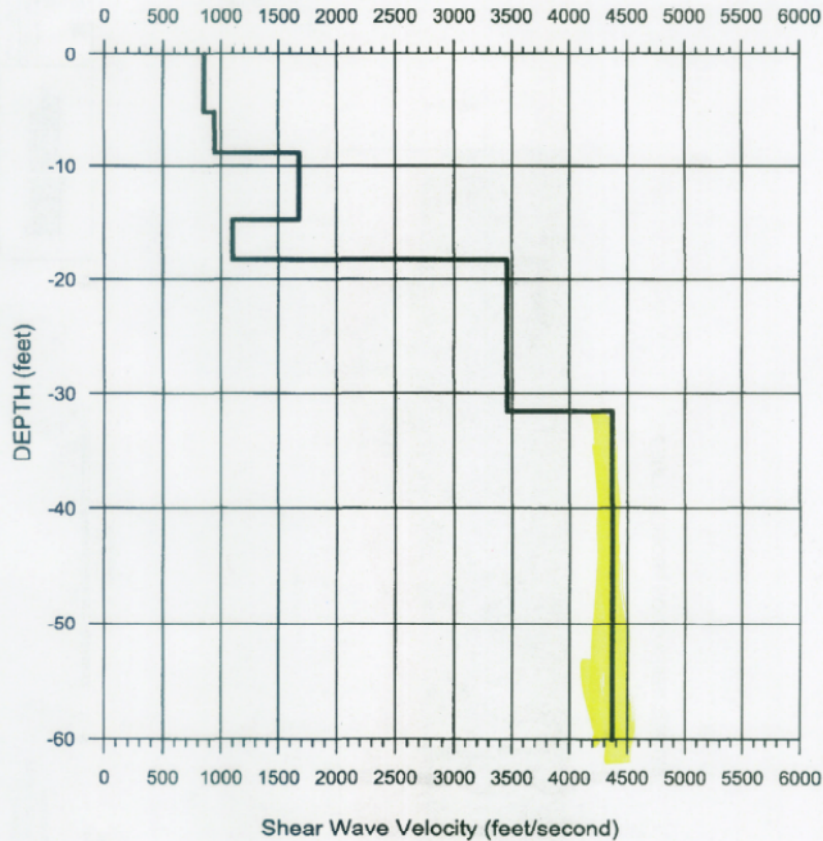
**LINE 6 SPREAD 1**

Shear-wave velocity profile from IP site.

13 profiles acquired with Surface wave-technique- All penetrated bedrock

(from GZA Hydrogeology report, Appendix O)  
ML 102910404

Very consistent velocities in upper portion of bedrock (Inwood)

<b>SHEAR WAVE VELOCITY PROFILE</b> ReMi RESULTS INDIAN POINT POWER PLANT	
	LOCATION: BUCHANAN, NEW YORK	
PROJECT #: 06-245-1	CLIENT: GZA GEOENVIRONMENTAL	FIGURE 8A
DATE: SEPTEMBER 20, 2006	DATE: 8/11/06	DRAWN BY: B. MILLER

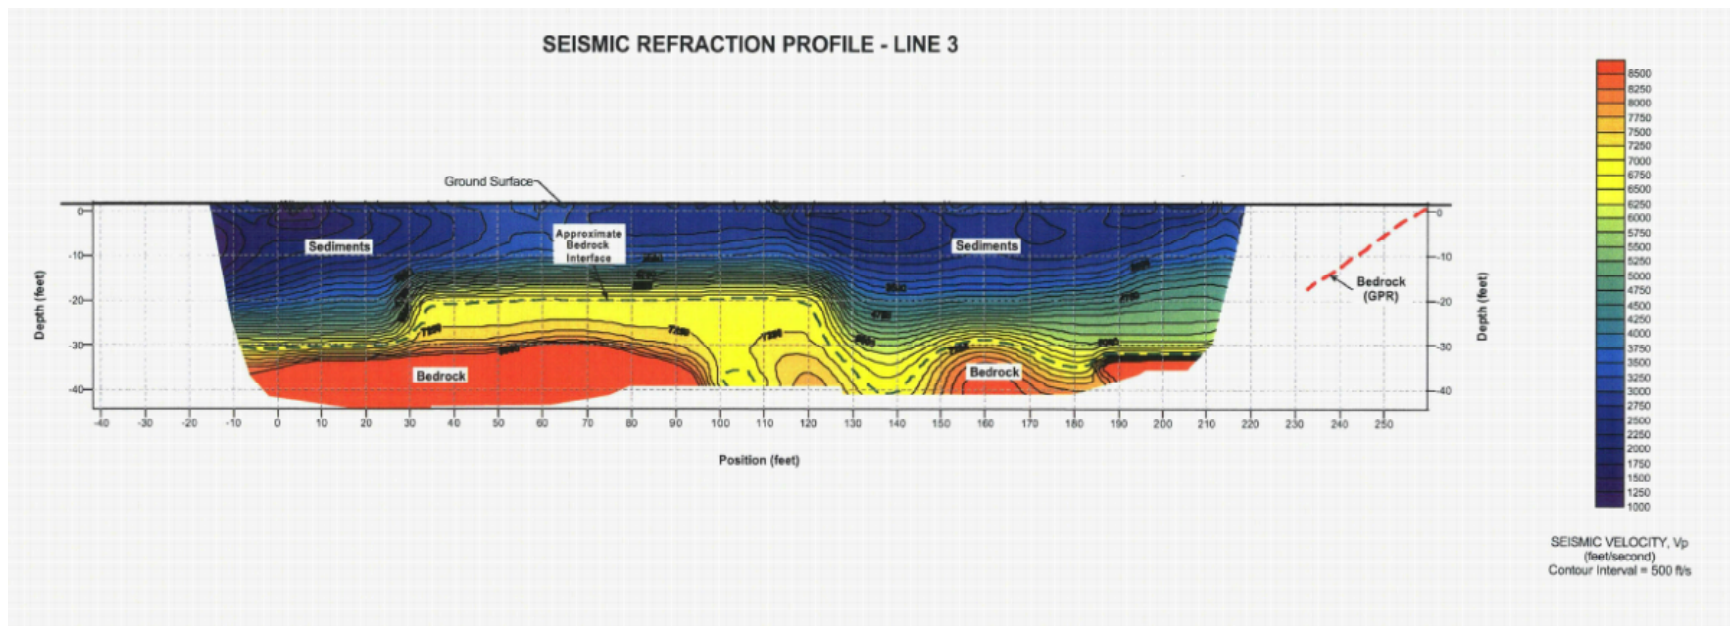
# GZA Report: Seismic Profiles

Independent P-wave data indicates  $V_p \sim 8-9000$  fps in near surface.

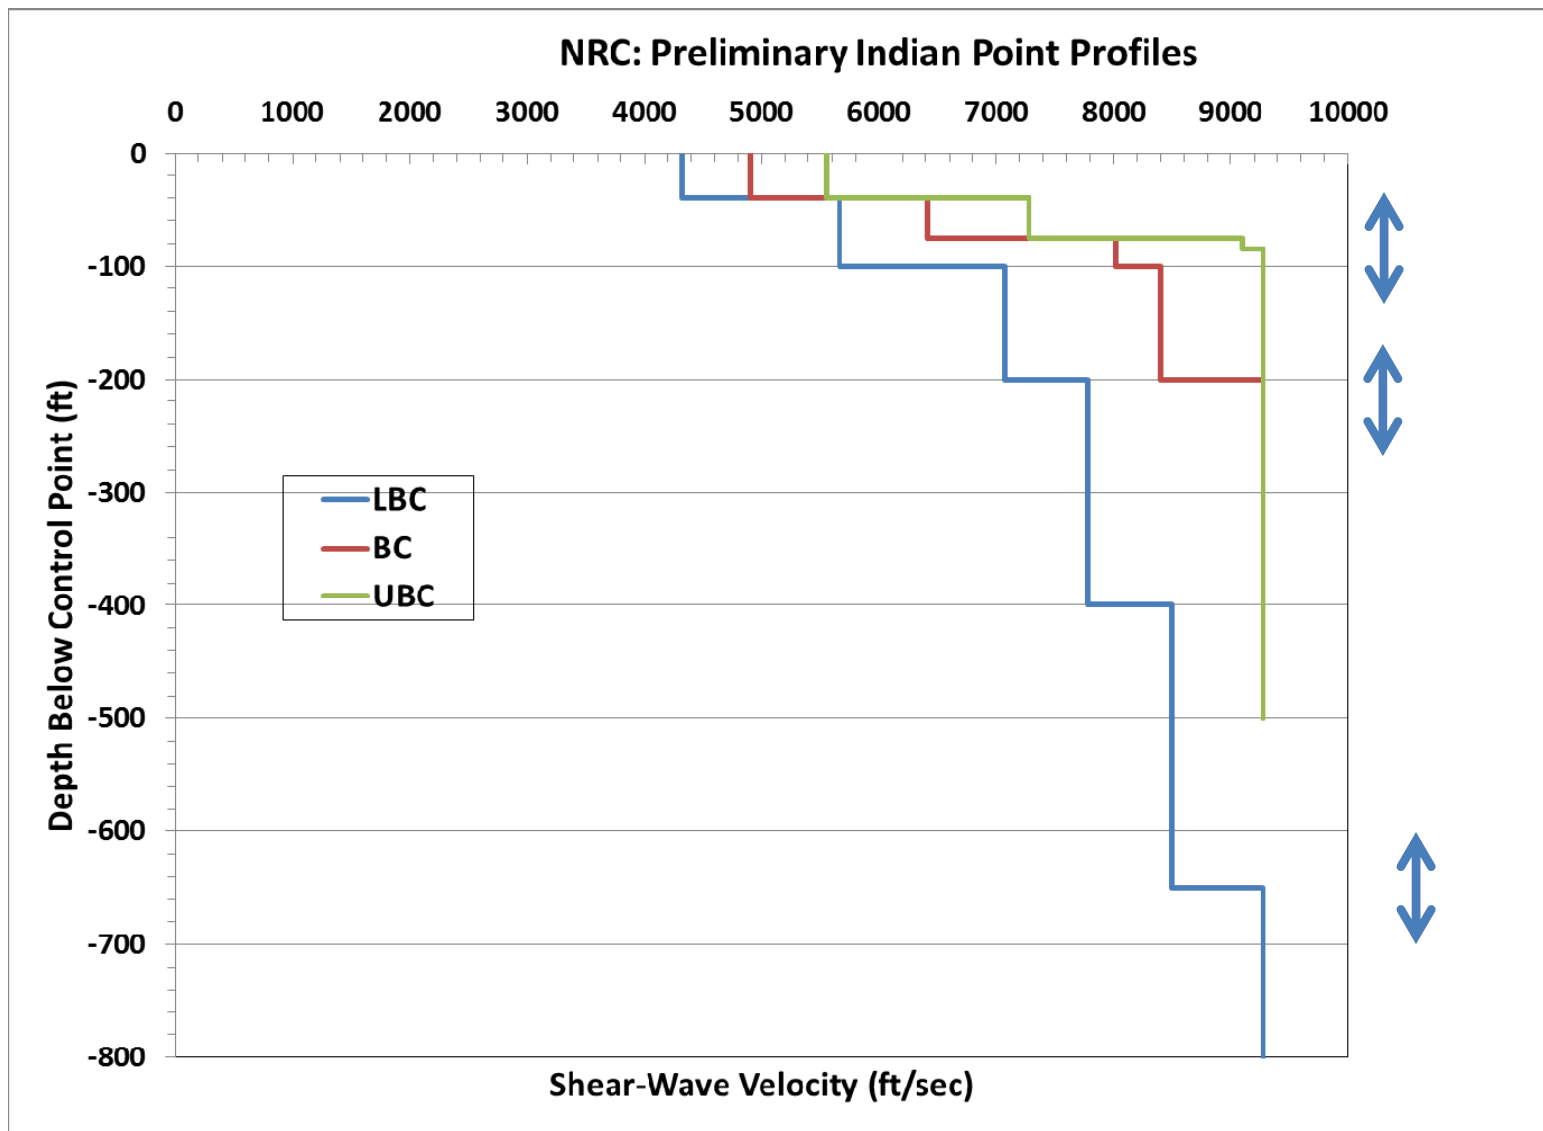
# Profiles Used in NRC Analysis

Layer	Depth (ft)	Velocity (ft/s)	Sigma-In (Vs)	G/Gmax&D	G/Gmax&D
BC-1	0-40	4900	0.15	EPRI Rock	Linear-1%
BC-2	40-75	6419	0.15	EPRI Rock	Linear-1%
BC-3	75-100	8024	0.15	EPRI Rock	Linear-1%
BC-4	100-200	8400	0.15	Linear-ND	Linear-ND
LBC-1	0-40	4320	0.15	EPRI Rock	Linear-1%
LBC-2	40-100	5662	0.15	EPRI Rock	Linear-1%
LBC-3	100-200	7077	0.15	EPRI Rock	Linear-1%
LBC-3	200-400	7785	0.15	Linear-ND	Linear-ND
LBC-4	400-800	8500	0.15	Linear-ND	Linear-ND
UBC-1	0-40	5555	0.15	EPRI Rock	Linear-1%
UBC-2	40-75	7277	0.15	EPRI Rock	Linear-1%
UBC-3	75-85	9000	0.10	EPRI Rock	Linear-1%

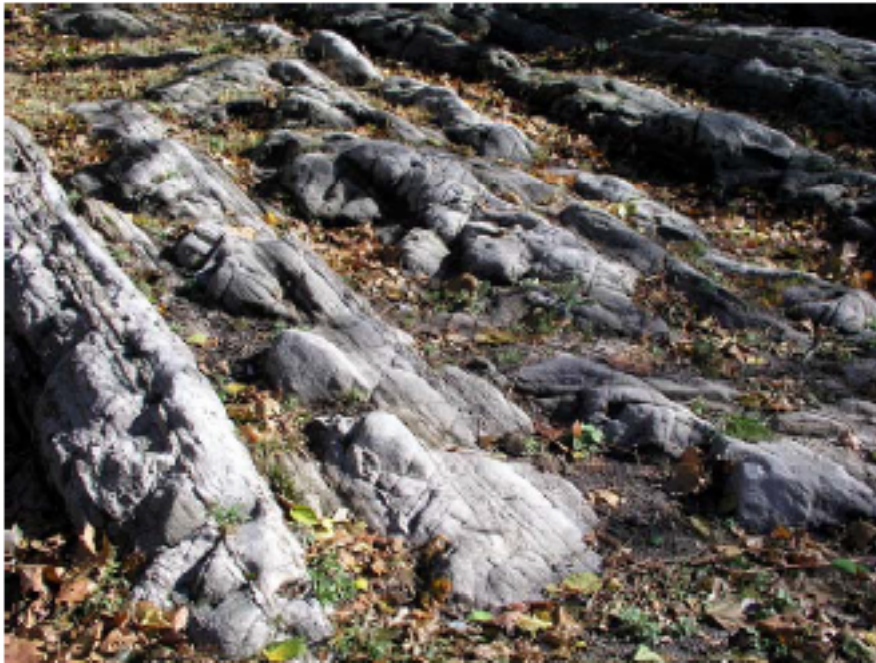
# Why P-Wave Refraction Results Should be Used With Caution Here

*Conclusion based on results of P-wave refraction. Velocities of 8000-16,000 fps cited.*

*Significant layered (bedding) in near-vertical attitude. Discontinuous "stringers" of very hard material. Very easy (maybe impossible not to) to bias refraction results to high value.*

*Vs for these Vp values: 4600-8550 fps (assuming  $\nu = 0.3$ ).*

*Existence of direct shear-wave results*
