Phase II Final Status Survey Report Mallinckrodt Columbium-Tantalum Plant

St. Louis, Missouri

Chapter 33

33.0 RESULTS SUMMARY FOR PLANT 7 PAVEMENT SU4

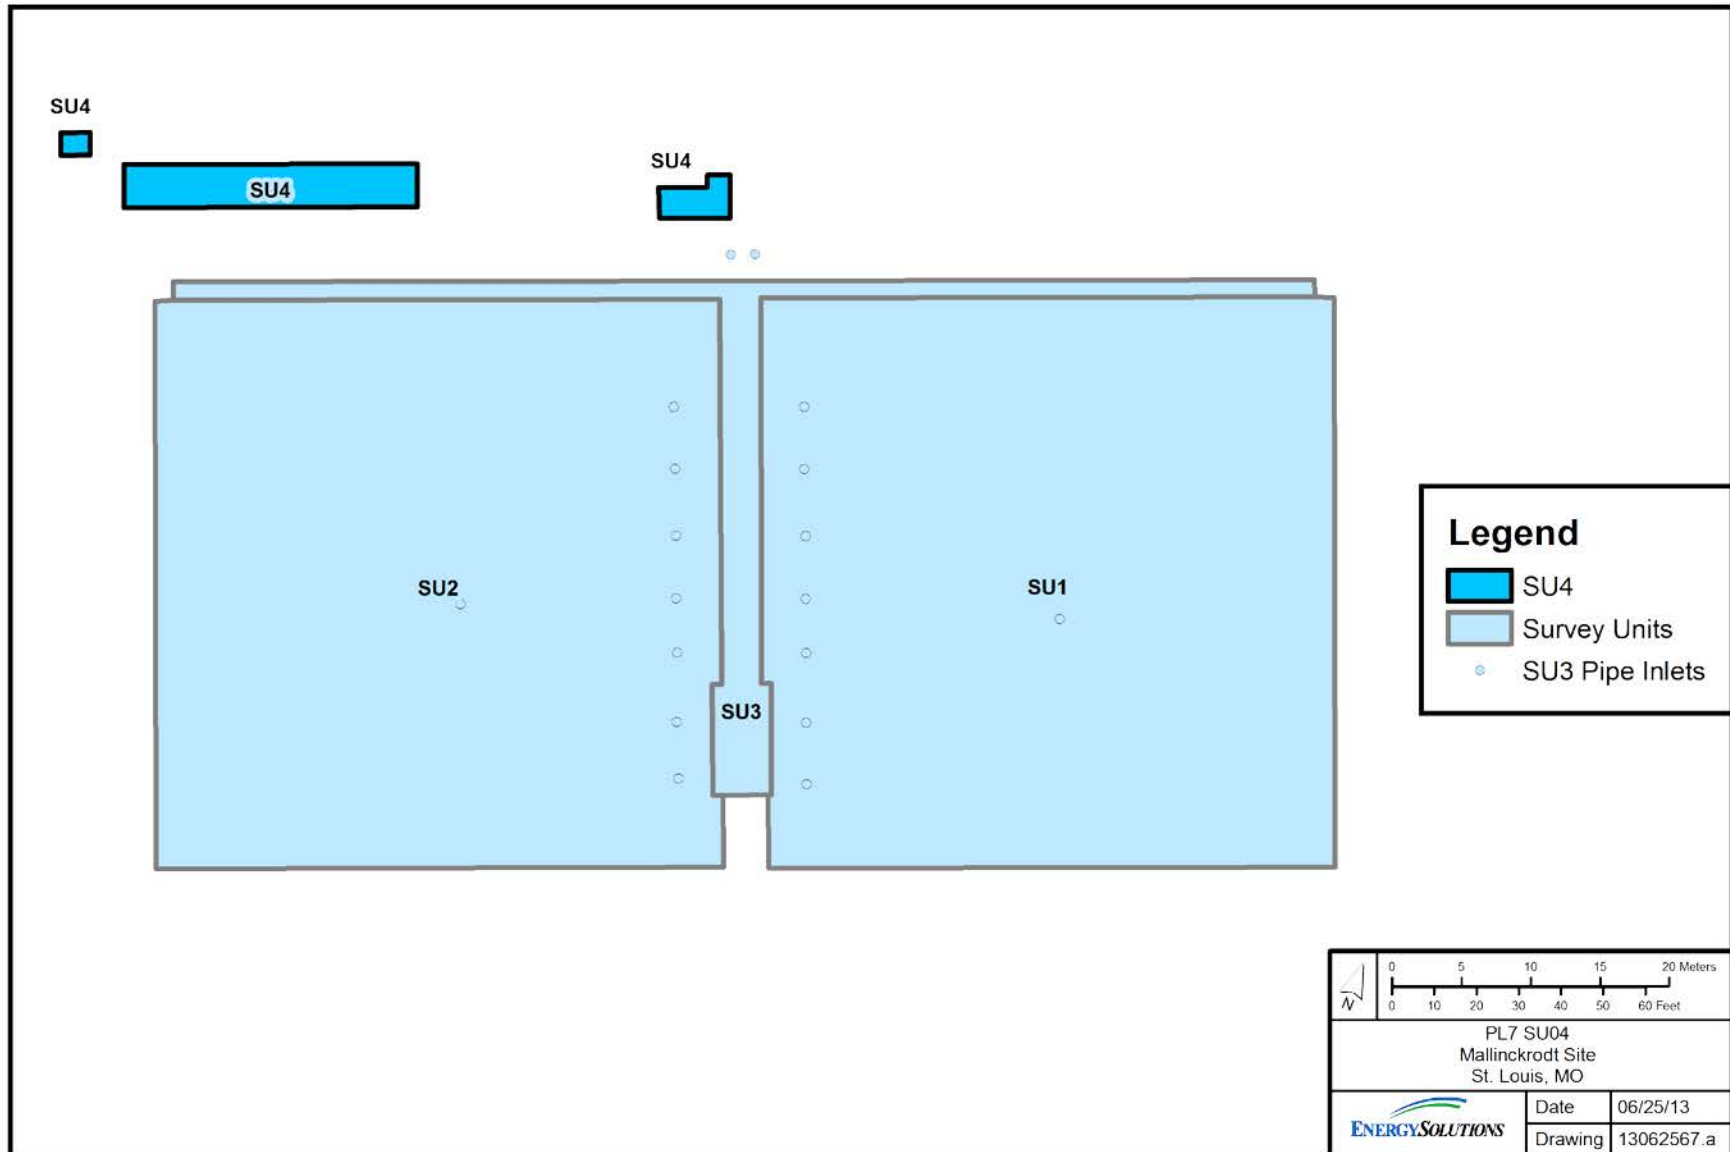
Figure 33-1 Location of Pavement SU4 in C-T Plant 7W

The survey unit is approximately 234 square meters (m²) in size, which is less than the size limit of 10,000 m² for Class 2 survey units for pavement (per C-T Phase II DP, Table 14-4). Class 2 was the appropriate classification because the survey unit had potential residual radioactivity that was not expected to exceed the DCGL_w. Figure 33-1 shows the location of SU4 within the Plant 7W area.

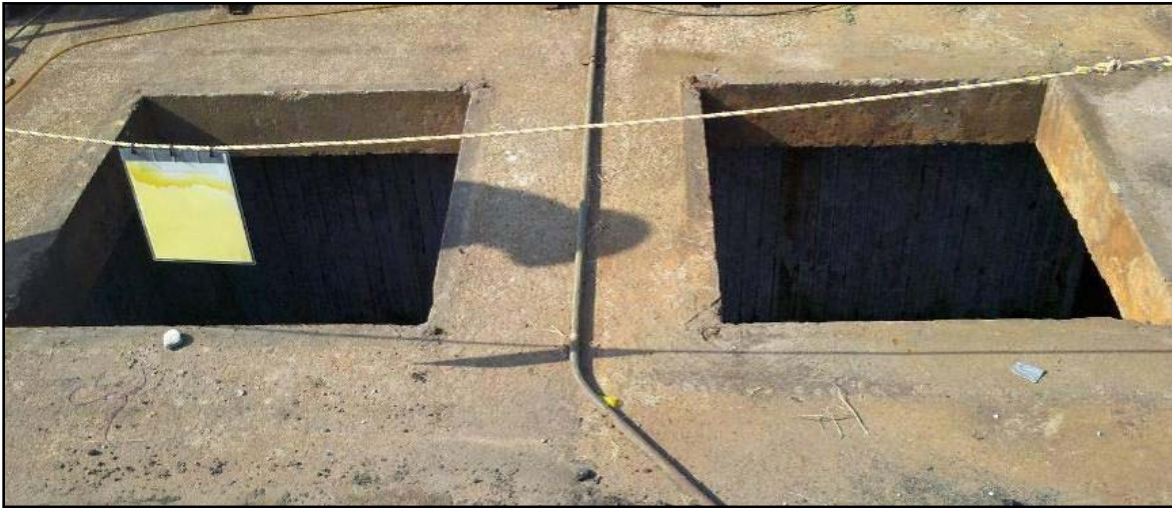
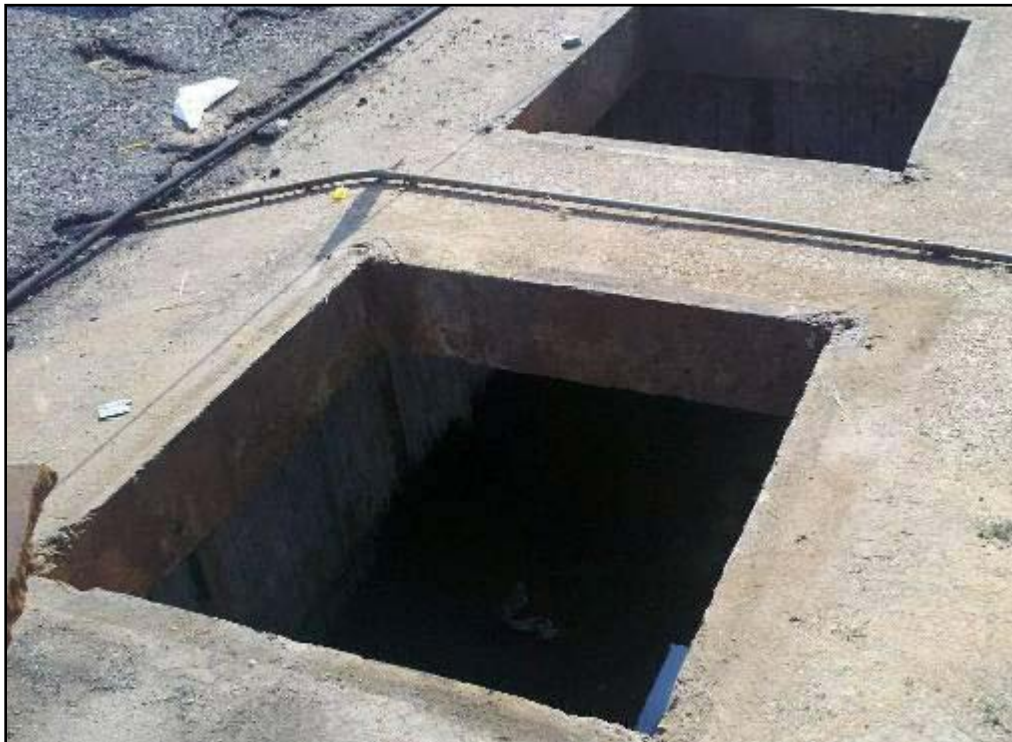
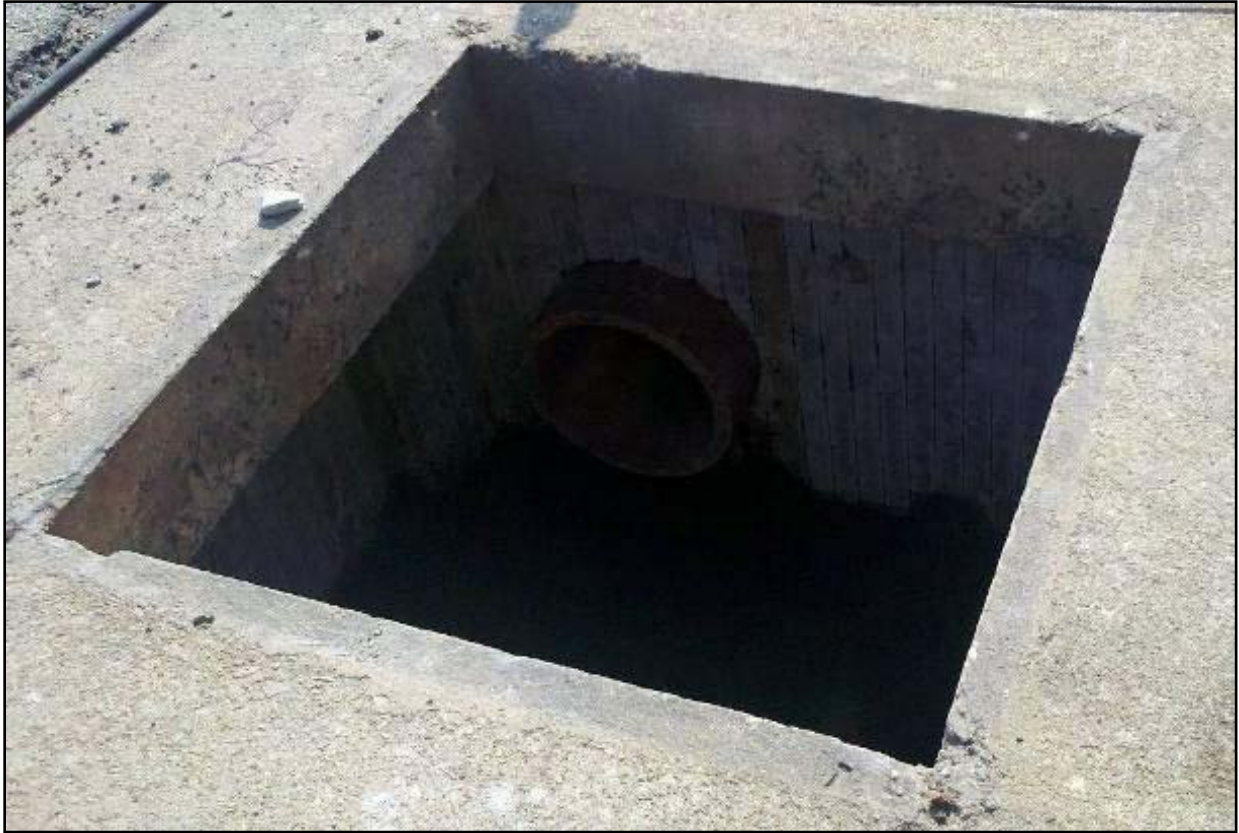
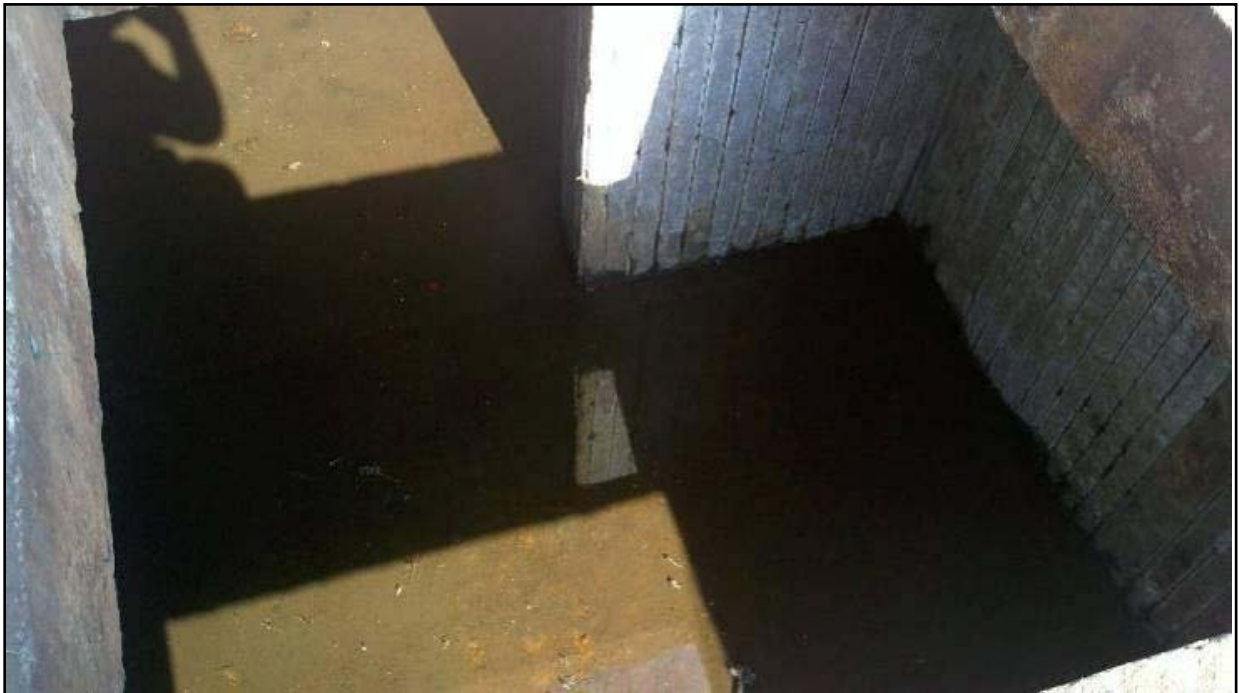
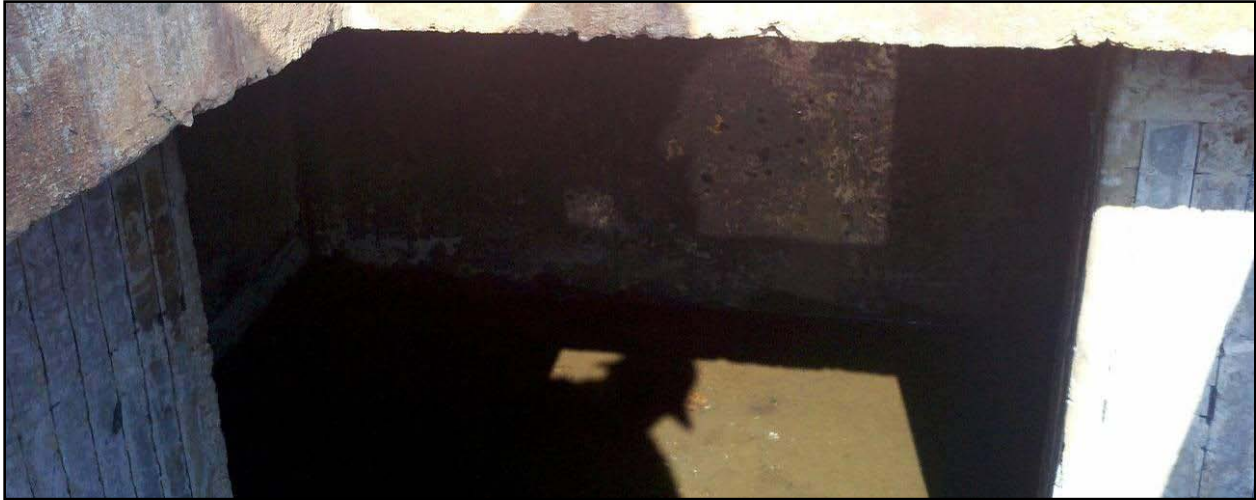
The Weir Chamber is a 5-foot (ft) deep underground “L” shaped concrete chamber approximately 18 ft long and 15 ft wide. It features a 12-inch pipe on the south end of the west wall. It is accessed by two 3-ft 7-inch square openings. When not pumped out, water collects several inches deep in the chamber before emptying farther into the storm sewer system. Figure 33-2 through Figure 33-6 are photographs of the Weir Chamber and features.

Figure 33-2 Photograph of Access to the Weir Chamber Looking North

Figure 33-3 Photograph of Access to the Weir Chamber Looking West

Figure 33-4 Photograph of 12-inch Pipe at Bottom of the Weir Chamber

Figure 33-5 Photograph of Main Section of Weir Chamber Looking East

Figure 33-6 Photograph of “L” Shaped Portion of Weir Chamber Looking East

Rubber inserts were removed from the walls of the Weir Chamber to expose all wall surfaces and the walls and floor were power-washed. Radiological analysis via gamma spectroscopy indicated modest activity in the sediment (gross sum of fractions [SOF] = 0.25, Sample 3061). The walls and floor were then scanned with beta-gamma scintillation detectors and 16 static measurements were taken along with 100 cm² smears.

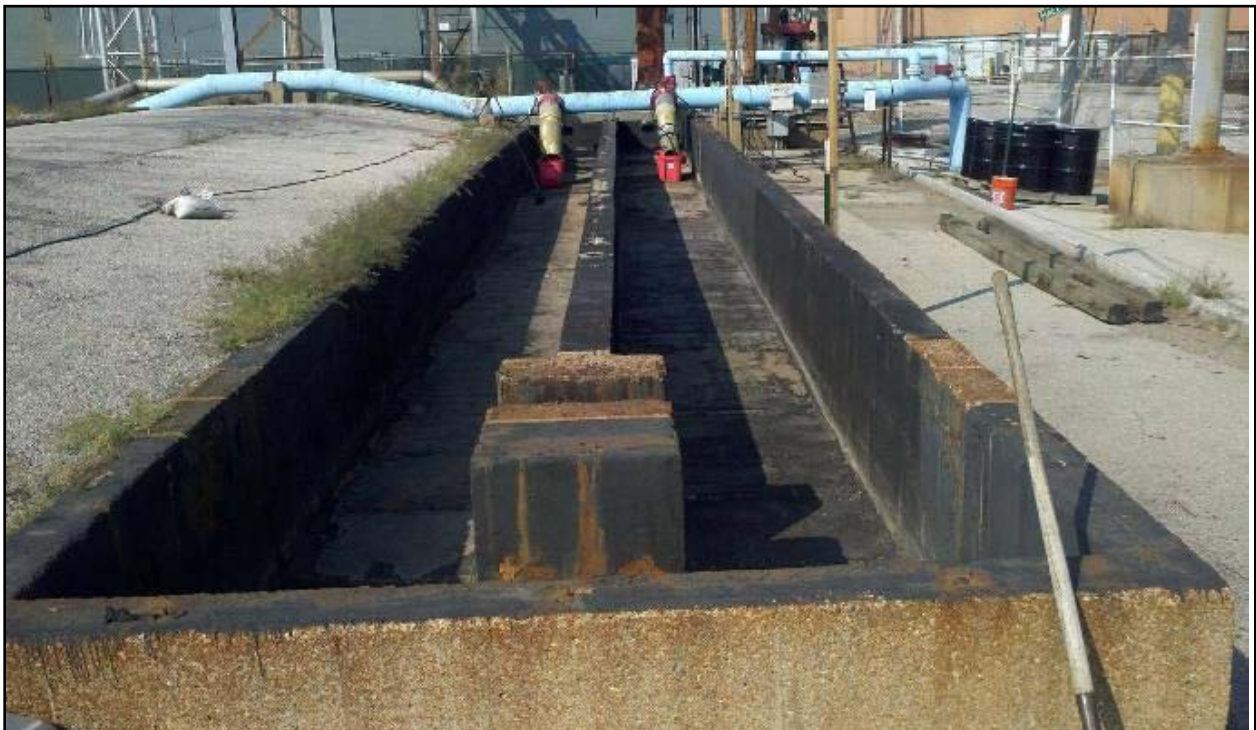
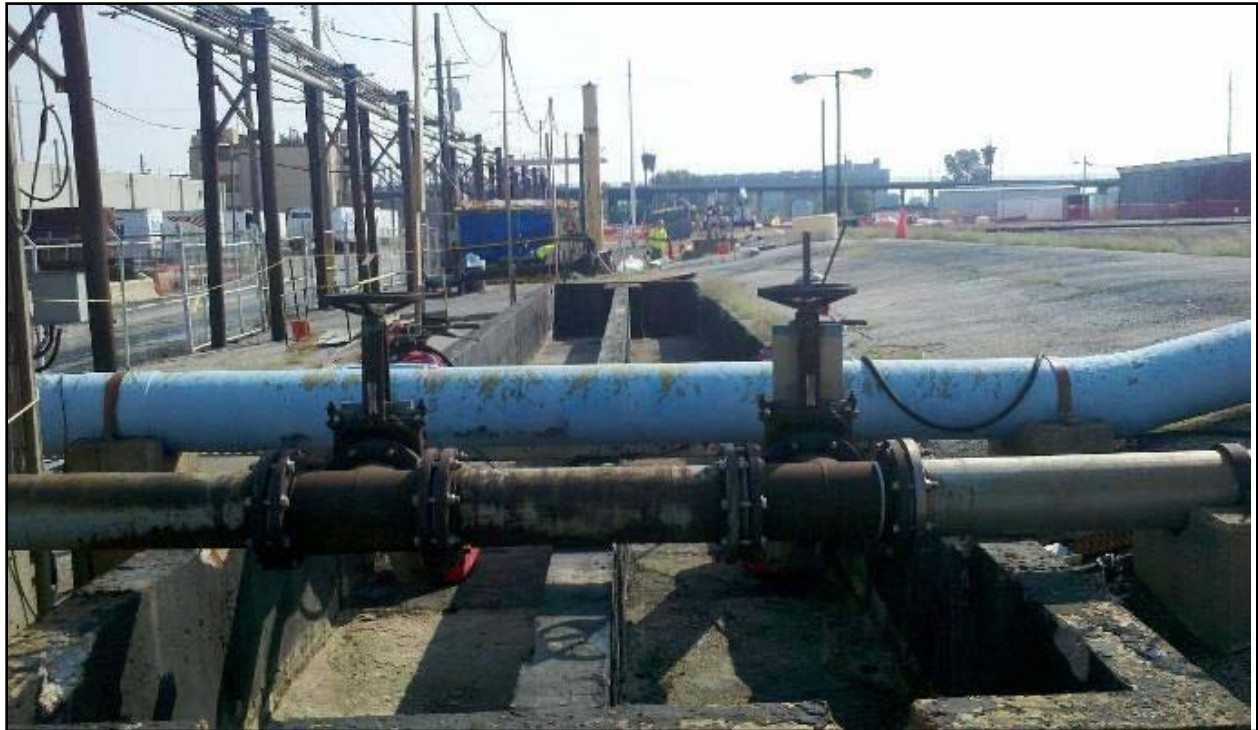
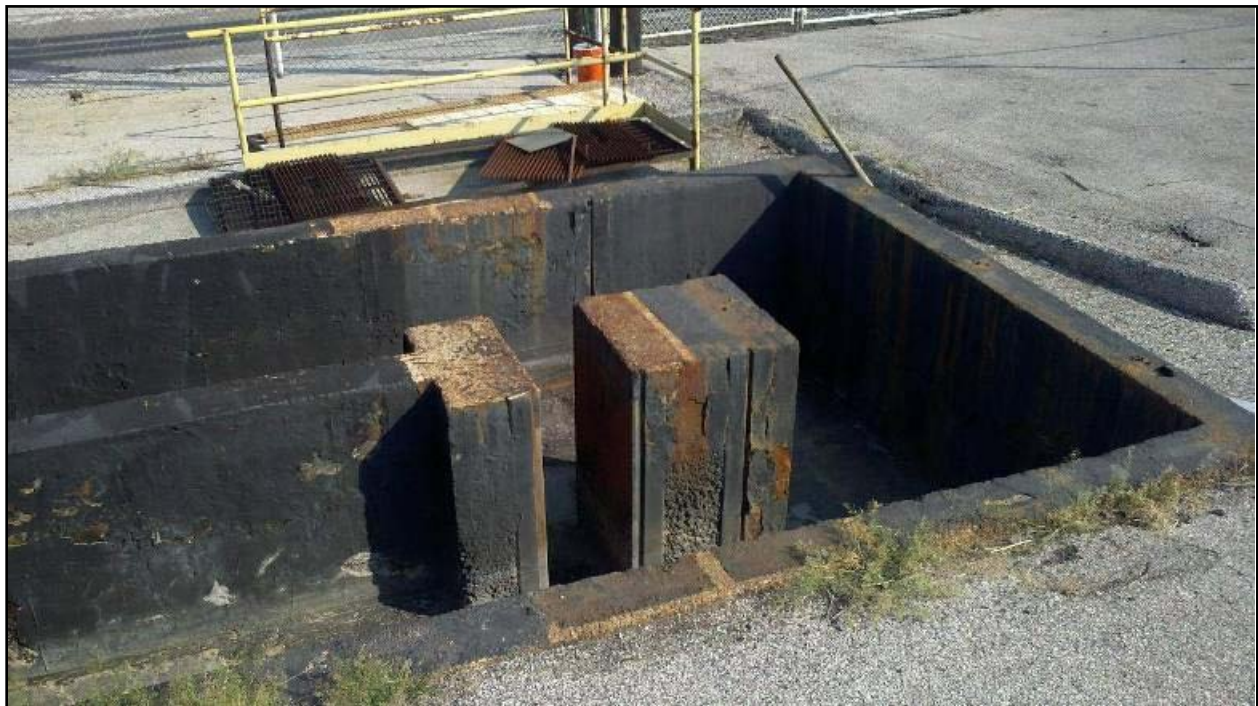
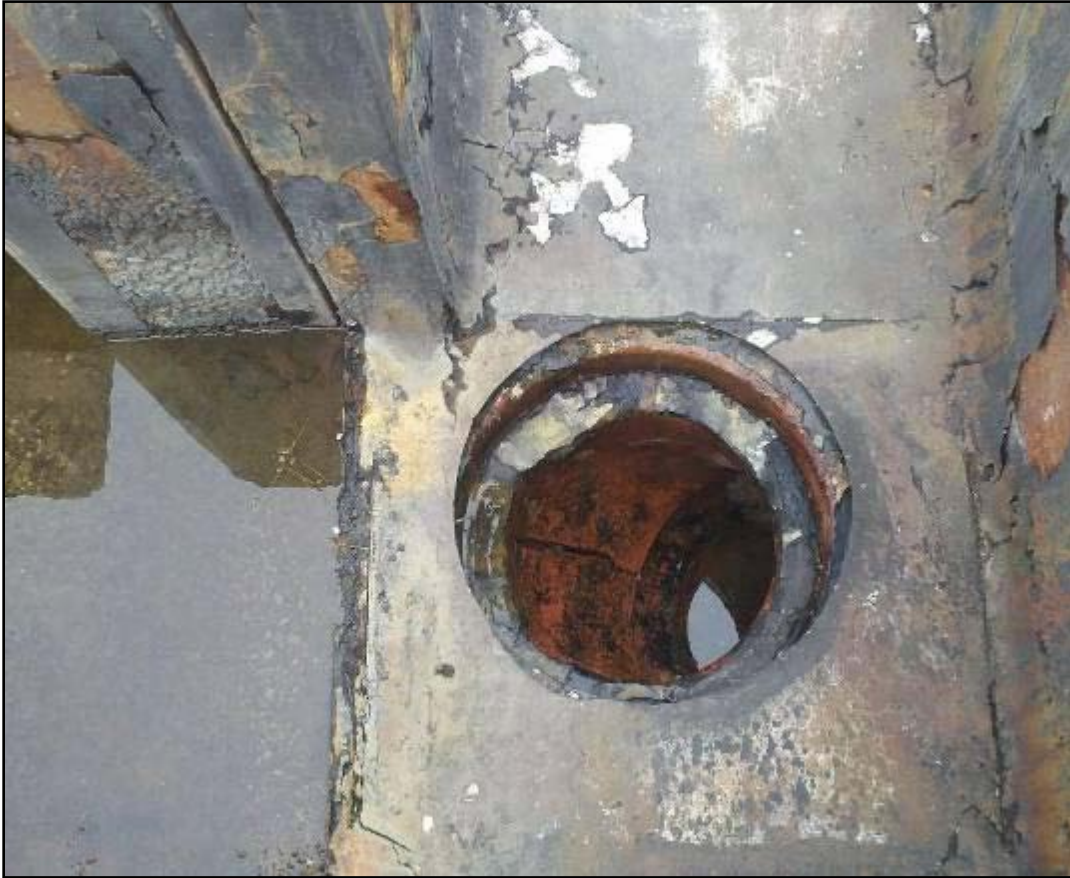
The Grit Chamber is an above ground concrete structure approximately 68 ft long, 9 ft wide, and 4 ft tall. It is separated into two sections and has a single drain in the southeast corner of the chamber. It was fed by a series of above ground pipes that came from the Pump Vault. Figure 33-7 through Figure 33-9 show the Grit Chamber and Figure 33-10 shows the drain in the southeast corner of the chamber.

Figure 33-7 Photograph of Grit Chamber Looking West

Figure 33-8 Photograph of Grit Chamber Looking East

Figure 33-9 Photograph of East End of Grit Chamber Looking North

Figure 33-10 Photograph of Southeast Drain of Grit Chamber

Debris was removed from the Grit Chamber and the entire structure was power washed. Radiological analysis via gamma spectroscopy indicated modest activity in the sediment (gross SOF < 0.29, Samples 3059 and 3060). The walls and floor were then scanned with beta-gamma scintillation detectors and 16 static measurements were taken along with 100 cm² smears.

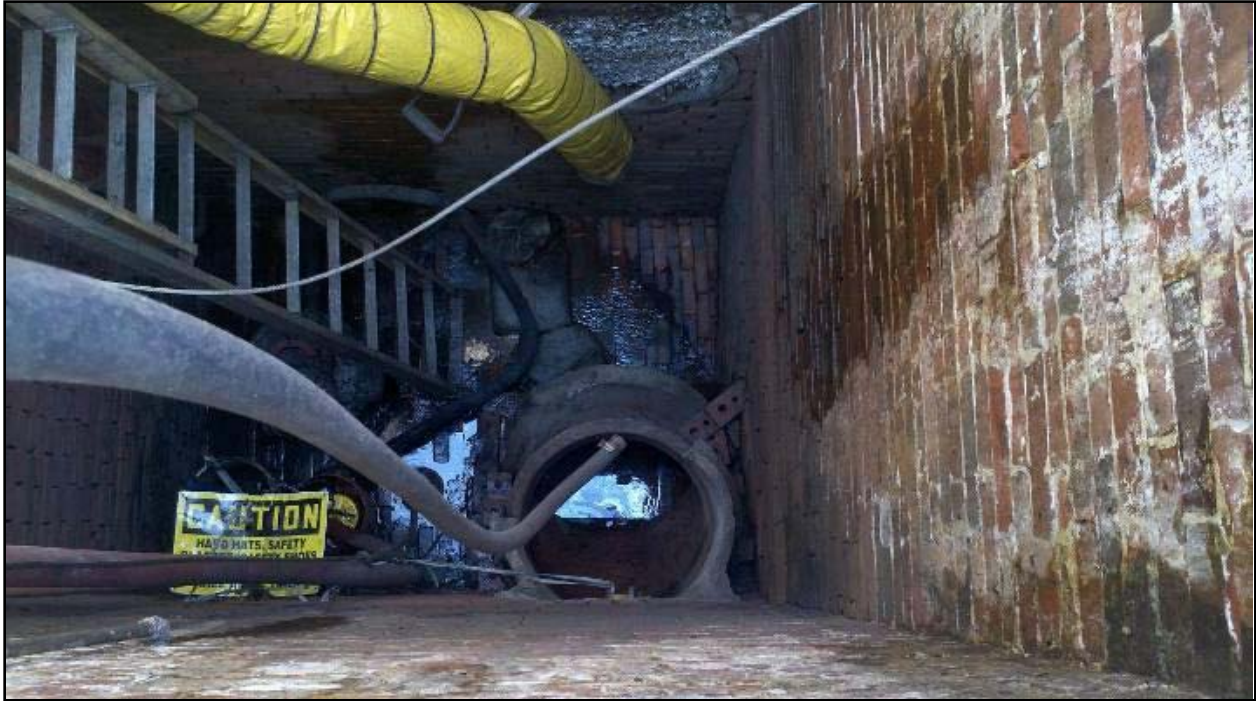
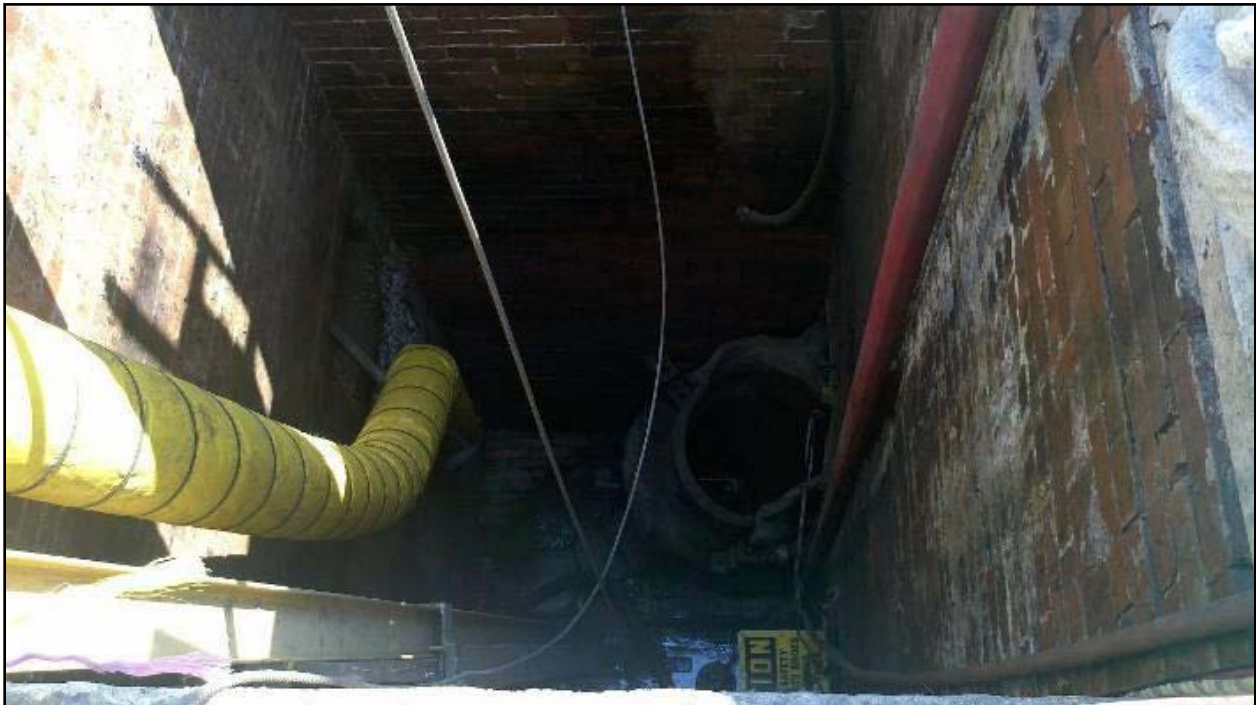
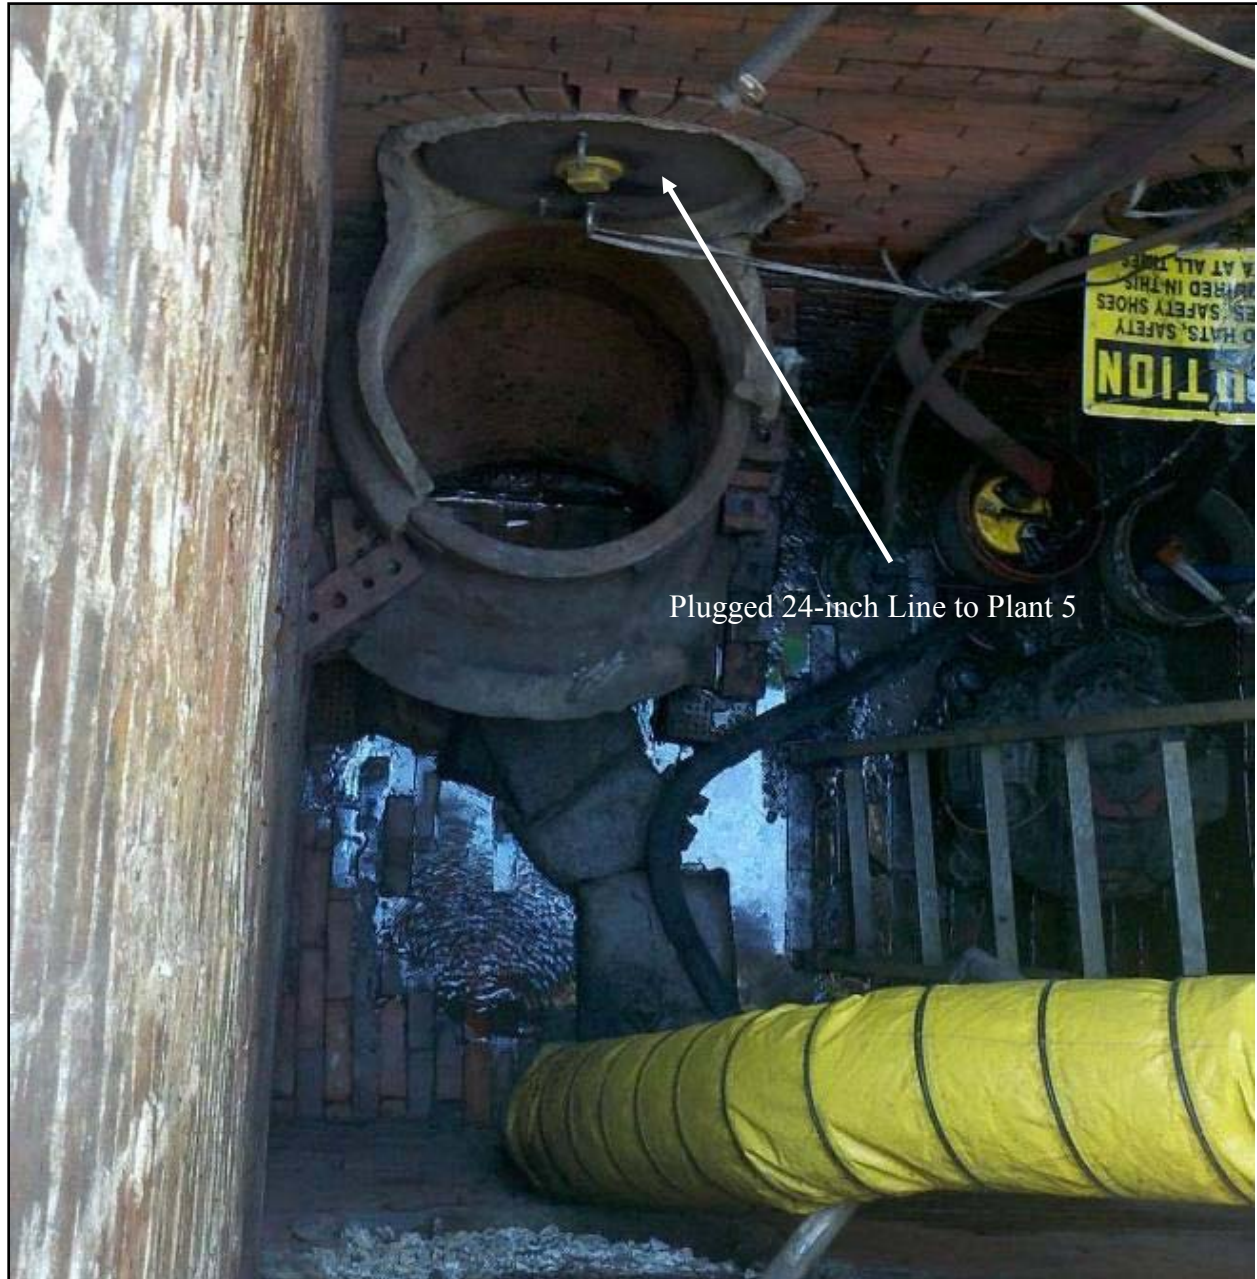
The Pump Vault is a brick-lined underground chamber in which several storm sewer pipes from Plant 5 and elsewhere on the site terminate. It is approximately 17 ft deep, 6 ft long, and 5 ft wide. The access to the vault is poured concrete extending approximately 3 ft above the surface. The presence of water in the bottom of this vault was a constant factor, despite plugging the northern 24-inch line coming from Plant 5. Figure 33-11 through Figure 33-13 are photographs of the Pump Vault.

Figure 33-11 Photograph of Pump Vault Looking East

Figure 33-12 Photograph of Pump Vault Looking South

Figure 33-13 Photograph of Pump Vault Looking West

Two functional lift station pumps were taken off-line and removed from the Pump Vault prior to initial entry into the Pump Vault. Considerable material had accumulated at the bottom of the vault, so a vacuum truck was initially employed to remove water and debris. After the vacuum truck had removed all loose material, project personnel removed the remainder of the material with hand methods and/or wet/dry vacuums. Initial hand removal had to be stopped due to the presence of volatile chemical components in the remaining sediment. Upon analyzing the sediment and donning appropriate respiratory protection, the remainder of the material was successfully removed. Radiological analysis via gamma spectroscopy indicated modest activity in the sediment (gross SOF = 0.19, Sample 3155). The walls were then scanned with beta-gamma scintillation detectors and 16 static measurements were taken along with 100 cm² smears. The presence of water at the bottom of the vault prevented initial survey of the floor of the Pump Vault.
