FINAL REPORT • JULY 2013

Preliminary Wetland Delineation for the PG&E Humboldt Bay Power Plant Canal Remediation Project, Humboldt County, California

PREPARED FOR
Pacific Gas & Electric Company
245 Market Street
San Francisco, CA 94105

PREPARED BY
Stillwater Sciences
850 G Street, Suite K
Arcata, CA 95519

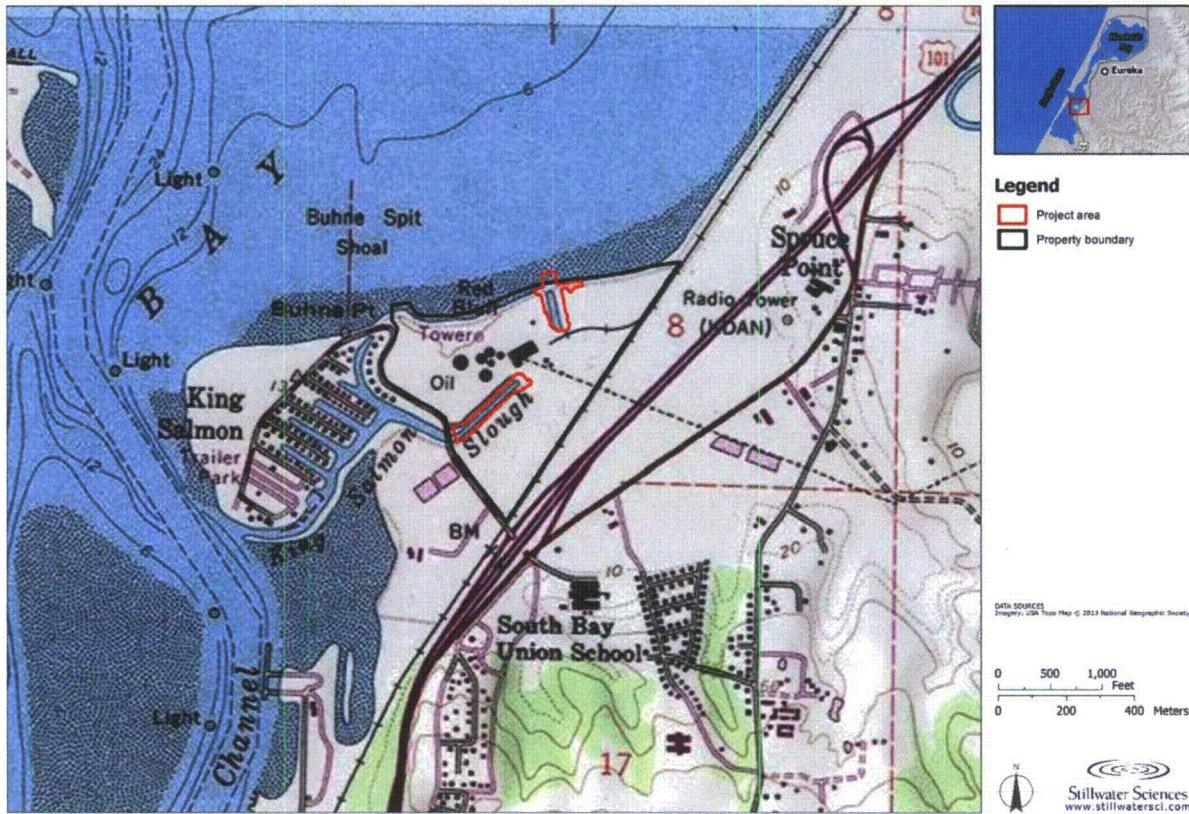
Figure 1. HBPP location and canal remediation project area.

The project area is a 5-ac (2-ha) portion of the HBPP property located at 1000 King Salmon Avenue in King Salmon, CA (Figure 1). The project area includes the intake and discharge canals and areas of potential ground disturbance around the canals and associated structures (e.g., intake structure, outfall structure, and sheet pile wall in Humboldt Bay to isolate the outfall structure) (Figure 2). The project area is located in Section 8 of Township 4 North, Range 1 West, of the Fields Landing, California U.S. Geological Survey (USGS) 7.5-minute topographic quadrangle (Figure 1). The project area as defined for this wetland delineation report encompasses the entire intake canal, although physical work will only be conducted in a portion of the canal as shown in Figure 2.

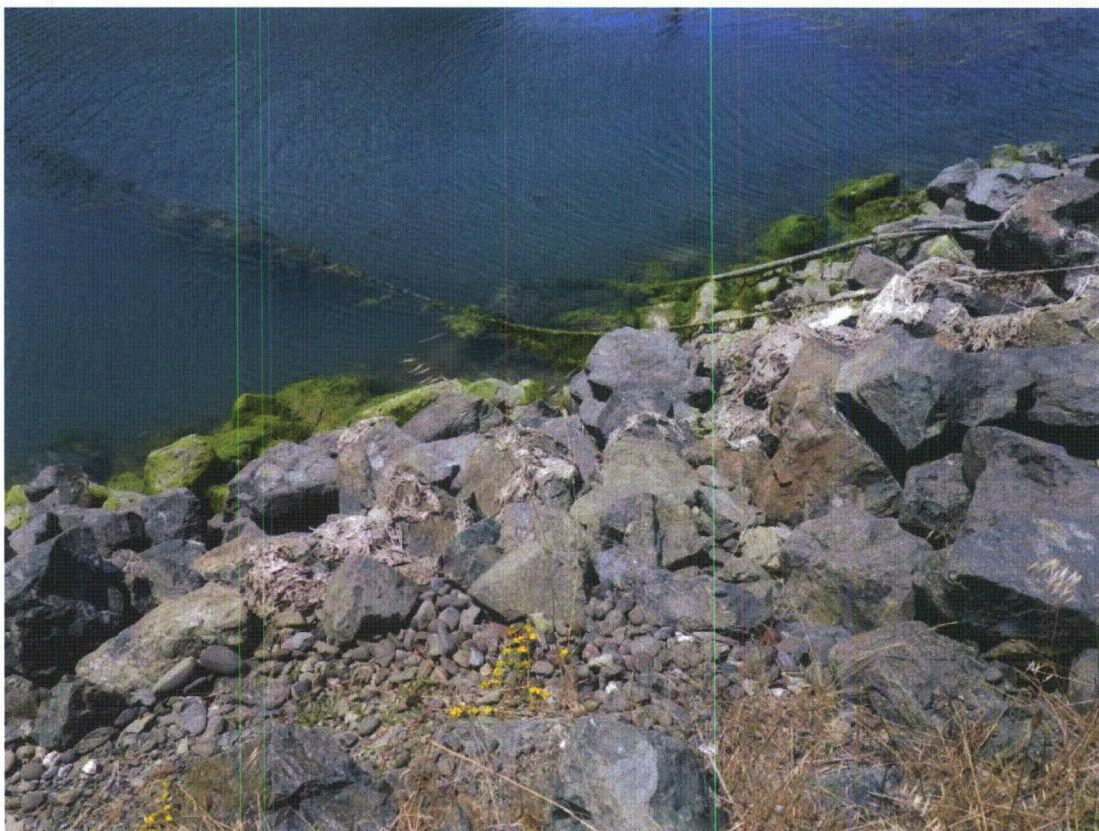
Figure 7. Typical high tide line indicators in the discharge canal including wrack debris line and algal growth on rip-rap.

In tidal waters, USACE jurisdictional waters of the U.S. (not including adjacent wetlands) extend to the high tide line¹. During the field delineation, the high tide line was identified by a nearly continuous deposit of fine debris on the shore, the landward edge of mud flats, algae growth on rip-rapped shorelines, and vegetation lines that delineate the general height reached by a rising tide. Because the majority of the project area was inaccessible due to steep slopes surrounding deep water canals with unconsolidated bottom substrate, the high tide line was recorded using several point measurements taken with a Trimble GeoXH 6000-series Geographic Positioning System (GPS) unit and a Trimble TruePulse 360 laser range finder.

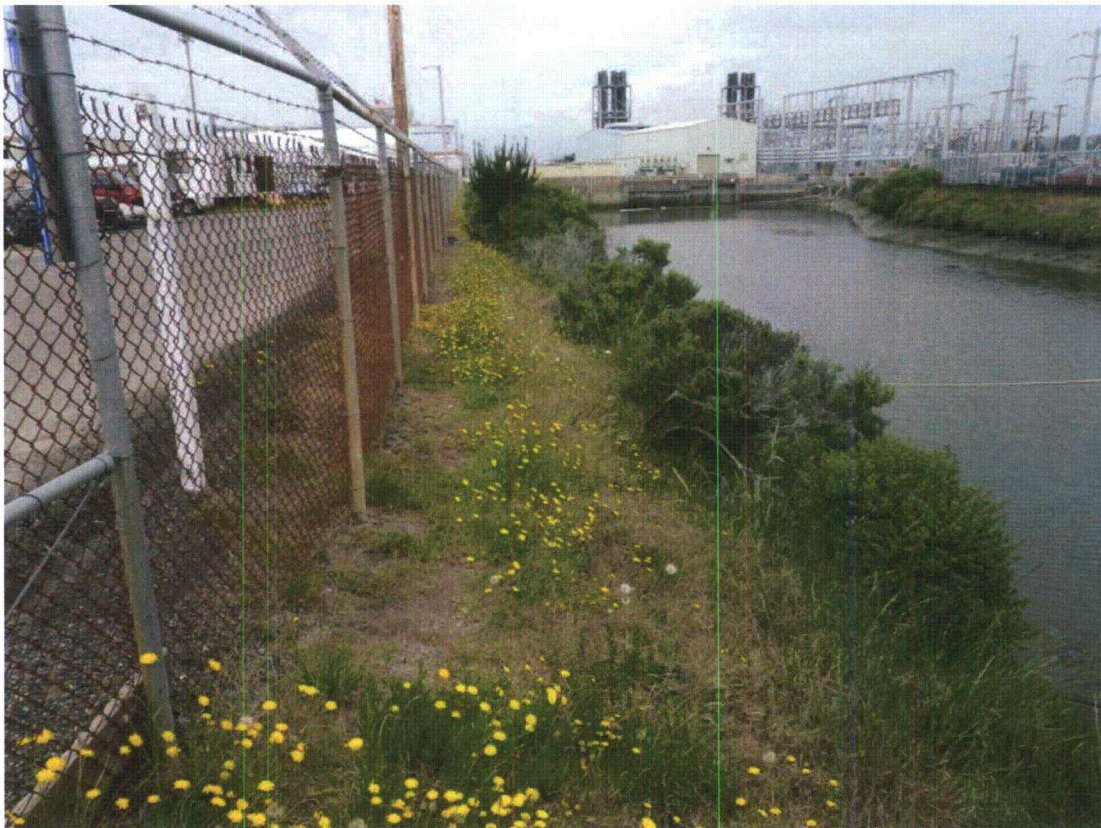
Figure 8. Typical vegetation in the area surrounding the intake canal above the high tide line.

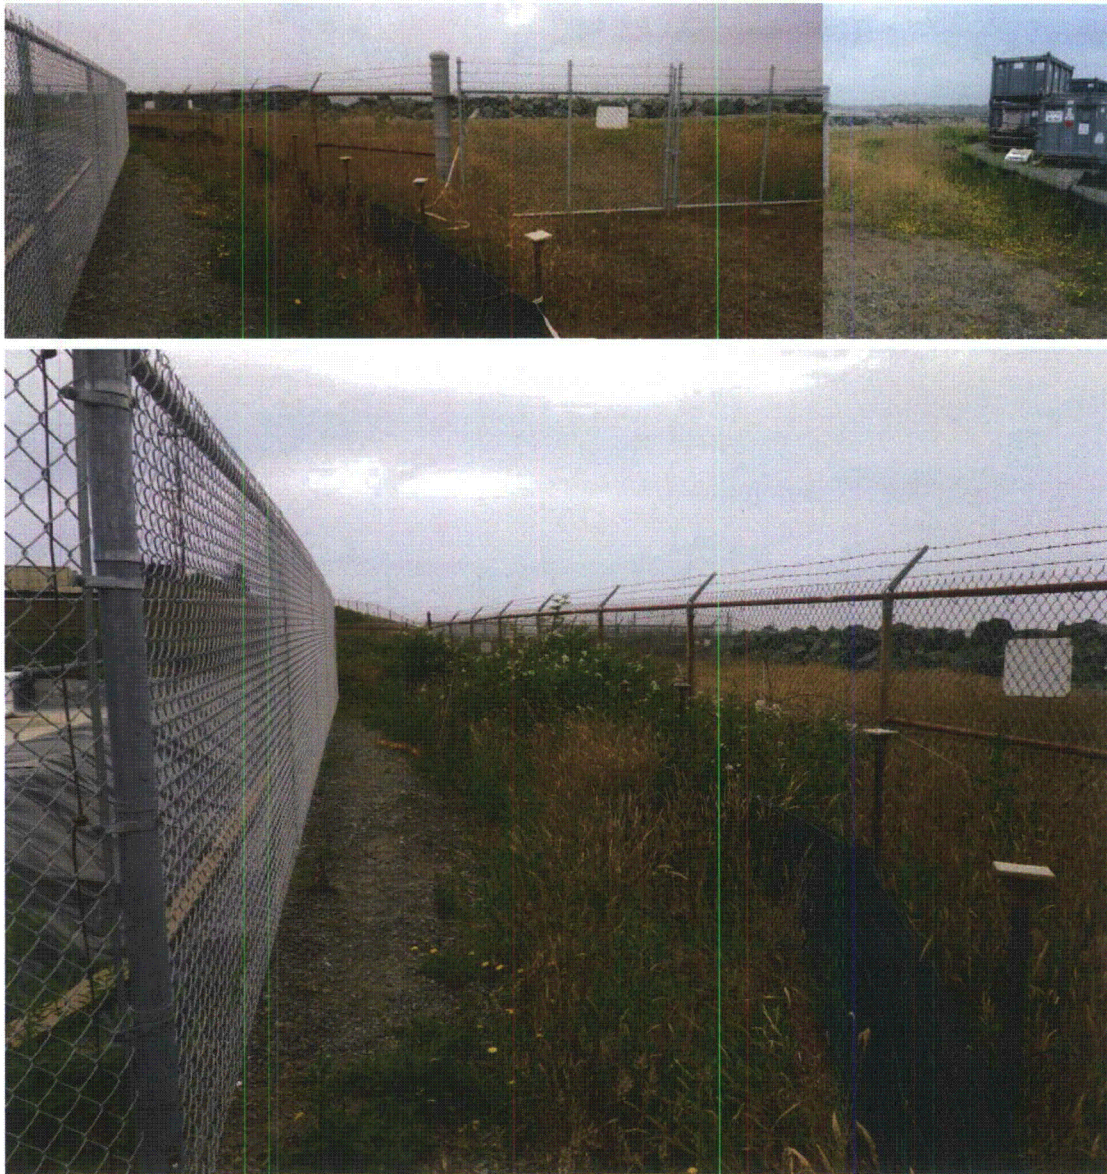
Figure 9. Upland vegetation in the area northeast of the discharge canal.

Wetlands potentially subject to the jurisdiction of the CCC that are outside of USACE jurisdictional wetlands were dominated by hydrophytic vegetation, but did not display positive indicators for hydric soils or wetland hydrology. Dominant vegetation at these locations consisted of tufted hairgrass (FACW), bird's foot trefoil (*Lotus corniculatus*, FAC), and common rush (FACW). In contrast, adjacent upland areas were typically dominated by hairy catsear (FACU), sweet vernal grass (FACU), and brome fescue (FACU). The area between the intake canal and the adjacent roads (Figure 6) was considered upland because of the dominance of hairy catsear (FACU) and coyote brush (FACU) (Figure 8). Though the area northeast of the discharge channel (Figure 5) was shown to contain CCC jurisdictional wetlands based on previous surveys (Mad River Biologists 2010), no depressions or areas where water may pond were noted in this area and current vegetation was dominated by sweet vernal grass (FACU), Himalayan blackberry (FACU), and hairy catsear (FACU). Therefore, this area was considered upland (Figure 9) and not a CCC jurisdictional wetland.
