Open-Phase Validation Test

NRC Public Meeting June 4, 2014

Mark Bowman
TVA

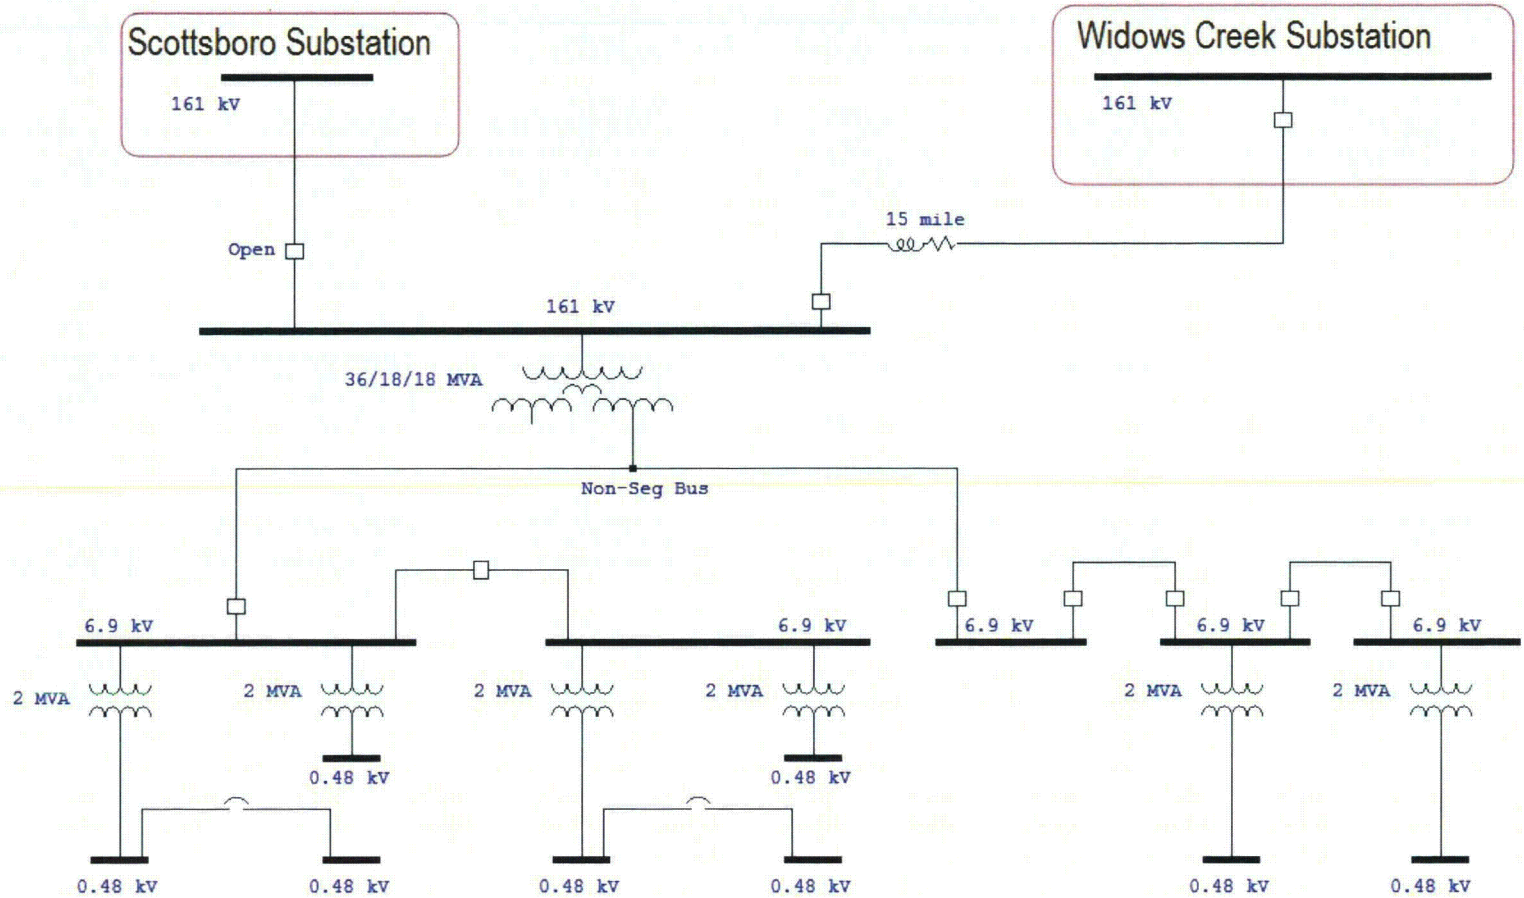
Test Configuration

- Install the EPRI OPD System on one offsite power transformer (36 MVA, 161-13.8/6.9 kV)
- Create an open-phase condition by removing a single 161kV conductor (stinger)
- Test with transformer unloaded
- Test with plant buses/loads connected
 - 13 total buses (switchgear and MCCs), both BOP and Class 1E systems
 - Energize 6.9kV-480V transformers (6-2000 kVA)
 - Start largest available motors (2-250 HP)

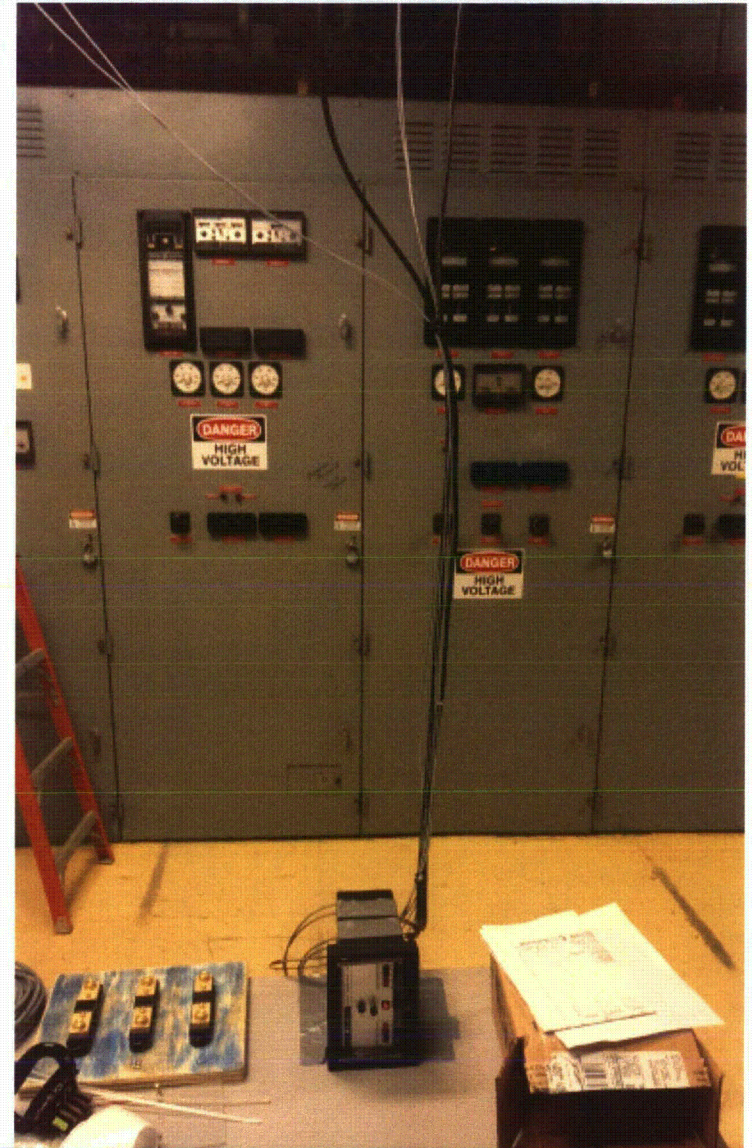
Test Configuration

- A voltage balance protective relay was installed to protect plant loads in case of unexpected results
- Provided opportunity to study relay's behavior during normal plant operation (transformer inrush, motor starting, bus transfers, etc.)

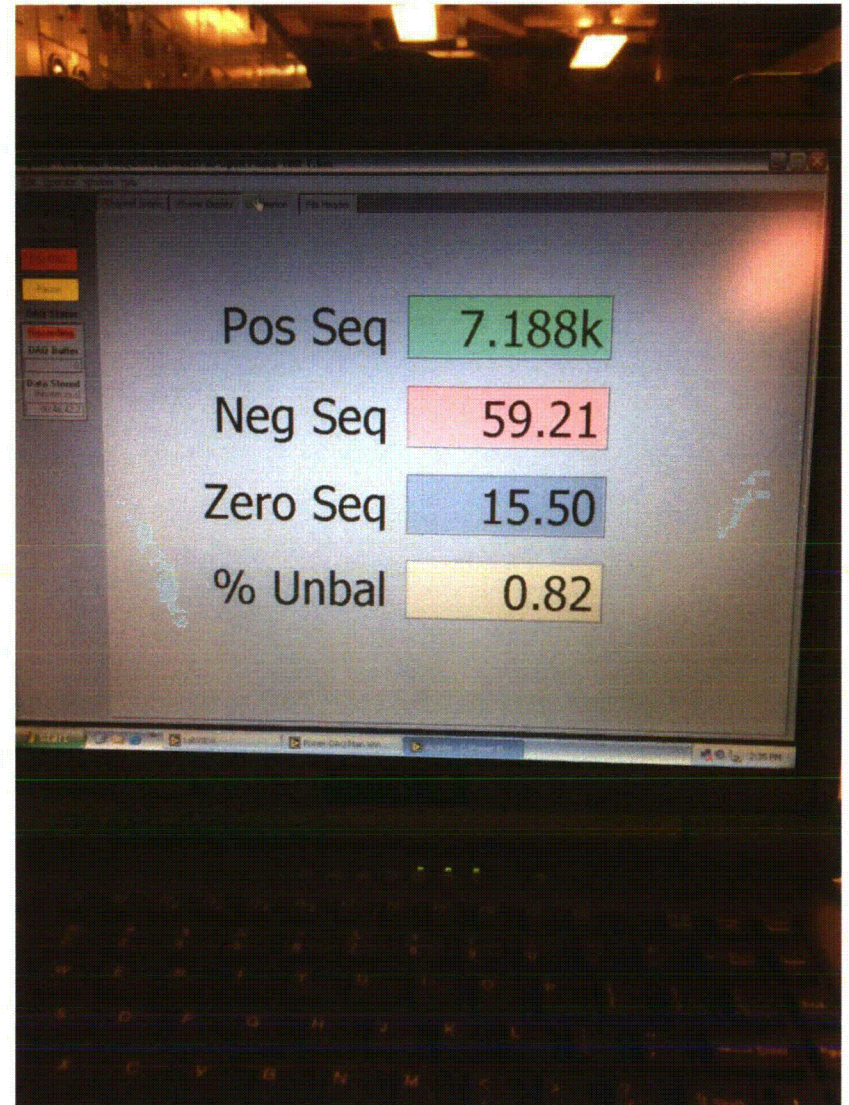
Open-Phase Test Results

- Plant exposed to open-phase condition for ~30 minutes without consequence
- At light loading (5%), in-plant voltages remain nearly balanced (<1%), as predicted

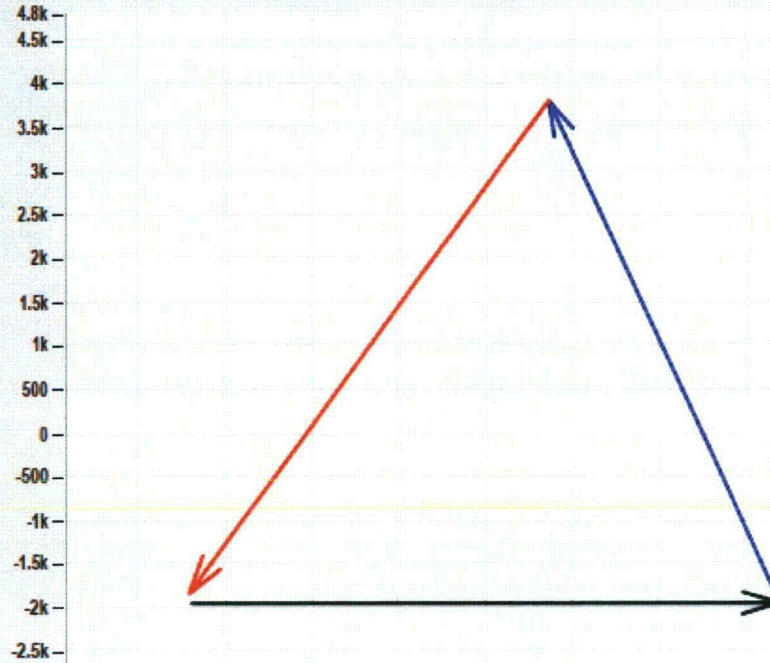
Phasor Diagram

Negative Sequence

Magnitude	Angle
428.8	76.31

Unbalance

6.4 %

During high peak loading conditions (~80%), in-plant voltages became more unbalanced (> 6%), as predicted

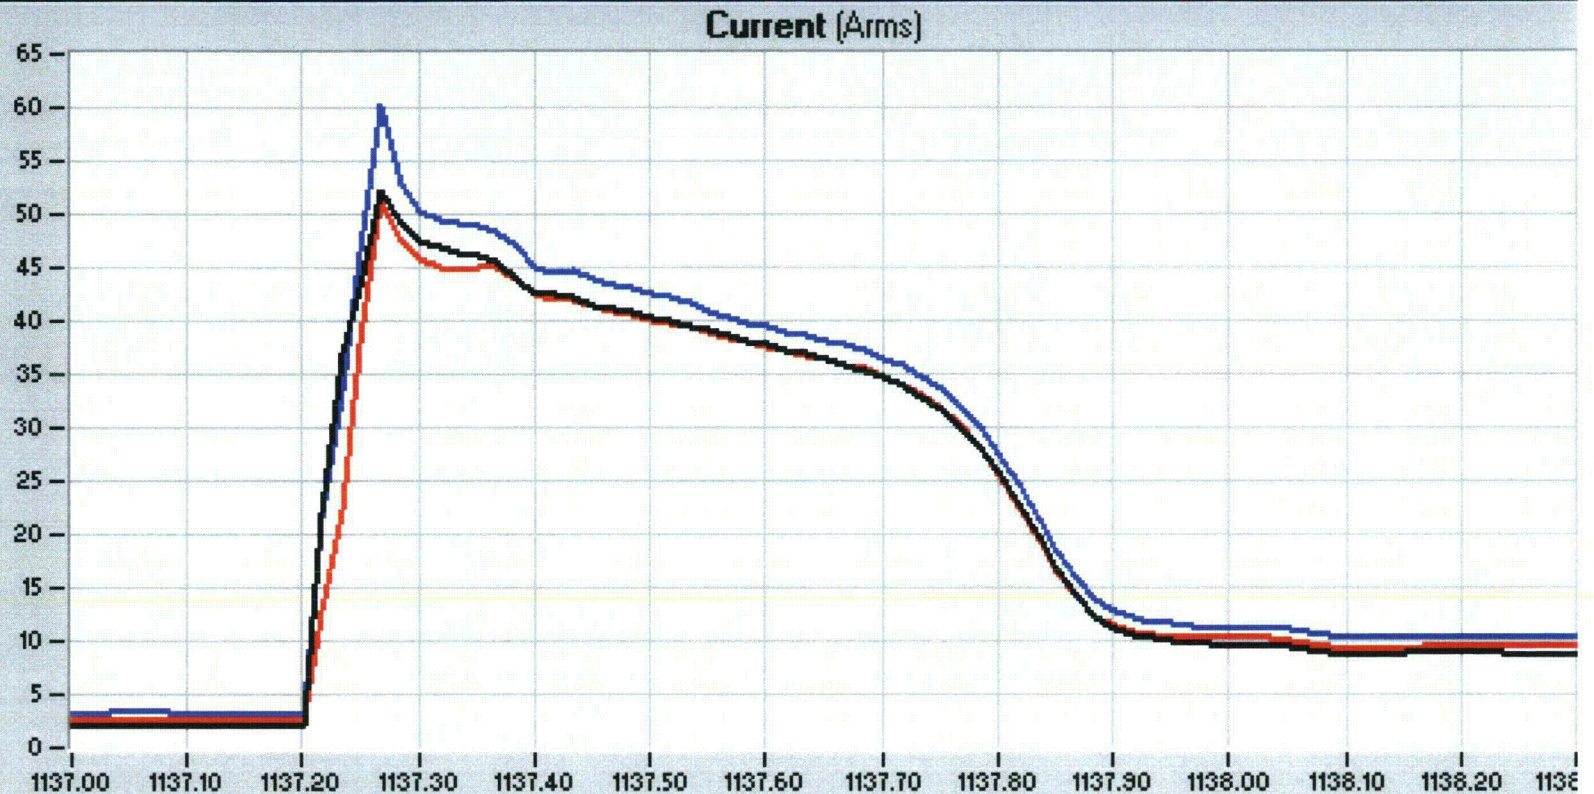
Open-Phase Test Results

- Motors started within normal timeframes, as predicted
