## SUSQUEHANNA RIVER BASIN COMMISSION

# Lower Susquehanna Subbasin Survey:

## *A Water Quality and Biological Assessment, June - November 2005*

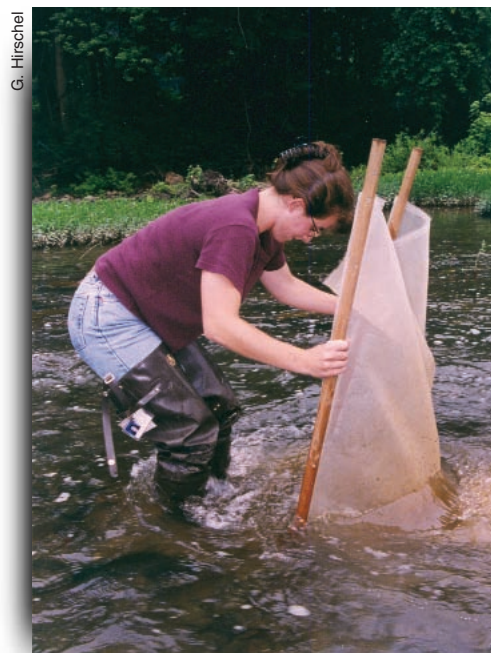
*Kick-screen sampling of macroinvertebrates.*

Benthic macroinvertebrates (organisms that live on the stream bottom, including aquatic insects, crayfish, clams, snails, and worms) were collected using a modified version of RBP III (Barbour and others, 1999). Two kick-screen samples were obtained at each station by disturbing the substrate of representative riffle/run areas and collecting dislodged material with a one-meter-square 600-micron mesh screen.
