Lower Susquehanna River Subbasin Year-1 Survey

Publication 282
September 2012

A Water Quality and Biological Assessment April - July 2011

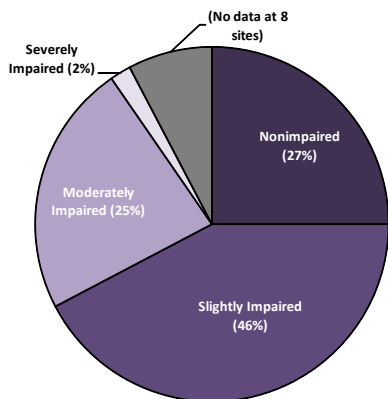
Figure 5. 2011 Biological Condition Categories for Sampled Lower Susquehanna Subbasin Sites

Water quality, macroinvertebrate, and habitat conditions for each sampling site in the Lower Susquehanna Subbasin in 2011 are depicted in Figure 4. Five of the 104 sites were located on the mainstem Susquehanna River and were not sampled due to high flows. The remaining 99 sites were sampled in the subbasin for water quality and habitat, and 96 of those sites were also sampled for benthic macroinvertebrates. Twenty-seven percent of the sampled sites had nonimpaired macroinvertebrate communities, 46 percent had slightly impaired communities, 25 percent had moderately impaired communities, and 2 percent had severely impaired communities (Figure 5).

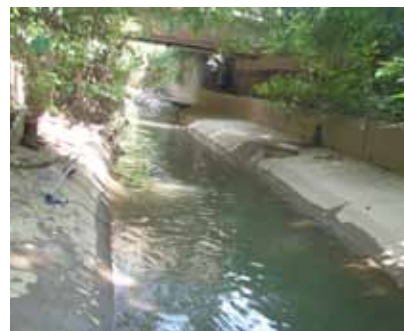
Downstream view of Paxton Creek, Dauphin Co., Pa.

in organism abundance and diversity and devoid of pollution sensitive taxa, nonsupporting habitat, and lower water quality from elevated nitrogen and total sodium. Severely impaired conditions at PAXT 0.5 are not surprising since the site is located in a concrete-lined channel in highly

urbanized Harrisburg, Pa., and receives strong stormwater pulses and combined sewer overflows. Paxton Creek was identified from 1996 through 2004 as impaired, requiring a TMDL for nutrients, siltation, organic enrichment, low dissolved oxygen, and suspended solids caused by agriculture, combined sewer overflows, urban runoff, storm sewers, construction, and unknown causes.

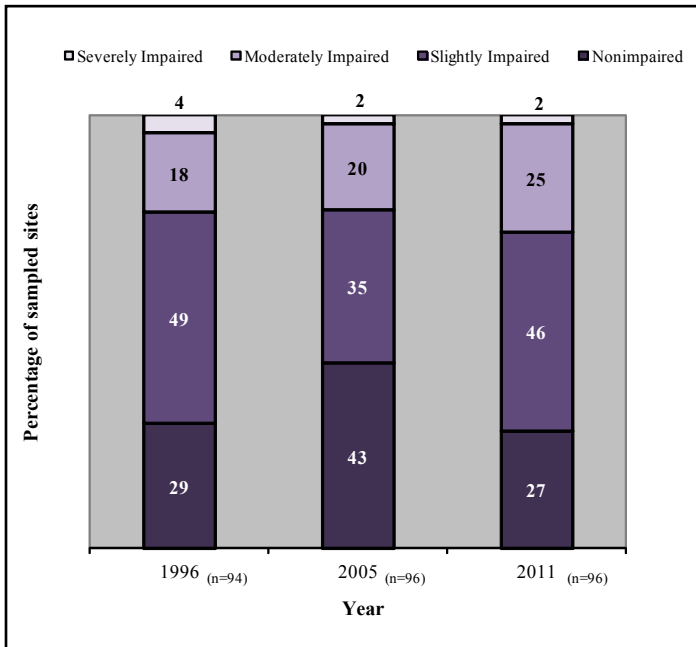
Figure 8. Historical Biological Condition Categories Among Sampled Sites in the Lower Susquehanna Subbasin Surveys

Overall, the 2011 biological results are similar to those observed in 1996, with the healthiest results being demonstrated in 2005 (Figure 8). The percentage of moderately impaired sites has steadily increased from 1996 (18 percent) to 2011 (27 percent), while the percentage of severely impaired sites has decreased from 1996 (4 percent) to 2011 (2 percent). Two of the four sites identified in 1996 as severely impaired—CODO 22.4 on Codorus Creek and WCON 35.5 on Conewago Creek—are currently classified as slightly impaired. The third site, SHAM 2.7 on Shamokin Creek, is now classified as moderately impaired, while the fourth site, PAXT 0.5 on heavily urbanized Paxton Creek, is still classified as severely impaired. A new site sampled for the first time in 2011, WICO 27.0 on Wiconisco Creek, was also classified as severely impaired.
