**Characterizations and Stress Corrosion Cracking Evaluations of Alloy 600
CRDM Nozzle Heats from the Davis Besse Nuclear Power Plant**

S. M. Bruemmer, M. J. Olszta, D. K. Schreiber, N. R. Overman and M. B. Toloczko
Pacific Northwest National Laboratory

Project JCN – N6925

Primary Water Stress Corrosion Cracking
of High-Chromium, Nickel-Base Alloys

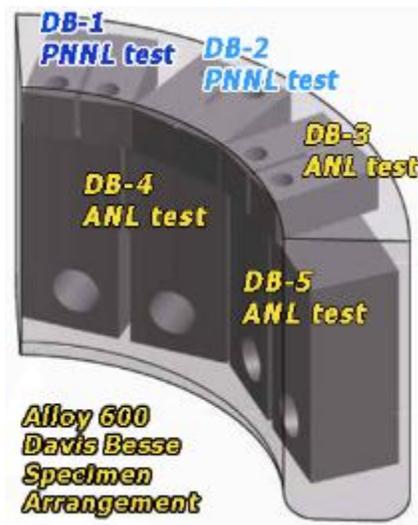
Figure 1. Orientation of DB-1 and DB-2 CT specimens relative to the alloy 600 CRDM tube from which they were machined. Original graphic was created by BWTS.

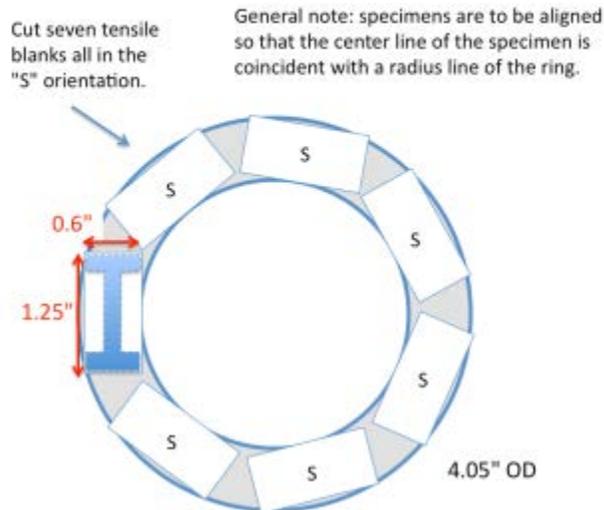
Figure 3. Cut plan for a ~1" tall slice of nozzle #1 from the original Davis Besse RPV head.

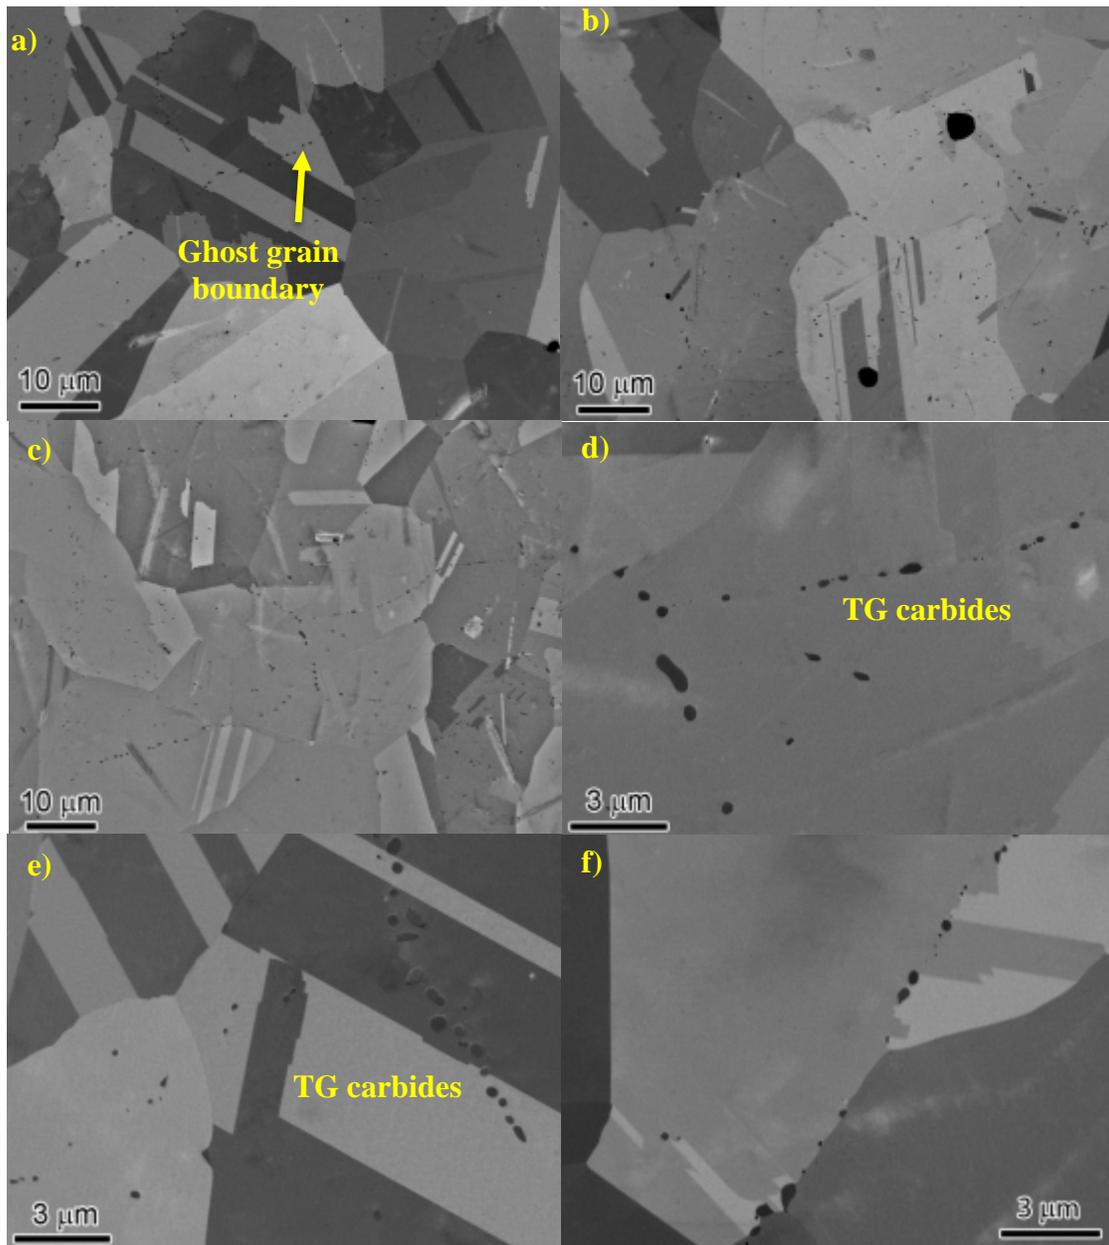
Figure 4. SEM-BSE images illustrating the general microstructures in the mill-annealed alloy 600 CRDM heat M7929 material.

Microstructures from CRDM nozzle heat M7929 (replacement head, nozzle #4) are shown in Figure 4, while microstructure for M3935 (original head, nozzle #1) are given in Figures 5 and 6. These two CRDM nozzles came from RPV heads produced by the same manufacturer, so it is surprising that they exhibit strikingly different microstructures. The large difference in grain size is immediately apparent between these two alloy 600 materials reported to be in the mill-annealed condition. The grains range in diameter from ~10-25 μm for M7929, whereas they from ~150-400 μm in diameter for M3935. Most carbides in M7929 were determined to transgranular (TG), while the carbides in M3935 are nearly all IG and spaced ~500 nm apart. The TG carbides in M7929 were not randomly dispersed throughout the grains, but typical associated with ghost or prior grain boundaries. This suggests that the final heat treatment for M7929 was not at sufficiently high temperature to dissolve the pre-existing carbides, but did cause grain boundary migration and create a new grain structure. In contrast, the M3935 material had an extremely large grain size, indicating that it was annealed at a temperature sufficient to dissolve most, if not all, the carbides and promote significant grain growth. Grain boundaries exhibited a semi-continuous distribution of carbides consistent with a slower cooling rate from the annealing temperature enabling precipitation to occur. At higher magnification using a 3 kV accelerating voltage (Figure 6), a population of elongated white particles was observed on many grain boundaries. These particles were determined to be Ni borides by atom probe tomography (APT) and are probably Ni_{23}B_6 forming adjacent to the Cr_7C_3 carbides.

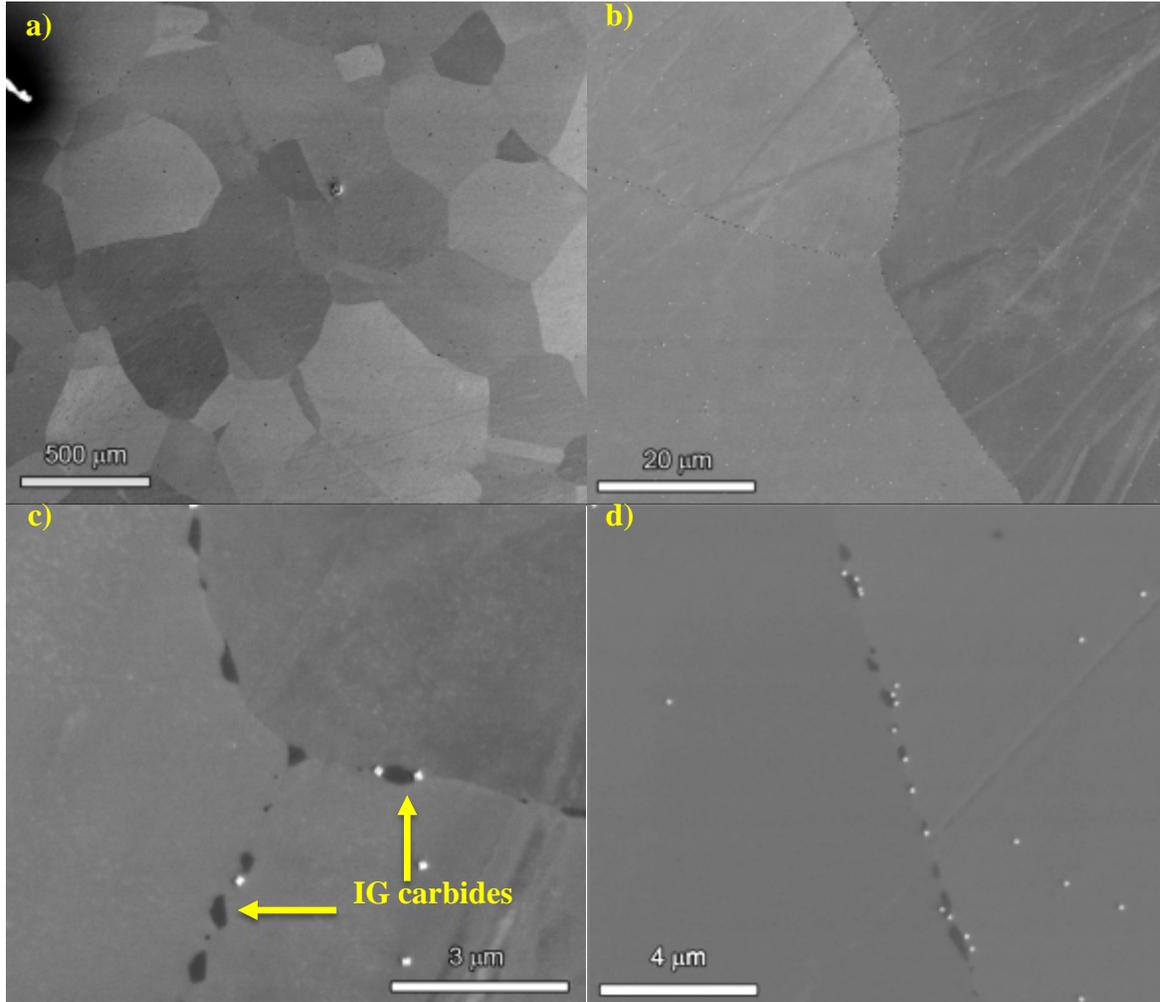
Figure 5. SEM-BSE images illustrating the general microstructures in the mill-annealed alloy 600 CRDM heat M3935 material. Small white particles in (c) and (d) are drying artifacts from the sample preparation process.

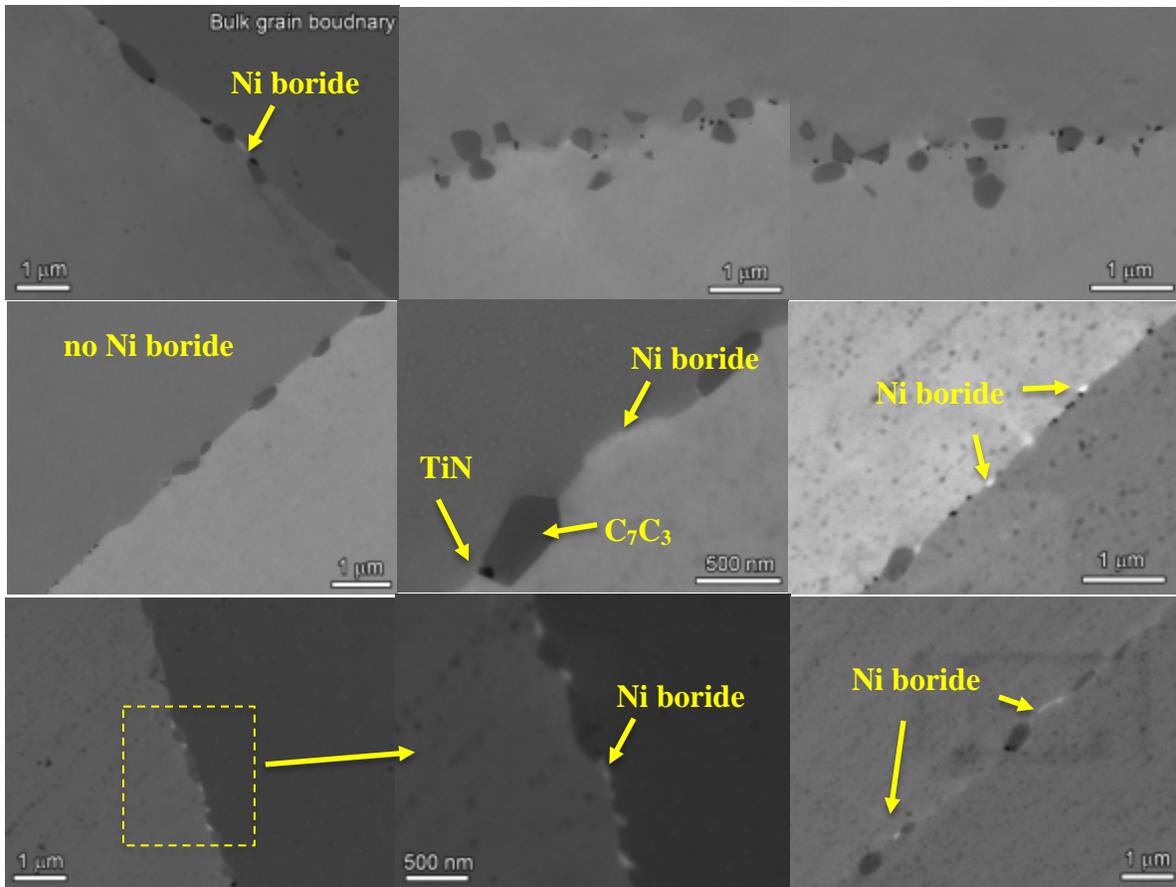
Figure 6. SEM-BSE images illustrating the general microstructures in the mill-annealed alloy 600 CRDM heat M3935 material at higher magnification illustrating the distribution of Cr₇C₃, TiN and Ni borides on the grain boundaries.

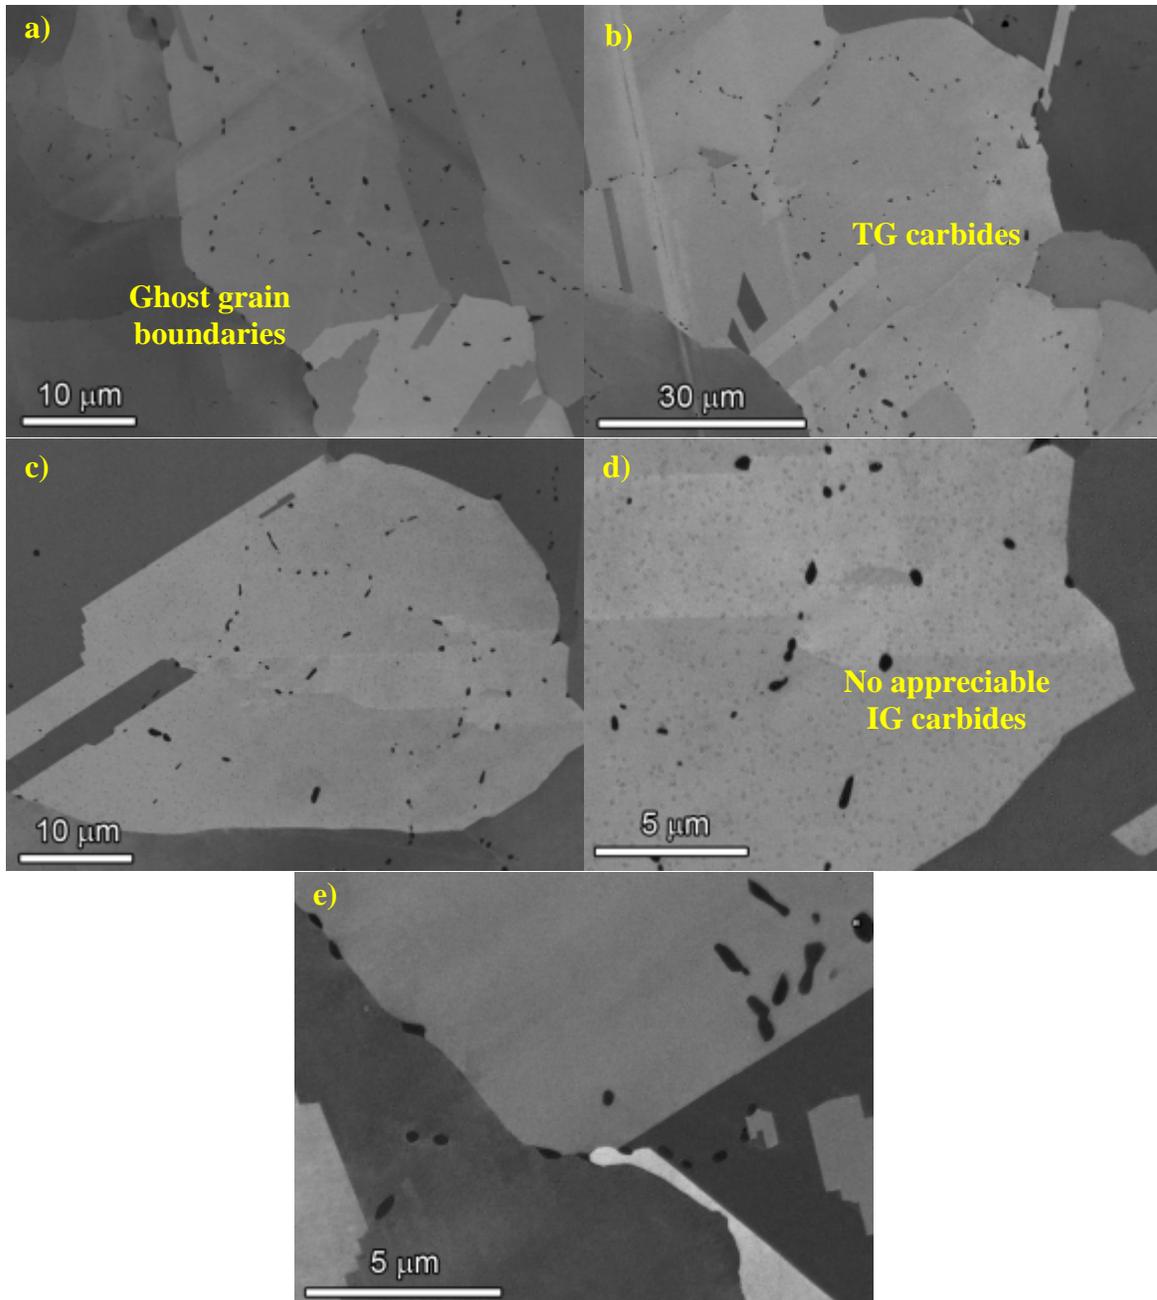
Figure 7. SEM-BSE images illustrating the general microstructures in the North Anna alloy 600 CRDM nozzle #31 material (NA2-N31).

The microstructure for the North Anna 2 alloy 600 CRDM nozzle 31 material (identified as NA2-N31) is illustrated in Figure 7. The sample had an equiaxed grain microstructure with grains ~50-70 μm in size. There was a high density of TG carbides along ghost grain boundaries similar to that for M7929 and only isolated IG carbides.

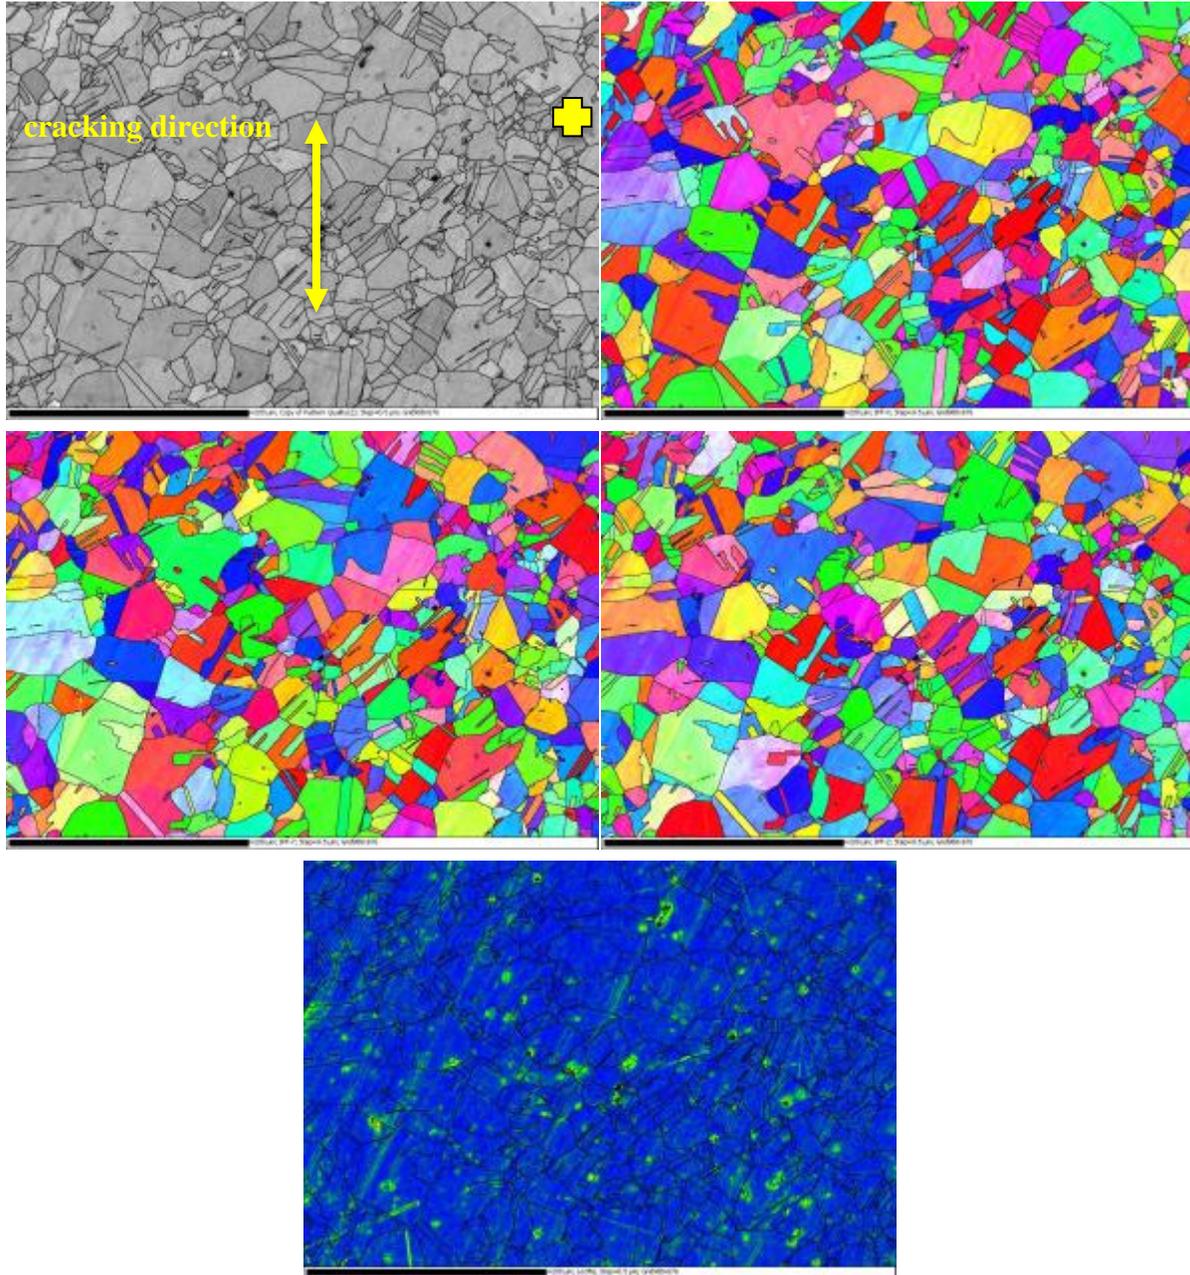
Figure 8. EBSD pattern quality map is shown in upper left image, inverse pole figure maps in upper right (X orientation), middle left (Y orientation) and middle right (Z orientation) images along with misorientation density map in bottom center for area #1 located ~1.5 mm head of the crack tip in the Davis Besse heat M7929, CT063 (DB-1) specimen crack growth plane. Yellow symbol in the pattern quality map is a reference overlap point for area #2 in Figure 9.

Additional characterizations were performed on the two Davis Besse heats using electron backscatter diffraction (EBSD) and hardness measurements. Overall general microstructure for heat M7929 as represented by EBSD is illustrated in Figures 8 and 9 revealing a small grain size (~15 μm diameter) and a moderate-to-high density of twins. Two different areas are shown from regions ~1.5 mm ahead of the final crack front of the SCC test specimen CT063 (DB-1). Area #1 lies right on the geometric crack path while area #2 is off to the side and overlaps slightly with area #1 as indicated by the reference points in the two figures. Misorientation density maps of these same two areas indicate small, discontinuous pockets of high strain.

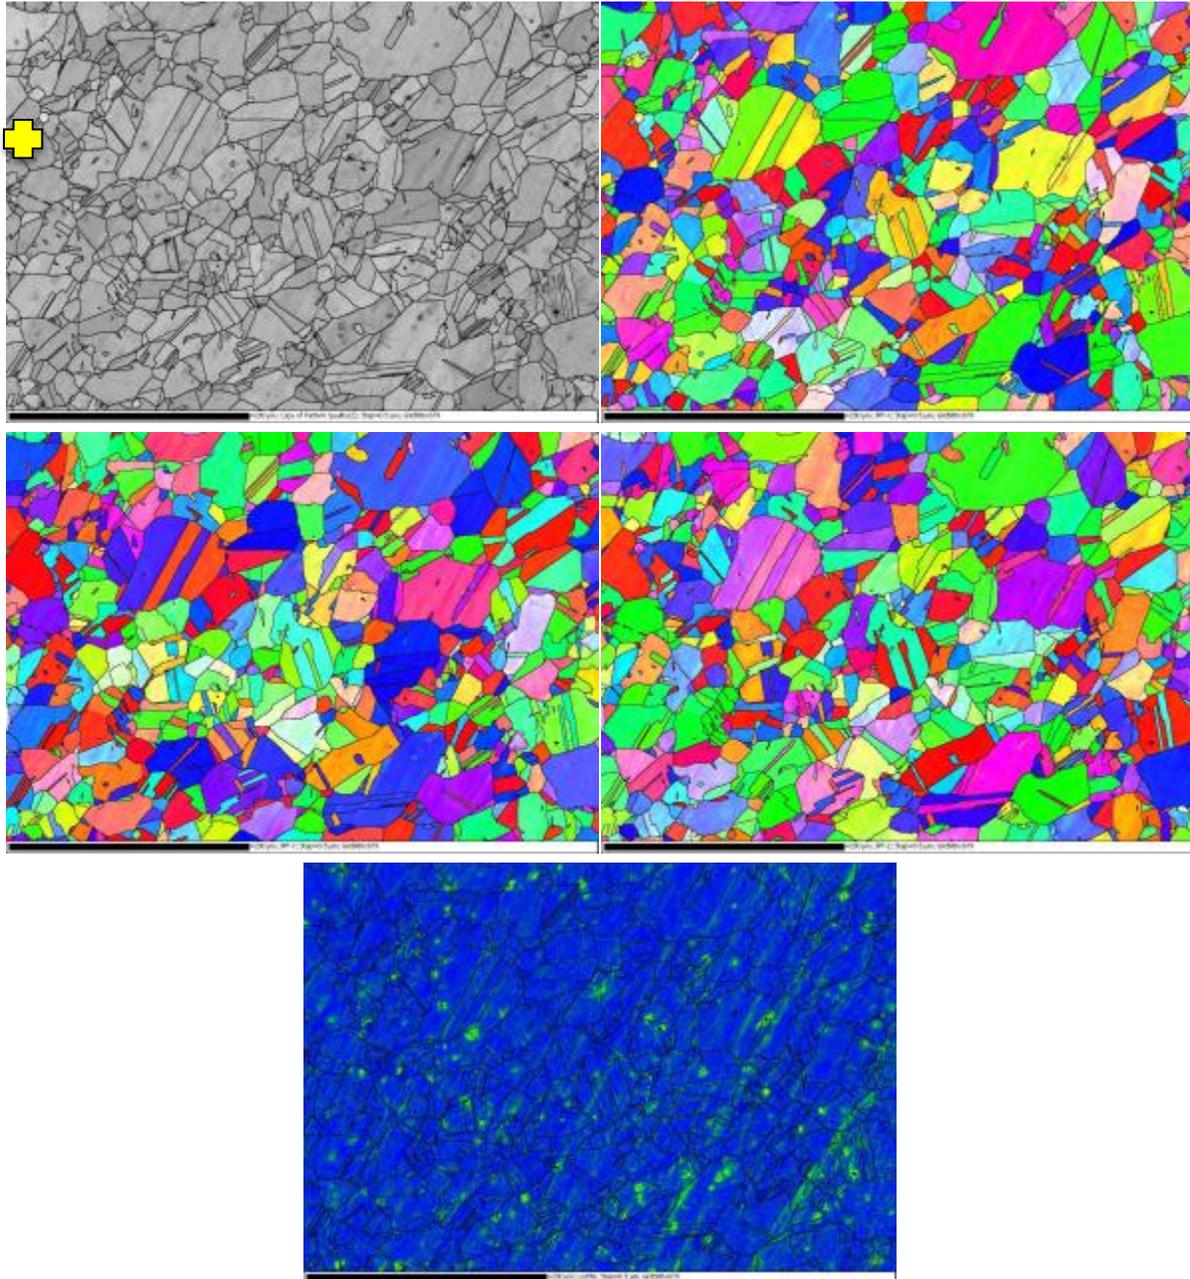
Figure 9. EBSD pattern quality map is shown in upper left image, inverse pole figure maps in upper right (X orientation), middle left (Y orientation) and middle right (Z orientation) images along with misorientation density map in bottom center for area #2 located off the crack plane adjacent to area #1 shown in Figure 8 for Davis Besse heat M7929. Yellow symbols in pattern quality maps show reference overlap point between area #1 and area #2.

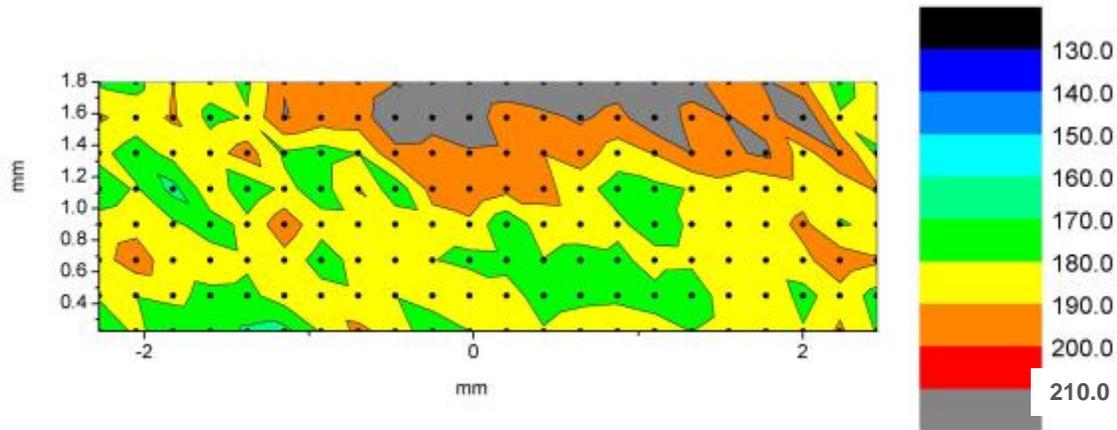
Figure 10. Vickers hardness map for Davis Besse heat M7929, CT063 specimen crack growth plane. The average measured hardness was 186.5 kg/mm^2 with a standard deviation of 9.6 kg/mm^2 .

A Vickers hardness map of a representative region from the side-surface cross-section sample is presented in Figure 10. Once again, this region is aligned ahead of the crack growth path for specimen CT063 and is near the EBSD examination locations. A region of locally higher hardness of ~210 kg/mm^2 is present in the map, however the average measured hardness was 186.5 kg/mm^2 with a standard deviation of 9.6 kg/mm^2 .

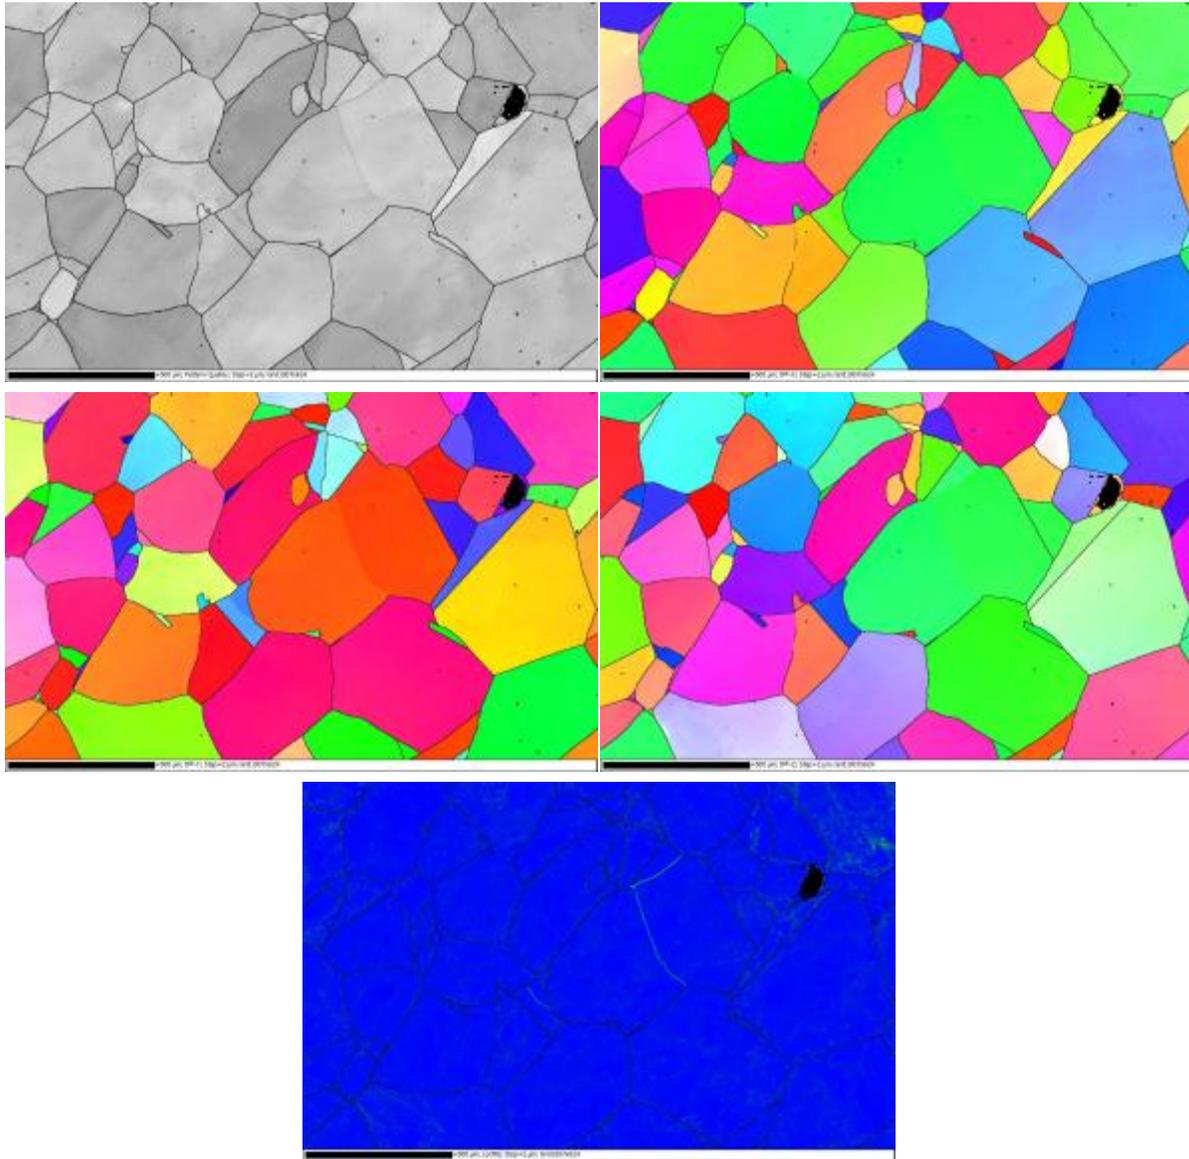
Figure 11. EBSD pattern quality map is shown in upper left image, inverse pole figure maps in upper right (X orientation), middle left (Y orientation) and middle right (Z orientation) images along with misorientation density map in bottom center for Davis Besse heat M3935, CT090 specimen crack growth plane.

The overall general microstructure for heat M3935 is represented by EBSD in Figure 11 revealing the extremely large grain size and a very low density of twins. This area is from a region ~ 1 to 1.5 mm ahead of the final crack front along the geometric crack path in the SCC test specimen CT090 (DB-H1N1 #1). Consistent with the lack of deformation twins, the misorientation density map of this area reveals low strains.

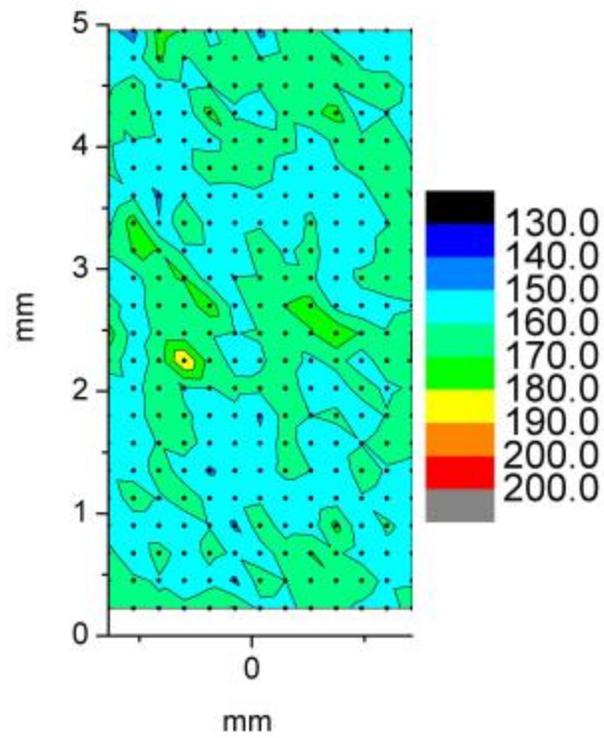
Figure 12. Vickers hardness map for Davis Besse heat M3935, CT090 specimen crack growth plane. The average measured hardness was 160.2 kg/mm^2 with a standard deviation of 6.5 kg/mm^2 .

A Vickers hardness map of a representative region from the side-surface cross-section sample is presented in Figure 12. Once again, this region is aligned with the geometric crack path for specimen CT090 and is near the EBSD examination location. With the exception of a single indentation that produced a hardness of $\sim 180 \text{ kg/mm}^2$, this region exhibited a consistent hardness of 160.2 kg/mm^2 with a standard deviation of 6.5 kg/mm^2 .

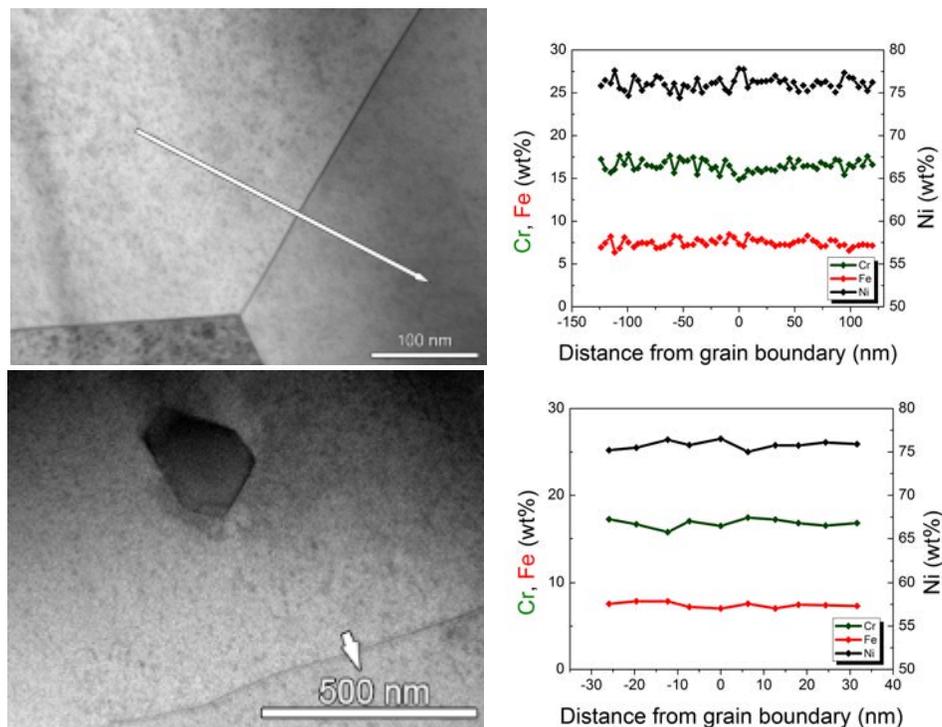
Figure 13. STEM EDS line scans across two grain boundaries in alloy 600 M7929 showing little to no Cr depletion.

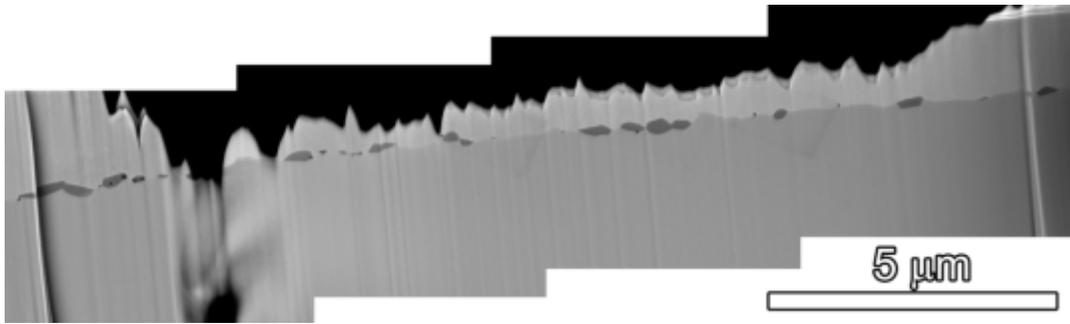
Figure 14. SEM-BSE montage of FIB machined TEM plate sample containing a grain boundary from alloy 600 M3935. In this region, there does not appear to be any Ni boride particles.

An SEM-BSE image of a FIB machined TEM plate sample from heat M3935 is shown in Figure 14. A high density of Cr carbides and sporadic TiN are observed along the grain boundary. Unlike the majority of SEM BSE images of this material in Figure 6, there are no apparent bright intergranular phases (Ni borides). It is possible that this section of grain boundary does not contain any. Using diffraction and darkfield imaging (Figures 15 and 16), the Cr rich carbides were determined to be primarily Cr_7C_3 . STEM brightfield and EDS elemental maps of the Cr_7C_3 and TiN precipitates are shown in Figures 17 and 18. Lastly, significant Cr depletion was identified to levels below 10 wt% in EDS line scans of grain boundary regions that did not contain carbides (Figure 19). More detailed analyses of grain boundary composition were made using atom probe tomography (APT) and is described in the following section. Both the TEM and APT characterizations were conducted under funding from a Department of Energy, Office of Basic Energy Sciences project at PNNL.

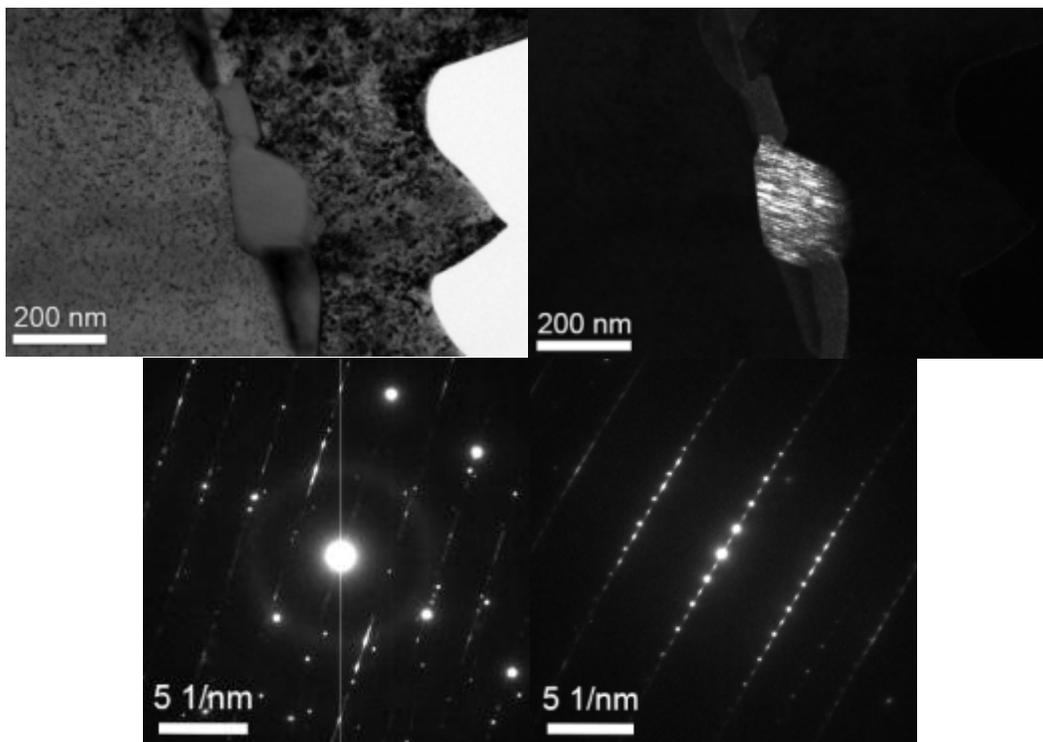
Figure 15. TEM BF/DF pair and selected area diffraction patterns of an IG Cr_7C_3 carbide in the alloy 600 M3935 material.

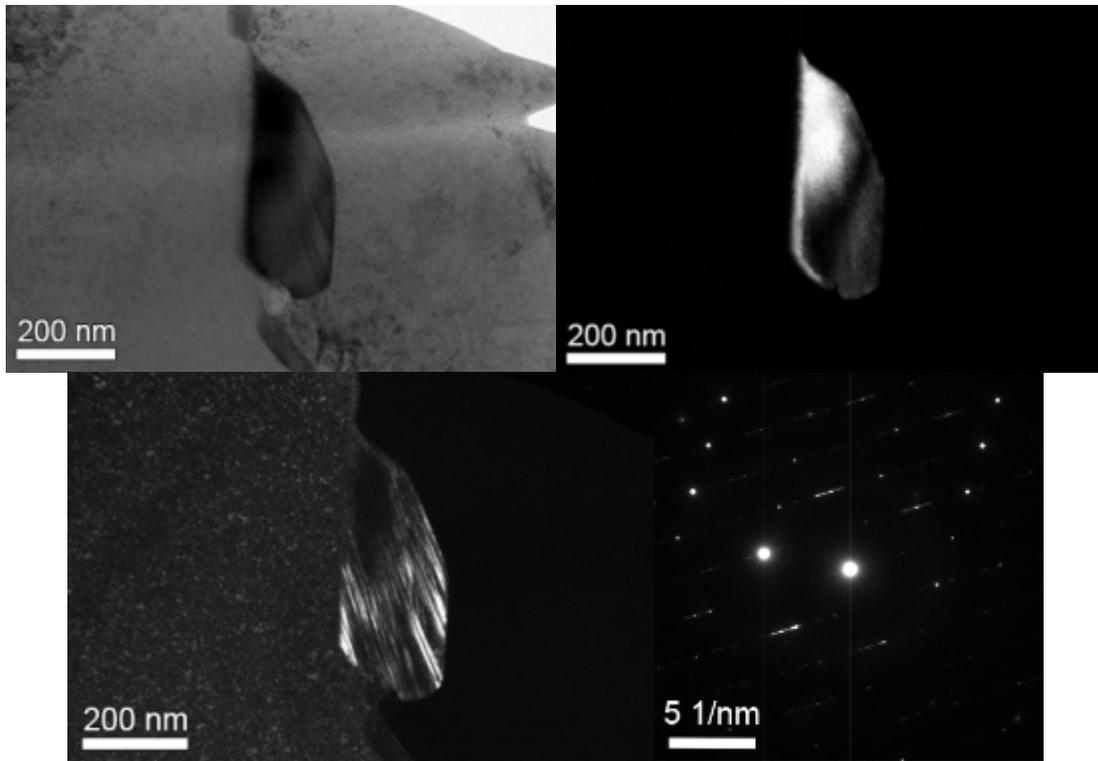
Figure 16. TEM BF/DF pair and selected area diffraction of an IG Cr_7C_3 carbide (two different reflections are used to illuminate the carbide) in the alloy 600 M3935 material.

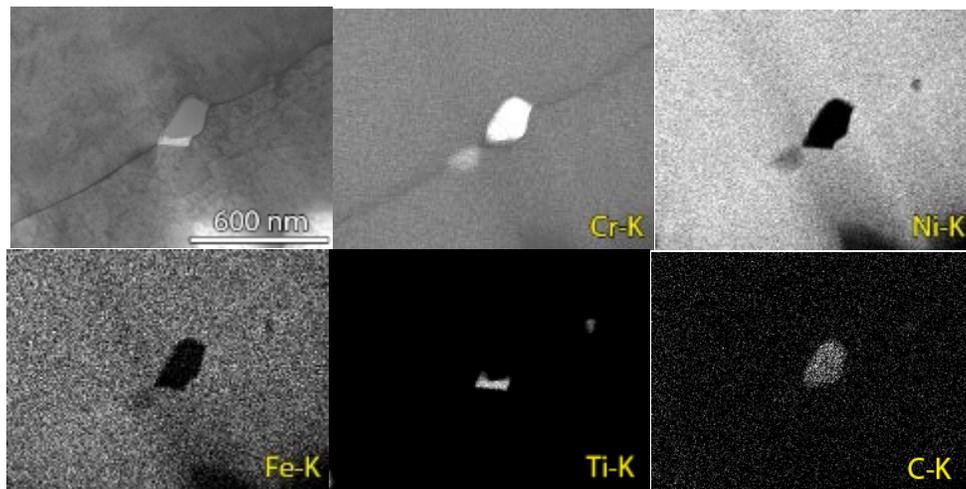
Figure 17. STEM/EDS elemental maps of a grain boundary in alloy 600 M3935. A ~ 100 nm, IG M_7C_3 carbide is observed on the grain boundary. Smaller (25-50 nm) Ti rich particles are also observed. With the grain boundary nearly on edge (as seen in the BF image), local Cr depletion is evident in the Cr-K map.

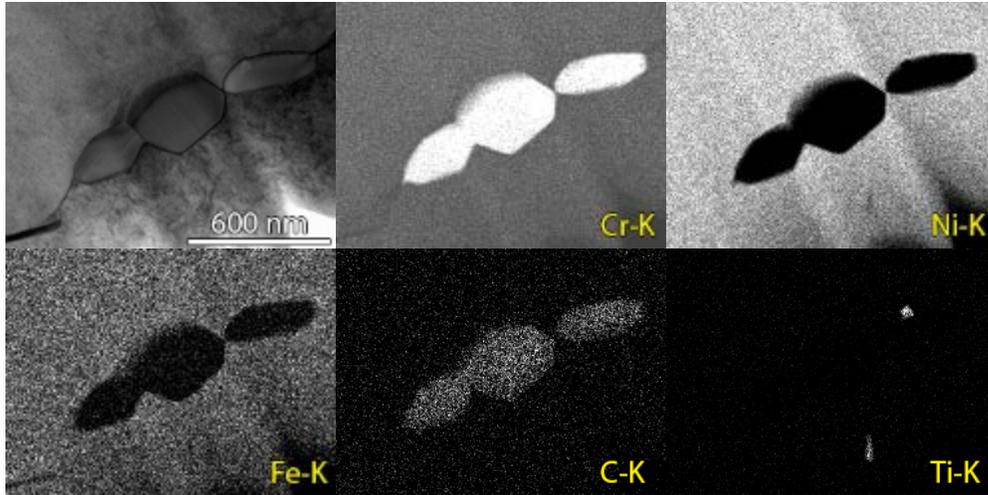
Figure 18. STEM/EDS elemental maps from a second region of the M3935 grain boundary.

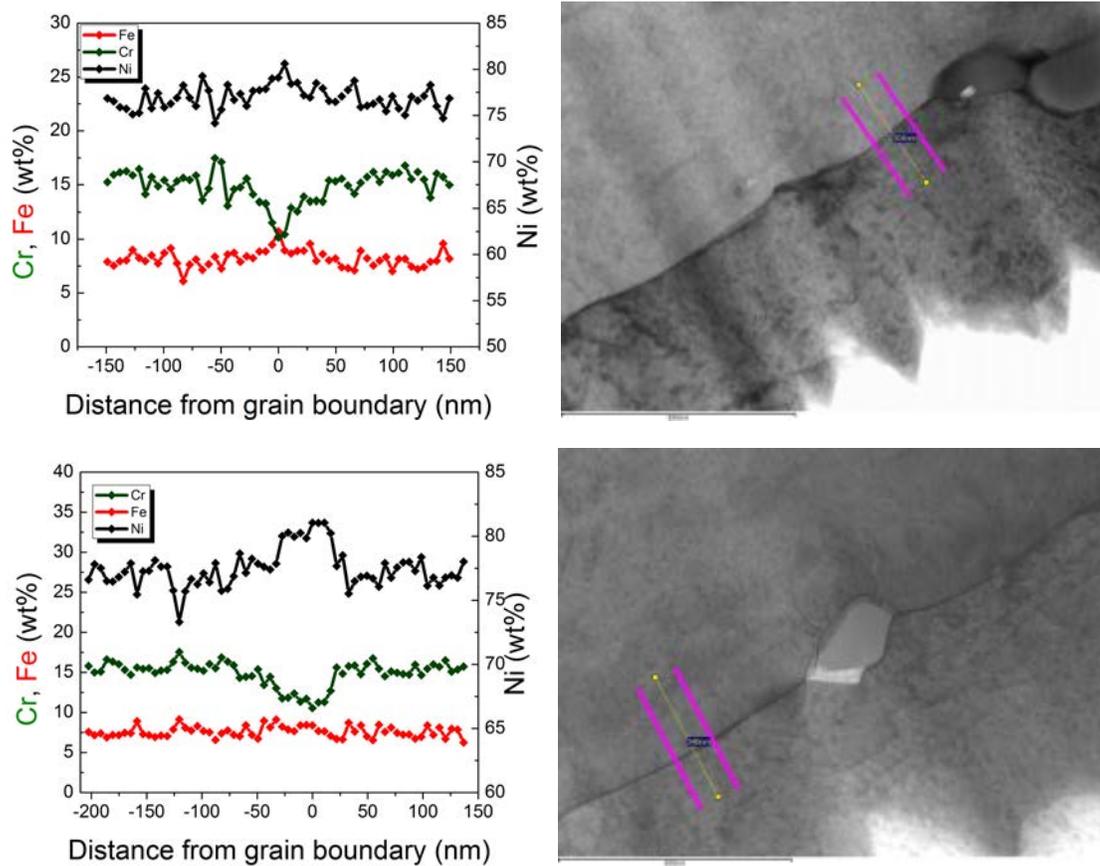
Figure 19. EDS line scans taken across two regions along the same grain boundary in alloy 600 M3935. The chromium depletion is observed to ~10-11 wt% in either lines can, with the top lines can showing a slightly sharper profile. From the top STEM BF image, it is readily apparent that the grain boundaries are not completely straight and are observed to be inclined even at distances of 500 nm apart.

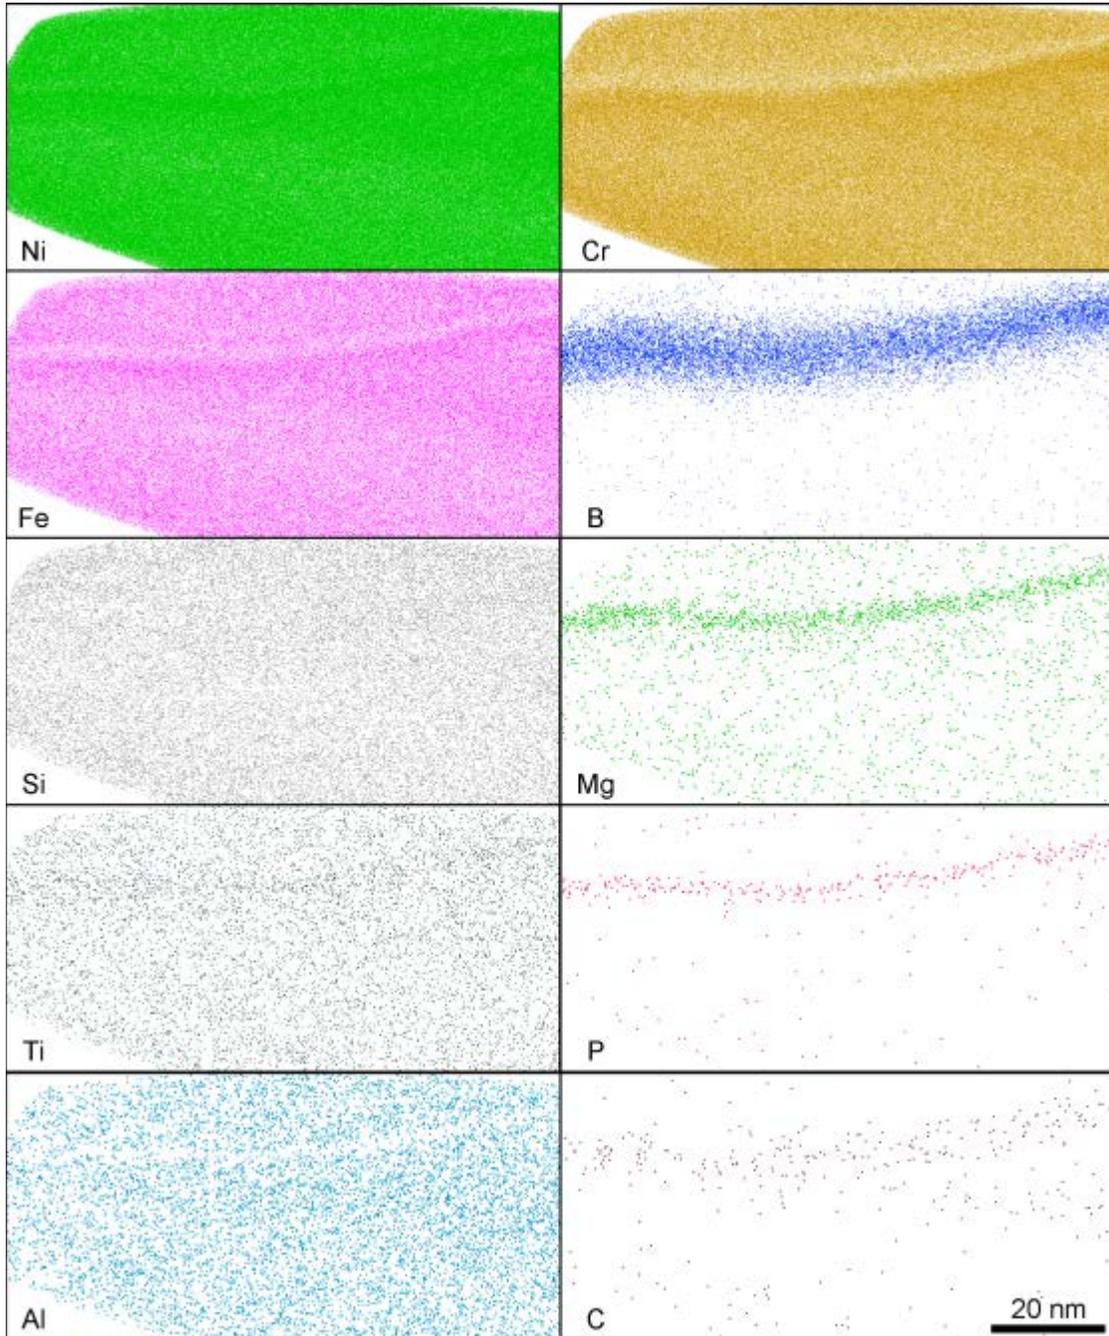
Figure 20. Atom maps (20 nm image depth) from Davis Besse CRDM heat M7929. Particularly strong segregation is apparent for B, Mg and P.

Representative atom maps from M7929 are depicted in Figure 20. Strong grain boundary segregation is apparent for B, Mg and P. The extent of segregation is quantified in Figure 21 using a proximity histogram across the boundary. This profile confirms strong segregation for B (2.6 at%), Mg (0.5 at%) and P (0.15 at%). By comparison, the Cr depletion observed (minimum 11.5 at%) is minor for a material that exhibited moderate grain boundary coverage of IG Cr

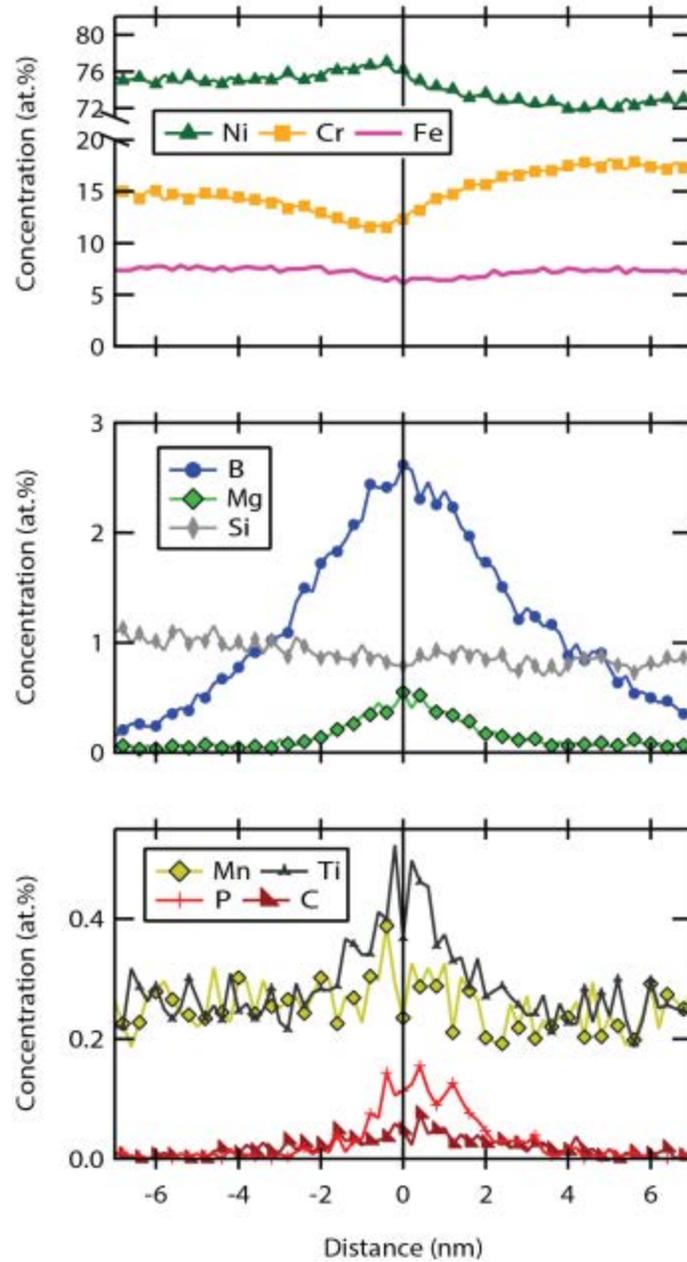
Figure 21. Proximity histogram taken across a high-angle grain boundary in Davis Besse CRDM heat M7929. Very strong interfacial segregation is apparent for B, Mg, Ti and P. Minor Cr depletion and Ni enrichment are also apparent.

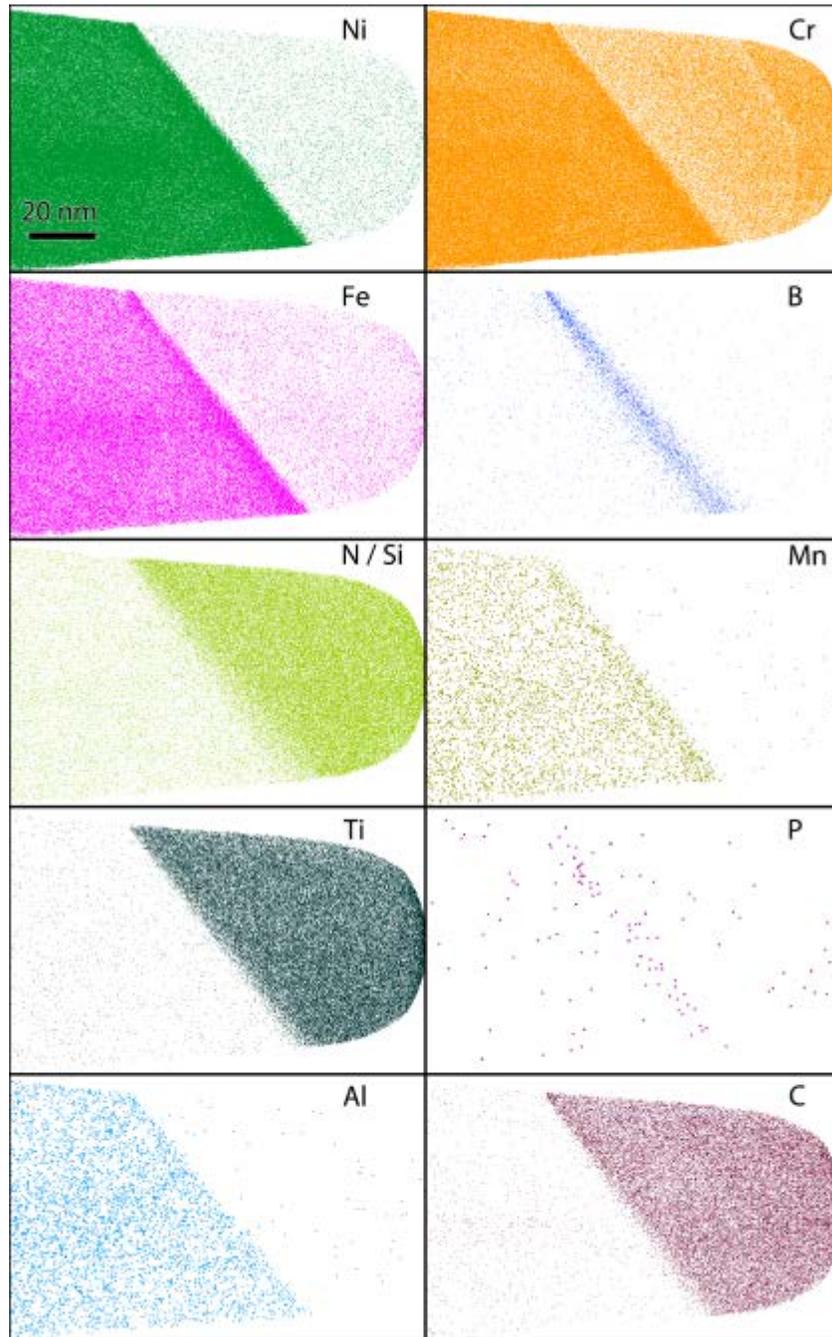
Figure 22. Atom map (10 nm image depth) of an IG Ti carbo-nitride in Davis Besse CRDM heat M3935. Strong interfacial segregation is apparent for B and weak segregation for P. Note that Si and N peaks are convoluted with one another and impossible to differentiate.

Two APT specimens from heat M3935 were collected intersecting IG precipitates. The first specimen was found to contain a Ti carbo-nitride covering the grain boundary across the entire width of the APT needle. The corresponding APT reconstruction is presented in Figure 22. The carbo-nitride precipitate is strongly enriched in Ti, C and N and strongly depleted of Ni, Fe, Al and Mn. Interfacial segregation is apparent for B and P. Note that peak overlap between $^{28}\text{Si}^{2+}$ and $^{14}\text{N}^{1+}$ prevents the analysis of any potential Si segregation in this specimen. A proximity histogram was produced at the carbo-nitride/metal interface to quantify both the precipitate composition and the interfacial segregation (Figure 23). The precipitate consists of ~50 at% Ti, 33 at% N, 6 at% C and 6 at% Cr. Interfacial segregation is very significant. Pronounced enrichment is apparent for B (to ~2.5 at%) and P (to 0.08 at%). Chromium exhibits a more complicated behavior in which some enrichment is apparent at the metal/precipitate interface, while Cr depletion also exists just outside this enriched interface, down to ~11 at%. Interfacial segregation to ~8 at% is also indicated for C.
