**Characterizations and Stress Corrosion Cracking Evaluations of Alloy 600
CRDM Nozzle Heats from the Davis Besse Nuclear Power Plant**

S. M. Bruemmer, M. J. Olszta, D. K. Schreiber, N. R. Overman and M. B. Toloczko
Pacific Northwest National Laboratory

Project JCN – N6925

Primary Water Stress Corrosion Cracking
of High-Chromium, Nickel-Base Alloys

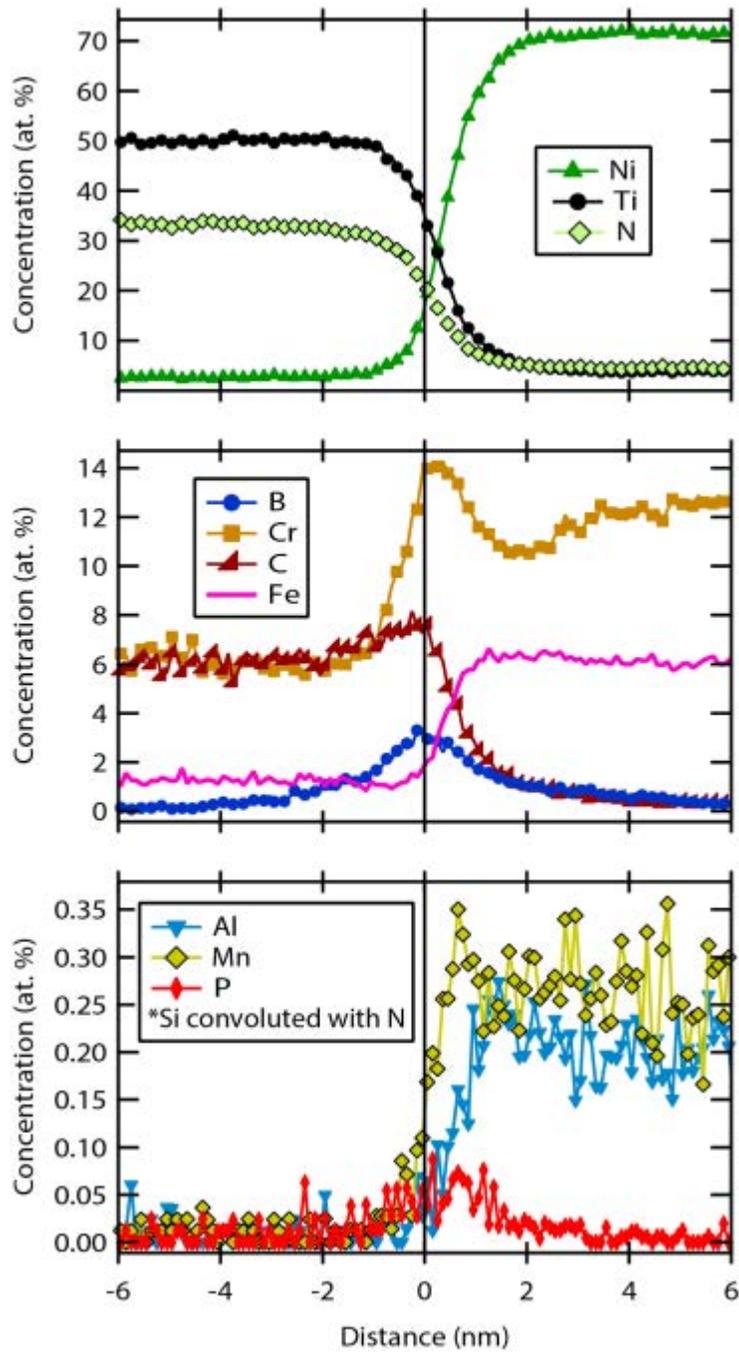
Figure 23. Proximity histogram across the Ti carbo-nitride/metal matrix interface in M3935. The precipitate contains a moderate concentration of Cr that is also strong segregated to the interface. B is strongly segregated (~3.3 at%) along with a small enrichment of P (~0.06 at%).

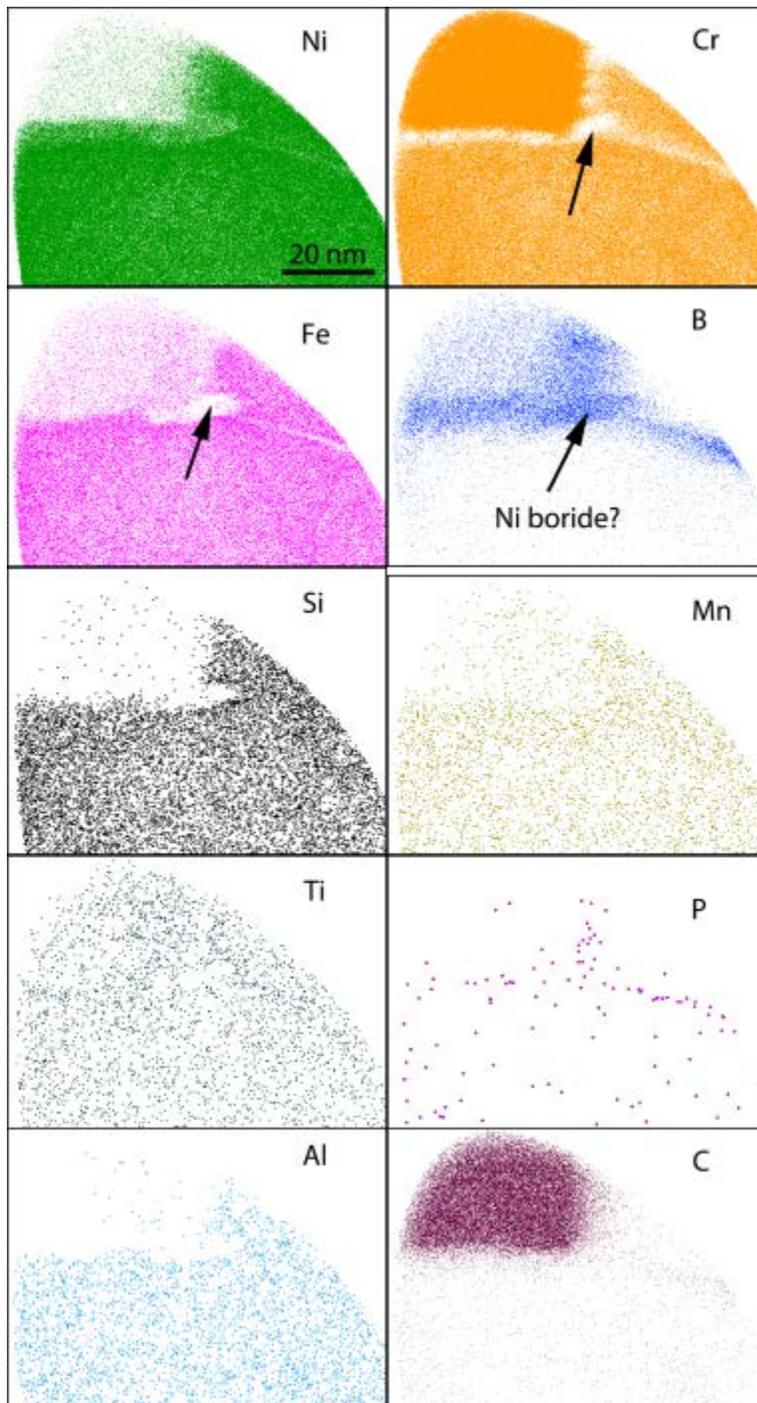
Figure 24. Atom maps from an IG Cr carbide and surrounding grain boundary in Davis Besse CRDM heat M3935. Very strong Cr depletion and B enrichment are apparent along the grain boundary and metal/carbide matrix. Particularly strong localized B enrichment and Cr depletion is suggestive of possible Ni boride precipitations (arrowed).

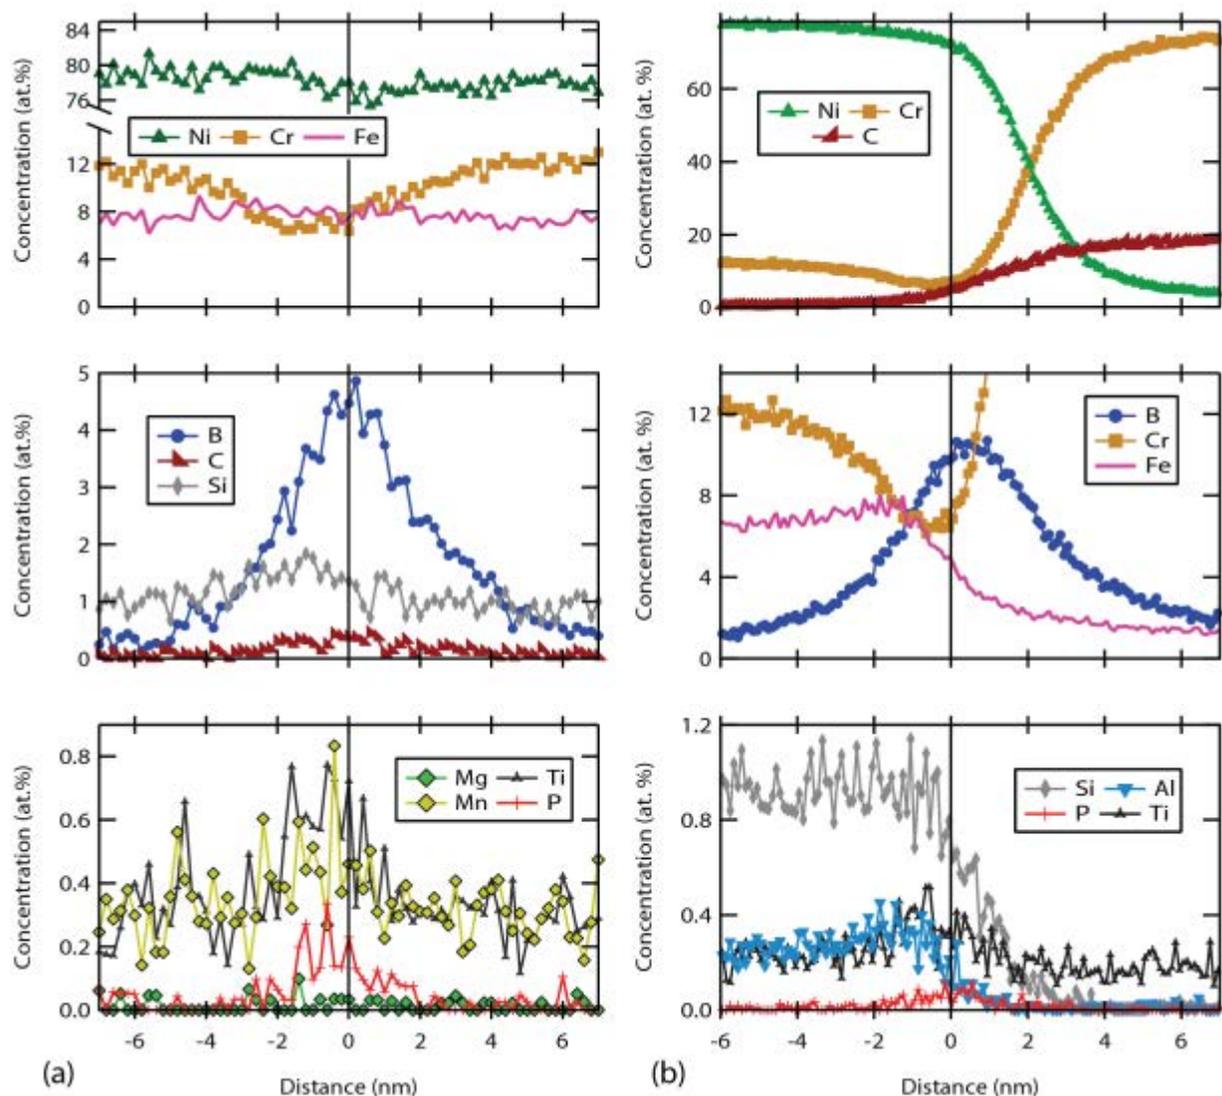
Figure 25. Concentration profiles across (a) the metal/metal grain boundary and (b) across the IG Cr carbide / metal interface in Davis Besse CRDM heat M3935. Both types of interfaces exhibit particularly strong B segregation (5 at% and 11 at%, respectively) and Cr depletion (<8 at% each). Relatively strong P segregation is apparent at each interface (~0.2 at%) and no significant Si segregation is observed.

Concentration profiles were produced across the metal/metal grain boundary adjacent to the IG carbide and also from the carbide/metal interface in Figure 25. Each profile quantifies extraordinarily high levels of interfacial B segregation up to 5 at% B and 11 at% B at the metal/metal and carbide/metal interfaces, respectively. These represent the highest levels of B segregation among alloy 600 examined by PNNL. Similar to the other CRDM heat (M7929), the grain boundary does not exhibit any detectable segregation of Si. Slight segregation is apparent for C, P, Mn and Ti at the grain boundary. IG Cr depletion, expected to be severe in such close proximity to an IG Cr carbide, was only moderate, with a minimum value of ~8 at% Cr. In general, the carbide/metal interface was very similar to the metal/metal grain boundary. Cr was depleted to ~7 at%, while slight segregation was seen for P and Ti with no Si enrichment.

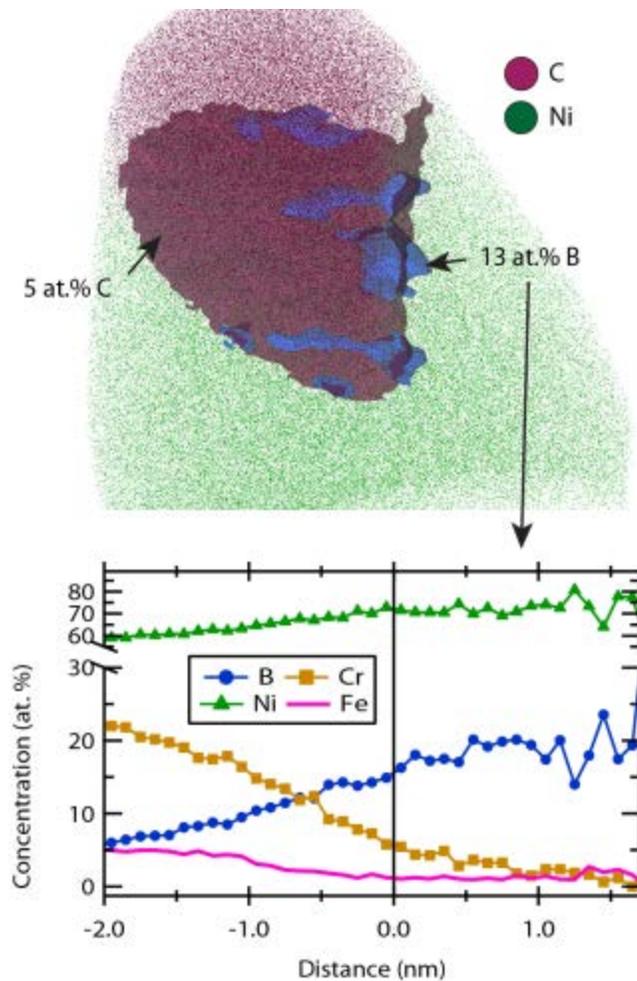
Figure 26. APT reconstruction of the IG carbide in the Davis Besse CRDM heat M3935. Isoconcentration surfaces at 5 at% C (maroon) and 13 at% B (blue) outline the Cr carbide and possible Ni boride, respectively. A proximity histogram (bottom) from around the 13 at% B isoconcentration surface confirms the coincident enrichment of Ni and B (up to 20 at%) that is suggestive of an interfacial Ni boride phase.

As mentioned when discussing the atom maps of this dataset, the extraordinarily high levels of B and localized Cr depletion at the carbide/metal interface suggest the possibility of Ni boride precipitation at the carbide/metal interface. To better visualize this possibility, a full three-dimensional reconstruction (rather than a thin two-dimensional slice of data) is presented in Figure 26. The three-dimensional morphology of the carbide is defined using a 5 at% C isoconcentration surface (maroon). Localized regions of particularly high B concentrations are defined along the carbide/metal interface with 13 at% B isoconcentration surfaces (blue).

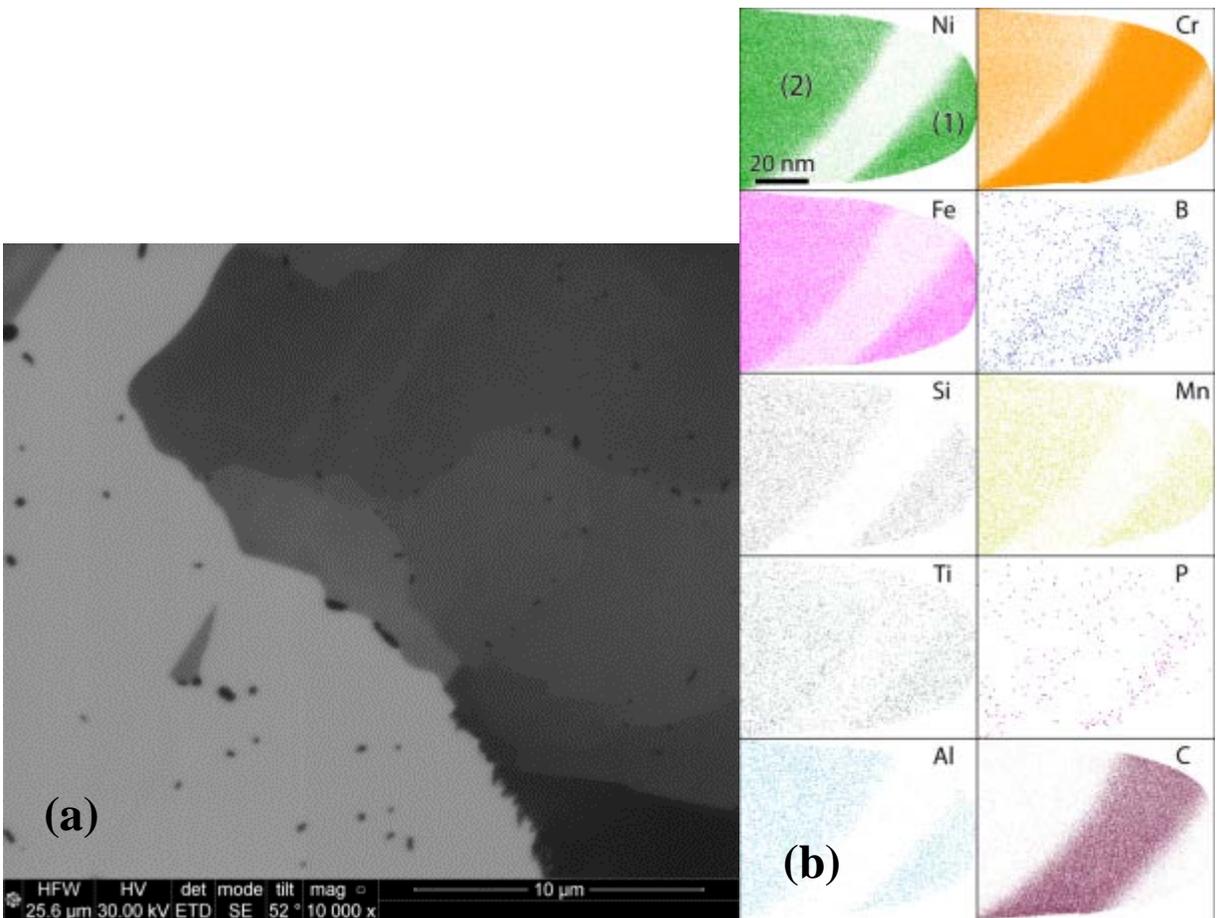
Figure 27. (a) Typical high-magnification ion-beam image of grain boundaries in the NA2-N31 alloy 600 material. A low density of IG carbides was apparent. The rough interface along the boundary in the lower right may be suggestive of cellular carbide formation. (b) APT atom maps (10 nm image depth) of an IG Cr carbide. Weak B and P segregation is apparent at the carbide/metal interface.

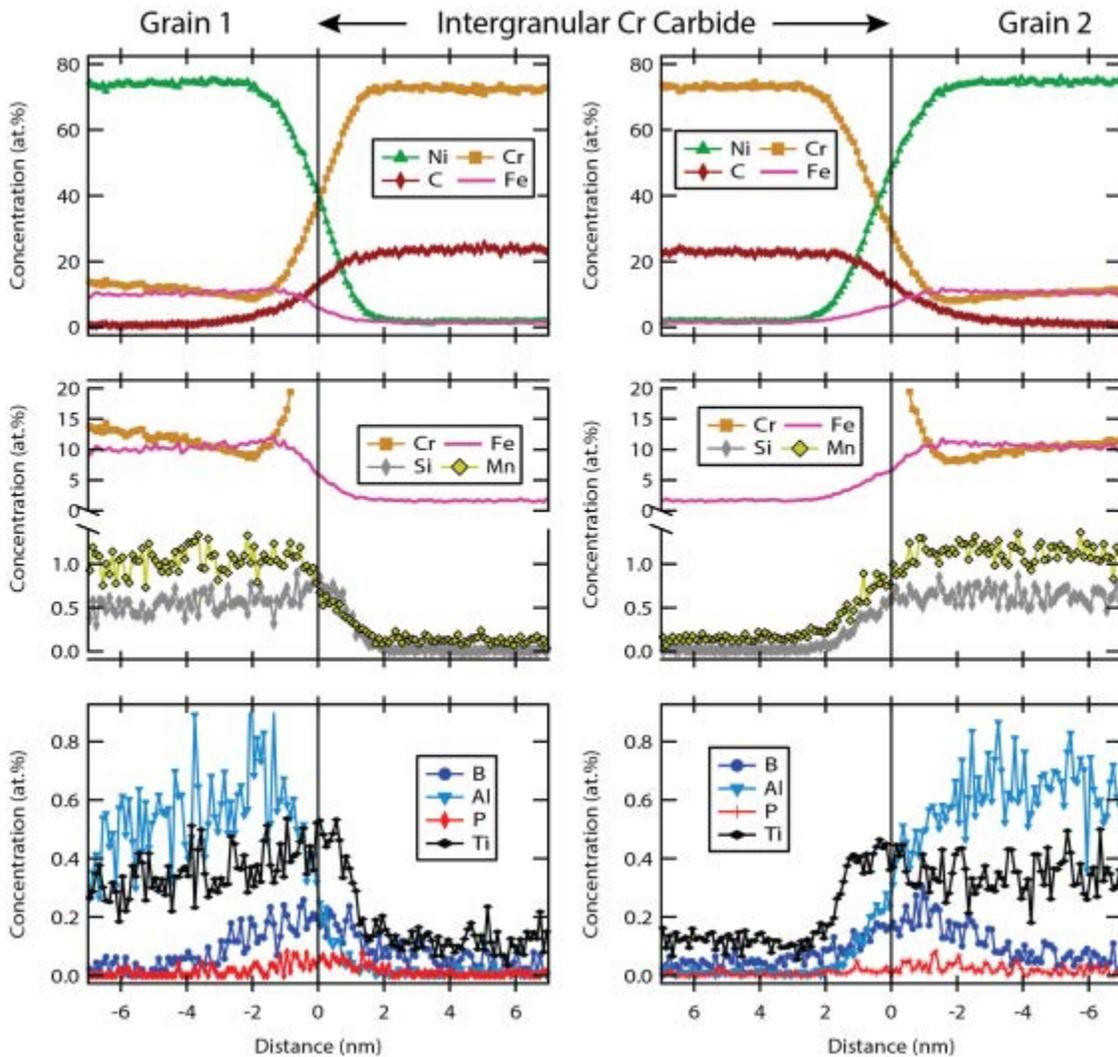
Figure 28. APT proximity histograms at the interface between the intergranular Cr carbide and (left) Grain 1 and (right) Grain 2 in Figure 20(b). The profiles quantitatively confirm the visually apparent weak segregation of B and P and also localized Cr depletion at both metal/carbide interfaces.

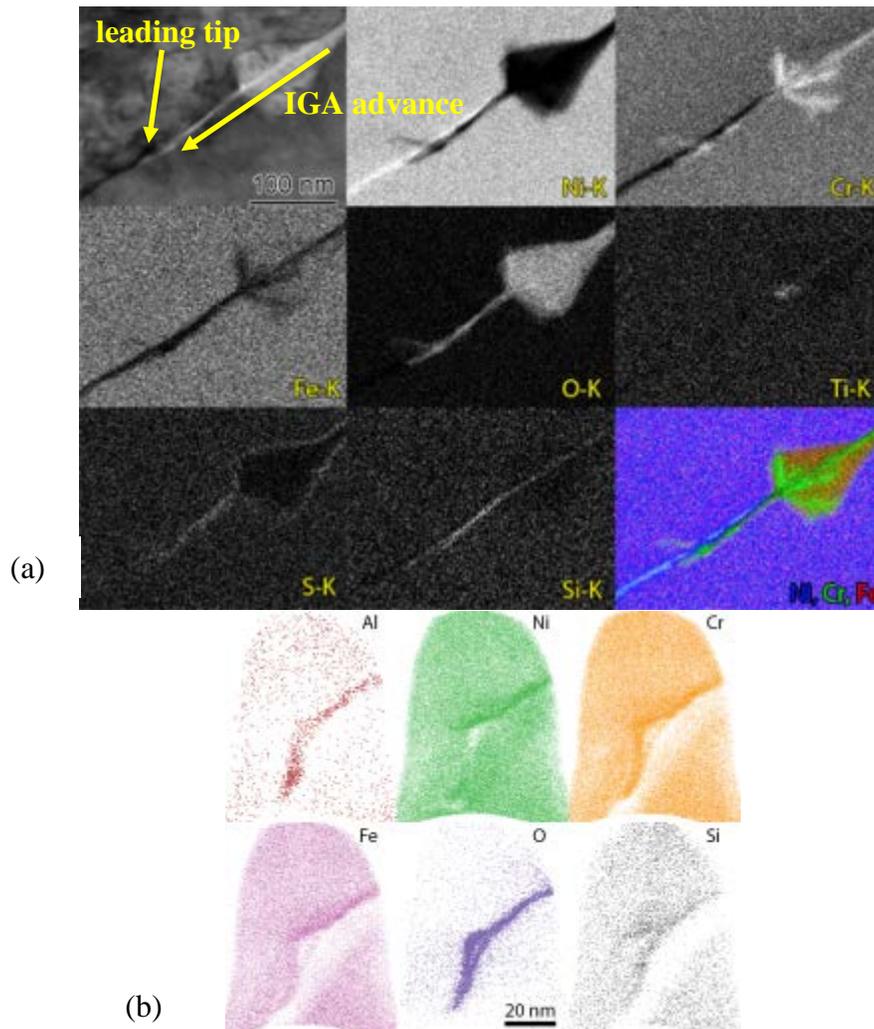
Figure 29. (a) STEM EDS elemental map of IGA in heat WF422 after exposure to simulated PWR primary water. Cr-rich oxide facets have formed with concomitant Ni enrichment and Cr depletion ahead. Electron diffraction (not shown) revealed the oxide to be comprised primarily of nanocrystalline MO-phase oxides. (b) Cross-section atom maps of the terminal IGA in heat WF422 after an additional 3000 h exposure showing Cr-rich oxides and substantial depletion of Cr, Fe and Si and grain boundary migration.

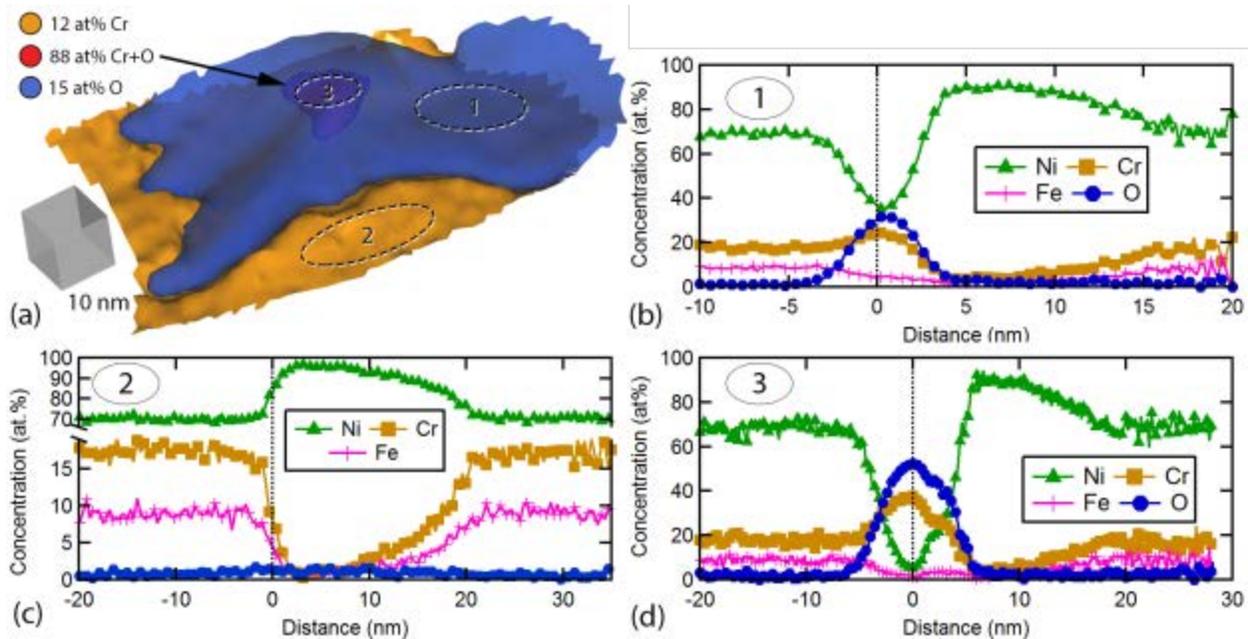
Figure 30. APT analysis of the terminal IGA of heat WF422 at 325 °C for 3500 h. (a) Isoconcentration surfaces at 15 at% O (blue) and 12 at% Cr (orange) define the oxidized region and unoxidized portions of an attacked grain boundary. An 88 at% Cr+O isoconcentration surface (red) defines a discrete Cr_2O_3 precipitate. (b)-(d) 1-D concentration profiles extracted across the indicated regions of the grain boundary. The oxide is Cr rich and Ni depleted and the surrounding metal is strongly depleted of Cr and Fe for a width of >10 nm.

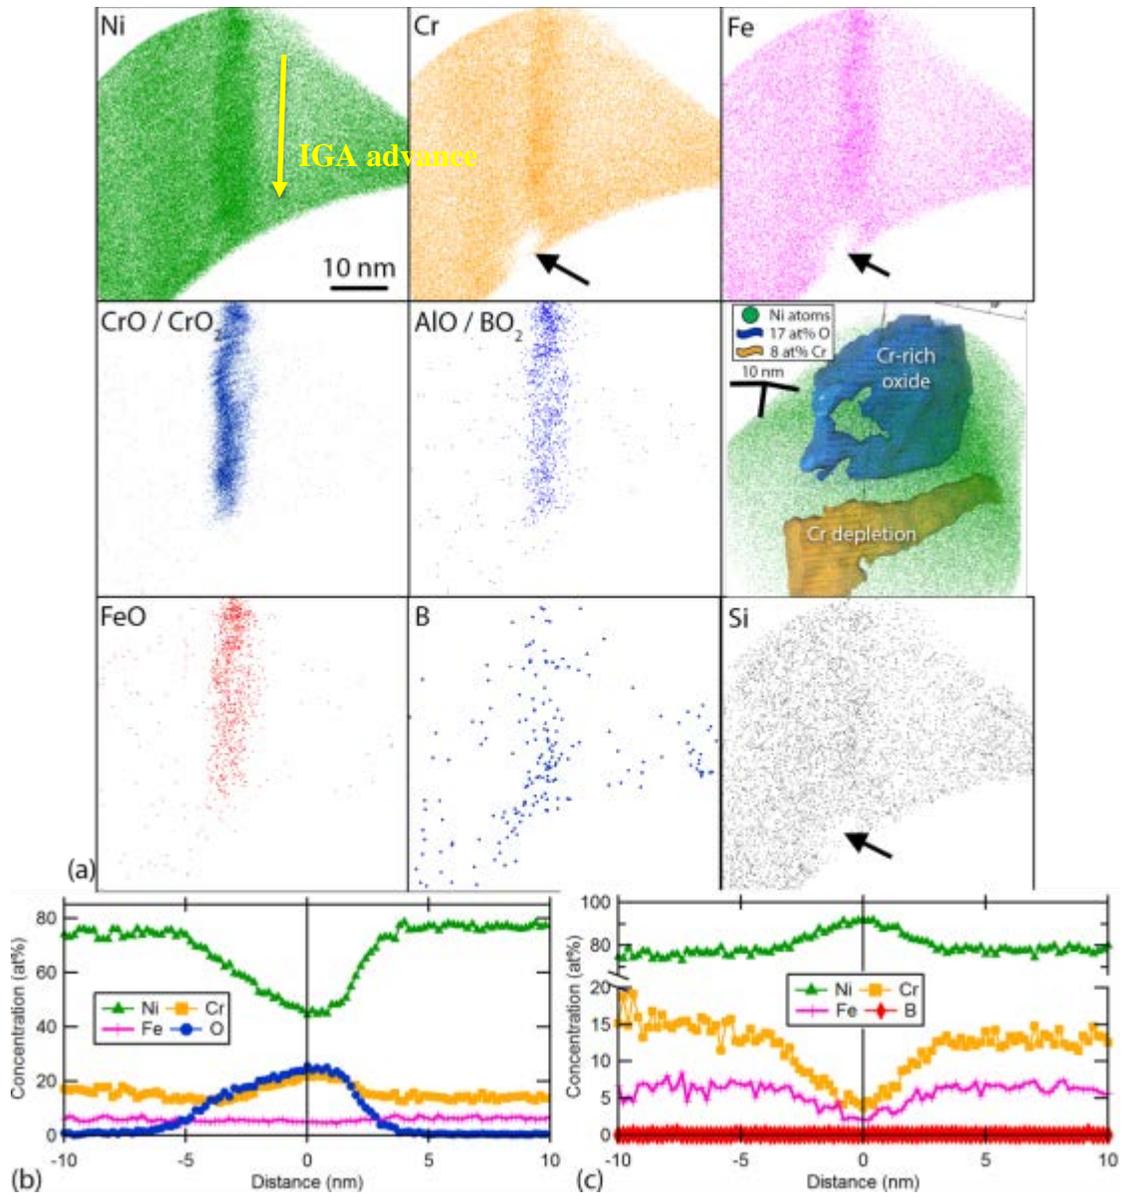
Figure 31. (a) Atom maps from the terminal IGA exhibited by alloy 600 heat M3935 after exposure to 330°C simulated PWR primary water for 100 h. Arrows indicate Cr, Fe and Si depletion ahead of the oxidation front. Isoconcentration surface at 17at% O (blue) and 8 at% Cr (orange) are used to depict the oxide morphology and zone of Cr depletion ahead of the IGA. Concentration profiles taken from (b) across and (c) ahead of the oxidation reveal a Cr-rich, Ni-depleted oxide followed by a Cr- and Fe-depleted and Ni-enriched metal. No measurable B was observed ahead of the oxidation front within the depleted zone.

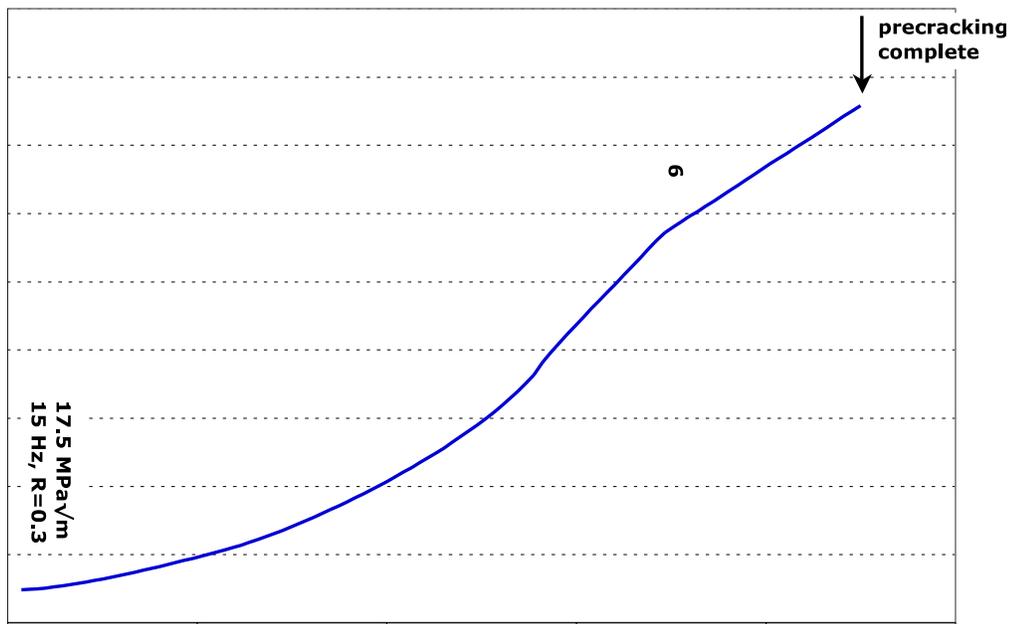
Figure 32. Air precracking response for the Davis Besse heat M7929 CT064 specimen.

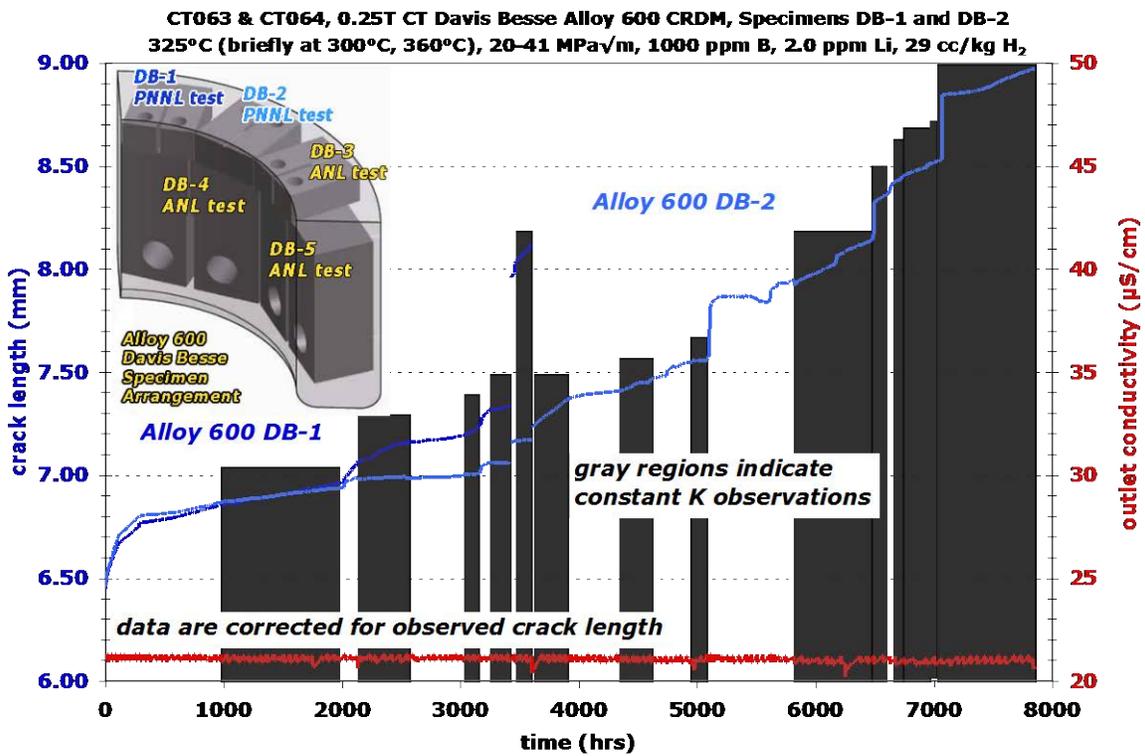
Figure 33. Corrected overview plot showing crack growth response for the Davis Besse alloy 600 specimens CT063 (DB-1) and CT064 (DB-2) in simulated PWR primary water.

The test on CT063 and CT064 was quite complex with many phases to first properly transition from a TG fatigue crack to an IG crack where SCC growth rates could be effectively measured. An overview of the entire SCC test for the two specimens is presented in Figure 33, and a detailed step-by-step test summary is given in Table 3. Information in both the overall plot and summary table has been corrected for observed crack length obtained after post-test examinations of the crack-growth surfaces. The test on the CT063 (DB-1) specimen was ended after ~3600 hours and comprised 14 separate test phases (steps in Table 3). At that point, the CT063 specimen was removed for characterization while testing continued on the CT064 (DB-2) specimen alone until ~7800 hours and 32 test phases. Descriptions of crack growth response are provided below for important parts of the test under constant K loading to illustrate the overall results for the two heat M7929 specimens from the Davis Besse replacement head.

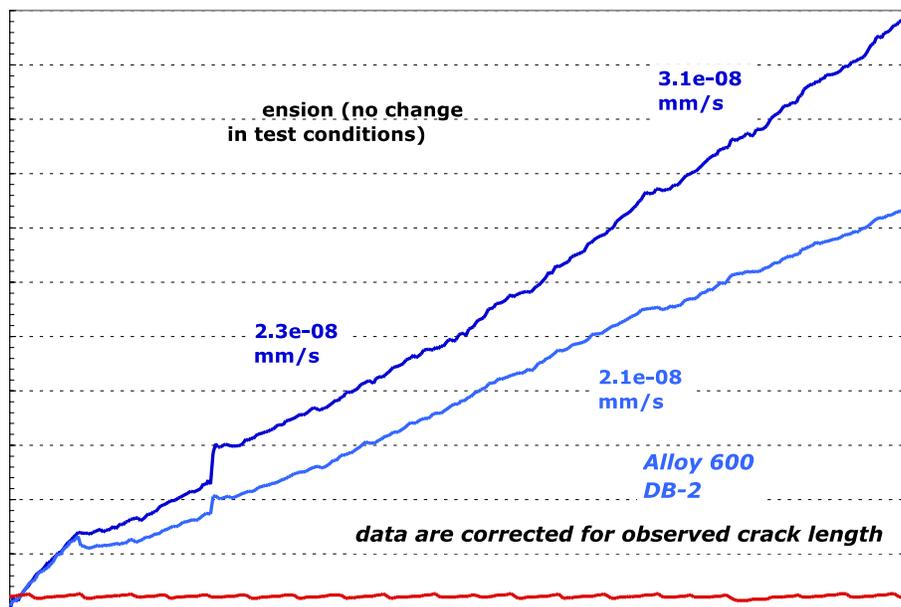
Figure 34. Crack-growth response at constant K in 325°C PWR primary water for the Davis Besse alloy 600 specimens CT063 (DB-1) and CT064 (DB-2).

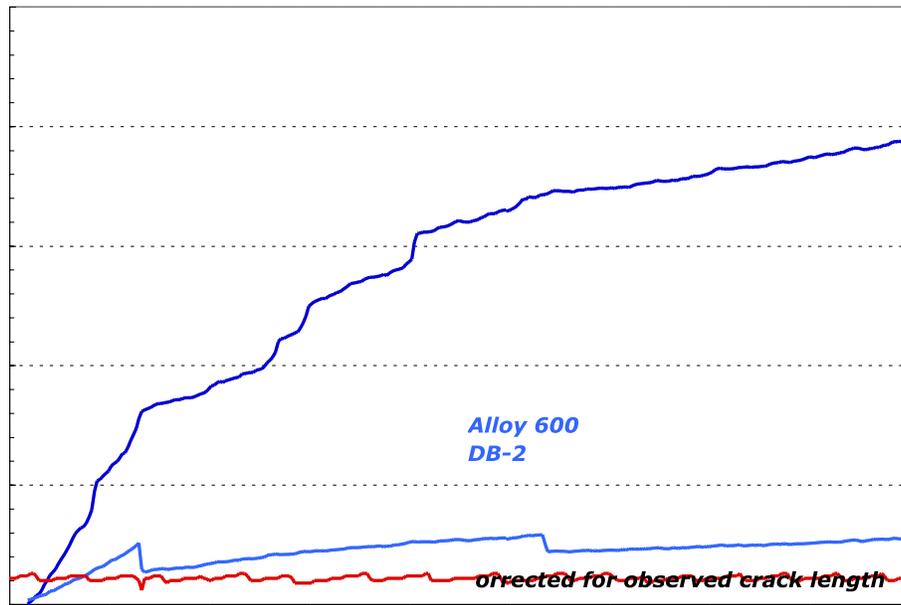
Figure 35. Measured SCC growth response as a function of test temperature in the Ni metal stability regime with ECP held at the same offset relative to the Ni/NiO stability line.

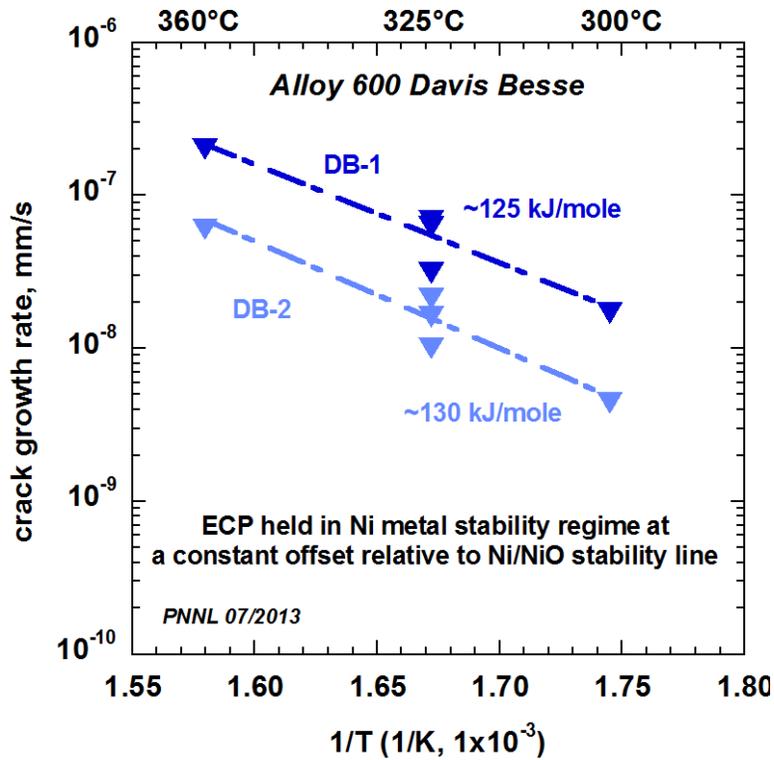
Figure 36. Temperature effect on SCC growth rate at 20 MPa \sqrt{m} for the Davis Besse alloy 600 CRDM specimens CT063 (DB-1) and CT064 (DB-2).

Upon returning to 325°C in step 8 (at ~2100 h), the CGR was ~2X higher at 6.8×10^{-8} mm/s for the DB-1 specimen than measured for the prior exposure at 325°C (step 6). The DB-2 specimen, however, returned to almost the same value. As documented in Table 3, two additional constant K evaluations were performed at 325°C and 29 cc/kg H₂ in steps 10 and 12 separated by a brief cycle + hold loading. The SCC growth rates remained at $5-7 \times 10^{-8}$ mm/s. Once again, jumps were seen in the crack length for the CT063 (DB-1) specimen during the constant K exposures. Exposure at 300°C produced stable, constant K crack growth in both specimens. Temperature effects on the measured SCC growth rates are summarized in Figure 36 showing a consistent increase in propagation rates with increasing temperature. An activation energy of ~125-130 kJ/mole is indicated.

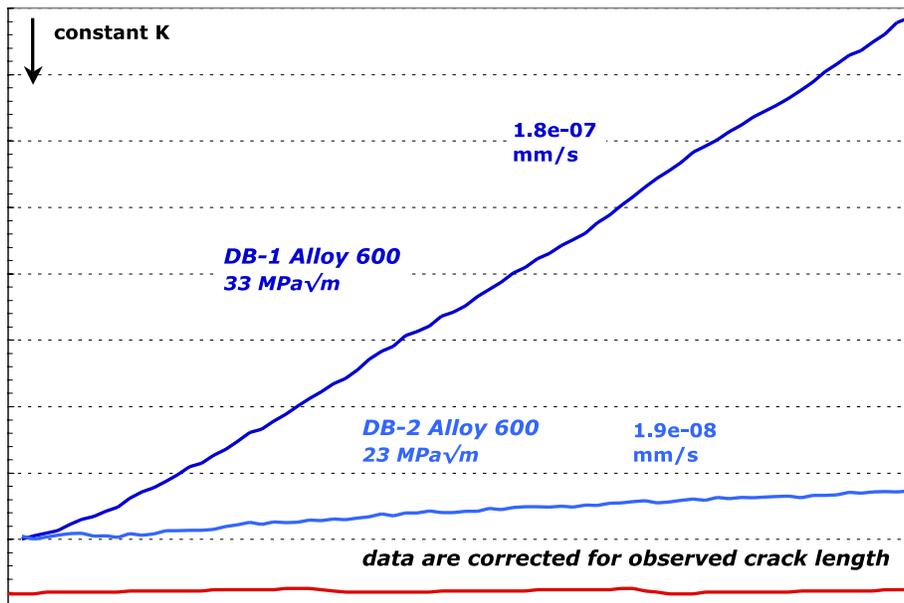
Figure 37. Constant K crack-growth response at a higher K level for the CT063 (DB-1) and the CT064 (DB-2) specimens in 325°C simulated PWR primary water.

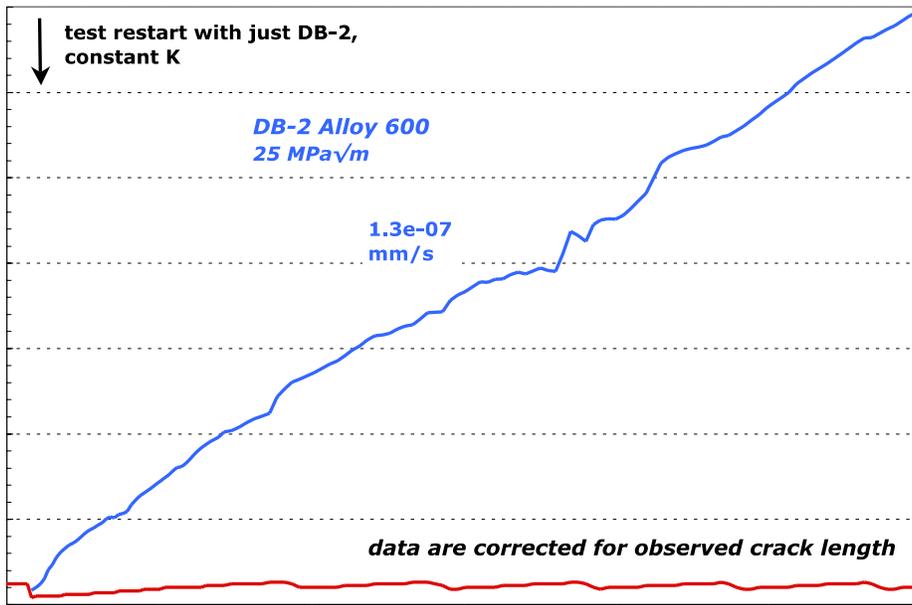
Figure 38. Constant K crack-growth response for Davis Besse specimen CT064 (DB-2) after test restart in 325°C simulated PWR primary water.

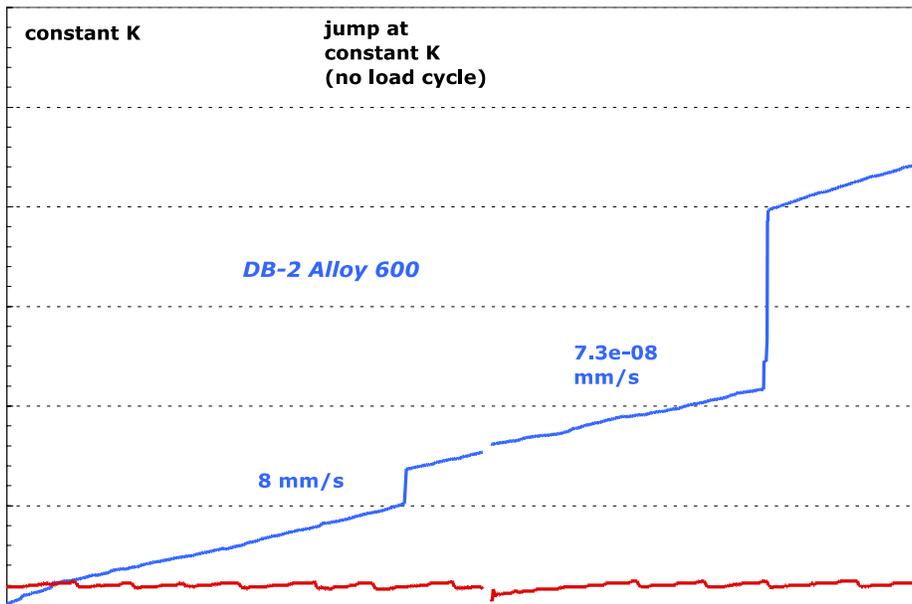
Figure 39. Constant K crack-growth response in steps 21-23 for Davis Besse specimen CT064 (DB-2) in 325°C simulated PWR primary water.

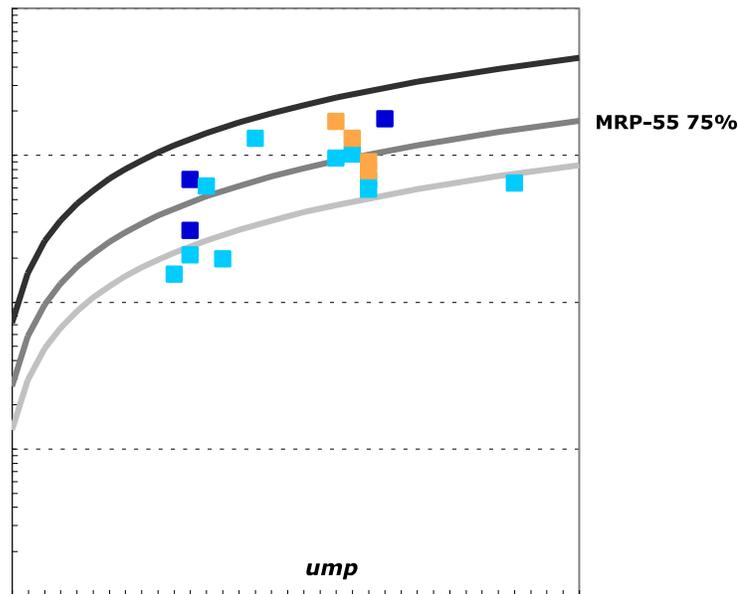
Figure 40. Corrected crack growth rate versus K plot for Davis Besse alloy 600 specimens CT063 (DB-1) and CT064 (DB-2) tested at PNNL.

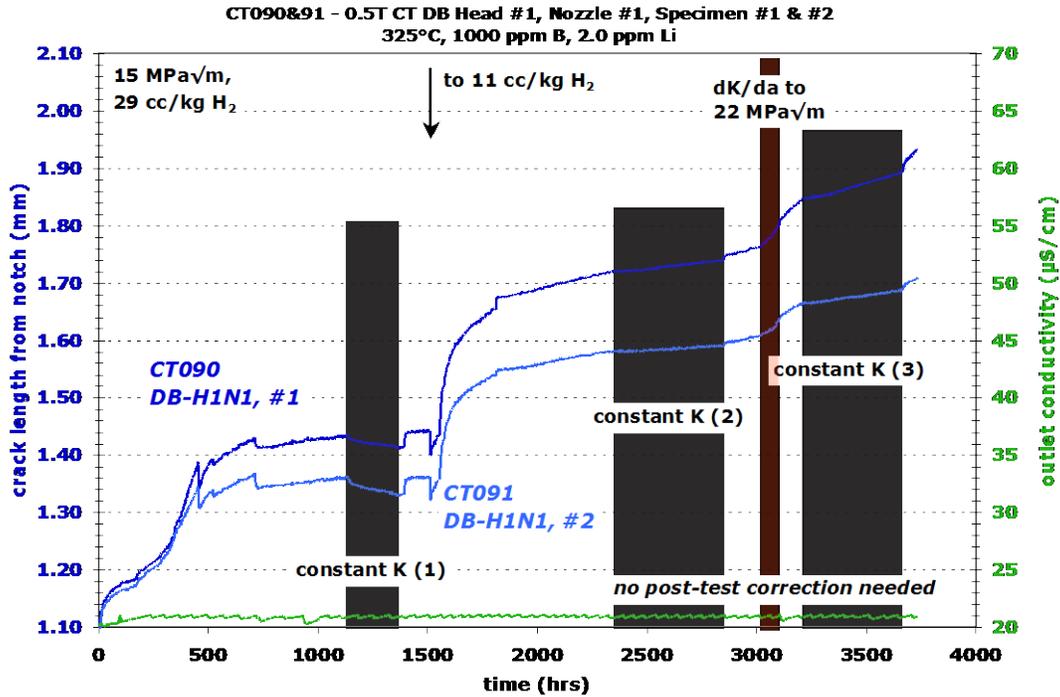
Figure 41. Overview plot showing crack growth response for the Davis Besse alloy 600 specimens CT090 (H1N1 #1) and CT091 (H1N1 #2) in simulated PWR primary water.

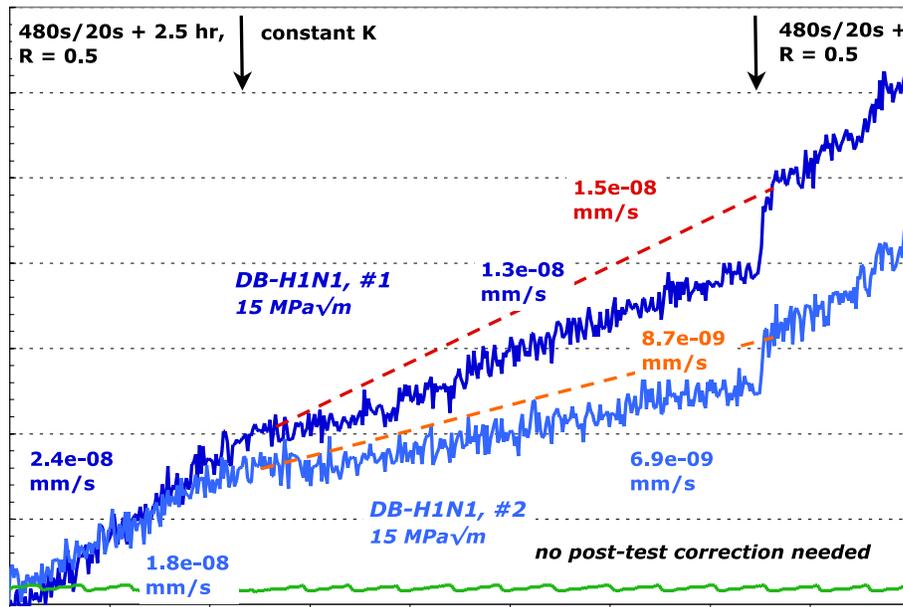
Figure 42. Constant K crack growth response of CT090 (H1N1 #1) and CT091 (H1N1 #2) in simulated PWR primary water.

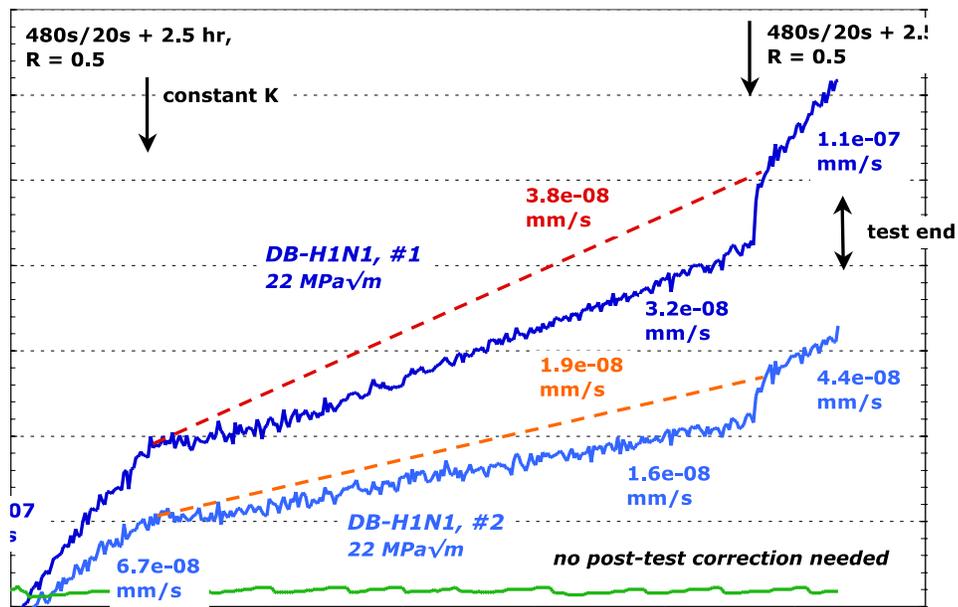
Figure 43. Final constant K crack growth response of CT090 (H1N1 #1) and CT091 (H1N1 #2) in simulated PWR primary water at the higher K level of 22 MPa√m.

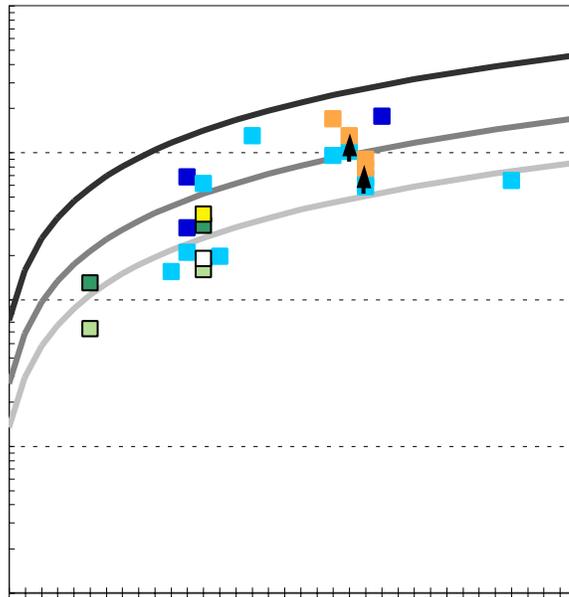
Figure 44. Constant K CGR versus stress intensity for the M3935 (DB-H1N1 #1, #2) and M7929 (DB-1, DB-2) Davis Besse CRDM materials removed from service.

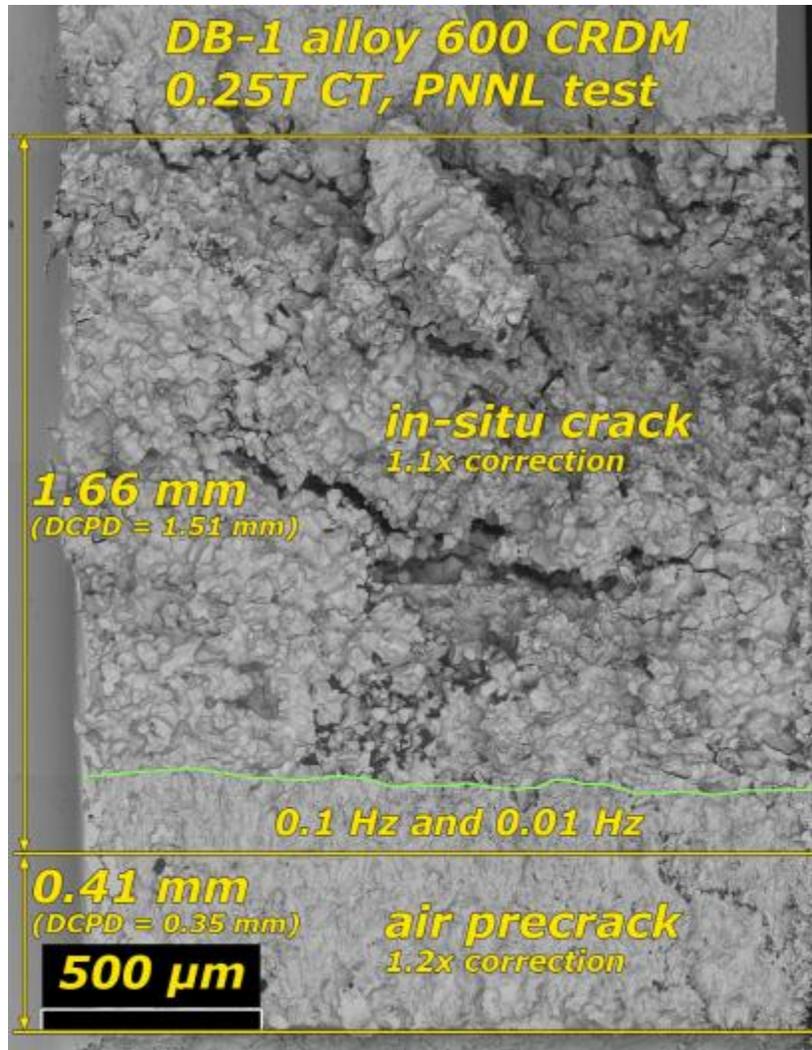
Figure 45. SEM-SE image of the crack growth surface of CT063 (DB-1) replacement head CRDM nozzle.

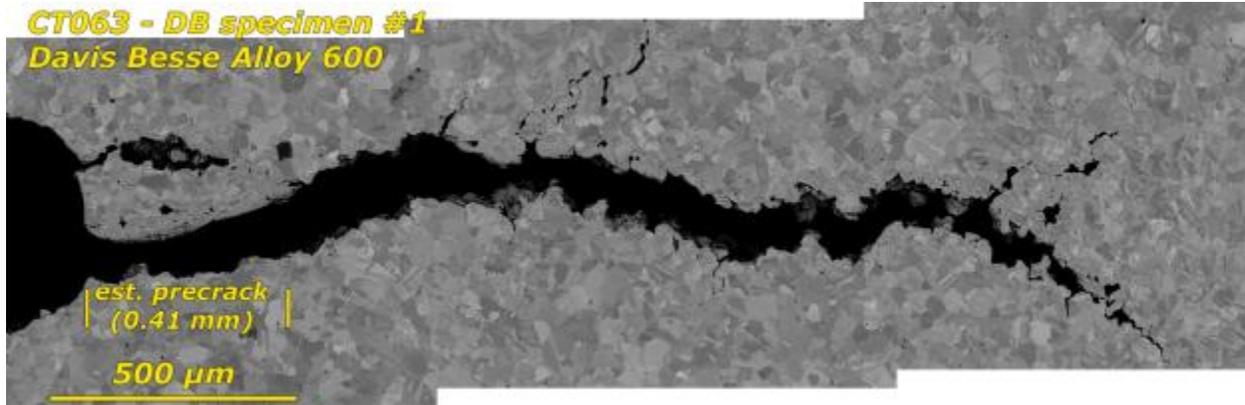
Figure 46. SEM-BSE image the crack cross section of the CT063 (DB-1) specimen.

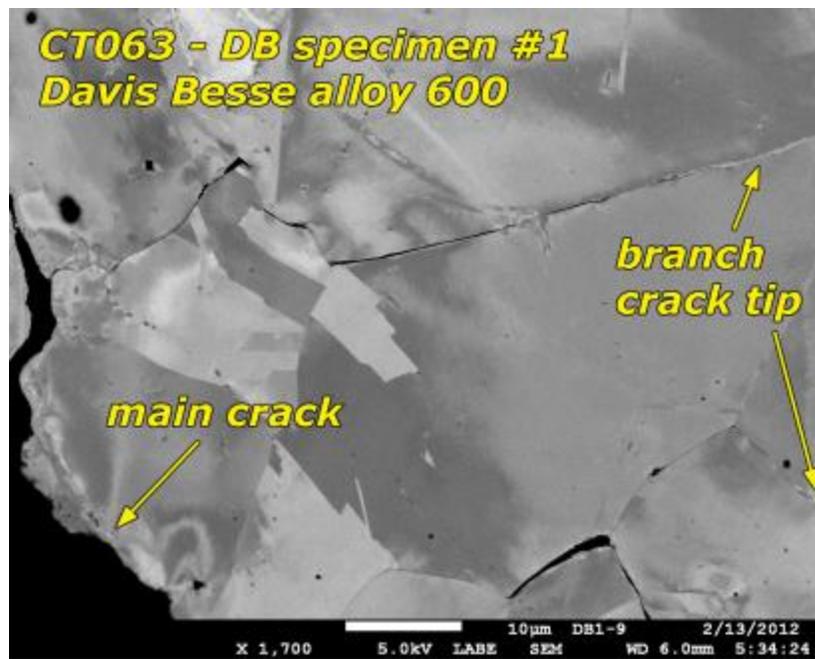
Figure 47. SEM-BSE crack cross section image of CT063 (DB-1) showing tight branch cracks.

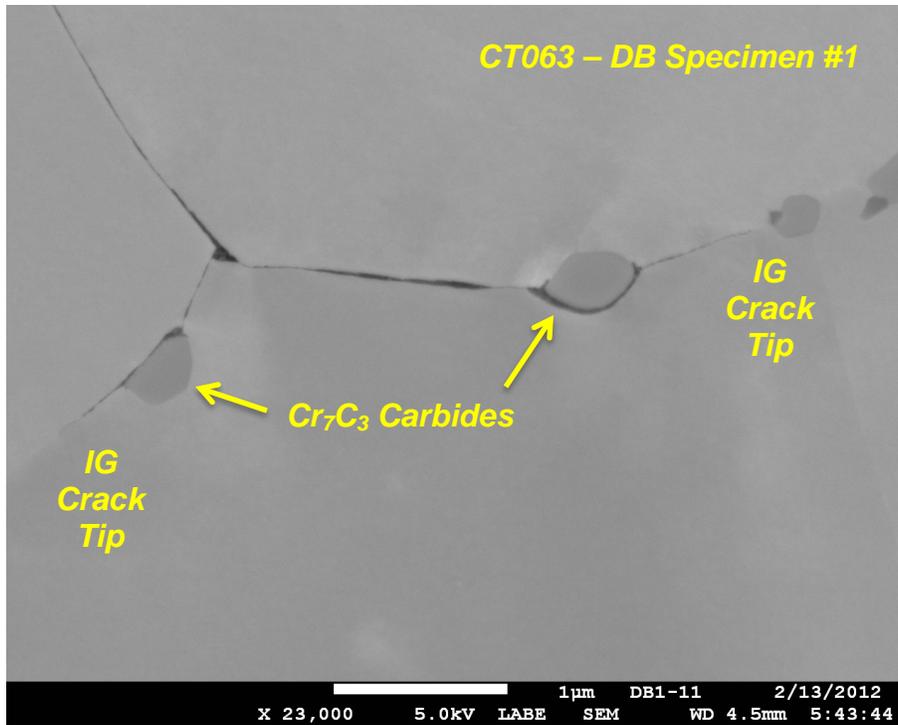
Figure 48. Higher magnification SEM-BSE crack cross section image of CT063 (DB-1) showing tight, branched cracks on grain boundaries with carbides.

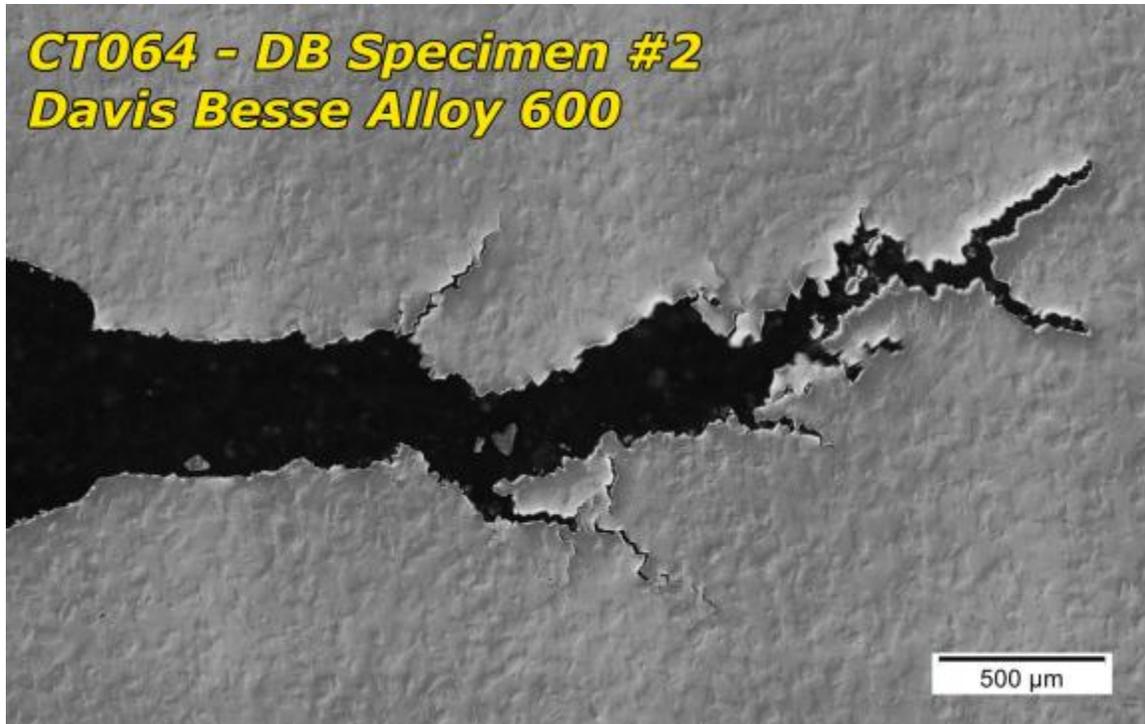
Figure 49. Optical image of the crack cross section of the CT064 (DB-2) specimen. Significant branching is apparent.
