**Characterizations and Stress Corrosion Cracking Evaluations of Alloy 600
CRDM Nozzle Heats from the Davis Besse Nuclear Power Plant**

S. M. Bruemmer, M. J. Olszta, D. K. Schreiber, N. R. Overman and M. B. Toloczko
Pacific Northwest National Laboratory

Project JCN – N6925

Primary Water Stress Corrosion Cracking
of High-Chromium, Nickel-Base Alloys

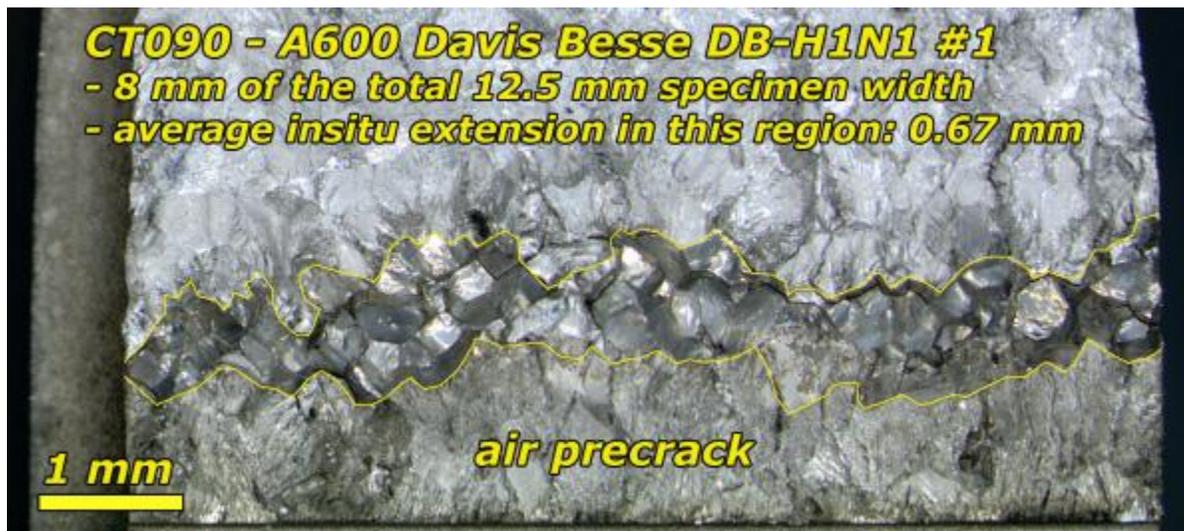
Figure 50. Optical image of the crack growth surface of CT090 - DB-H1N1 #1 (M3935). The yellow lines indicate the air precrack and final crack front locations. Note IG facets illustrating large grain sizes of ~0.5 mm in diameter.

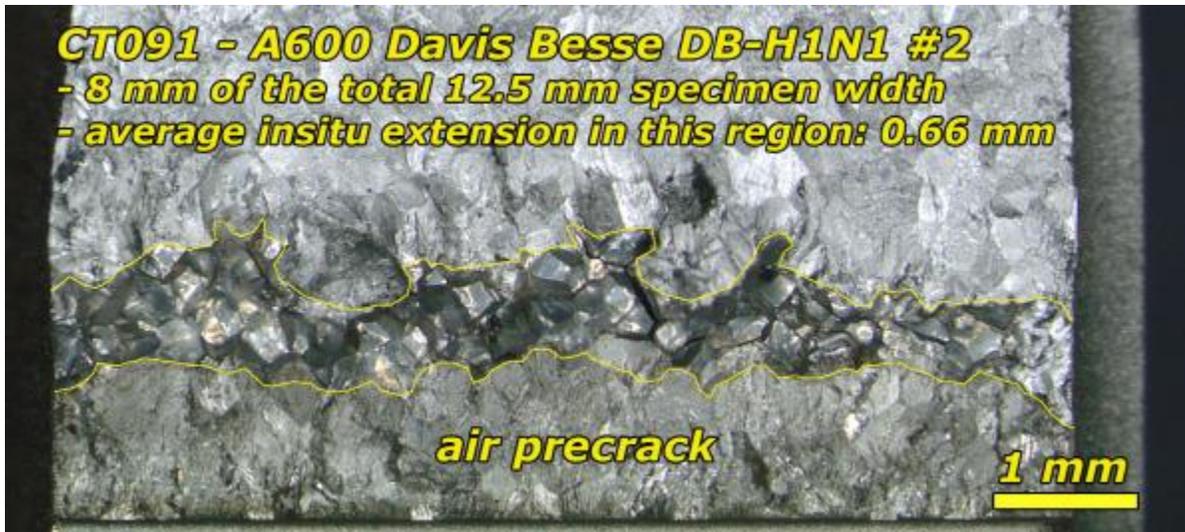
Figure 51. Optical image of the crack growth surface of CT091 - DB-H1N1 #2 (M3935). The yellow lines indicate the air precrack and final crack front locations.

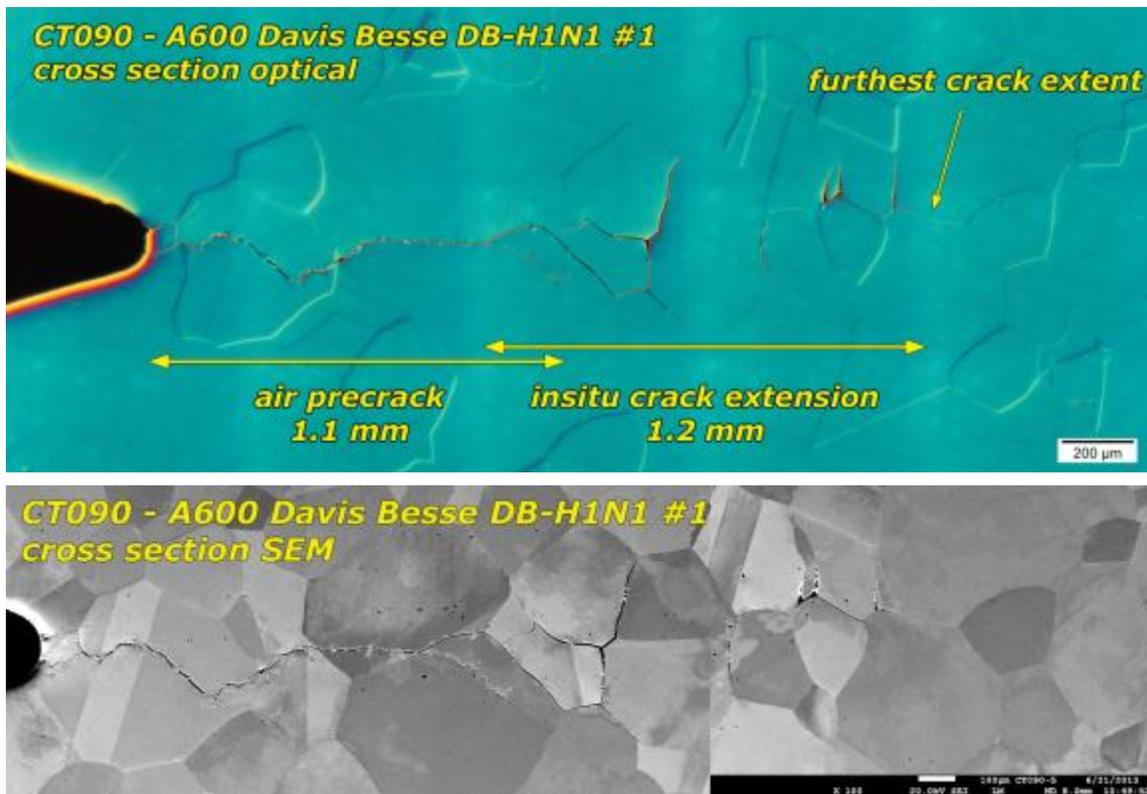
Figure 52. Optical (top) and SEM-SE (bottom) images of crack profile from side surface cross-section sample for CT090 (H1N1 #1) M3935 specimen.

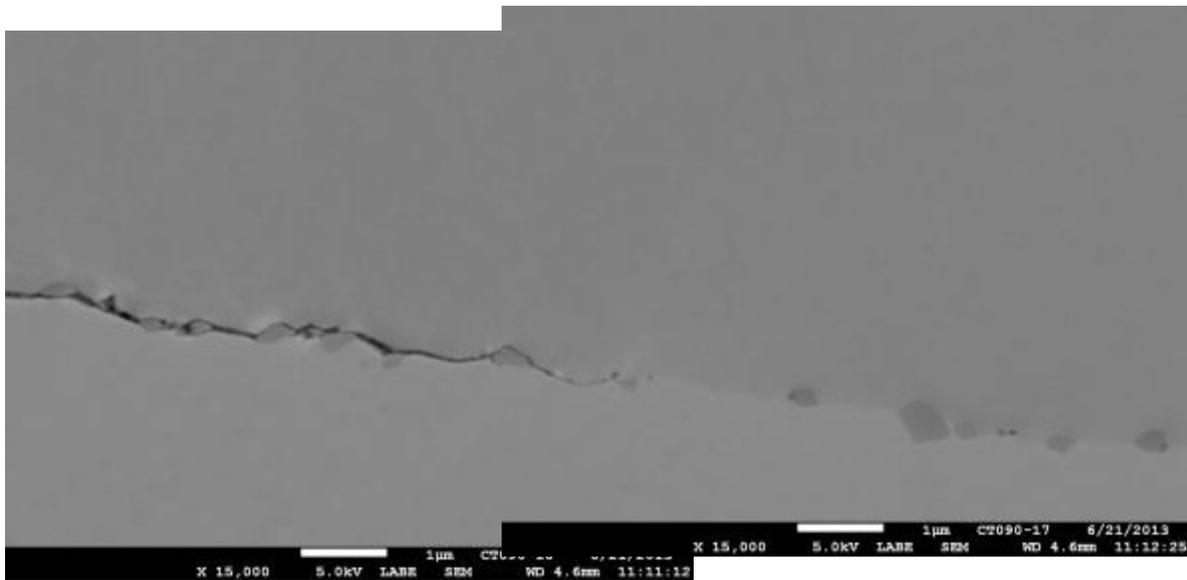
Figure 53. SEM-BSE images showing the IG crack tip in the CT090 specimen (M3935).

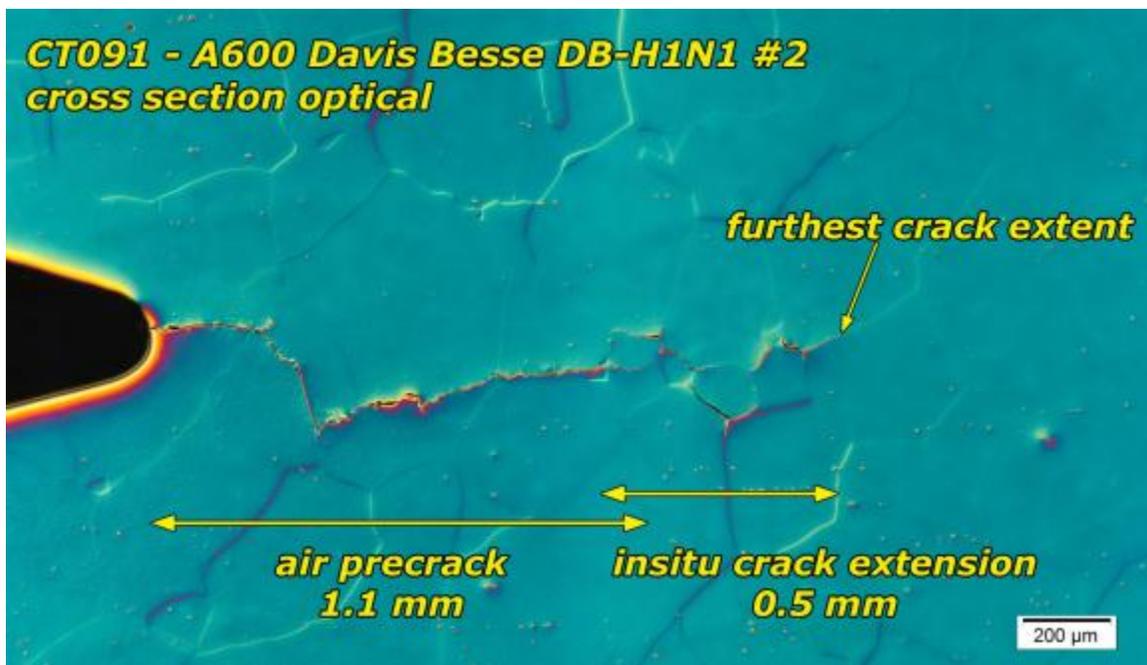
Figure 54. Optical image of crack profile of the CT091 (H1N1 #2) specimen (M3935).

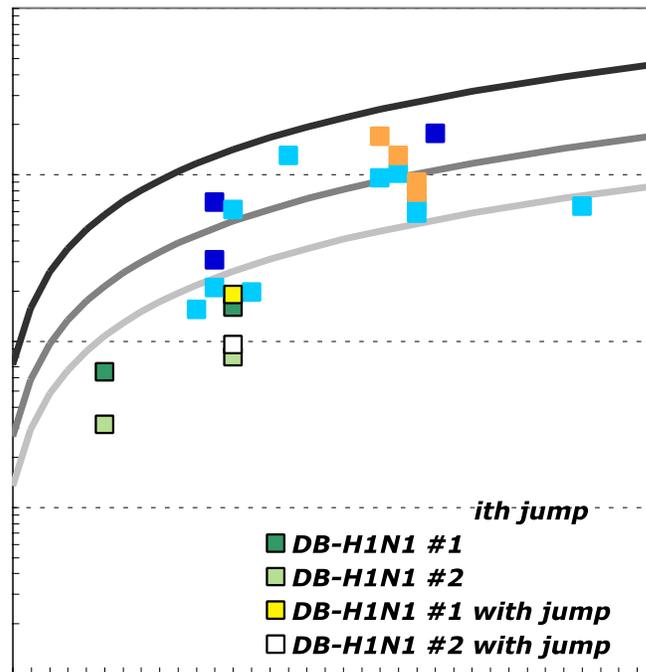
Figure 55. Measured SCC propagation rates versus K for the original Davis Besse head M3935 nozzle (DB-H1N1 #1 and DB-H1N1 #2) and the replacement Davis Besse head M7929 nozzle (DB-1 and DB-2) materials.
