Testing and Analyses of Davis-Besse Alloy 600 Control Rod Drive Mechanism Nozzles

Technical Letter Report

U.S. Nuclear Regulatory Commission
Office of Nuclear Regulatory Research

November, 2014

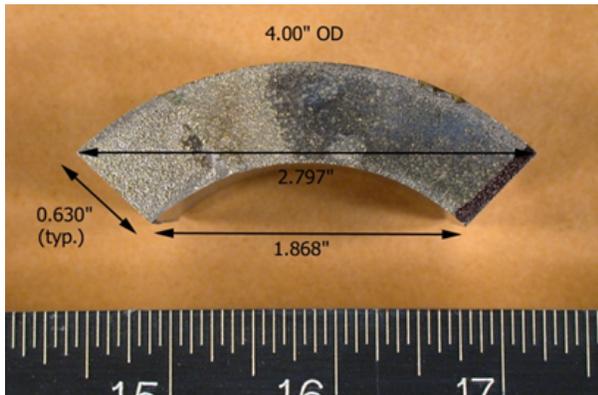
Figure 3. Top view of nozzle #4 section and dimensional measurements

Initial fluorescent dye penetrant testing (PT) and dimensional measurements were obtained to determine the useable dimensions of the 90 degree section of heat M7929. The dimensions of the nozzle section and photographs taken during PT are shown in Figures 3 to 6. The PT test did not reveal any surface breaking flaws and allowed the entire nozzle section to be used to produce test specimens. A specimen layout was developed to determine possible compact tension (CT) specimen placement and orientation. Based on the nozzle section dimensions, both ¼T-CT and ½T-CT specimens could be machined (Figure 7). The ¼T-CT and ½T-CT specimens machined from the 90 degree section of heat M7929 are shown in Figure 8. The

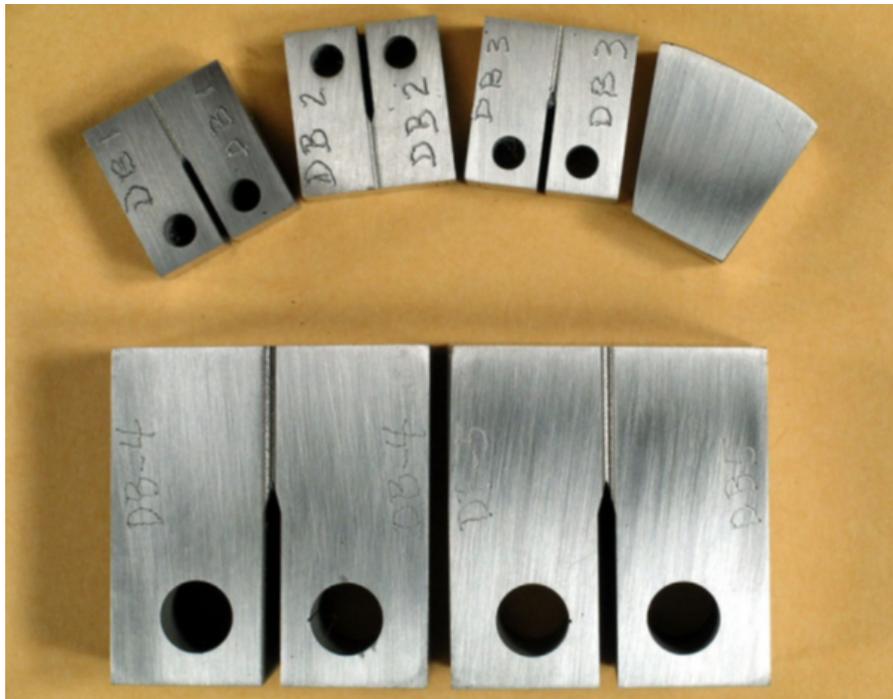
Figure 8. Alloy 600 heat M7925 compact tension test specimens and extra piece for metallurgical analyses (to the right of specimen DB-3) after machining and decontamination

Specimens DB-3, DB-4 and DB-5 (see Figures 7 and 8) of alloy 600 heat M7929 from RPVH #2 were tested at ANL. These specimens displayed a tendency to form ligaments or small sections of material behind the main crack front that were not fractured. The formation of ligaments behind the advancing crack front occurs under constant load conditions and cyclic loading tends to break the ligaments and straighten the crack front. Cyclic loading after prolonged time at constant load resulted in a higher than the expected cyclic CGR and was interpreted as the breaking of ligaments that formed under constant load conditions. The formation of ligaments affects DCPD measurement of crack length and artificially lowers the measured CGRs. To account for this effect, the crack length measured by DCPD was adjusted to include the rapid crack length increase observed under cyclic loading after long constant load CGR measurements. Taking the formation of ligaments into account, the M7929 specimens tested at ANL had crack growth rates that varied between the 25th to the 95th percentile of the alloy 600 crack growth rates.
