SEABROOK UPDATED FSAR

CONTAINMENT LINER ANCHOR LOAD TESTS

FINAL REPORT
CONTAINMENT LINER ANCHOR LOAD TESTS

Edwin G. Burdette

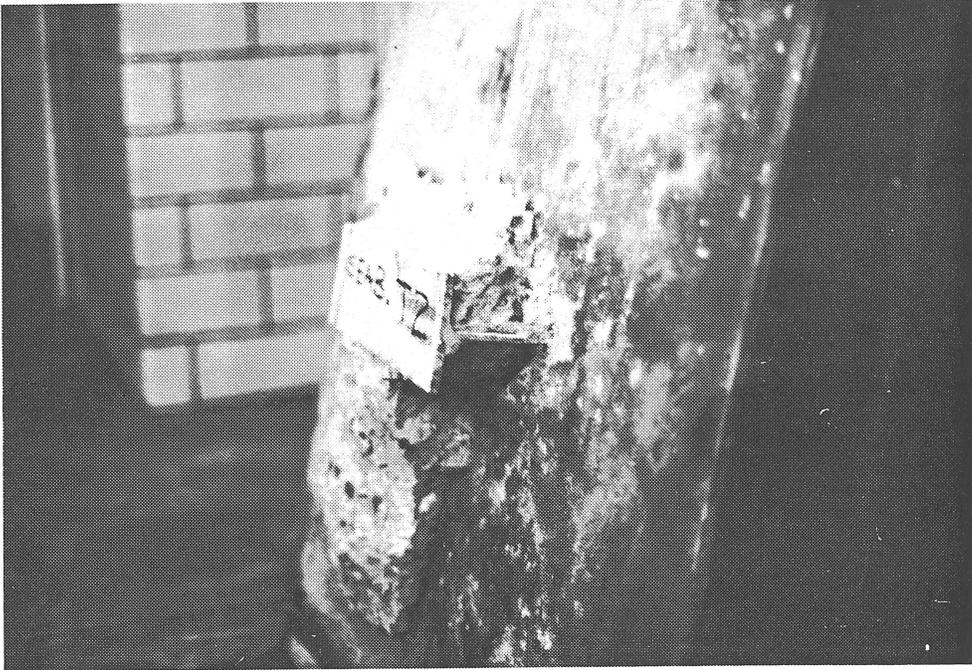
Plate B7: Specimen T-2. Liner and Tee at End of Test
