5.12 Long Term Maintenance Plan

6.0 TAMPA BAY WATERSHED – BROOKER CREEK PRESERVE SITE

The Brooker Creek Preserve mitigation site (BCP) is located in the Tampa Bay Watershed and will offset herbaceous and forested wetland impacts associated with the installation of new transmission lines by DEF for the LNP project (Figure 6-1). More specifically, the BCP site will offset primarily herbaceous wetland impacts through the restoration of historic flow patterns and the enhancement and restoration of existing low quality wetlands.

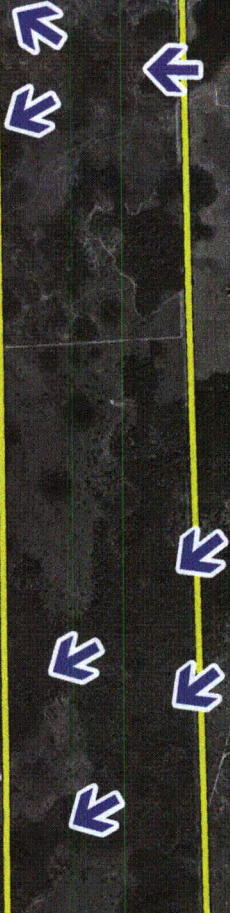
| Figure: | 6-3 |

The Preserve was historically populated by flatwood systems with both isolated and contiguous forested wetlands throughout. Numerous braided creek systems eventually joined to form the Brooker Creek system, which flowed west towards Lake Tarpon and ultimately into Upper Tampa Bay, which eventually feeds into the Gulf of Mexico (Figure 6-3).

1957 Historic Aerial Imagery
Brooker Creek Preserve Site
Pinellas County, Florida

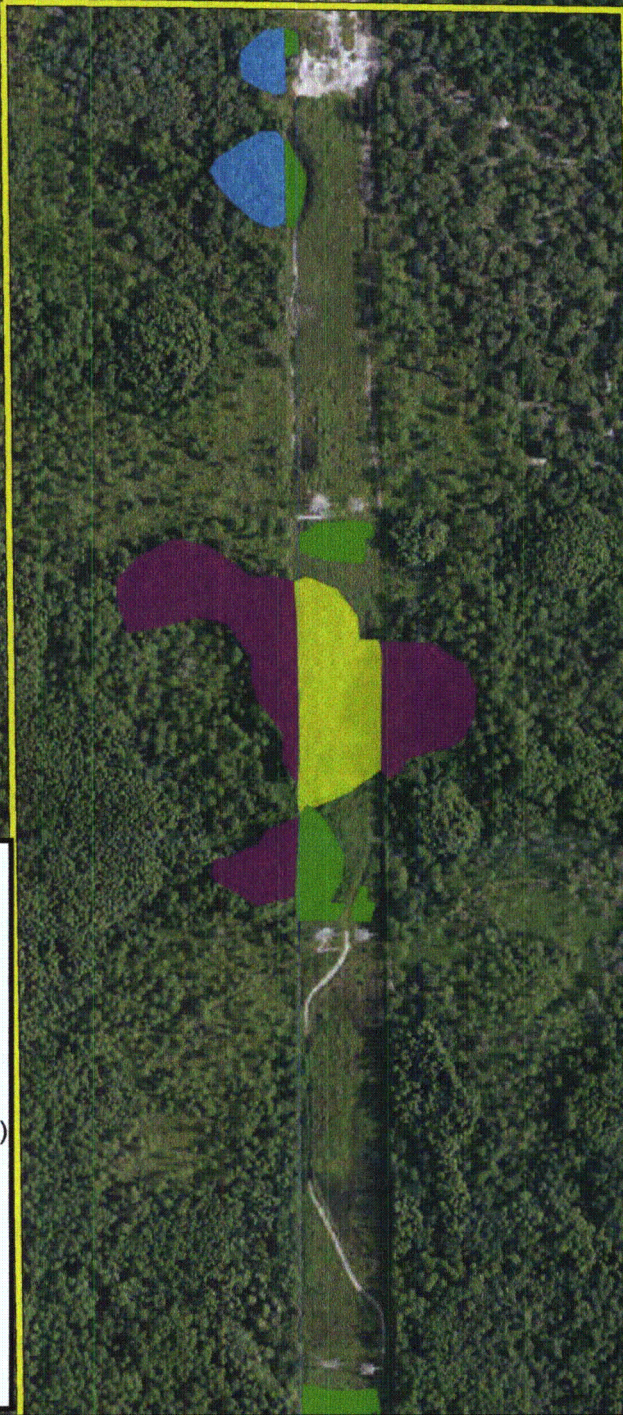
| Figure: | 6-6 |

- Parcel Boundary
- Planting and Treatment (33.0 ac.±)
- Treatment Only (10.5 ac.±)
- Ditch (1.9 ac.±)
- Brooker North LWC (4.0 ac.±)
- Wetland Adjacent to Brooker North LWC (7.6 ac.±)
- Brooker South LWC (4.5 ac.±)
- Wetland Adjacent to Brooker South LWC (99.6 ac.±)

NOTE: LWC = Low Water Crossing

1. Wetland Enhancement (treatment and planting). The proposed wetland enhancement is located in several wetland areas throughout the TLC. The enhancement will consist of a combination of treating existing populations of invasive/exotic species, and then planting emergent aquatic vegetation where necessary. Treatment of invasive/exotic species will include mainly the use of herbicides, but some mechanical removal may be necessary. Some areas will be excavated to remove the seed source and encourage additional hydrologic flow. Due to the varying sizes and conditions of the proposed enhancement areas, each wetland will be assessed individually to determine the best combination of treatment, excavation and planting. See Figures 6-6, 6-6a through 6-6d for details of the specific action for each wetland.

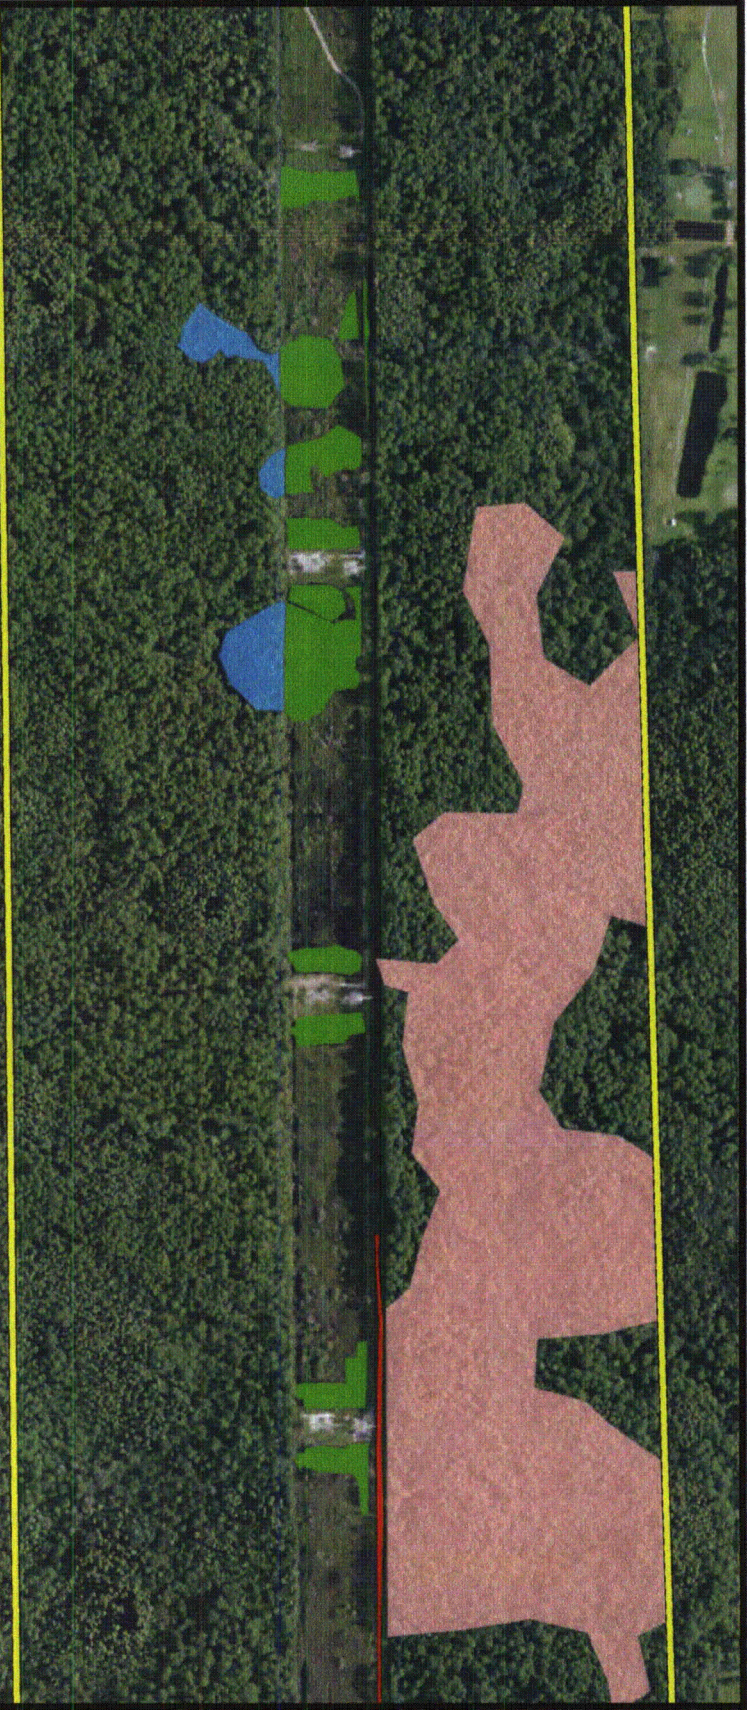
| Figure: | 6-6b |

Proposed Mitigation Activities
Brooker Creek Preserve Site
 Pinellas County, Florida
