## RADIOLOGICAL CHARACTERIZATION REPORT FOR THE HIGH LEVEL WASTE CANISTER INTERIM STORAGE AREA

### TASK ORDER 9 WEST VALLEY DEMONSTRATION PROJECT ENVIRONMENTAL CHARACTERIZATION SERVICES WEST VALLEY, NEW YORK

SEC-RCR Rev. 1

**April 2014**

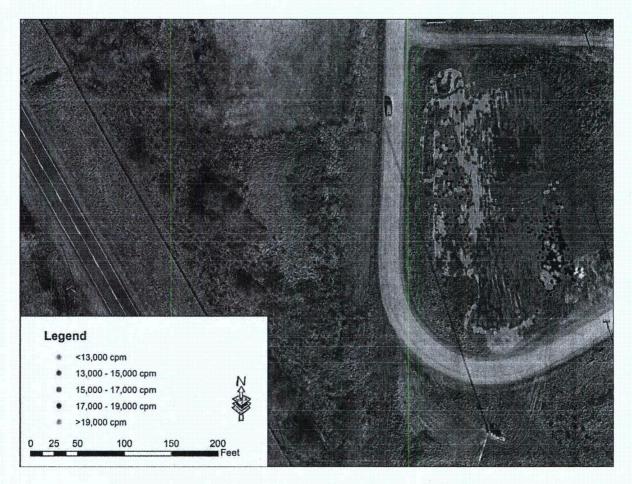
Figure 2-5. GWS for Fourth Lift as Spoils Pile Was Constructed

Figure 2-5 shows the GWS for the fourth lift of the spoils pile. The surveyor detected elevated radiation signal when performing the GWS after the lift was constructed. The construction contractor was notified and this resulted in a careful survey of additional soil as it was excavated so that it could be segregated and removed before placement on the spoils pile. The contaminated

material that had been placed on the spoils pile was remediated as was practicable using only the gamma radiation surveys to guide the removal. No soil sampling was performed to verify that the contaminated material was removed because laboratory results could not be obtained immediately and further excavation and deposition on the spoils pile could not cease due to work scheduling needs.

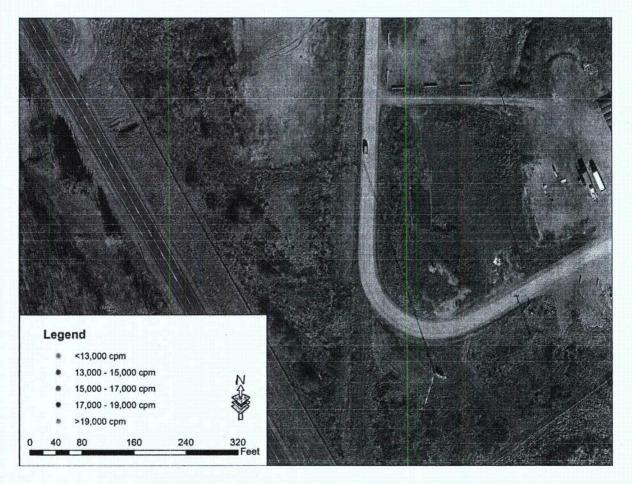
Figure 2-7. GWS for Sixth (and Final) Lift as Spoils Pile Was Constructed

Figure 2-7 shows the GWS for the sixth and final lift. This survey was completed for the spoils pile in its final configuration. No radiation above background was detected from this final lift. Note that this survey was for the top of the spoils pile and did not include the side slopes. The side slopes were already surveyed for the other lifts as they were completed.

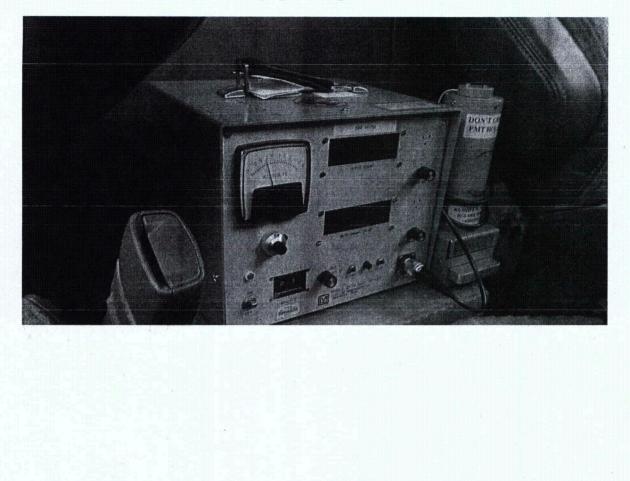
### Photograph 4. Swipe Counter

Sample tools and drilling equipment was wiped clean with masslin and 409 cleaning solution as necessary to remove visible dirt. Tools were scanned for alpha and beta-gamma radiation and a swipe for radioactive contamination was collected. The swipe was counted in a low background counter in the sampling van. No gross alpha radiation exceeding the instrument lower critical level (Lc) of 1 cpm was ever detected on the sampling equipment. No gross beta-gamma contamination exceeding the Lc of 19 cpm was ever detected on the sampling equipment. The swipe counter is shown in Photograph 4 in Appendix A.
