## 5.0 MELTER EXAMINATION

### 5.1 CONTAINMENT BOX AND LID

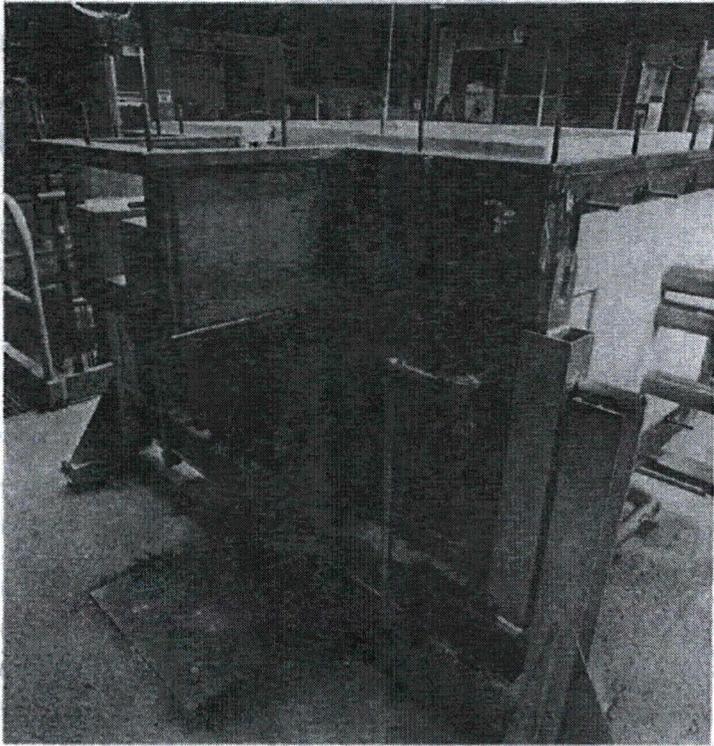
**FIGURE 22.** Distortion of Lower Southeast Containment Box Cooling Jacket

**DISTORTED  
COOLING  
JACKET**

Following the melter draining, the external insulation was removed from the stainless steel containment box. The melter box was found to be in generally good condition, with a few discolored areas from exposure to elevated temperatures. The areas of discoloration were found primarily in the overflow drain section where the internal insulation was at a minimum. The only physical distortion of the containment box was bowing of the lower south-east cooling jacket. This deflection, shown in Figure 22, was probably the result of the elimination of the water coolant flow in the lower cooling jackets. This change was intended to increase the operating temperature of the refractory near the melter floor to minimize the deposition of precipitates from the glass. Following the coolant shut off, sufficient steam pressure to cause the bowing could have occurred as residual water in the jacket began to boil. Also, if the melter drain system pressurized, water could have been injected into the cooling jacket producing the same results. Minor changes in the cooling system design to reduce the coolant flow restrictions can eliminate this problem.

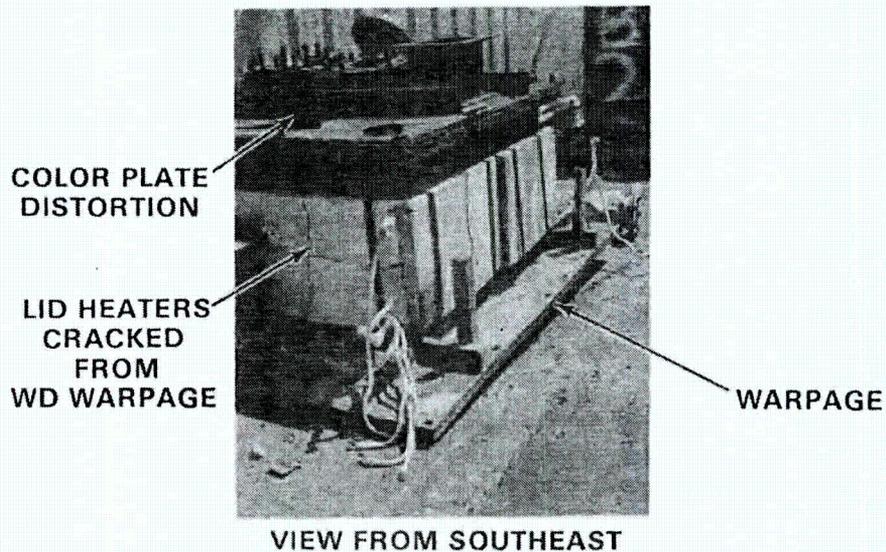
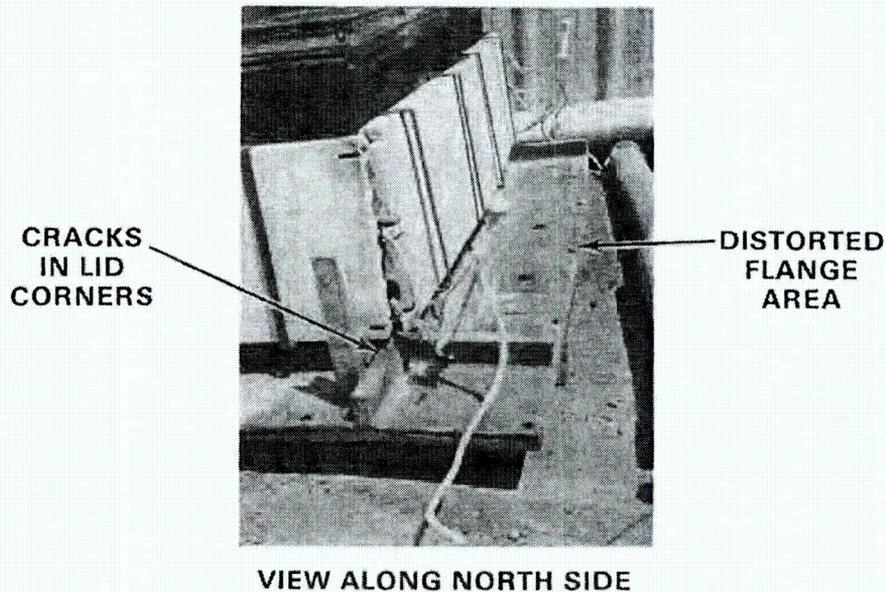
FIGURE 23. Melter Lid Assembly Following Removal

The lid assembly was more seriously affected by the melter operating cycles. Figure 23 shows the melter lid following removal. The photograph illustrates the bowing of the assembly's vertical surfaces, tears in the flanges where the lid is joined to the melter box, and the warpage of the cover plate.

Because lid heaters were installed on the exterior surface of the lid, it also served as a radiative heat source during the melter startup and on other occasions when the external lid heaters were employed. The thermal cycling caused by normal operations, combined with periods of lid heater use resulted in the lid warpage. In some locations, the lid warpage was sufficient to crack the lid heaters, as shown in Figure 23.

The tears in the lid, which developed in each of the corners, are also the result of temperature cycling. Free thermal expansion of the lid was restrained by the water-cooled melter box. This restricted thermal expansion, combined with the different thermal expansion coefficient for the stainless steel and Inconel 601 components, caused the lid weld failures.

The operating temperature cycles and stress concentrations from the numerous penetrations, welds, and dissimilar construction metals account for the severe warpage of the cover plate. The cover plate deformation explains air inleakage experienced early in the operating life of the melter. The distortion of the cover plate, combined with the high-temperature degradation of the asbestos gasketing material initially used to seal the cover plate to the lid assembly, forced the removal of the asbestos rope and the welding of the cover plate to the lid assembly to seal the melter.

The difference in the condition of the lid and melter box was expected as the containment box was protected by substantial internal insulation, whereas the lid assembly was insulated only externally. The lid, therefore, experienced the full effects of the thermal cycling induced during the operation of the melter.

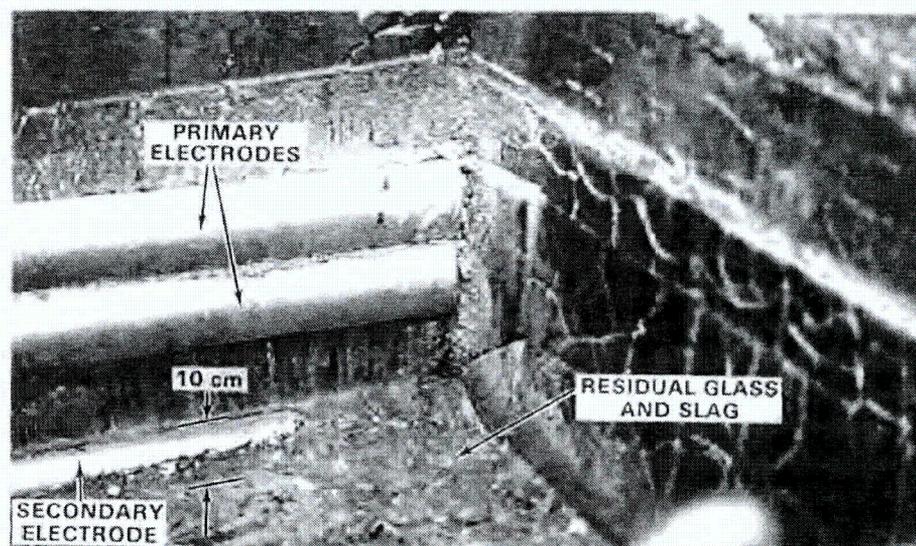
FIGURE 24. Slag and Residual Glass Remaining on Melter Floor Following Shutdown

The melting cavity contained significant quantities of residual glass and precipitated crystals (slag) after the melter was drained, as pictured in Figure 24. The slag in this photograph covers approximately the bottom 7.5 cm

of the 10.2-cm secondary electrode. Figure 25 is a contour plot of the melter floor showing the depth of slag deposits in centimeters. The empty area in the figure is an area on the melter floor where the slag deposits were disturbed in an early effort to determine the condition of the riser inlet nozzle. Thus, accurate measurement of the slag deposit depth in this region could not be determined.

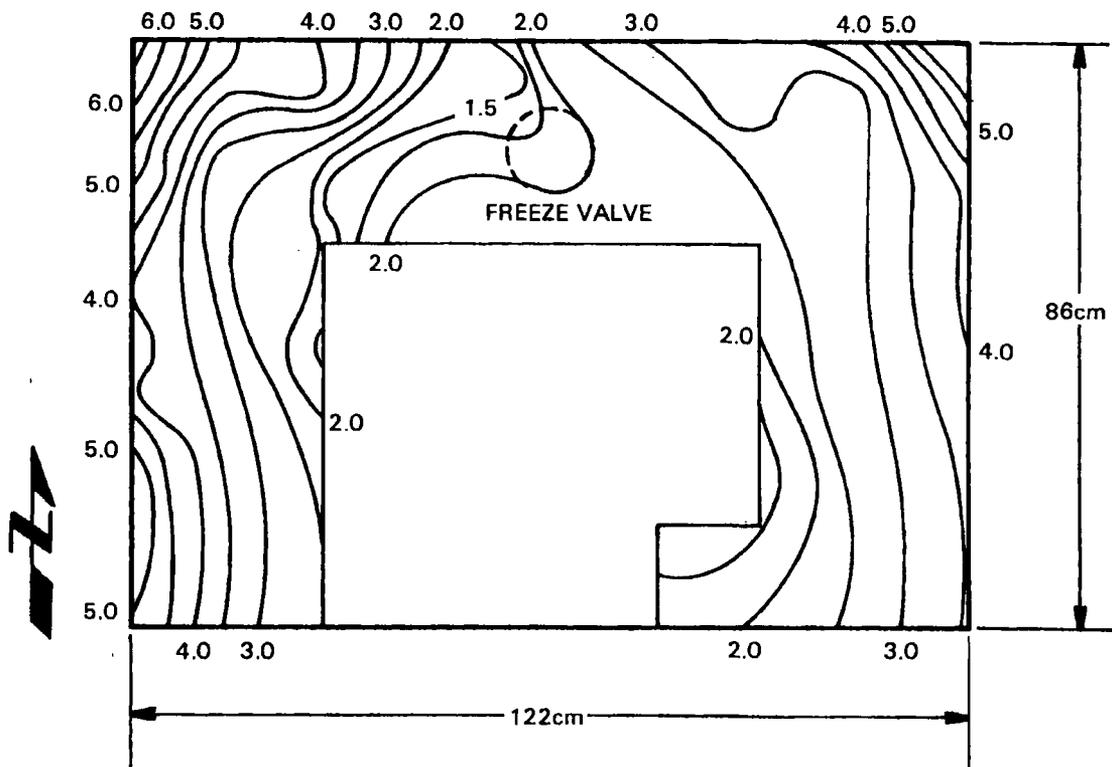
FIGURE 25. Depth at Slag Deposits in LFCM (cm)

From Figure 25 it is apparent that there is a slag depth gradient from the electrode walls down to the center. Also, the deposits in the corners of the north wall are deeper than the corresponding corners of the south wall. This pattern is the result of the corners and edges being the coldest locations along the melter floor (thereby tending to precipitate crystalline phases), and of the two convection cells that are present in the melter. These major convection cells were predicted by melter modeling (Quigley and Kreid 1979). The convection cells rise along the melter's east-west

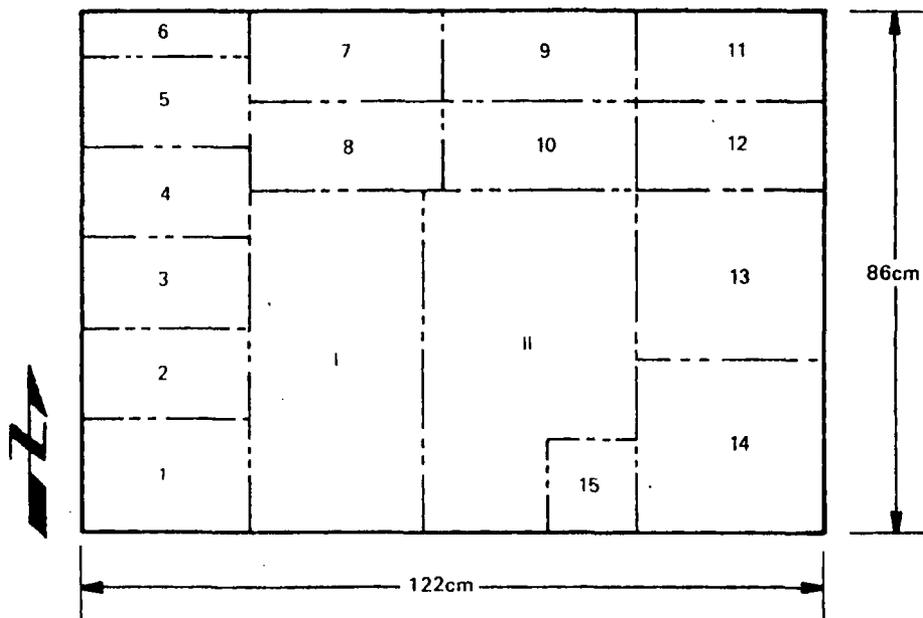
FIGURE 26. Slag Excavation Grid Pattern on LFCM Floor

One of the objectives of this investigation was to determine if the concentration of any of the feed chemicals in the slag was greater at one location than at another. This was accomplished by systematically excavating the slag deposit by grids. The grid pattern is shown in Figure 26. Samples were

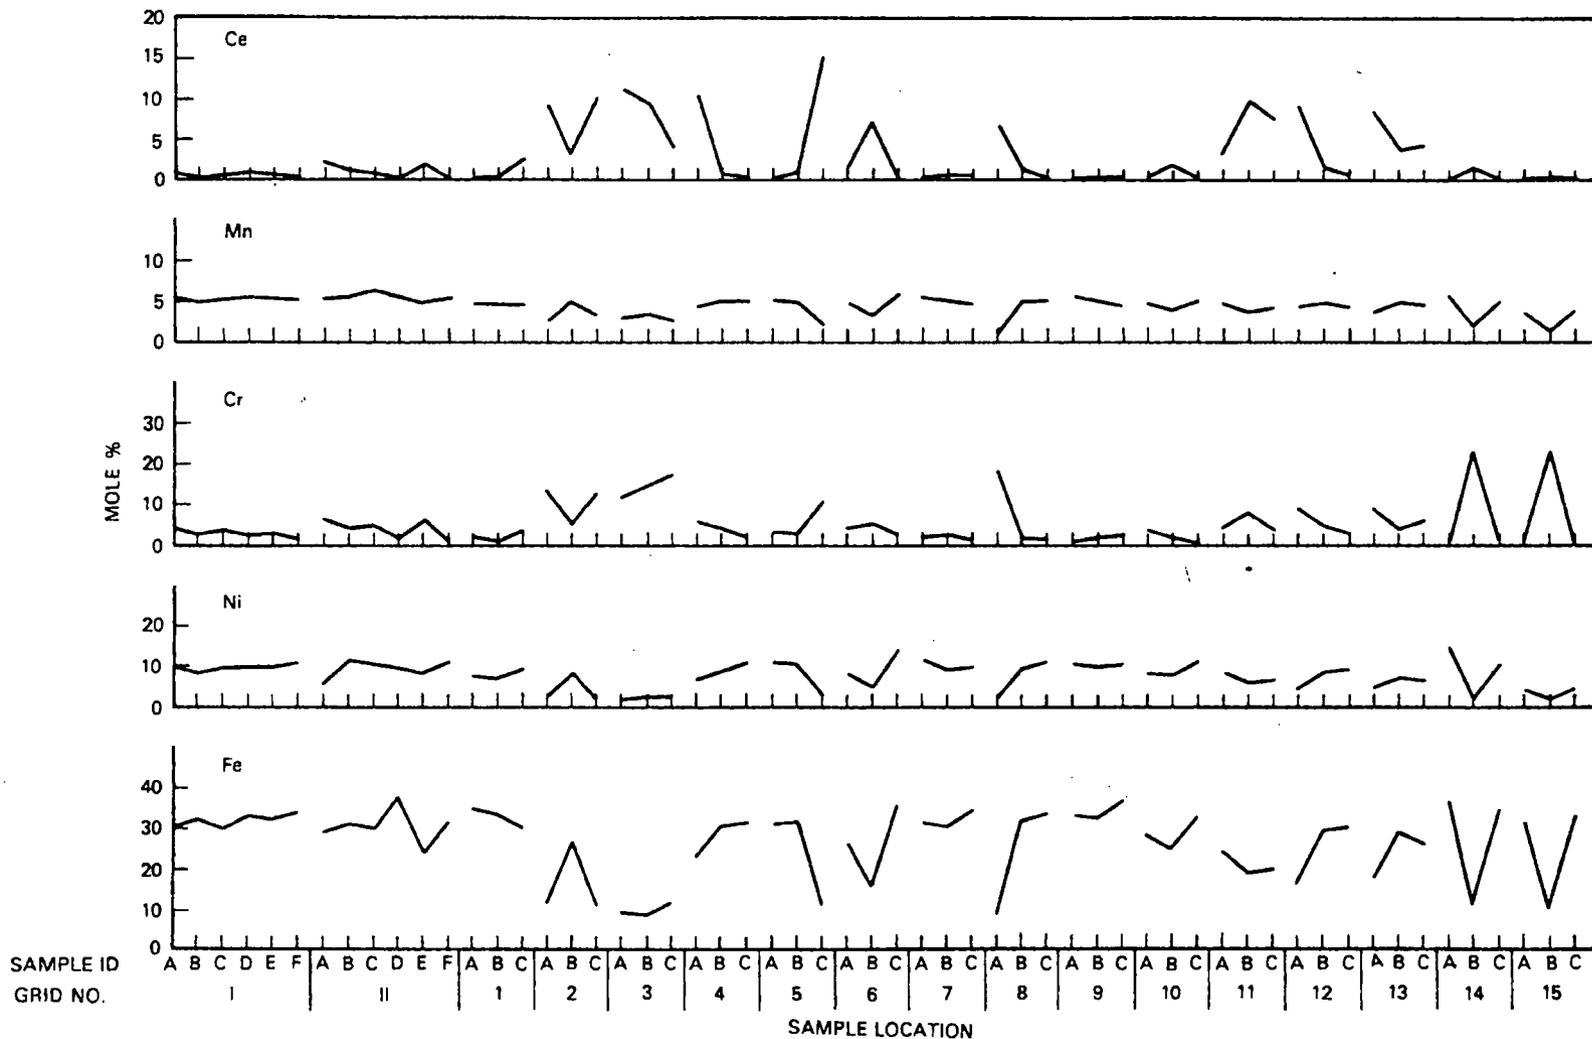
FIGURE 27. Metal Concentrations for Samples Removed from the LFCM Slag, by Grid Number

removed from the various grids and examined by x-ray fluorescence to determine the composition. The results of the analysis are presented in Figures 27 and 28. The results are inconclusive because the elemental concentrations were not found to be constant among the samples removed from a particular grid. However, two findings are apparent from this data. First, the samples containing relatively large concentrations of cerium oxide were removed from areas of the melter floor containing the deepest deposits. This was expected because cerium was a feed component only in the early melter tests and therefore should be found in the older, deeper slag deposits.

Second, a relationship between the concentrations of two groups of elements in the slag was observed. The concentration of Ce, Cr, and Zn vary inversely with the concentration of Fe, Mn, and Ni for all of the locations on the melter floor. This relationship is a result of the time that the slag was formed. The data indicate that the slags formed during the early processing tests were cerium oxide, Zn-Cr spinel, and chromium oxide. These chemicals were common components of the early feeds. Also, the release of  $\text{Cr}_2\text{O}_3$  from the Monofrax K-3 corrosion would be expected to be maximum during the early tests before the spinel layers on the refractory were fully developed. The more recent process test feeds, however, contained substantial quantities of iron, manganese, and nickel, and would tend to form (Mn, Ni)  $\text{Fe}_2\text{O}_4$  spinels. Therefore, the variation in the slag composition is a result of the operating period during which they were formed.

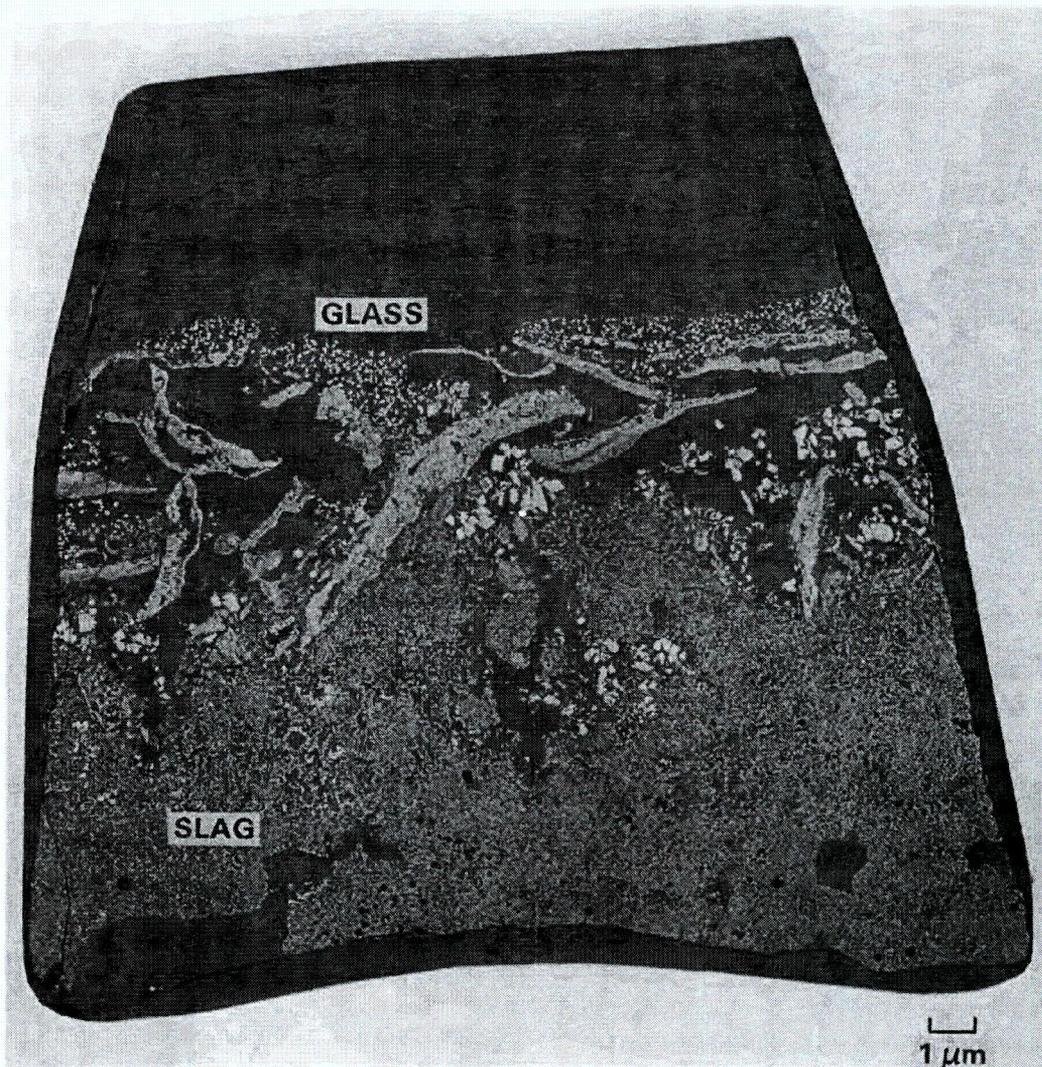
FIGURE 29. Enlargement of Slag Sample Removed from Grid Sector II

The appearance of the slag is pictured in Figure 29. The samples pictured here were removed from the upper layers of the slag. The composition of the material was shown to be primarily a spinel,  $[(\text{Fe},\text{Mn},\text{Ni})(\text{Fe},\text{Cr})_2\text{O}_4]$ , with sporadic appearances of other crystalline phases. In general, the slag was found to be a complex mixture of glass compositions, Mn-Ni-Fe-Cr spinels, Cr-Fe-Zr crystals,  $\text{CeO}_2$  deposits,  $\text{Al}_2\text{O}_3$  nodules, Ru phases, and trace quantities of all of the other feed components. Additionally, a metallic nickel alloy with small quantities of chromium and iron was found in the slag.

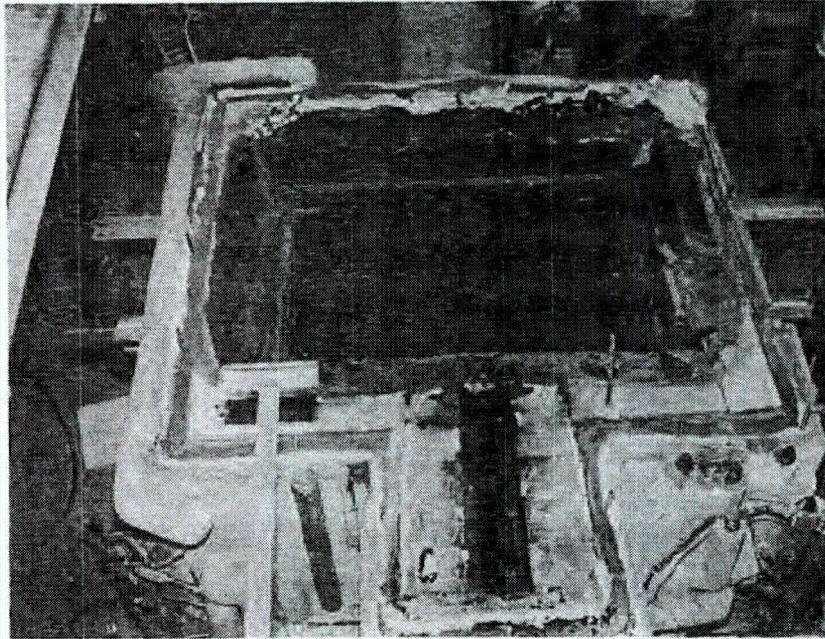
FIGURE 30. Melting Cavity North Monofrax K-3 Wall

The Monofrax K-3 refractory following the melter shut down is pictured in Figures 30, 31, and 32. The most apparent features are the general uniformity of the cracking present in the bricks and the intact cold wall (wall opposite

The photographs and respective contour plots display the difference between the conditions of the north and south walls. The mechanisms for crack formation in the Monofrax K-3 is discussed in detail in the stress analysis section of this report (Section 6.0). Briefly, the Monofrax K-3 cracking is due to excessive stresses developed by thermal expansion, and thermal shocking of the refractory during liquid-feed initiation.

Although both refractory walls are severely cracked, the cold wall remains intact because the cracks are oriented perpendicularly to the glass contact face. This is due to the characteristics of the temperature distribution in the wall. However, the thermal gradients present in the hot wall are oriented such that the cracks are inclined with respect to the glass contact face. Therefore, the cracked portions of the north wall remain in place, but the damaged south wall refractory tended to slough off onto the floor.

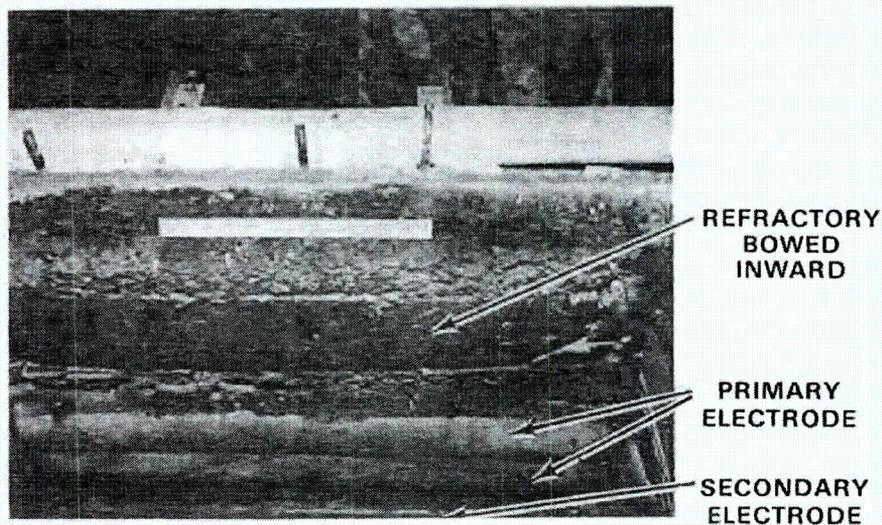
FIGURE 35. Melting Cavity East Electrode Wall

Another indication that high refractory stresses are present can be seen in the photograph and contour plot of the east electrode wall, Figures 35 and 36. The refractory above the primary electrodes has bowed toward the melting

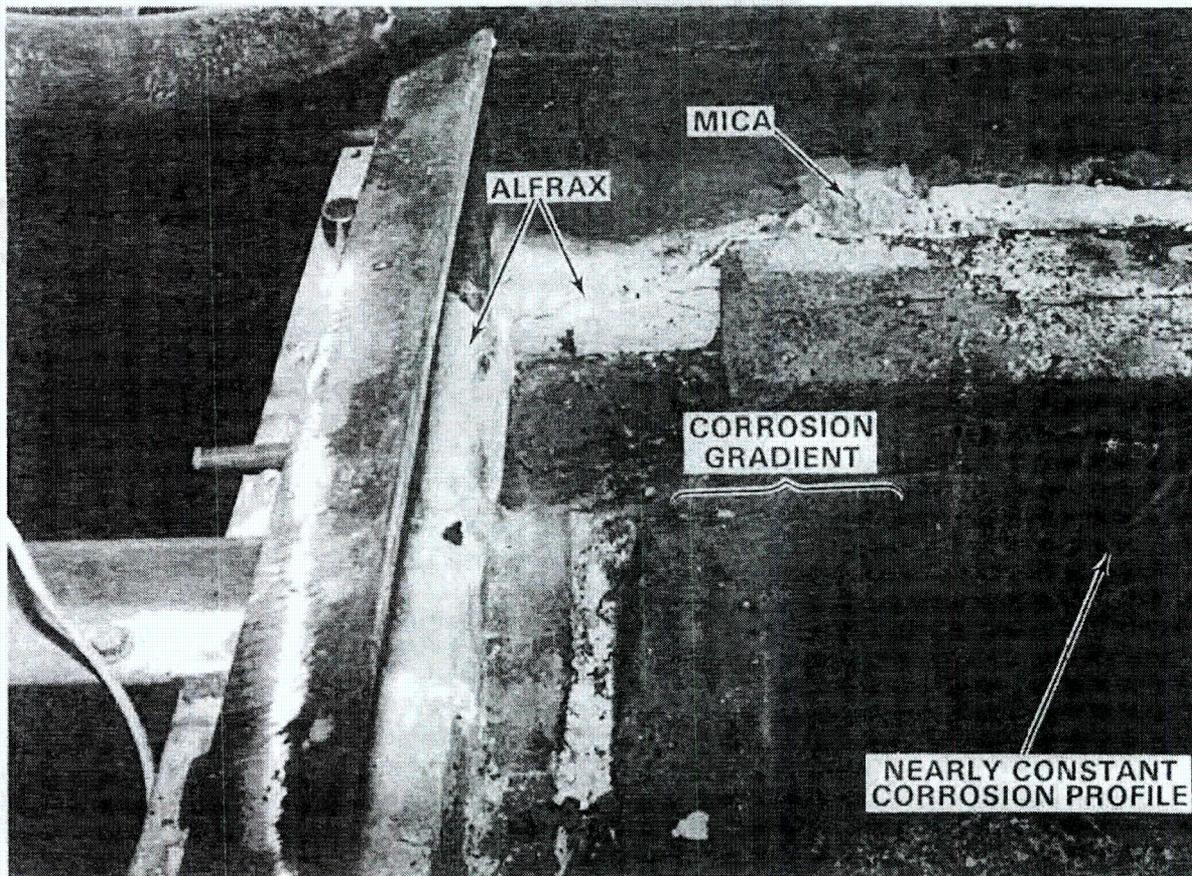
FIGURE 37. Corrosion Profile on North Wall Near Electrodes

In general, the Monofrax K-3 was found to be highly corrosion resistant. The north wall underwent a generally uniform corrosion, with the maximum loss of roughly 2.5 cm at the center. The flat corrosion profile of this refractory is established very near the electrodes, as can be seen in Figure 37. The riser drain is another example of the applicability of Monofrax K-3. Figures 38 and 39 are photographs of the drain. The riser inlet has grown during service (original size of inlet shown in Figure 38) as the slag built up, yet the riser itself remains circular and in good condition (Figure 39). The

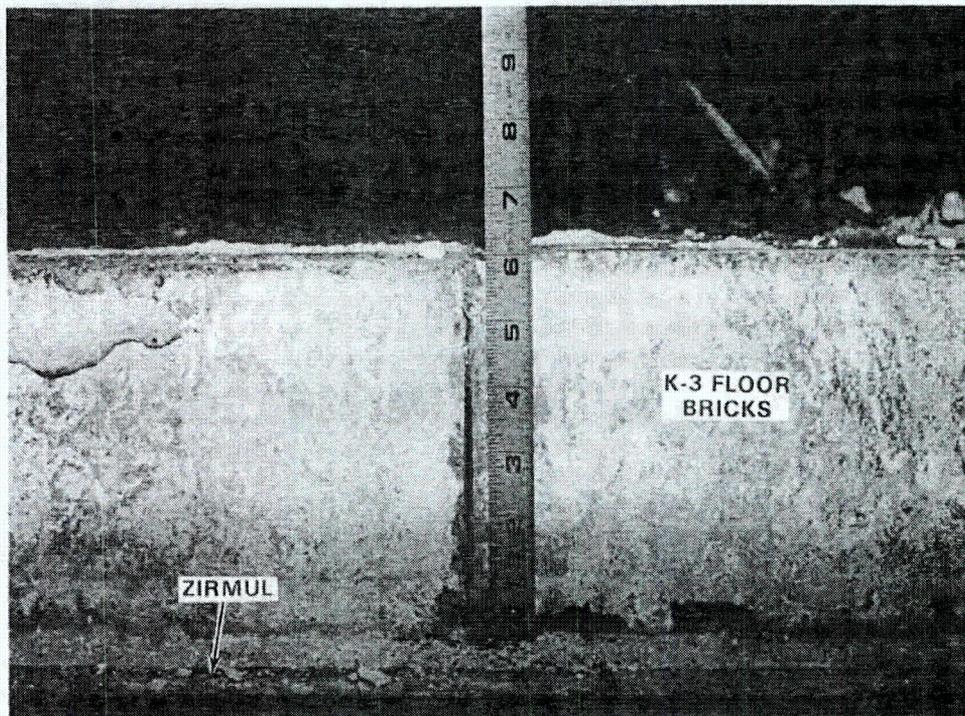
FIGURE 40. Condition of Monofrax K-3 Floor Blocks

Monofrax K-3 forming the melter floor remains in nearly new condition, remaining at the original 6-in. (15.2-cm) thickness, as shown in Figure 40.

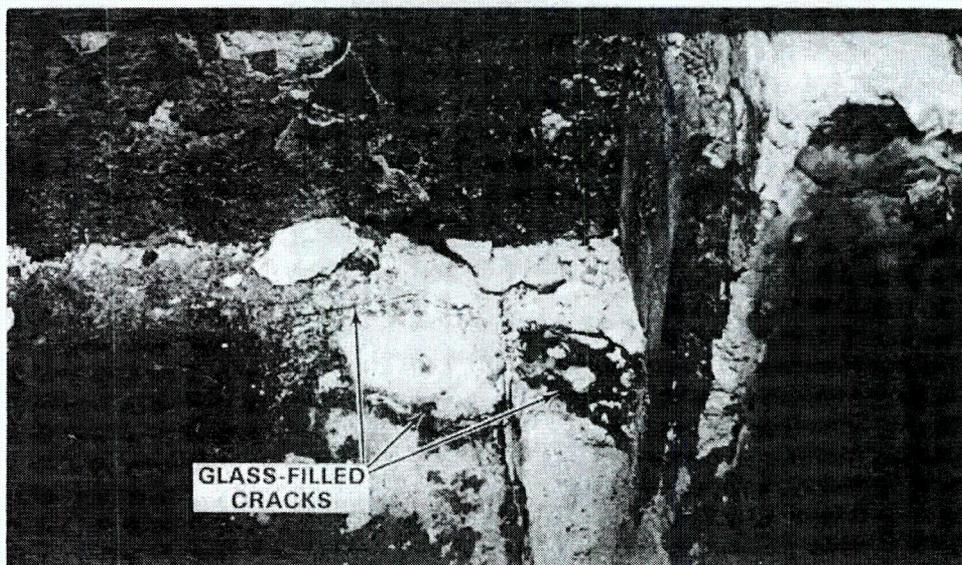
FIGURE 41. Cracking of Alfrax 66 Around Riser Block

As the disassembly progressed, the Alfrax 66 was found to contain many glass-filled cracks. This was especially true in the Alfrax 66 cast around the riser block, Figure 41. A significant quantity of glass penetrated the Alfrax 66 along the north wall. One of the large glass-filled cracks and the large glass pool behind the Alfrax 66 are pictured in Figure 42. This was by far the largest glass penetration found in the examination, forming a solidified layer against the containment box roughly 75-cm by 60-cm by 0.5-cm thick. Minor glass migrations were also found behind the electrodes, but the glass did not penetrate the Alfrax 66 to the containment box in this region

The Alfrax 66 was subjected to conditions most likely to create structural failures in the LFCM application. Alfrax 66 is a castable refractory (mixed with water and cast into place, much like concrete). The solidified Alfrax 66 contains both free water and water of hydration. As the temperature of the refractory exceeds  $100^{\circ}\text{C}$ , the free water begins to vaporize, forming microscopic steam pockets in the refractory. If this water vapor is not allowed to diffuse from the Alfrax 66 (by maintaining the refractory near

After the Alfrax is cured, temperature changes should be <40<sup>0</sup>C/h. Also, Alfrax 66 has different initial thermal expansion characteristics than the Monofrax K-3. During Alfrax 66 curing, the thermal expansion is offset by shrinkage of the refractory caused by the water loss. In this refractory installation, the Alfrax 66 was cast behind and above the Monofrax K-3. Therefore, during startup the Monofrax K-3 would expand as the temperature was increased; the Alfrax 66 would tend to retain its initial dimensions. This produces tensile stresses in the Alfrax 66, which could lead to the cracking observed.

Glass samples removed from the cracks near the large glass migration in the north wall and at the base of the riser block resemble glass formulations processed in early melter testing. This supports the conclusion that the Alfrax 66 cracking was the result of the rapid startup and thermal expansion differences between the Monofrax K-3 and the Alfrax 66 refractories. Much of the Alfrax 66 cracking discovered in the LFCM can be prevented in the future by following the recommended curing schedule and by assuring that slip planes are included in the refractory design to permit the Monofrax K-3 to expand during the Alfrax 66 curing period.

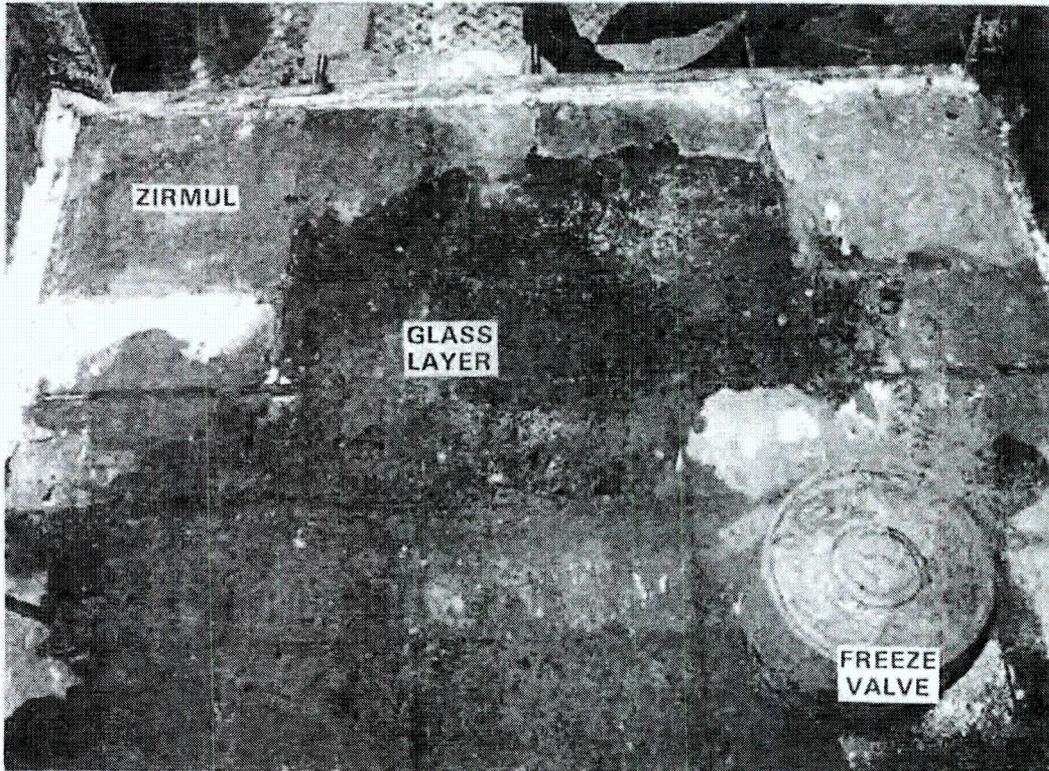
FIGURE 43. Glass Layer on the Zirmul Floor Blocks

The Zirmul bricks installed beneath the Monofrax K-3 floor were in excellent condition on removal from the melter. The bricks were covered with a thin layer of glass in the center of the floor, Figure 43, and glass had

penetrated the interbrick joints in this region. Glass was also found in Zirmul cracks near the freeze valve. Visual inspection of the Zirmul revealed no significant interaction between the glass and the refractory. The most severely affected regions were discolored up to 0.5 cm into the bricks. Other than the discoloration, no effects on the Zirmul were detected.

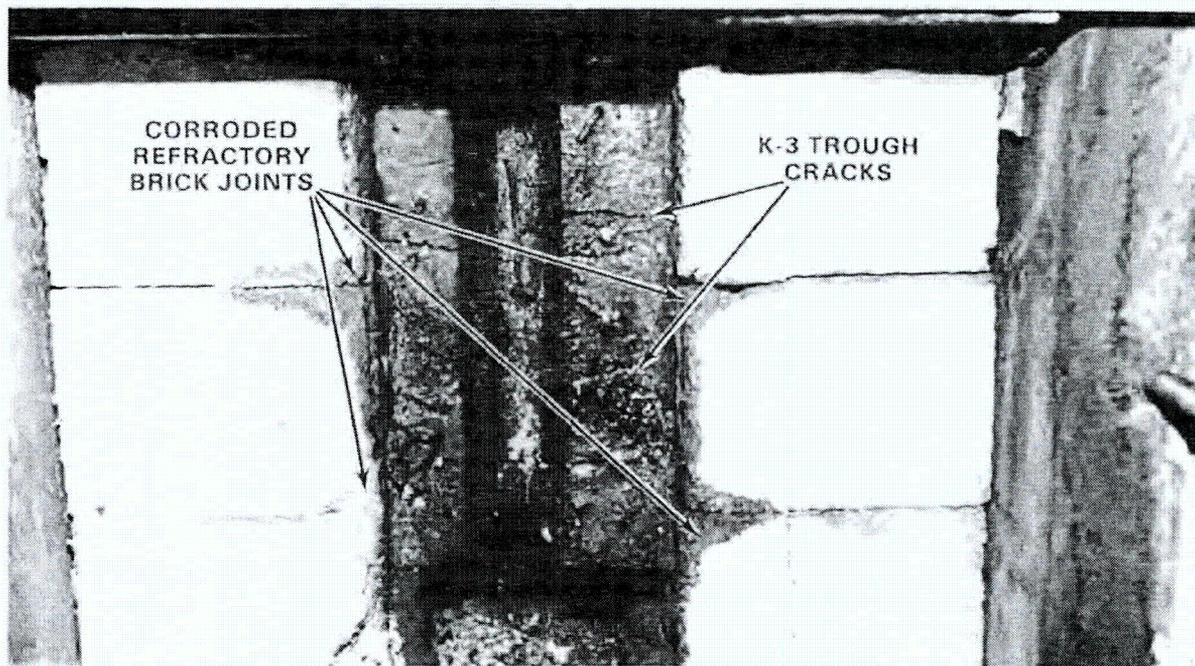
FIGURE 45. Glass Attack of Insulating Bricks in Overflow Drain

A more serious concern may be the corrosion of the low density bricks by glass that migrated from the drain. Figure 45 shows the glass covering these bricks. The glass easily penetrated the pores of these bricks and some rounding of the corners is apparent. Use of higher density, more corrosion-resistant bricks may be considered for future designs to prevent loss of structural integrity in this region.

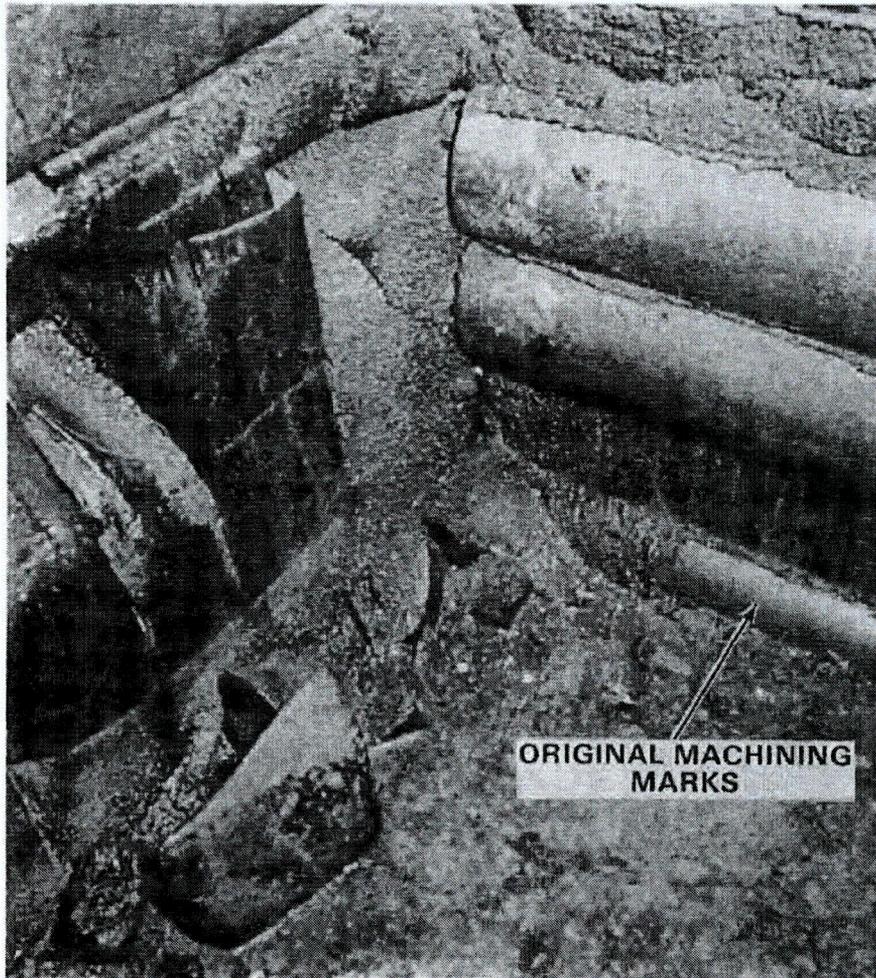
FIGURE 47. West Electrodes Following Operation

The primary and secondary electrodes are pictured in Figure 46 (east electrodes) and Figure 47 (west electrodes) after the three years of exposure

The changes in dimensions of the LFCM electrodes are presented in Table 1. Based on this data and assuming that the dimensional changes are only due to material loss (i.e., the effects of high-temperature creep and volume changes related to changing solid phases in the alloy following the extended heat treatment received do not contribute to the measured dimensional changes), the metal loss from the electrodes is 3  $\mu\text{m}/\text{d}$  or less.

Following removal from the melter, the east primary and secondary electrodes were sectioned near the centerline and samples were removed for detailed corrosion examination. The results of these tests are presented in Section 7.2.1 of this document.

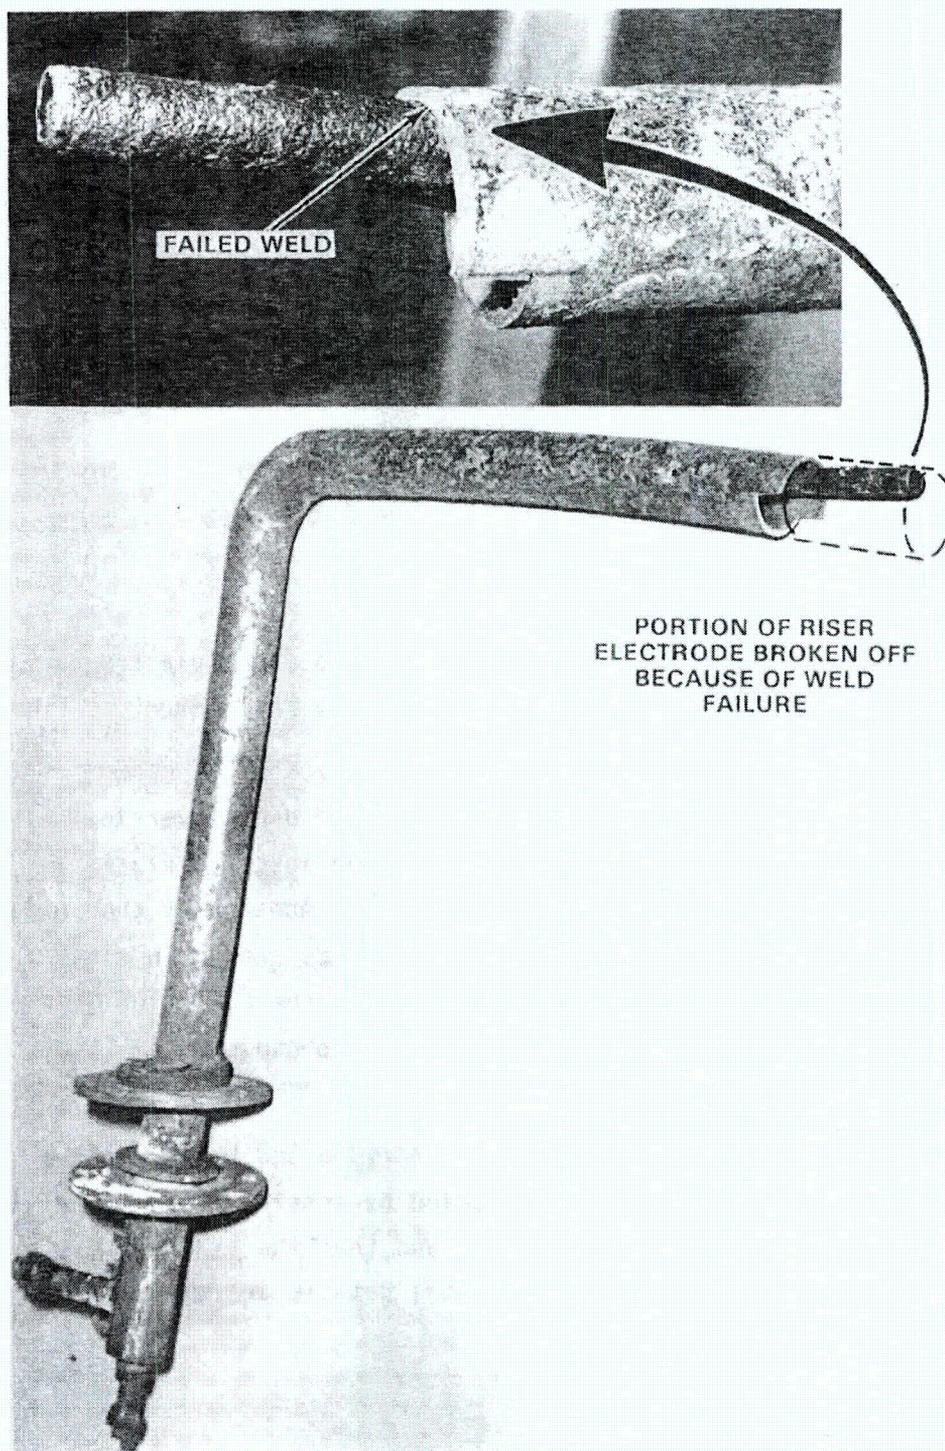
FIGURE 48. Ionic Booster Electrode After Removal from LFCM

When the electrodes were removed, the welded zones had become very brittle. The metal bellows used to seal the system and permit vertical electrode motion had developed pin-hole penetrations and had lost all elasticity. Traces of glass were detected in the electrode interior. Apparently the cooling air inside the electrodes blowing past the leakage sites sucked in glass-forming materials during feeding periods. Figure 48 shows the condition of the ionic booster electrodes after removal. Figure 49 is a photograph of the corroded bellows.

Analyses of samples removed from the electrode and bellows showed that the embrittlement of the electrode was caused by sensitization (formation of chromium carbides at the grain boundaries) and that the bellows were corroded by halogens and sulfur compounds. Additional details are presented in Sections 7.2.4 and 7.2.5.

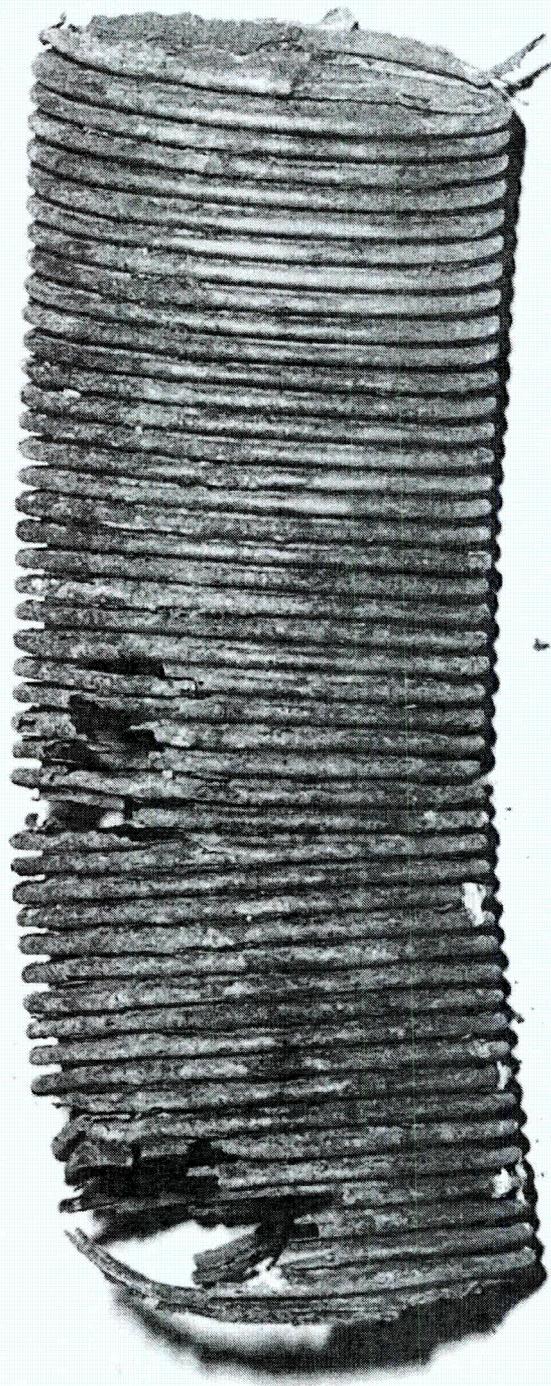
FIGURE 50. Corroded Offgas Piping

The stainless steel, convoluted piping from which the offgas connecting section immediately adjacent to the melter was fabricated, failed 106 h into the first slurry feeding test. A section of the corroded metal is pictured in Figure 50. This experiment was unique up to that point because the lid heaters were used to increase the slurry feed processing rate. This additional energy input from above the feed resulted in offgas temperatures approaching 600°C. At this temperature the type 204L, stainless steels piping was severely attacked by chlorine and sulfur compounds. The details of the particular corrosion mechanisms are presented in Section 7.2.6.

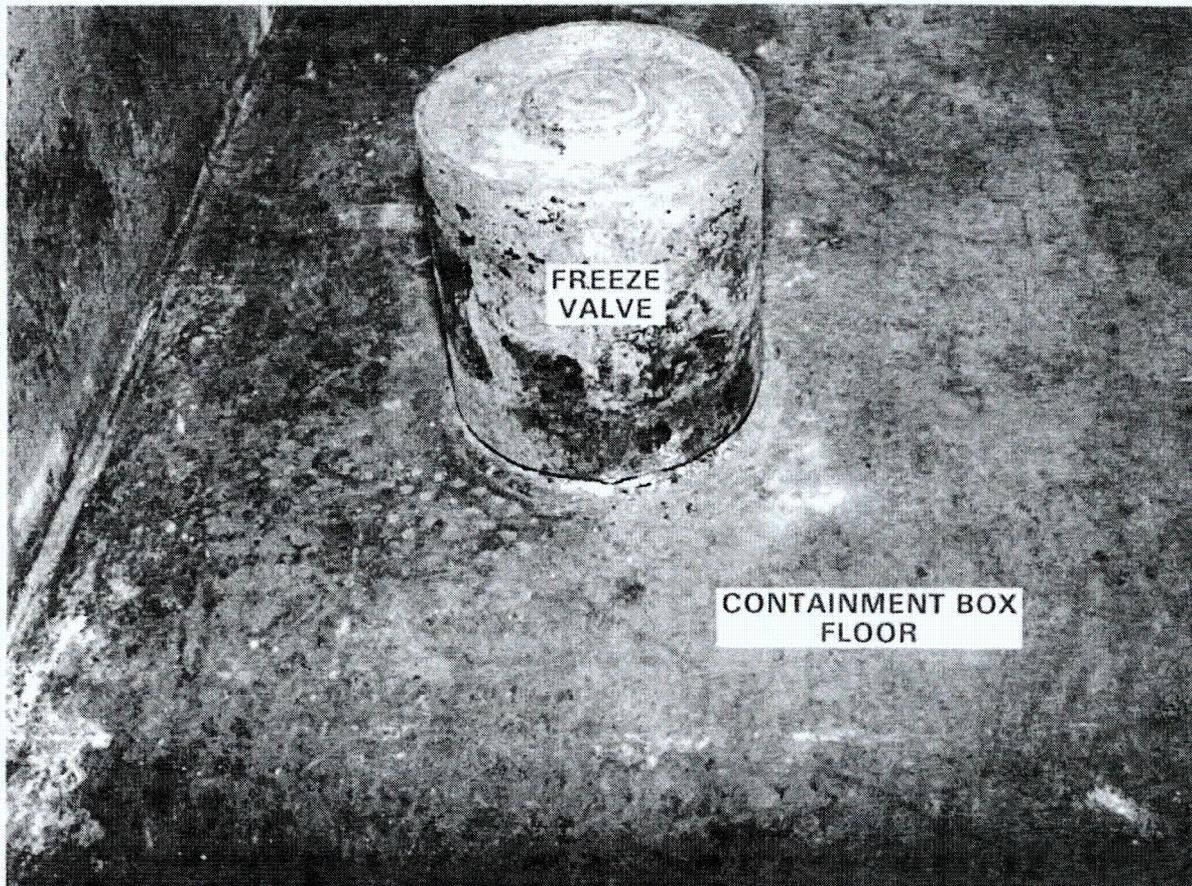
FIGURE 51. LFCM Freeze Valve

Figure 51 is a photograph of the freeze valve following removal of the refractory. The refractories and slag deposits prevented any damage to the freeze valve during the melter operation, and it was reinstalled in the rebuilt LFCM.

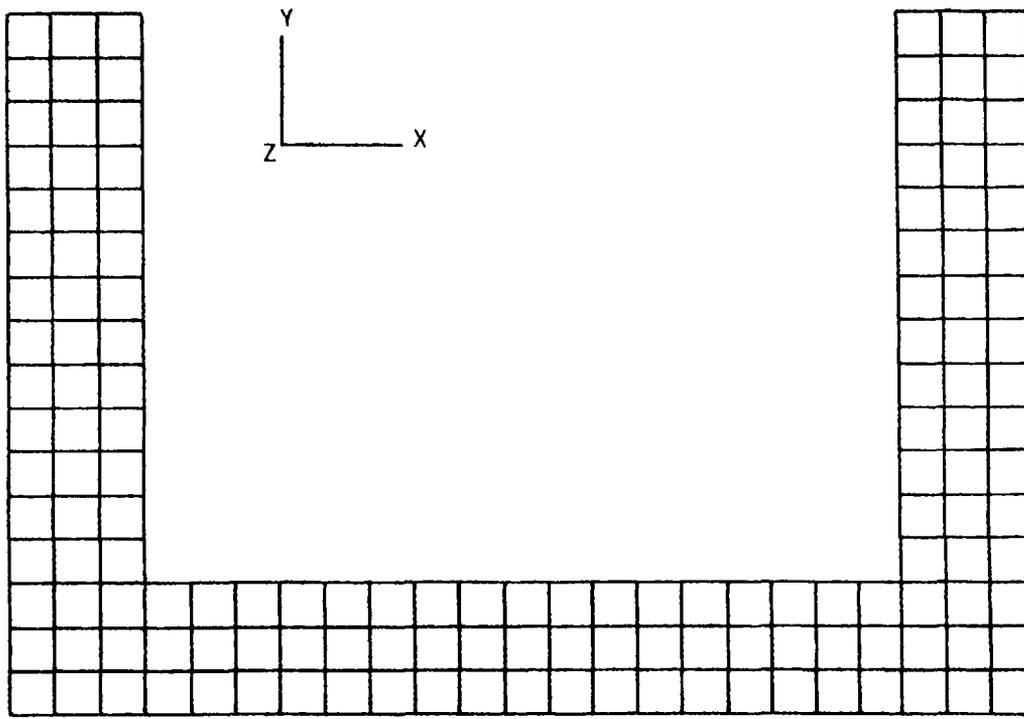
**FIGURE 52.** Simple Model of Melter Used in Preliminary Calculations

Two models, based on the ANSYS code, were used to predict the refractory stress levels in a design similar to the LFCM with various boundary conditions. The initial, simplified model, shown in Figure 52, is based on 15.2-cm Monofrax K-3 walls and floor assuming no Alfrax 66, fiberboard, or containment box. This model was given temperature boundary conditions and allowed to expand

freely, but was not permitted translational or rotational motion. With these conditions very low refractory stresses were produced, but the upper corners of the walls were displaced outwards roughly 5 cm. In the next simulation, an additional boundary condition was added which constrained the upper refractory ends from moving. These assumptions produced stresses as high as 345 MPa. The published Monofrax K-3 ultimate compressive strength is 138 MPa (Carborundum Company 1980). The degree of thermal strain allowed in the structure, therefore, will determine the magnitude of the thermal stresses. If the refractory is allowed to expand thermally without restraint, the thermal stresses will be low. Conversely, if the refractory is constrained, the thermal stresses will be high and will generally cause failure of the material.

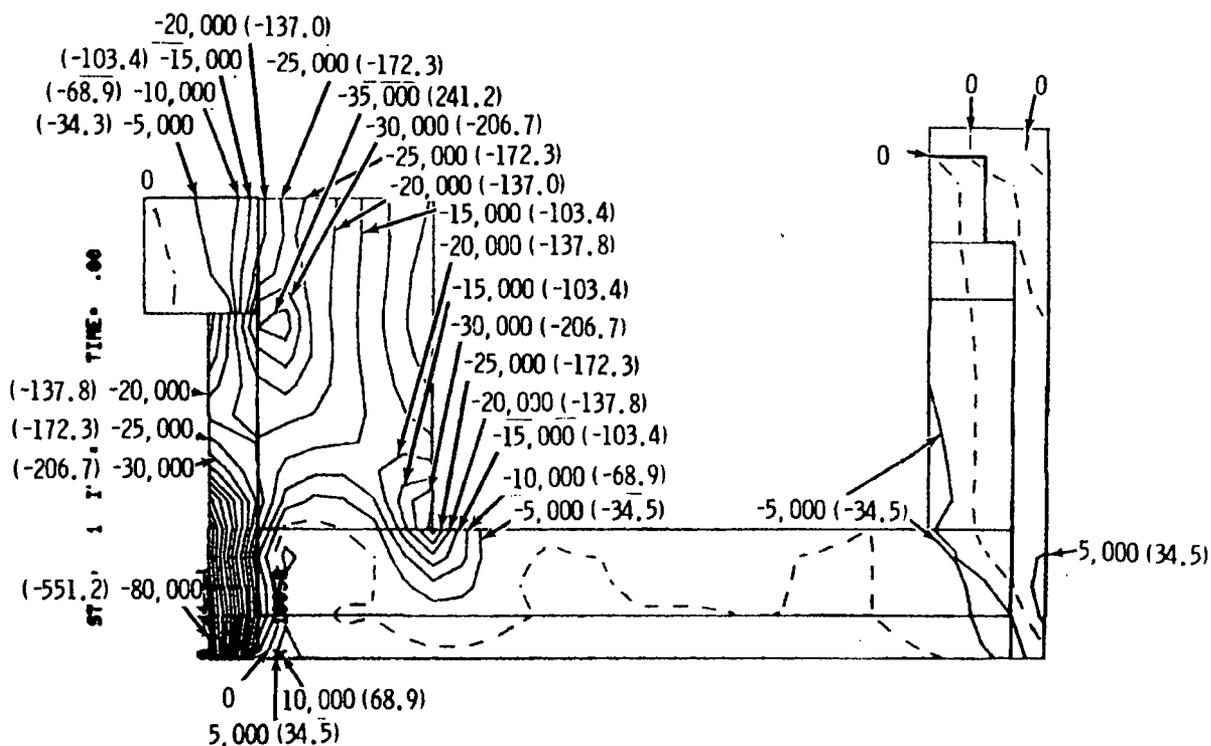
FIGURE 62. Vertical Stress Profiles for Cut #2 Idling with Upper Portion of Riser Block Constrained

The effect of restraining the thermal expansion of the riser block on the refractory stress levels is graphically shown in Figure 62. The magnitude of the stresses predicted with this additional boundary condition are nearly twice the rupture strength of Monofrax K-3 and reach 551 MPa in the Zirmul flooring. Neither of these two boundary conditions (total or no restraint from vertical expansion) are likely to represent the actual conditions present in a melter of the LFCM design. The actual stress level is probably a transient function
