## 5.0 MELTER EXAMINATION

### 5.1 CONTAINMENT BOX AND LID

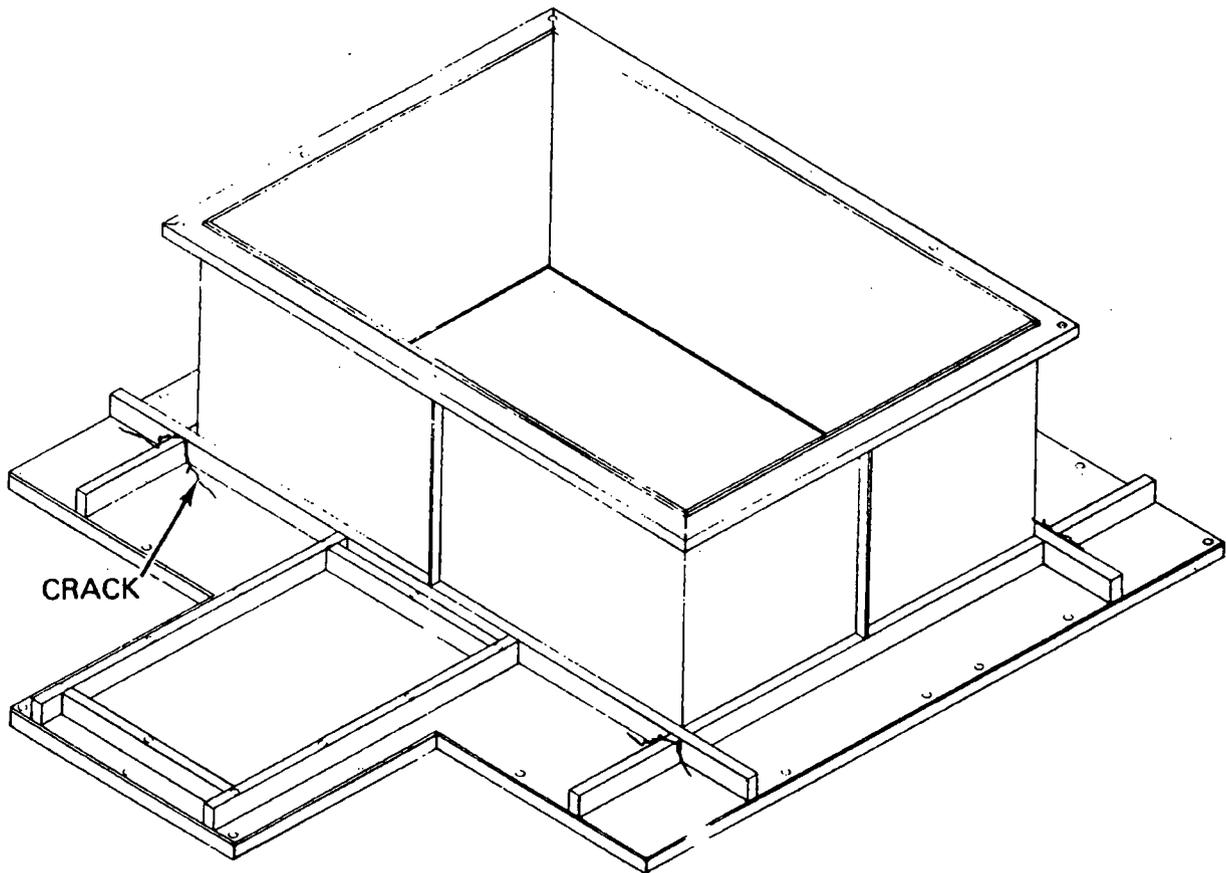
FIGURE 72. Melter Lid Indicating Position of Strongback Weld Cracks

The failures were the result of differential thermal expansion and excessive thermal stresses in the stiffening members. Because the melter lid was

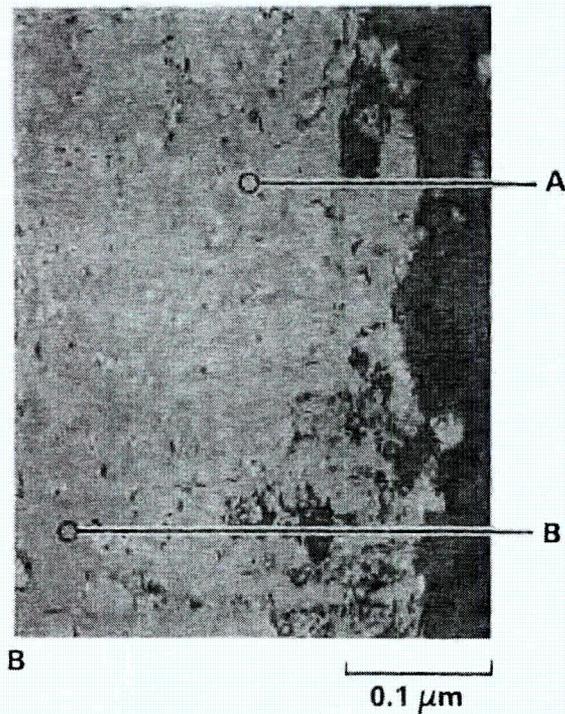
FIGURE 74. Monofrax K-3 Microstructure

shrinkage voids. The cooled refractory is a solid solution of two phases. These phases are visible in Figure 74. The light-gray phase is primarily composed of alumina ( $Al_2O_3$ ) with chromium oxide. The darker-gray phase is

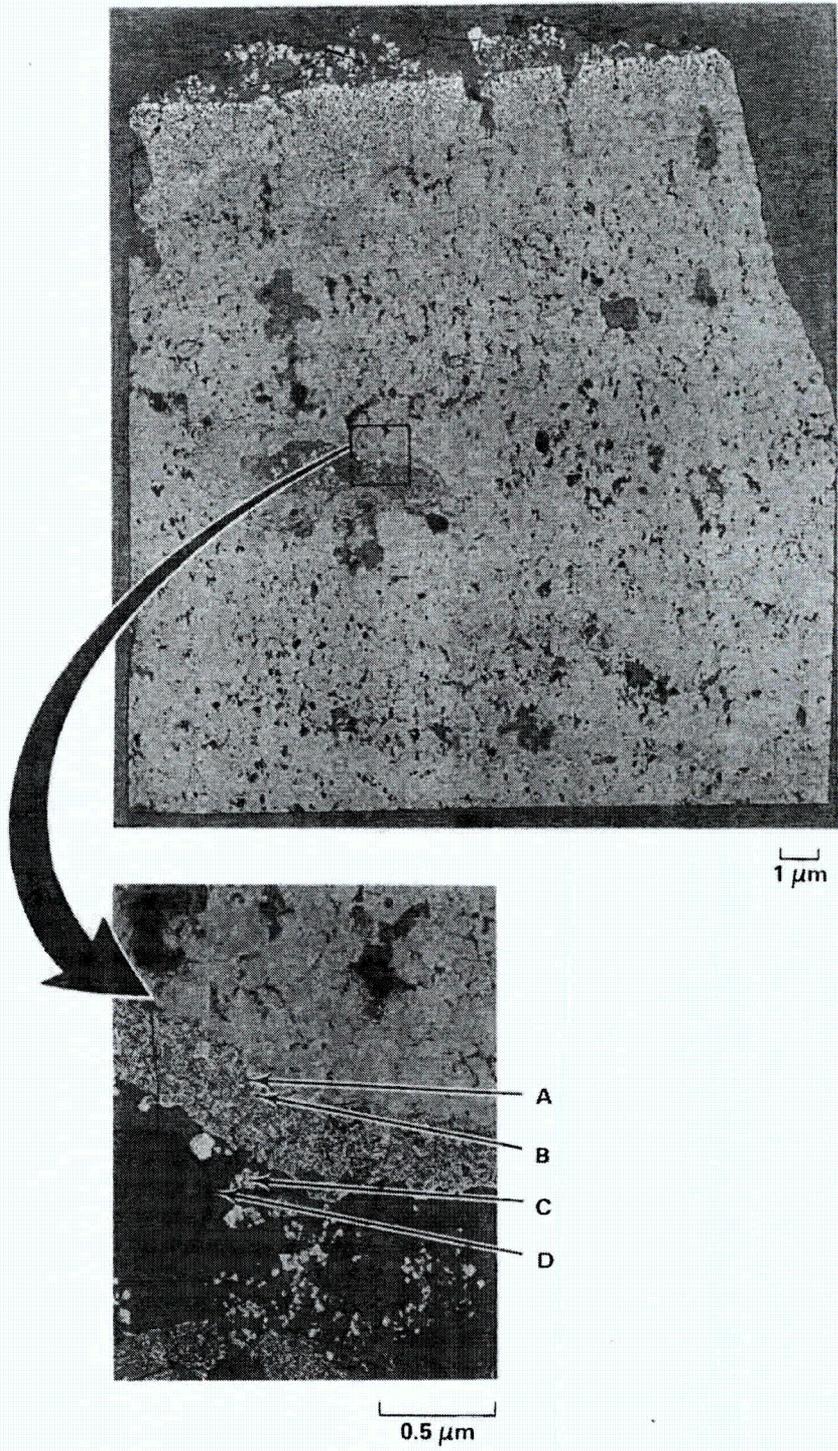
FIGURE 81. Pore in Monofrax K-3 Core

A particularly interesting feature of Figure 81 is the crystalline and glass phase present in the large pore at left center. Table 7 lists the phase composition at the positions indicated. This region is of interest because of the uniformity of the phases present. Location A of the figure was representative of all of the crystals present in this band. This band is also much more similar in composition with respect to the larger crystals (phase C) than similar phases at the refractory/bulk glass boundary. This information, combined with the relatively high Zn content of the phases present (Zn has not been a component of the glasses produced with LFCM since May 1977; see Appendix B) and the similarity of the glass compositions (phases B and D), indicates

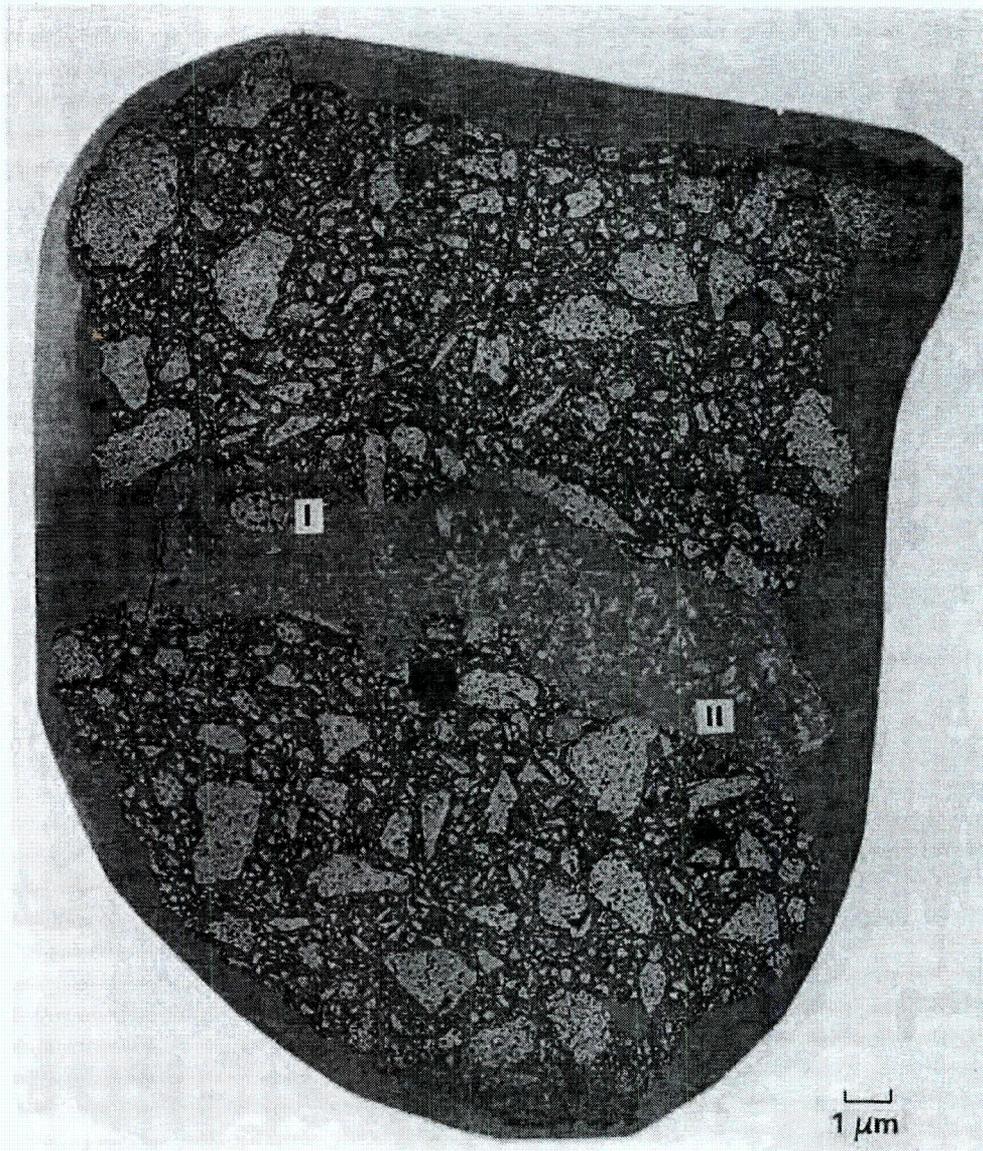
FIGURE 83. Glass-Filled Crack in the Alfrax 66 from North Wall

The Alfrax 66 refractory is composed of a pure, crystalline  $Al_2O_3$  phase suspended in a continuous phase of aluminum and calcium oxides. Figure 83 shows the Alfrax 66 microstructure. The light-gray region in the center is a glass-filled crack. The glass phases in the samples investigated contained

From examination of Figure 83 it is apparent that the Ca phase is attacked more severely than are the alumina crystals. This can be seen by comparing the fracture surfaces at the edge of the sample to the surfaces exposed to the glass. At the sample edges, the majority of the alumina crystal surfaces retain some of the continuous calcium oxide phase. The alumina crystals at the glass-crack interface do not have this coating. Also, the continuous phase appears to have been dissolved away from several of the crystals, leaving the aluminum oxide phases jutting out into the glass. This effect is more clearly seen in Figure 84 where a section of the Alfrax 66 has
