NUREG/CR-7198  
ORNL/TM-2014/214

# **Mechanical Fatigue Testing of High-Burnup Fuel for Transportation Applications**

# Mechanical Fatigue Testing of High-Burnup Fuel for Transportation Applications

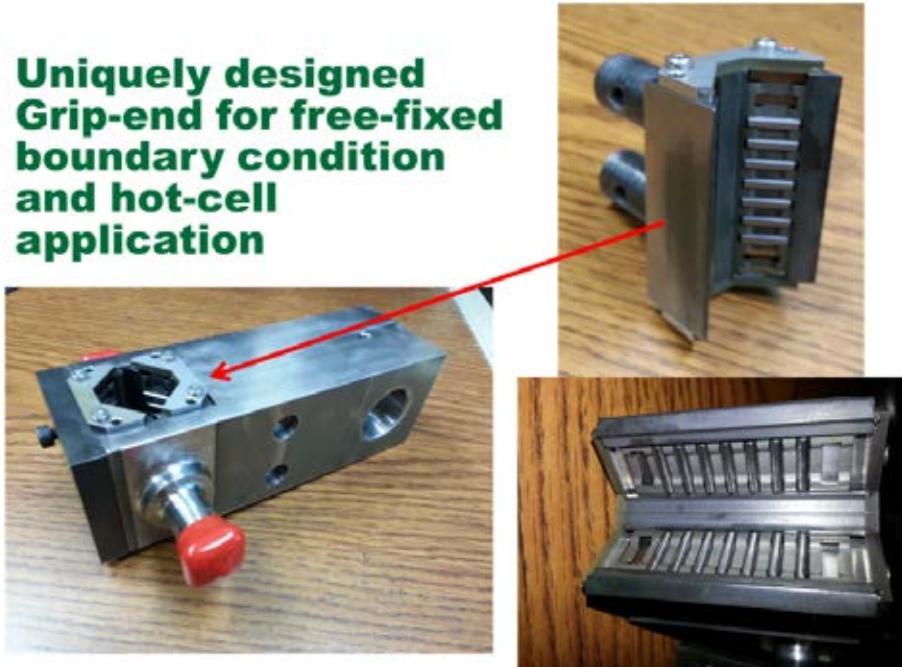
Figure 3. Assembled grip (left) and two views (right) of detached grip body.

Each grip consists of a V-shaped block integrated into the rigid arm of the U-frame, and a V-shaped end-block (Figure 3). The surfaces of the blocks serve as contacts to the specimen assembly and have been equipped with linear roller bearing sets embedded to ensure the free axial movement of the specimen when the force is being transferred. The rod specimen is secured by opening and closing the end-blocks in two grips.<sup>4,5,6,7</sup> A partly exposed view on one end of the specimen is shown in Figure 4 with the end-block removed. The specimen has a pair of rigid sleeves on both holding areas. The sleeves protect the specimen from any contact damage through a compliant layer between the specimen and sleeves. The rigid sleeves also enable the specimen to move freely in the axial direction while being set against the embedded linear roller bearing sets. The free axial movement of the specimen is a critical requirement in pure bending, as discussed elsewhere in the literature.<sup>3</sup>

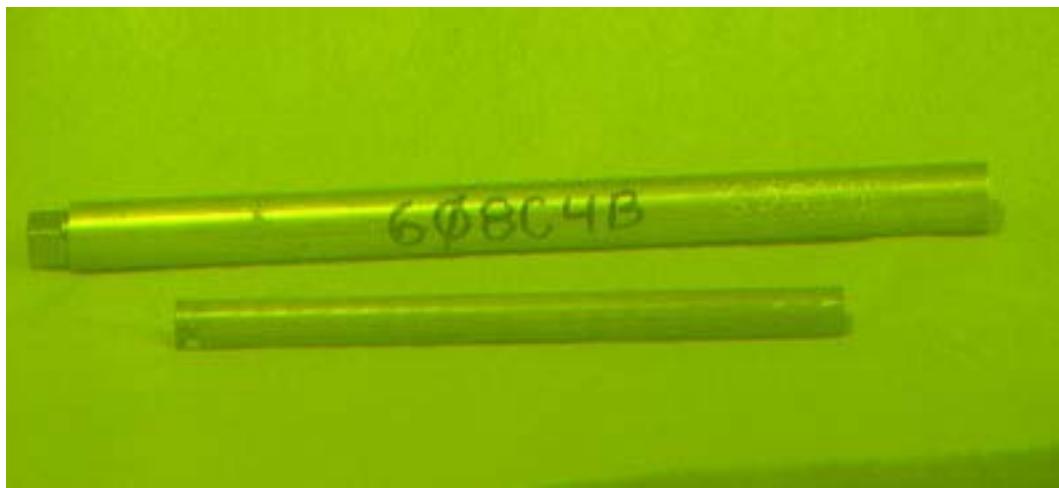
**Figure 8. Segment 608C4B for DL2 taken from rod G10, with the storage tube.**

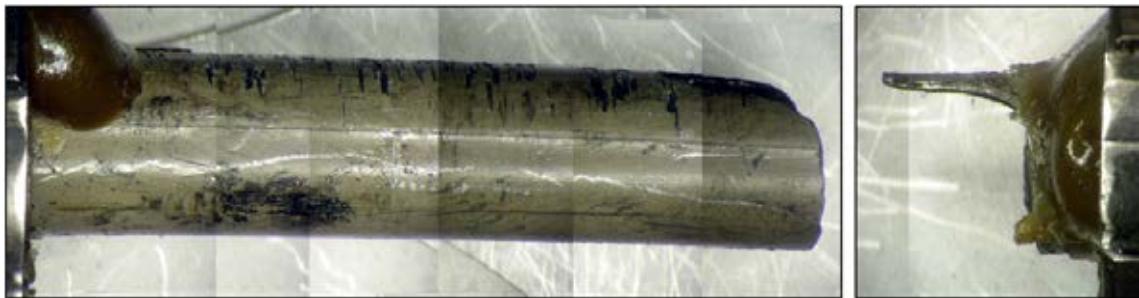
(d)

The cladding surface (Figure 13 [c] and [d]) near the neutral axis of the bending rod is free of visible surface oxide spalling, which is expected since these regions experienced little stress. In contrast, one of the stressed lateral surfaces which experienced the maximum flexural stress is covered with significant visible circumferential surface oxide spalling.

**Figure 13. Mating fracture surfaces (a) and (b); lateral sides near the neutral axis of the bending rod for S1 (606C3C) (c) and (d).** The rod was subjected to four repeat static cycles to 24 mm maximum relative displacement followed by dynamic cyclic loading  $\pm 25.40$  to  $30.48$  N·m at 5 Hz;  $1.4 \times 10^4$  failure cycles, 0.9 gram fuel particles collected. Note: This specimen appears to have been loaded into the test machine at  $90^\circ$  off from the ID marks

Since the machine capacity was reached and no failure occurred to the specimen, a follow-up dynamic test was conducted with reversible bending under  $\pm 25.40$  to  $30.48 \text{ N}\cdot\text{m}$  at 5 Hz. As mentioned above, the purpose of this procedure was to test the specimen to failure for further postmortem examination. The rod failed after approximately  $1.4 \times 10^4$  moment reversals. The failure occurred near motor 1 (right side) with a fuel release of 0.9 grams. Optical images of the fracture surfaces are shown in Figure 13. The pellet end-face can be identified from the haze zone characterized by a brown-blue color (indicated by the arrow in Figure 13a). This indicates that the rod failure may have initiated at the pellet-to-pellet interface. At the same time, a serrated shear fracture surface of the cladding was observed. The serrated fracture surface was believed to be the end stage of the crack propagation upon the fatigued CIRFT sample fractured. Note that this specimen appears to have been loaded into the test machine at  $90^\circ$  from the specimen ID marks.

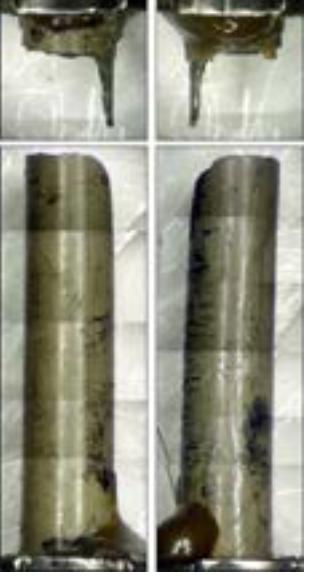
| Specimen ID | Specimen burnup | Testing condition and result | Fracture surfaces | Side view of fractured specimens |
|---|---|--|--|---|
| S1,<br>606C3C | 66.8 GWd/MTU | Four static cycles to 24 mm max. relative displacement, 85.5 N·m max. moment, followed by dynamic loading $\pm 25.40$ to $30.48$ N·m, 5 Hz; $1.4 \times 10^4$ failure cycles, 0.9 g fuel fragments collected | | |

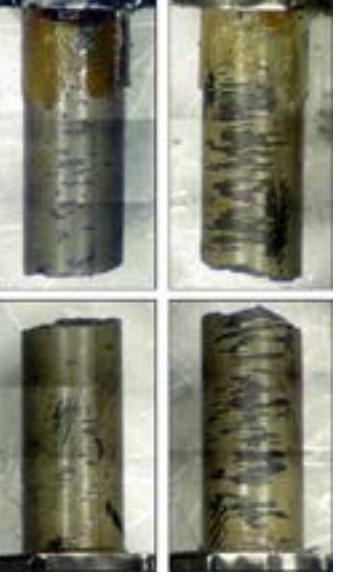
| Specimen ID | Specimen burnup | Testing condition and result | Fracture surfaces | Side view of fractured specimens |
|---|---|--|--|---|
| S2,<br>605D1E | 66.5 GWd/MTU | Three static cycles to 24 mm max. relative displacement, 87.2 N·m max. moment, followed by dynamic cyclic loading $\pm 30.48$ N·m, 5Hz; $7.2 \times 10^3$ failure cycles, 0.6 g fuel particles collected | | |

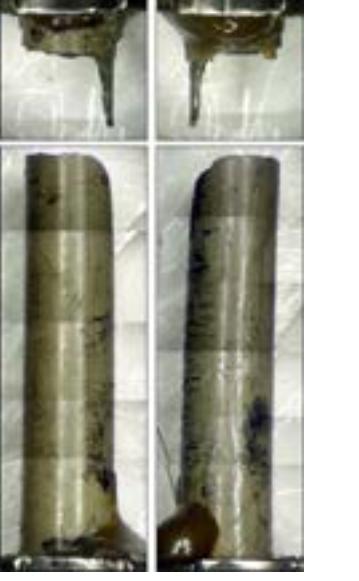
| Specimen ID | Specimen burnup | Testing condition and result | Fracture surfaces | Side view of fractured specimens |
|---|---|--|--|---|
| S3, 609C5 | 66.5 GWd/MTU | Three static cycles to 24 mm max. relative displacement, 85.8 N·m max. moment, followed by dynamic loading: $\pm 30.48$ N·m, 5Hz; $9.6 \times 10^3$ failure cycles, 0.2g fuel particles collected | | |

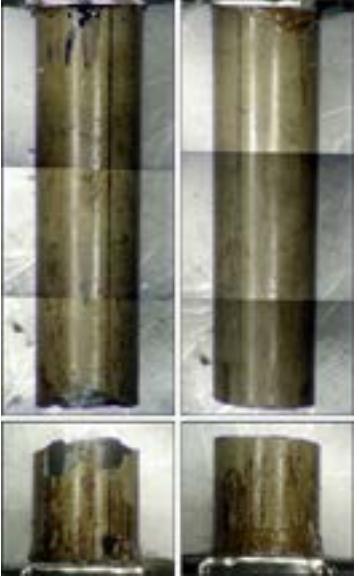
| Spec label | Applied Moment amplitude<br><b>N·m</b> | $\Delta\kappa$<br><b>m<sup>-1</sup></b> | Number of cycles to failure | Cross section | | Lateral view |
|---|--|---|---|---|--|---|
| D1,<br>607C4B | 15.24 | 0.6346 | $1.10 \times 10^5$ | | | |

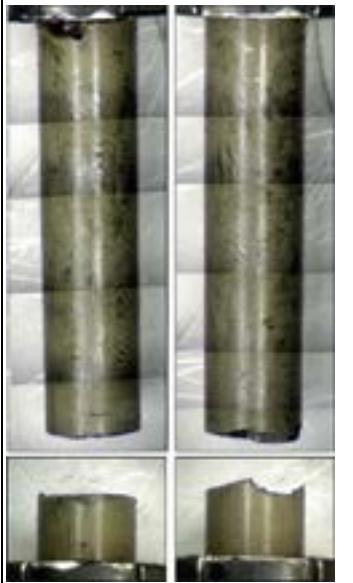
| Spec label | Moment amplitude<br>N.m | $\Delta\kappa$<br>$m^{-1}$ | Number of cycles to failure | Cross section | | Lateral view |
|---|---|---|---|--|---|---|
| D7, 609C3 | 20.32 | 0.9693 | $6.50 \times 10^4$ | | | <br> |

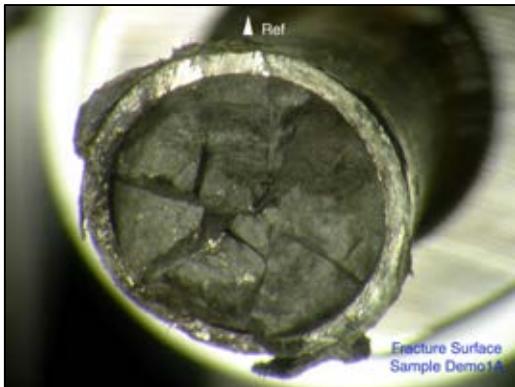
**Figure C.2.** Variations in (a) curvature range, (b) applied moment range, and (c) flexural rigidity as a function of number of cycles for Demo1 (606B2);  $N_f = 3.96 \times 10^3$  cycles under  $\pm 30.48$  N·m 5 Hz. The specimen was subjected to repeats of static loading before the cycle test.
