NUREG/CR-1715  
EGG-2061

# Fuel Rod Behavior During Tests PCM 8-1 RS, CHF Scoping, and PCM 8-1 RF

November 1980

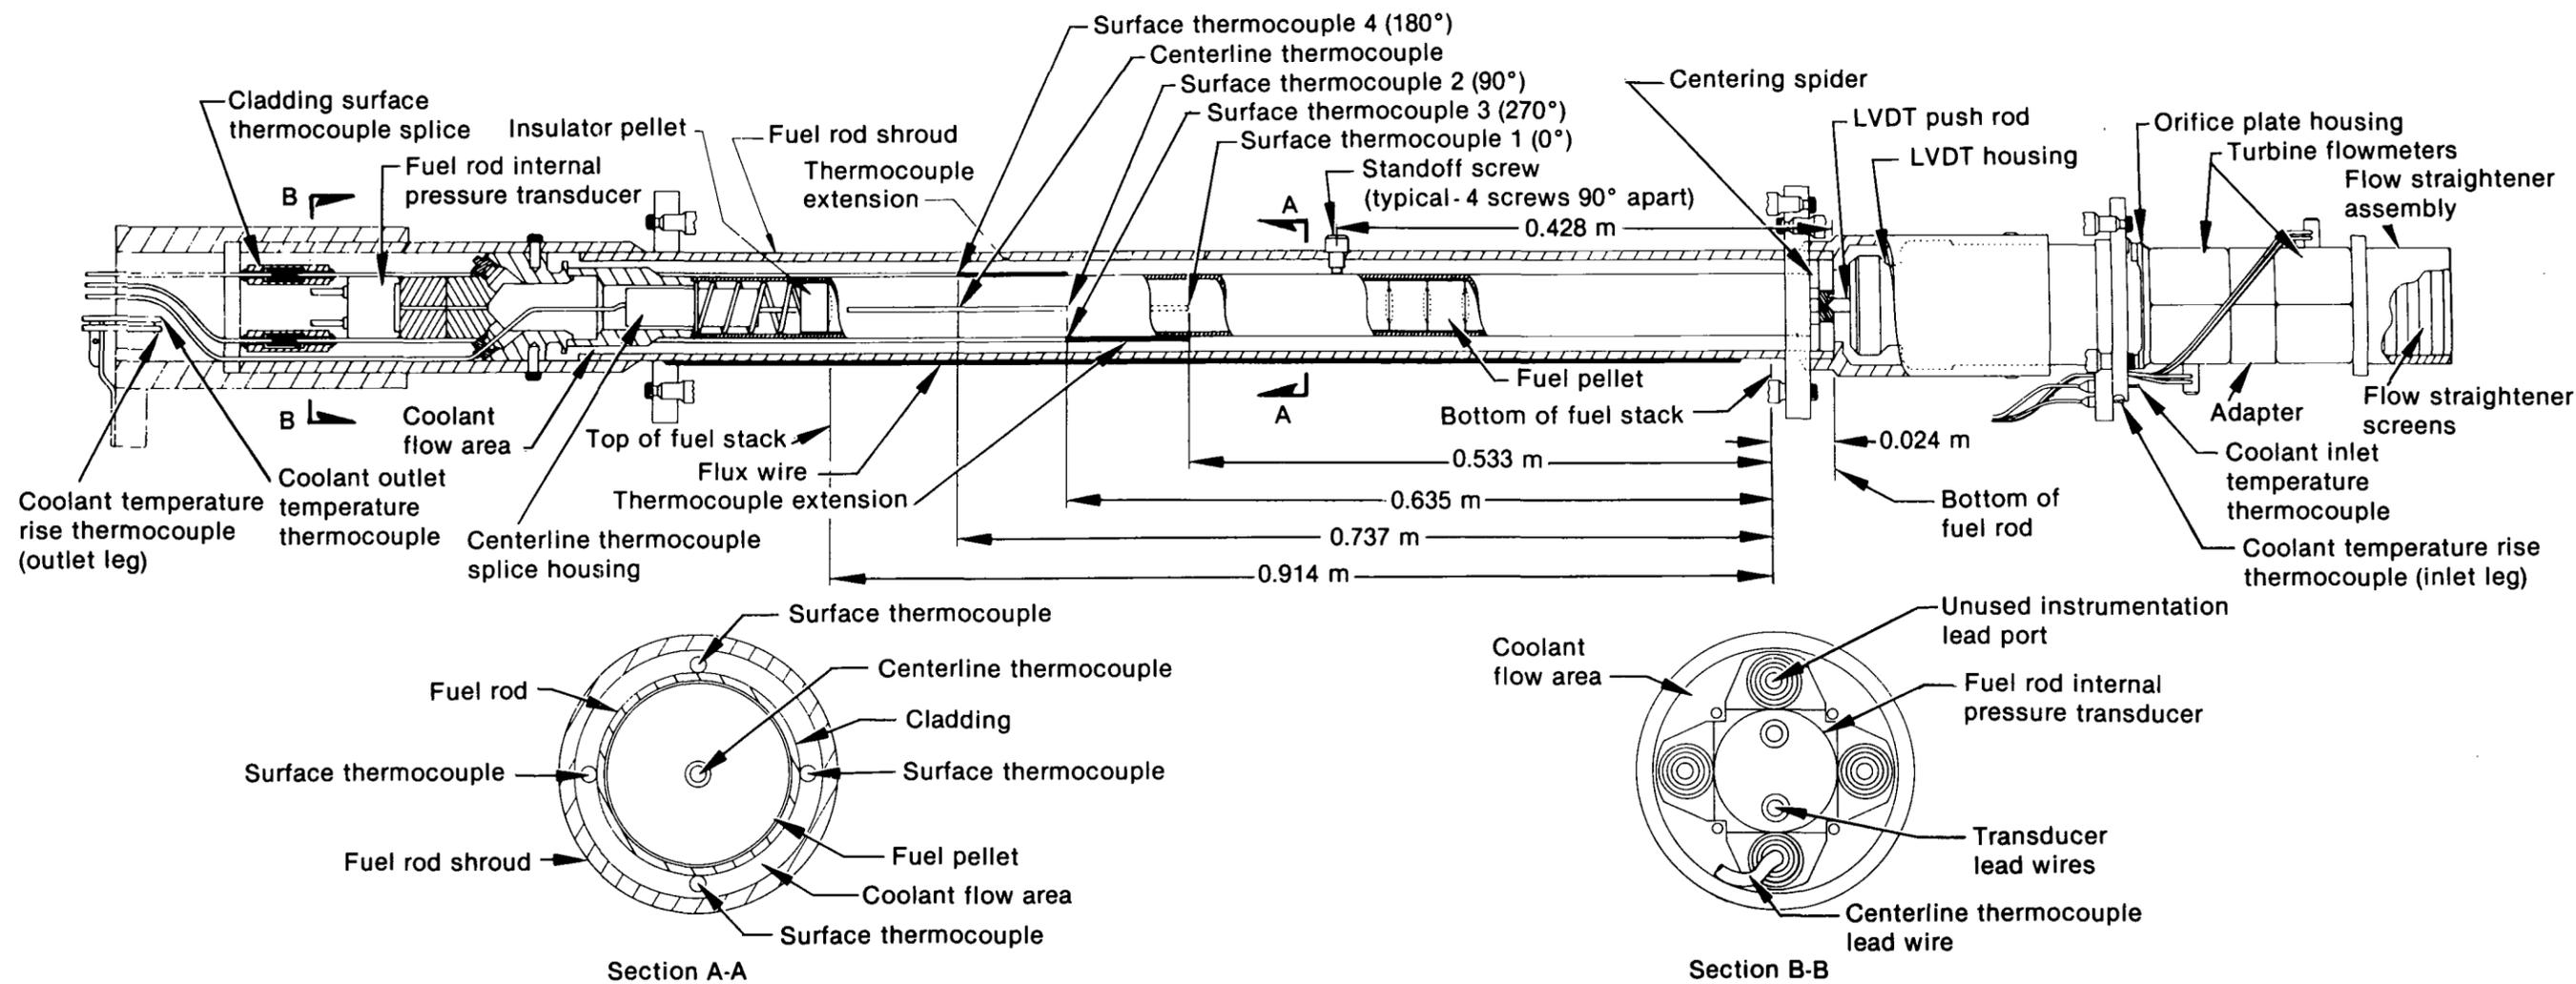
Note: For clarity, the thermocouples are not shown in their correct azimuthal positions.

Figure 1. Test 8-1 RF fuel rod and instrumentation shown installed in flow shroud.

Conditions external to the fuel rod during each of the tests were monitored by instruments mounted within or in the vicinity of the flow shroud. Transducer locations for Test 8-1 RF are shown in Figure 1; transducers were similarly located for the other two tests. Table 5 lists the instruments used for each of the three tests.

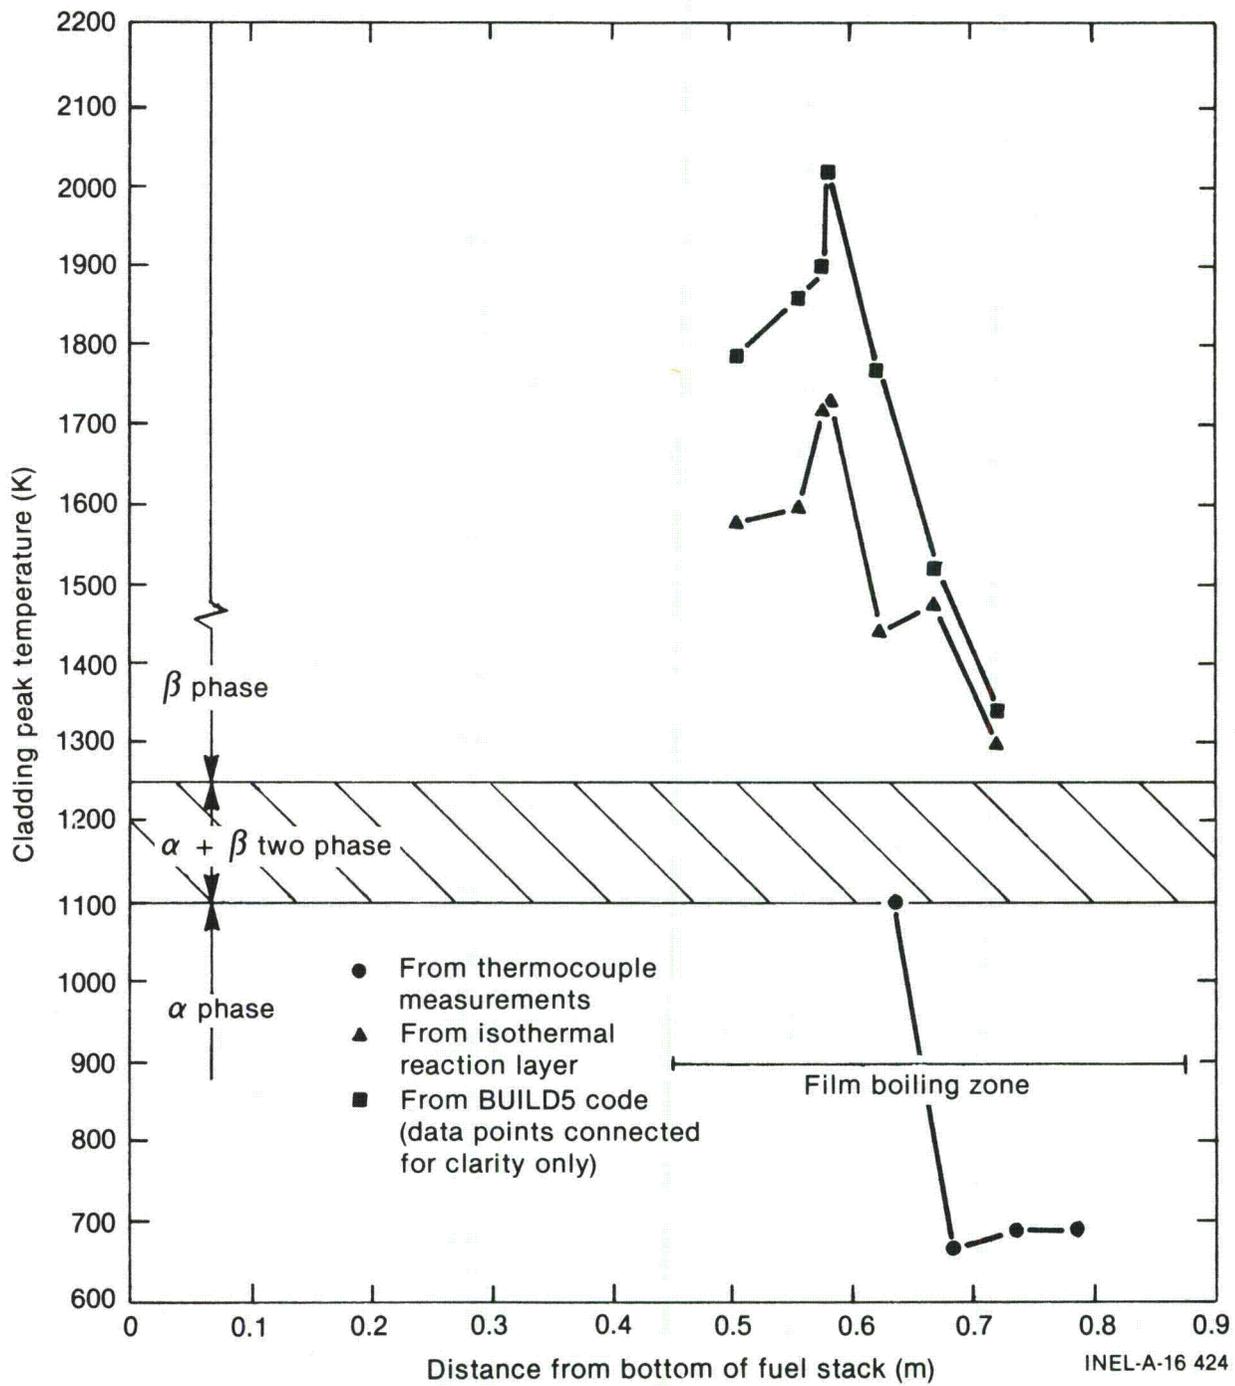
Figure 12. Cladding peak temperatures during Test 8-1 RS.

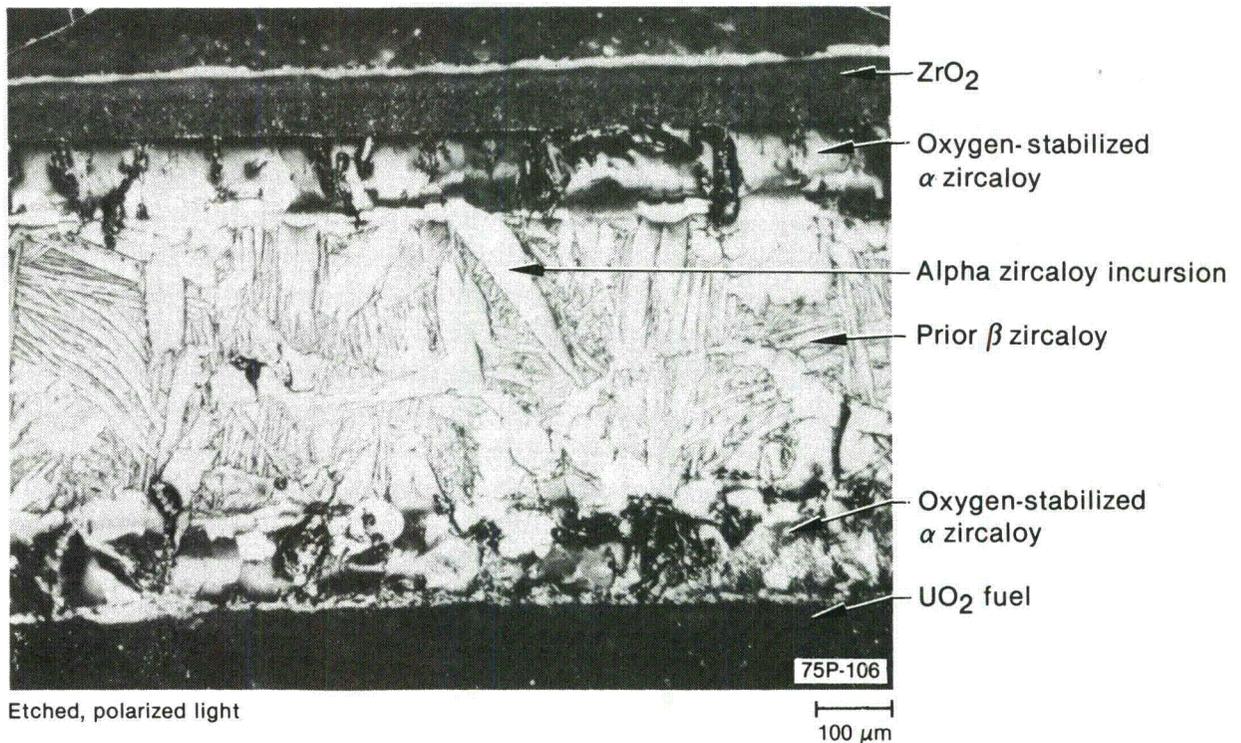
Figure 13. Longitudinal section of fuel rod at 0.556 m from bottom of fuel stack showing cladding microstructure (Test 8-1 RS).

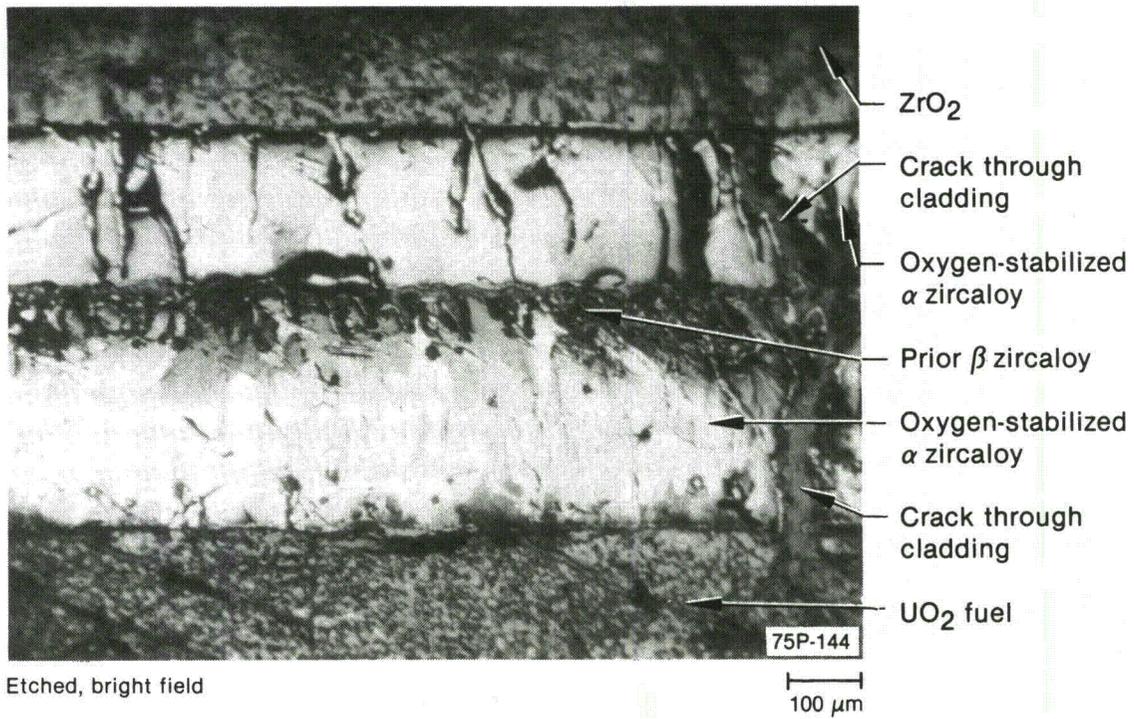
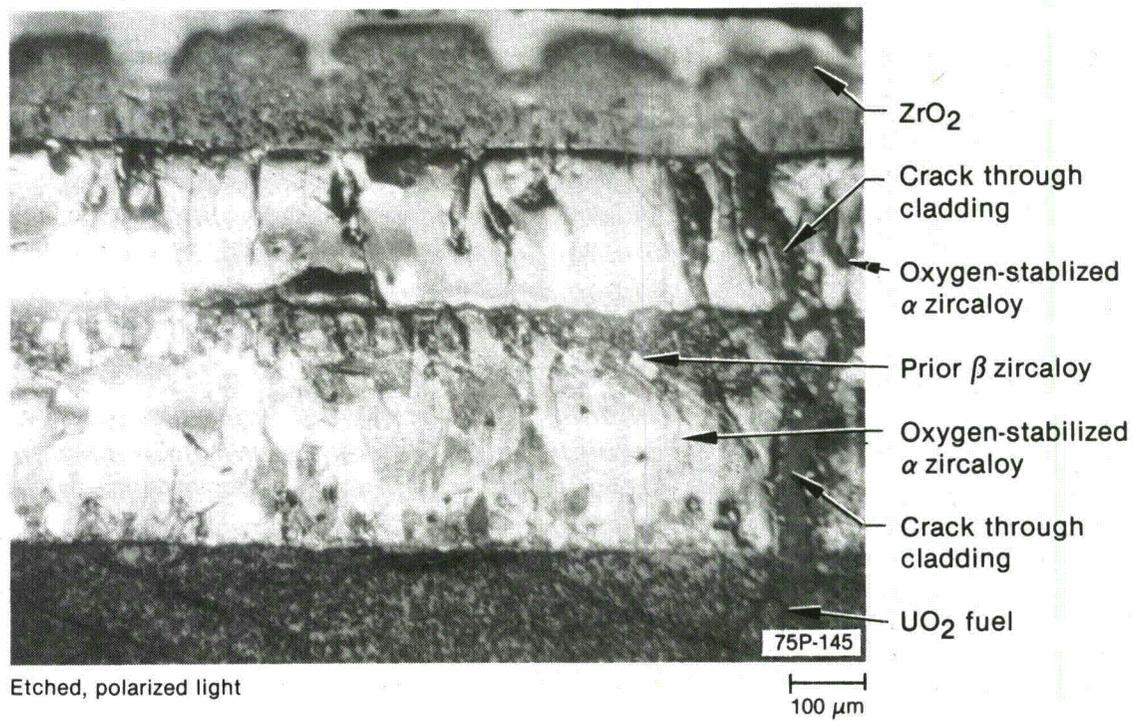
Figure 14. Longitudinal section of fuel rod at 0.581 m from bottom of fuel stack showing cladding microstructure (Test 8-1 RS).

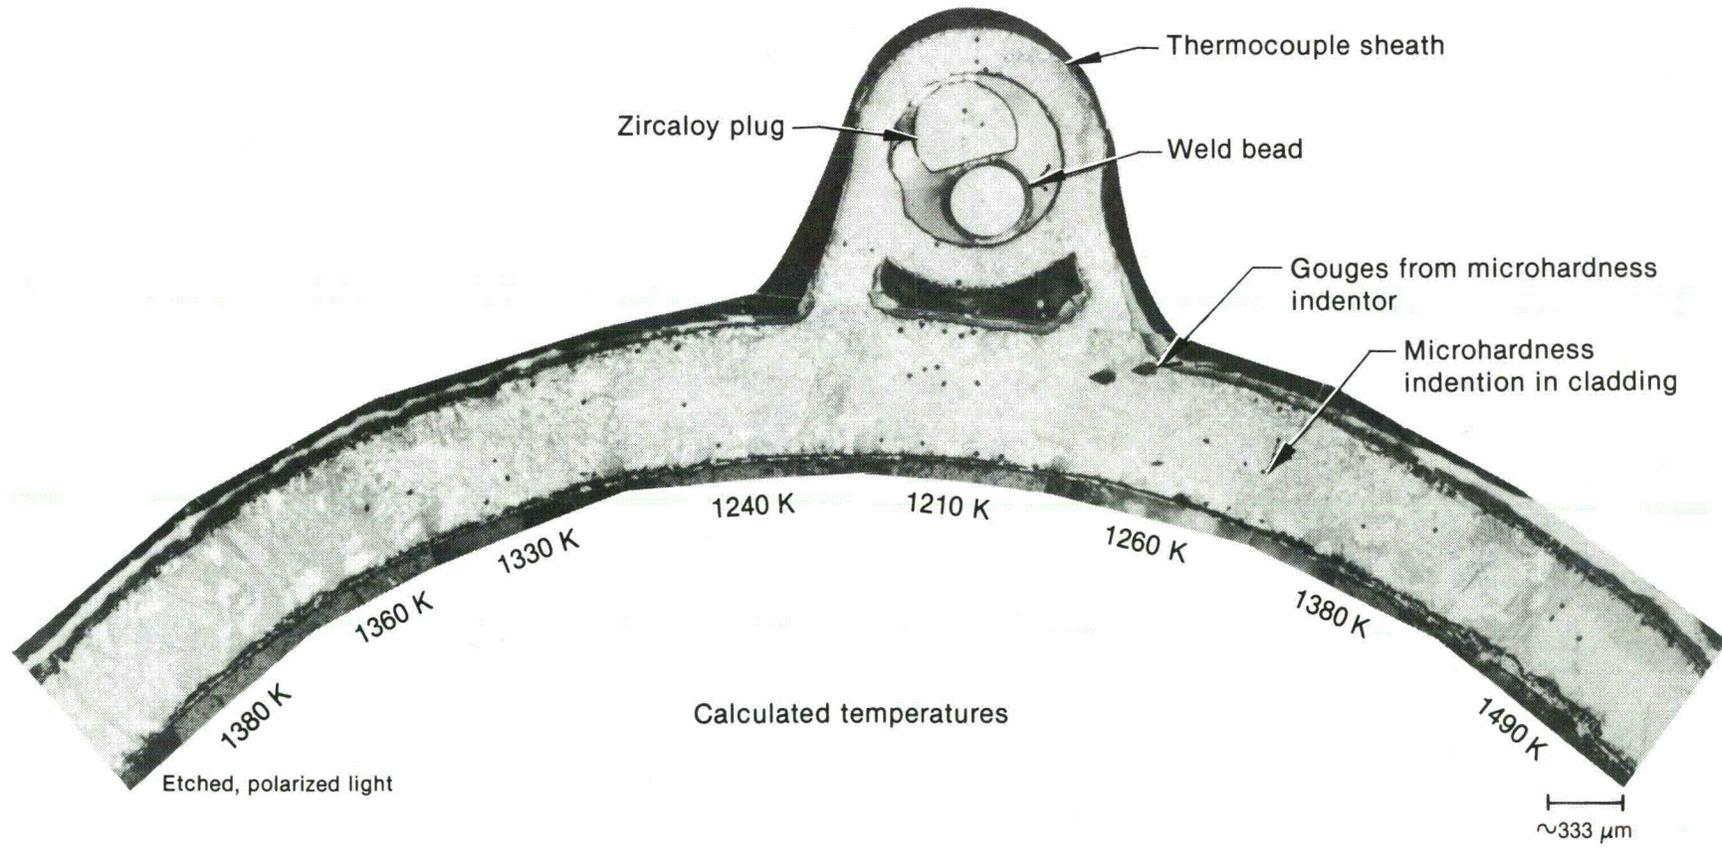
Figure 15. Composite transverse section of fuel rod showing microstructure in cladding near 0.635-m thermocouple (0.622-m location) (Test 8-1 RS).

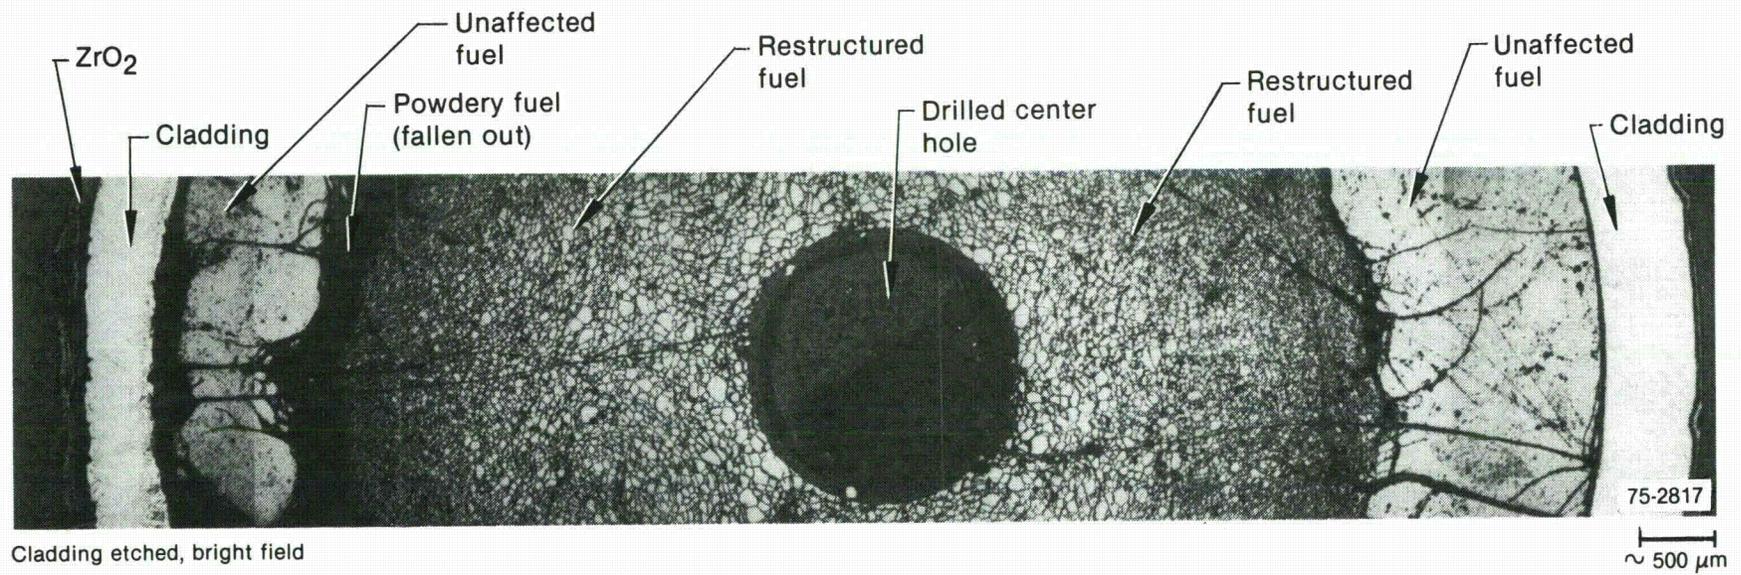
Figure 16. Composite photomicrograph across fuel rod at about 0.622 m from bottom of fuel stack showing fuel restructuring and cladding oxidation (Test 8-1 RS).

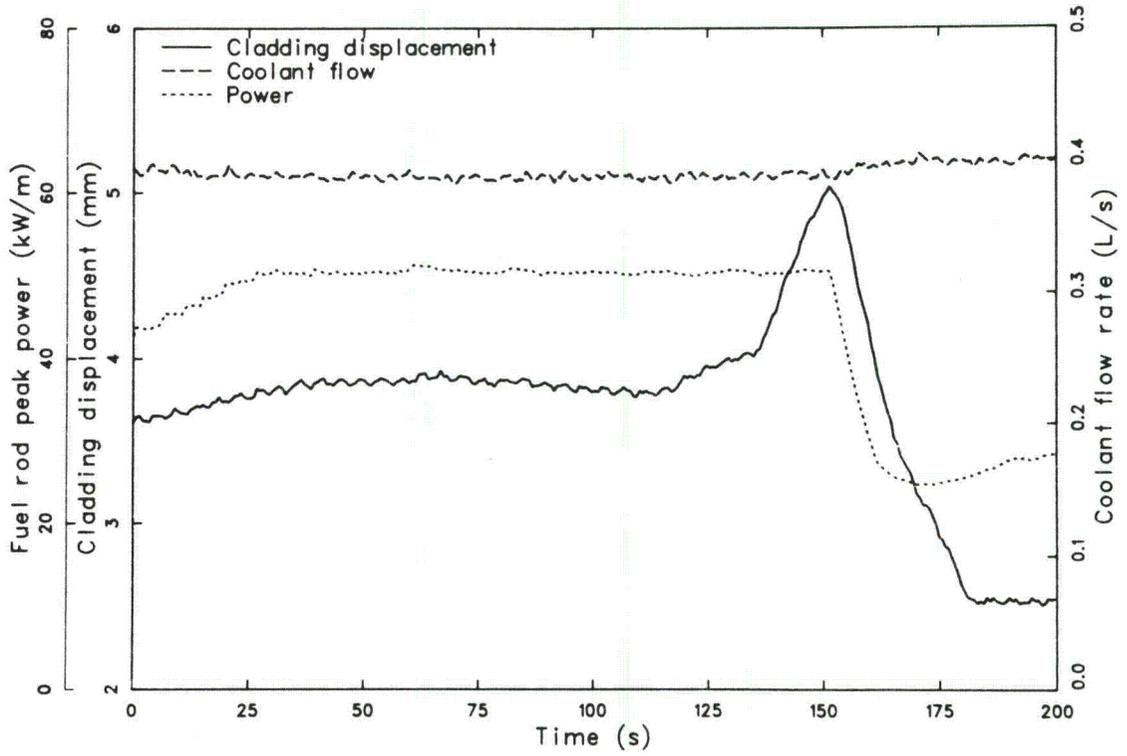
Figure 19. Fuel rod peak power, cladding displacement, and coolant flow rate versus time during Test CHF Scoping (DNB Cycle 1).

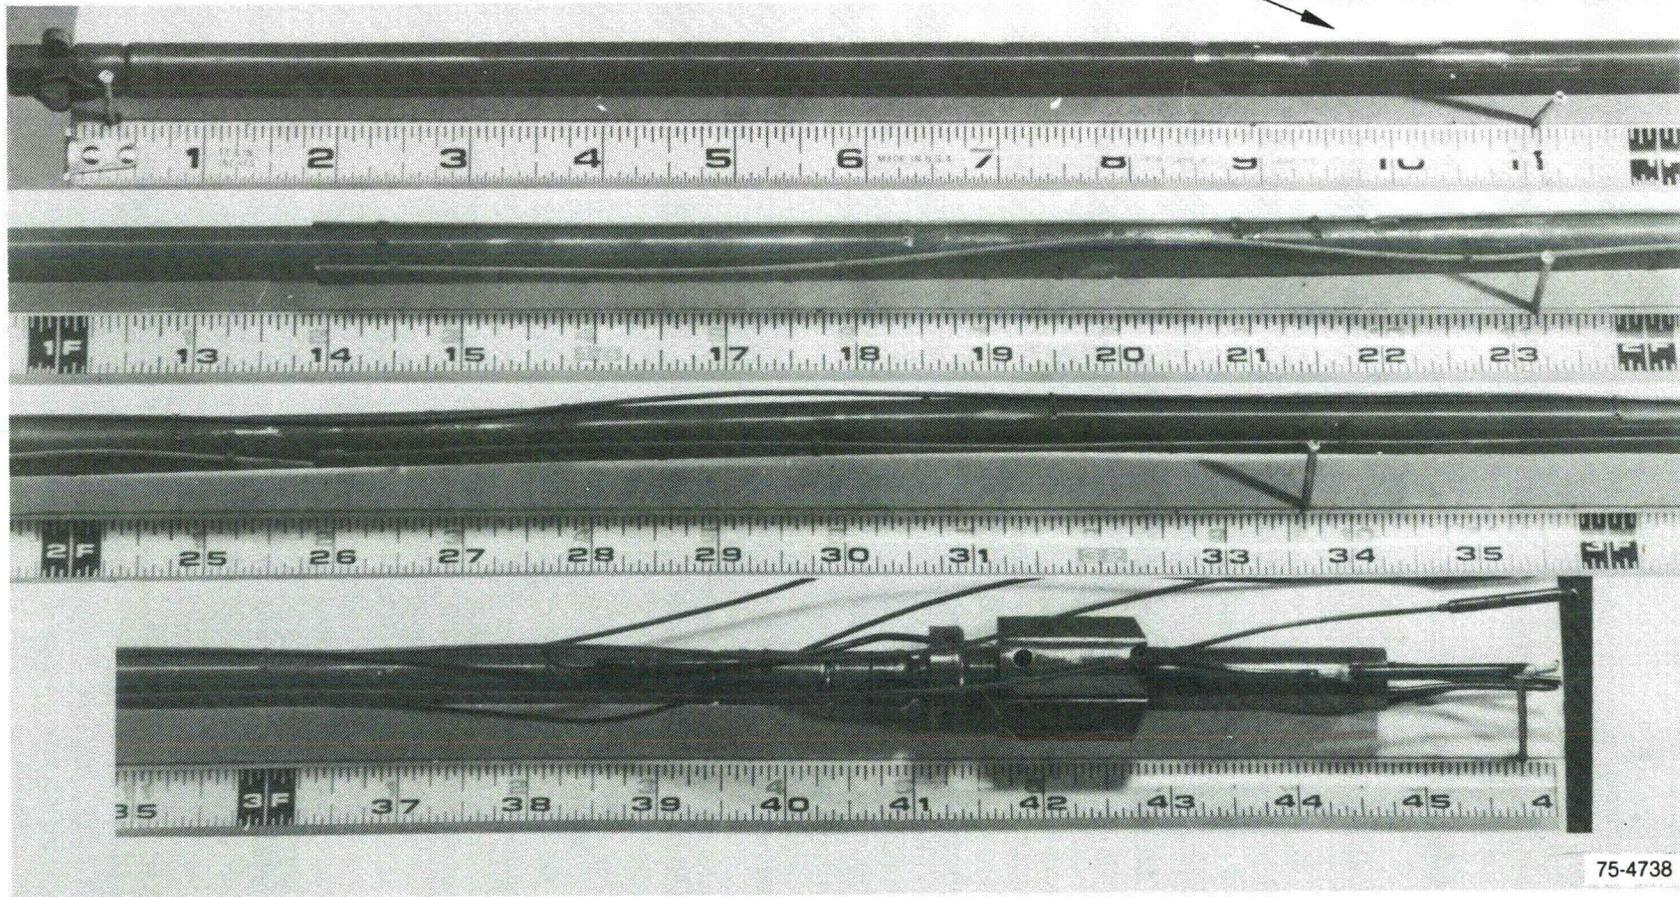
View of rod at higher magnification showing details of rod condition

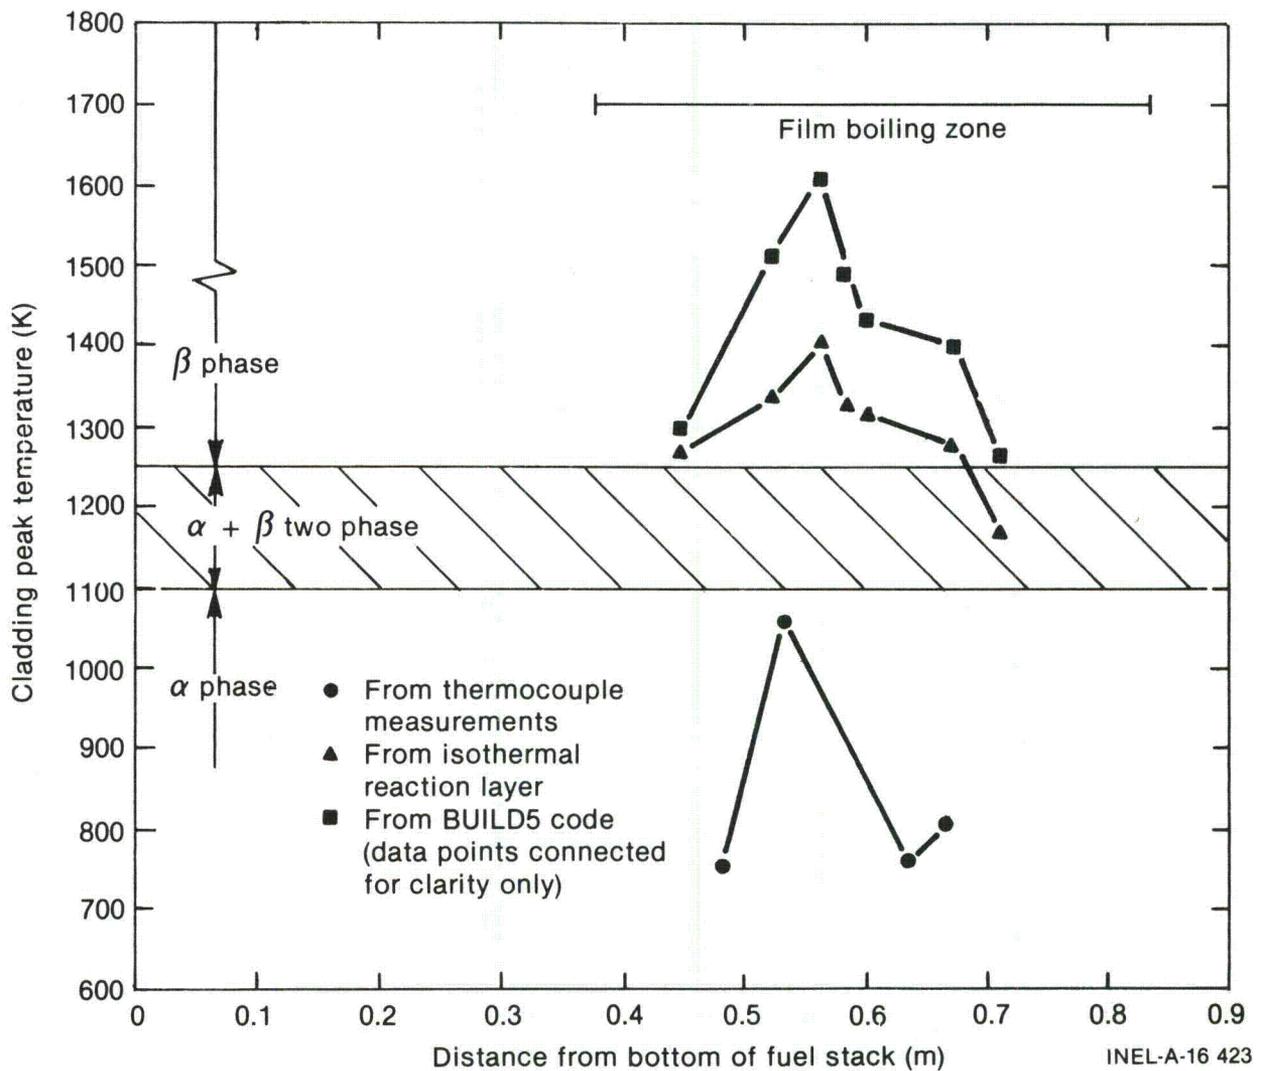
Figure 34. Cladding peak temperatures during Test CHF Scoping.

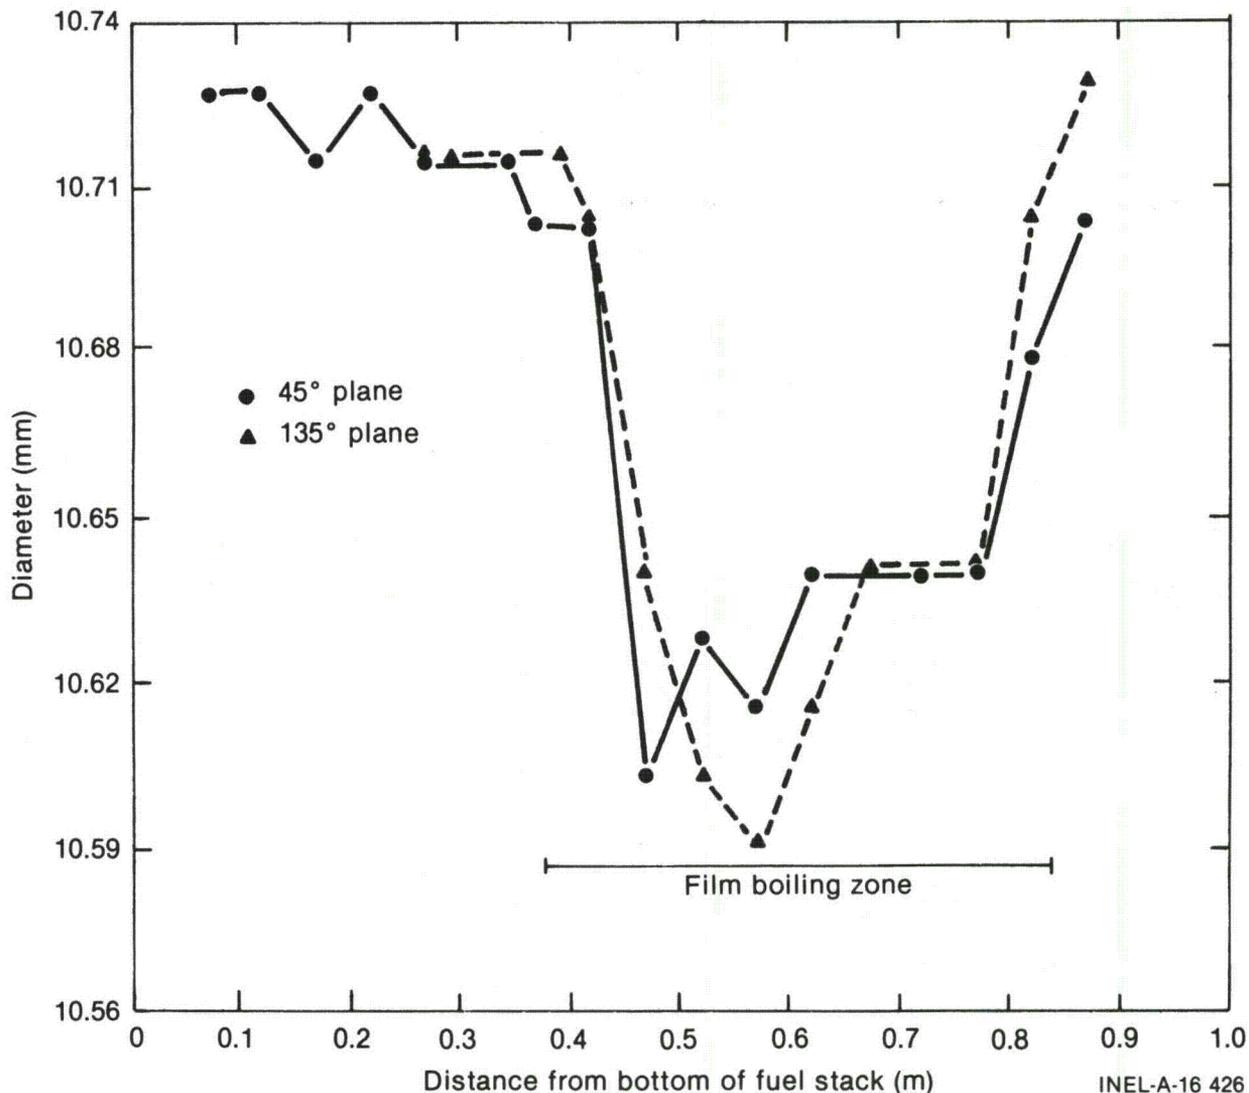
Figure 35. Diametral measurements of Test CHF Scoping fuel rod.

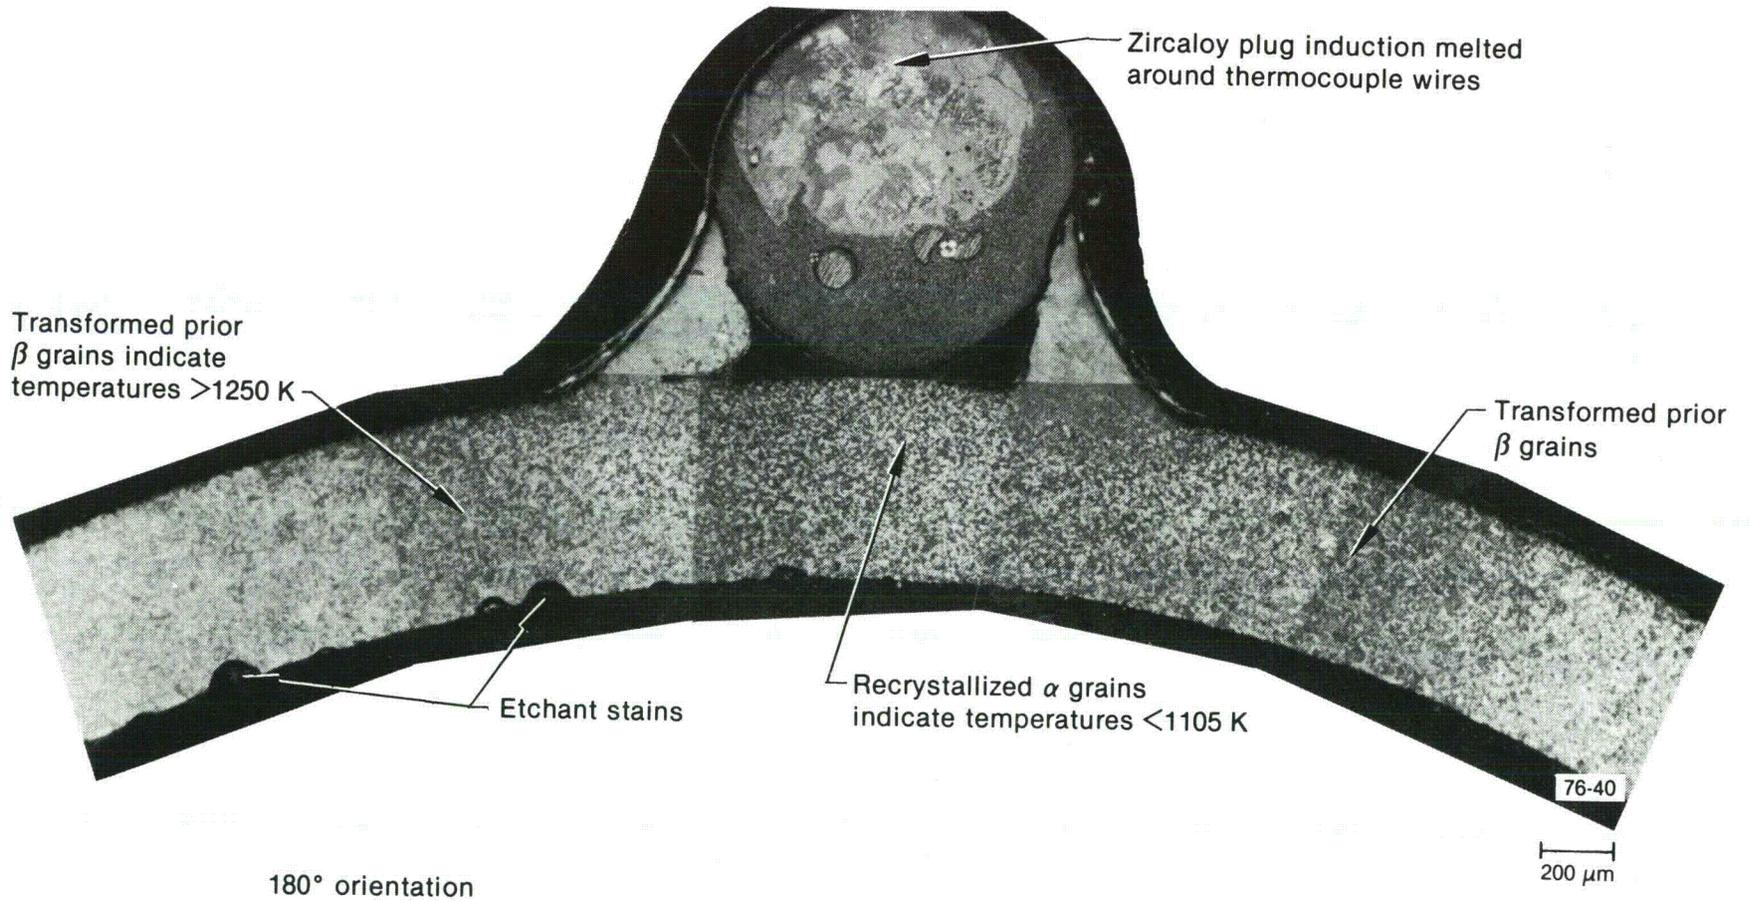
Figure 36. Transverse section of Test CHF Scoping fuel rod showing the microstructure near the 180-degree thermocouple on a plane located 0.525 m from the bottom of the fuel stack.

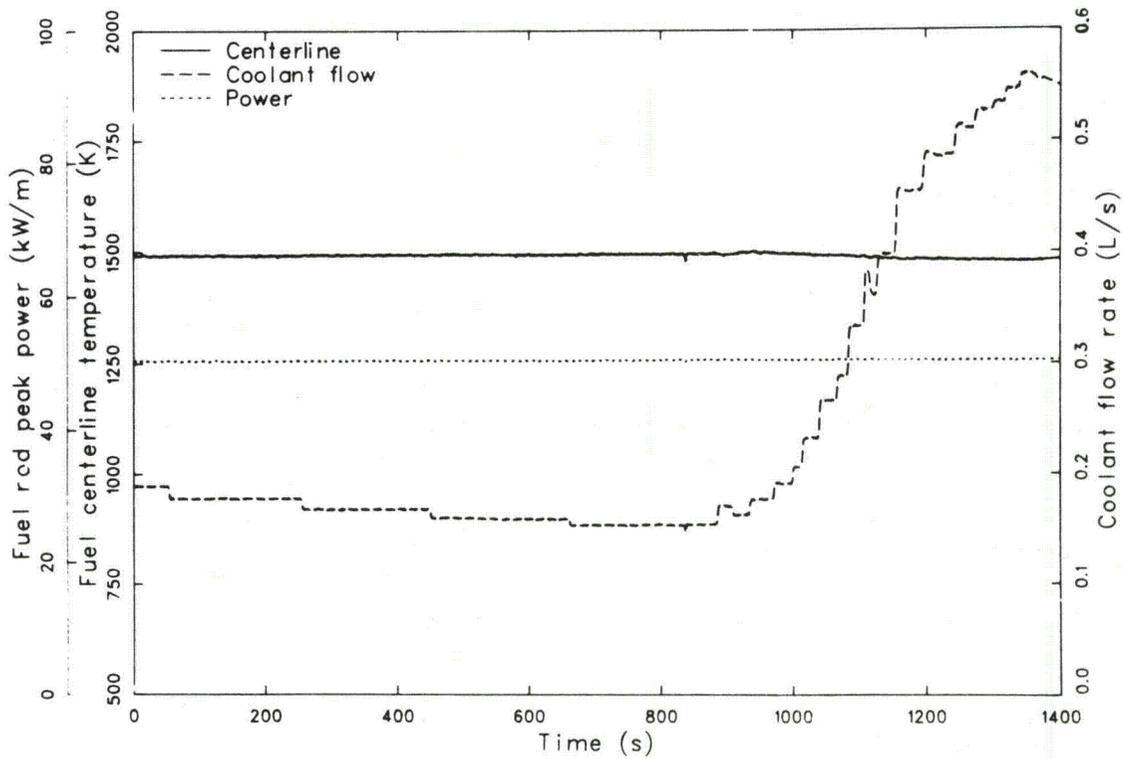
Figure 37. Fuel rod peak power, fuel centerline temperature, and coolant flow rate versus time during Test 8-1 RF (DNB Cycle 1).

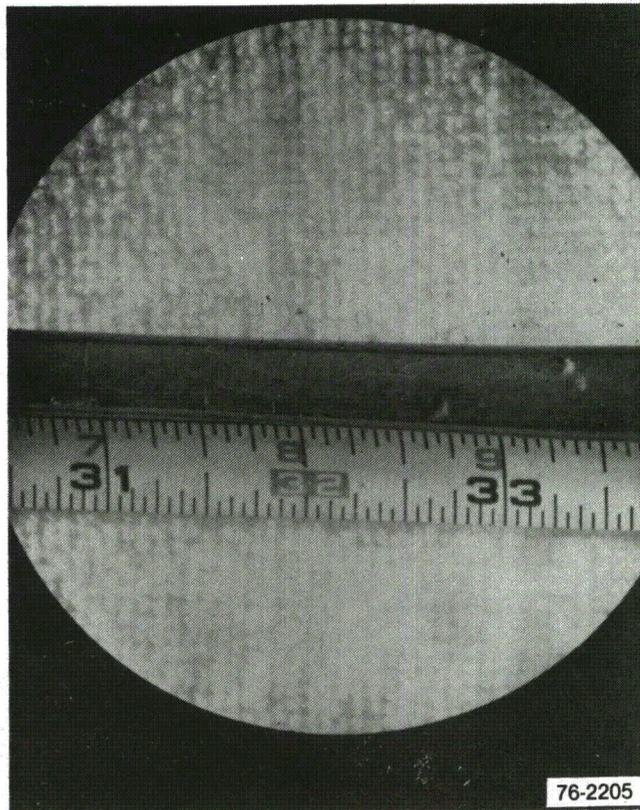
Figure 44. Cladding collapsed into interfaces and chipped regions at ends of Test 8-1 RF fuel pellets. The scale represents the distance from the bottom of the Test 8-1 RF fuel rod.

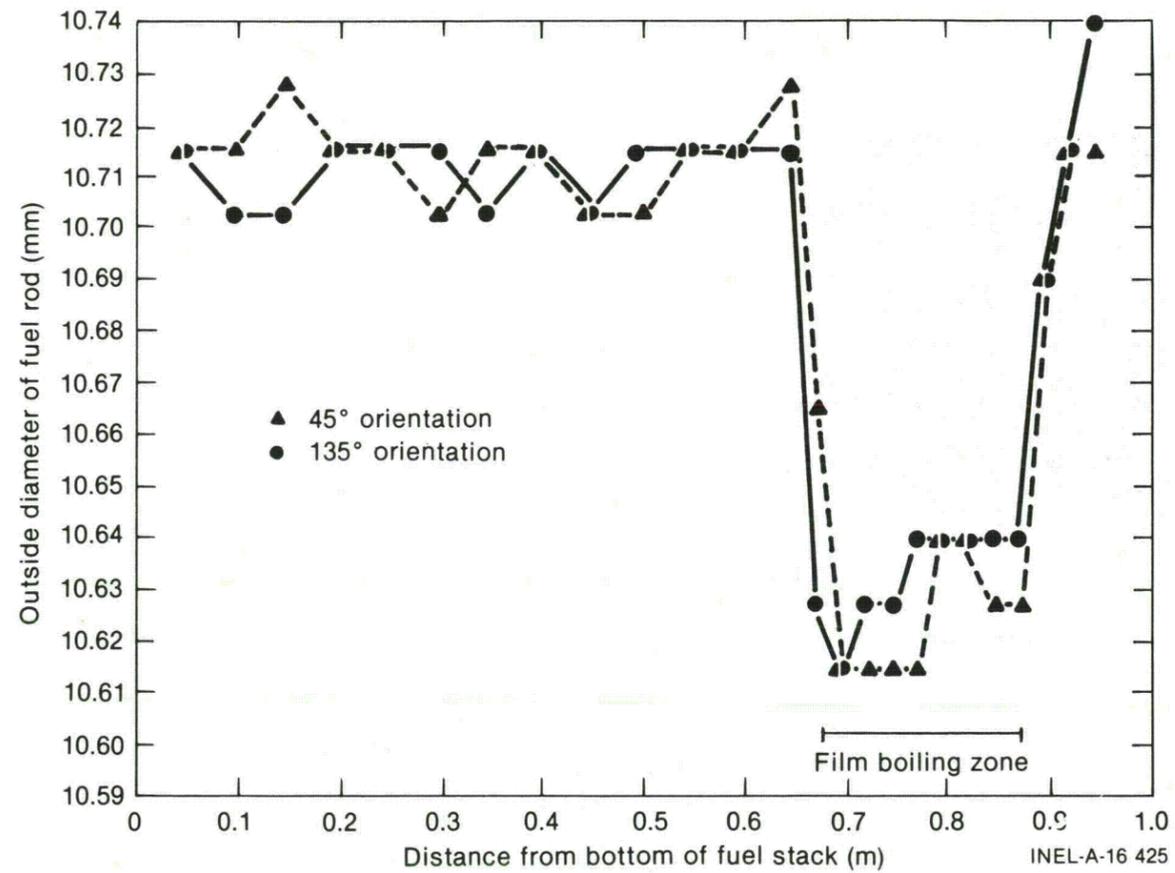
Figure 45. Postirradiation diametral measurements of Test 8-1 RF fuel rod.

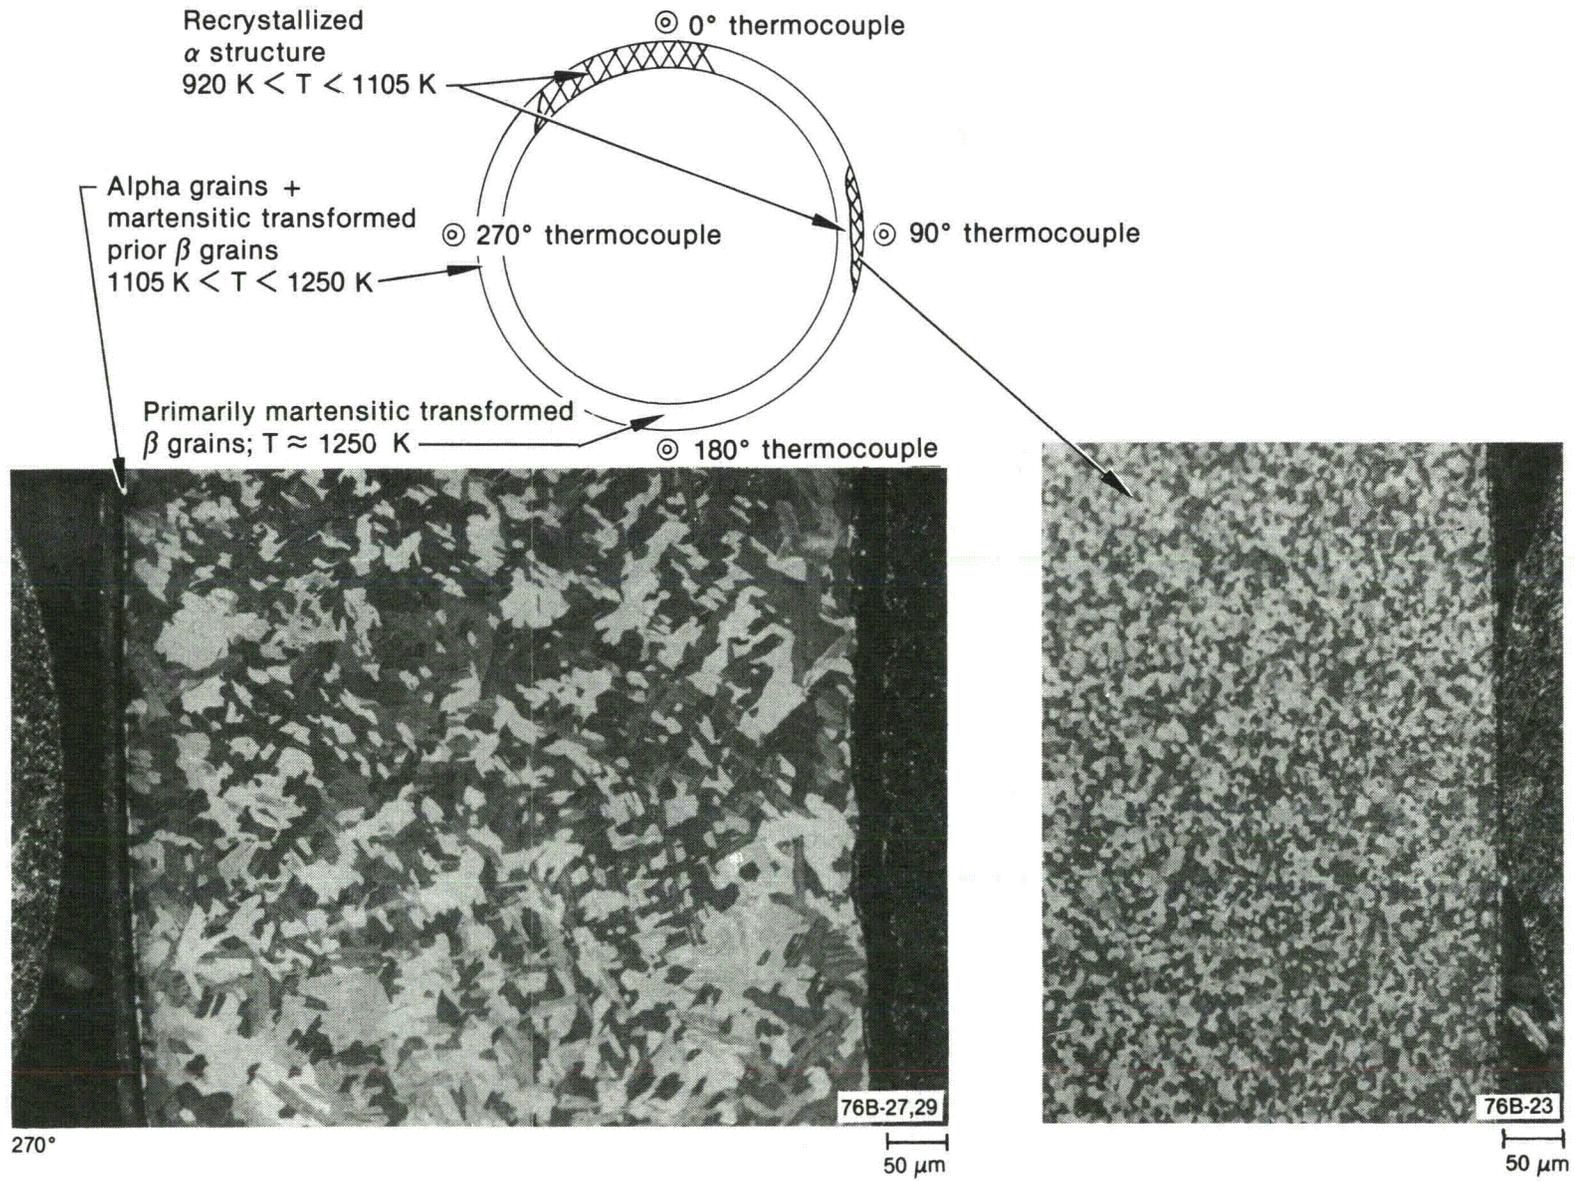
Figure 49. Transverse section of Test 8-1 RF fuel rod showing cladding microstructures observed 0.779 m above the bottom of the fuel stack.

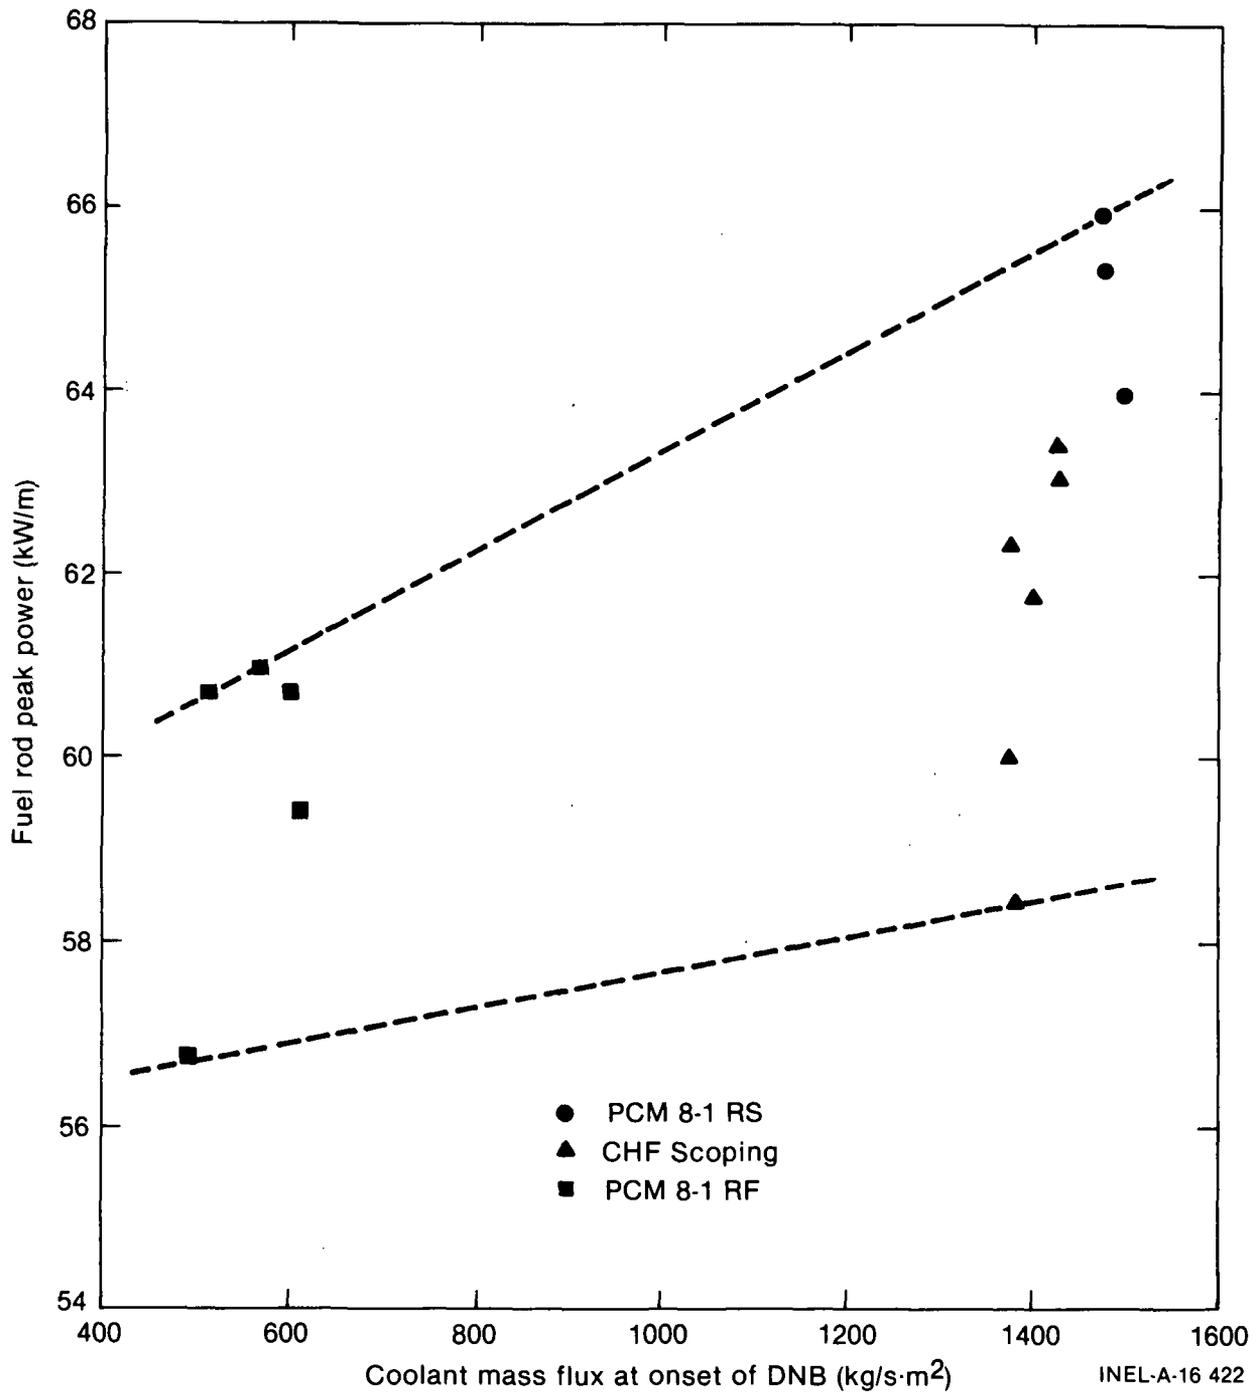
Figure 50. Power/flow at onset of DNB for Tests PCM 8-1 RS, CHF Scoping, and PCM 8-1 RF.

During Tests 8-1 RS and CHF Scoping, DNB first occurred at lower than expected fuel rod peak powers; this premature occurrence of DNB was attributed to adsorbed gases on the cladding surface. Performance of a cladding aging phase (1 h at 53 kW/m rod peak power) before the performance of the DNB cycles for Test 8-1 RF effectively eliminated the occurrence of premature DNB. Numerous self-terminating occurrences of DNB were detected during Test 8-1 RS. These occurrences may have been caused by inlet coolant flow variations, the control of which was improved for Tests CHF Scoping and 8-1 RF. During Tests 8-1 RS and CHF Scoping, the rod peak power at the onset of DNB varied from cycle to cycle. No consistent pattern was obvious; however, with the exception of the premature DNB occurrences, the variations did not exceed about 10% when considered in terms of the differences in coolant mass flow rates. Similarly, the measured coolant mass flow rate at the onset of DNB during Test 8-1 RF varied from cycle to cycle, but, again, not more than about 10% when considered in terms of the differences in fuel rod peak powers. Figure 50 shows the fuel rod peak power versus coolant mass flux at the onset of DNB for the three tests (the premature DNB occurrences during Tests 8-1 RS and CHF Scoping are not included). Calculated values of the fuel rod peak power or coolant mass flow required to cause DNB using the W-3<sup>10</sup> and B&W-2<sup>11</sup> correlations varied in terms of agreement with measured values. The W-3 correlation more closely predicted the experimental measurements; the calculated fuel rod peak powers at the onset of DNB were within 10% of measurements during Tests 8-1 RS and CHF Scoping, and the calculated coolant mass flow rates at the onset of DNB were within 40% for Test 8-1 RF.
