NUREG/CR-1715  
EGG-2061

# Fuel Rod Behavior During Tests PCM 8-1 RS, CHF Scoping, and PCM 8-1 RF

November 1980

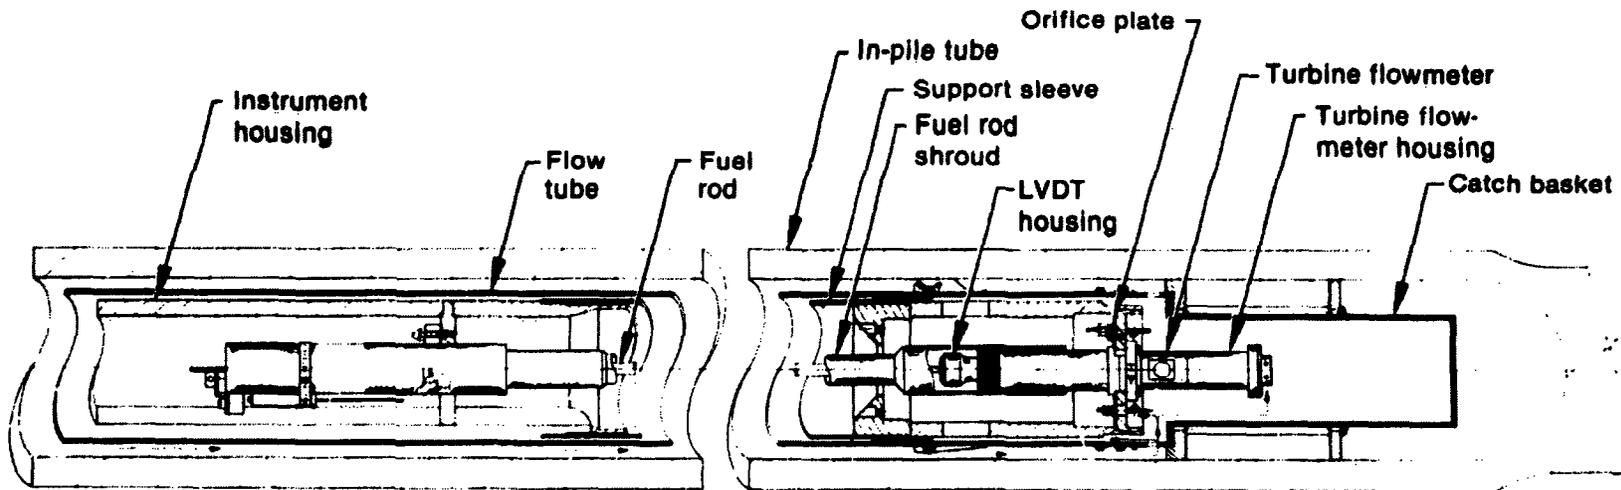
Figure B-1. Test 8-1 RS test assembly shown installed in PBF in-pile tube.

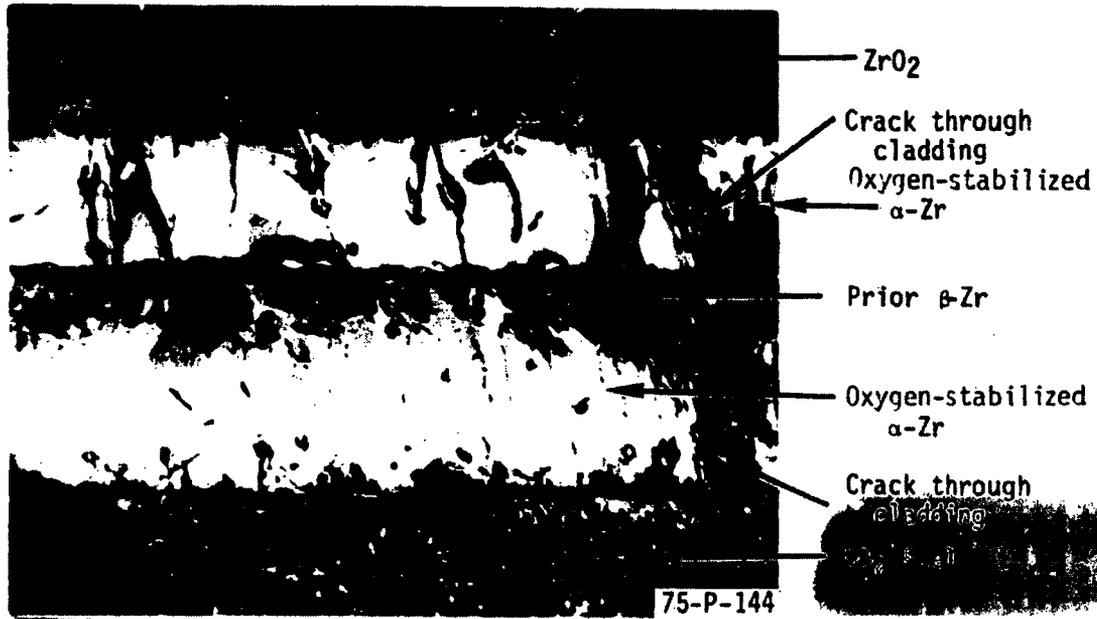
A. 100X

Figure D-6. Heavily oxidized cladding. Oxygen-stabilized alpha zirconium taking up most of cladding wall thickness, 24-1/2 in. from bottom of rod. Note crack through cladding (Test 8-1 RS).

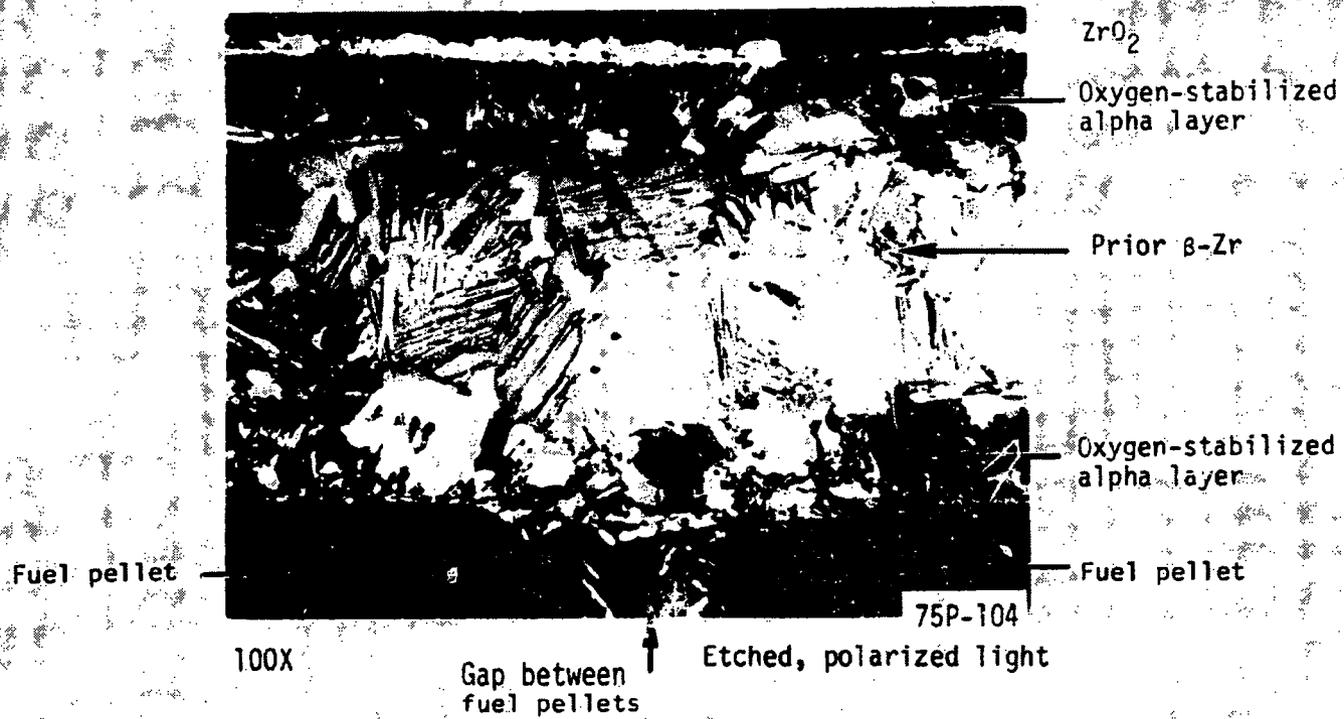
Figure D-7: Photomicrograph showing absence of oxygen-stabilized alpha layer on inner surface of cladding adjacent to gap between fuel pellets (Test 8-1 RS).

Oxygen-stabilized alpha layers of roughly the same thickness were observed on both the inside and outside surfaces of the cladding. The oxygen-stabilized alpha layer on the inside surface of the cladding is most likely the result of UO<sub>2</sub>-Zr reaction. The obvious disappearance of this layer in the cladding adjacent to the gaps between pellets (Figure D-7) is

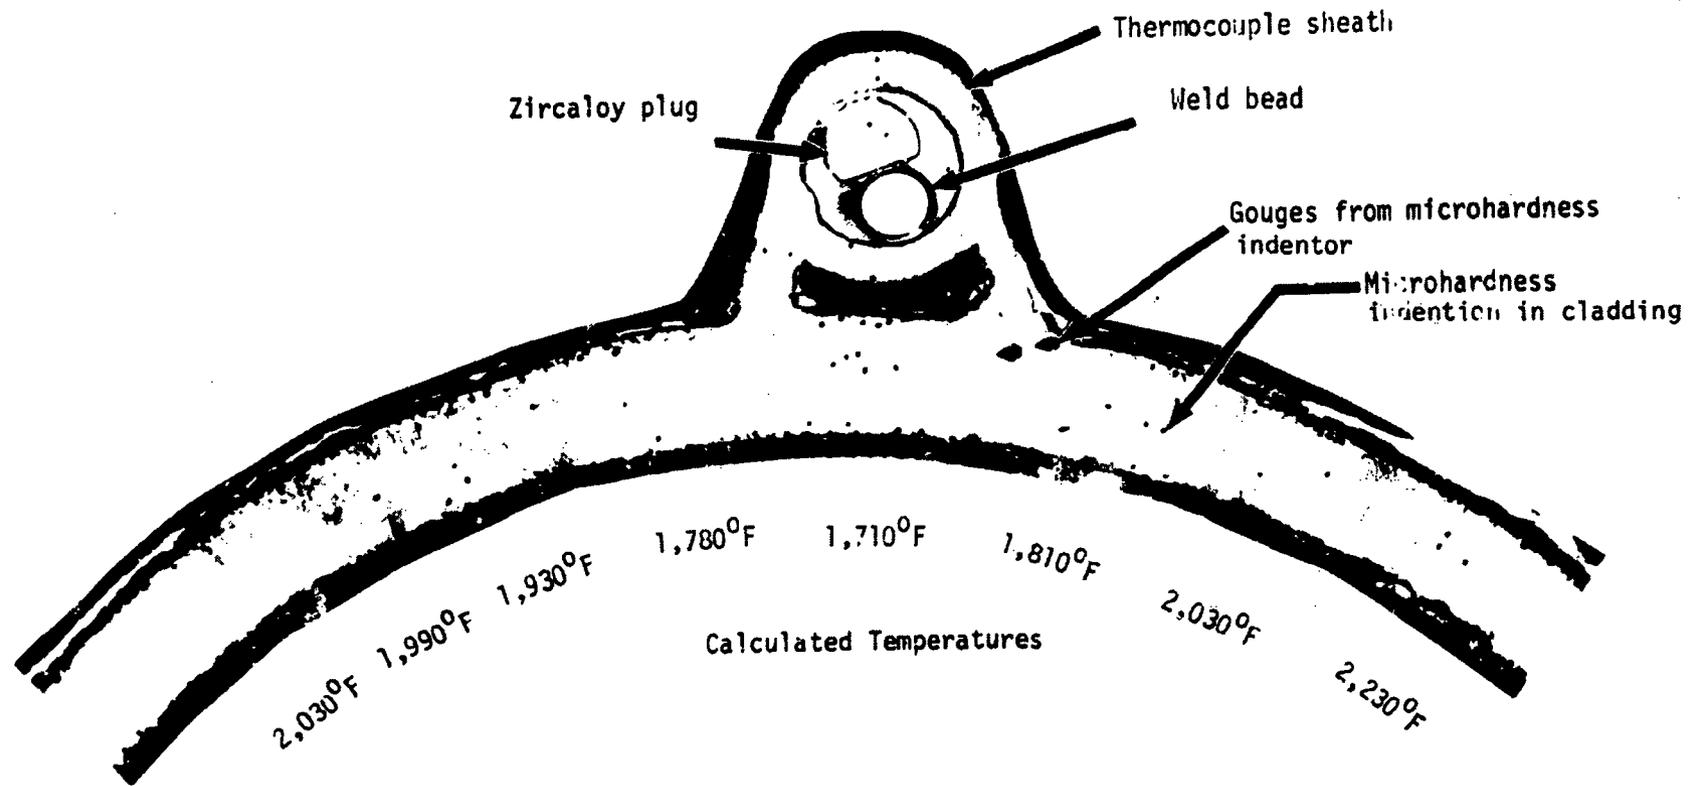
About 30X

Figure D-10. Composite transverse section of fuel rod showing microstructure in cladding near 25-in. thermocouple. Cladding temperatures have been estimated by the thickness of  $ZrO_2$  and oxygen-stabilized alpha zirconium and are displayed beneath each photomicrograph (Test 8-1 RS).

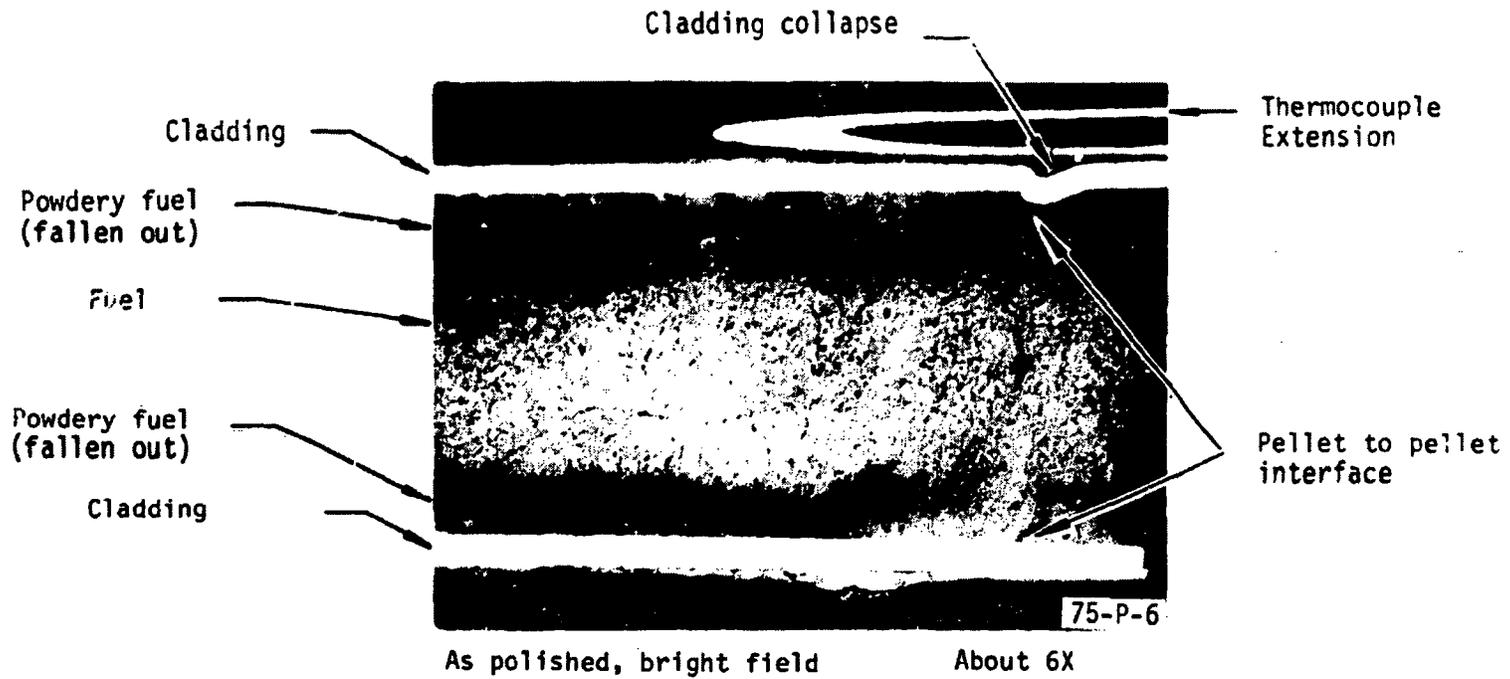
Figure D-11. Longitudinal section of fuel rod taken at about 27 in. from bottom of rod. Note that a portion of cladding has collapsed into a void between two fuel pellets (Test 8-1 RS).

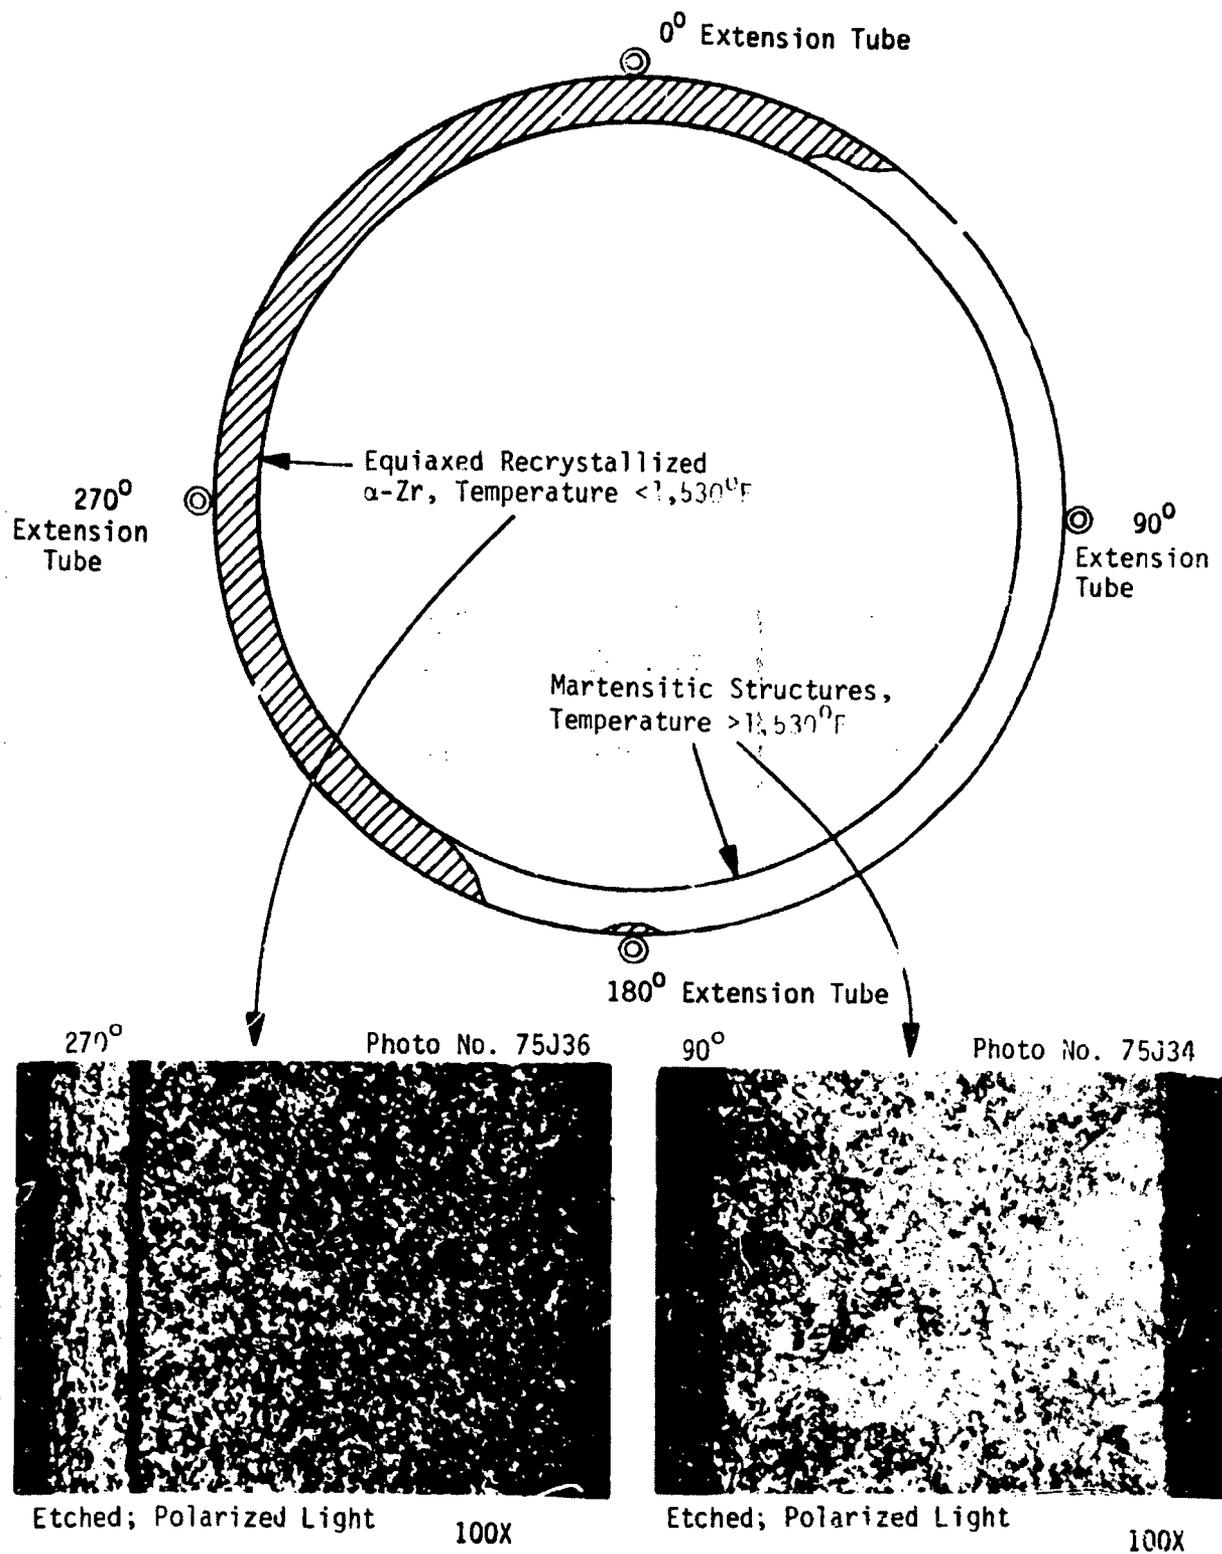
Figure D-24. Transverse section of Test CHF Scoping fuel rod showing microstructures, 17-11/16 in. from bottom of fuel stack.

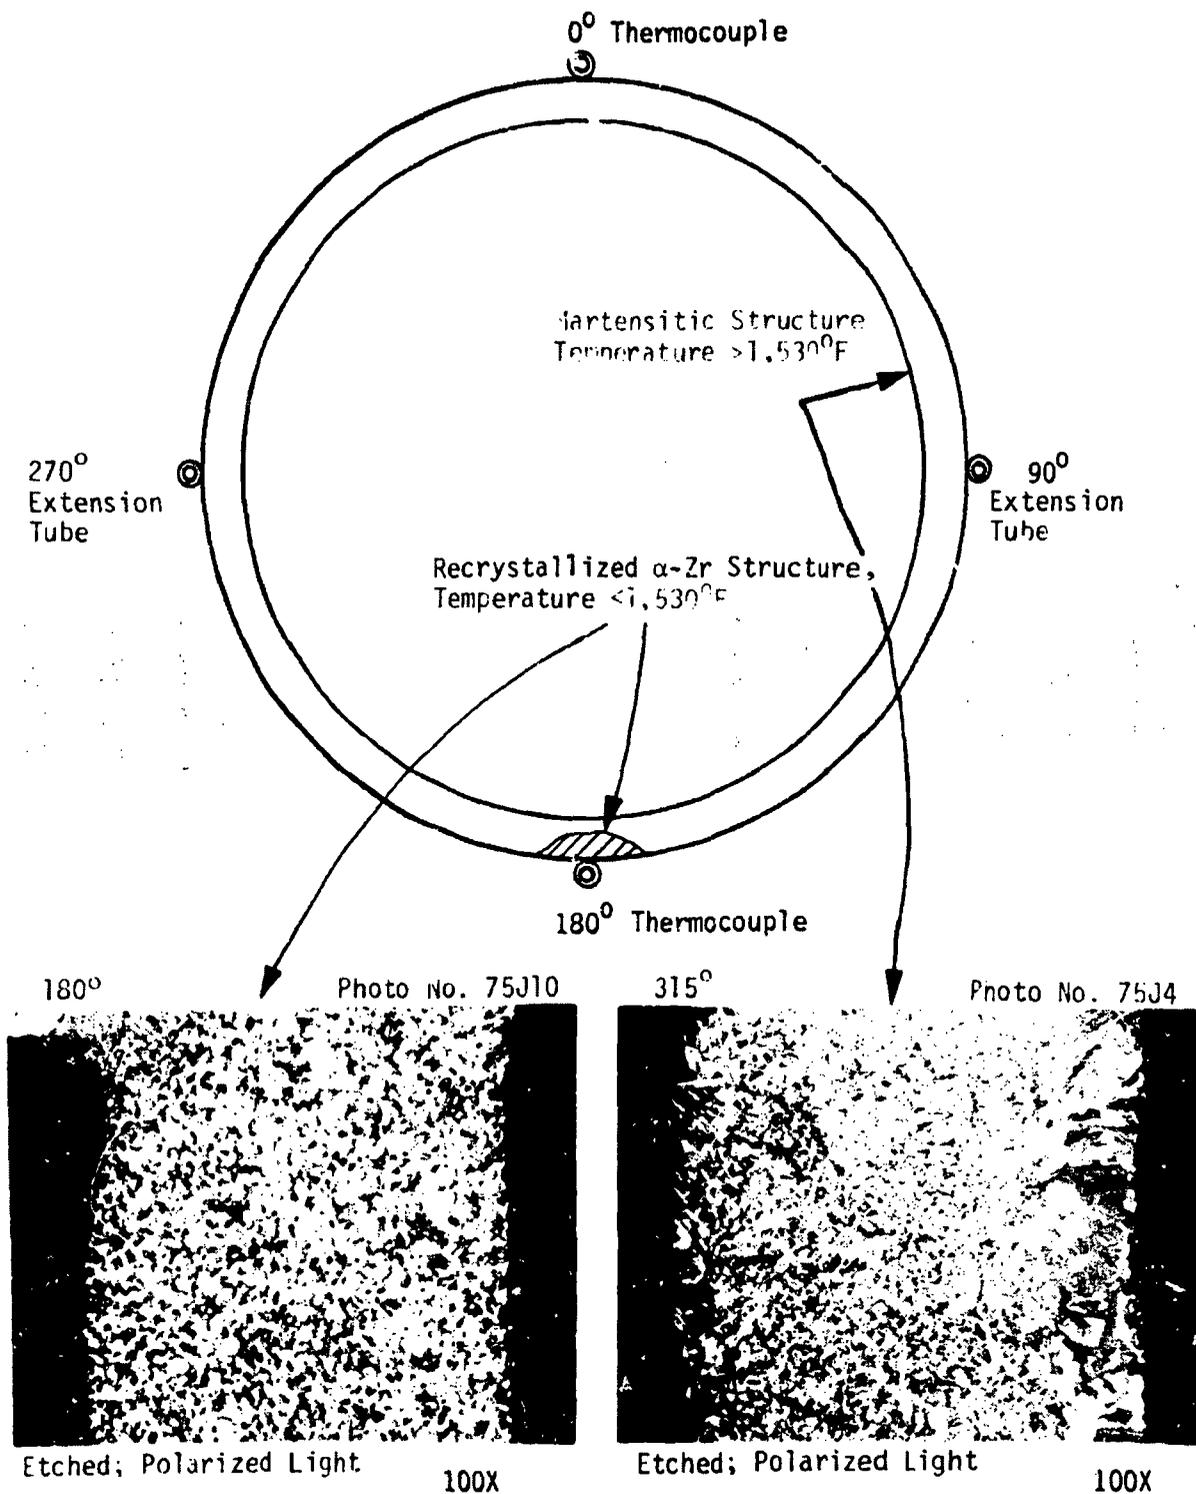
Figure D-25. Transverse section of Test CHF Scoping fuel rod showing microstructures on the plane of an external thermocouple, 20-15/16 in. from bottom of fuel stack.

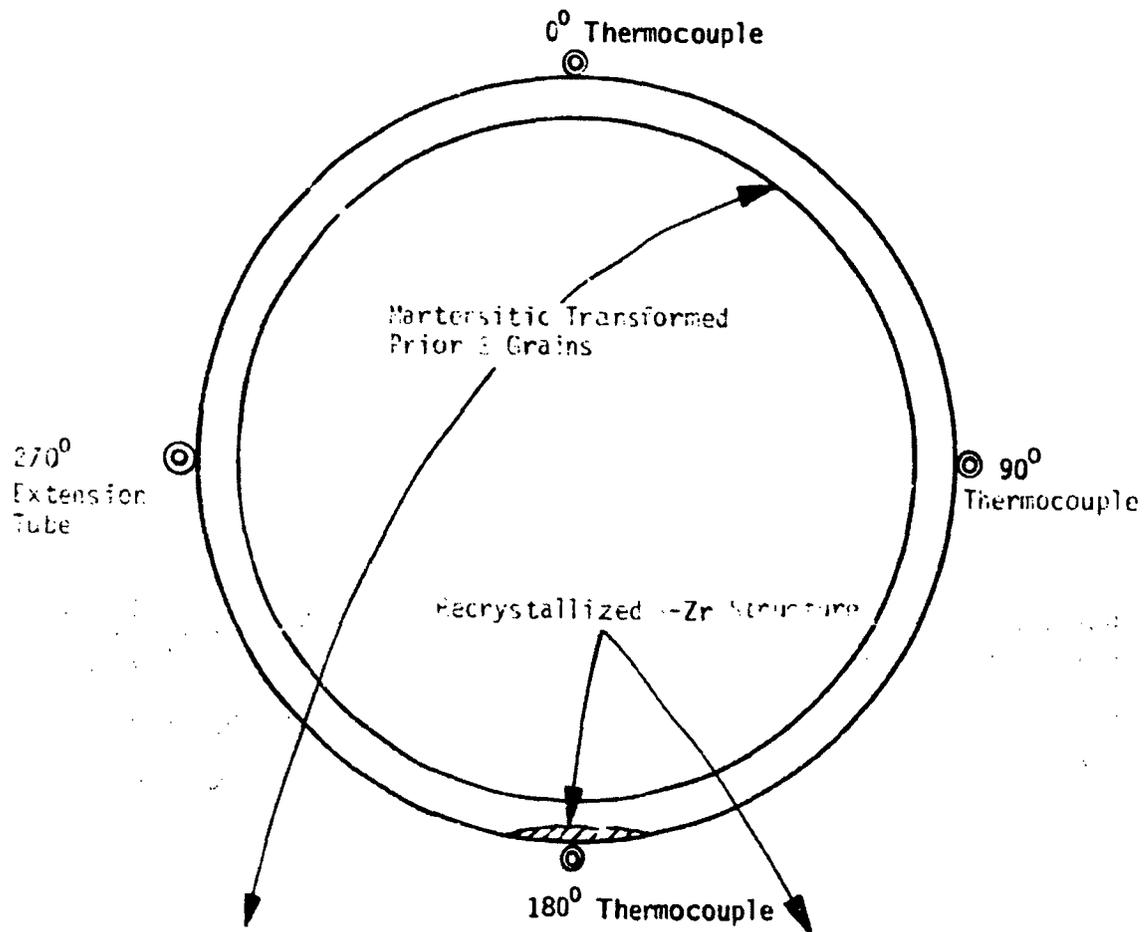
Figure D-28. Transverse section of Test CHF Scoping fuel rod showing microstructure, 26-11/16 in. from bottom of fuel stack.

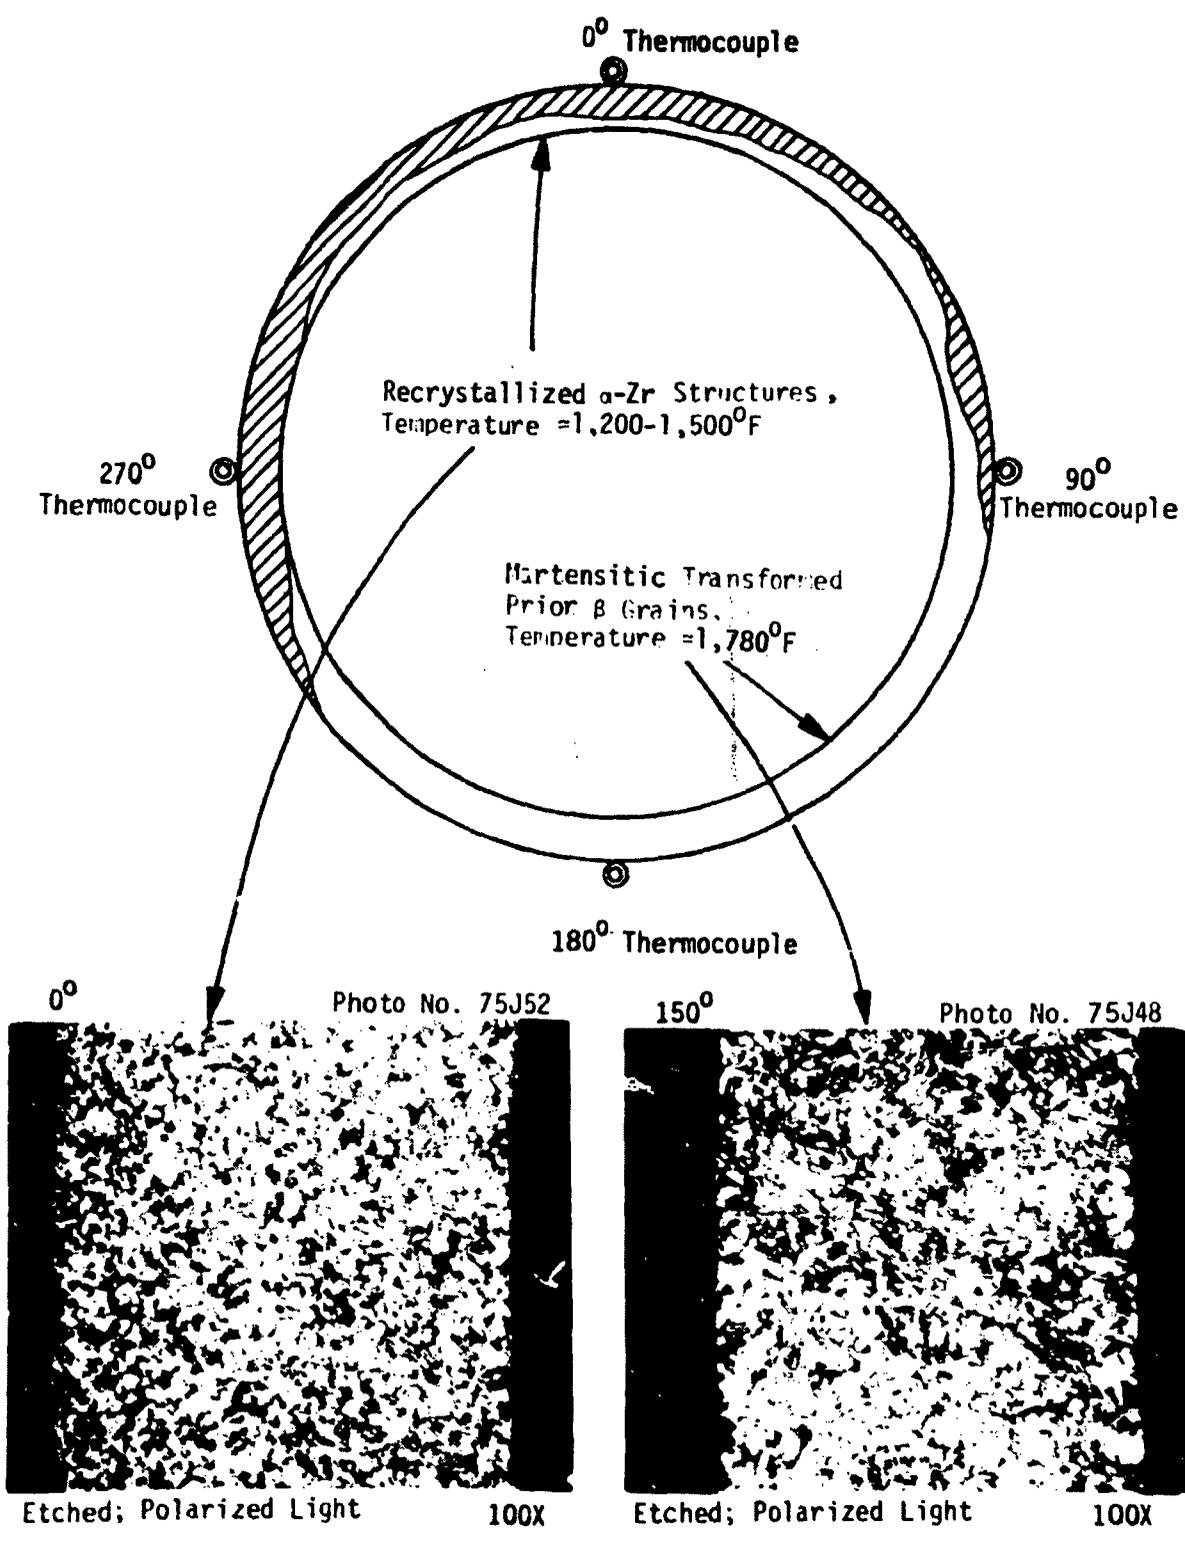
Figure D-29. Transverse section of Test CHF Scoping fuel rod showing recrystallized alpha zirconium and martensitic transformed prior beta grains, 28-3/16 in. from bottom of fuel stack.

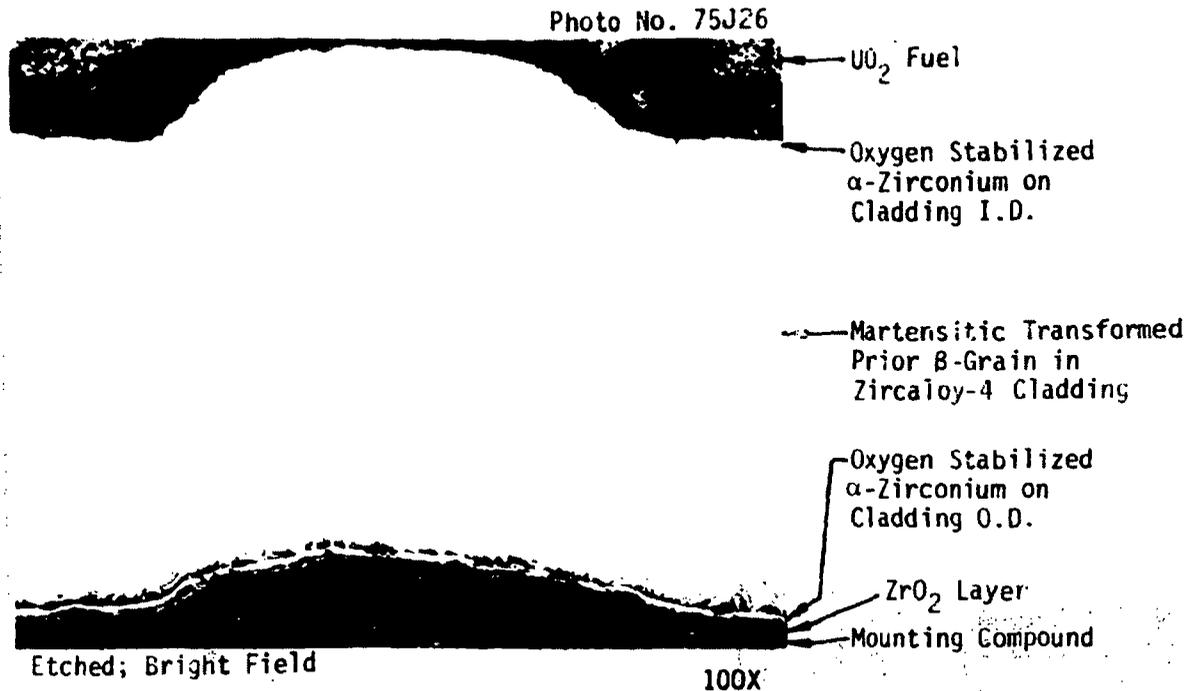
Figure D-31. Longitudinal section of Test CHF Scoping fuel rod showing collapse of zircaloy cladding into a gap between fuel pellets, 23-1/2 in. above bottom of fuel stack.

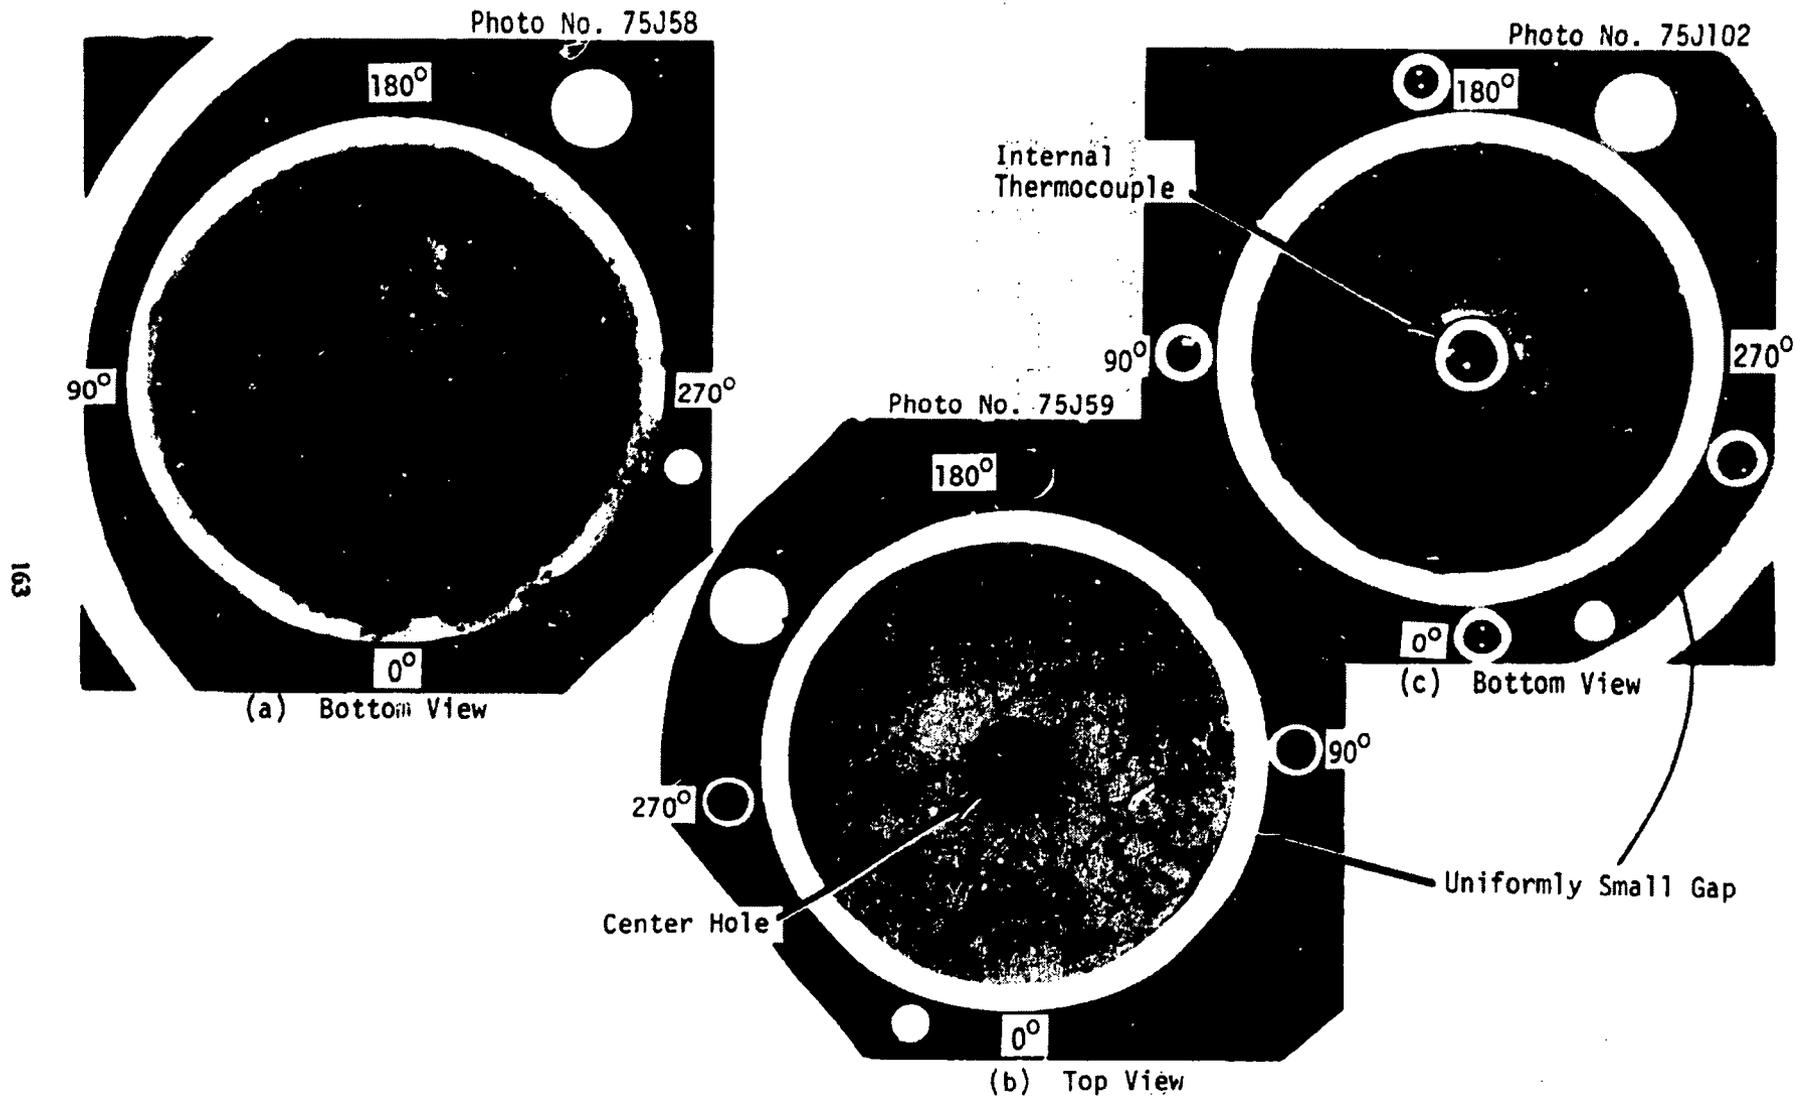
Figure D-32. Transverse sections showing macrographs of Test CHF Scoping fuel rod (a) 6-3/4, (b) 20-15/16, and (c) 26-11/16 in. from bottom of fuel stack.

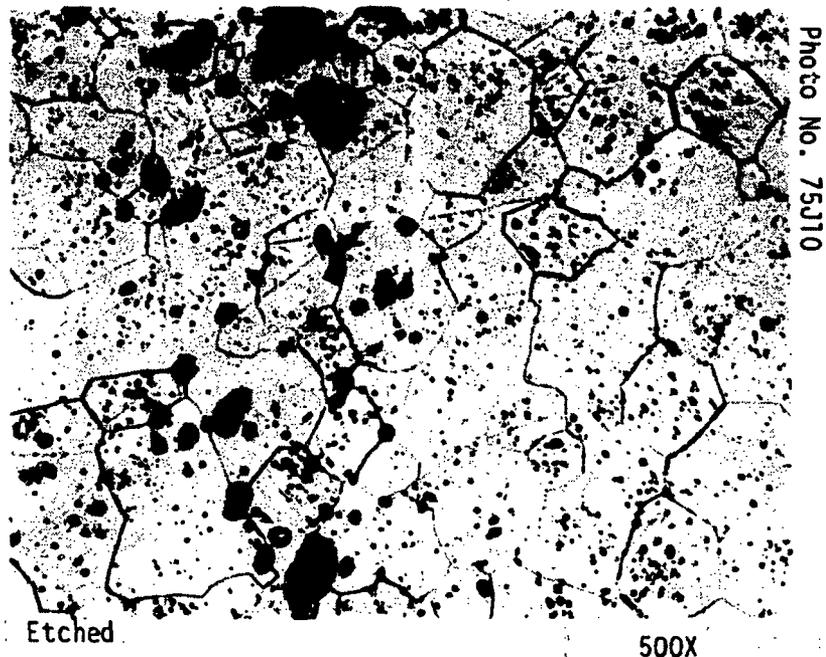
Figure D-35. Longitudinal section of Test CHF Scoping fuel rod showing  $UO_2$  microstructure at center of a solid pellet, 18-7/8 in. above bottom of fuel stack.

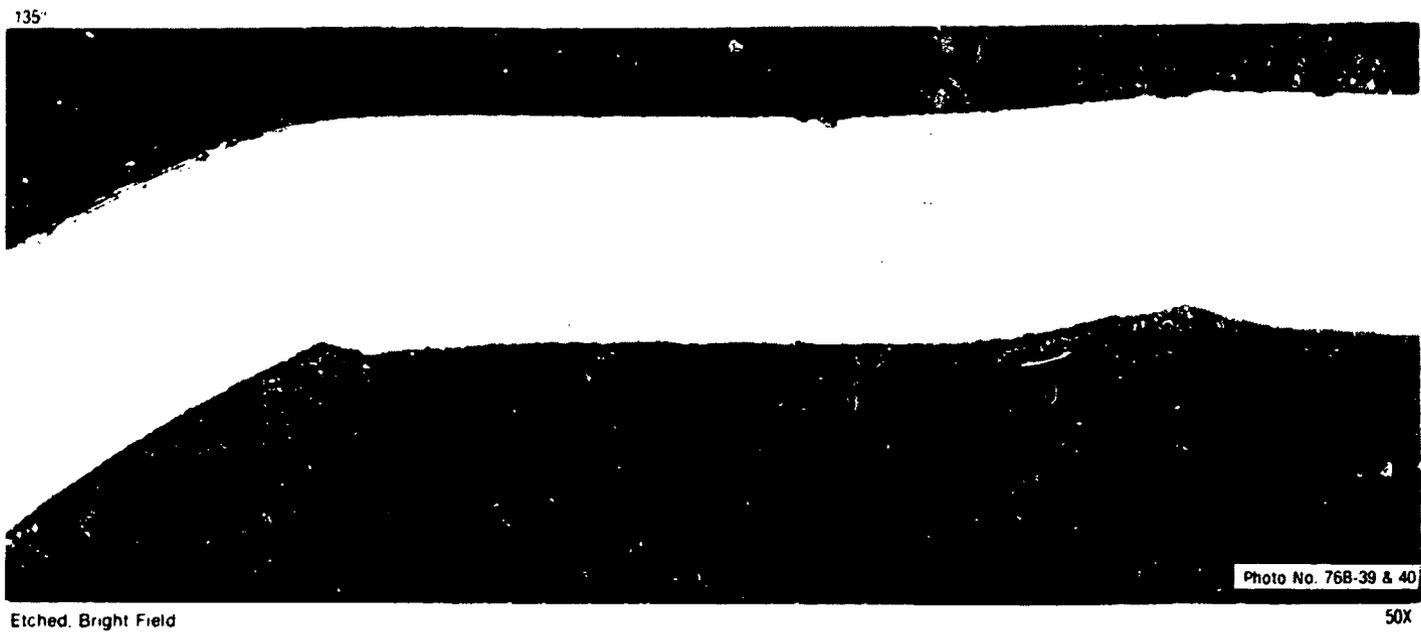
**Figure D-41.** Transverse section of Test 8-1 RF fuel rod showing collapse of zircaloy cladding into voids of a chipped fuel pellet, 30-11/16 in. above bottom of fuel stack. The cladding at an angular orientation of 135 degrees is not completely collapsed into the void.

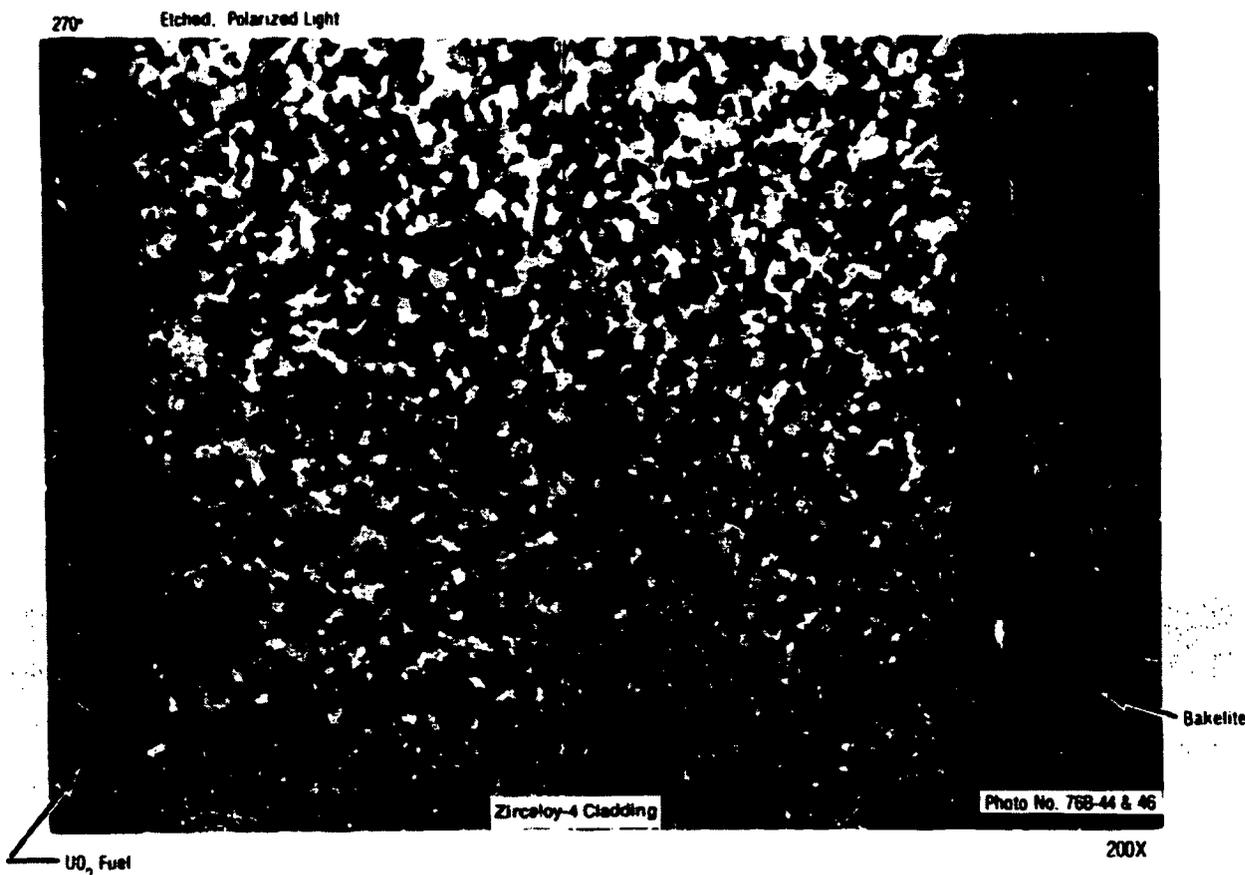
Figure D-45. Transverse section of Test 8-1 RF fuel rod showing equiaxed, recrystallized alpha grains representative of those observed over the entire transverse section, 32-15/32 in. above bottom of fuel stack.

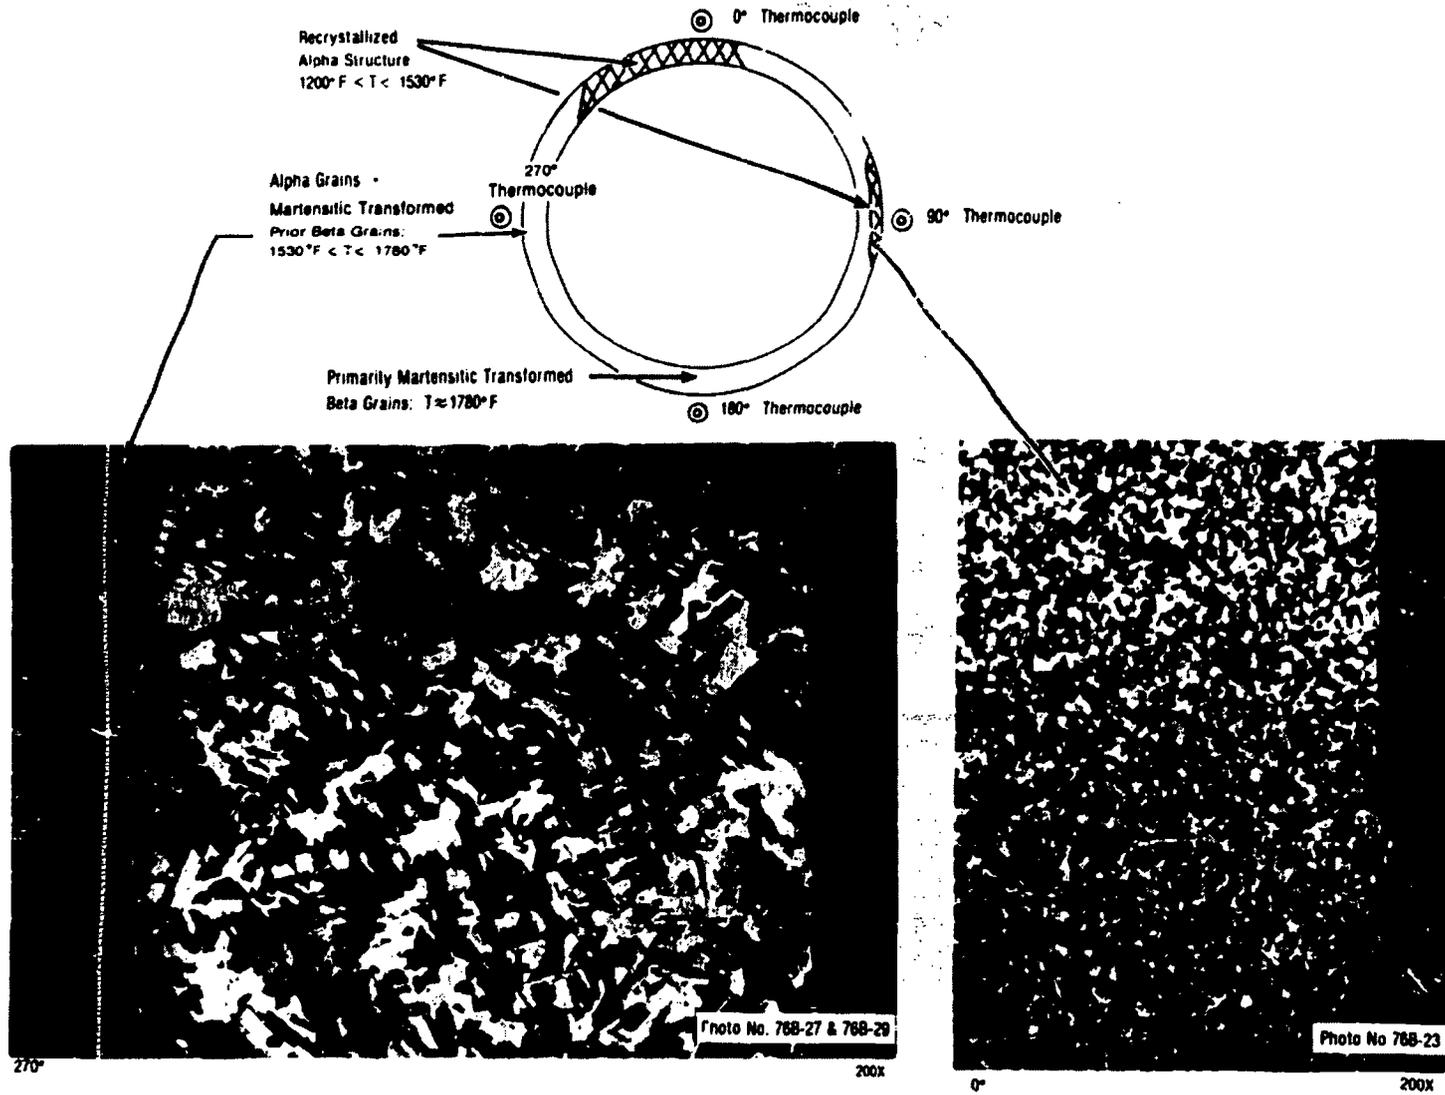
Figure D-47. Transverse section of Test 8-1 RF fuel rod showing microstructures, 30-11/16 in. above bottom of fuel stack.

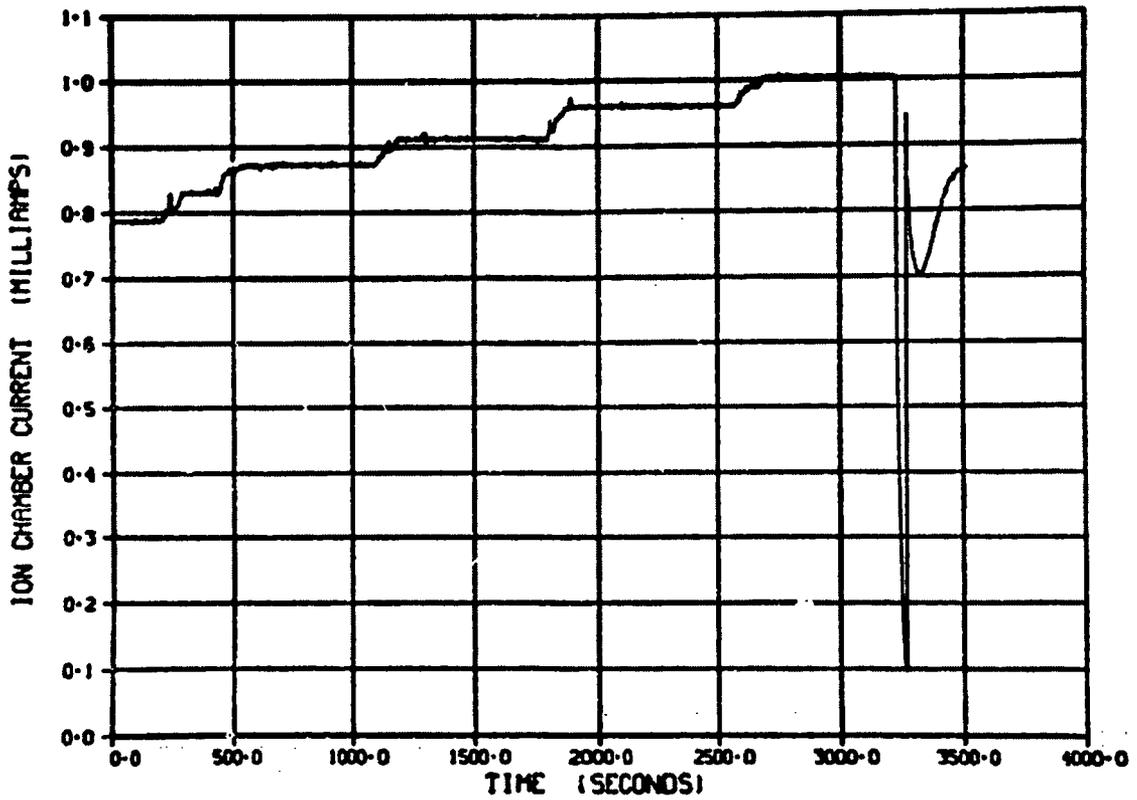
Figure E-3. Ion chamber current time history during Test 8-1 RS (Cycle 3).
