watershed inventory and analysis

3 watershed inventory and analysis

3.1 INTRODUCTION

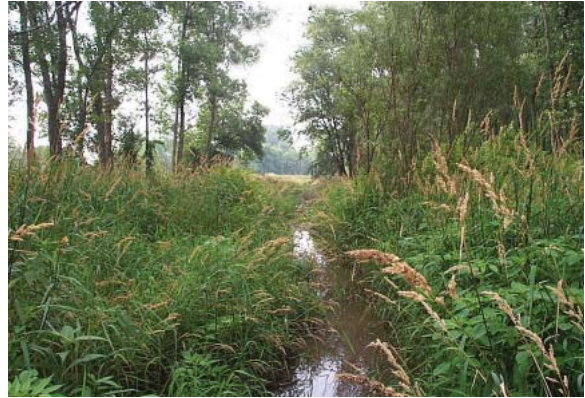
Bull Creek headwaters near Lewis Avenue (BL04).

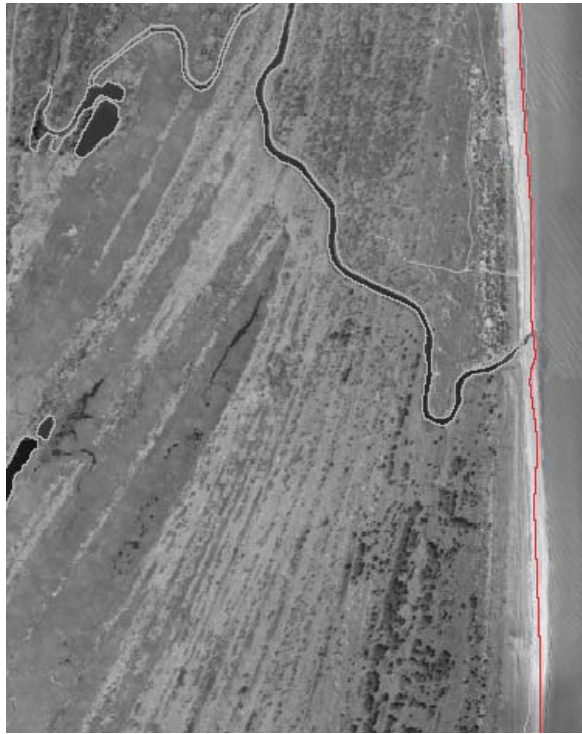
**FIGURE 3.2 ILLINOIS BEACH STATE PARK
DUNE AND SWALE SYSTEM**

expanse of coastal land formed by deposition and migration of a succession of nearly parallel beach sand ridges. Sixty-six acres of the globally rare Panne ecosystem type is found here. Pannes are groundwater fed wetlands found within the depressions between sand ridges or dunes. Coastal processes, such as waves, nearshore currents and fluctuating lake levels, cause the erosion, movement and distribution of sand and sediment along the Lake Michigan shore, which present shoreline erosion and coastal management issues. The net direction of this sand movement is southward due to prevailing winds from the north and northeast that push wave action south along the shoreline.

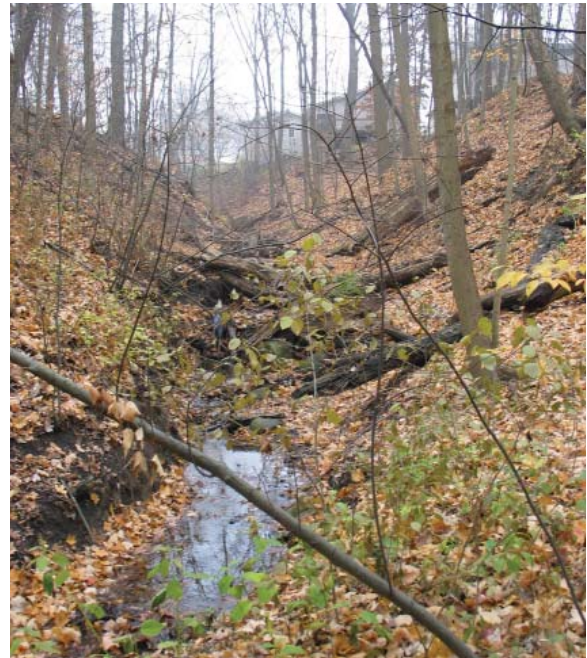
Typical ravine

The bluff and ravine system associated with the Lake Michigan coastal plain and Bull Creek deserves special mention because it is a unique landform feature. These ravines formed prior to European settlement when water running off the western areas of the watershed towards Lake Michigan found the path of least resistance creating a small channel down the eastern slope of the moraine. As more water followed this same course, the channel deepened until the ravines were deeply cut through the moraine. The locations of the ravines are illustrated in Figure 3.4.

Over time, the ravines developed some interesting characteristics. The incision of the ravines into the underlying soils eventually intersected with the groundwater table in some locations, and water slowly seeped out through the steep ravine banks. This water caused wetland-like conditions to develop at the bottom of the slopes, creating unique, [groundwater-fed growing conditions and plant assemblies called fens or seeps](#). These fens are rare in northeastern Illinois and deserve special consideration for preservation. These are described in further detail in Section 3.11.3.

impervious cover, and stormwater collection and conveyance systems, a greater volume of runoff water reaches the stream and ravines more quickly today than in the past, subjecting the relatively fragile slopes to more destructive runoff energy than prior to development. This increased speed and volume of runoff entering ravines has led to destabilization and erosion of the stream and ravine banks and incision of the stream bed. Debris blockages, common in ravines, can trap sediment and cause water to back up behind the blockage and, in some cases, cause flooding. Blockages also divert water towards the streambanks, further exacerbating erosion problems. Development near or adjacent to ravine edges and bluffs has further compromised these systems. Removal of vegetation for development reduces the stability of the soil and can cause significant and catastrophic bank failure, threatening property and infrastructure. Roof and footing drains direct water into the ravines, adding to erosional forces. The sensitivity of these ravine systems, combined with the problems associated with development of the watershed, create special management challenges for watershed stakeholders.

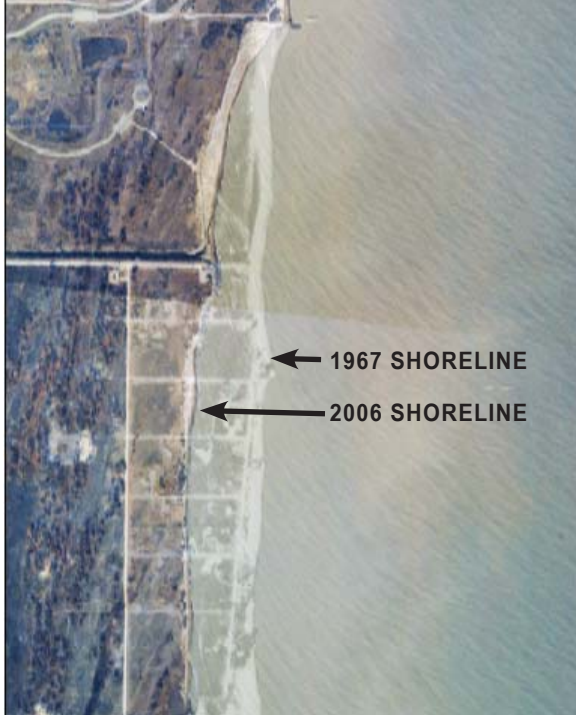
FIGURE 3.15 ILLINOIS BEACH STATE PARK SHORELINE EROSION

Sand movement along the Lake Michigan shoreline (also called *littoral transport*, see Figure 3.16) is a natural process driven by wind and currents that serves to regenerate and maintain the natural shoreline and the communities that depend on it. Some of the threatened and endangered species found in the park depend on this sand movement to maintain their habitat, such as the piping plover and Pitcher's thistle. However, beach erosion, driven by wind, water currents, and shoreline structures, is a major management issue for Illinois Beach State Park and has already caused the loss of a number of acres of beach and dune plant communities, including the unique Lake Michigan panne ecosystem type and habitat for threatened and endangered species. The area most affected by beach erosion extends generally from the marina south to the Zion Nuclear Power Station, but other areas may be more mildly affected. If this loss of beach continues, these species and the rare habitat that supports them, could be lost forever. Figure 3.15 shows the extent of erosion between 1967 and 2006.

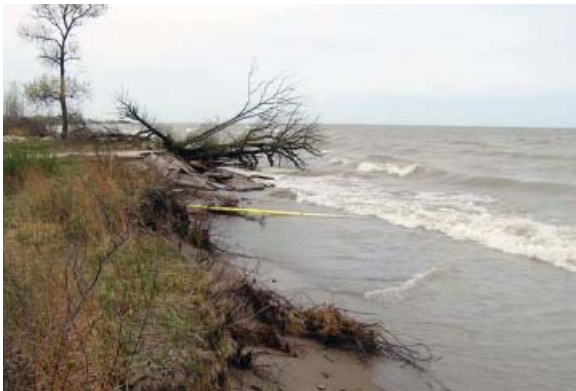
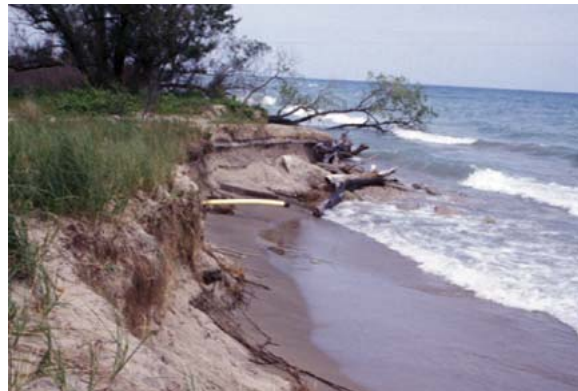
Beach erosion has exposed this buried pipe from 11 feet in 2003 to over 20 feet in 2005, Illinois Beach State Park

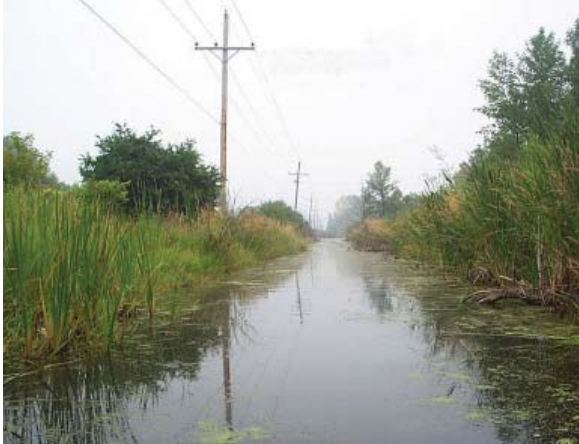
A channelized reach of the Glen Flora Tributary within Illinois Beach State Park

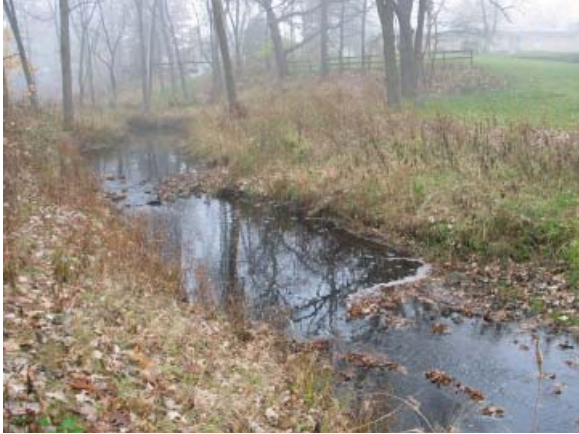
Relatively stable streambanks resulting from the Bull Creek stabilization project. (BL07)

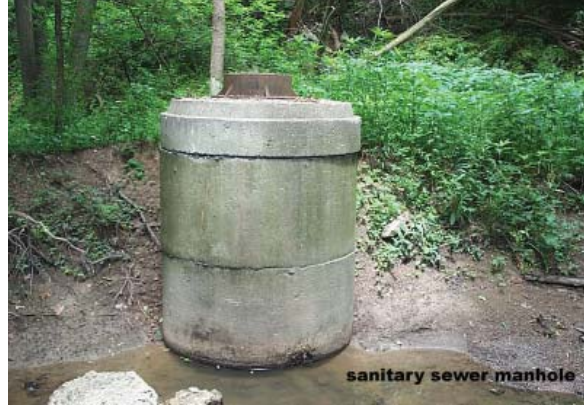
Exposed sanitary sewer manhole exposed by eroding streambank and streambed (BL08).

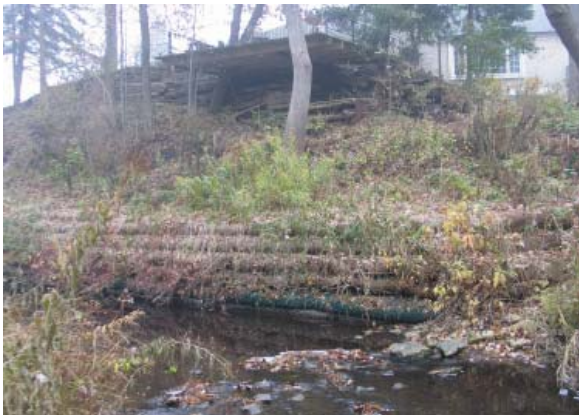
Soil lifts stabilizing the streambank, Bull Creek restoration project (BL07)

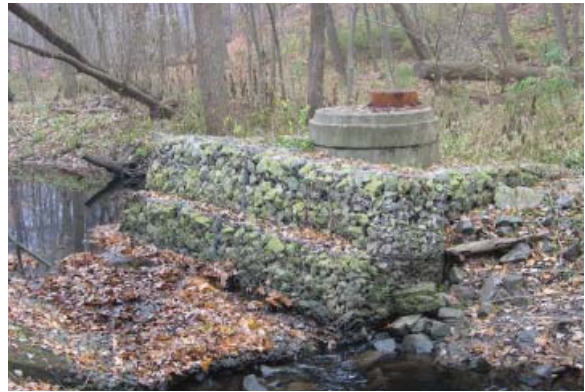
Structural, hard-edge protection for sewer infrastructure (BL08) protects the sewer but does not provide a natural stream habitat condition.

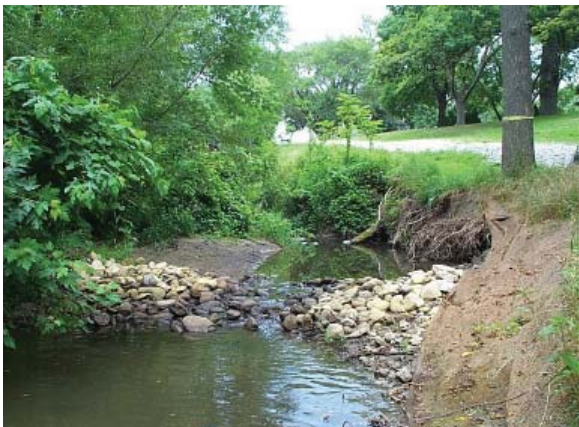
Artificial riffle installed in the downstream reach of Bull Creek to provide grade stabilization (BL07).

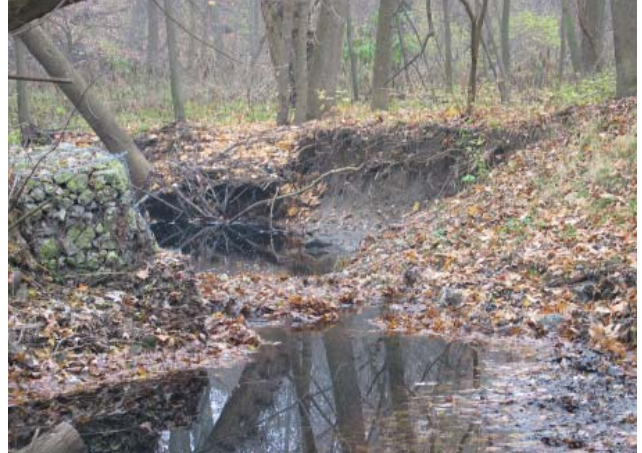
Erosion of the streambank opposite the sewer stabilization project (BL08).

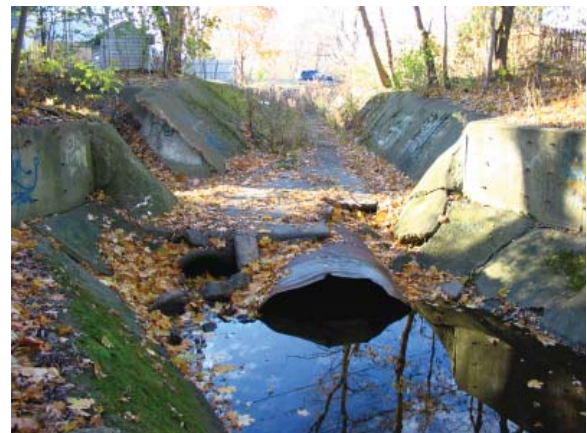
Severely impacted stream channel and armoring where reach BL15 crosses Wilson Street near Howard Street.

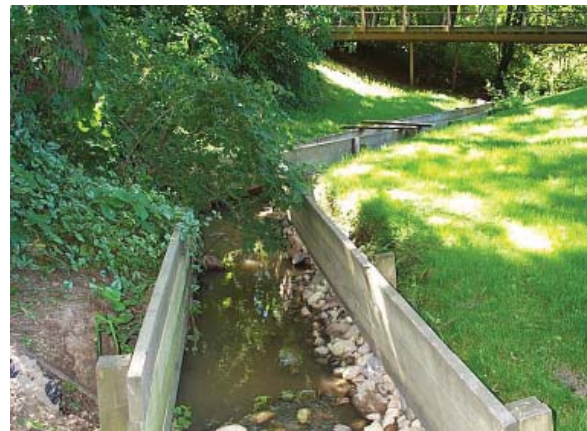
Armoring such as this wood retaining wall helps stabilize the streambanks but reduces the quality of the stream habitat for aquatic plants and animals (BL11).

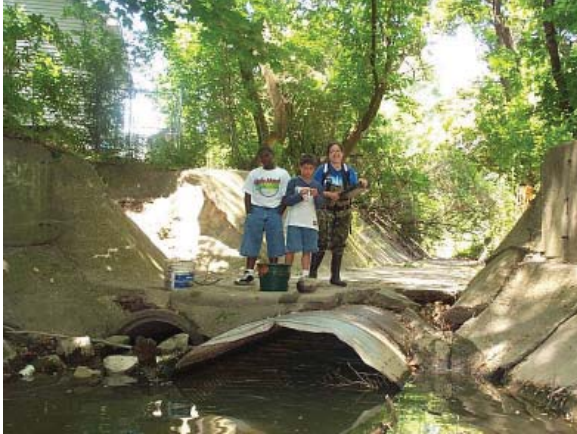
Severe streambank armoring and channelization improves flow but has significant detrimental effects on channel health and habitat quality (convergence of BL13, BL14, and BL15)

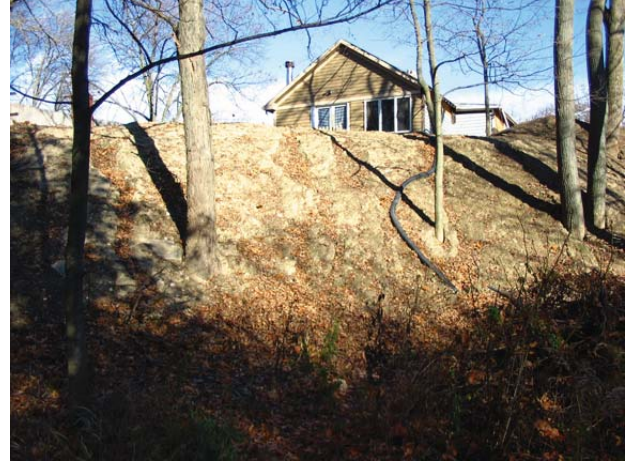
The bare dirt in this photo appears to have been recently deposited on the slope of this ravine, and the plastic residential drain installed so that it discharges runoff onto the slope, which causes erosion, rather than into the bottom of the ravine, which is the preferred discharge location for these types of drains (BL12).

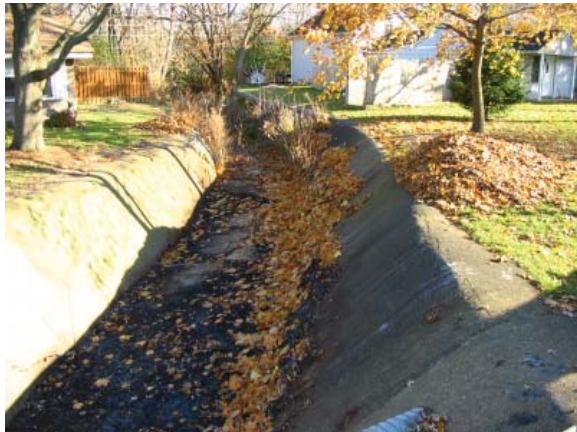
Cement-lined stream channel armoring is often used to stabilize and eroding channel and improve drainage, but it destroys the natural channel and is not supportive of a healthy stream condition. (BL15)

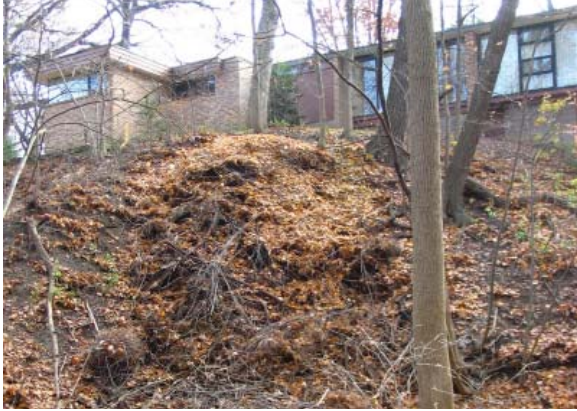
Yard waste dumping into ravine (BL02) contributes nutrients to the stream and smothers ground vegetation that helps hold the slope in place. Yard waste should be composted, applied as mulch, or disposed of in yard waste collection facilities.

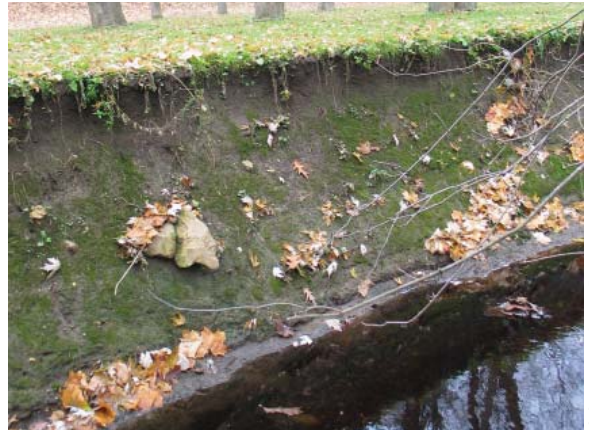
Severe streambank erosion causes sedimentation in the stream and loss of property (BL19).

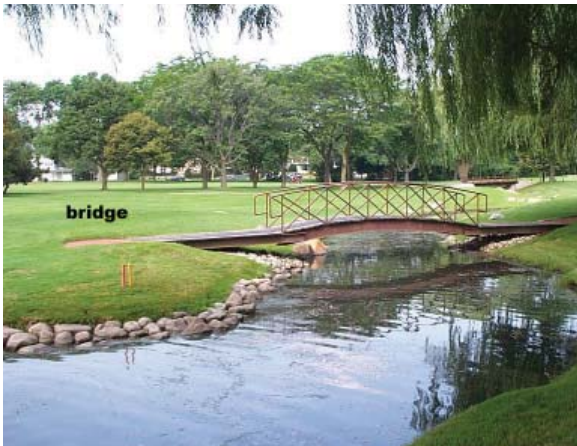
The turf grass and rock stream edges in Glen Flora Country Club should be converted to native plant edges to help hold the banks in place and filter runoff from the golf course, thereby improving water quality (BL03).

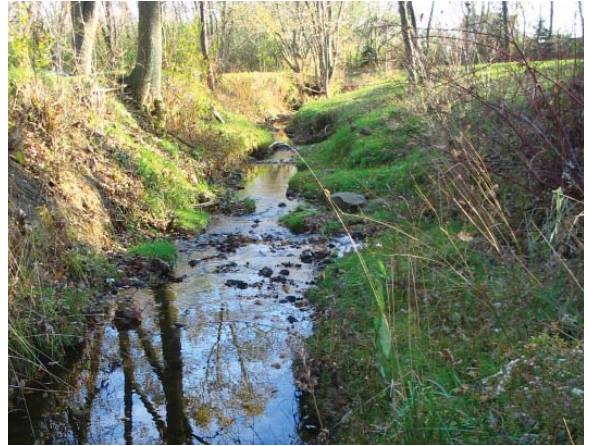
Streambank erosion and bank slumping (BL16) illustrates the effects of stormwater runoff.

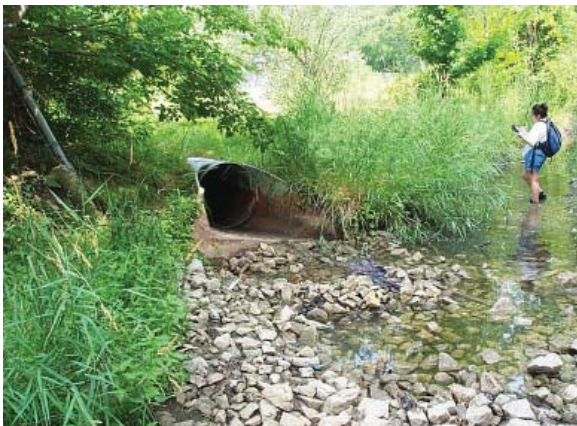
Stormwater outfall stabilized with rock rip rap (BL04).

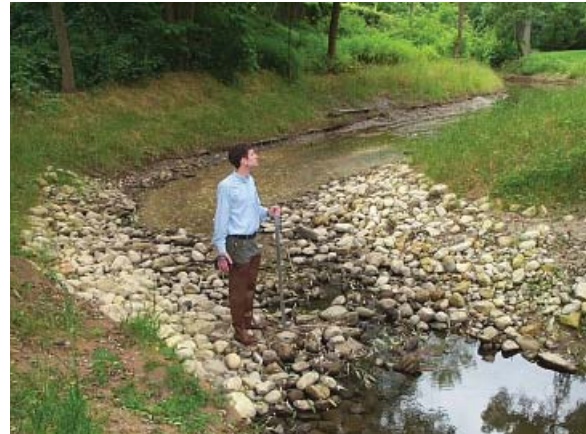
Rock riffle installed over exposed sanitary line to protect it.

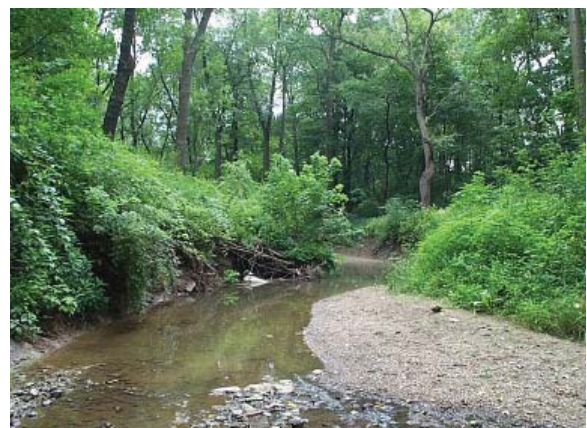
Relatively stable reach of Bull Creek (BL07) channel shows gravel and sediment that have been transported from upstream by water flow and deposited here where the stream gradient is fairly flat.
