Calvert Cliffs GSI-191 Program

Chemical Effects Testing Update
Option 2b Closure Approach

August 2015

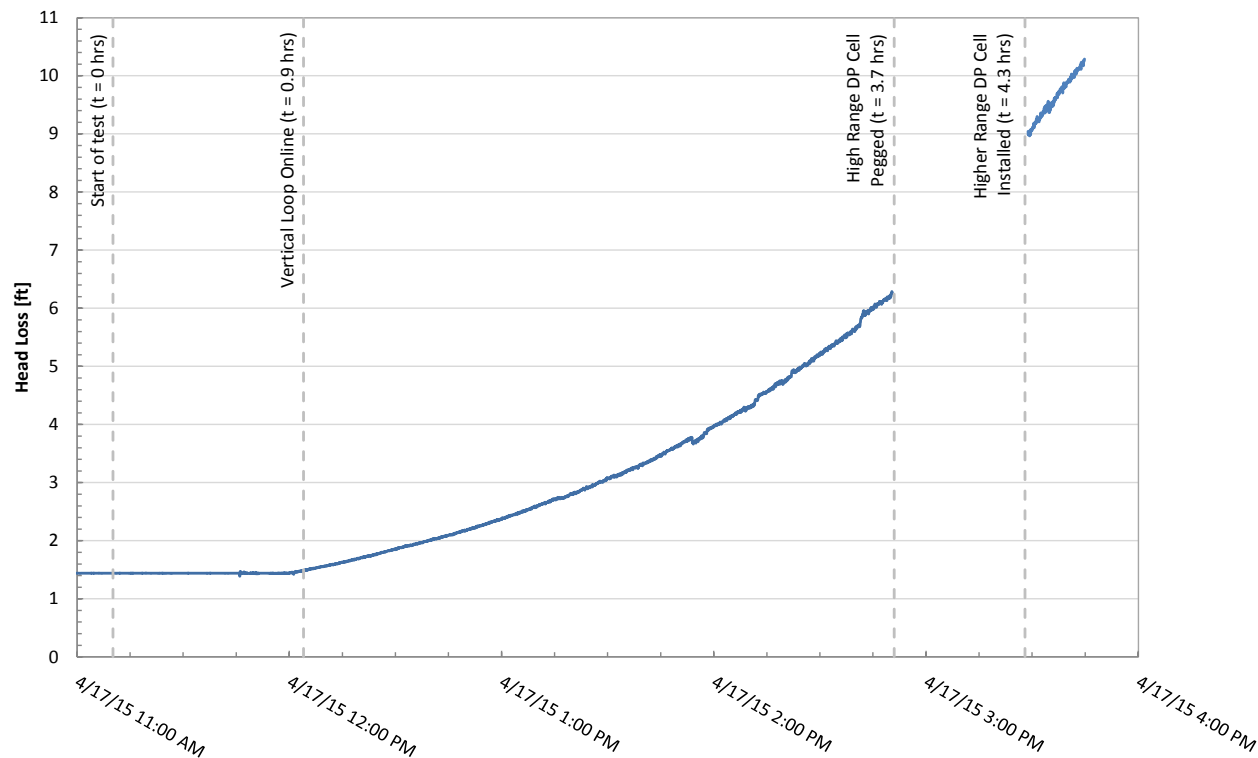
- First Integrated Test Initiated April 17, 2015
- Detector Bed Head Loss Immediately Started Increasing
- Head loss increased until the test was terminated
 - Started at 1.44 ft
 - Test terminated at 10.25 ft, and rising
- Test lasted approximately 4.6 hrs

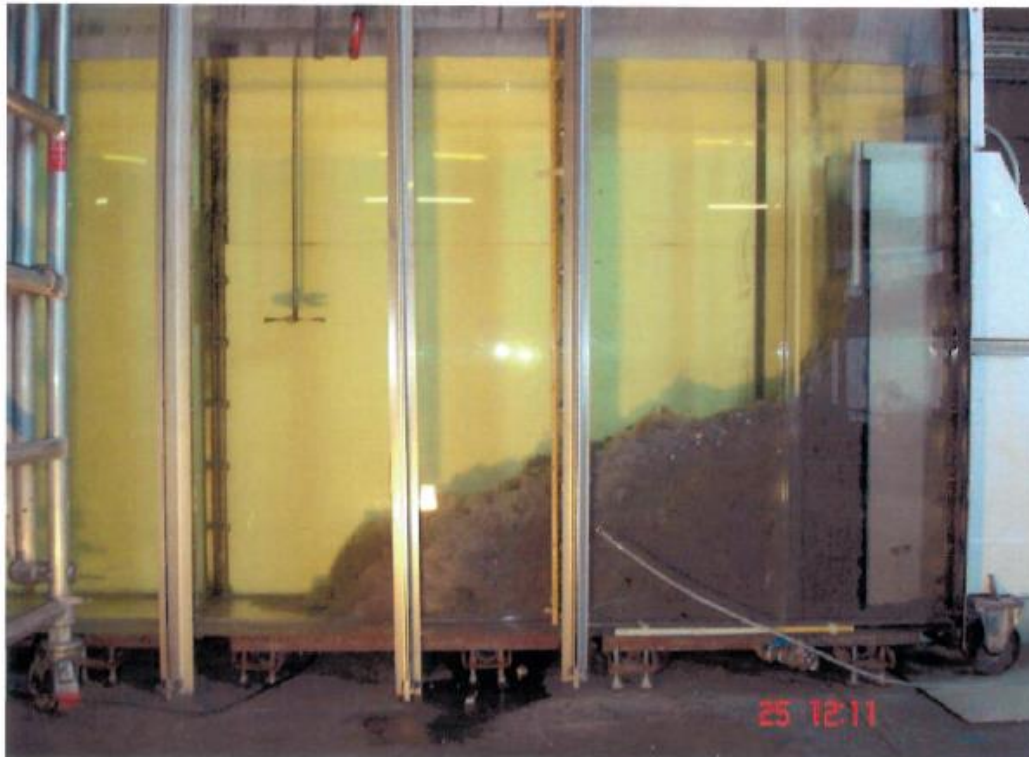
- CCNPP Conducted 7 Strainer Head Loss Tests in 2010
 - Tests included WCAP-16530 Chemical Precipitate Surrogate
- Test #1 Included Fine and Small Fibrous Debris
 - Maximum Head Loss 1.75 inches of water
 - Non-Uniform Debris Deposition
 - Conclusion: Testing with Small Pieces is Non-Conservative

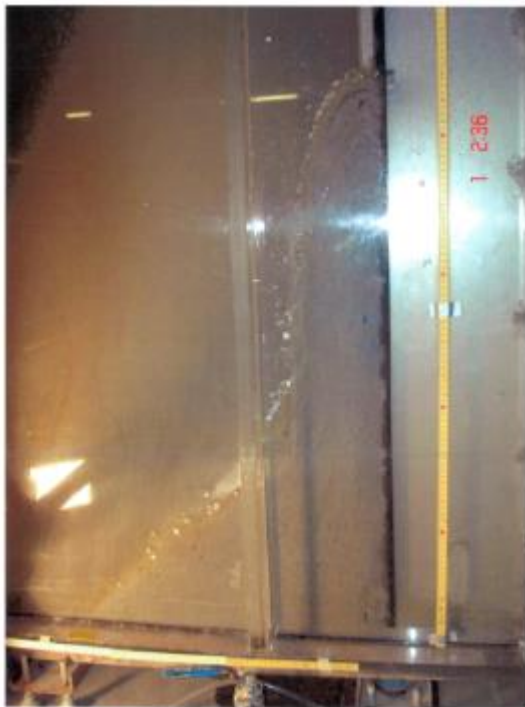
Picture 27: Debris layer without precipitate

- Remaining Tests Used Only Fine Fibrous Debris
 - Full load of particulates and precipitates
 - Test for Success Campaign
 - Break-throughs experienced during each test

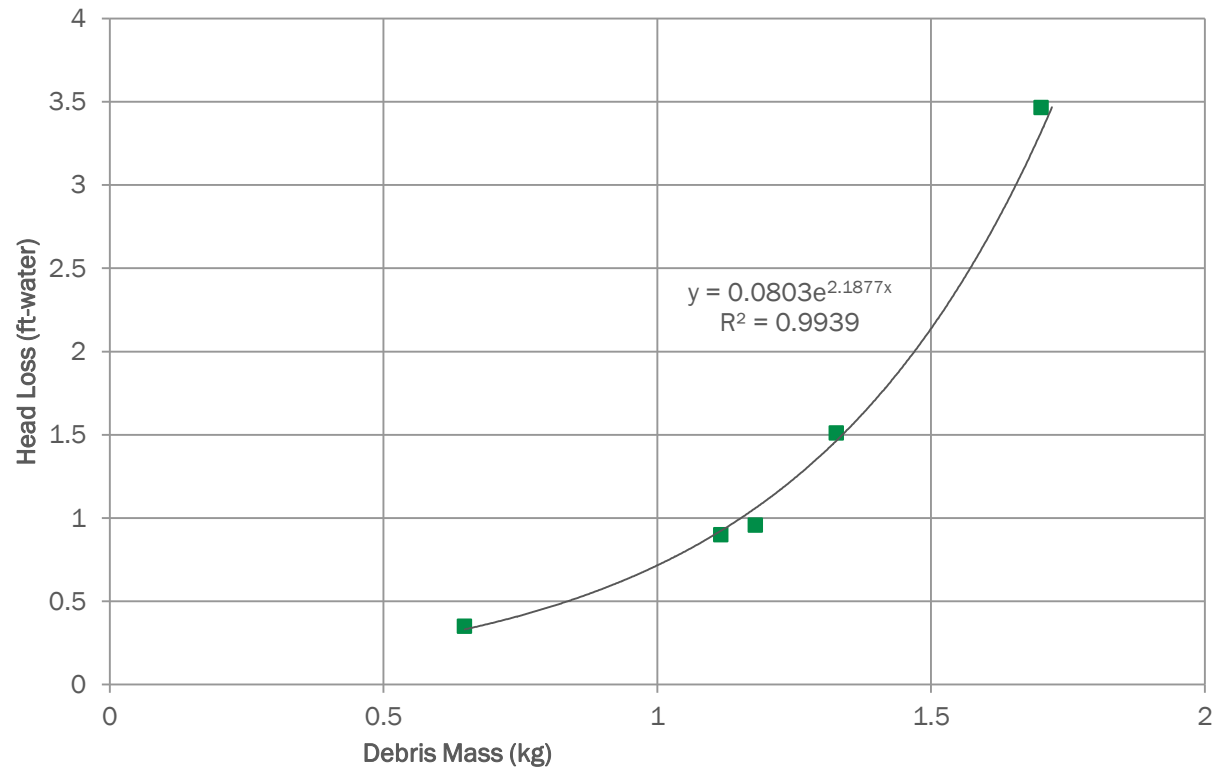
Head Loss Data - Test Data + Clean Screen

- Plot of Head Loss –vs- Fiber Mass produces well correlated curve fit
- Plot includes clean strainer head loss
