SAVANNAH RIVER REMEDIATION LLC

U-ESR-H-00128

Tank 16 – Response To NRC Comments On Closure Module

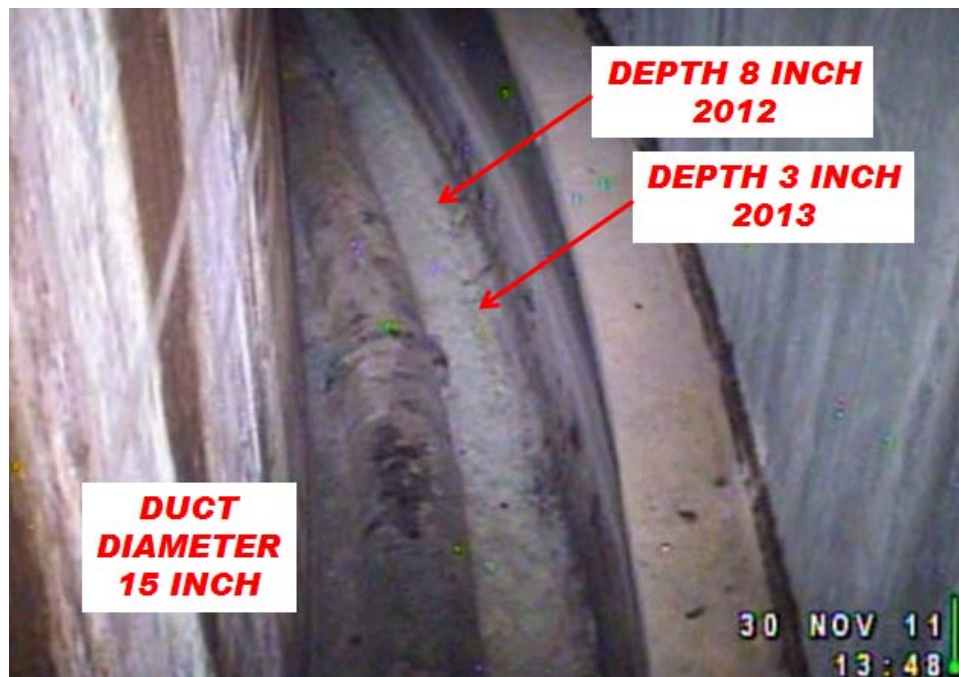
Figure 2: (Area at STA 5+00 estimated to a height of 8 inches in 2012. Attachment SRR-LWE-2012-00039)

Photographs of STA 5+00 below show an area that was revised from 8 inch height in 2012 to 3 inch height in 2013. Waste height outside the duct at STA 6+00 was assigned a height of 2 inches based on interpolation of the 2 inch measured height at STA 7+00. The photograph from 2012 was used to assign a height of 8 inches to this area without close sampling measurements (Figure 2). The closest sampling data in 2012 was from 20 feet away. This value was believed to be the most realistic height based on the visual evidence at the time. The 2013 sampling effort at STA 3+50 indicated a height of 3 inches. Photo I from U-ESR-H-00113 displays the area in more detail (Figure 3). The measured sample height of 3 inches was assigned to this area because it was believed that Photo I was consistent with a height of 3 inches.

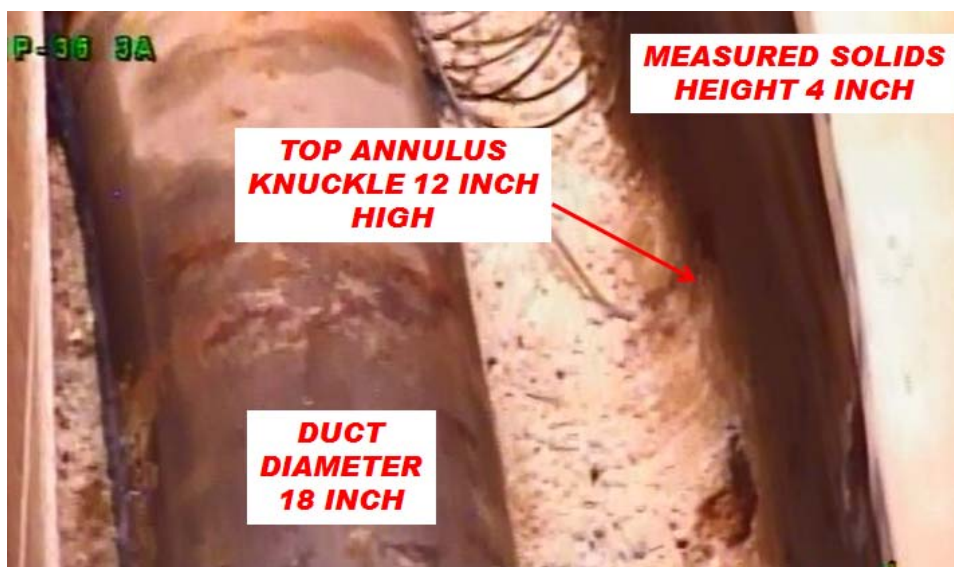
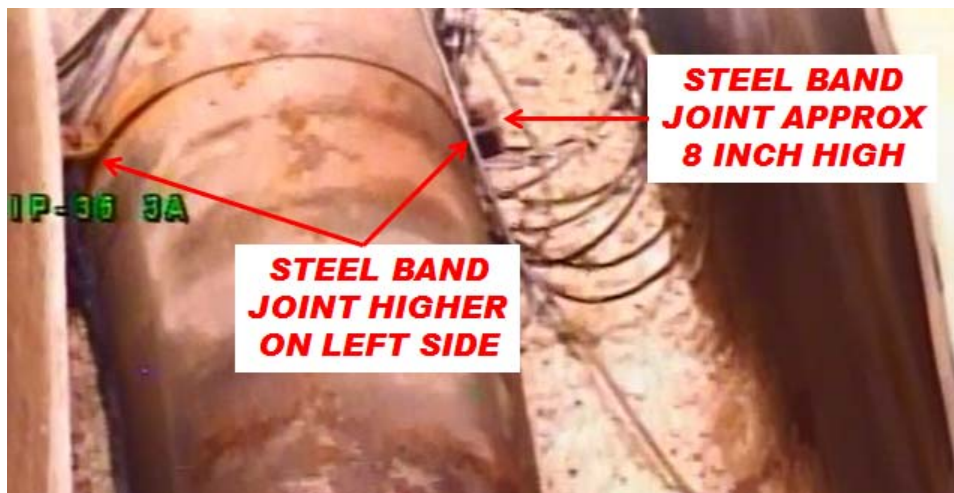
Figure 6: (Area at STA 1+80 measured at 4 inches. Photo E U-ESR-H-00113)

The measured height at STA 1+80 was 4 inches in 2013. This is consistent with the measured value at South Riser STA 0+00 in 2012. A photo of the area in question is provided below (Figure 6). There are no landmarks in the area that are close to being 4 inches tall. The annulus knuckle has a 12 inch radius and the duct steel band joint is approximately 8 inches off the floor. Note that the steel band joint appears higher on the left side (Figure 7). If the steel band was configured with the joint horizontal, the level of the joint would be 10.4 inches. The solids layer in this area is below all available landmarks. There is no evidence to suggest that 4 inches is not an accurate depth for this area.

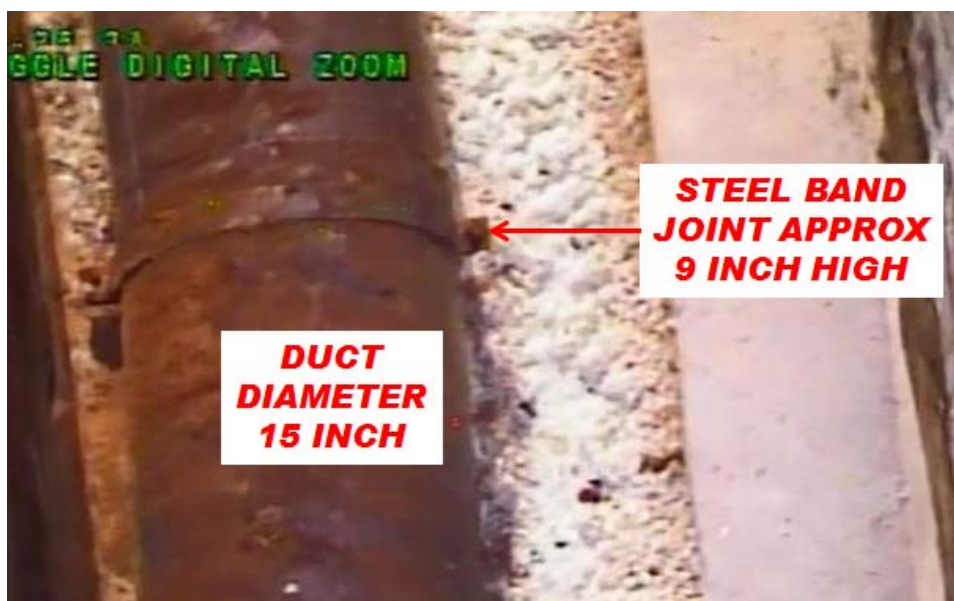
Figure 8: (Area at STA 3+00 near STA 3+50 measured at 3 inches. Photo F U-ESR-H-00113)

The measured height at STA 3+50 was 3 inches in 2013. A photo of nearby area 3+00 is provided below (Figure 8). There are no landmarks in the area that are close to being 3 inches tall. The steel band joint at this point is 8.9 inches. Notice the distance between the joint and where the shadow is cast on the solids surface. There is no evidence to suggest that 3 inches is not an accurate depth for this area.

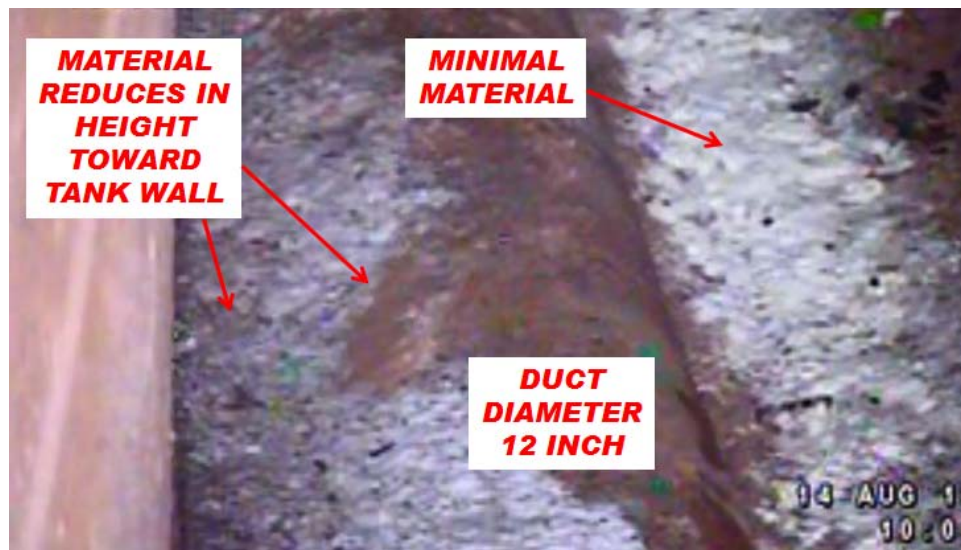
Figure 10: (Area at STA 10+00 interpolated to a height of 3 inches. Photo M U-ESR-H-00113)

STA 10+00 is an area between two measured values of 2 inches and 5.5 inches. Visual evidence suggests that the solids height did not increase between the two sample locations, therefore the value at STA 10+00 would be 5 inches or less. There is a minimal amount of material to the right side of the duct, material is coating the left side of the duct, then the material appears to decrease in height away from the duct to the left (Figure 10). Several data points were used to assign a value:

The interpolated height from the nearest measured heights (3 inches) was assigned for this area, and evaluation of visual evidence did not result in adjustment to the interpolated height. Visual depth perception was a factor in the decision to not adjust the interpolated height. A photo of the area is included below (Figure 10).

As stated in our methodology, an interpolation between measured sample heights was used in conjunction with visual observation to assign a height to the material in this area. STA 10+00 is an area between two measured values of 2 inches and 5.5 inches. Visual evidence suggests that the solids height did not increase between the two sample locations, therefore the value at STA 10+00 would be 5 inches or less. There is a minimal amount of material to the right side of the duct, material is coating the left side of the duct, then the material appears to decrease in height away from the duct to the left (Figure 10). Several data points were used to assign a value:

The interpolated height from the nearest measured heights (3 inches) was assigned for this area, and evaluation of visual evidence did not result in adjustment to the interpolated height. Visual depth perception was a factor in the decision to not adjust the interpolated height.

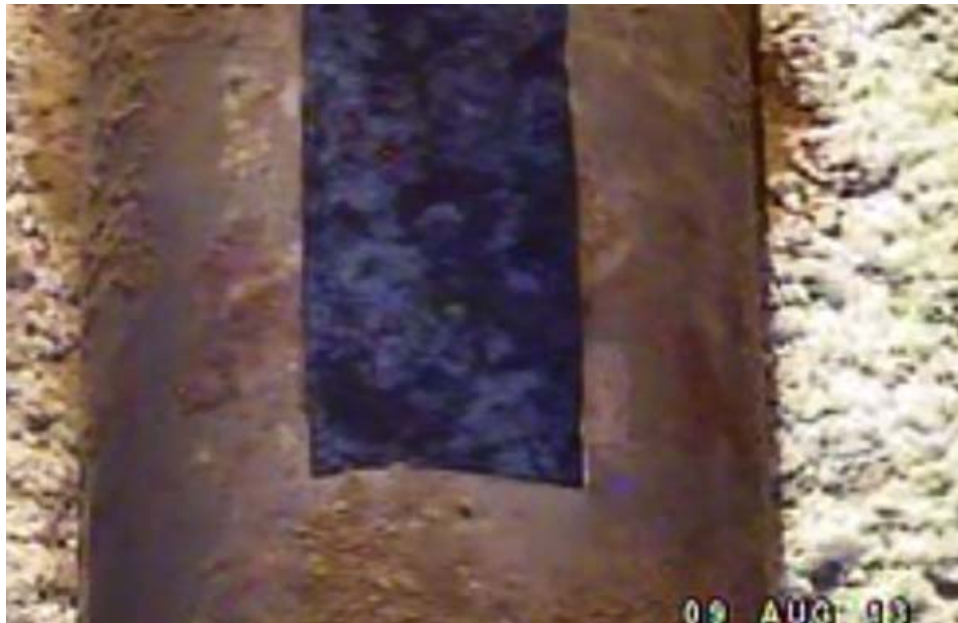
Figure 11: (Area at STA 15+40 interpolated to a height of 3 inches. Photo R U-ESR-H-00113)

Visibility is very poor due to lighting inside of the duct at STA 15+40. Photo R is included below (Figure 11). Lessened confidence due to depth perception again factored in to the decision not to adjust the interpolated values. In accordance with our methodology, a solids height of 3 inches inside the duct at STA 15+00, 15+40, and STA 16+00 were interpolated from an adjoining sample location (STA 13+67) that measured 3 inch height. The value assigned was reasonable and in accordance with this photograph (Figure 11).

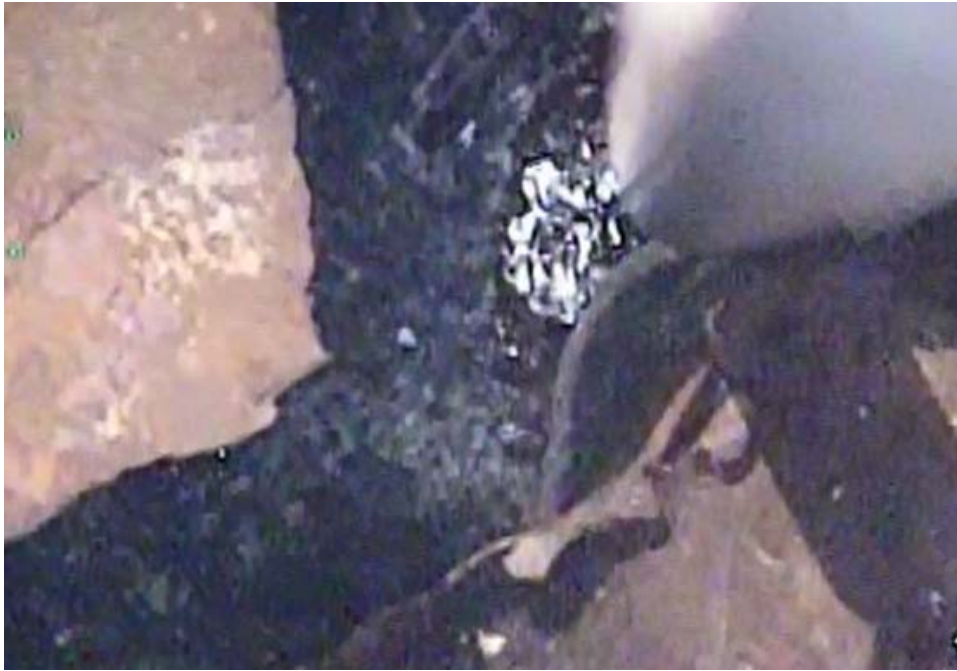
Figure 12: (Area at STA 0+00. Photo B U-ESR-H-00113)

The measuring process provided confidence in the validity of the measured height values in the area of STA 0+00. Visibility in this area is very poor and the vantage point is exactly vertical from the area in question. Photos A, B, and C demonstrate that height estimation from a near vertical vantage point, inside of a duct, with no local landmarks is inconclusive. There is no evidence to suggest that the 5.25 inches measured value is not correct. Photo B is included below (Figure 12).

Photo B in SRR-LWE-2014-00151 does not indicate that the duct is corroded. The large hole in the duct is the result of earlier sampling or waste removal efforts. There is no indication that the bottom of the duct has collapsed. Photo A is included below (Figure 18). It shows a wider view of the area than what is provided in Photo B.

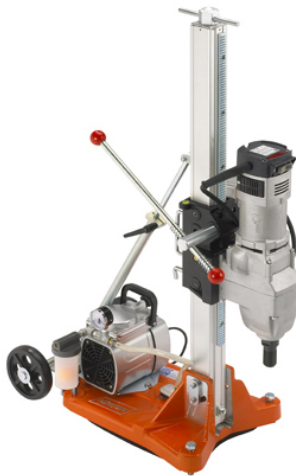
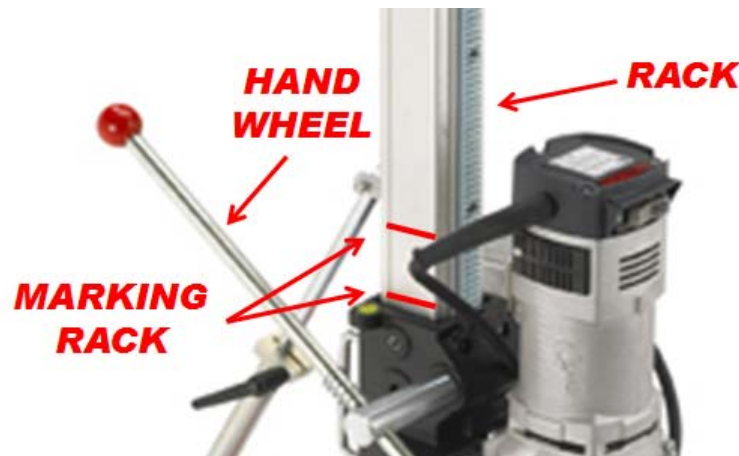
Figure 13: Portable Drill Rig

The drill rig used is similar to the one pictured below (Figures 13 and 14). Vertical moment is controlled by the handwheel. The gear on the handwheel interfaces with a rack on the vertical column to hold or adjust vertical position. Marking and measuring vertical position on the column is simple and accurate. Uncertainty in this measurement would be very low.

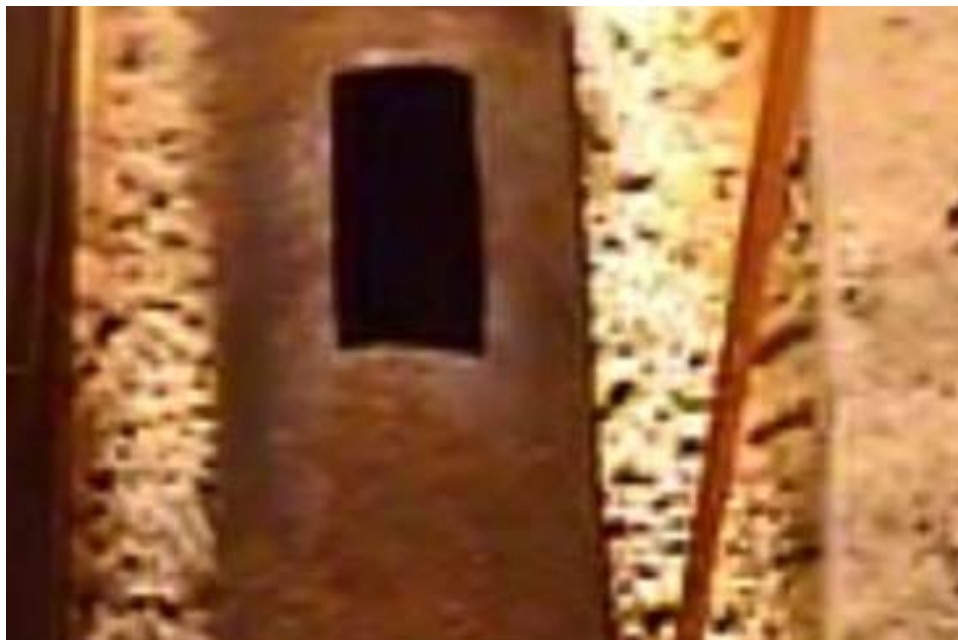
Figure 15: (Area near IP 151 and STA 15+40. Photo Q U-ESR-H-00113)

There are areas where the residual solids have a definite “texture”. An example of this is shown below near STA 15+40 (Figure 15). The material in this area was measured at 8 inches. The shadows thrown across the surface of the solids indicate that the surface is not completely smooth, but the height irregularities are not substantial. This is a common situation when determining volume. The uncertainty created by the surface irregularities is expected to be relatively insignificant and is encapsulated in the overall uncertainty.

Generally, solids were not observed accumulating on vertical surfaces (Figure 15). In some areas where solids height was minimal along the outside of the annulus, the level appears to conform to the curvature of the knuckle. Volumes estimated in these areas are determined according to the mapping team's judgement and experience. This was accounted for in the uncertainty values.

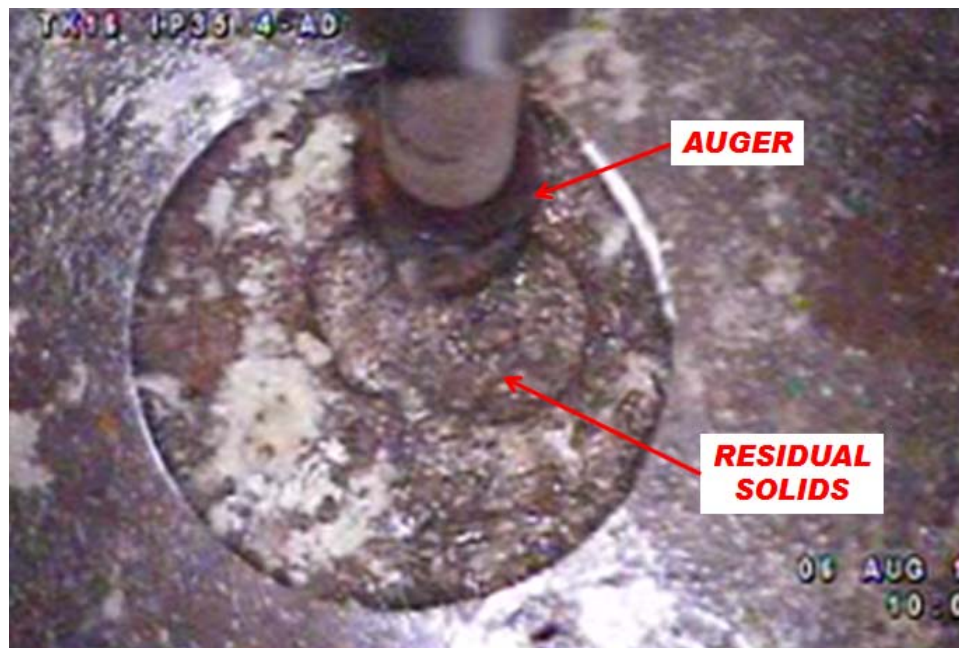
Figure 17: (Sample at IP-35. Sample bore location visible from above. SRR-LWE-2013-0027)

Measurements inside the duct were performed in the same manner as those outside the duct. Auger contact with the solids was apparent when the shaft was no longer hanging freely in space. Operators indicated that it was readily apparent when the auger contacted the solids. As seen below, while sampling through a hole in the duct, the auger and residual solids can be seen from the camera vantage point (Figure 17). This was useful when positioning the auger.

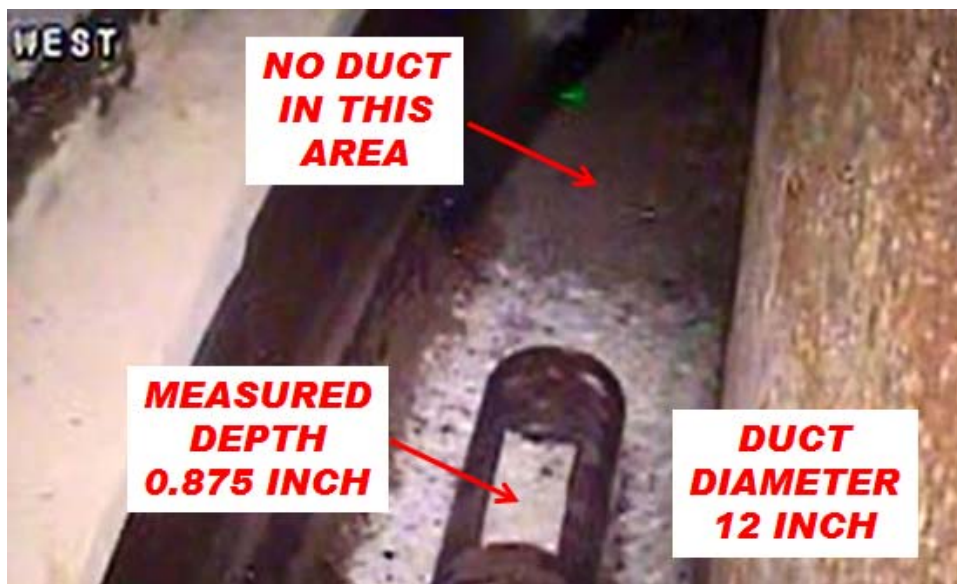
Figure 19: (Area at STA 8+00. Photo L U-ESR-H-00113)

The measured height of 0.875 inches is applied to this region of the duct. Considering that visual interpretation of solids heights can be influenced by factors such as depth perception and shadows / poor lighting, the visual evidence did not compel a change to the measured value. Solids reported at a depth of 0 inches in Photo L are at a region where there is no duct – therefore there are no solids in the duct (Figure 19).

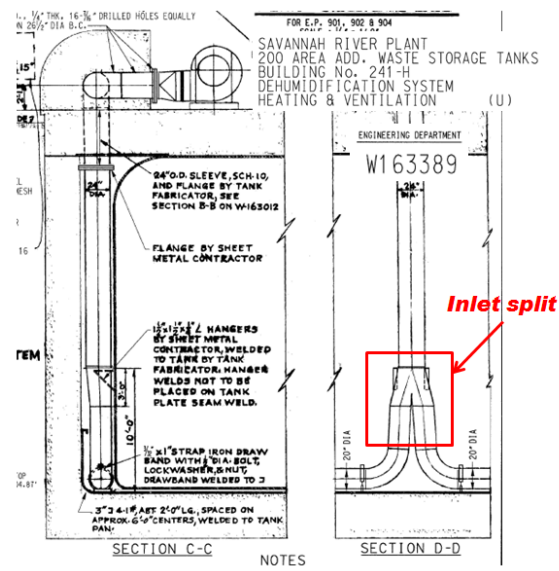
Figure 20: Annulus Duct Split

Justification: This is the inlet of the annulus exhaust and the duct splits into two at an elevation well above the solids level on the floor. Therefore the two horizontal halves of the duct are not connected at this point. Since there is no visual evidence otherwise, it has been assumed that the solids level inside the duct on either side is similar to the level measured during sampling. This remains conservative as the highest observed levels on each side of the split duct are assumed and there is no reduction taken for the gap in the duct as it rises (see Figure 20, which is Figure 3.2-2 in U-ESR-H-00113).
