U-ESR-H-00128

Tank 16, Volume, Mapping

**Tank 16 – Response To NRC Comments  
On Closure Module**

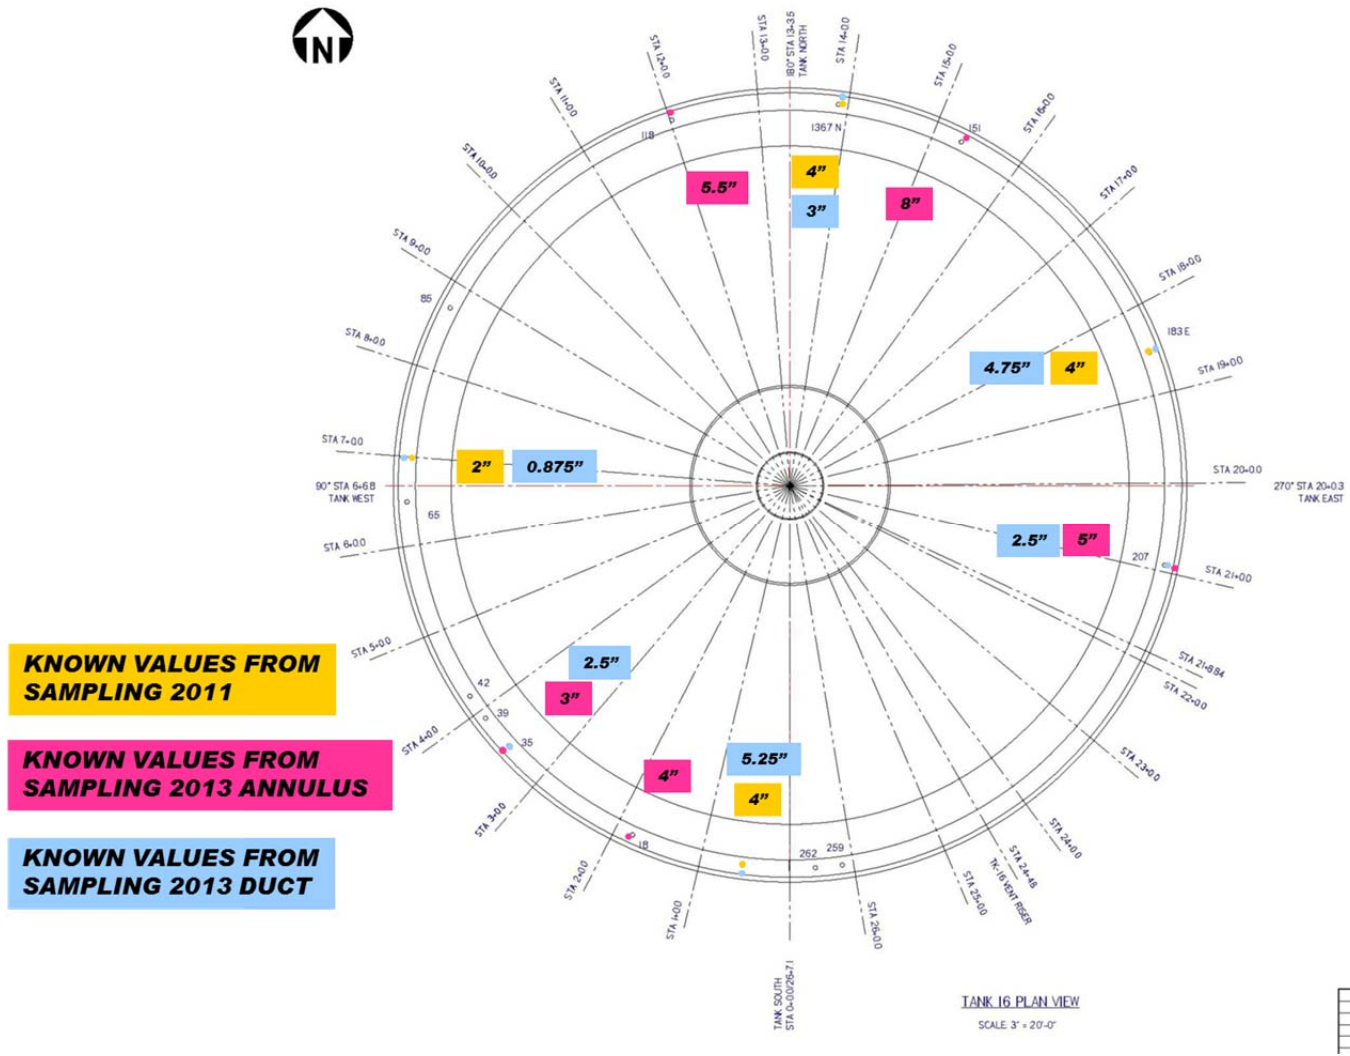
Figure 1: Tank 16 orientation and sample locations

Figure 1 provides orientation (station locations, sample locations, and photograph locations) around that Tank 16 annulus to support the individual comment responses in this document.

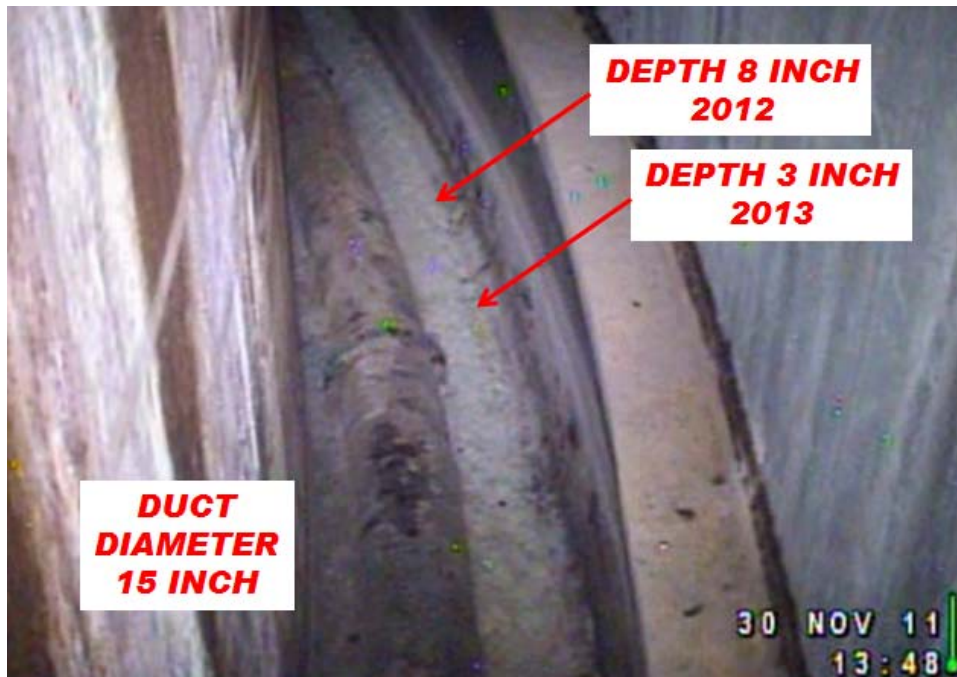
Figure 2: (Area at STA 5+00 estimated to a height of 8 inches in 2012. Attachment SRR-LWE-2012-00039)

Photographs of STA 5+00 below show an area that was revised from 8 inch height in 2012 to 3 inch height in 2013. Waste height outside the duct at STA 6+00 was assigned a height of 2 inches based on interpolation of the 2 inch measured height at STA 7+00. The photograph from 2012 was used to assign a height of 8 inches to this area without close sampling measurements (Figure 2). The closest sampling data in 2012 was from 20 feet away. This value was believed to be the most realistic height based on the visual evidence at the time. The 2013 sampling effort at STA 3+50 indicated a height of 3 inches. Photo I from U-ESR-H-00113 displays the area in more detail (Figure 3). The measured sample height of 3 inches was assigned to this area because it was believed that Photo I was consistent with a height of 3 inches.

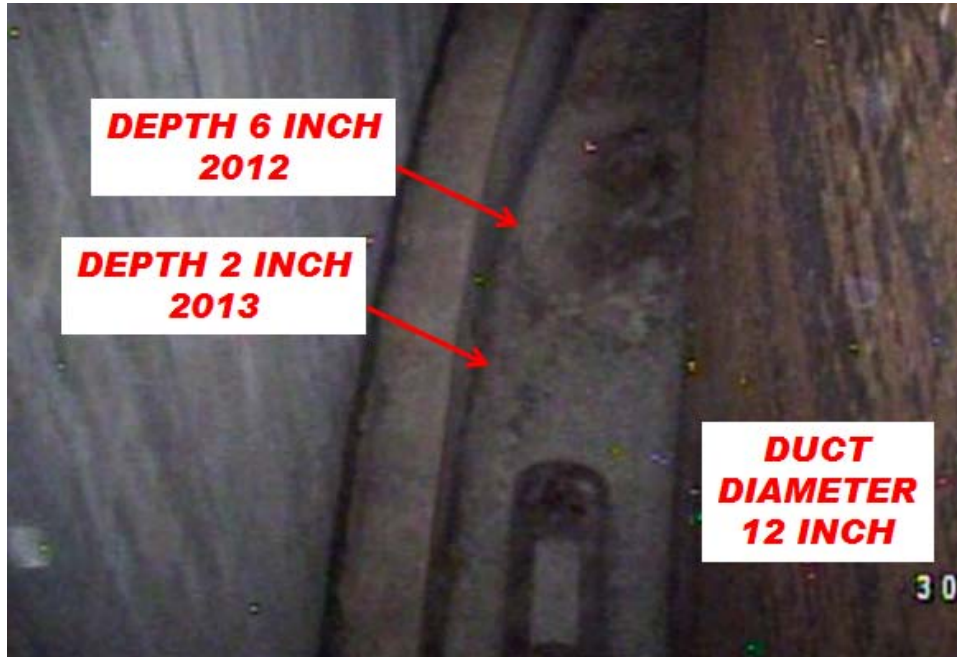
Figure 4: (Area at STA 8+00 interpolated to a height of 6 inches in 2012. Attachment SRR-LWE-2012-00039)

Photographs of STA 8+00 below show an area that was revised from 6 inch height in the 2012 volume estimate to 2 inch height in the 2013 volume estimate. The photograph from 2012 was

used to assign a height of 6 inches to this area (Figure 4) from visual observation. Based on photographs available at the time, this value would have been higher in 2012 if not for the measured sample height of 2 inches in the vicinity. This value was believed to be an accurate representation of the area based on both visual observation and measurement data. Photo L from U-ESR-H-00113 displays the area in more detail from 2013 (Figure 5). The measured sample height of 2 inches was interpolated across STA 8+00 due to the appearance of minimal material in the newer photos. Note the improved quality of the photograph in 2013 compared to the 2012 photograph.

These two examples were areas of large height change from the 2012 volume estimate to the 2013 volume estimate. As is illustrated from the included photos, lighting and the angles can make objects appear differently. The team that estimated the annulus volume in 2012 also estimated the volume in 2013, providing continuity and historical knowledge. Solids heights were a consensus agreement by the subject matter experts. The final report and estimation was verified / checked by an independent, qualified person.

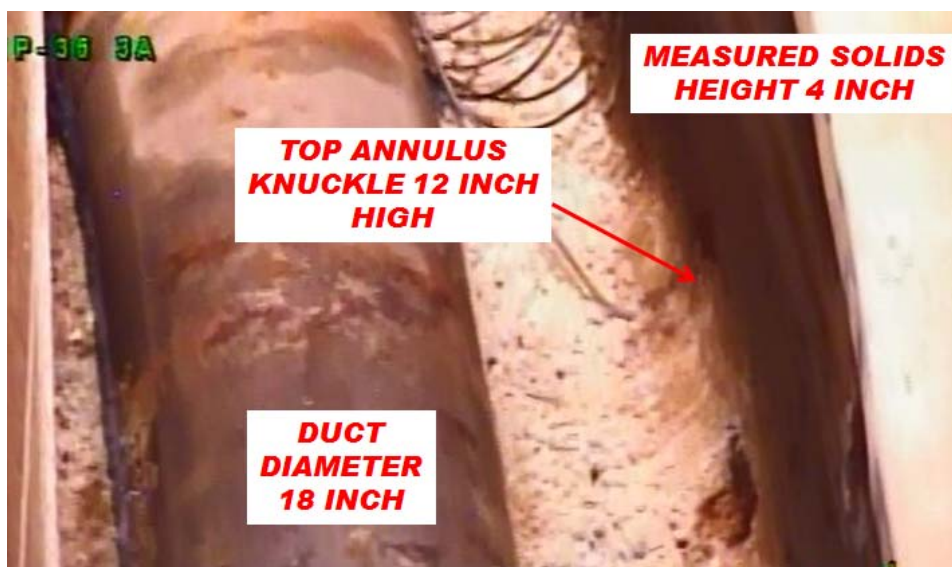
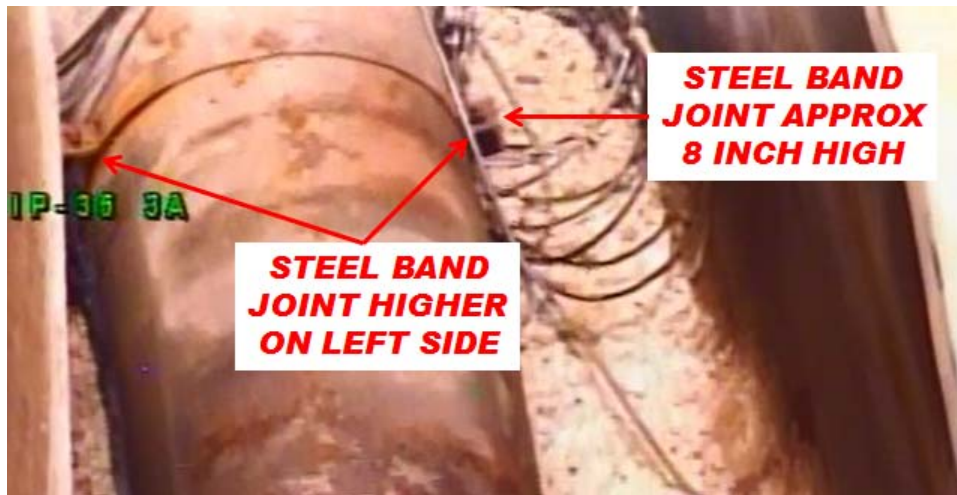
Figure 6: (Area at STA 1+80 measured at 4 inches. Photo E U-ESR-H-00113)

The measured height at STA 1+80 was 4 inches in 2013. This is consistent with the measured value at South Riser STA 0+00 in 2012. A photo of the area in question is provided below (Figure 6). There are no landmarks in the area that are close to being 4 inches tall. The annulus knuckle has a 12 inch radius and the duct steel band joint is approximately 8 inches off the floor. Note that the steel band joint appears higher on the left side (Figure 7). If the steel band was configured with the joint horizontal, the level of the joint would be 10.4 inches. The solids layer in this area is below all available landmarks. There is no evidence to suggest that 4 inches is not an accurate depth for this area.

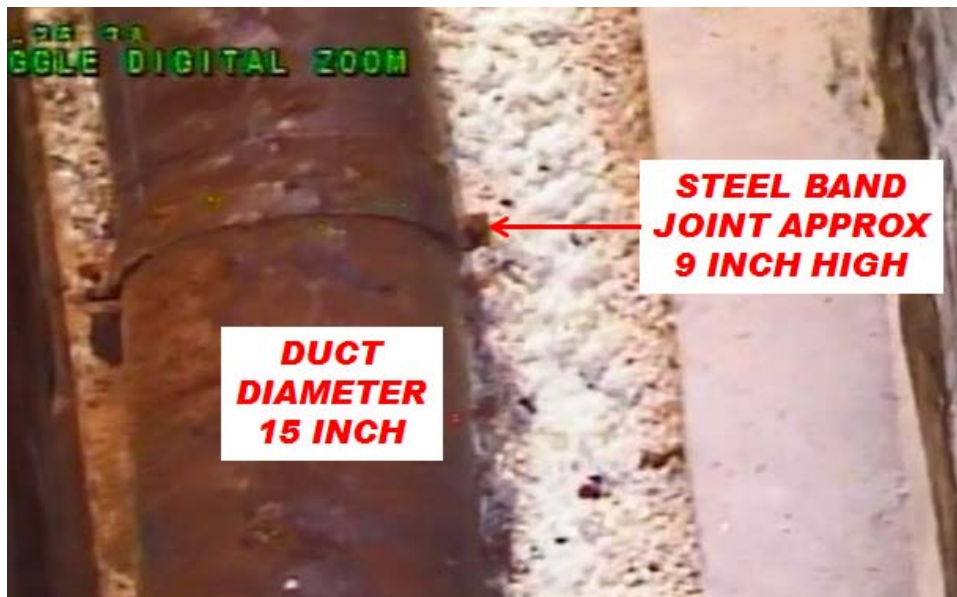
Figure 8: (Area at STA 3+00 near STA 3+50 measured at 3 inches. Photo F U-ESR-H-00113)

The measured height at STA 3+50 was 3 inches in 2013. A photo of nearby area 3+00 is provided below (Figure 8). There are no landmarks in the area that are close to being 3 inches tall. The steel band joint at this point is 8.9 inches. Notice the distance between the joint and where the shadow is cast on the solids surface. There is no evidence to suggest that 3 inches is not an accurate depth for this area.

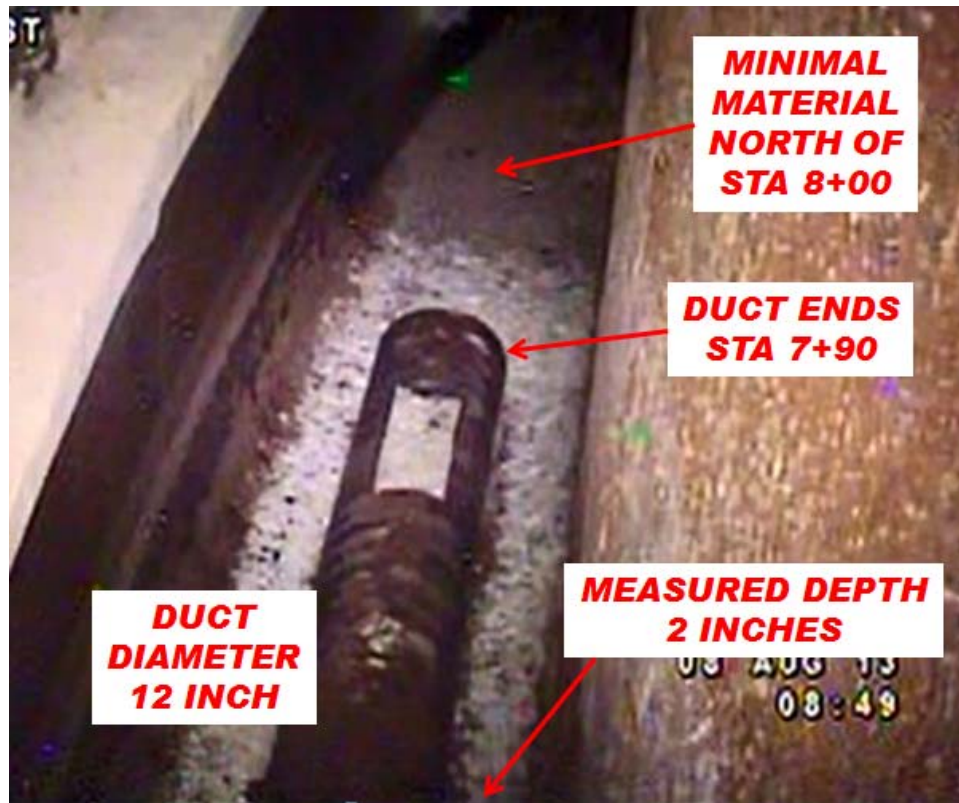
Figure 9: (Area at STA 8+00 near STA 7+00 measured at 2 inches. Photo L U-ESR-H-00113)

The measured height at STA 7+00 was 2 inches in 2012. A photo of nearby area 8+00 is provided below (Figure 9). There are no landmarks in the area that are close to being 2 inches tall. There is a definite change in material color. Material north of STA 8+00 appears to be minimal and reducing as it continues north. There is no evidence to suggest that 2 inches is not an accurate depth for this area.

The measured height at STA 7+00 was 2 inches in 2013. A photo of nearby area 8+00 was provided in Figure 9. There are no landmarks in the area that are close to being 2 inches tall. There is a definite change in material color. Material north of STA 8+00 appears to be minimal and reducing as it continues north. There is no evidence to suggest that 2 inches is not an accurate depth for STA 8+00. Material height at STA 9+00 was reported to be 1 inch from visual observation that indicated solids were reducing in height toward the north.

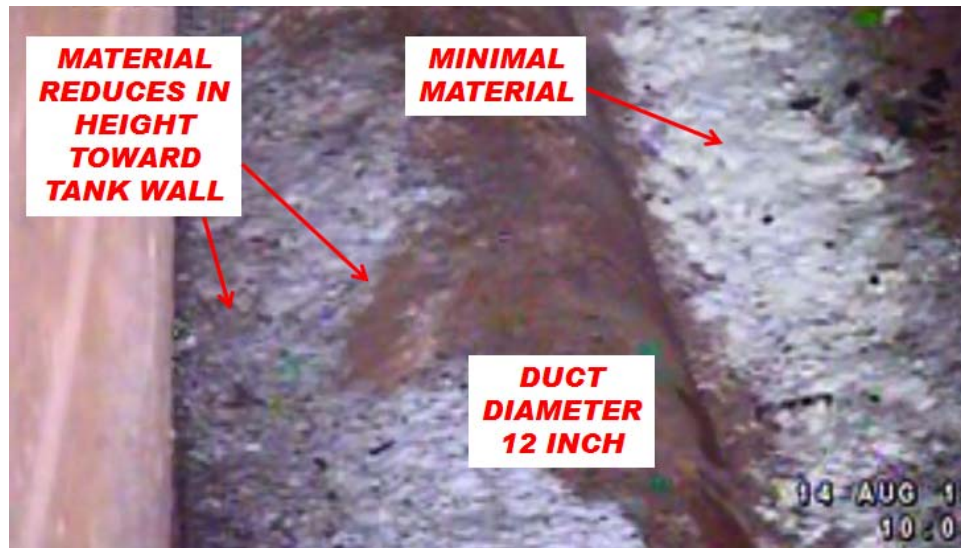
Figure 10: (Area at STA 10+00 interpolated to a height of 3 inches. Photo M U-ESR-H-00113)

STA 10+00 is an area between two measured values of 2 inches and 5.5 inches. Visual evidence suggests that the solids height did not increase between the two sample locations, therefore the value at STA 10+00 would be 5 inches or less. There is a minimal amount of material to the right of the duct, material is coating the left side of the duct, then the material appears to decrease in height away from the duct to the left (Figure 10). Several data points were used to assign a value:

- material height to the right and left
- duct height for material collected on the duct
- the appearance of decreasing material as the annulus continues to the west

The interpolated height from the nearest measured heights (3 inches) was assigned for this area, and evaluation of visual evidence did not result in adjustment to the interpolated height. Visual depth perception was a factor in the decision to not adjust the interpolated height. A photo of the area is included below (Figure 10).

As stated in our methodology, an interpolation between measured sample heights was used in conjunction with visual observation to assign a height to the material in this area. STA 10+00 is an area between two measured values of 2 inches and 5.5 inches. Visual evidence suggests that the solids height did not increase between the two sample locations, therefore the value at STA 10+00 would be 5 inches or less. There is a minimal amount of material to the right side of the duct, material is coating the left side of the duct, then the material appears to decrease in height away from the duct to the left (Figure 10). Several data points were used to assign a value:

The interpolated height from the nearest measured heights (3 inches) was assigned for this area, and evaluation of visual evidence did not result in adjustment to the interpolated height. Visual depth perception was a factor in the decision to not adjust the interpolated height.

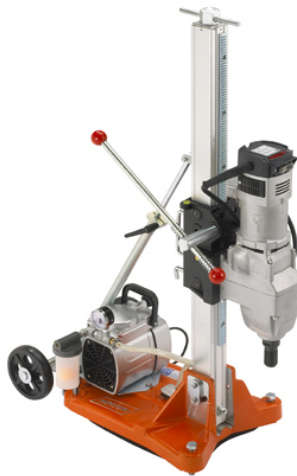
Figure 13: Portable Drill Rig

The drill rig used is similar to the one pictured below (Figures 13 and 14). Vertical moment is controlled by the handwheel. The gear on the handwheel interfaces with a rack on the vertical column to hold or adjust vertical position. Marking and measuring vertical position on the column is simple and accurate. Uncertainty in this measurement would be very low.

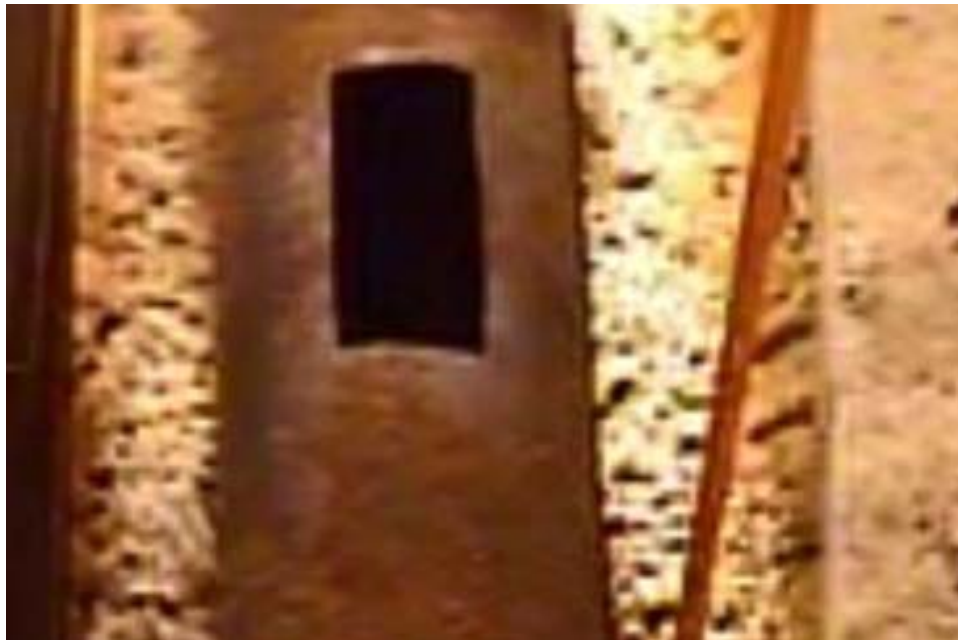
Figure 15: (Area near IP 151 and STA 15+40. Photo Q U-ESR-H-00113)

There are areas where the residual solids have a definite “texture”. An example of this is shown below near STA 15+40 (Figure 15). The material in this area was measured at 8 inches. The shadows thrown across the surface of the solids indicate that the surface is not completely smooth, but the height irregularities are not substantial. This is a common situation when determining volume. The uncertainty created by the surface irregularities is expected to be relatively insignificant and is encapsulated in the overall uncertainty.

Generally, solids were not observed accumulating on vertical surfaces (Figure 15). In some areas where solids height was minimal along the outside of the annulus, the level appears to conform to the curvature of the knuckle. Volumes estimated in these areas are determined according to the mapping team's judgement and experience. This was accounted for in the uncertainty values.

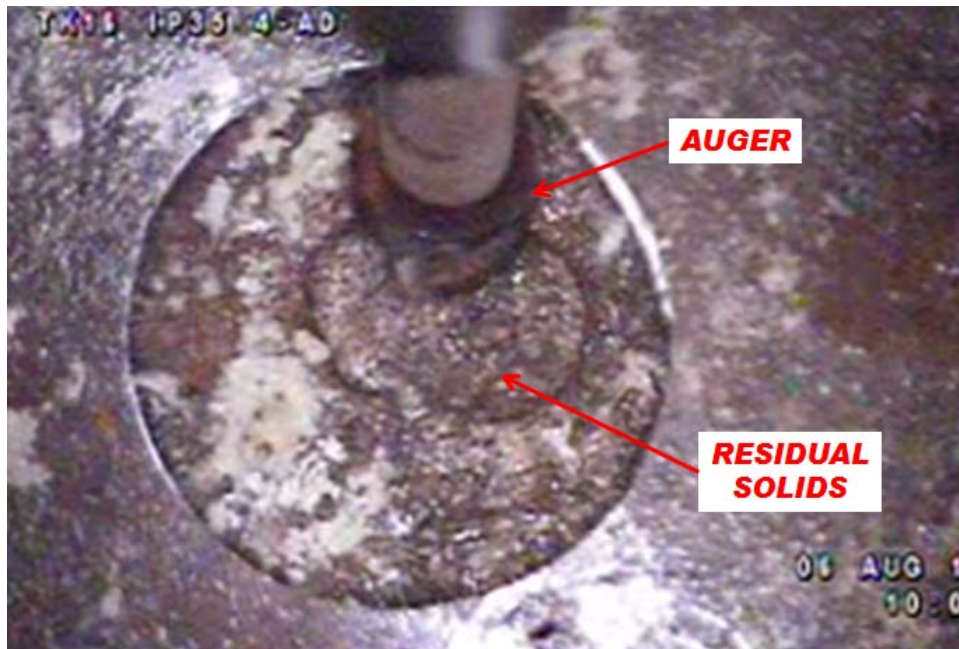
Figure 17: (Sample at IP-35. Sample bore location visible from above. SRR-LWE-2013-0027)

Measurements inside the duct were performed in the same manner as those outside the duct. Auger contact with the solids was apparent when the shaft was no longer hanging freely in space. Operators indicated that it was readily apparent when the auger contacted the solids. As seen below, while sampling through a hole in the duct, the auger and residual solids can be seen from the camera vantage point (Figure 17). This was useful when positioning the auger.

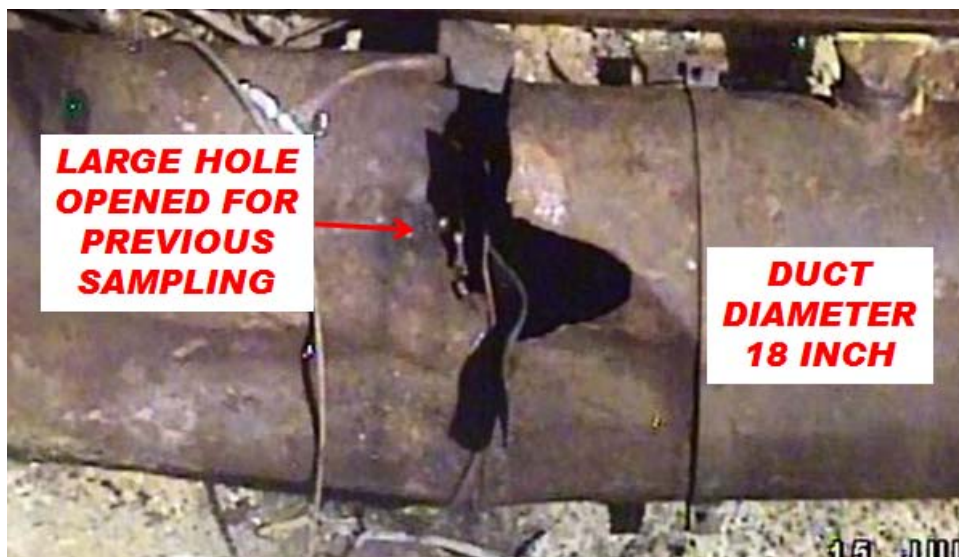
Figure 18: (Area at STA 0+00 measured at 5.25 inches. Photo A U-ESR-H-00113)

Photo B in SRR-LWE-2014-00151 does not indicate that the duct is corroded. The large hole in the duct is the result of earlier sampling or waste removal efforts. There is no indication that the bottom of the duct has collapsed. Photo A is included below (Figure 18). It shows a wider view of the area than what is provided in Photo B.

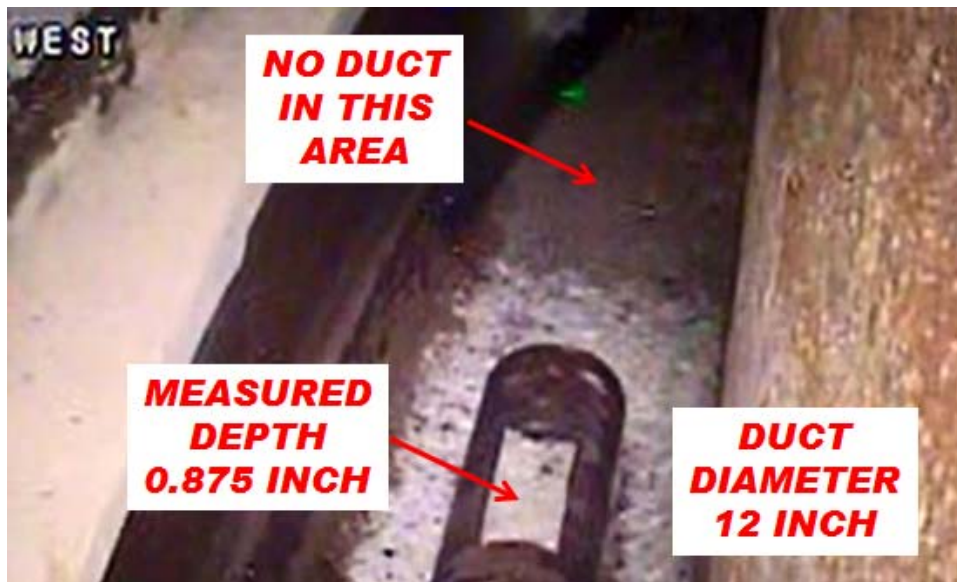
Figure 19: (Area at STA 8+00. Photo L U-ESR-H-00113)

The measured height of 0.875 inches is applied to this region of the duct. Considering that visual interpretation of solids heights can be influenced by factors such as depth perception and shadows / poor lighting, the visual evidence did not compel a change to the measured value. Solids reported at a depth of 0 inches in Photo L are at a region where there is no duct – therefore there are no solids in the duct (Figure 19).

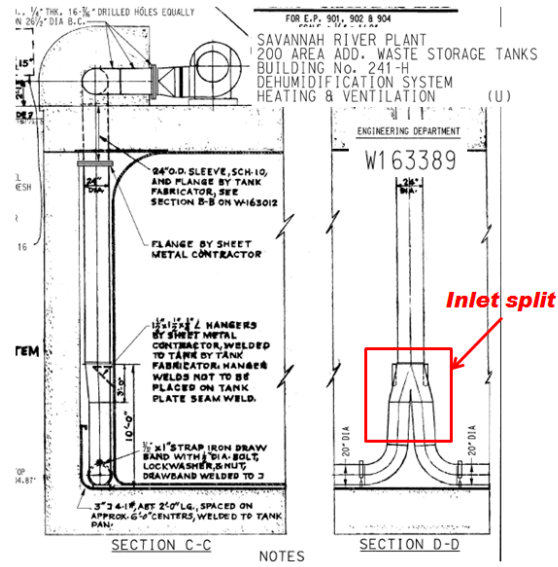
Figure 20: Annulus Duct Split

- Annulus duct solids level is assumed to abruptly change at Station 22+00.  
**Justification:** This is the inlet of the annulus exhaust and the duct splits into two at an elevation well above the solids level on the floor. Therefore the two horizontal halves of the duct are not connected at this point. Since there is no visual evidence otherwise, it has been assumed that the solids level inside the duct on either side is similar to the level measured during sampling. This remains conservative as the highest observed levels on each side of the split duct are assumed and there is no reduction taken for the gap in the duct as it rises (see Figure 20, which is Figure 3.2-2 in U-ESR-H-00113).
