Applying Ultrasonic Testing in Lieu of Radiography for Volumetric Examination of Carbon Steel Piping

AVAILABILITY OF REFERENCE MATERIALS IN NRC PUBLICATIONS

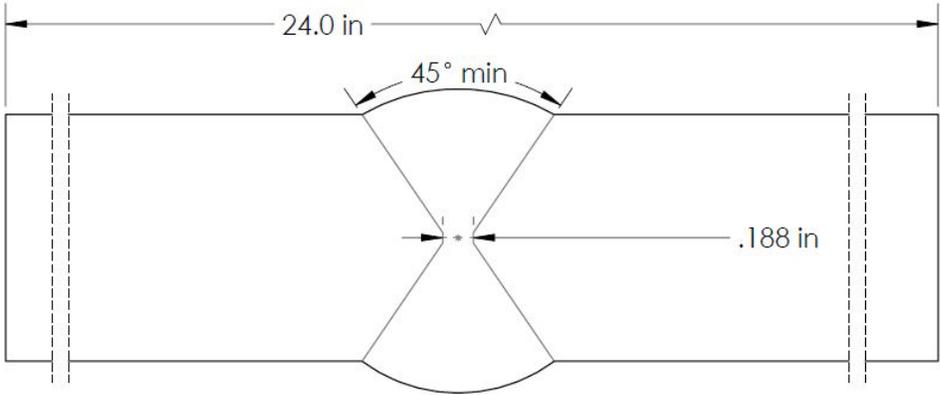
Figure 3-4 Double-V Butt Weld Configurations Used in the Navy Carbon Steel Plates

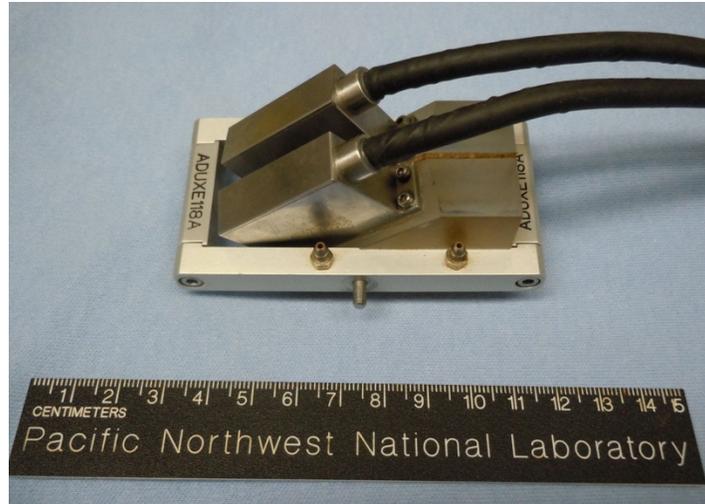
Figure 4-2 4.0-MHz TRS Phased-Array Probe

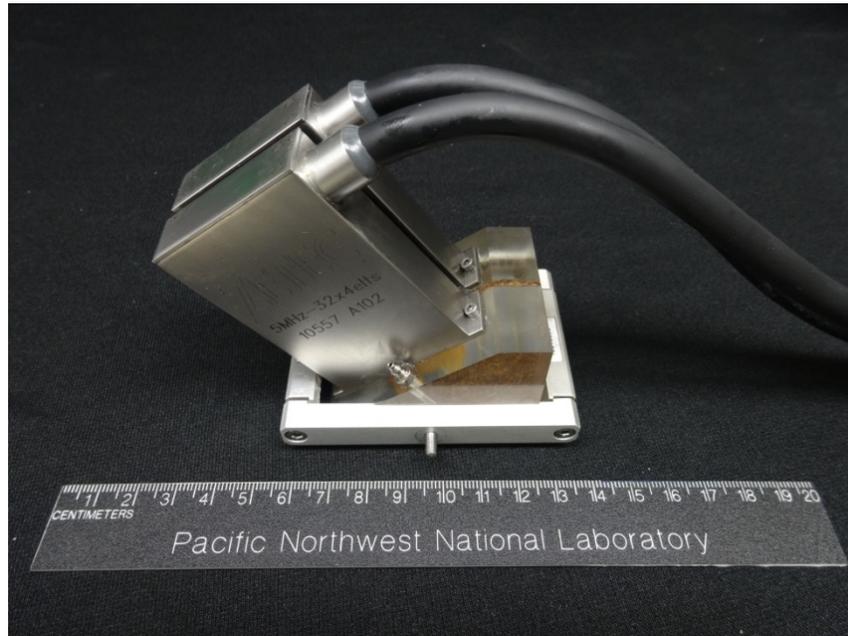
Figure 4-6 5-MHz TRS Phased-Array Probe on Wedge Assembly

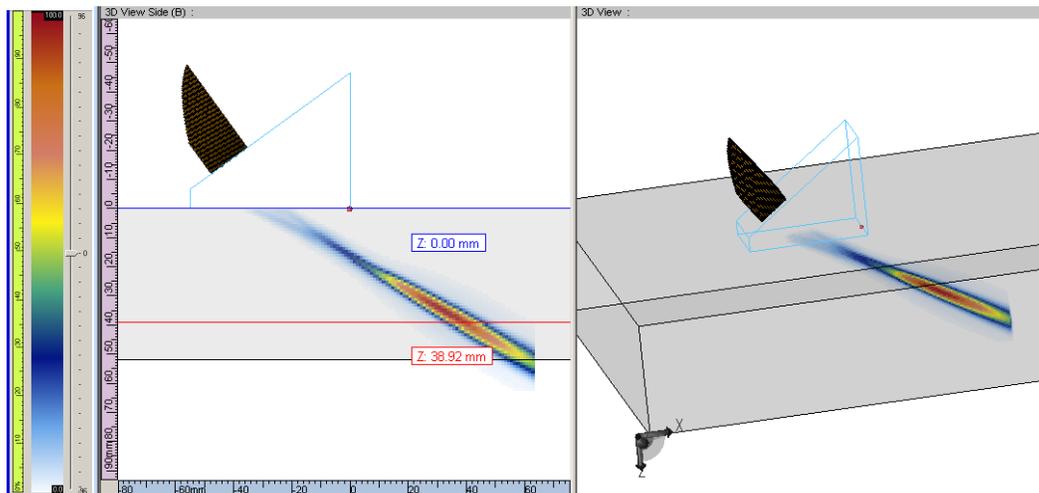
Figure 4-9 5.0-MHz Probe, 60-Degree Beam Simulation on 50.8-mm (2.0-in.) Thick Plate Component. Target focus at $3/4T$ (T = wall thickness).

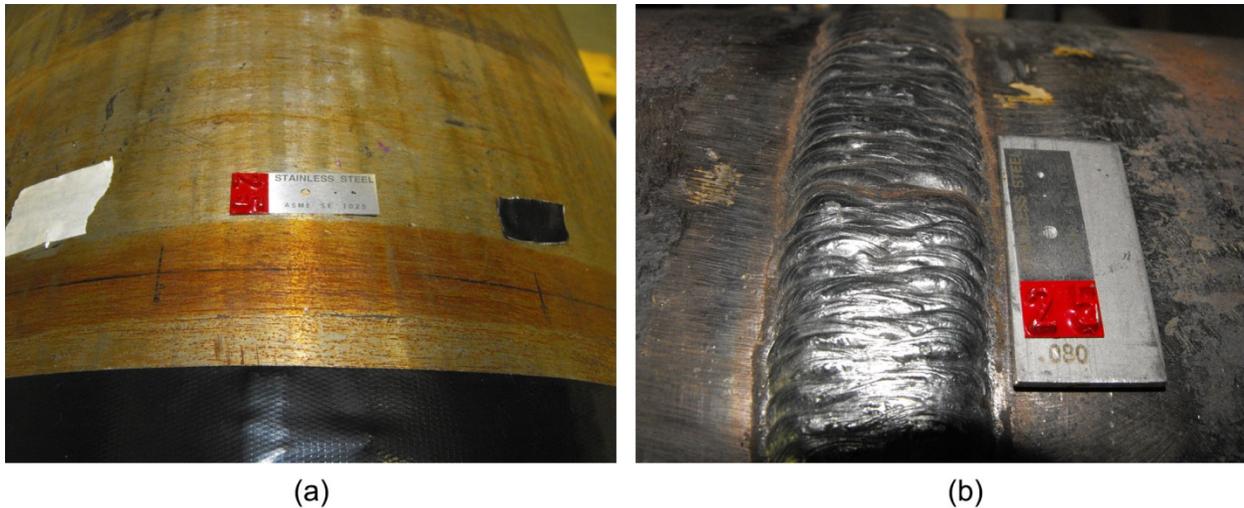
Figure 5-7 Placement of Penetrameter on Pipe

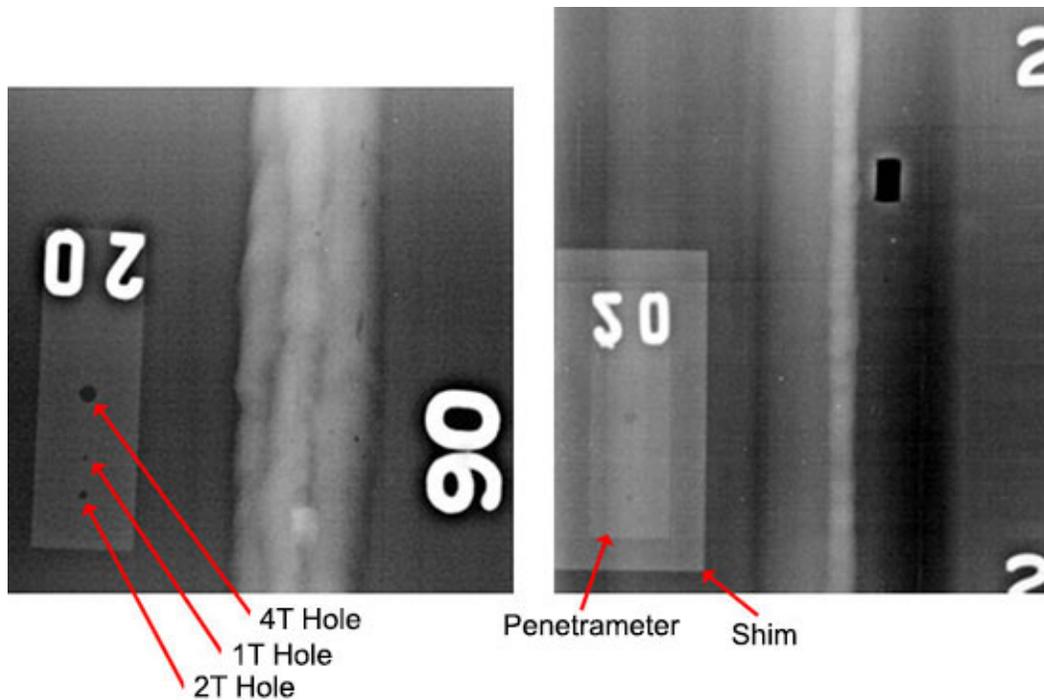
Figure 5-8 Typical Radiographs Displaying the Use of a Penetrameter

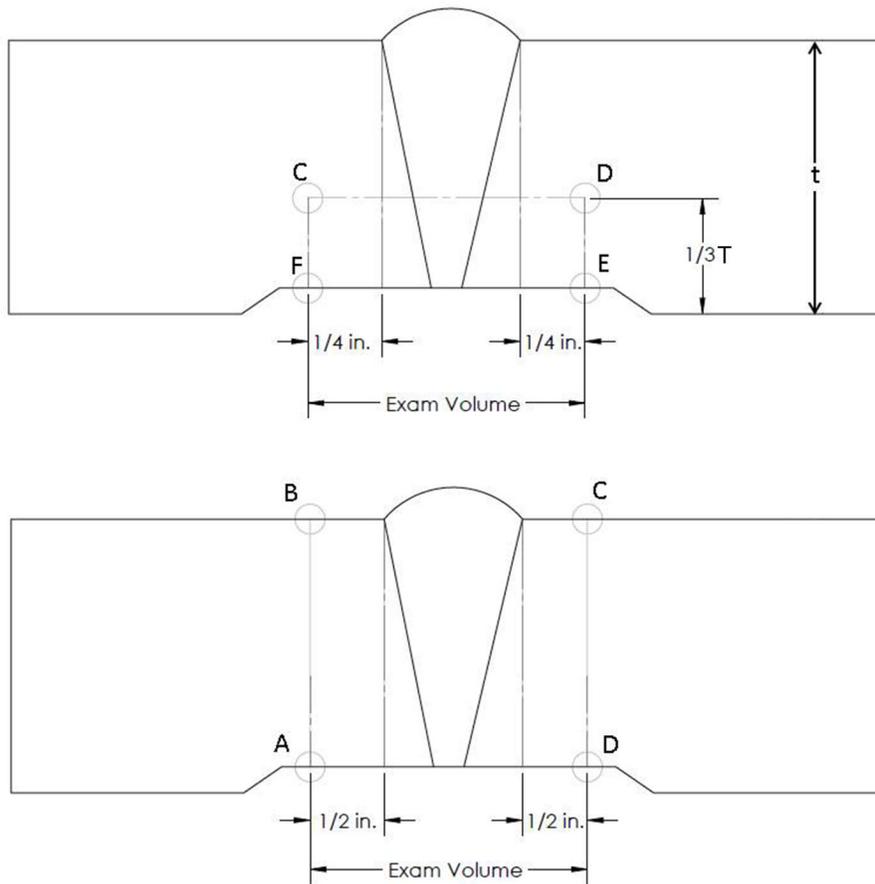
Figure 6-4 (a) ASME Code, Section XI, Inservice Inspection Volume – Inner 1/3 Thickness and (b) Inspection Volume required for Repair/Replacement – Entire Thickness

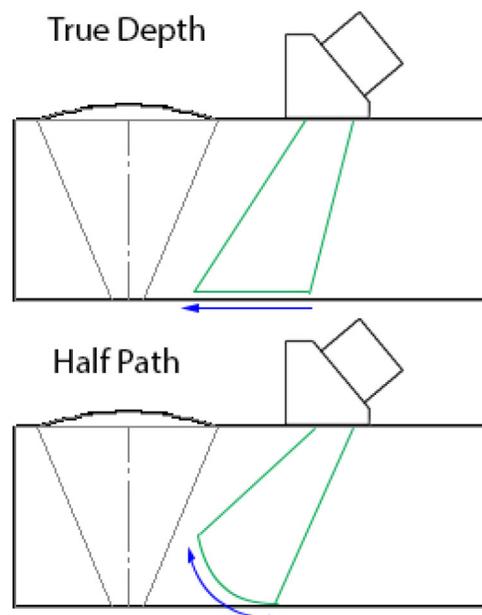
Figure 6-7 True Depth, Focusing at a Fixed Depth, and Half Path, Focusing at a Fixed Part Path, Focal Styles are Demonstrated

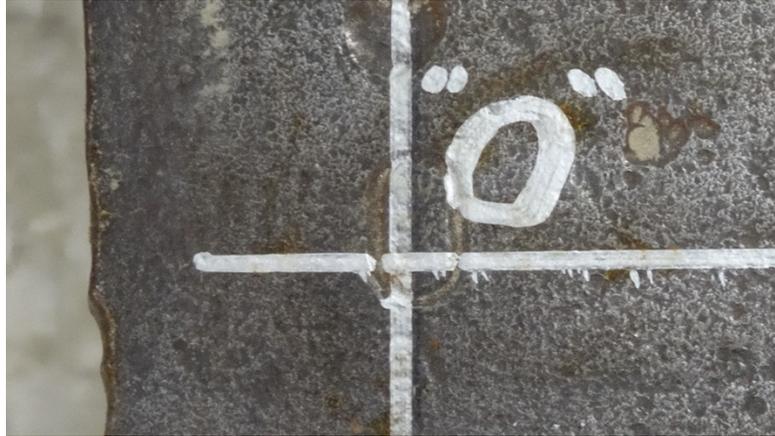
Figure 6-8 “0” Stamp Shown for Navy Plate 23 (etched lines drawn over with marker for scanning)

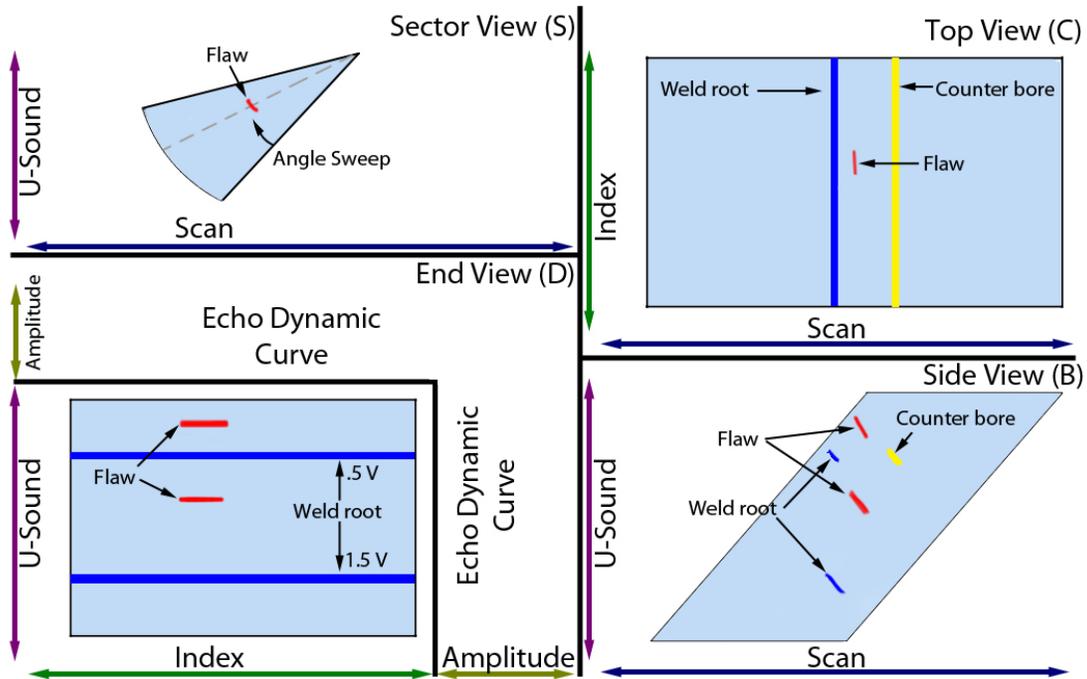
Figure 7-2 Description of a Typical PA-UT Analysis Screen Identifying Relevant Features and Locations of Weld Responses

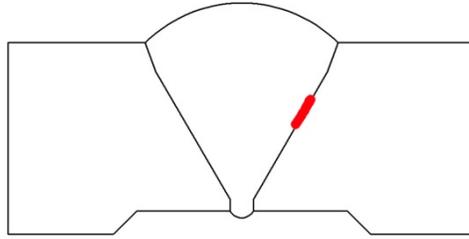
Figure 7-3 Weld Schematic for Lack of Fusion

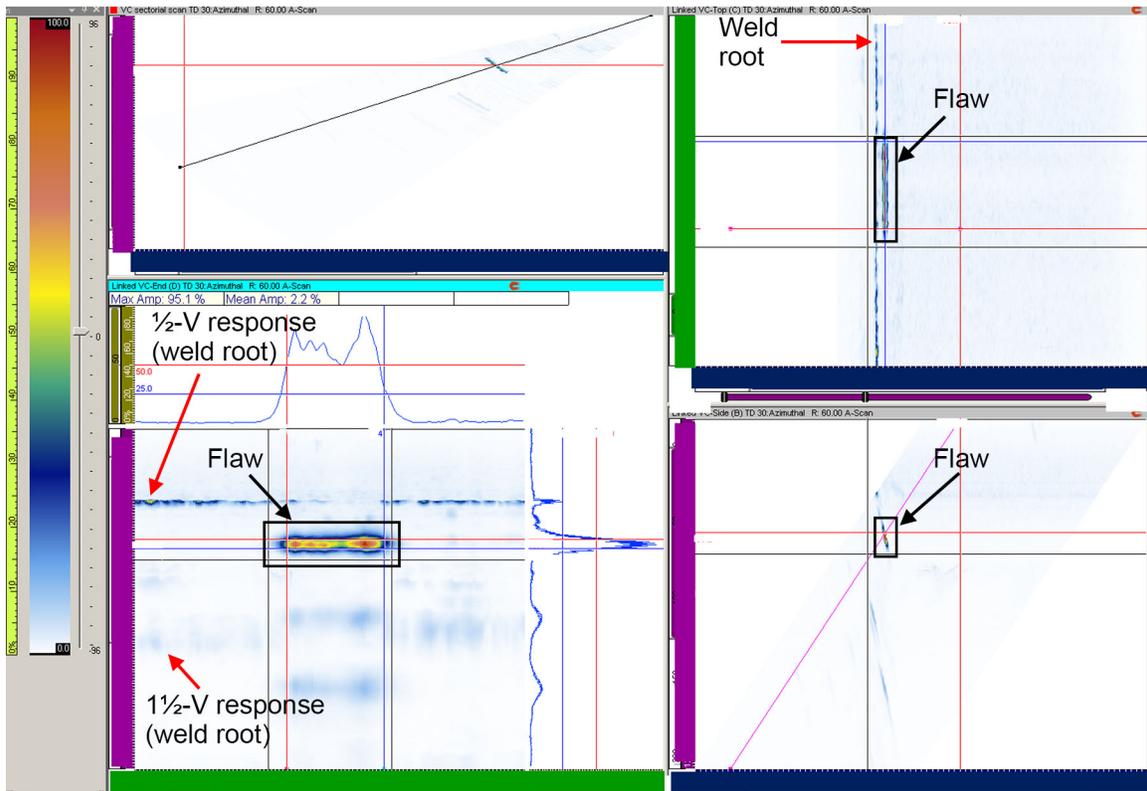
Figure 7-5 Ultrasonic Image of Lack of Fusion

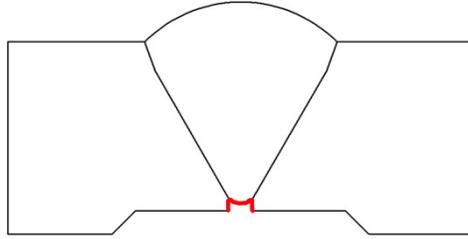
Figure 7-6 Weld Schematic of Lack of Penetration (incomplete penetration)

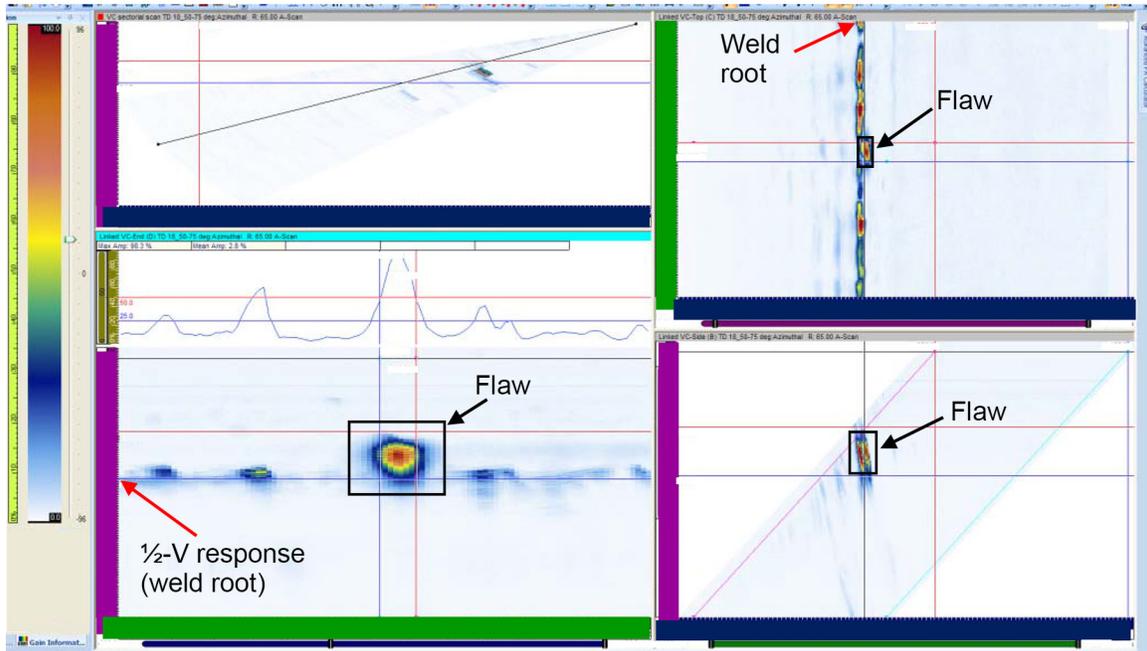
Figure 7-8 Ultrasonic Image of LOP

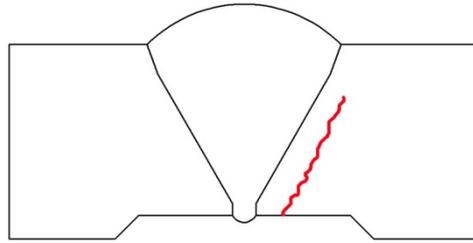
Figure 7-9 Weld Schematic of Crack

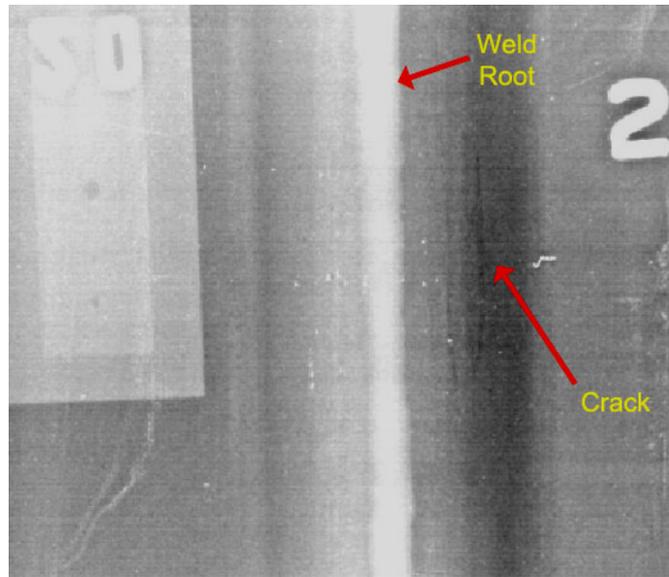
Figure 7-10 Radiographic Image of a Crack. Note: This image has been magnified 2X to enhance the visibility of the flaw for the reader.

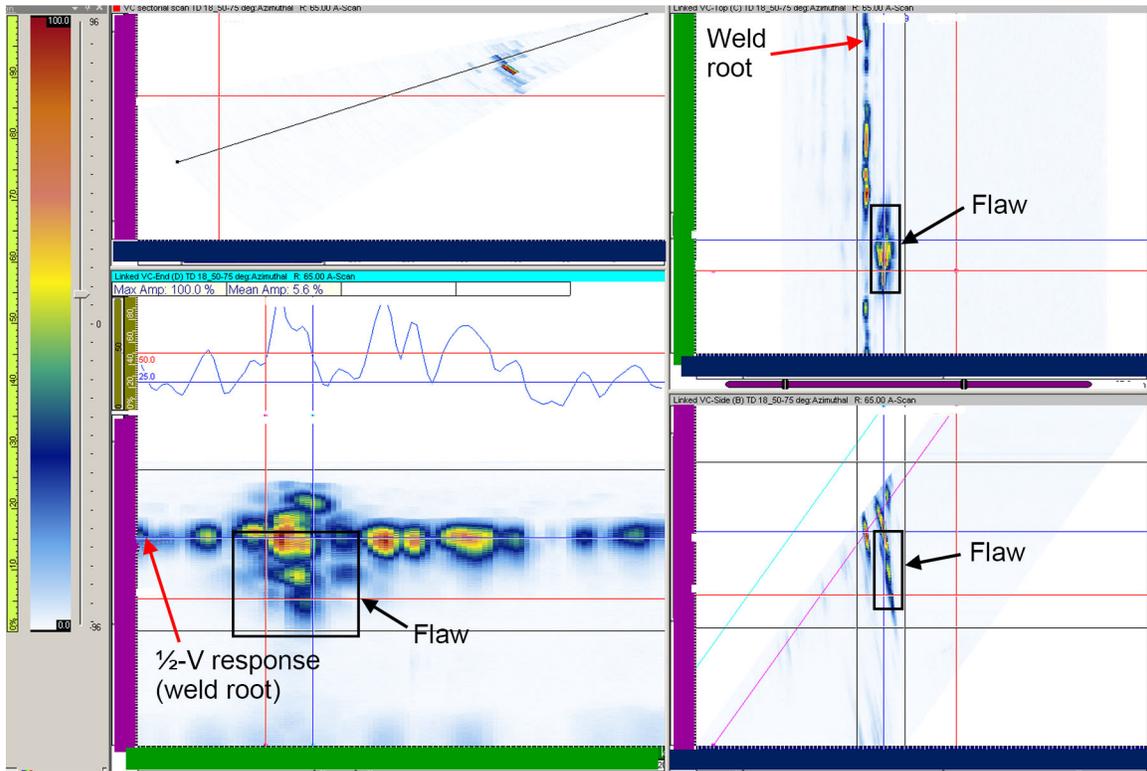
Figure 7-11 Ultrasonic Image of a Crack

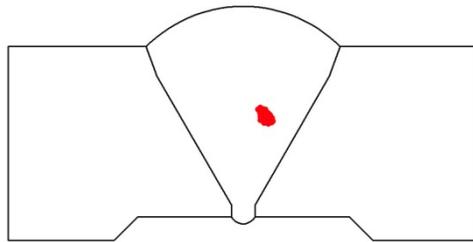
Figure 7-12 Weld Schematic of Slag

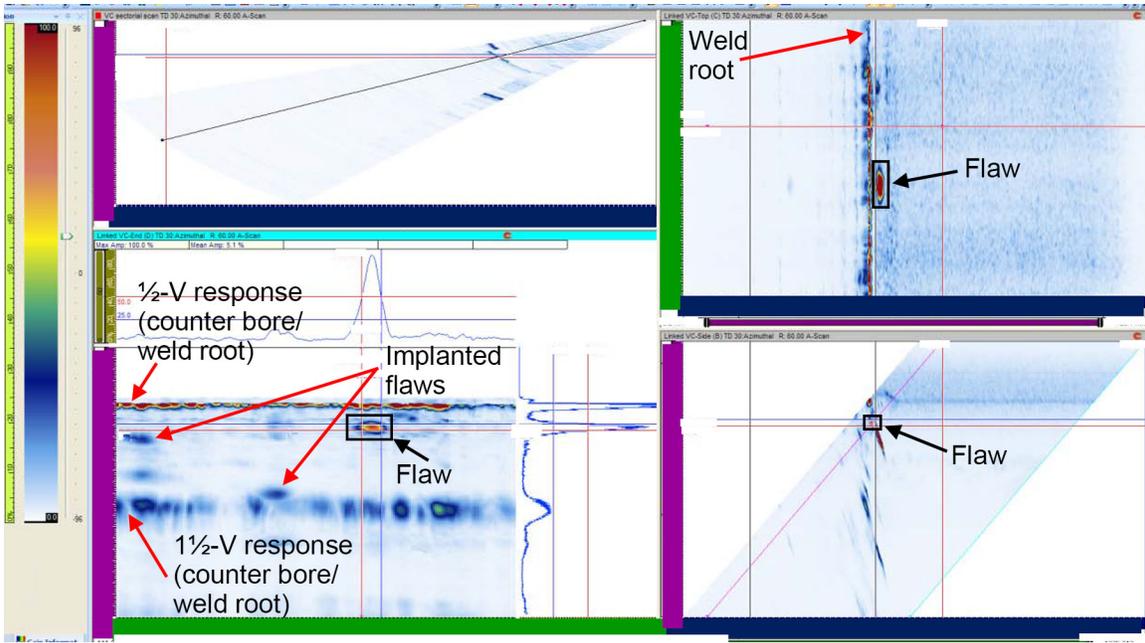
Figure 7-14 Ultrasonic Image of Slag

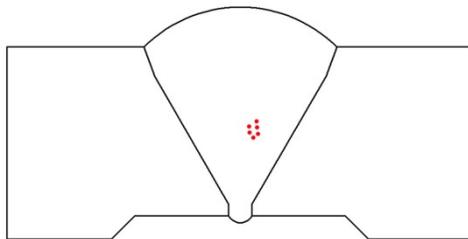
Figure 7-15 Weld Schematic of Porosity

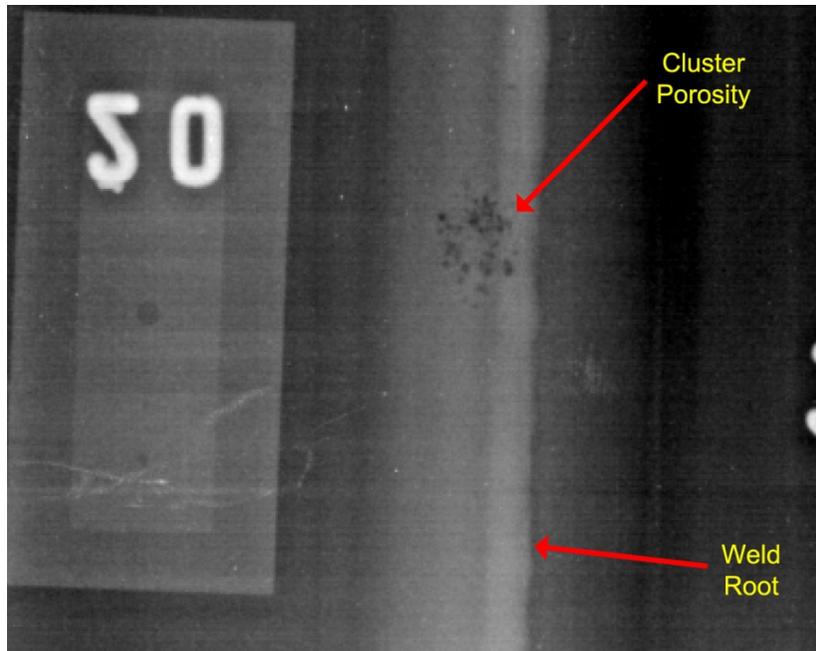
Figure 7-16 Radiographic Image of Cluster Porosity. Note: This image has been magnified approximately 2X to enhance the visibility of the flaw for the reader.

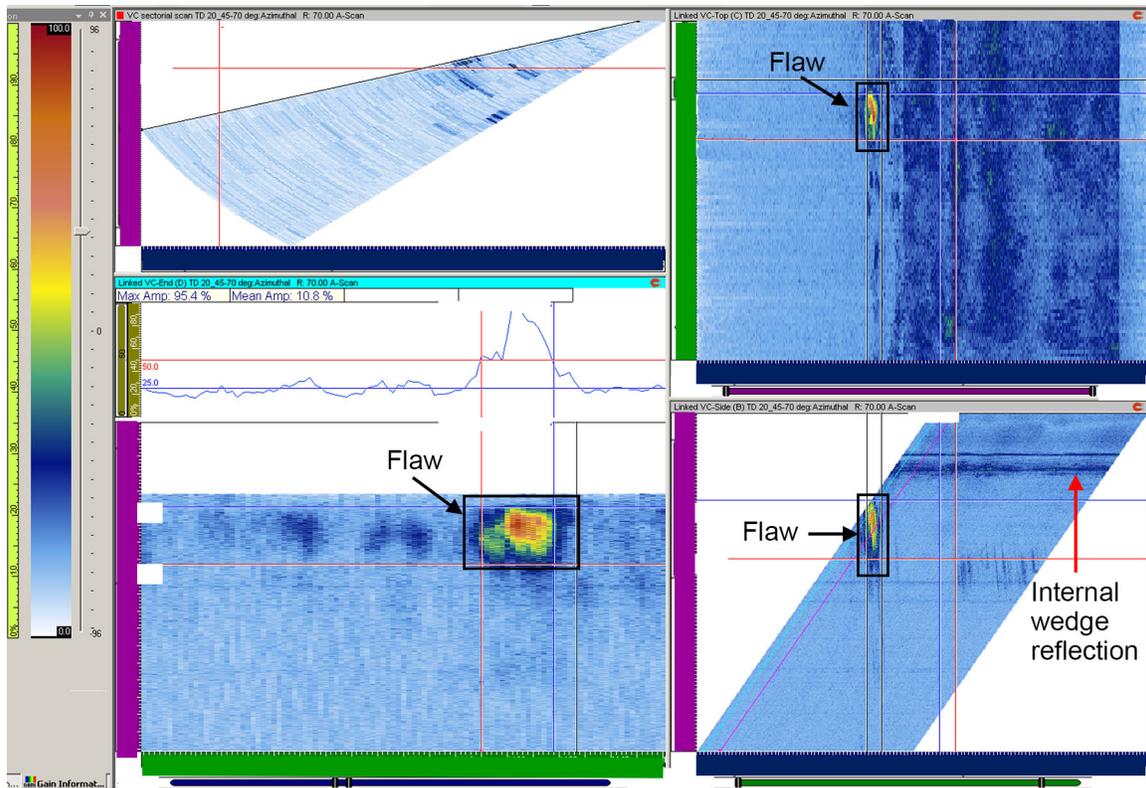
Figure 7-17 Ultrasonic Image of Porosity

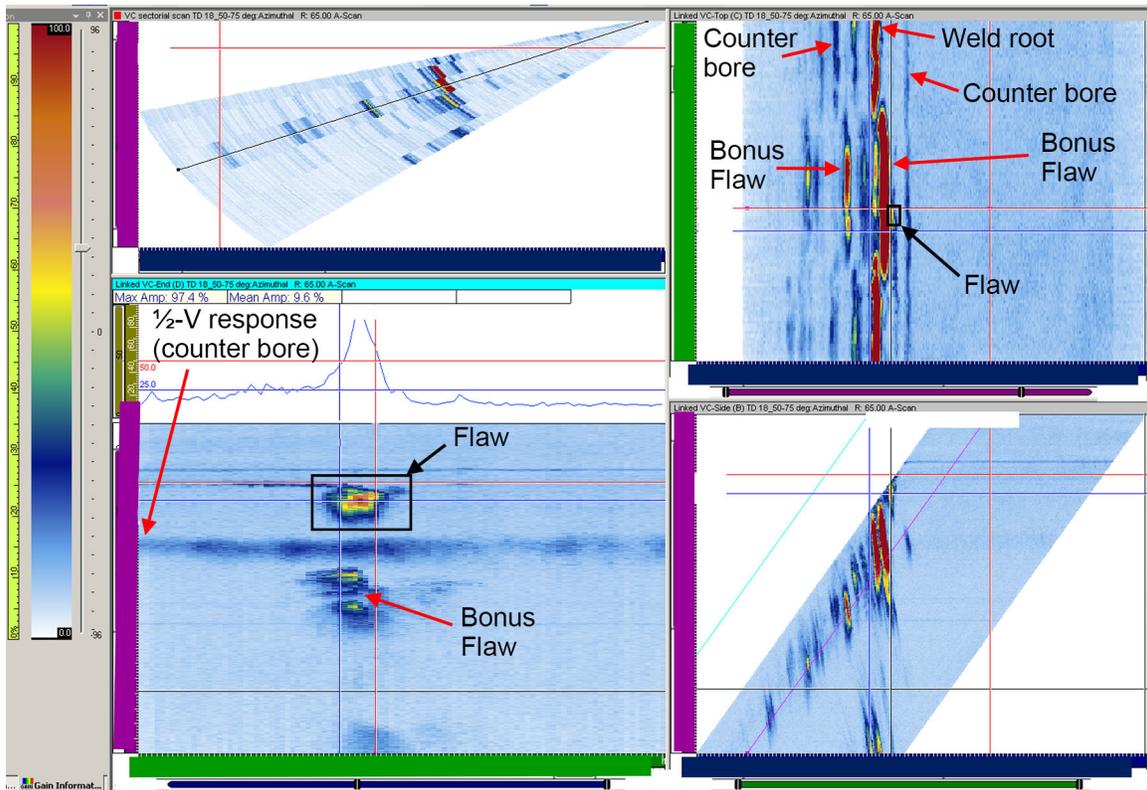
Figure 7-18 Example of Bonus Flaws

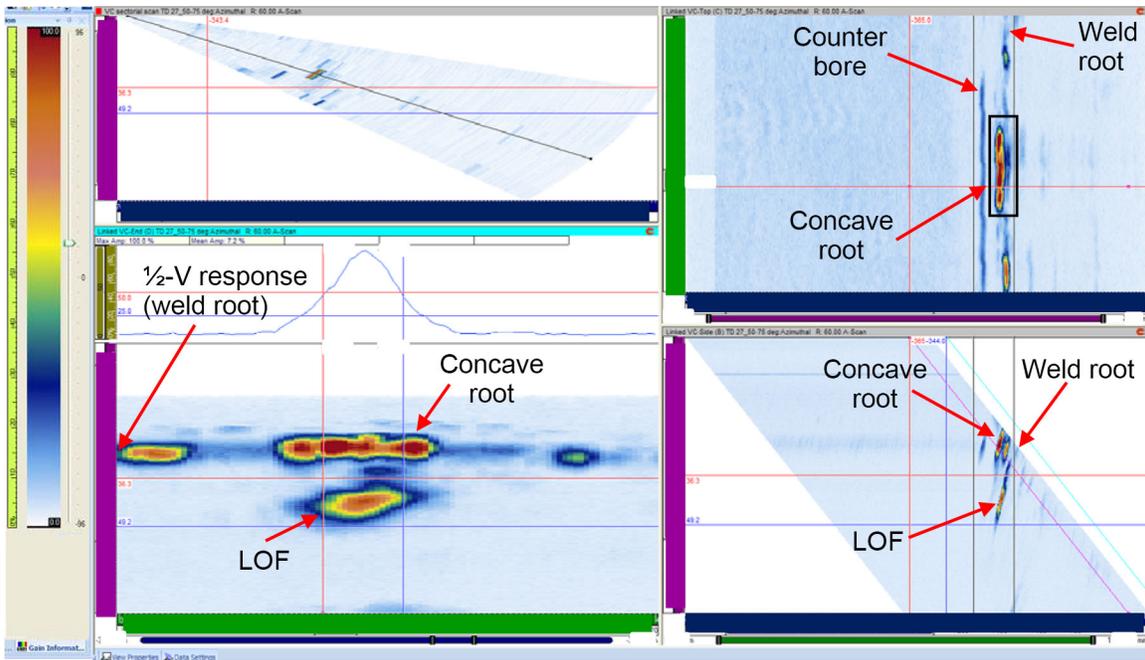
Figure 7-22 Example of LOF that was Not Detected by RT

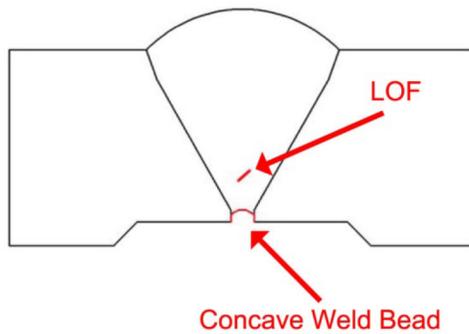
Figure 7-23 Schematic of LOF and Concave Weld Root as Shown in Figure 7-22 PA-UT and Figure 7-24 RT Images

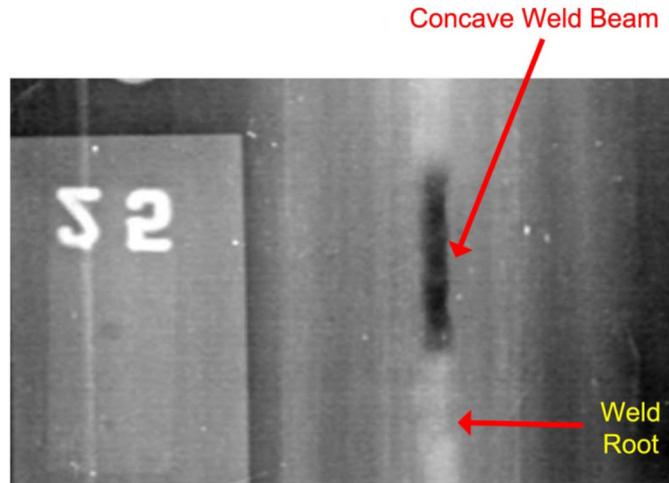
Figure 7-24 RT Image of Concave Weld Root

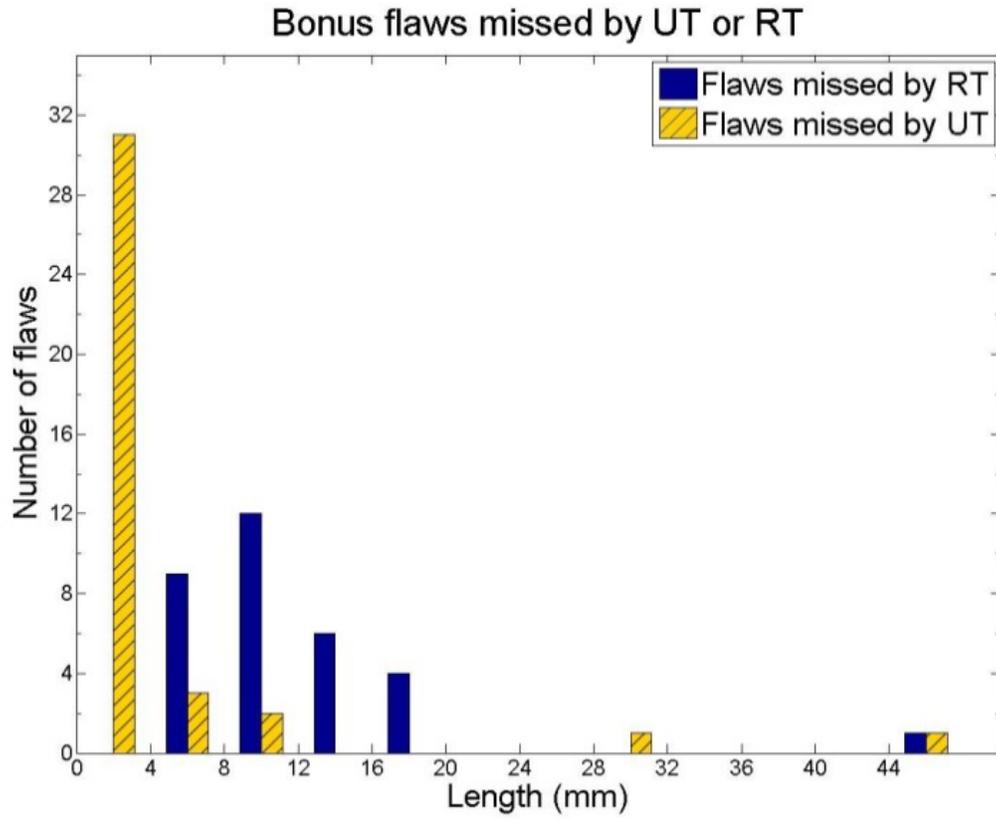
Figure 7-25 Bonus Flaws Missed by UT (38) or RT (32)

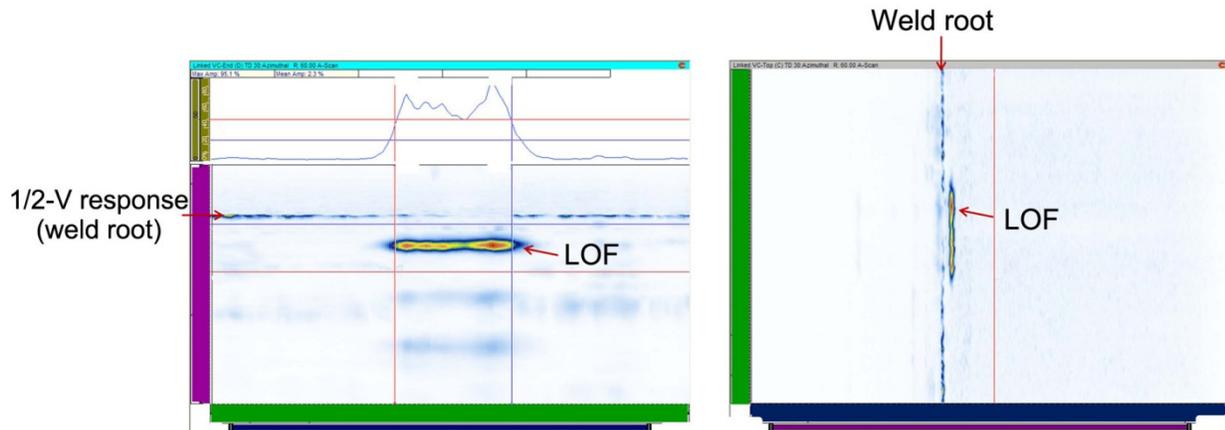
Figure 7-27 Example of Side Wall LOF (D-scan view on left and C-scan view on right)

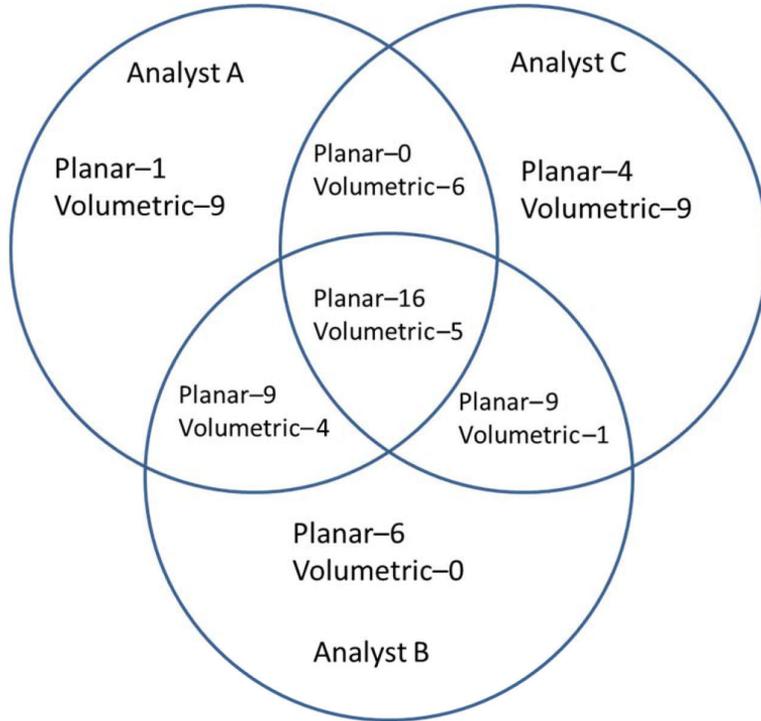
to flaw characterization discrepancies. The use of the weld profile overlay in the data was helpful in locating the flaw within the weld volume, but there was analyst subjectivity in placement of the weld overlay, which may also affect the flaw typing.

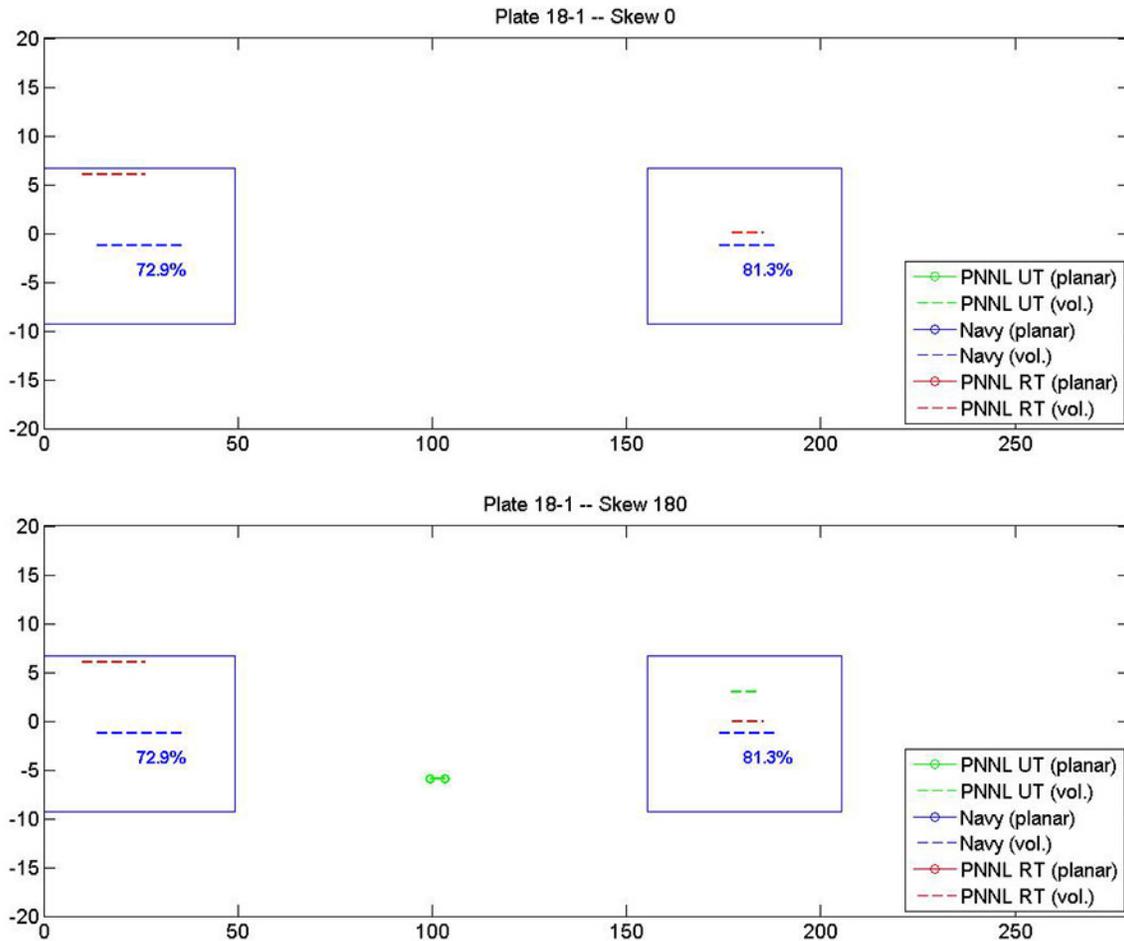
Figure 7-33 Flaw Map of Plate 18 Station 1, Axes Units are in mm
