Subject: Intermediate Milestone 17860.04.004.510: Feasibility Study of Acoustic Emission Monitoring for Cracking of Waste-Stabilizing Tank Grout and Saltstone—A Progress Report

Feasibility Study of Acoustic Emission Monitoring for Cracking of Waste-Stabilizing Tank Grout and Saltstone

A Progress Report

September 2015

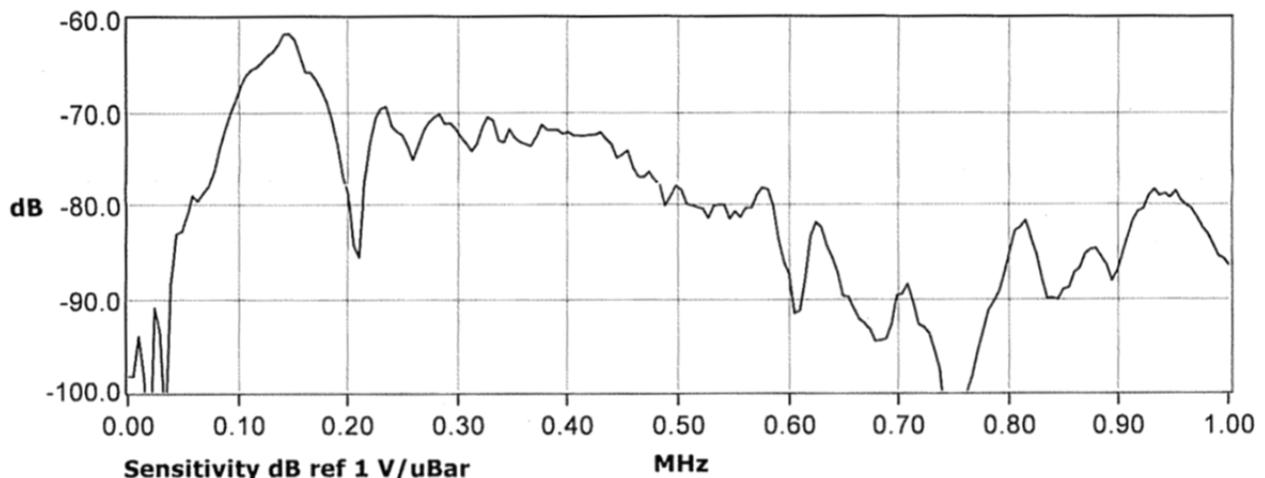
Figure 2-1. Frequency Response of MISTRAS R15a Acoustic Emission Sensor

Due to the long lead times required to purchase AE probes, CNWRA selected a commercially available probe model for the study prior to the creation or testing of grout specimens. Without foreknowledge about the frequency response characteristics of the two grout materials, CNWRA opted to select an AE probe model that had a wide, relatively uniform operating frequency range. A literature review of other AE work conducted on gel-like grout indicated that peak signal detection occurred in the 100–200 kHz range (McLaskey, 2007; Chotard, 2003). Based on the available information, MISTRAS sensor model R15a was selected for this work. A representative frequency response for the probe model is shown in Figure 2-1.

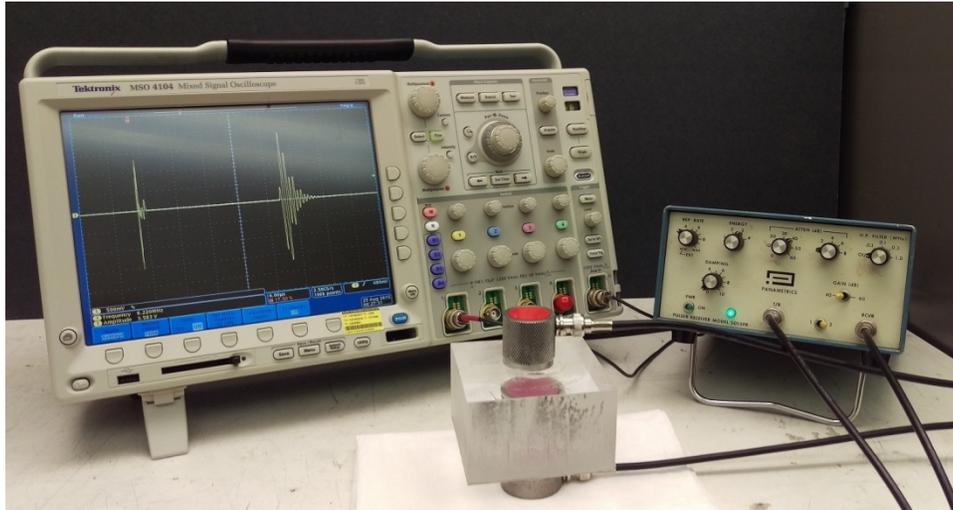
Figure 3-1. Equipment Setup for Ultrasonic Through-Transmission Measurement With Brittek Transducers Positioned on Lucite Velocity Calibration Block

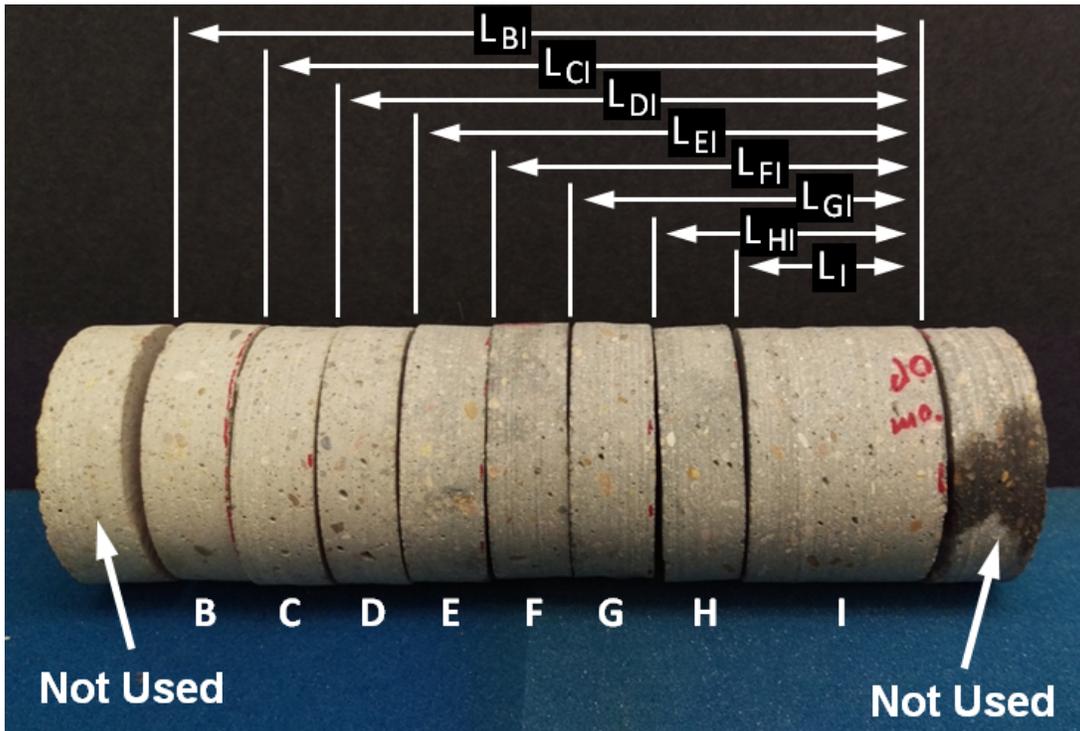
Figure 3-2. Sectioned Tank Grout Proxy Specimen After Ultrasonic Through-Transmission Testing; Upper End of Cylinder is to the Left

The captured waveform was digitally processed and reviewed to determine the ultrasonic time-of-flight and peak amplitude response. Once the measurement was performed with each pair of probes, a section of the specimen was removed from one end of the cylinder, and the measurements are repeated on the shortened cylinder. This procedure was repeated until the cylinder became too short to section further. A sectioned specimen is shown in Figure 3-2.

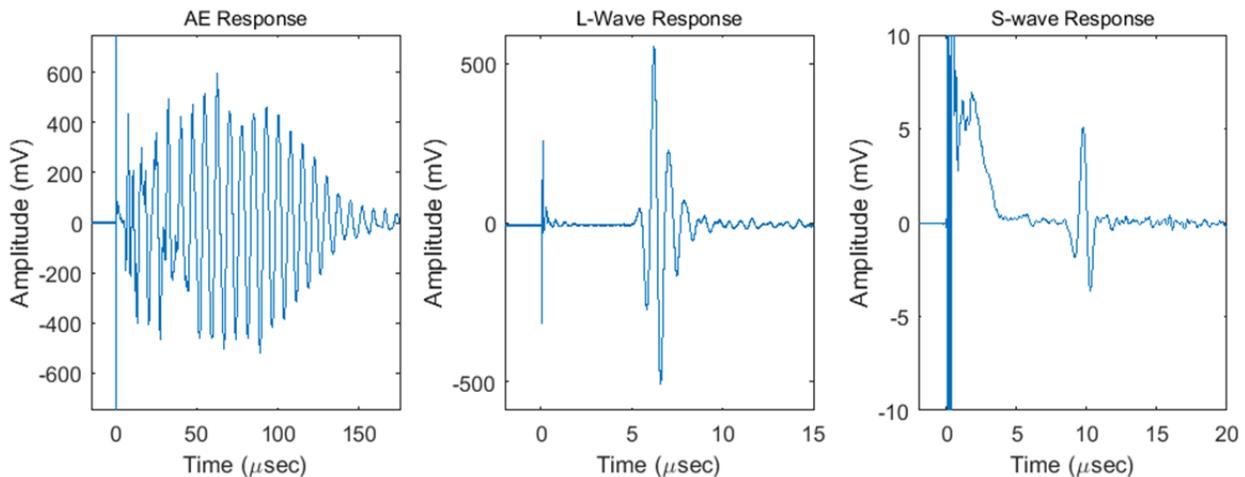
Figure 3-3. Comparison AE, L-Wave, and S-Wave Signals Captured After Transmission Through 20 mm [0.8 in] Section of SRS Reducing Tank Grout Specimen

For the four ~1-L [1-qt] specimens tested, the waveforms transmitted in L-wave and S-wave modes exhibited roughly comparable attenuation rates, but signals transmitted in the S-wave mode were detected with substantially less amplitude than their L-wave counterparts. Over the largest propagation distances, the S-wave signals were typically too small to detect. In almost all cases, when the S-wave mode was detected, it presented amplitudes that were at least 30 dB smaller than the L-wave mode. For reference, Figure 3-3 compares the waveforms captured by the three pairs of probes after transmission through a 20 mm [0.8 in] section of tank grout. Based on the poor S-wave signal response, it is unlikely that S-waves will be detected during AE monitoring. The absence of the S-wave mode will simplify AE monitoring by eliminating the need to separate S-waves and L-waves for event detection.

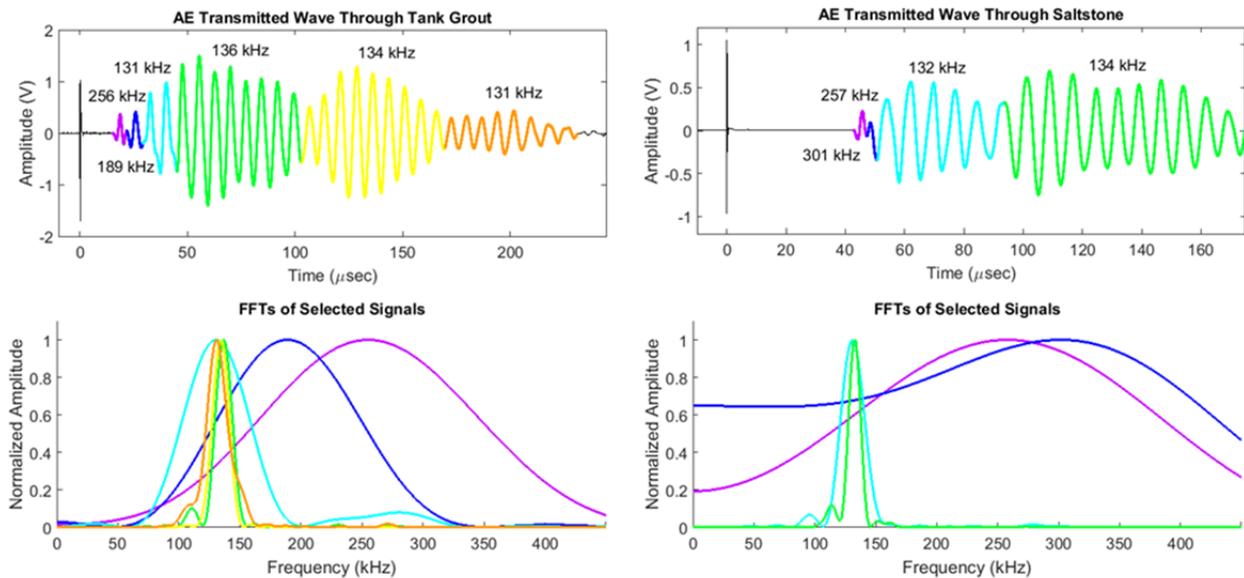
Figure 3-4. Typical Frequency Responses for AE Signal Transmitted Through SRS Reducing Tank Grout (Left) and SRS Radionuclide-Free Saltstone (Right)

Typical signals captured using AE sensors after transmission through SRS reducing tank grout and SRS radionuclide-free saltstone are shown in Figure 3-4. In both materials, the majority of the received signal had a frequency near 130 kHz. For tank grout, the main signal envelope (shown in cyan and green) tended to respond with a peak frequency of 130–140 kHz and bandwidth of 30–40 kHz. For saltstone, the main signal envelope (shown in cyan) tended to respond with a peak frequency of 120–150 kHz and a bandwidth of 25–35 kHz. The main signal envelope for saltstone was often less clearly separable from subsequent reverberations than for tank grout. The captured waveforms for both materials also exhibited low amplitude, broad bandwidth initiation signals that mark the first arrival of the wave. Because these initiation signals often exceed 10 μs in duration, accurate identification of these signals is critical to locating the position of acoustic events.

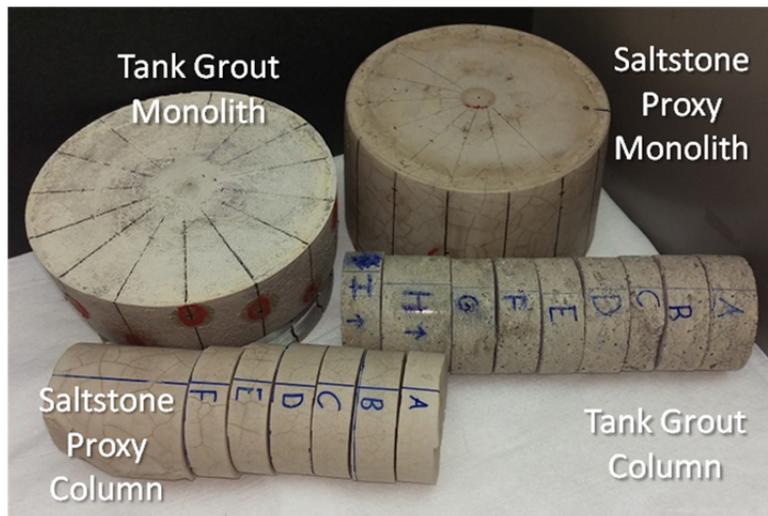
Figure 3-5. Photograph of Bench-Top Monoliths and Sectioned Cylinders of Tank Grout and Proxy Saltstone

The two bench-top specimens were cast in half-gallon buckets to achieve an approximately cylindrical form factor similar to the larger mesoscale specimens that would be tested in later experiments (Figure 3-5). Both bench-top specimens were allowed to set up under ambient laboratory conditions. As the saltstone proxy specimen set up, salt precipitated out of the saltstone and formed a layer of crystals covering the upper surface. After one month, the specimen was removed from the bucket, and the top surface was sanded smooth. A network of hairline cracks was observed around the side and bottom surface of the specimen. The SRS reducing tank grout specimen was removed from the bucket after one month of hydration and required no additional surface preparation. No visible cracks or loose aggregate was observed to break the surface of the specimen, but a number of small vesicles were observed around its circumference. The dimensions and wave speeds of both specimens are provided in Table 3-5, where wave speed was measured using a simplified variation of the ultrasonic through-transmission technique discussed in Section 3.1.

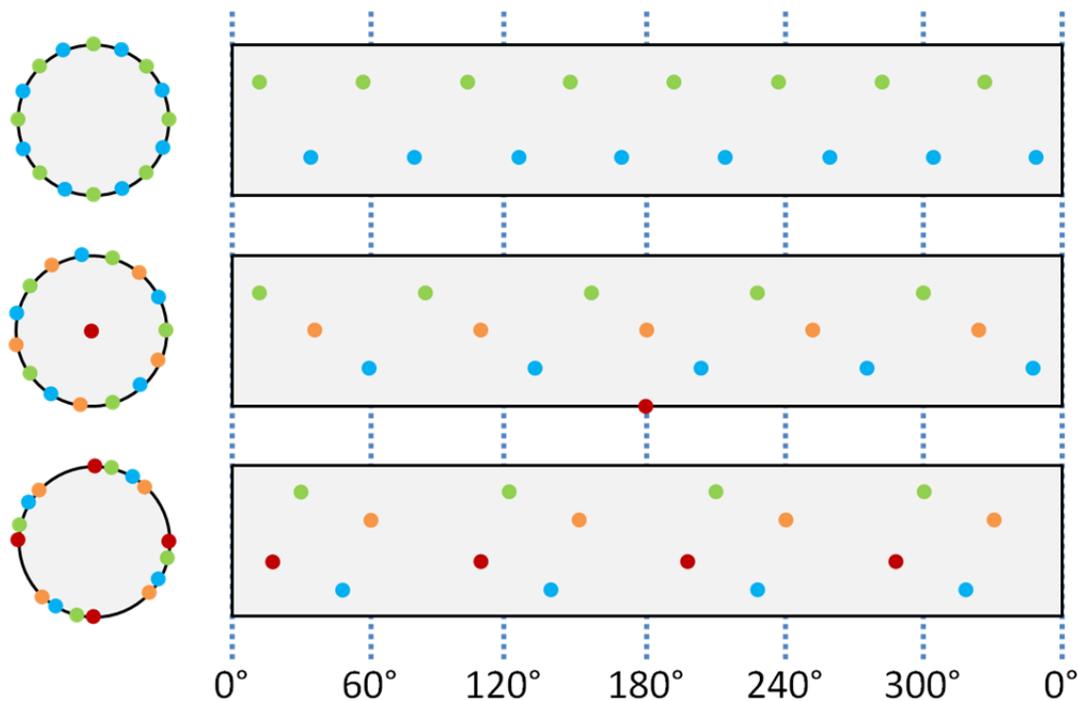
Figure 3-6. Alternative AE Sensor Arrangements Around Circumference of Cylindrical Grout Specimens

Various AE sensor configurations were applied to the saltstone proxy specimen. Preliminary evaluations of the capability of a configuration to detect and locate crack events were made by performing pencil breaks on the top, bottom, and side of the specimen and by evaluating the detection rate and location accuracy of the recorded events. The studied sensor configurations focused heavily on placement of the sensors on the wall of the specimen. Note that without refined AE acquisition settings, a rigorous evaluation of each sensor configuration could not be made at this point in testing. Illustrations of some alternative sensor layouts are shown in Figure 3-6, where sensor placement is illustrated as an overhead view and as an “unwrapped” side view of the specimen.

The upper arrangement illustrated in Figure 3-6 shows the sensor configuration that was originally recommended for the specimens. It consists of two bands of eight AE sensors that are staggered in clocking position. While this arrangement offers good detection coverage, the arrangement lacks redundancy in overlapping coverage needed for accurate event location. The alternative shown in the lower arrangement solves this by positioning sensors in tighter clusters about the circumference of the specimen. This method improves the location accuracy of many, but not all, detected events, but exhibits inferior detection coverage. The middle arrangement (Figure 3-6) improves upon the location accuracy of the upper arrangement while still maintaining comparable detection coverage over the specimen. At the time of the test, the middle arrangement had also been tested in a preliminary fashion on the mesoscale test stand that was being developed for later experiments, so it was somewhat more refined in implementation than the other configurations. This arrangement proved to provide both a high rate of event detection and appeared to be the configuration that was most likely to locate events accurately once the AE system had been appropriately tuned.

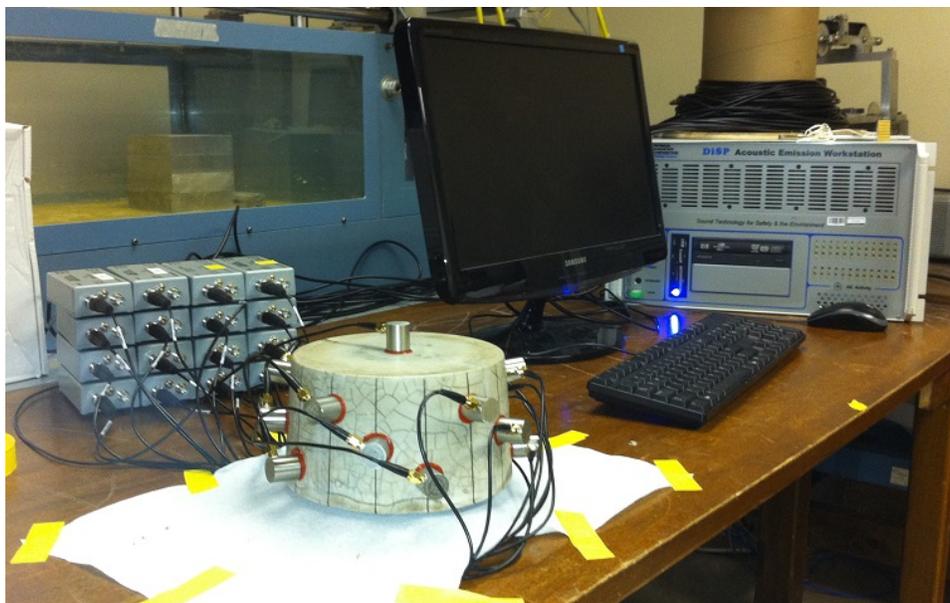
Figure 3-7. AE Experimental Setup on Bench-Top Saltstone Proxy Specimen

Installation of the AE system on the saltstone specimen was completed, as shown in Figure 3-7. An AST was performed, where each AE sensor was actively pulsed in sequence and every other sensor recorded the transmitted wave. Using the resulting data set, estimates of wave velocity through the specimen were made. The AST returned an average velocity of 2.75 mm/ μ s.

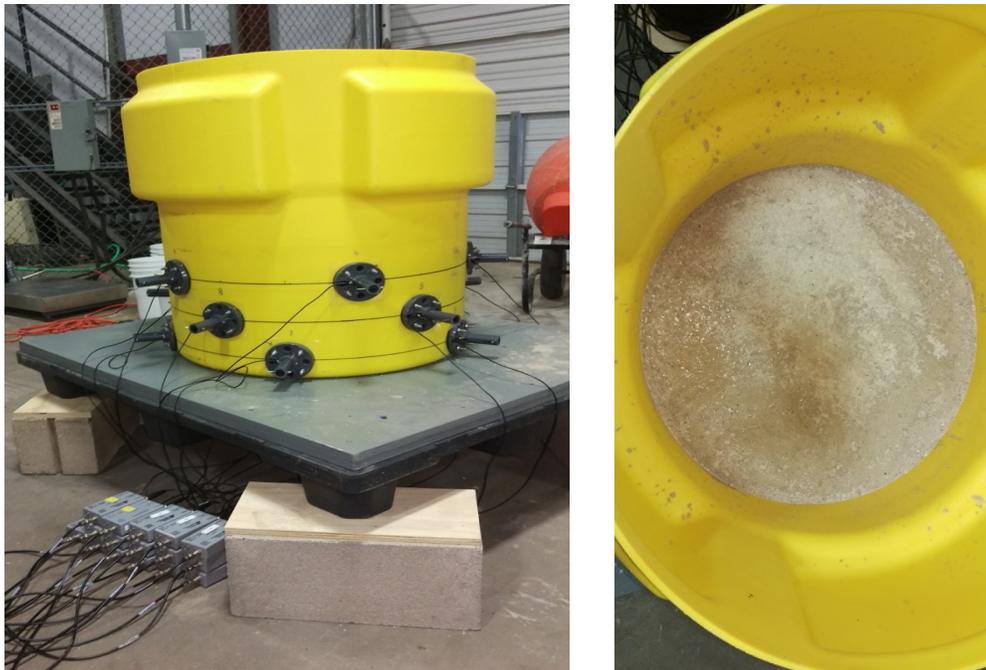
Figure 3-8. Acoustic Emission Test Fixture (Left) and SRS Reducing Tank Grout in Test Fixture Bucket (Right)

An AE test fixture for monitoring grout was constructed by installing a series of sensor mounts into a 360 L [95 gal] high density polyethylene overpack drum (Figure 3-8). The probe mount configuration consisted of three bands of five probe mounts spaced evenly around the circumference of the drum. The bands are positioned at heights of 51, 152, and 254 mm [2, 6, and 10 in] relative to the base of the drum. Each band of probe mounts is circumferentially staggered by 24° from the preceding band. Viewed from overhead, there are 15 probe positions clocked at 24° intervals about the circumference of the drum, designated CH01 through CH15. A final probe, designated CH16, is centrally located at the base of the drum.

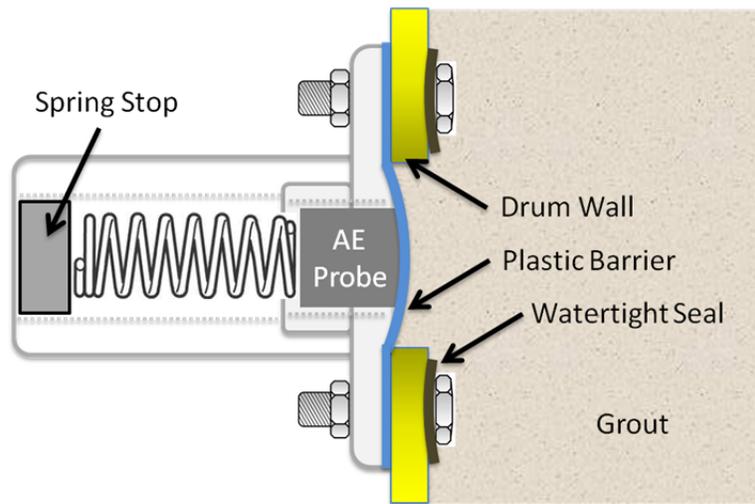
Figure 3-9. Spring-Loaded AE Sensor Mount

Each AE probe is held in place by a spring-loaded probe mount (Figure 3-9), similar to the setup described by Abeele et al. (2009). As the specimen expands and contracts throughout the hydration process, the spring ensures that the probe remains in contact with the specimen. The probe is coupled to the grout through a thin plastic film fitted between the fixture and the specimen that is attached to the probe face by a thin layer of room temperature vulcanization silicone.

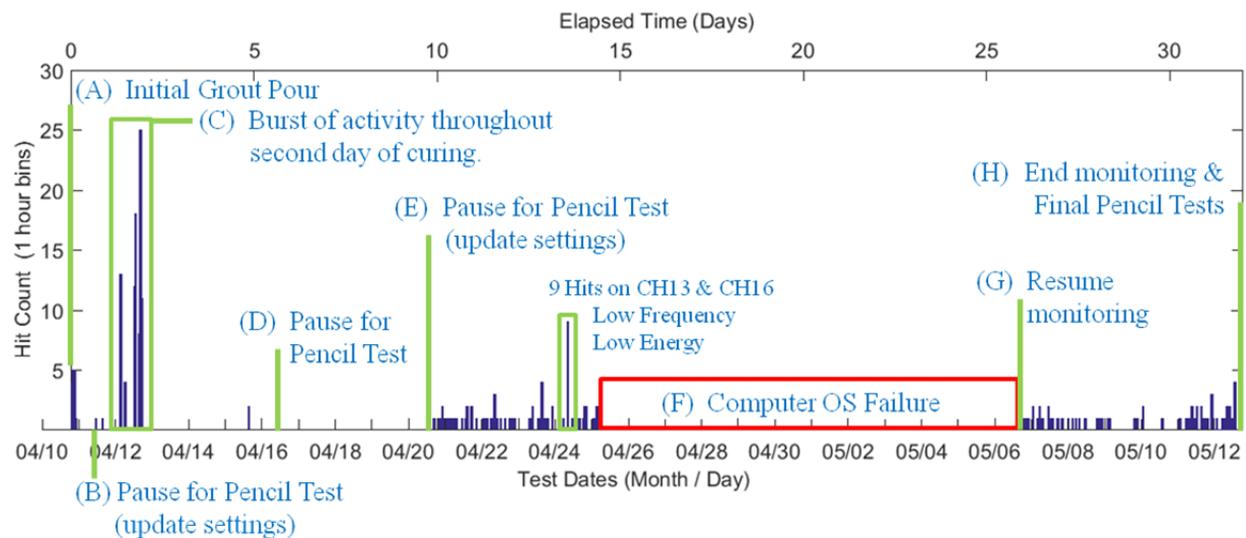
Figure 3-10. AE Hit Activity Log Shown as a Timeline Over 32-Day Monitoring Period

During the first 18 hrs after the grout pour, the AE system detected only 32 minor signal hits, (Figure 3-10; Table 3-6). Monitoring was briefly paused to conduct pencil lead break tests to check sound propagation. Testing confirmed that induced sound readily propagated to multiple sensors that are in contact with the material. Therefore, the paucity of signals indicated that the early stages of setting and hydration were not very noisy. This implied that monitoring grout for cracking during this early stage should be effective because there should be few extraneous signals that could be confused with cracking.

Nearly 2 days after the grout pour, 84 unique acoustic signals were detected over a timespan of approximately 14 hrs (Figure 3-10; Table 3-6). The energy levels of these signals were low (i.e., on the order of 10 nJ) and the event locations therefore remained indeterminate because they were generally only detected by a single sensor, rendering triangulation impossible. It can be inferred that these events were probably located close to the single sensor that detected them. Acoustic signals of this type shared several common identifying features and should be distinguishable from more typical cracking signals.

Over the next several days, two additional pencil lead break tests were performed to check sensor operation and detection sensitivity, but the grout specimen showed no further signs of notable AE events. After 10 days of testing, sufficient data had been collected on the test specimen to permit modification of the acquisition system settings to improve the instrument sensitivity by 15 dB. Monitoring for the remainder of this test continued with the revised acquisition settings. On April 24, an operating system failure caused the AEwin monitoring software program to close (Figure 3-10; Table 3-6). Once this problem had been identified, the monitoring program was reset and resumed monitoring from May 6 through May 12 (Figure 3-10; Table 3-6).

*Event labels are the same as given in Figure 3-10 and Table 3-6.

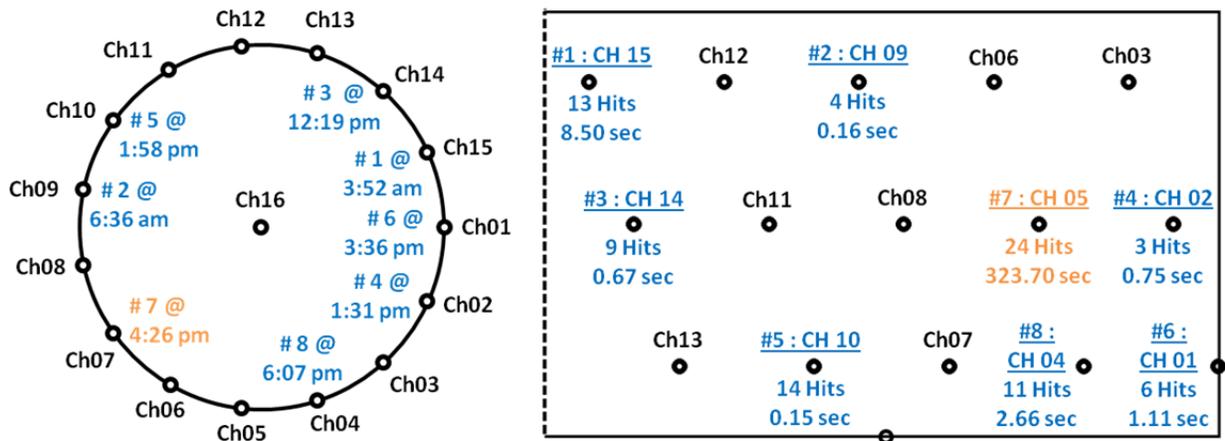
Figure 3-11. Illustration of Burst Sequence Phenomena Recorded on Second Day of Monitoring, Shown in Overhead and Unwrapped Views

The burst sequence phenomenon was observed by 8 of 16 AE sensors at different times. The detection sequence began in the top sensor row and ended in the bottom sensor row. An illustration of the order of the burst sequence is shown in Figure 3-11. Given their low energy levels, these hits are suspected to have been generated by minor source events that were located near the detecting sensors. It is possible that a larger number of these source

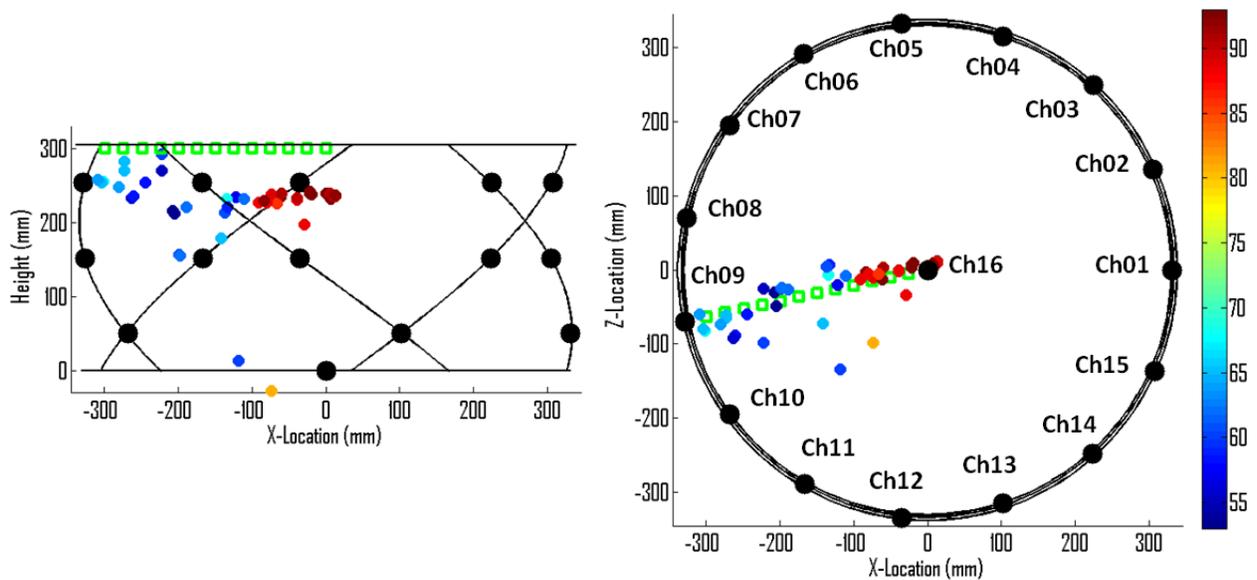
Figure 3-12. AE Event Locations for 39 Pencil Lead Breaks Performed in Sets of 3 Along 13 Locations in a Line Between the Top Center of the Specimen and CH09. Located Events are Color Coded by Maximum Signal Response in dB.

In the XZ-plane only, events were detected with an average location error of 11.6 mm [0.46 in] and a standard deviation of 10.7 mm [0.42 in]. When the volumetric location accuracy was considered, the location error increased to 60.3 mm [2.4 in] with a standard deviation of 33.3 mm [1.3 in], due largely to a systematic depth error. A significant part of the depth error was produced by a limitation of the location algorithm. The algorithm employed had difficulty accurately locating events that were found outside of the volume enclosed by the sensor grid, and tended to find the nearest match within the grid volume. A large fraction of the AE events were aligned with the top row of sensors. This limitation may be corrected in future experiments by modifying the sensor arrangement and adjusting how the algorithm handles preliminary event locations found near sensor boundaries.

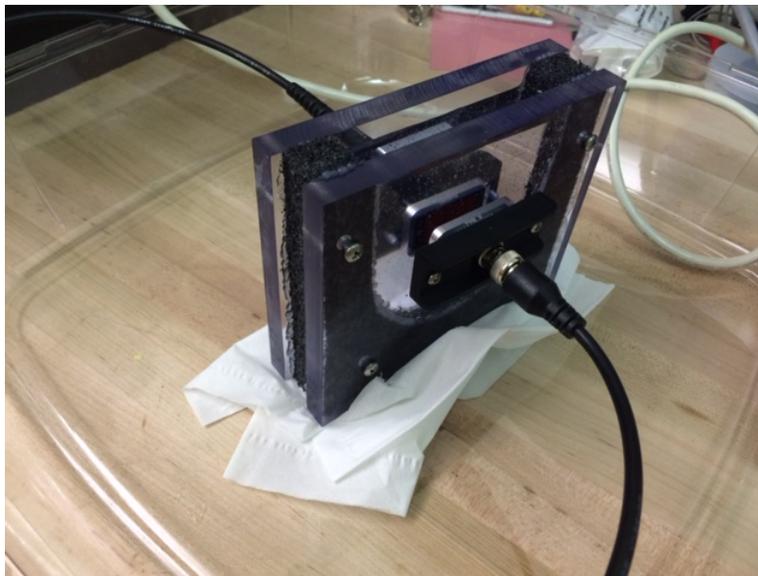
Figure 3-13. Phase Velocity and Attenuation Measurement Test Fixture

An ultrasonic through-transmission experiment similar to the setup described by Aggelis et al. (2005) was designed to measure the L-wave phase velocity and attenuation during the hydration and hardening of SRS reducing tank grout, where group velocity is computed from the phase velocity information. Two Panametrics V413 transducers {500 kHz center frequency, 13 mm × 25 mm [0.5 in × 1 in]} were mounted within cavities machined into rectangular acrylic plates (Figure 3-13). The two plates were bolted together with machined metal standoffs to control the separation between the two transducers, and closed-cell foam material combined with vacuum grease were compressed between the two plates to form a cavity for the tank grout. Once the cavity was filled with fresh grout, ultrasonic waves were transmitted through the grout. Data were collected at multiple frequencies, and this information was used to quantify wave propagation time through the material and the amplitude of the received signals.

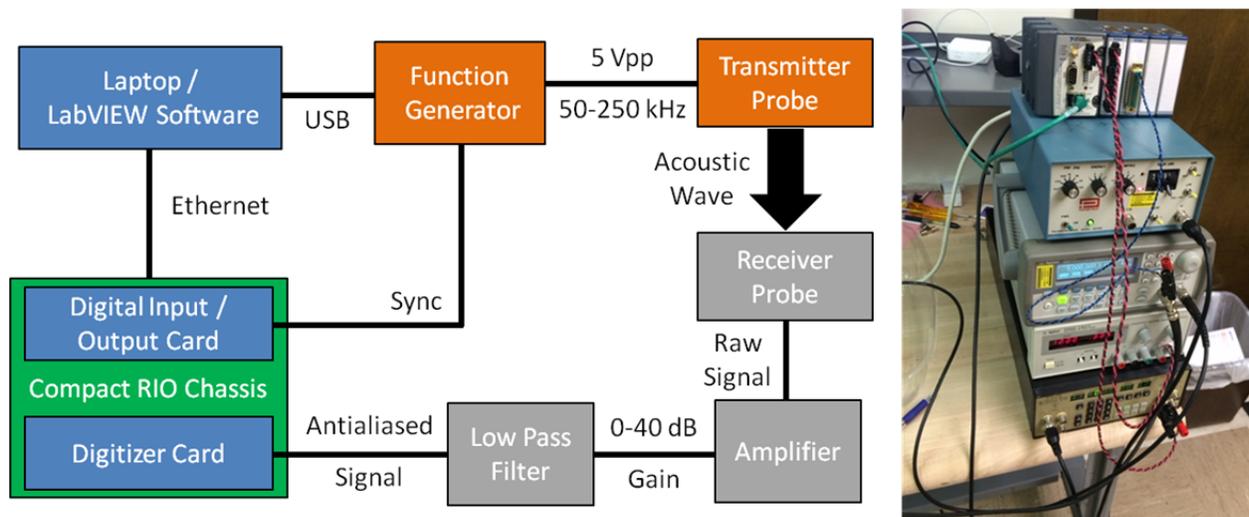
Figure 3-14. Functional Block Diagram Showing Signal Paths in Experimental Approach (Left) and Laboratory Electronics Used With Ultrasonic Setup (Right)

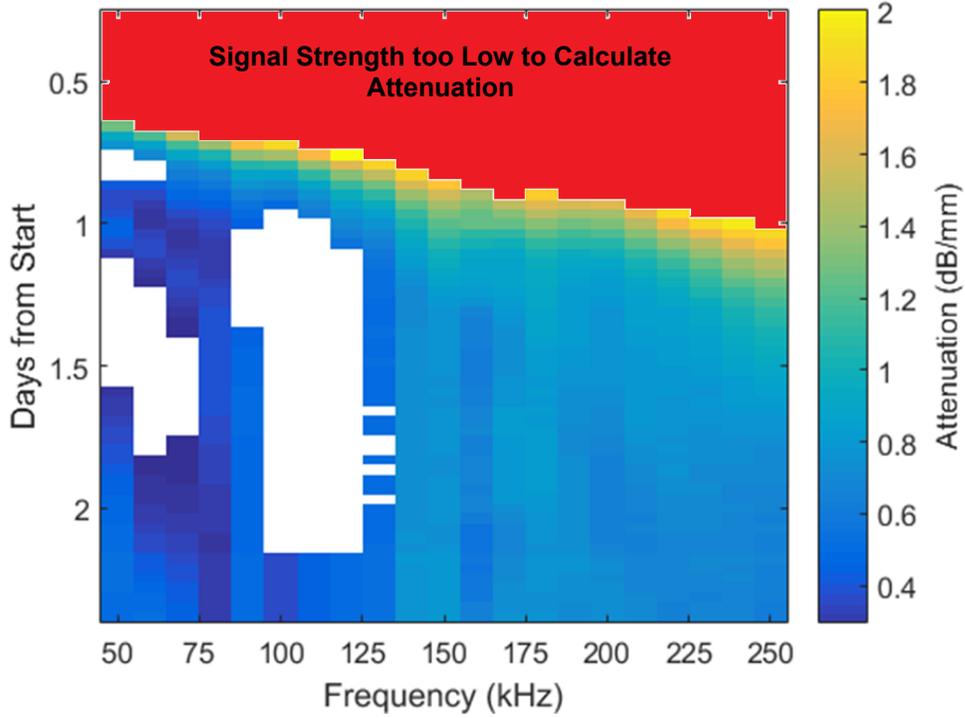
Figure 3-15. Measured Overall Attenuation Relative to Water

The overall attenuation results are shown in Figure 3-15. For the attenuation results, the peak measured attenuation was approximately 2 dB/mm [50 dB/in]. Using the existing equipment setup, it was not possible to generate sufficient signal amplitude to measure greater attenuation levels, so instances of even higher attenuation were not calculated. This is observed as a large red region that spans the upper portion of Figure 3-15. After the first day, attenuation decreased significantly and settled to nominally steady-state values during the second day. An example attenuation over time curve for the 140 kHz frequency data is shown in Figure 3-16, where attenuation appears to reach a steady-state value of 0.77 dB/mm [19 dB/in] after 2.2 days.

Two large white regions are also observed in Figure 3-15 in the 50–75 kHz range and the 100–130 kHz range. These regions correspond to instances where recorded signals became saturated. Across the 70 data sets collected in the first 2.4 days at all 21 frequencies, a total of 144 measured waveforms were saturated and therefore not useable (out of 1,470 waveforms). These two regions likely correspond to relatively low attenuation. Throughout testing, the fixed gain had been adjusted based on the signal response at 250 kHz. Less attenuation was anticipated at lower frequencies, but actual amplitude variation across the frequency range during each acquisition cycle was larger than anticipated. If attenuation is needed for these unmeasured regions, the experiment would need to be repeated or redesigned to compensate for the large dynamic range of the signals as a function of frequency.

Although the attenuation profile shown in Figure 3-15 is consistent with values found in the literature for similar materials (Aggelis, 2005), it is not consistent with the measured attenuation discussed in Table 3-2 or the AE results discussed in Table 3-6. In Table 3-2, the attenuation in fully hydrated grout was measured as approximately 0.06–0.08 dB/mm [1.5–2.0 dB/in]. Furthermore, if attenuation values comparable to those shown in Figure 3-15 had been observed in the AE experiment to monitor hydrating SRS reducing tank grout, then it is highly unlikely that pencil break tests performed throughout the monitoring period would have registered as detectable events. One of the major differences between the two attenuation measurement approaches is that in Section 3.1, attenuation was measured using two different grout specimens with two different thicknesses, but in this experiment, attenuation was measured relative to water in place of the grout. It was decided to test whether this difference in approach would result in substantially different results by using the amplitude information available from the two different hydrating grout experiments. The analysis equation for computing attenuation was updated as shown here:

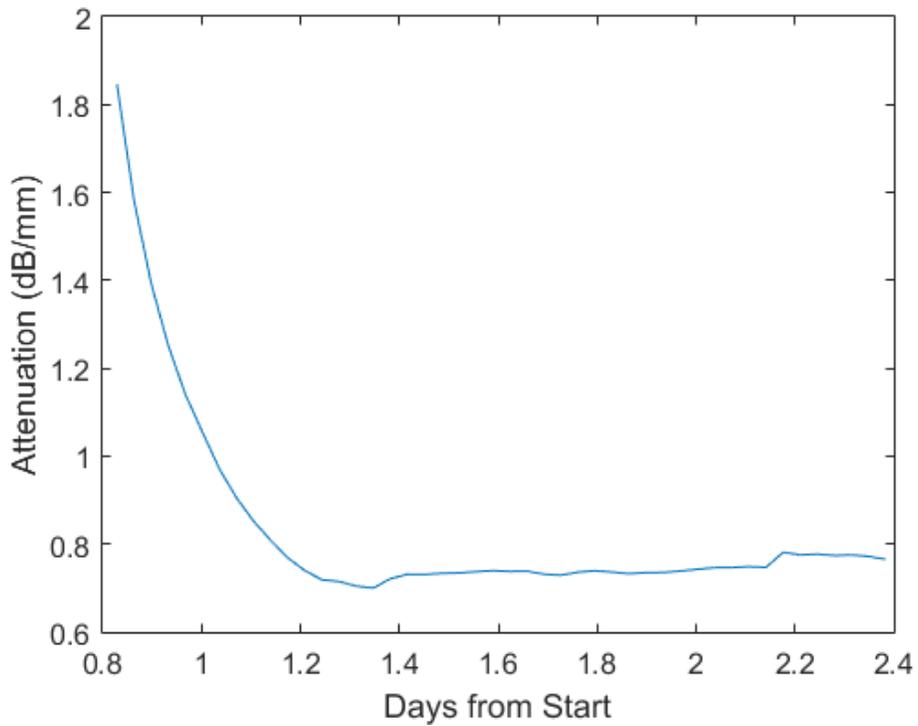
Figure 3-16. Measured Attenuation for the 140 kHz Input Frequency Signal as a Function of Time From Experiment Start

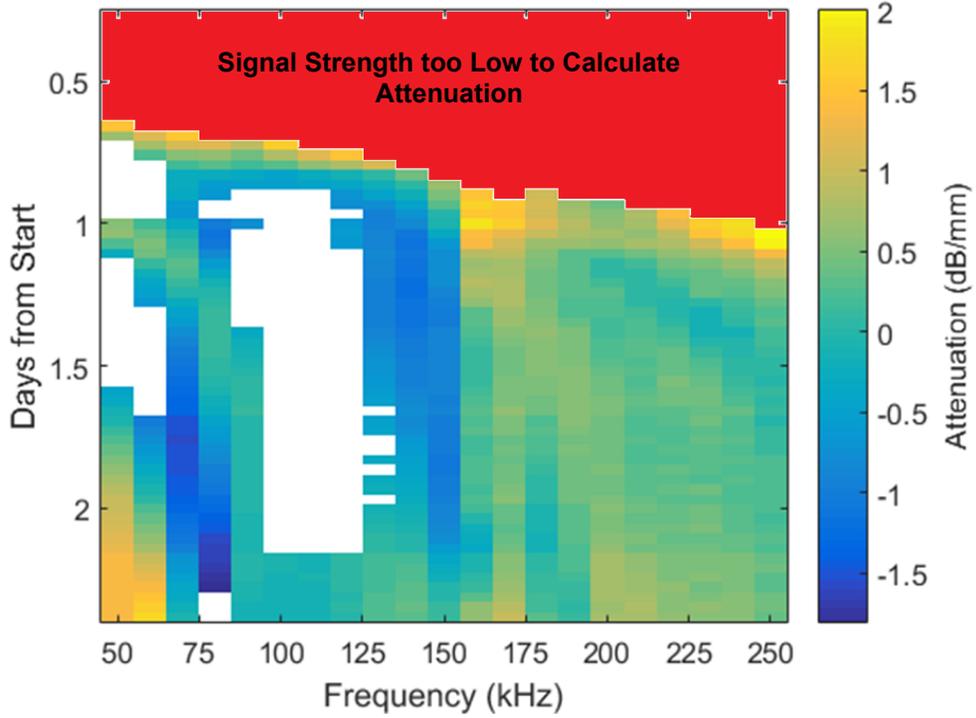
Figure 3-17. Measured Overall Attenuation Using Two Grout Thicknesses for the Calculation

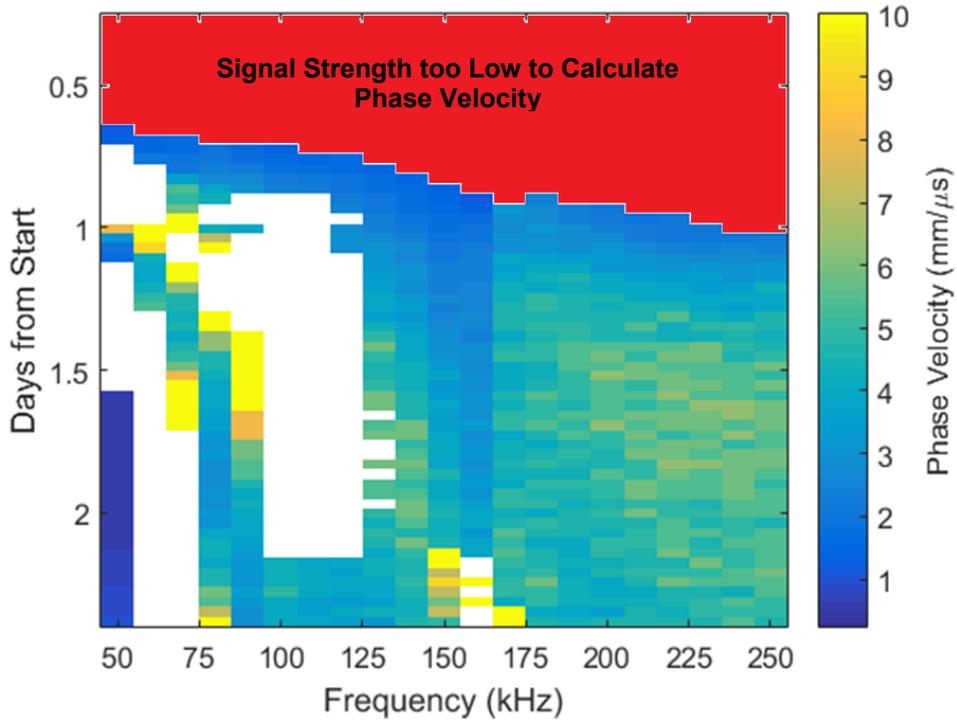
Figure 3-18. Measured Overall Phase Velocity

The overall phase velocity measurement results are shown in Figure 3-18. Note that causes of the amplitude variations discussed for the attenuation measurements should not grossly affect the results of this analysis. As with the attenuation measurements, there was insufficient signal amplitude to perform the analysis during the initial experiment stages, denoted by the red region at the top of the figure. After the first day of setting, the phase velocity appears to slowly increase from a value of approximately 2 mm/μs to a steady-state value. For example, Figure 3-19 shows the phase velocity versus time curve for the 140 kHz test frequency. For this example, the phase velocity steady state value approaches 5.5 mm/μs. There are also regions

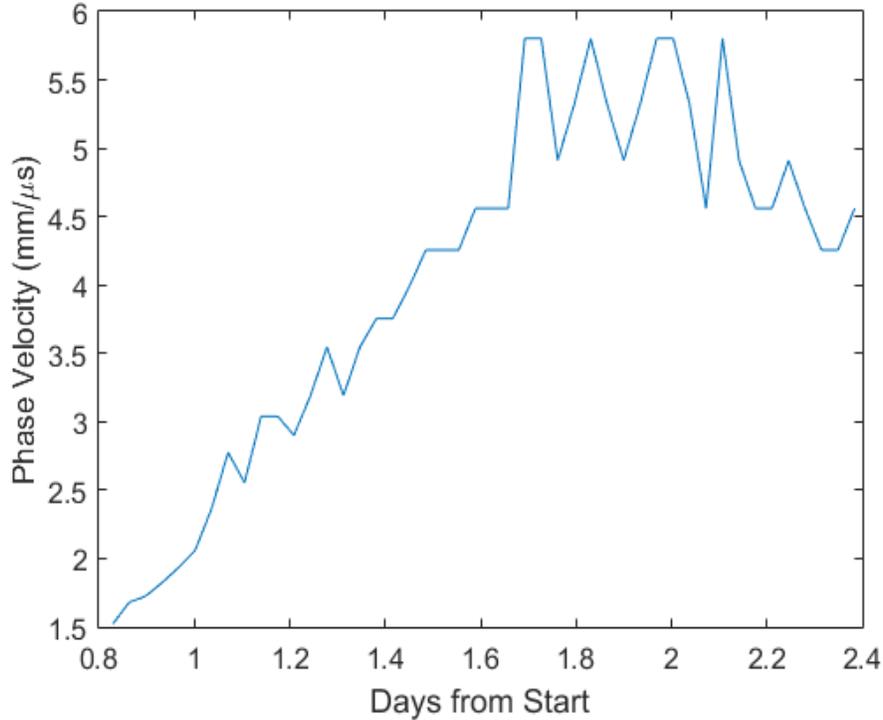
Figure 3-19. Measured Phase Velocity for the 140 kHz Input Frequency Signal as a Function of Time From Experiment Start
