Subject: Intermediate Milestone 17860.04.004.515: Tank Grout Water Conditioning Tests—Status Report

TANK GROUT WATER CONDITIONING TESTS— STATUS REPORT

September 2015

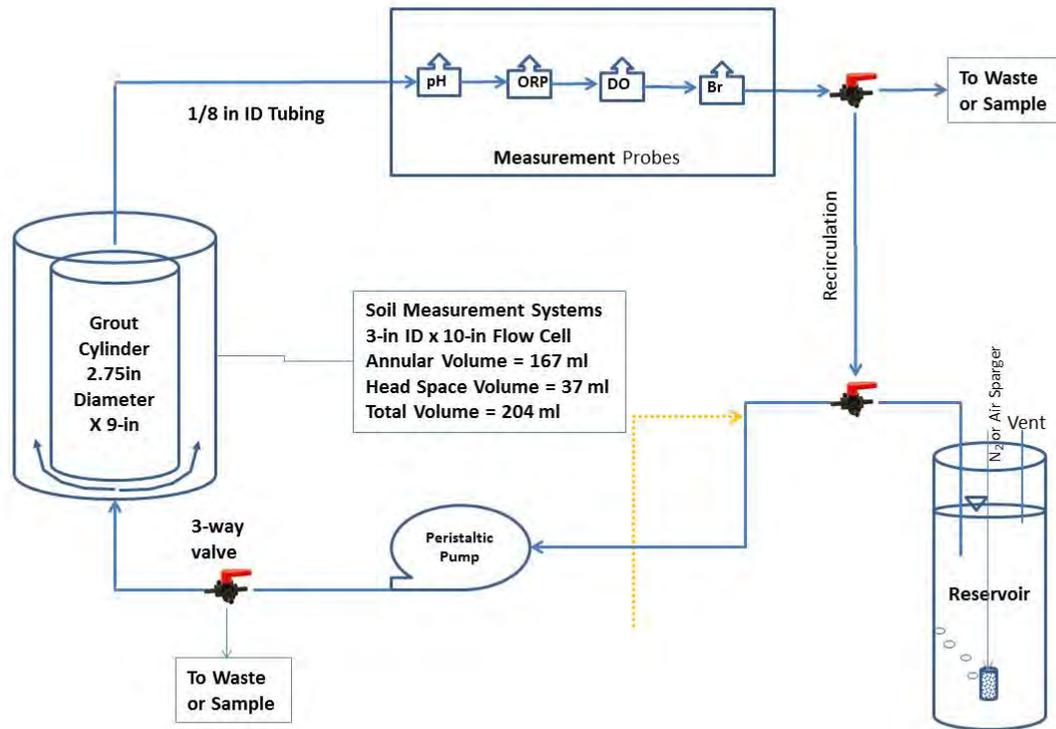
Figure 2-1. General Configuration of Tank Grout Water Conditions Tests

The general design of the dynamic flow tests is illustrated in Figure 2-1, although various modifications were made as the testing evolved. Simulated Savannah River Site (sSRS) groundwater, described in Section 2.2, was circulated through an acrylic flow cell containing a core sample from the Intermediate Scale Grout Monolith of Walter et al. (2010) and then through a sequence of flow cells in which the pH, dissolved oxygen (DO), oxidation-reduction potential (ORP), and bromide (Br) were measured. The water was introduced from a reservoir that could be sparged with either atmospheric air to produce aerated water or a gas mixture of nitrogen and 388 ppmv carbon dioxide (custom gas mix primary standard from AirGas) to produce deaerated water. Water was pumped from the reservoir using an ISMATEC peristaltic pump capable of flow rates of 0.1 to 10 milliliters (mL) [0.0033 to 0.33 fl oz] per minute. The flow system was set up so that it could be operated in either an open-loop or closed-loop configuration. In the open-loop configuration, water flowed past the core sample and then to waste (once-through test). In the closed-loop configuration, water could be recirculated through the flow loop.

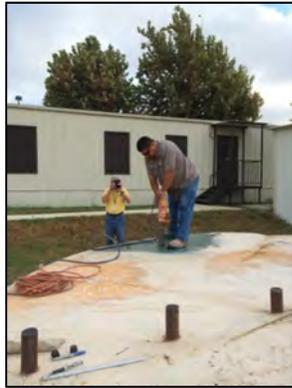
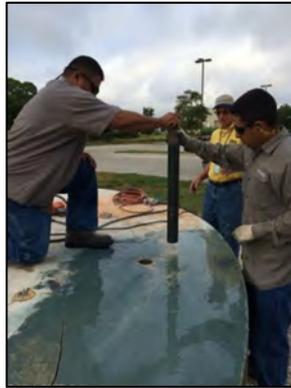
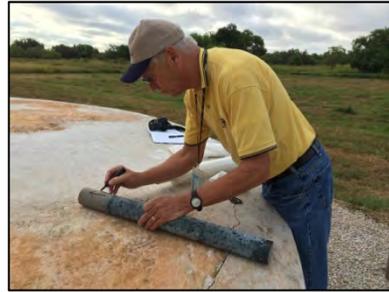
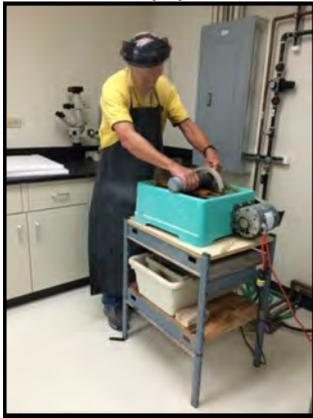
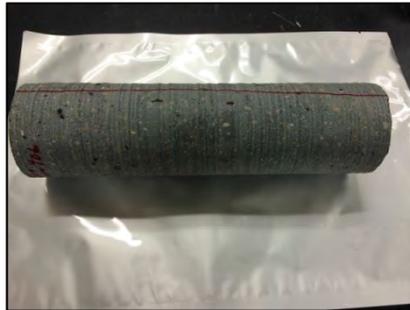
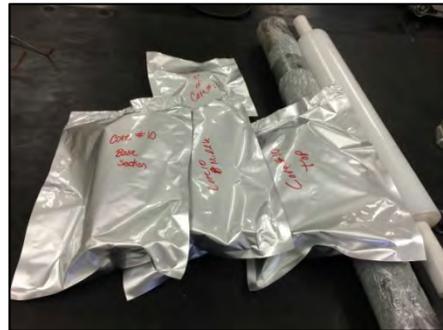
Figure 2-2. Collection and Preparation of Core Samples: (A) Wet Coring of Intermediate Scale Grout Monolith; (B) Removal of Core From Monolith; (C) Marking of Core After Retrieval; (D) Cutting of Core in Laboratory; (E) Core Before Sealing in Mylar Bag; (F) Core Samples in Mylar Bags

The core samples were collected from the Intermediate Scale-Grout Monolith on September 11, 2014, by wet coring the monolith at three locations. Each core was approximately 76 cm [30 in] long and represented the entire thickness of the Intermediate Scale-Grout Monolith. The core samples were dried, then cut into 23-cm [9-in] subsamples using a wet diamond rock saw, redried, and sealed in Mylar bags containing an oxygen absorbing packet (300 cc, OxygenAbsorbers.com). The entire process from core collection to sealing in the Mylar bags required approximate 2 hours. The steps in the core collection process are shown in Figure 2-2.

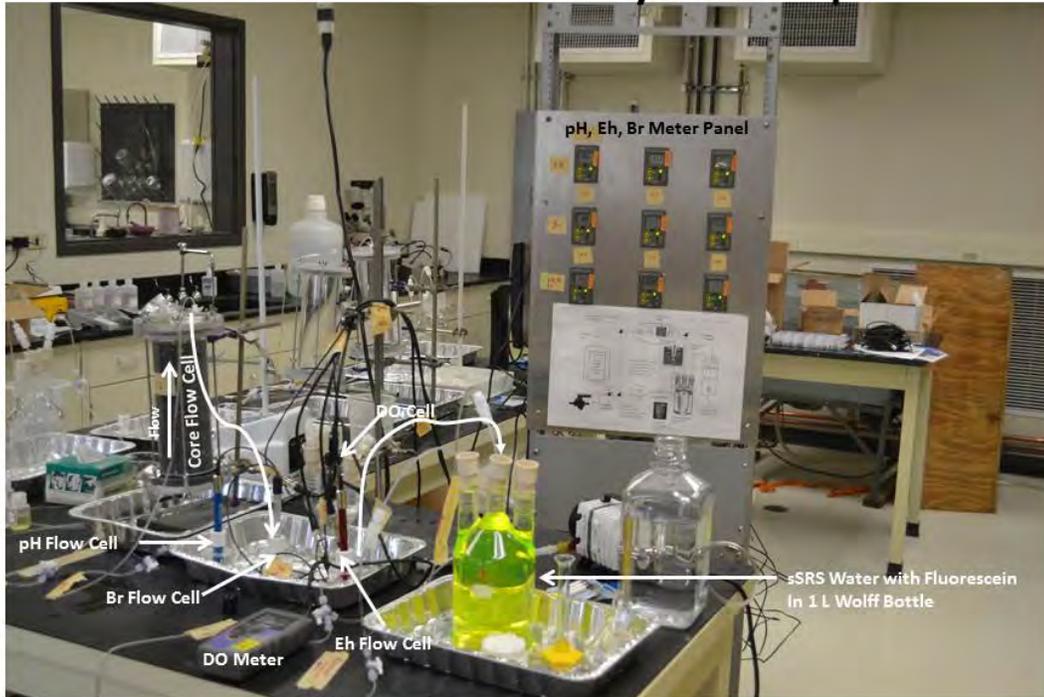
Figure 3-1. Flow Loop Apparatus Used for Core 11, Middle Section Closed-Loop Aerated Test

Dissolved oxygen (DO) concentrations were measured using Oakton galvanic DO probes and Oakton DO + 6 meters. The DO probes were calibrated by setting the reading to 100 percent oxygen saturation with the probe exposed to air and then 0 percent oxygen saturation with the probe submerged in a Zero Oxygen Standard (Ricca Chemical Co.) The DO probes were placed in a 100 mL 3-neck flask connected in the flow loop (Figure 3-2). The DO readings were recorded manually.

The components of the flow loop were connected with 1/8-in [3.175 mm] outside diameter (OD) by 1/16-in [1.59 mm] internal diameter (ID) poly vinyl chloride (PVC) tubing. Flow through the loop was induced using a 3-channel ISMATEC peristaltic pump capable of flow rates between 0.1 and 10 mL/minute [3.3×10^{-3} to 0.33 fl oz/min]. The water in the loop was drawn from the 1 L [34 fl oz] Wolff bottle (Figure 3-1) containing sSRS water that was aerated using an aquarium pump to bubble air through the water. The reservoir was isolated from the flow loop to perform closed-loop tests. Alternatively, the reservoir continuously fed the flow loop during open loop tests with the water discharged to waste. Water flowed from the peristaltic pump to the core flow cell. The acrylic core flow cell (Soil Measurement Systems) had an ID of 7.62 cm [3 in] and length of 25.4 cm [10 in]. The grout core, with a diameter of 6.99 cm [2.75 in] and length of 22.9 cm [9 in], was placed in the core flow cell. The resulting annular space between the core and the inner wall of the core flow cell was 0.32 cm [0.125 in]. Water flowed from the core cell to the pH, ORP, DO, and bromide probes and then was either recirculated through the flow loop or discharged to waste. The total water volume in the flow loop was approximately

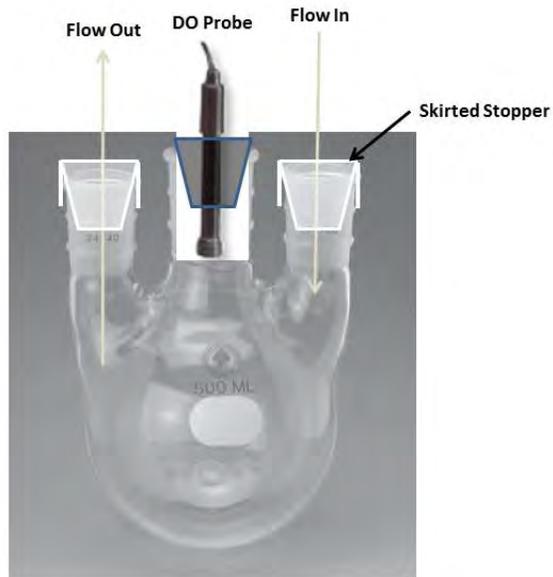
Figure 3-2. Configuration of the Dissolved Oxygen Flow Cell Used in Core 11 Middle Section Tests In November and December 2014

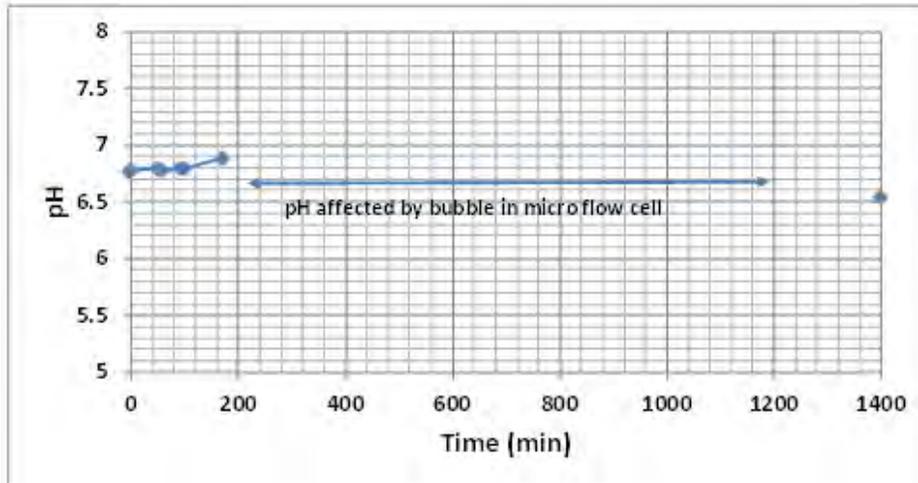
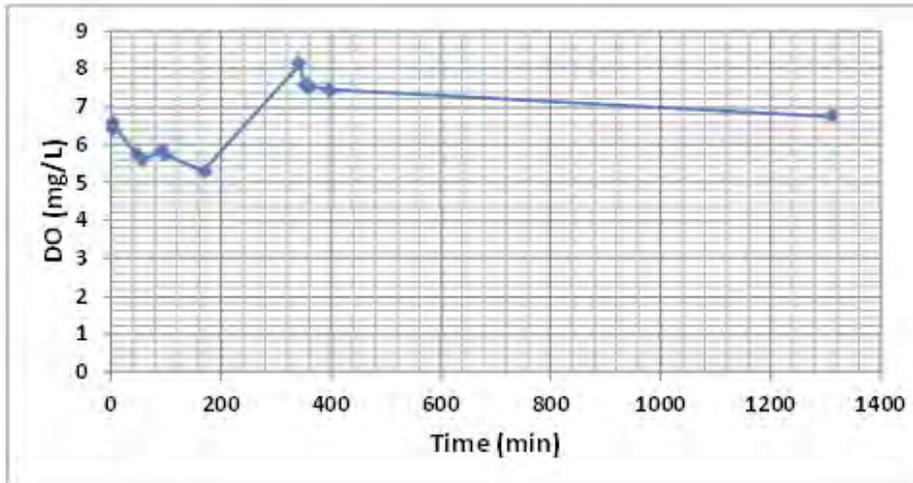
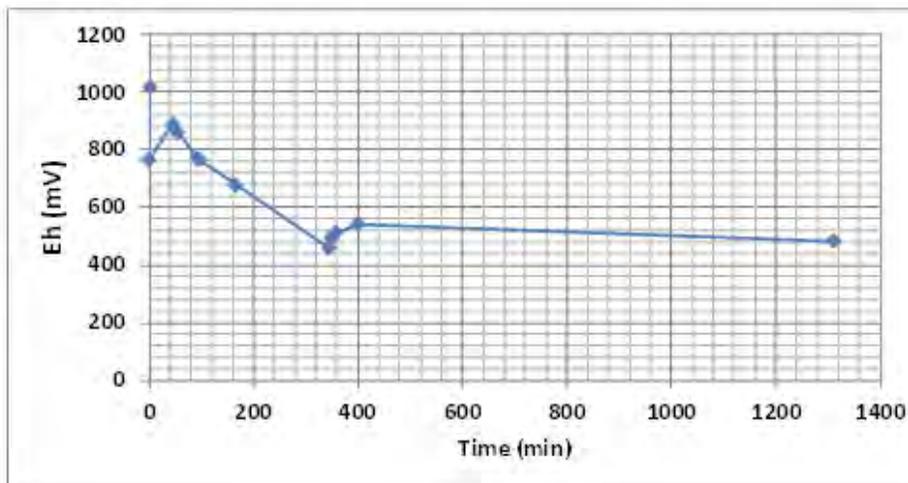
Figure 3-3. Core 11, Middle Section, Closed-Loop Pretest Measurements Prior to Placing Core in Flow Loop

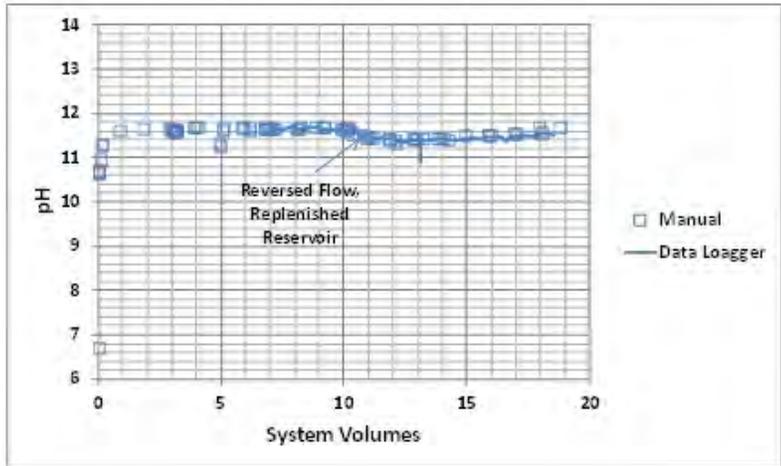
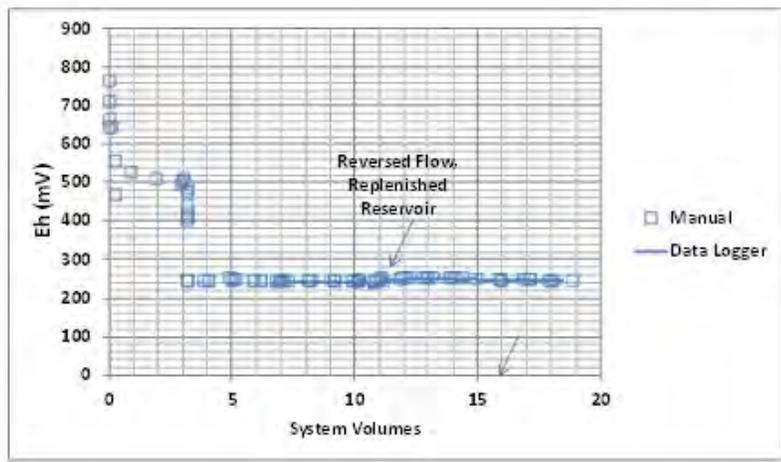
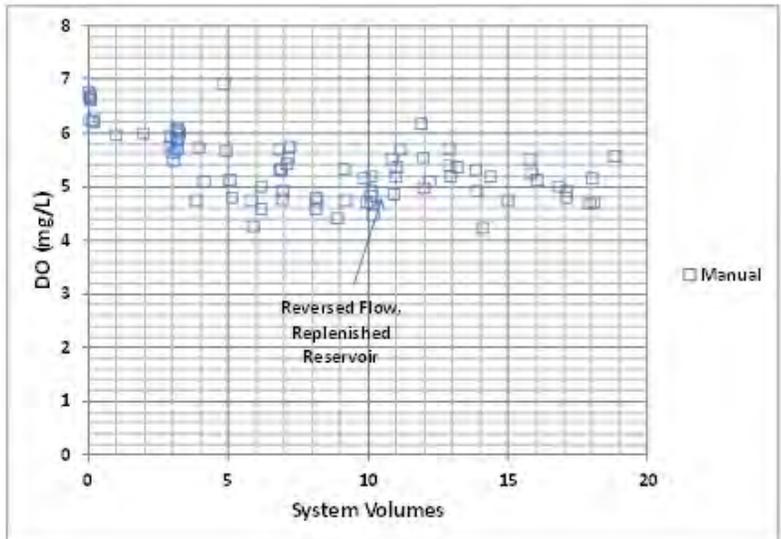
Figure 3-4. Core 11, Middle Section, Closed-Loop, Aerated Measurements Versus Flow Loop System Volumes (1 System Volume Approximately Equals 1 Day)

DO decreased gradually from 6.7 mg/L [6.7 ppm] during the first 5 system volumes (approximately 5 days), then fluctuated around 5 mg/L [5 ppm] for the remainder of the test. The DO, and possibly the ORP, measurements were affected by small gas bubbles that formed in the flow loop, particularly in the 3-neck flask containing the DO probe. The DO measurements may also have been affected by drift in the performance of the DO probe and the relatively large volume and slow water circulation rate in the 100 ml [3.4 fl oz] 3-neck flask. The DO measurements will be discussed further in Section 3.1.3.

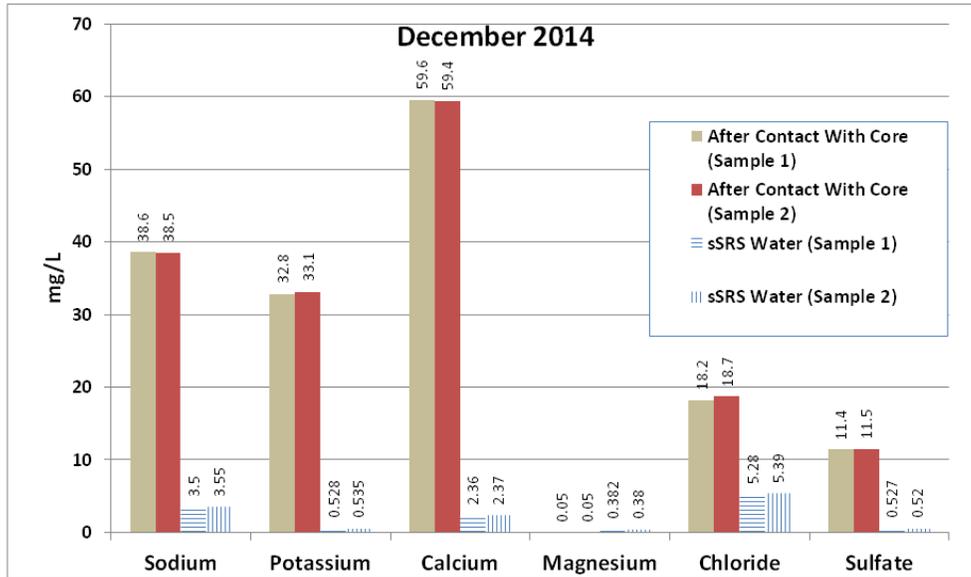
Figure 3-5. Comparison of Major Ion Concentrations Before and After Contact With Grout Core, Core 11 Middle Section Closed-Loop Aerated Test

Figure 3-5 shows the change in major ions between the water that contacted the core and the original sSRS water. The major ions, except magnesium, increased significantly after contact with the grout core, but magnesium was below the detection limit of 0.05 mg/L [0.05 ppm]. The charge balance for the major ions in the samples that contacted the grout shows a significant anion deficiency that is attributed to carbonate species not included in the analytical suite. Based on the high pH of the water contacting the grout, the carbonate species should be predominately carbonate (CO_3^{-2}). Back calculating from the charge imbalance, the CO_3^{-2} concentration would be approximately 140 mg/L [140 ppm].

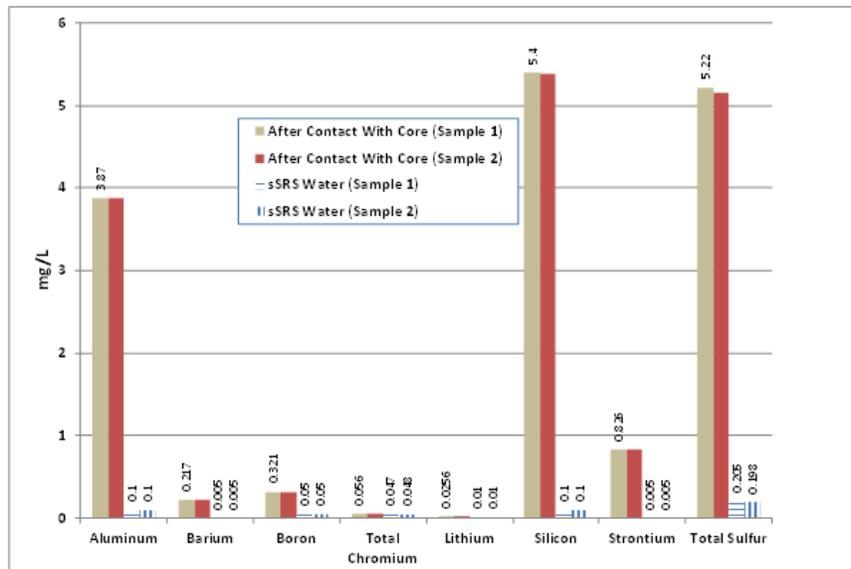
Figure 3-6. Comparison of Metals in Water Samples Before and After Contact With Grout Core, Core 11 Middle Section Closed-Loop Aerated Test

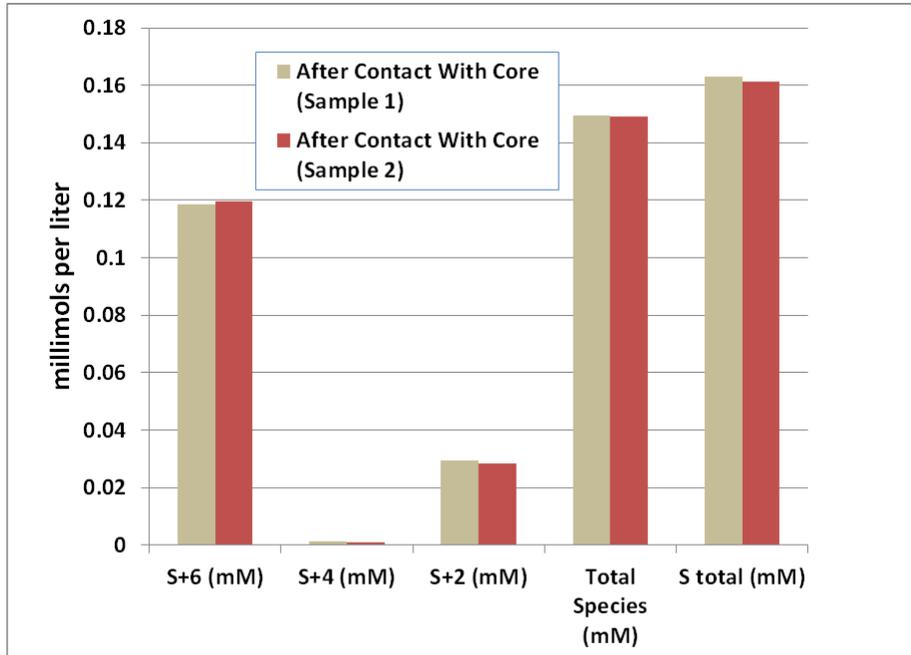
Figure 3-7. Sulfur Molar Speciation in Contact Water, Core 11 Middle Section Closed-Loop Aerated Test. Total Species is the Total of the Analyzed Species. S Total is the Total Sulfur from the ICP Analyses.

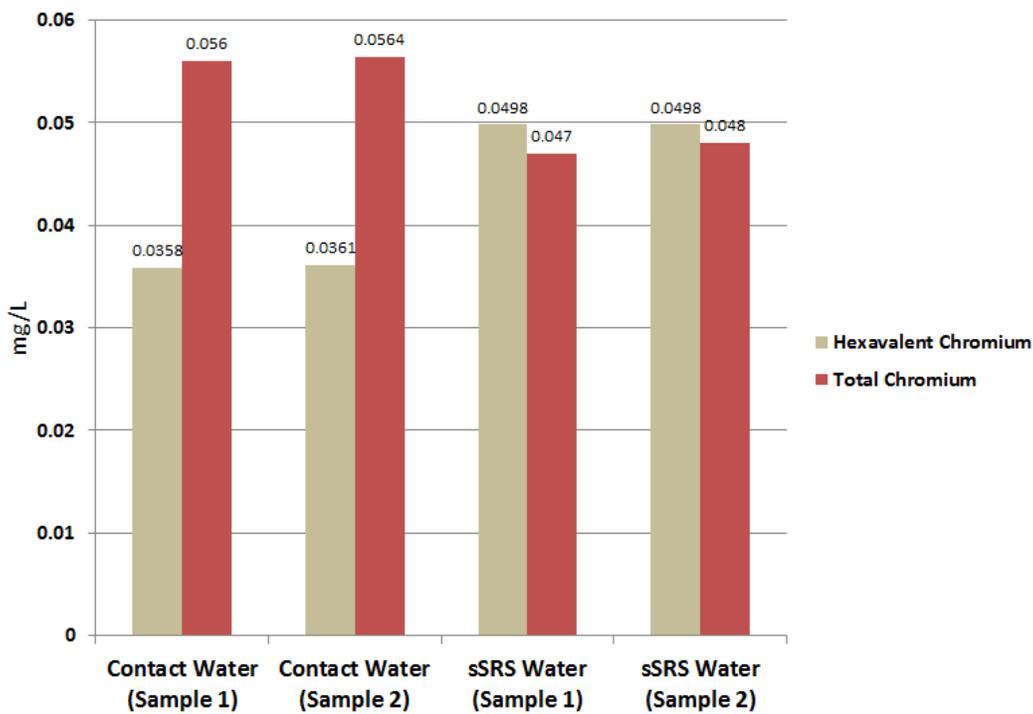
Figure 3-8. Comparison of Hexavalent and Total Chromium Concentration in sSRS Water and Water Contacted With Grout.

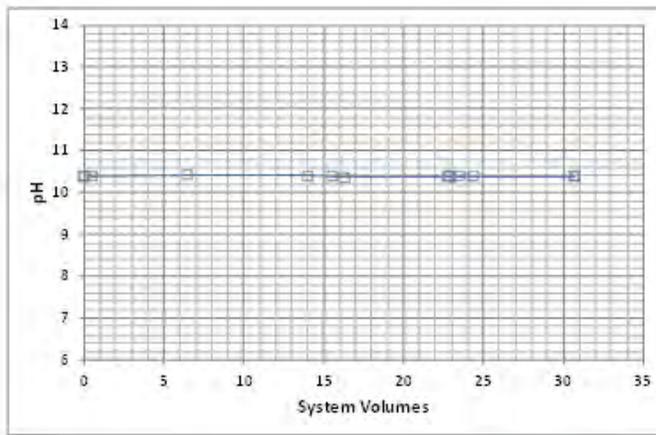
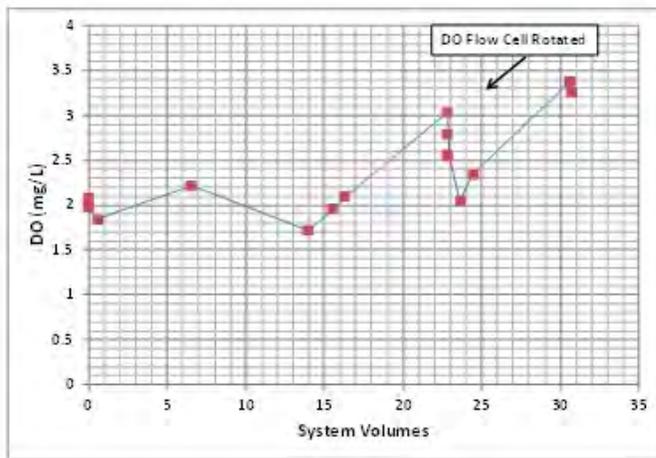
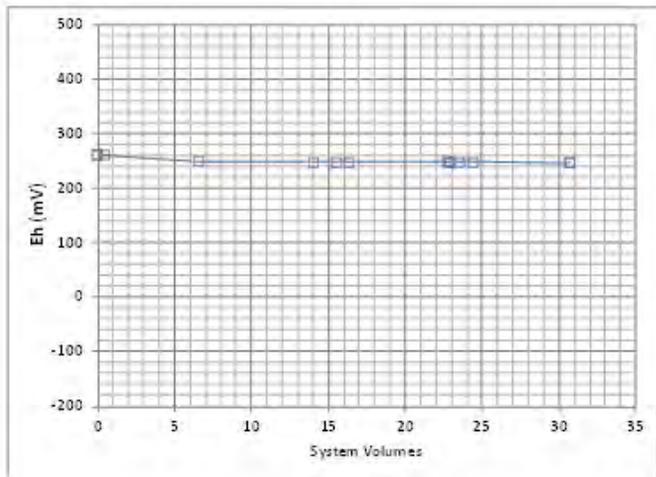
Figure 3-9. pH, DO, and Eh Measured During Core 11 Middle Section Closed-Loop, Deaerated Test

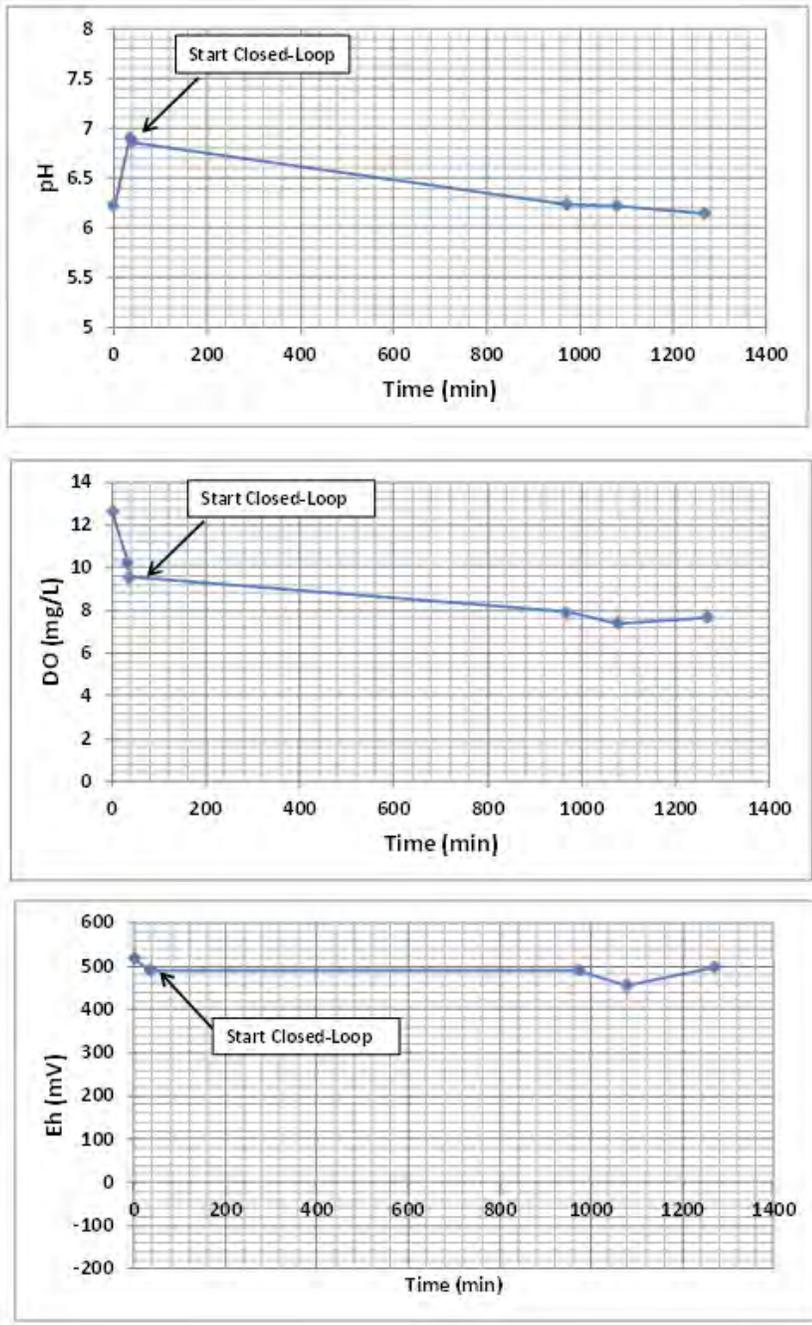
Figure 3-10. Pretest Measurements of pH, DO, and Eh for Core 12 Middle Section Closed-Loop, Aerated Test

shown in Figure 3-10. The initially very high DO values {greater than 12 mg/L [12 ppm]} were due to a bubble trapped on the DO probe. DO and Eh stabilized prior to starting the core test, but pH was dropping slowly.

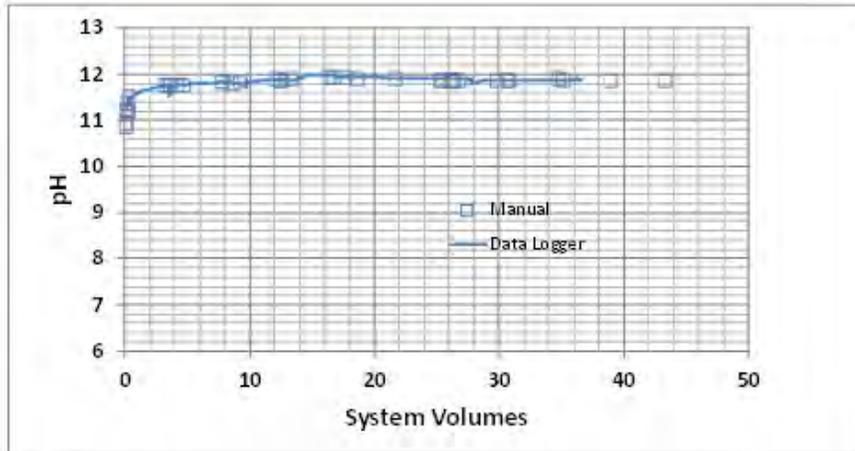
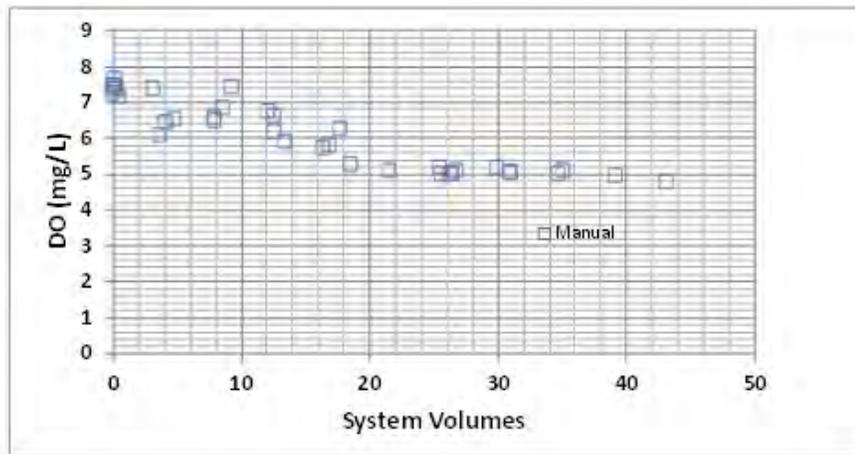
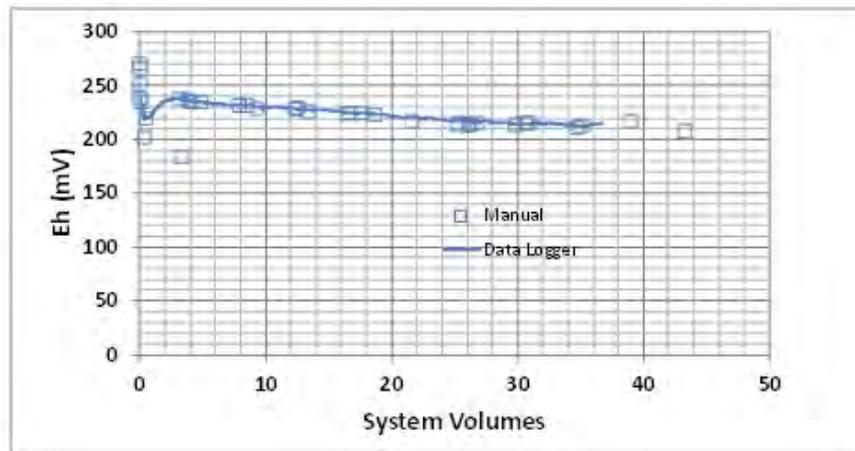
Figure 3-11. pH, DO, and Eh Measured During Core 12 Middle Section Closed-Loop, Aerated Test

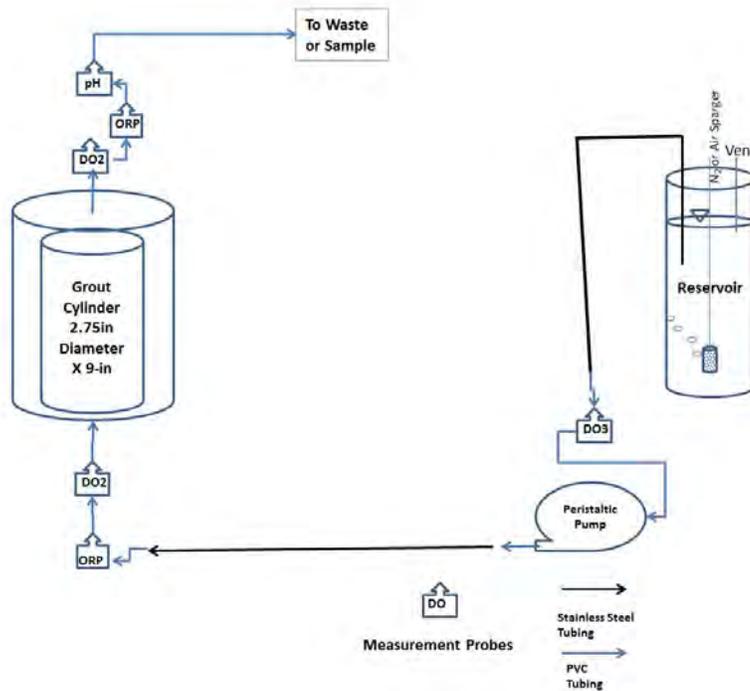
Figure 3-12. Revised Flow Loop Configuration Used in June–July Deaerated Dynamic Flow Tests

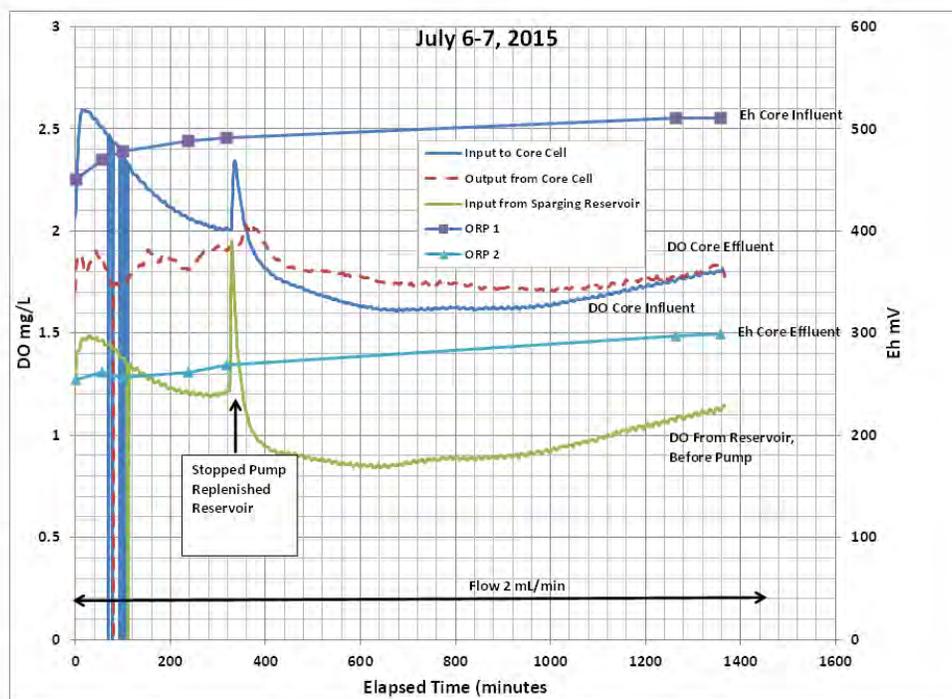
Figure 3-13. Results of July 6–7, 2015, Deaerated Dynamic Flow Test Showing Changes in Dissolved Oxygen (DO) and Eh Before and After the Core Cell.

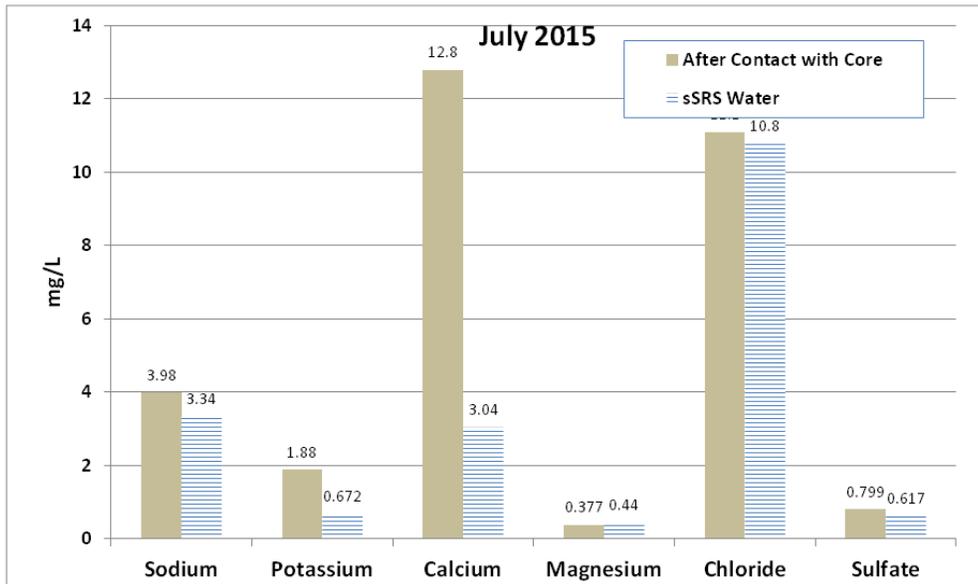
Figure 3-14. Comparison of Major Constituents in Water Samples Before and After Contact With the Core for July 2015 Core 11 Deaerated Test

Figure 3-14 shows the major constituent composition of the sSRS water and the water that had contacted the core. Calcium and potassium were the only major constituents that increased after contact with the core. Figure 3-15 compares the major constituents in the contact water between the December 2014 samples and the July 2015 samples. All the major constituent concentrations were much lower in the July 2015 contact water sample than in the December 2014 samples, indicating that these constituents had been leached from the surface of the core as a result of the intervening tests.

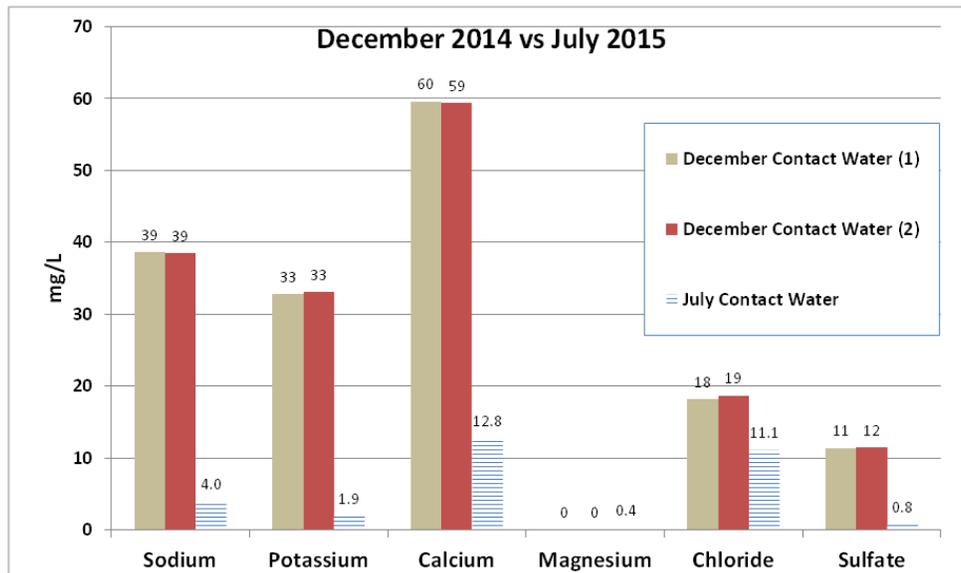
Figure 3-15. Comparison of Major Constituents in Contact Water Samples Between December 2014 and July 2015 for Core 11 Tests

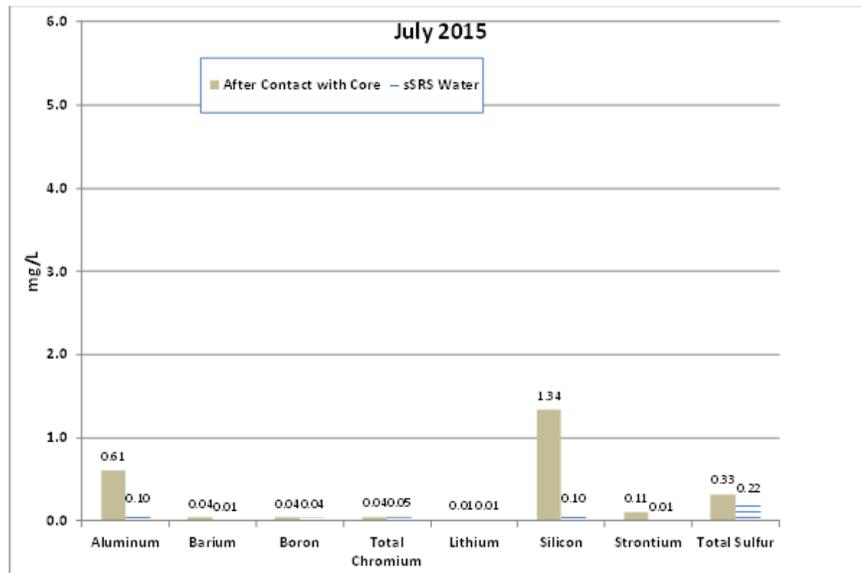
Figure 3-16. Metals Detected in Water Samples Before and After Contact With Core for July 2015 Core 11 Test

Figure 3-16 shows the metals detected in the water samples from the July 2015 test and Figure 3-17 compares the metals detected in the contact water samples between the December 2014 and July 2015 tests. Aluminum and silicon were the only metals that increased significantly after contact with the core in the July 2015 tests and, as shown in Figure 3-17, the metal concentrations in the contact water sample from the July 2015 test were much lower than those detected in the December 2014 contact water samples. Although the December 2014 test was performed under aerated conditions and the July 2015 under deaerated conditions, the pH and Eh values measured during both tests were similar. This suggests that the difference in dissolved metals between the tests was due to leaching of the surface of the core rather than differences in geochemical conditions.

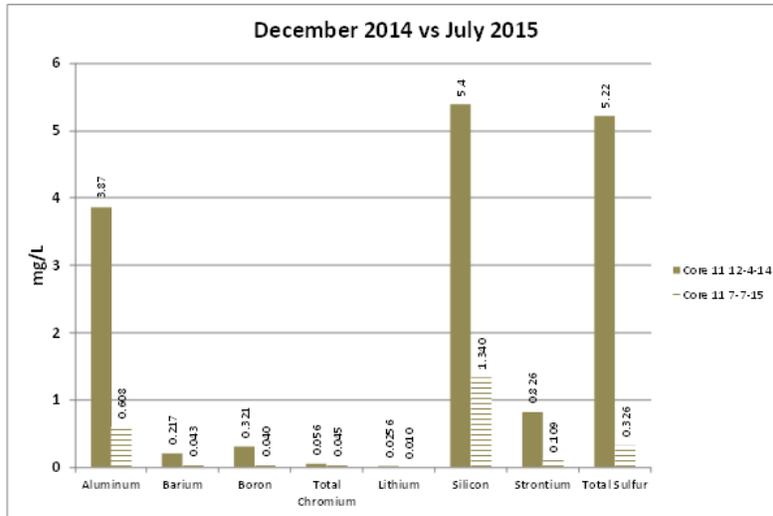
Figure 3-17. Comparison of Metals Detected in December 2014 Contact Water Samples With Metals Detected in July 2015 Contact Water Samples for Core 11 Tests

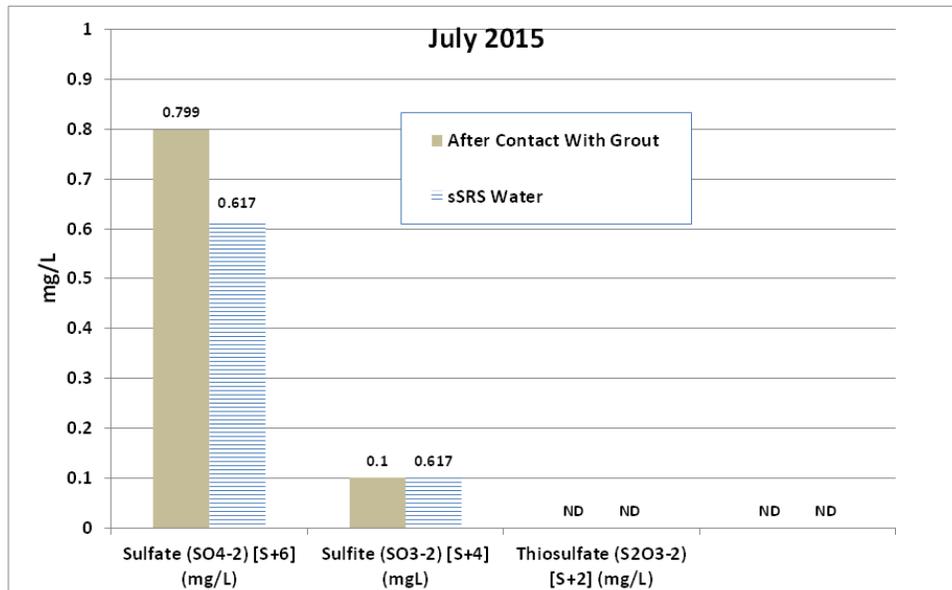
Figure 3-18. Sulfur Speciation in sSRS Water and Core Contact Water for the July 2015 Core 11 Test

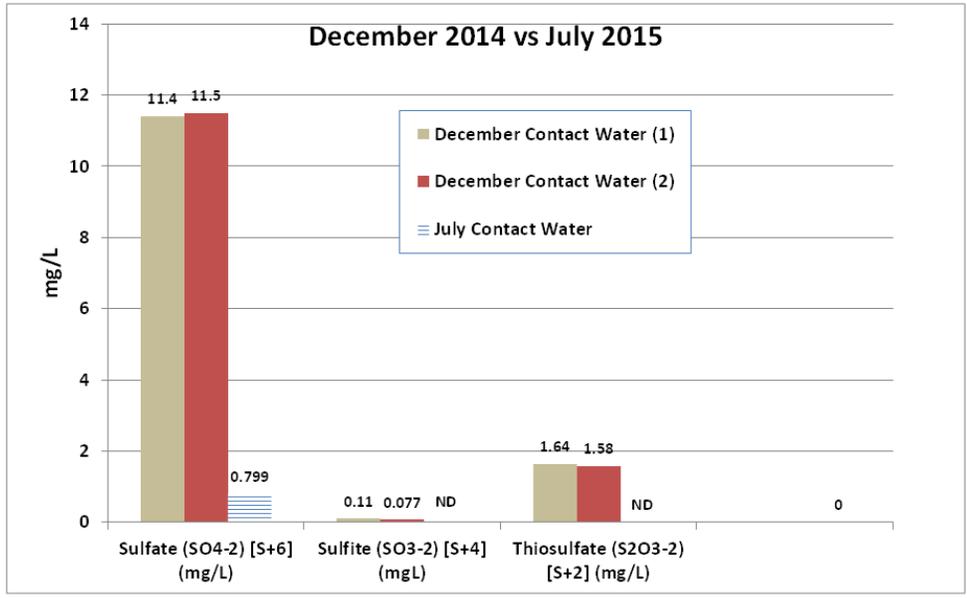
Figure 3-19. Comparison of Sulfur Speciation Between Contact Water for the December 2014 Core 11 Test With Contact Water for the July 2015 Test

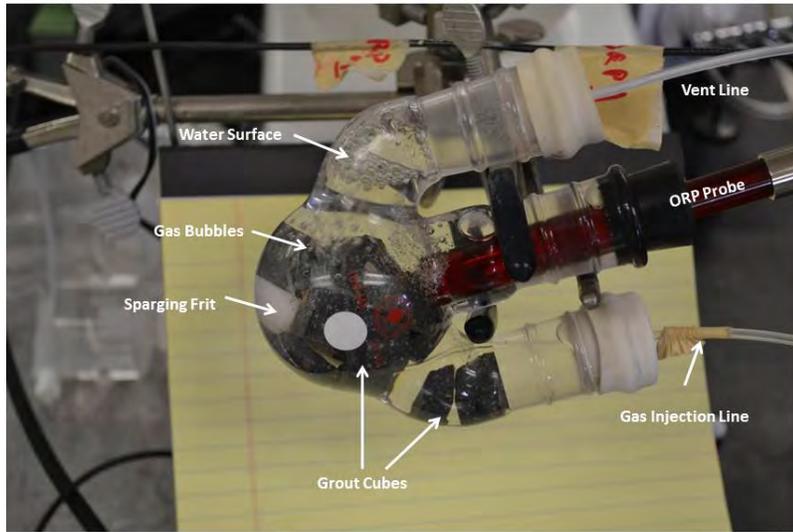
Figure 4-1. Preliminary Static Test Apparatus

A preliminary test was performed on a subsample of the middle section of Core 11 using the apparatus shown in Figure 4-1. The core was selected to test the preliminary static test apparatus, although it had been used in previous dynamic flow tests and had been subject to oxidizing conditions, to avoid sacrificing a pristine core if the static test design did not work. The subsample was collected by cutting the core into nominally 1.27-cm [0.5-in]-thick discs using a water-wet diamond saw and then cutting the discs into nominally 1-cm [0.4-in] cubes using the pattern shown in Figure 4-2. The volume of the grout cubes was approximately 26.2 cm³ [1.6 in³] and their surface area was approximately 122 cm² [18.9 in²] based on measurements of the dimensions of each cube.

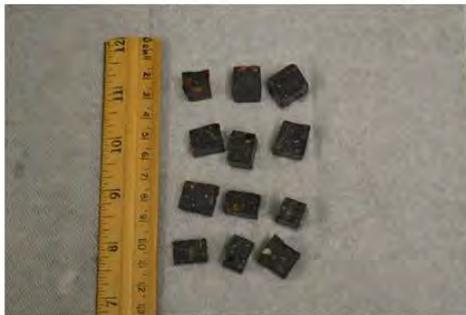
Figure 4-2. Pattern Used to Cut Core Cubes and Cubes From Core 11, Middle Section, Used in Preliminary Static Test

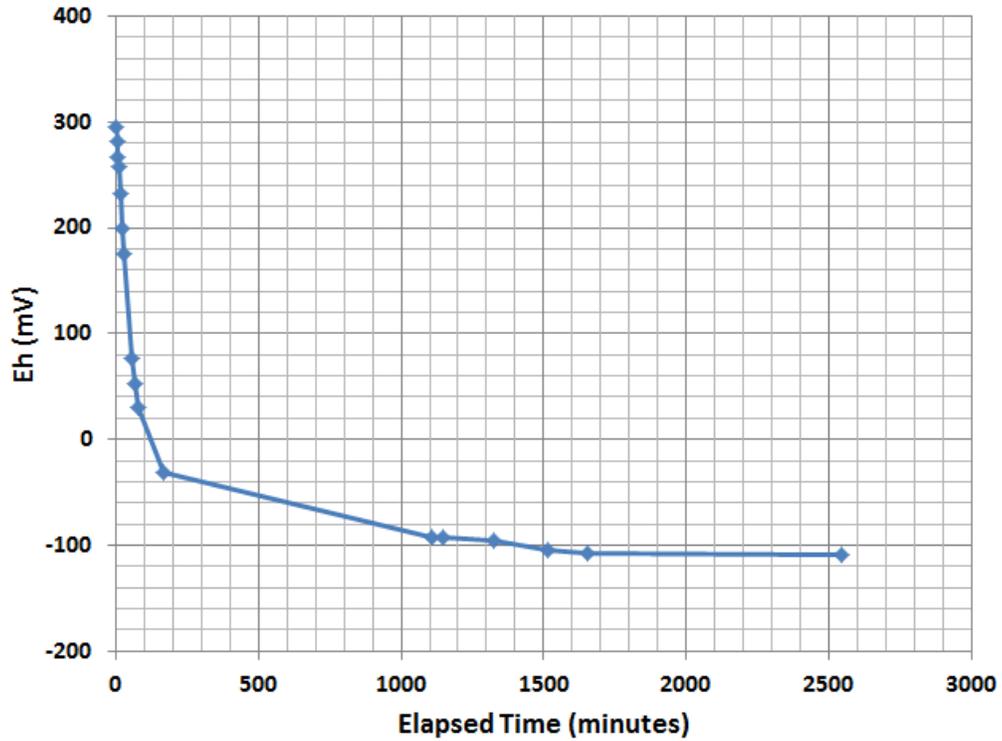
Figure 4-3. Eh Based on ORP Measurements for Preliminary Static Test July 21–23, 2015

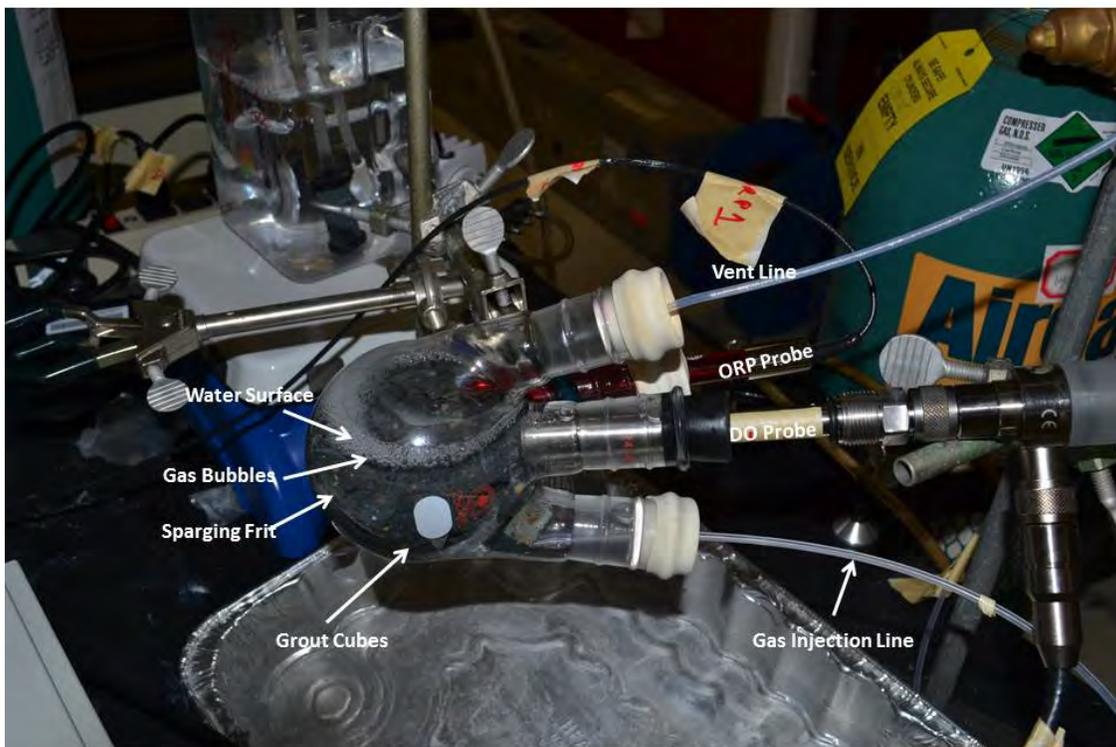
Figure 4-4. Apparatus Used in July 30–August 3, 2015 Static Test on Core 10

Based on the results of the preliminary static test, the 3-neck flask was replaced with a 250-mL [8.5-fl oz], 4-neck flask so that both DO and ORP could be measured during the test. The revised test apparatus is shown in Figure 4-4. The static test started on July 30, 2015, was performed using the lower section of Core 10 that had been kept in a heat-sealed mylar bag with an oxygen absorber packet since it was collected in September, 2014. The core was sliced into three nominally 1.27-cm [0.5-in]-thick discs using a water-cooled diamond saw. Each disc was then broken into chips using a hammer to avoid further wetting of the core samples. 176 grams of the chips were placed in the 4-neck flask with 255 mL [8.6 fl oz] of sSRS water. The sizes and shapes of the chips used in the test are shown in Figure 4-5. The Weiss ORP probe and Hamilton DO sensor used in the preliminary static test were then placed in the 4-neck flask (Figure 4-4) and the flask was sparged with the N₂/CO₂ gas described previously. The DO and ORP measurements were recorded manually and the DO percent saturation was recorded using the Hamilton Data Management software.

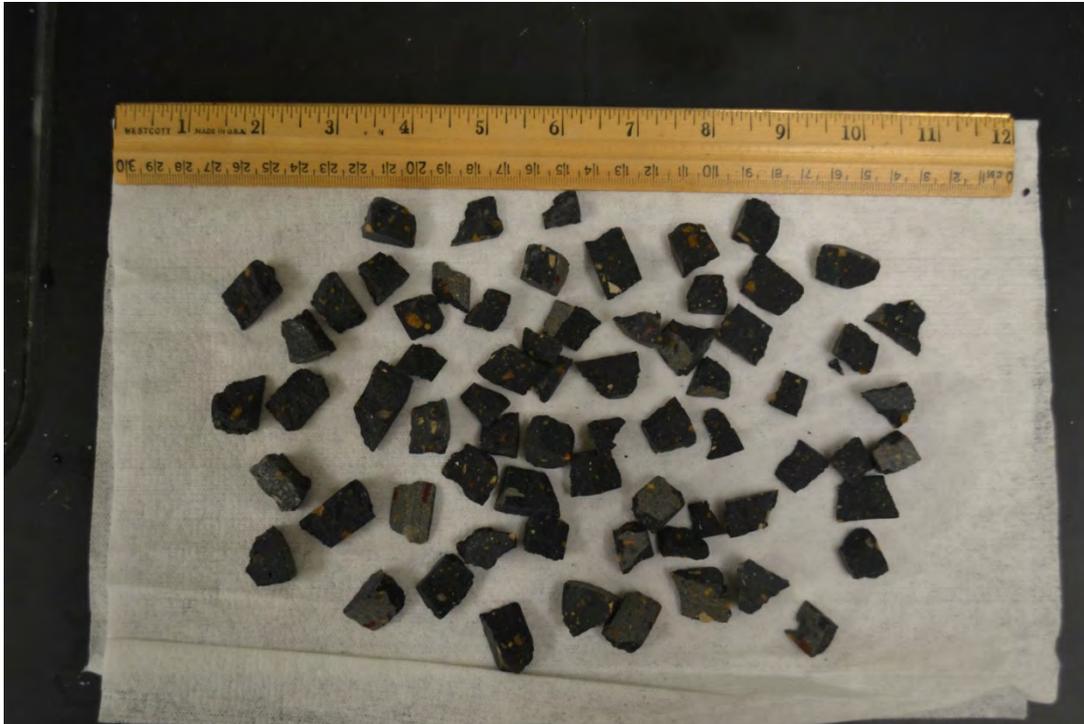
Figure 4-5. Chips of Core 10 Used in July 30–August 3, 2015 Static Test

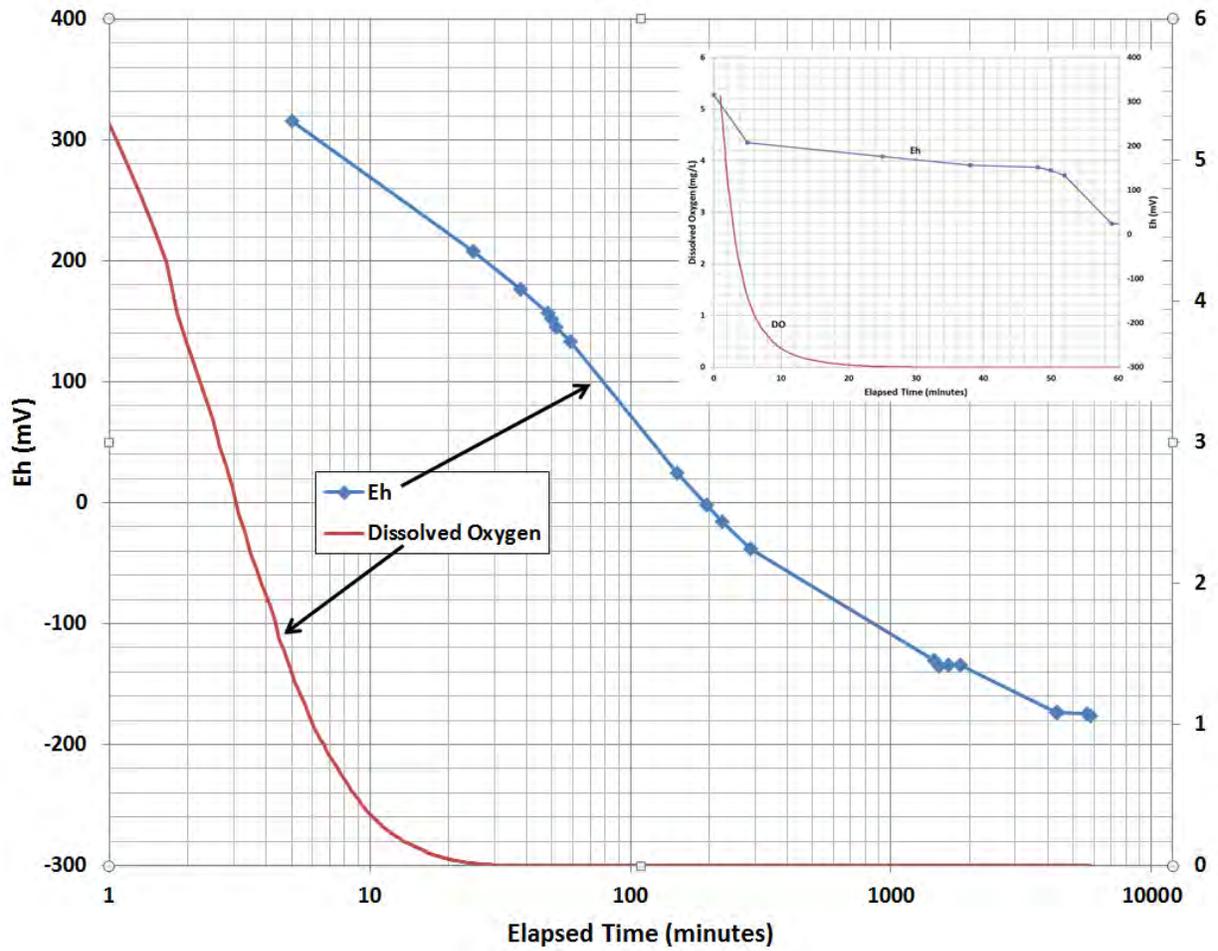
Figure 4-6. DO and Eh Measured During Static Test on Core 10, Bottom Section July 30–August 3, 2015. The Insert Shows the Changes During the First 60 Minutes of the Test on a Linear Time Scale.

Figure 4-6 shows the changes in DO (as mg/L) and Eh (ORP Ag|AgCl plus 200 mV) measured during the test. The DO concentration was converted from percent saturation using the conversion factor described in Section 3.2. Figure 4-6 shows that the DO in the 4-neck flask decreased rapidly during the first 10 minutes of the test and reached the detection limit of the DO probe (nominally 0.004 mg/L [0.004 ppm]) after 30 minutes. The Eh decreased from an initial value of approximately +320 mV to -180 mV after 5,640 minutes (i.e., almost 4 days). The final Eh was approximately 70 mV lower than the final Eh measured for the test on Core 11. The lower Eh for Core 10 could have been due to Core 10 not having been exposed to oxygenated conditions for as long as Core 11. The difference could also be due to the higher surface area of the Core 10 chips, but the surface area of the Core 10 chips could not be directly estimated because of their highly irregular shapes.
