Calvert Cliffs GSI-191 Program

Strainer Head Loss Testing and
Option 2b Closure Approach

December 2015

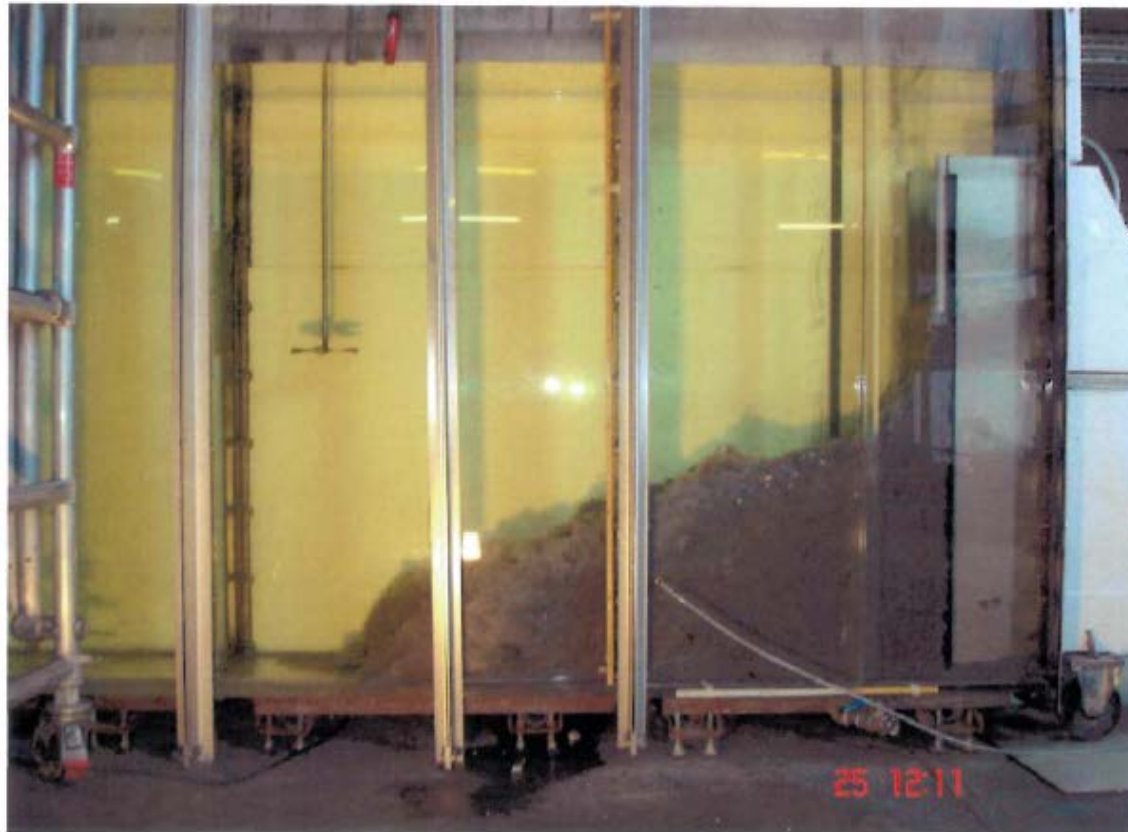
- Test #1 Included Fine and Small Fibrous Debris
 - Maximum Head Loss 1.75 inches of water
 - Non-Uniform Debris Deposition
 - Conclusion: Testing with Small Pieces is Non-Conservative
 - Results of Test #1 were Rejected as Non-Conservative

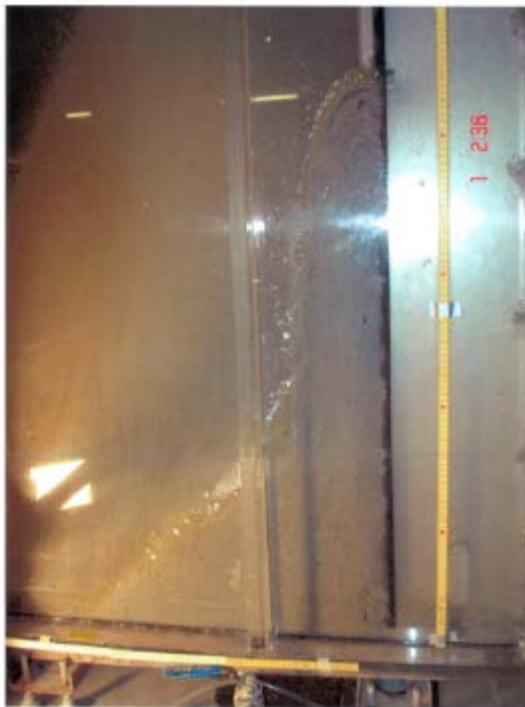
Picture 27: Debris layer without precipitate

- Remaining Tests Used Only Fine Fibrous Debris
 - Full load of particulates and precipitates
 - Test for Success Campaign
 - Break-throughs experienced during each test

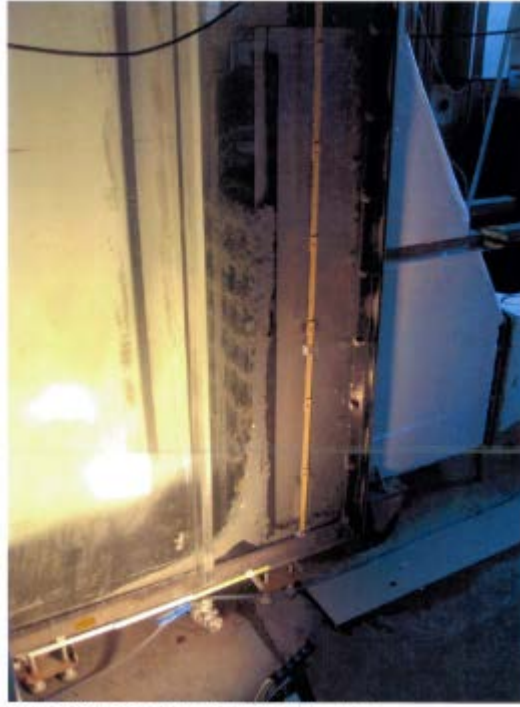
Picture 28: Debris layer at approximate 75 mbar head loss

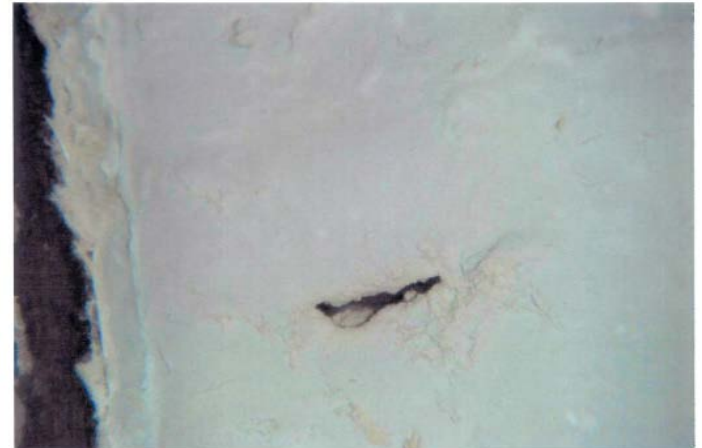
Picture 30: Underwater picture of breakthrough

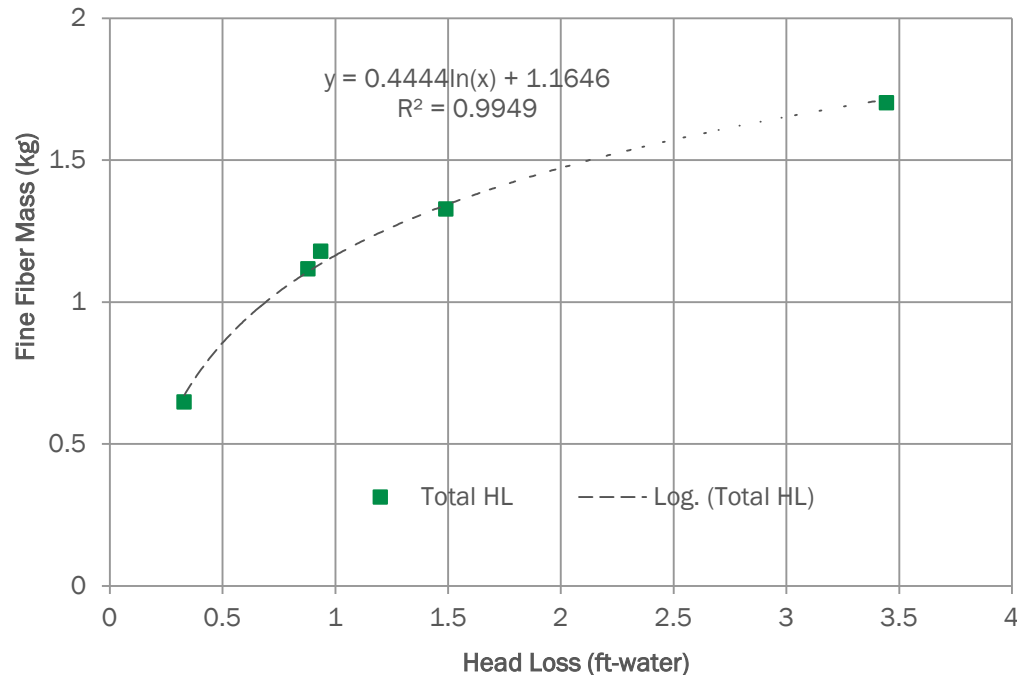
Head Loss Data - Test Data + Clean Screen

Demonstrates Head Loss Proportional to Mass of Fine Fiber

- Plot of Head Loss -vs- Fiber Mass produces well correlated curve fit
- Plot includes clean strainer head loss
- Empirical Correlation based on Calvert Cliffs Prototypical Strainer Head Loss Testing

Test	Debris HL	CS HL	Total HL
2	0.05	0.28	0.33
3	3.165	0.28	3.445
4	0.599	0.28	0.879
5	1.211	0.28	1.491
7	0.656	0.28	0.936

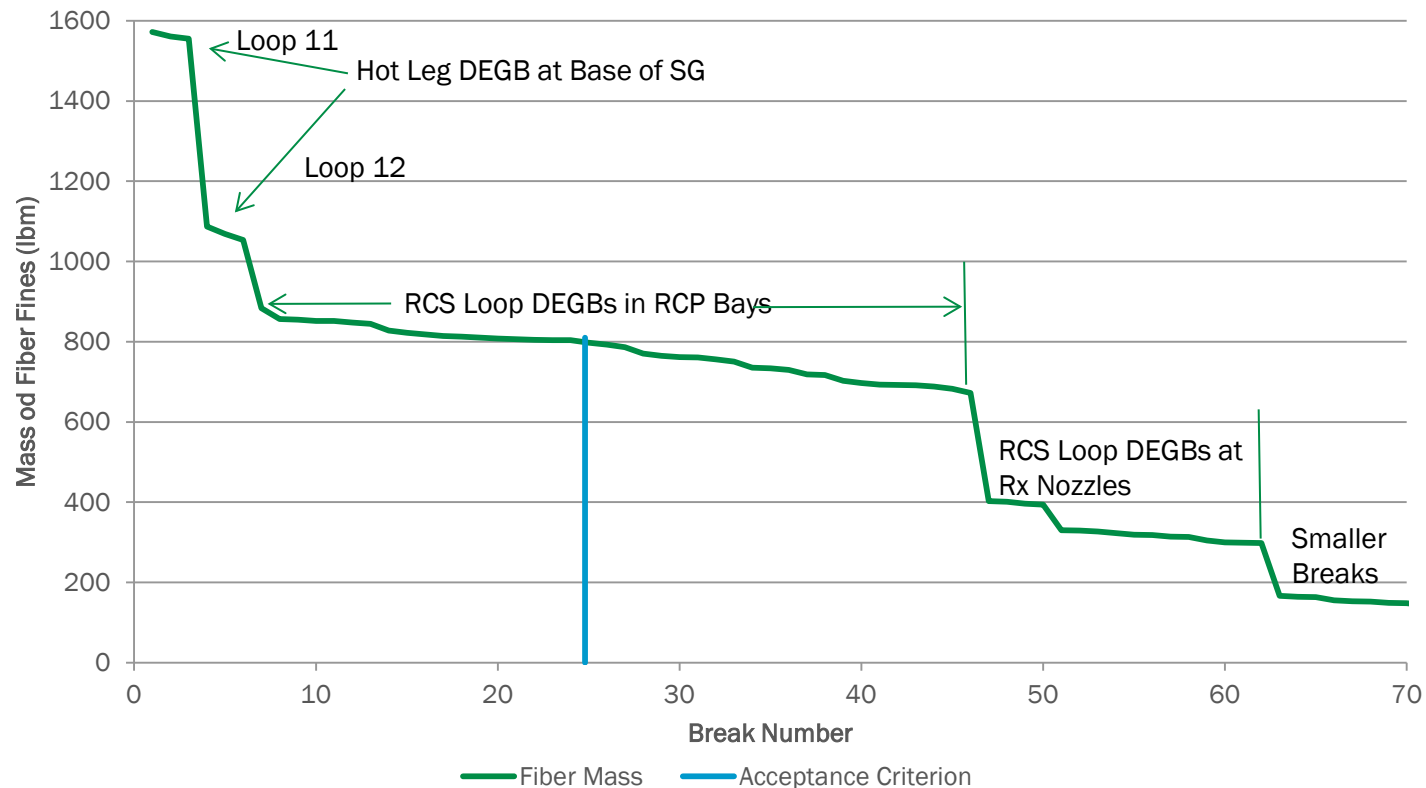
DEGB Fiber Fines Mass for 70 Largest Breaks

- Risk-Informed Debris Generation Calculation Results
 - Breaks Analyzed at 437 Circumferential Welds
 - Longitudinal Welds Currently Being Analyzed
 - ISI 30-RC-11A-6 is break #25 below

- Test 5 and DEGB @ ISI 30-RC-11A-6 (Crossover Leg at RCP Suction Elbow)
 - Test 5 used equivalent of 825.7 lbm Fiber Fines
 - Use 800 lbm Acceptance Criterion
 - DEGB @ ISI 30-RC-11A-6 generated 797.8 lbm Fiber Fines
