Performance of Metal and Polymeric O-Ring Seals in Beyond-Design-Basis Temperature Excursions

This report documents the beyond-design-basis thermal exposure test results of the performance of metallic and polymeric seals typically used in radioactive material transportation packages. The overall objective of the project is to provide test data and insights regarding the performance of these O-ring seals (metallic or polymeric) when exposed to beyond-design-basis temperature conditions that could result due to a severe fire. Tests were conducted using a small-scale test package (pressure vessel) made of stainless steel SS 304 filled with helium initially pressurized at either 5 bar or 2 bar at room temperature. The test package was then exposed in an electric furnace to temperatures equal to, or above the specified maximum operating temperatures of these seals (up to 900 °C) for a pre-determined period (typically 8 h to 9 h). These O-ring temperatures and test periods are more severe than the 800°C for 30 minutes hypothetical accident conditions described in 10 CFR Part 71. In addition, the 800°C and 900°C seal temperatures are much higher than would be expected in real world condi

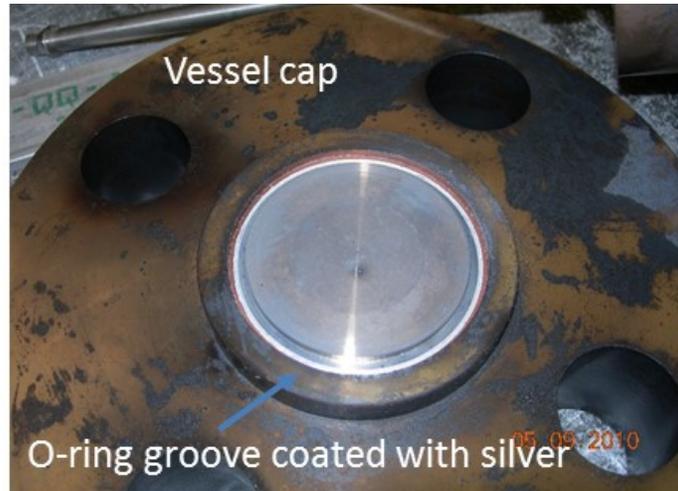
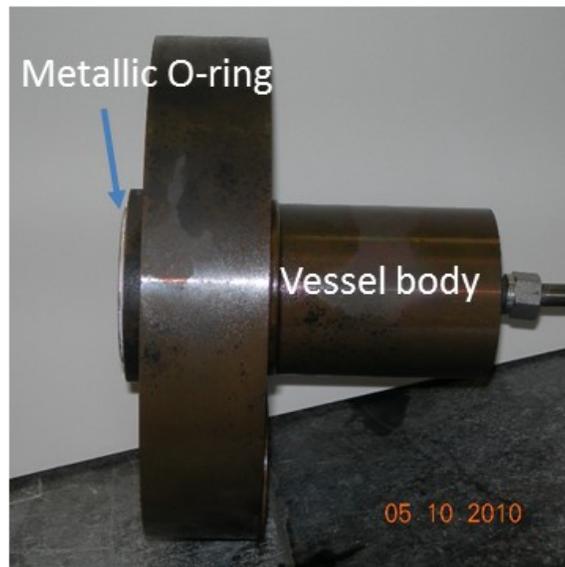
Figure 3-1. Post-test photographs showing silver from the metallic O-ring deposited on the O-ring groove and the O-ring bonded to the test vessel (Vessel #1) body.

A post-test inspection of the test vessel revealed that the metallic seal was soldered to the flange of the vessel body and a silver-color coating was imprinted on the surface of the O-ring groove, as shown in Figure 3-1. The high-temperature exposure also discolored the test fixture.

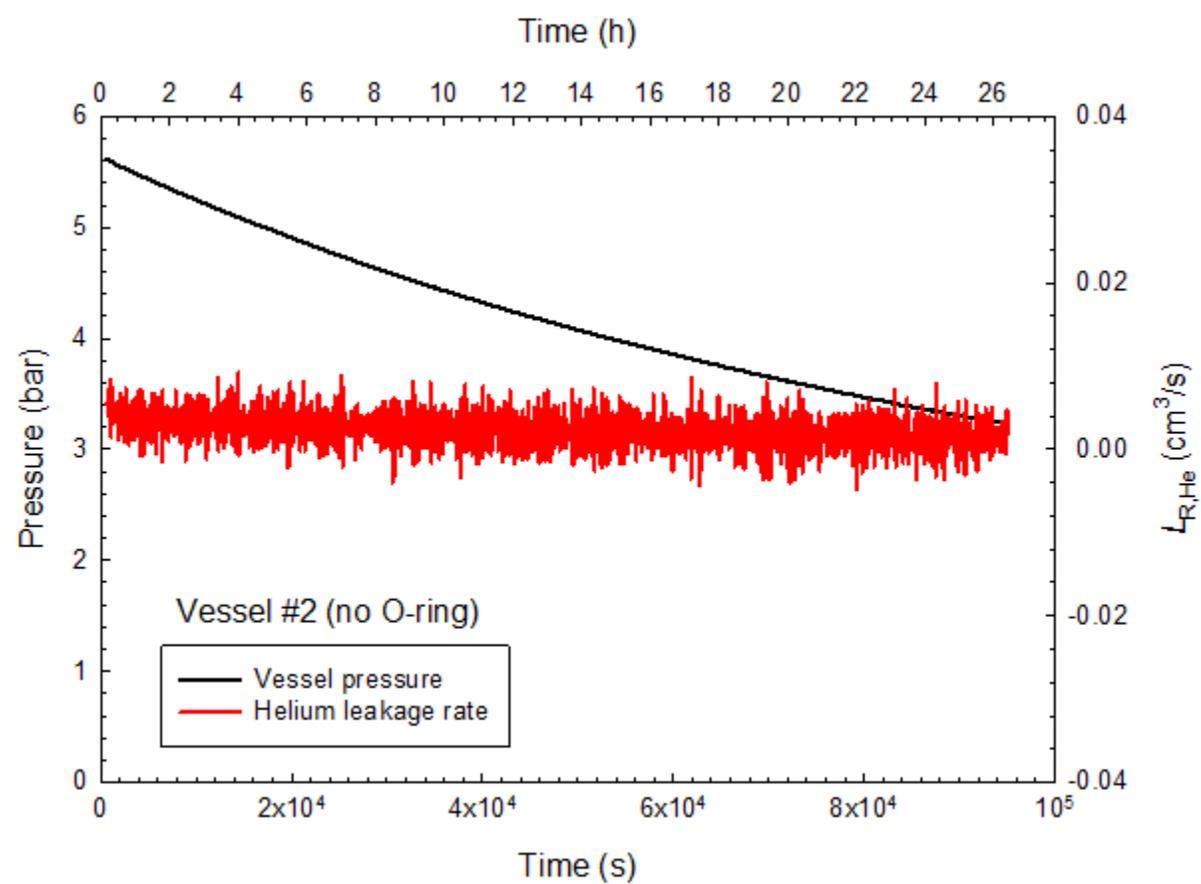
Figure 3-2. Temporal variations of vessel pressure at 24 °C without metallic O-ring.

temperature. Figure 3-2 is the test result, which indicates that the vessel pressure began to drop and leakage occurred immediately at the start of the test and continued slowly over the entire experimental run-time (26.43 h). The reference helium leakage rates $L_{R,He}$ (ref·cm³/s) were estimated based on the method described in Appendix D. The time-averaged leakage rate is estimated to be 2.4×10^{-3} ref·cm³/s.

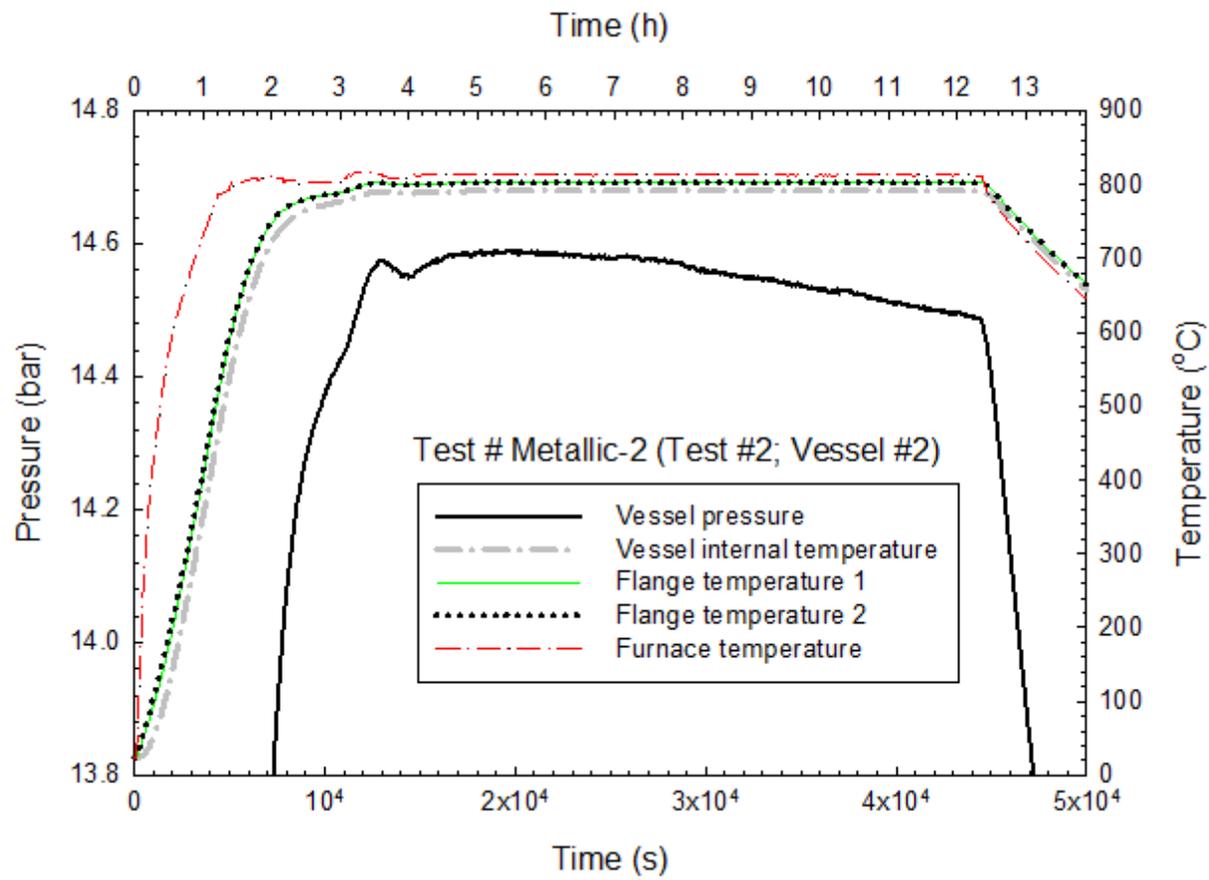
Figure 3-3. Temporal variations of vessel pressure and temperature in Test # Metallic-2 (Test #2).

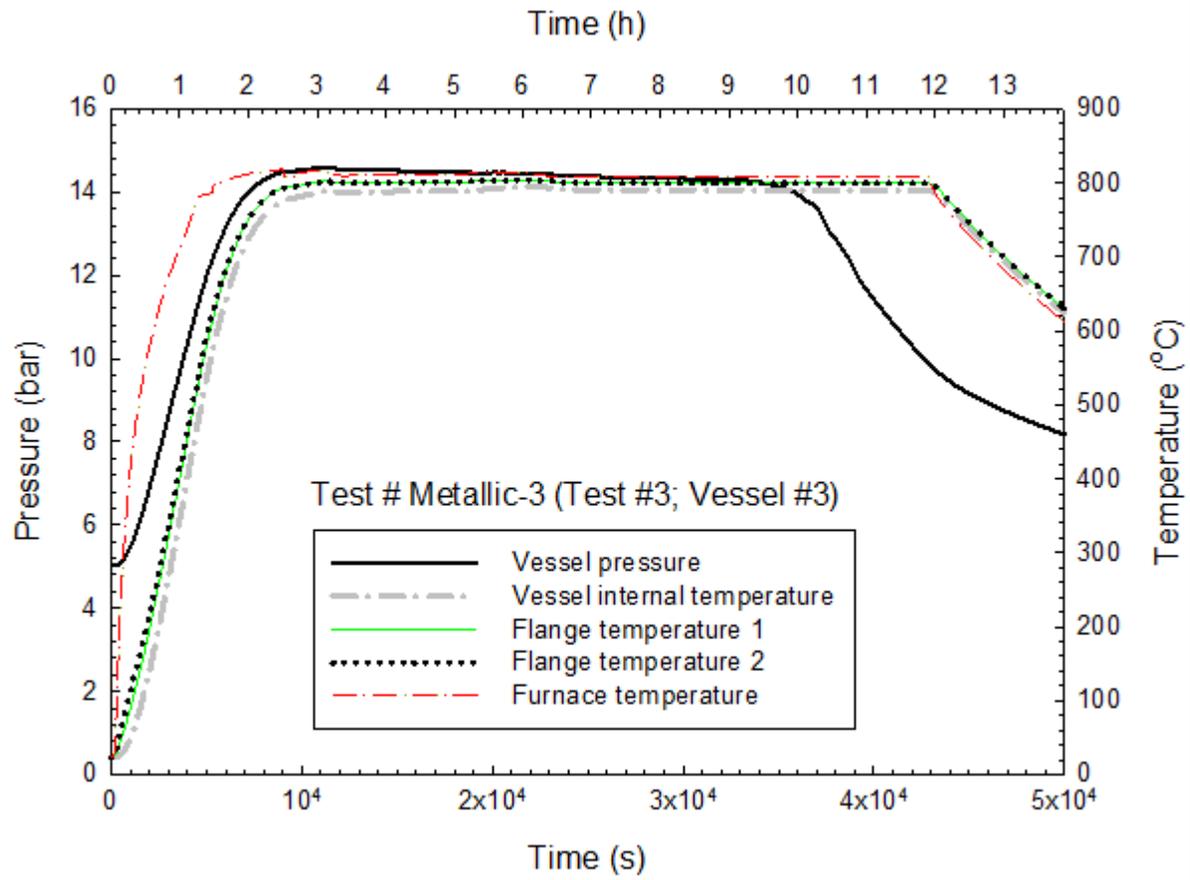
Figure 3-5. Temporal variations of vessel pressure and temperature in Test # Metallic-3 (Test #3).

Test # Metallic-3 (Tests #3) is a repeat of Test # Metallic-2 (Test #2). Figure 3-5 presents the test results which show the occurrence of a leak during the 9 h constant-temperature heating phase at 800 °C (1472 °F). In Test # Metallic-3, the vessel pressure decreases slowly initially and then significantly after about 25,000 s (6.9 h) at 800 °C (1472 °F). Since the leakage rate is directly proportional to the time rate of change of pressure, this two-stage decrease in pressure indicates a slower leak rate (small time derivatives of vessel pressure $[dP/dt]$) at first and then a faster leak rate (large dP/dt) at the end. Another leak indicator is revealed in Figure 3-6, which shows the entire time history of the test. After cooling to room temperature, the vessel does not recover its initial charge pressure of approximately 5 bar because of the leak. Isothermal reference helium leakage rates ($L_{R,He}$) during the 9 h heating in this test are shown in Figure 3-7.

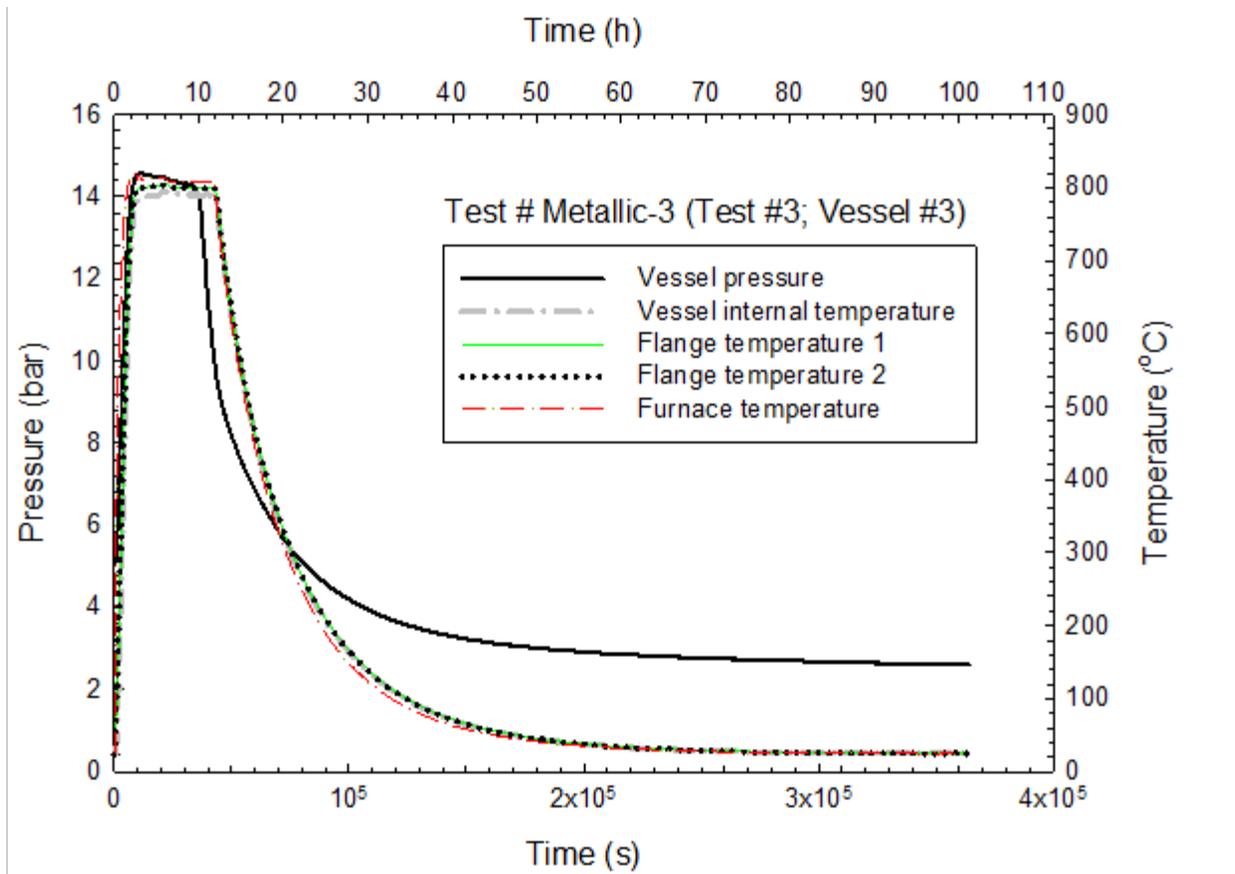
Figure 3-6. Temporal variations of vessel pressure and temperature in Test # Metallic-3 (Test #3) with time scale extended, including the cool-down phase.

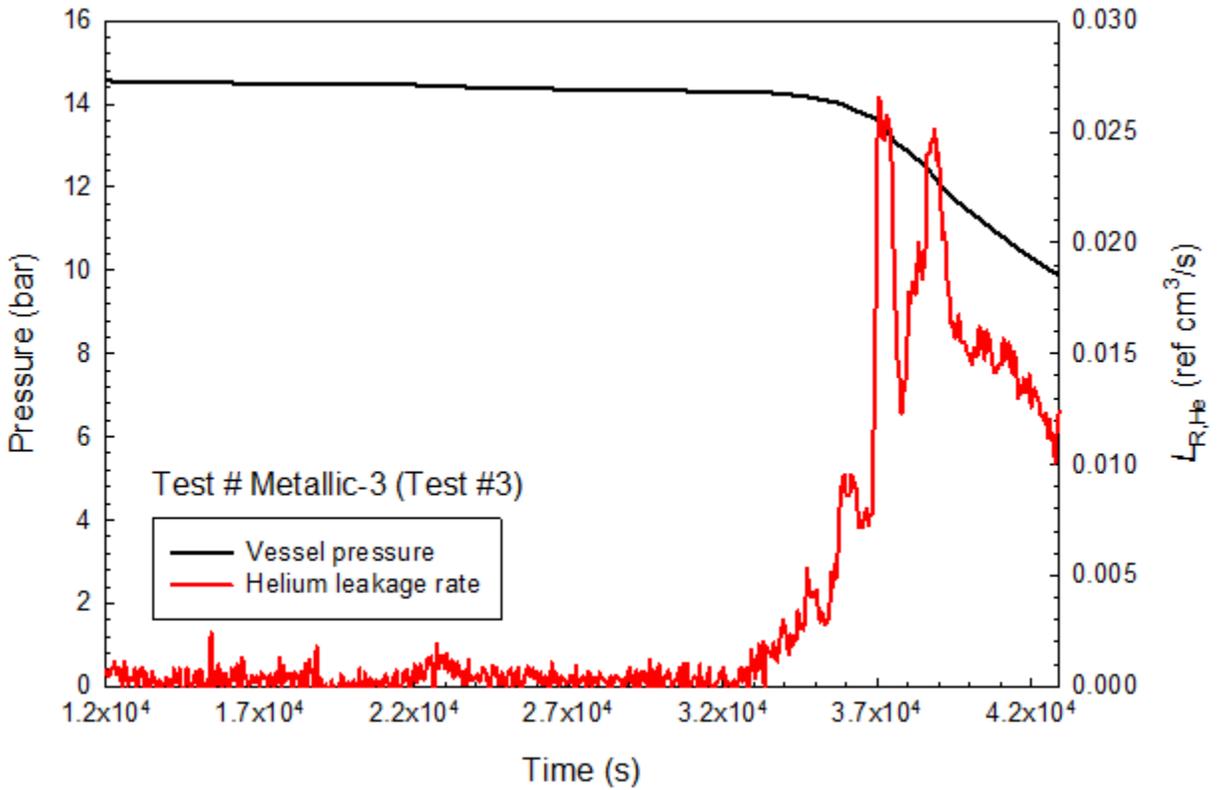
Figure 3-7. Isothermal reference helium leakage rate during the 9 h heating in Test # Metallic-3 (Test #3).

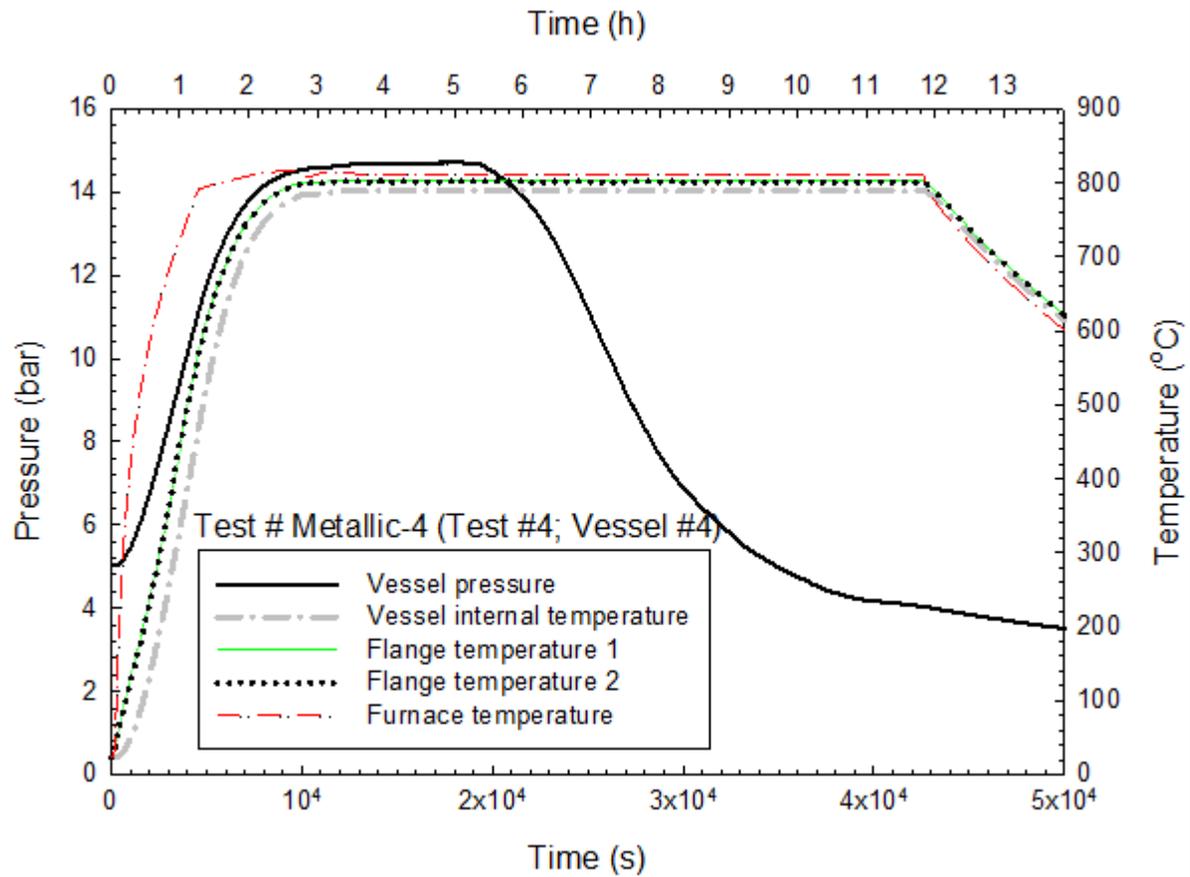
Figure 3-8. Temporal variations of vessel pressure and temperature in Test # Metallic-4 (Test #4).

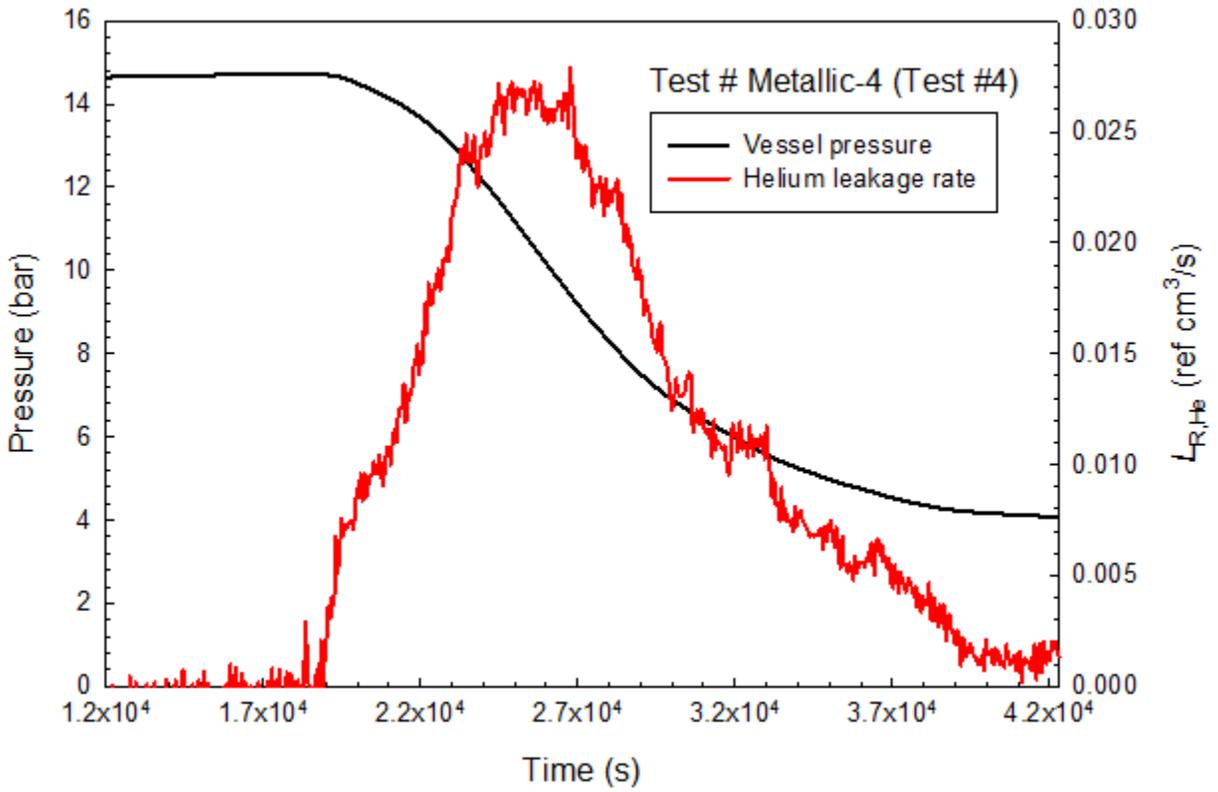
Figure 3-10. Isothermal reference helium leakage rate during the 9 h heating in Test # Metallic-4 (Test #4).

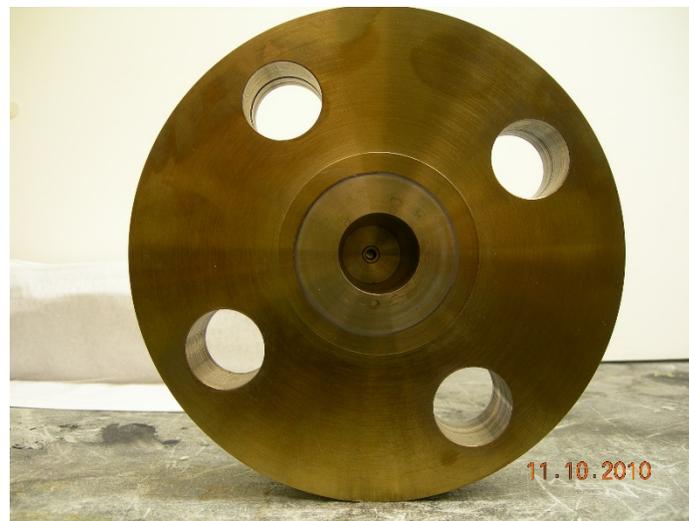
Figure 3-13. Post-test photograph of Vessel #5 (vessel body with O-ring removed) after exposure at 427 °C (800 °F) for 9 h.

A photograph of the exposed vessel is shown in Figure 3-13. The extent of discoloration of the vessel depends on the test temperature (Figure 3-1 vs. Figure 3-13). A post-test inspection revealed that the metallic O-ring seal was not soldered to either flange surfaces, and no silver coating from the seal was transferred to the O-ring groove.

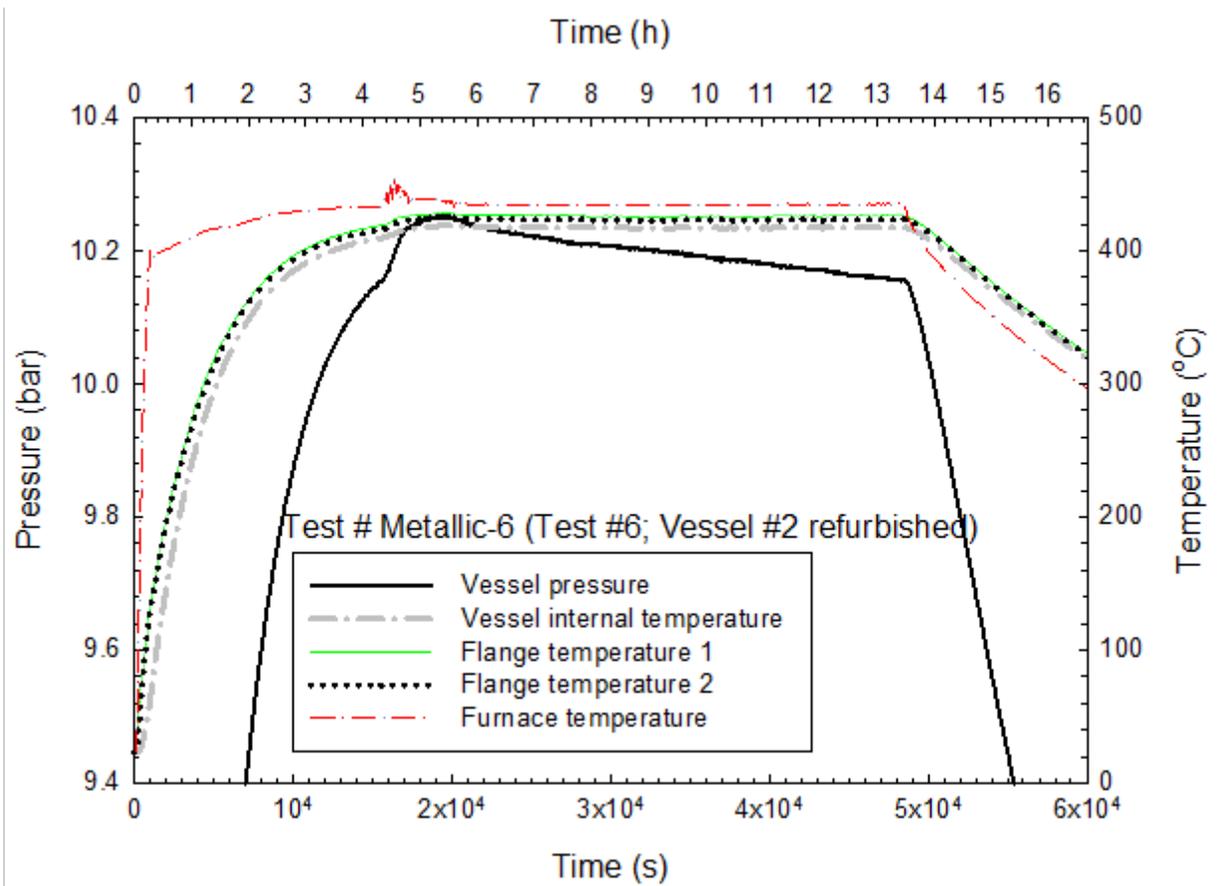
Figure 3-14. Temporal variations of vessel pressure and temperature in Test # Metallic-6 (Test #6).

The results for Test # Metallic-6 (Test #6) using the refurbished Vessel #2 are shown in Figure 3-14. The refurbishment only involved the re-facing of the surfaces of the flanges and O-ring groove to the specified tolerances. For this test, the vessel pressure started to decrease very slowly during the constant-temperature heating period. The scale of the ordinate is magnified in Figure 3-14 to elucidate the continuous decrease in pressure. However, the small pressure drop is within the pressure measurement uncertainty of 0.11 bar. Although the continuous decrease in pressure does seem to imply that a very small leak might have occurred during the test, the initial charge pressure was restored when the vessel was cooled to room temperature after the thermal exposure (as shown in Figure 3-15), an indication of no leakage.

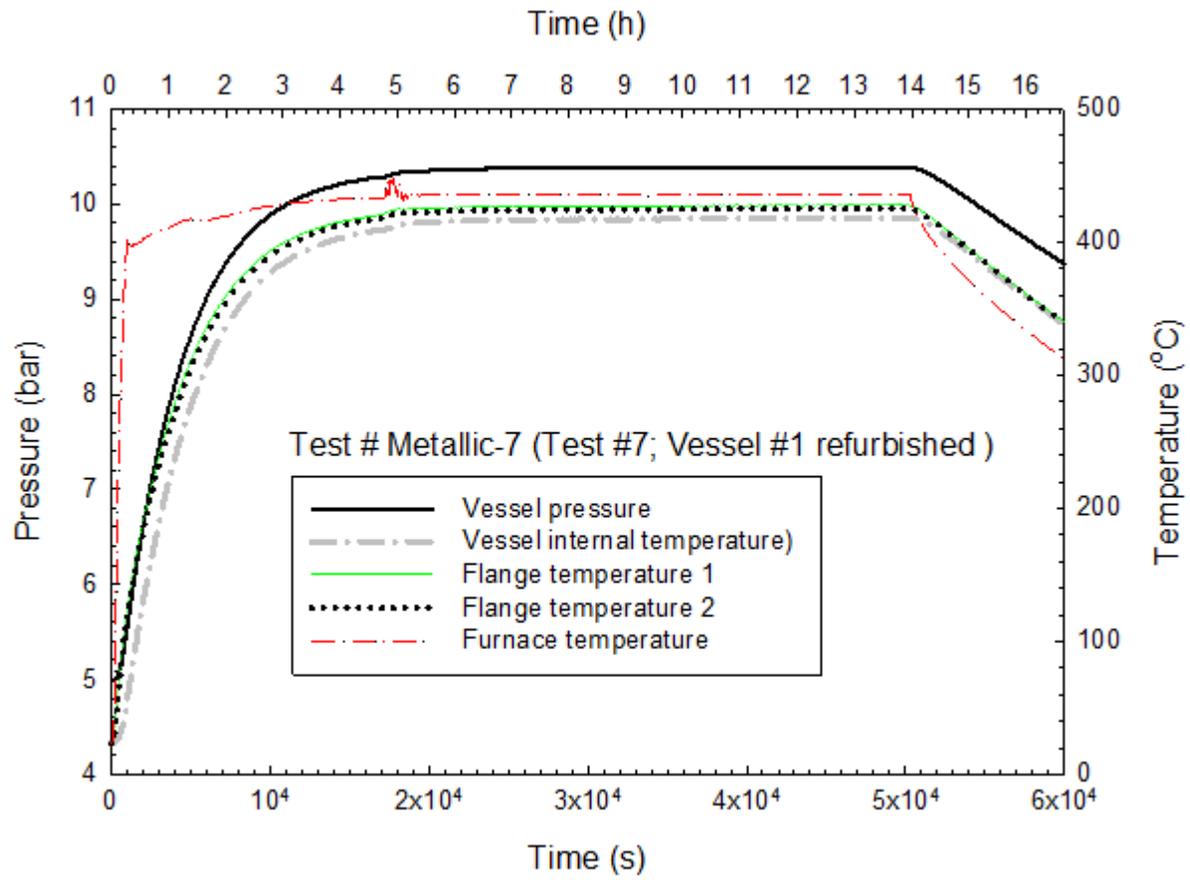
Figure 3-16. Temporal variations of vessel pressure and temperature in Test # Metallic-7 (Test #7).

Figure 3-16 shows the results for Test # Metallic-7 (Test #7) using the refurbished Vessel #1. The same refurbishing process used in Vessel #2 was applied to Vessel #1. As indicated in the figure, the vessel pressure remained unchanged during the 9-h constant-temperature heating period. No leakage was observed during Test # Metallic-7. Figure 3-17 is the complete thermal exposure history of Test # Metallic-7.

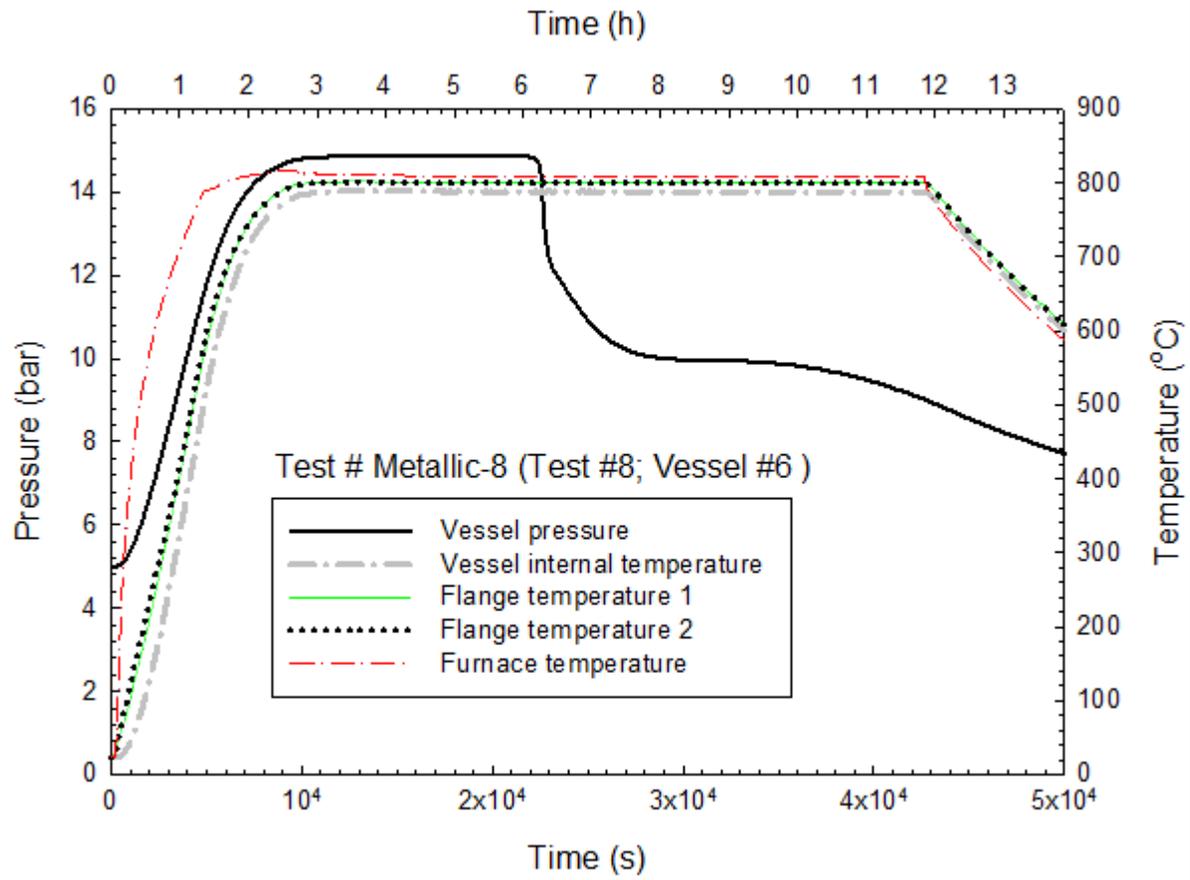
Figure 3-18. Temporal variations of vessel pressure and temperature in Test # Metallic-8 (Test #8).

The test conditions were similar to Tests # Metallic-2, Metallic-3, and Metallic-4. Figure 3-18 shows the thermal exposure results for Vessel #6. The pressure trace indicates that leakage occurs after about 3-h exposure to 800 °C (1472 °F). For this test, the pressure initially decreases very rapidly, followed by a gradually decrease in vessel pressure. However, the pressure never dropped below 2 bar, indicating that the seal had some residual sealing capacity. Figure 3-19 is the complete time-pressure and time-temperature histories of Test # Metallic-8 (Test #8). Figure 3-20 shows the calculated isothermal reference helium leakage rates during the 9-h heating.

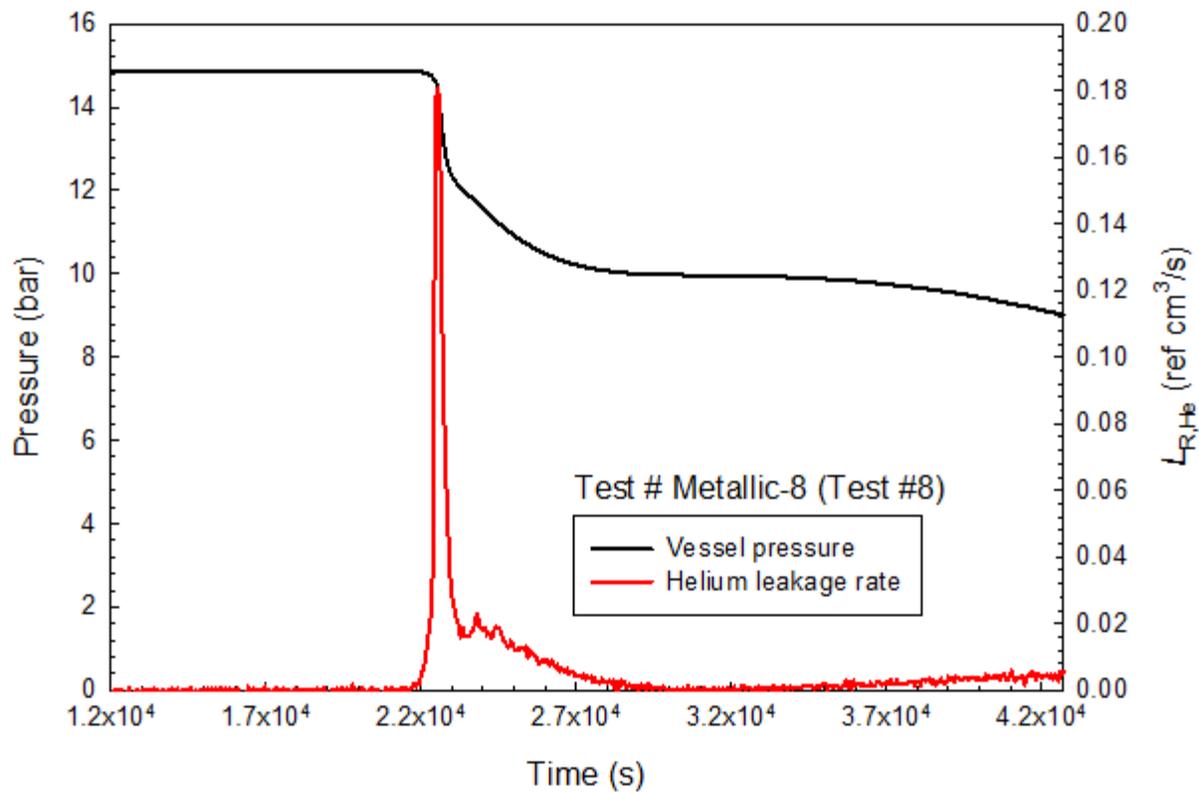
Figure 3-20. Isothermal reference helium leakage rate during the 9 h heating in Test # Metallic-8 (Test #8).

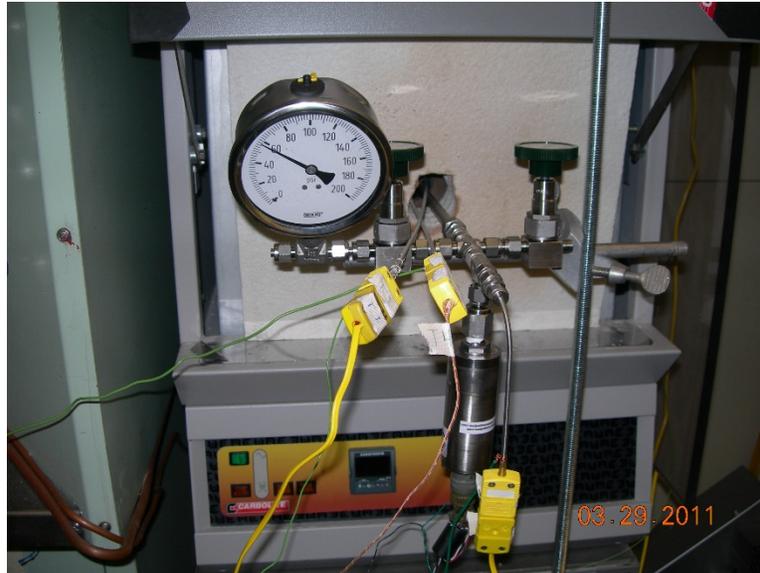
Figure 3-21. A photograph showing the pressure gauge used to check the pressure transducer performance.

Test # Metallic-9 (Test #9) was performed using Vessel #1, which had been used once at 800 °C (1472 °F) for 30 min and once at 427 °C (800 °F) for 9 h and refurbished twice. The sole intent of this test was to check the performance of the pressure transducer against a pressure gauge¹³ to ensure that the pressure transducer functioned properly. Figure 3-21 shows the set-up used for this comparative test. The only difference between this arrangement and the original was the addition of a pressure gauge.

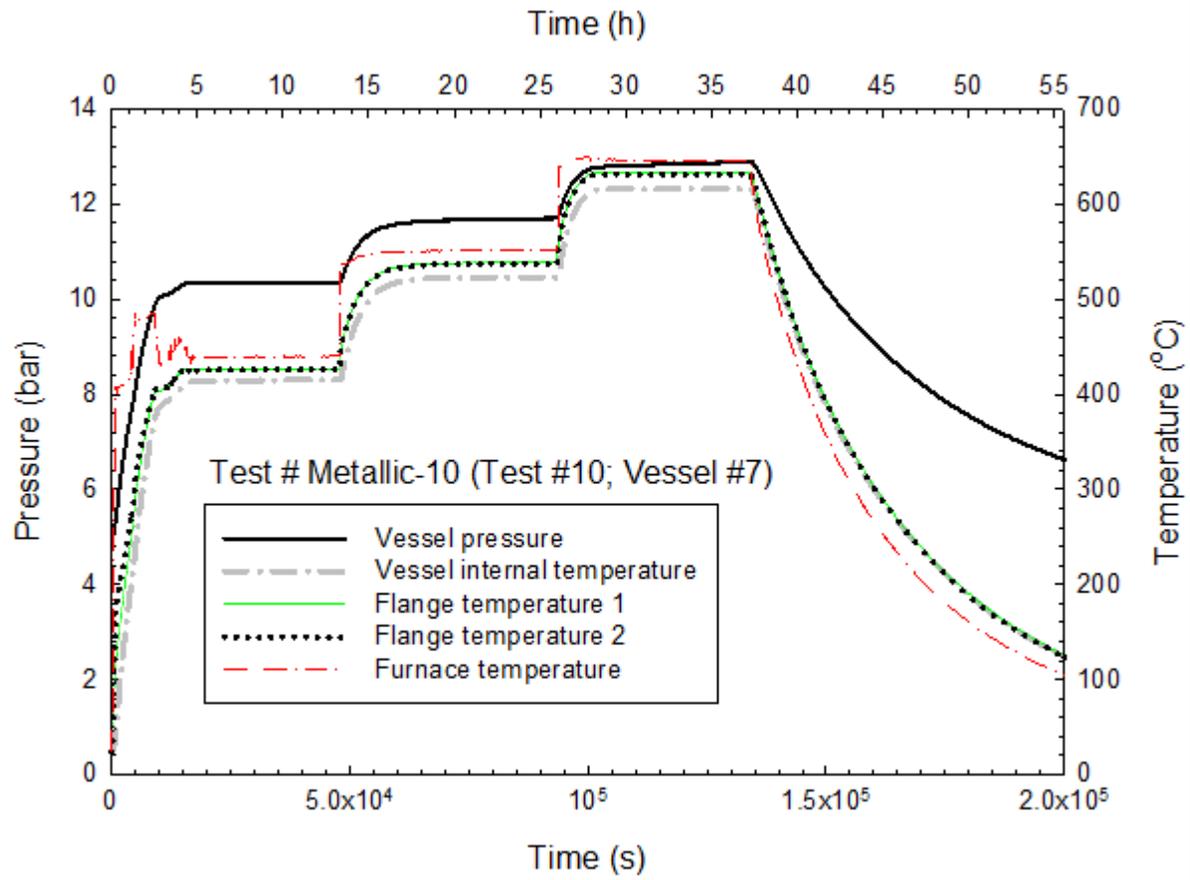
Figure 3-25. Temporal variations of vessel pressure and temperature in Test # Metallic-10 (Test #10).

In Test # Metallic-10 (Test #10), an incremental heating protocol was used to assess the metallic seal performance. The vessel was initially heated to 427 °C (800 °F) and held for 9 h at this temperature. Then, the furnace temperature was raised to 527 °C (981 °F), and the vessel was heated at 527 °C (981 °F) overnight (more than 9 h). The vessel was then heated to 627 °C (1161 °F) for 9 h. Figure 3-25 and Figure 3-26 show the test results. No leak was observed based on the pressure traces at the test temperatures, 427 °C (800 °F), 527 °C (981 °F), and 627 °C (1161 °F), and the recovery of the initial pressure at room temperature. Post-test removal of the O-ring from the groove was very easy. A post-test inspection of the vessel indicated that the metallic seal did not bond onto the O-ring groove.

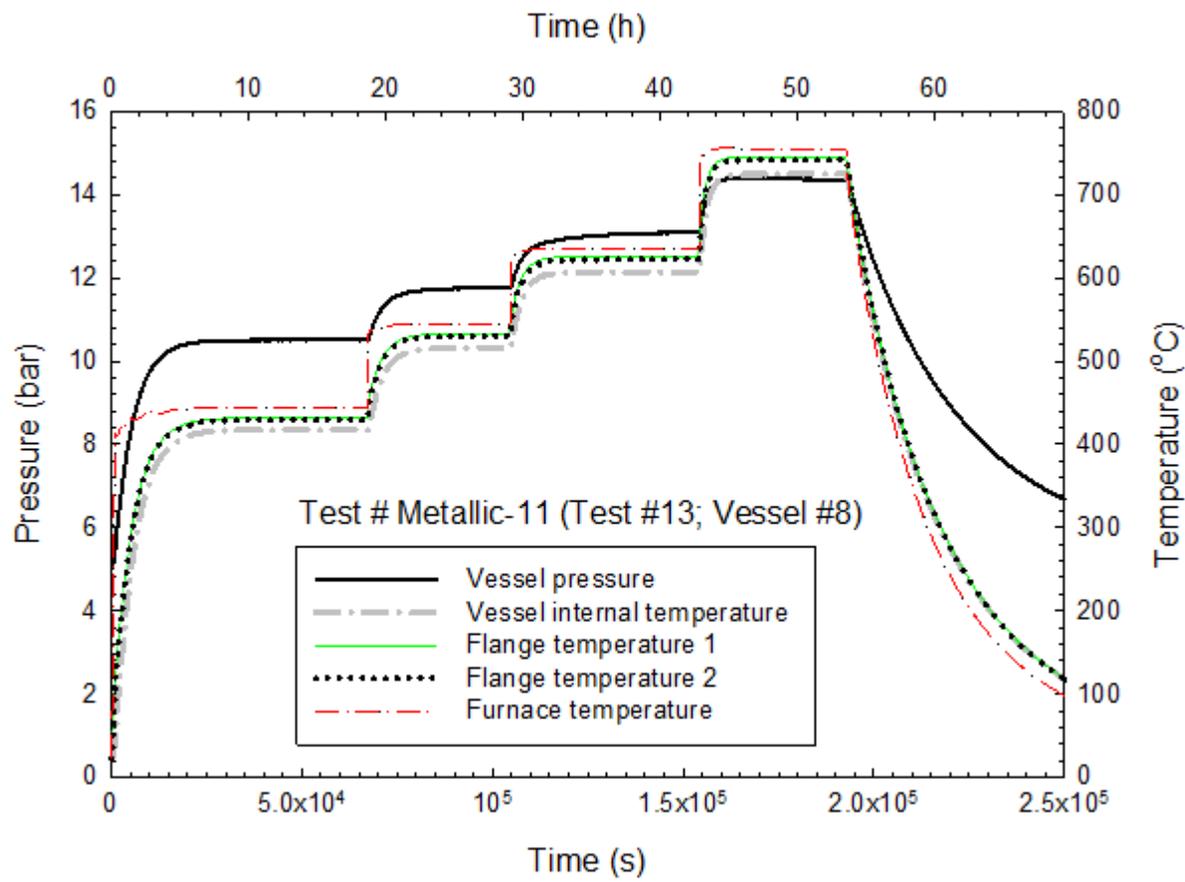
Figure 3-27. Temporal variations of vessel pressure and temperature in Test # Metallic-11 (Test #13).

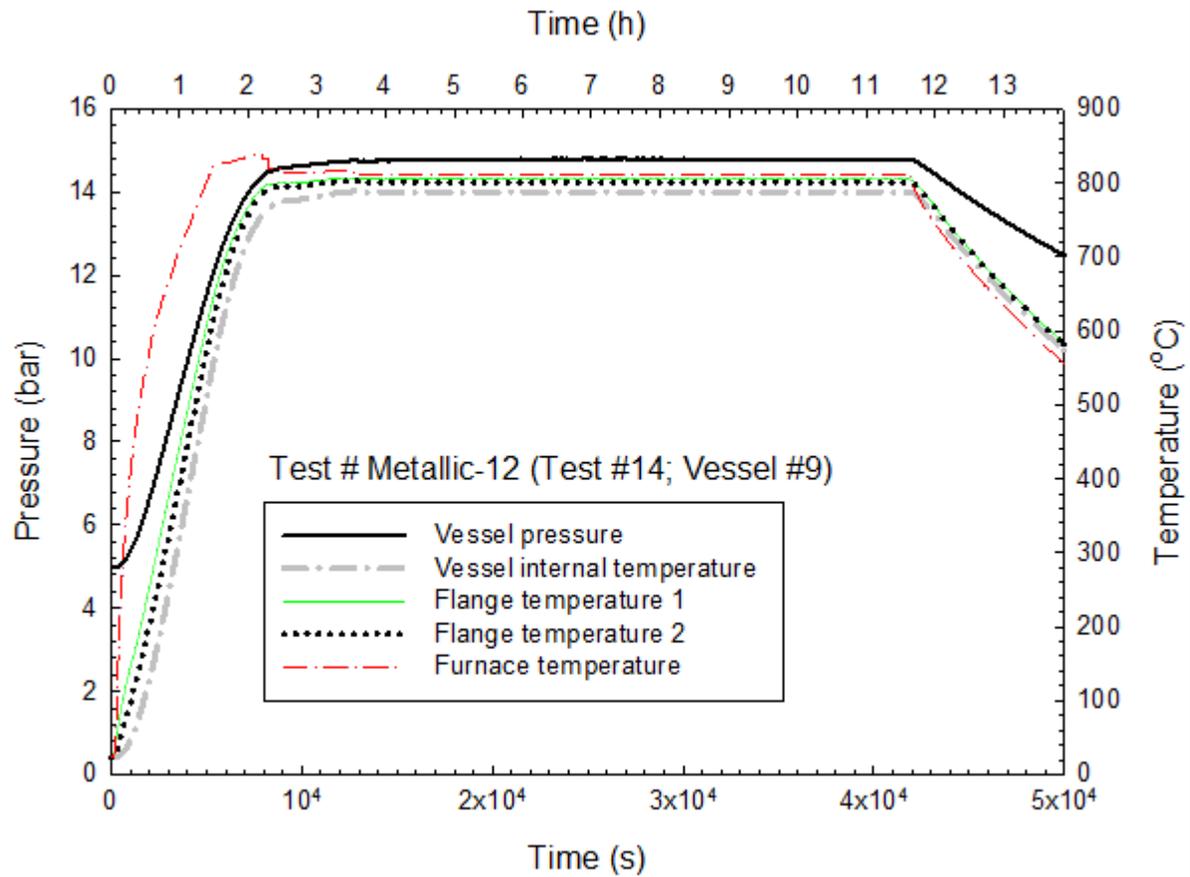
Figure 3-29. Temporal variations of vessel pressure and temperature in Test # Metallic-12 (Test #14).

In Test # Metallic-12 (Test #14), a new vessel with a metallic seal was used. The vessel was evacuated and charged with helium three times to prepare for the test. This test was a repeat of Tests # Metallic-2, Metallic-3, and Metallic-4. Figure 3-29 shows the first 50,000 s (≈ 14 h) of the pressure-time and temperature-time histories to illustrate the absence of a leak (constant pressure at constant temperature). The pressure-time and temperature-histories during the complete heating and cooling cycle is shown in Figure 3-30. However, similar to the observation in Test # Metallic-11, after the test vessel was cooled down to room temperature, the vessel pressure did not recover to its starting value (≈ 5 bar) but remained at a slightly higher constant value of ≈ 5.2 bar over a duration of more than 50 h. Again, this was not due to the drift of the pressure transducer because when the vessel content was released to the atmosphere, the pressure transducer gave an atmospheric pressure reading.

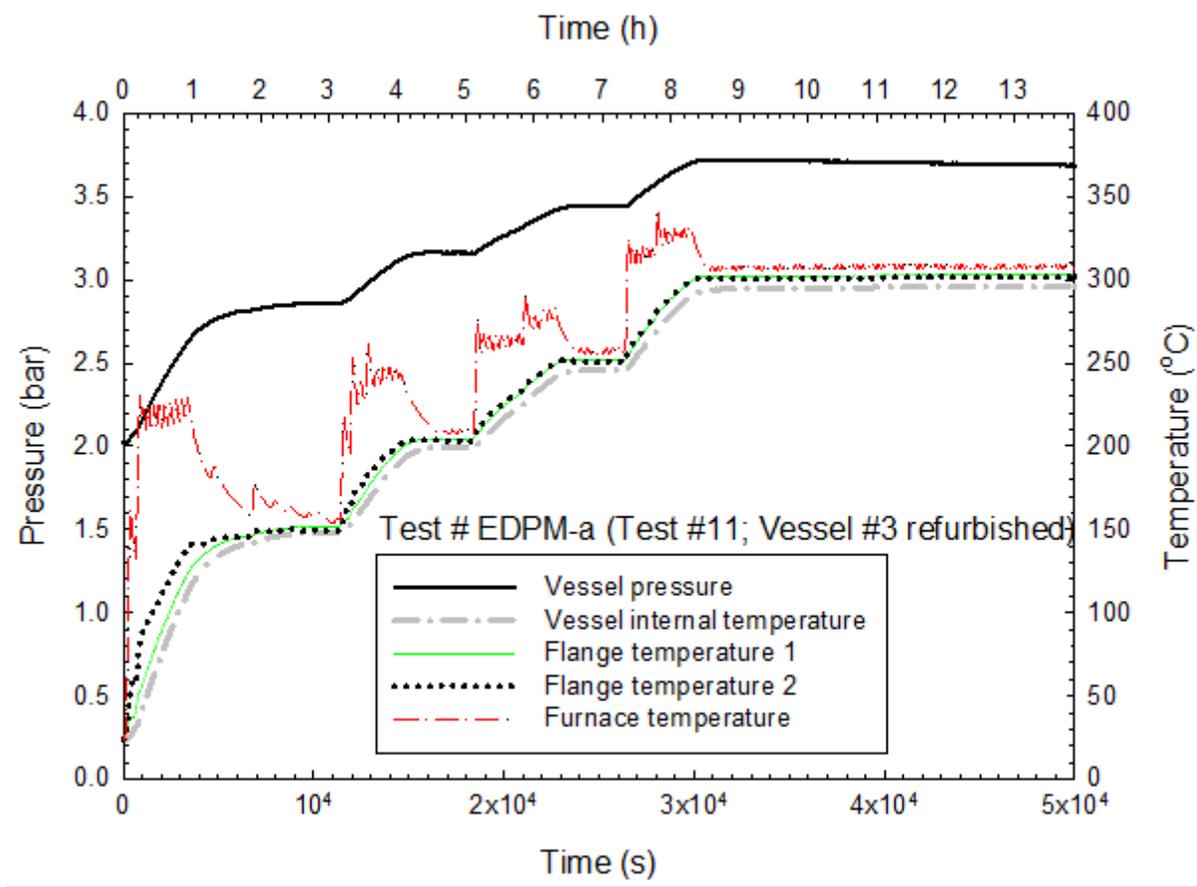
Figure 3-31. Temporal variations of vessel pressure and temperature in Test # EDPM-a (Test #11).

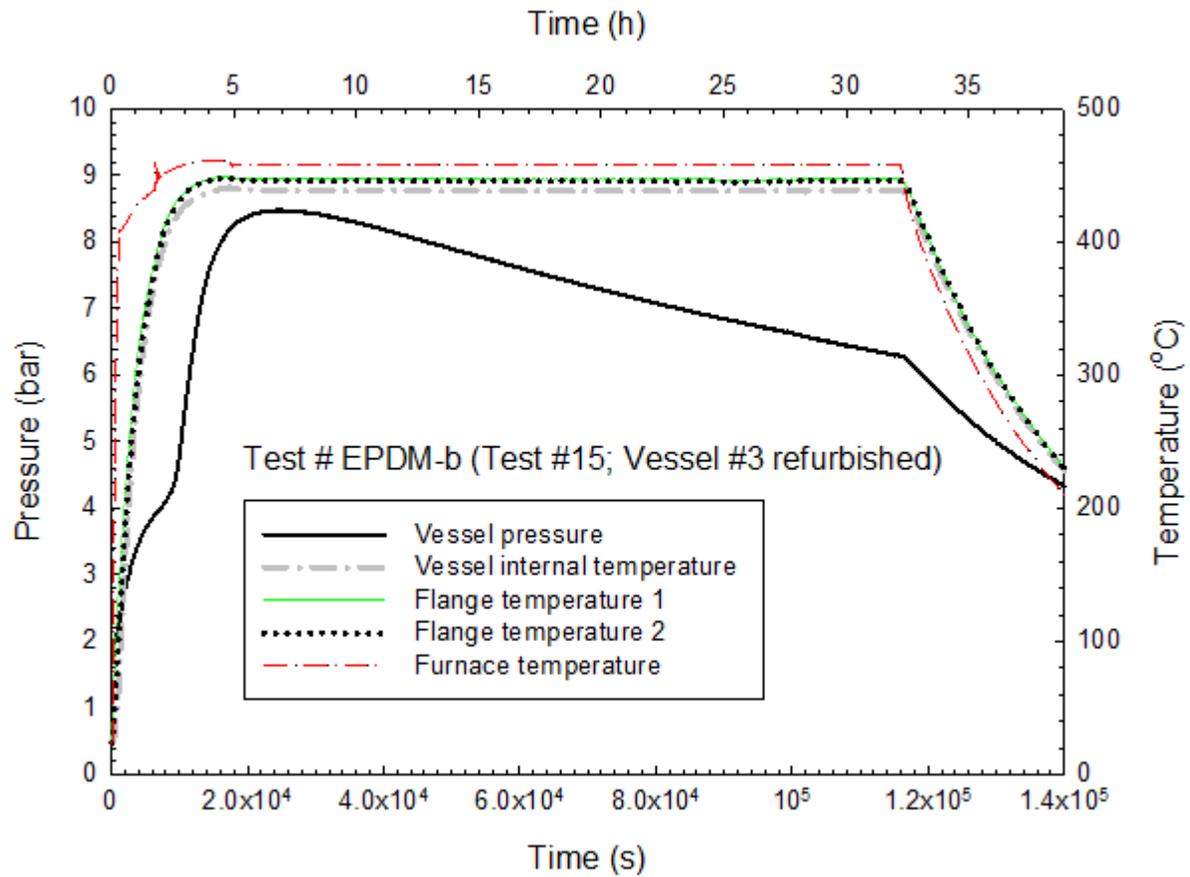
Figure 3-33. Temporal variations of vessel pressure and temperature in Test # EPDM-b (Test #15).

Figure 3-33 shows the first 39 h of the pressure-time and temperature-time histories obtained from this test. The pressure and temperature histories for the complete heating and cooling cycle are given in Figure 3-34. The pressure trace in Figure 3-33 clearly indicates a leak occurred soon after the vessel had attained the nominal target temperature of 450 °C (842 °F). Figure 3-35 shows the calculated reference helium leakage rates over the 25 h isothermal heating period at 450 °C (842 °F) with a time-averaged reference leakage rate of 9.2×10^{-4} ref-cm³/s.

From Figure 3-33 and Figure 3-34, a peculiarity is noted. The measured attainable pressure (≈ 8.5 bar) at $450\text{ }^{\circ}\text{C}$ ($842\text{ }^{\circ}\text{F}$) before the leak occurred is noticeably higher than the pressure calculated using the ideal gas law (≈ 4.9 bar), even assuming no thermal expansion of the vessel volume. The addition of vapor mass from the potential thermal decomposition and off-gas of the O-ring and the lubricant used at $450\text{ }^{\circ}\text{C}$ ($842\text{ }^{\circ}\text{F}$) is conjectured to be the cause for this unusually high pressure. Another abnormality is that after the vessel was cooled down to room temperature, the pressure never recovered to its original value (≈ 2 bar) but remained relatively constant at ≈ 2.16 bar over a duration of more than 100 h, implying the O-ring still possessed some residual sealing capability. A post-test inspection of the tested vessel revealed that the interior vessel wall and the thermocouple inserted into the vessel interior were coated with a thin layer of black substance. Although the O-ring was still properly seated in the groove (see Figure 3-36), it had turned into a packed layer of powdery charred material and could not be removed from the groove without destroying its structural integrity (see Figure 3-37). Additional tests would be needed to further examine this finding.

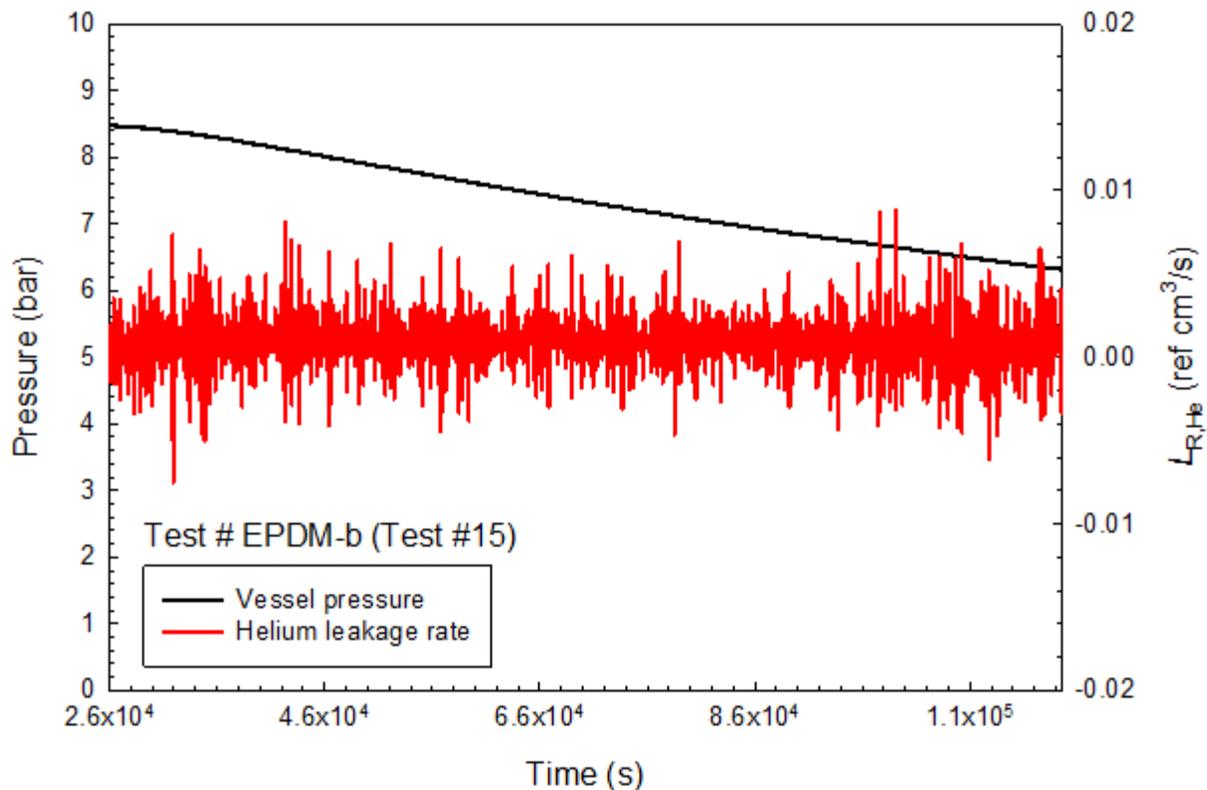
Figure 3-35. Isothermal reference helium leakage rate during the 25 h heating in Test # EPDM-b (Test #15).

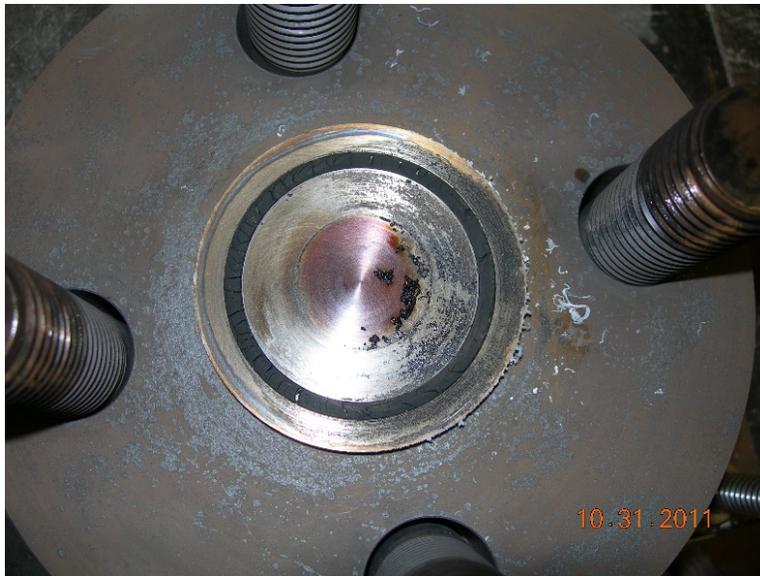
Figure 3-36. Photograph of the EPDM O-ring after thermal exposure.
