Performance of Metal and Polymeric O-Ring Seals in Beyond-Design-Basis Temperature Excursions

This report documents the beyond-design-basis thermal exposure test results of the performance of metallic and polymeric seals typically used in radioactive material transportation packages. The overall objective of the project is to provide test data and insights regarding the performance of these O-ring seals (metallic or polymeric) when exposed to beyond-design-basis temperature conditions that could result due to a severe fire. Tests were conducted using a small-scale test package (pressure vessel) made of stainless steel SS 304 filled with helium initially pressurized at either 5 bar or 2 bar at room temperature. The test package was then exposed in an electric furnace to temperatures equal to, or above the specified maximum operating temperatures of these seals (up to 900 °C) for a pre-determined period (typically 8 h to 9 h). These O-ring temperatures and test periods are more severe than the 800°C for 30 minutes hypothetical accident conditions described in 10 CFR Part 71. In addition, the 800°C and 900°C seal temperatures are much higher than would be expected in real world condi

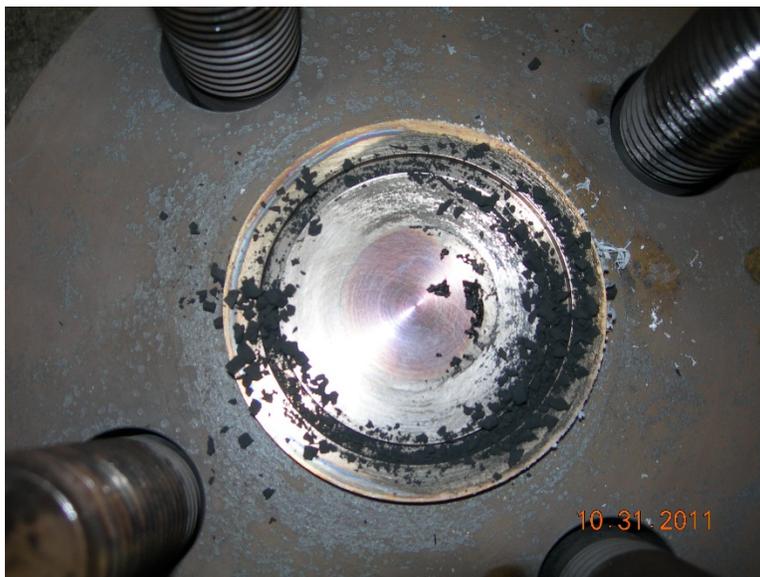
Figure 3-37. Photograph showing the disintegration of the tested EPDM O-ring when an attempt was made to remove the O-ring from the groove.

From Figure 3-33 and Figure 3-34, a peculiarity is noted. The measured attainable pressure (≈ 8.5 bar) at $450\text{ }^{\circ}\text{C}$ ($842\text{ }^{\circ}\text{F}$) before the leak occurred is noticeably higher than the pressure calculated using the ideal gas law (≈ 4.9 bar), even assuming no thermal expansion of the vessel volume. The addition of vapor mass from the potential thermal decomposition and off-gas of the O-ring and the lubricant used at $450\text{ }^{\circ}\text{C}$ ($842\text{ }^{\circ}\text{F}$) is conjectured to be the cause for this unusually high pressure. Another abnormality is that after the vessel was cooled down to room temperature, the pressure never recovered to its original value (≈ 2 bar) but remained relatively constant at ≈ 2.16 bar over a duration of more than 100 h, implying the O-ring still possessed some residual sealing capability. A post-test inspection of the tested vessel revealed that the interior vessel wall and the thermocouple inserted into the vessel interior were coated with a thin layer of black substance. Although the O-ring was still properly seated in the groove (see Figure 3-36), it had turned into a packed layer of powdery charred material and could not be removed from the groove without destroying its structural integrity (see Figure 3-37). Additional tests would be needed to further examine this finding.

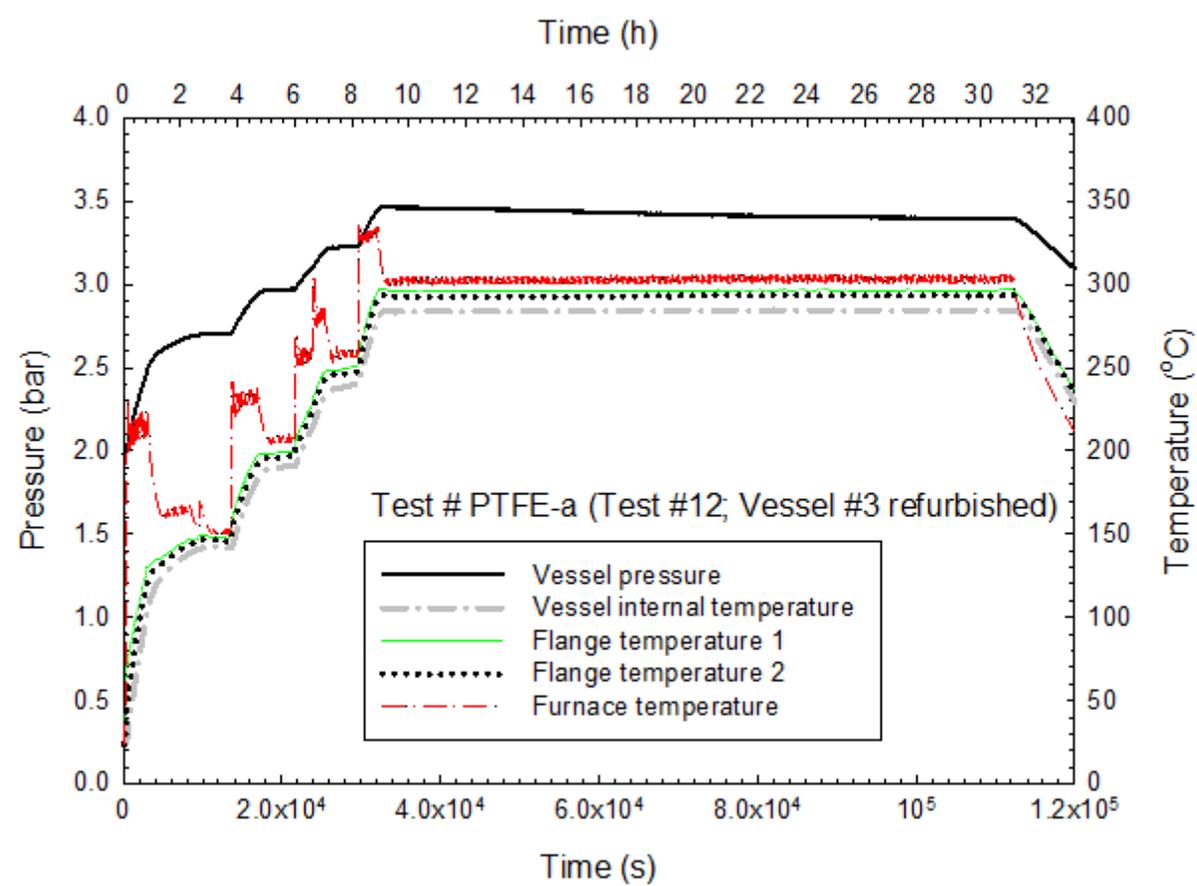
Figure 3-38. Temporal variations of vessel pressure and temperature in Test # PTFE-a (Test #12).

this test. The refurbishment of the vessel simply consisted of cleaning of the O-ring groove previously used for the EPDM seal test (Test # EPDM-a). Figure 3-38 and Figure 3-39 show the results during the heating phase and the complete heating-cooling history respectively. During the 22 h heating at 300 °C (572 °F), there was a slight drop in vessel pressure at the end of the isothermal heating phase; however, the pressure decrease was within the measurement uncertainty of the pressure transducer. Figure 3-40, which shows the calculated reference helium leakage rates during the 22 h heating period, indicates a time-averaged reference leakage rate of 4.5×10^{-5} ref-cm³/s. The fluctuation in the leakage rate data was due to the taking of numerical time derivatives of the unsmoothed pressure-time data. As indicated in the pressure trace, leakage was observed in this test during the cooling phase. The original pressure (≈ 2 bar) did not recover, and the vessel pressure dropped below the original pressure at room temperature. Post-test inspection of the exposed vessel revealed that the compressed O-ring was still intact and could be easily removed from the O-ring groove.

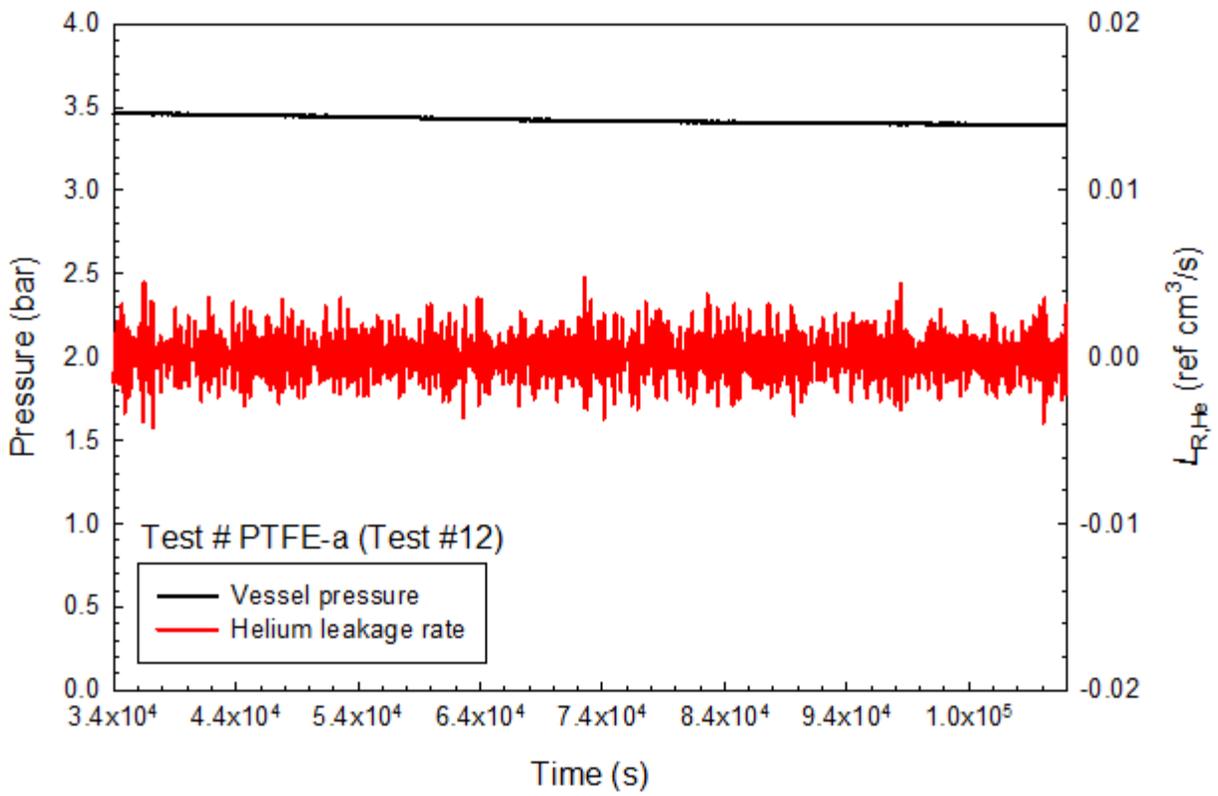
Figure 3-40. Isothermal reference helium leakage rate during the 22 h heating in Test # PTFE-a (Test #12).

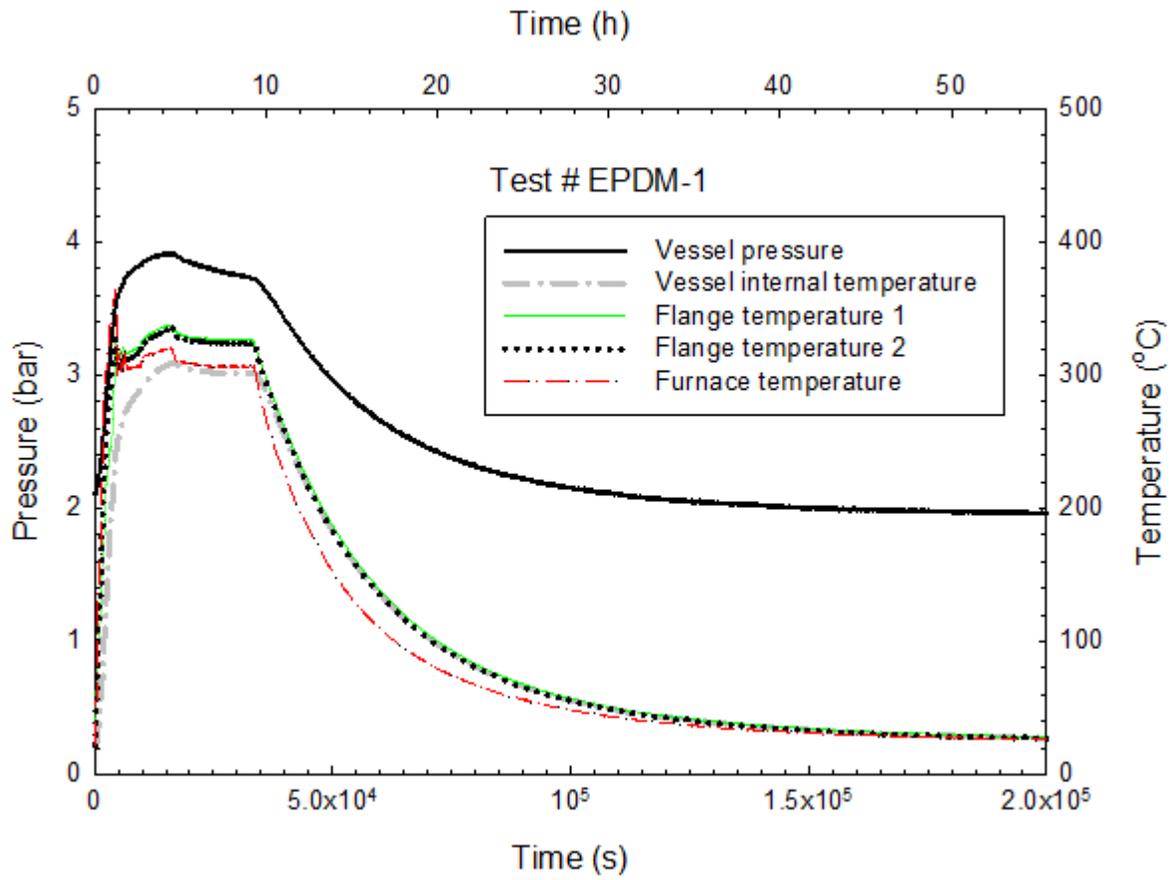
Figure 3-41. Temporal variations of vessel pressure and temperatures in Test # EPDM-1.

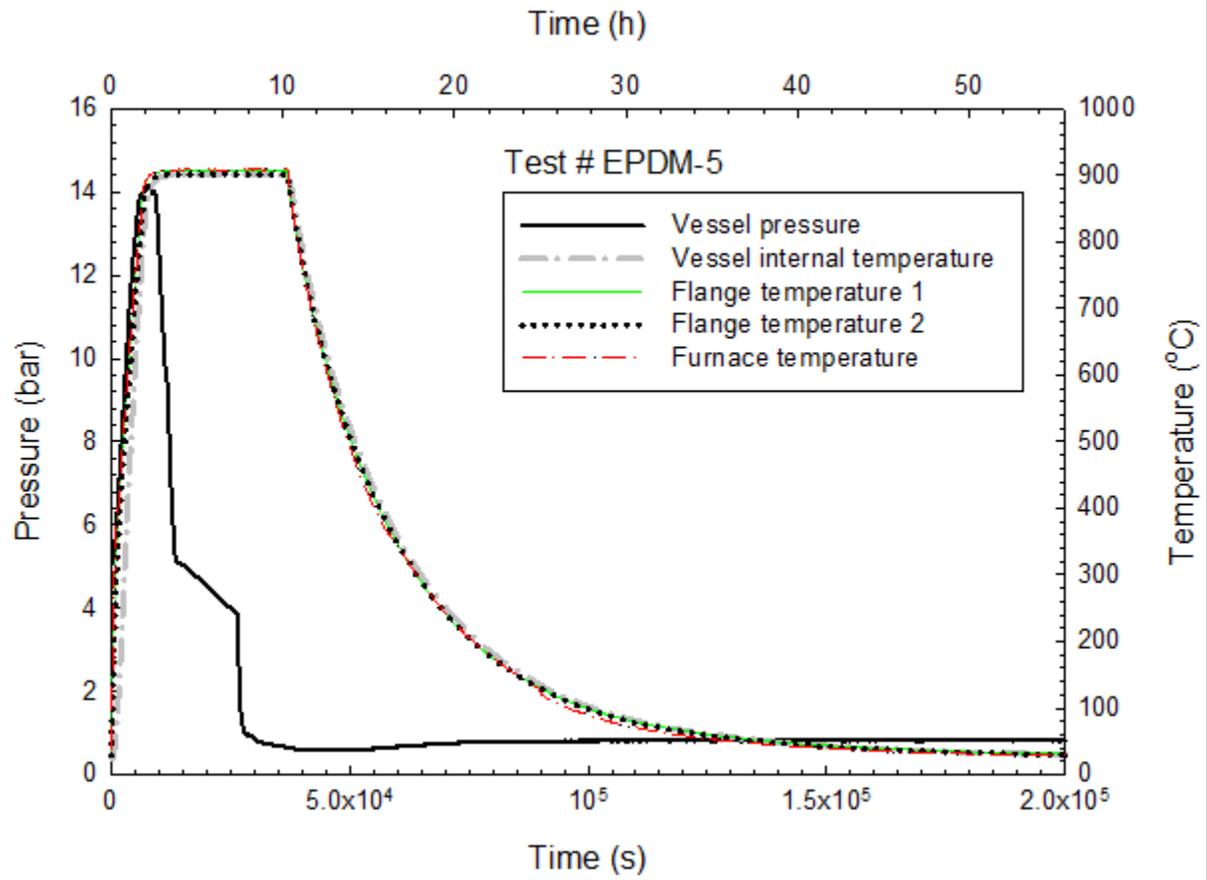
Figure 3-45. Temporal variations of vessel pressure and temperatures in Test # EPDM-5.

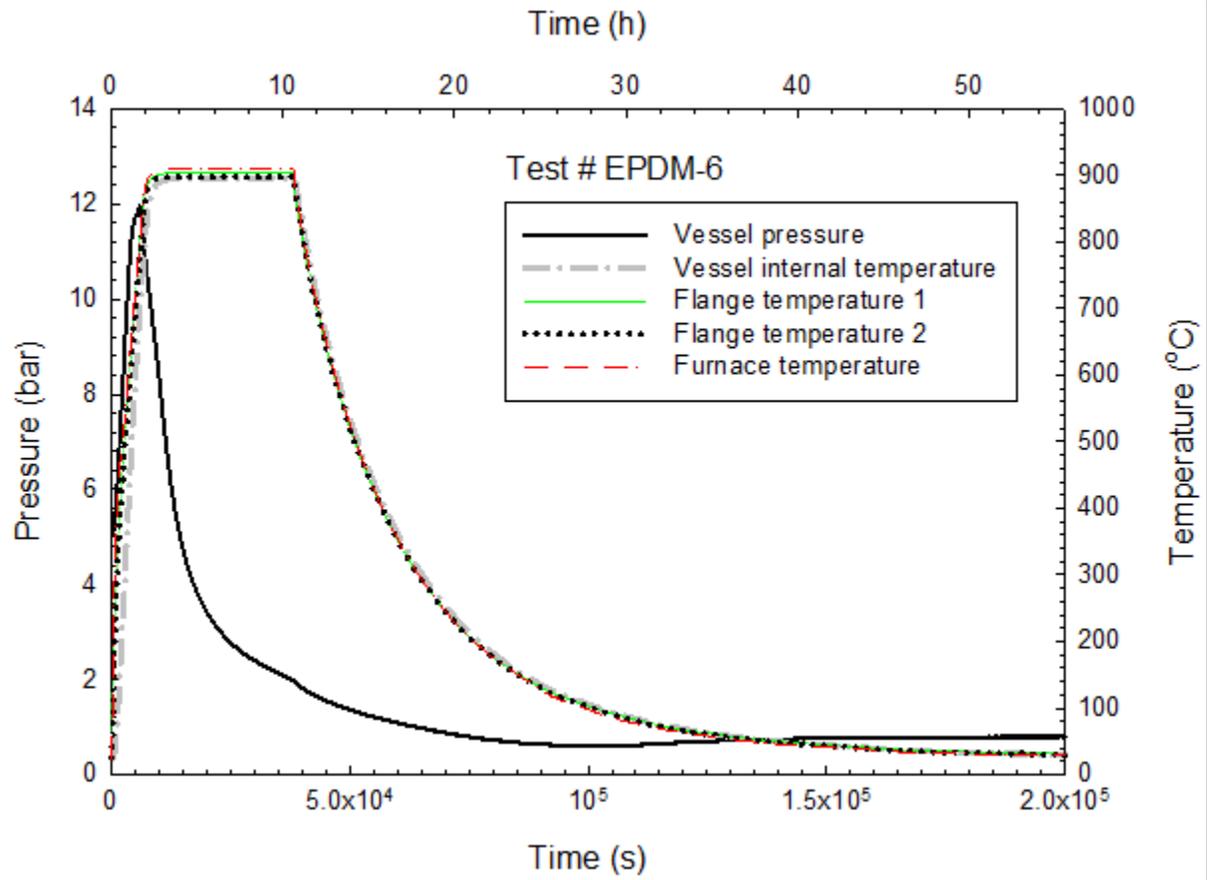
Figure 3-46. Temporal variations of vessel pressure and temperatures in Test # EPDM-6.

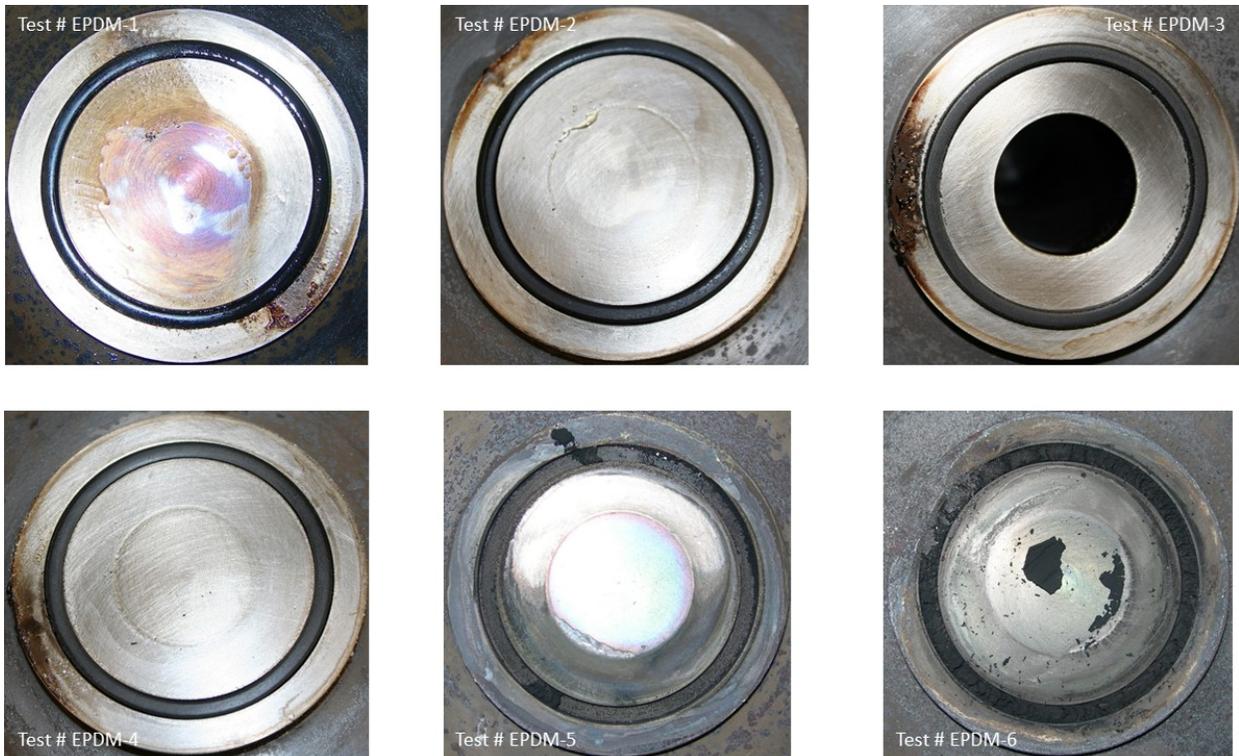
Figure 3-47. Photographs showing the thermally degraded EPDM O-ring after 8-h thermal exposure at 316 °C (600 °F) from the four EPDM O-ring tests (Tests # EPDM-1, EPDM-2, EPDM-3, and EPDM-4). Tests # EPDM-5 and # EPDM-6 were conducted at 900 °C for 9 h.

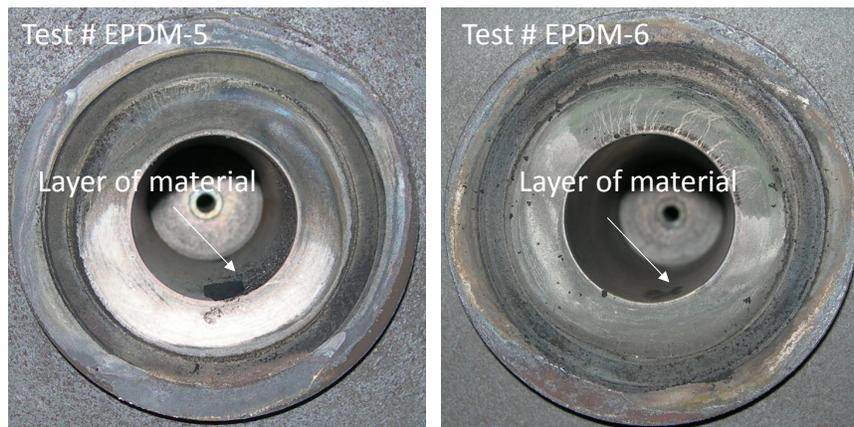
Figure 3-48. Photographs showing the vessel interiors after 9 h thermal exposure at 900 °C from Tests # EPDM-5 and EPDM-6.

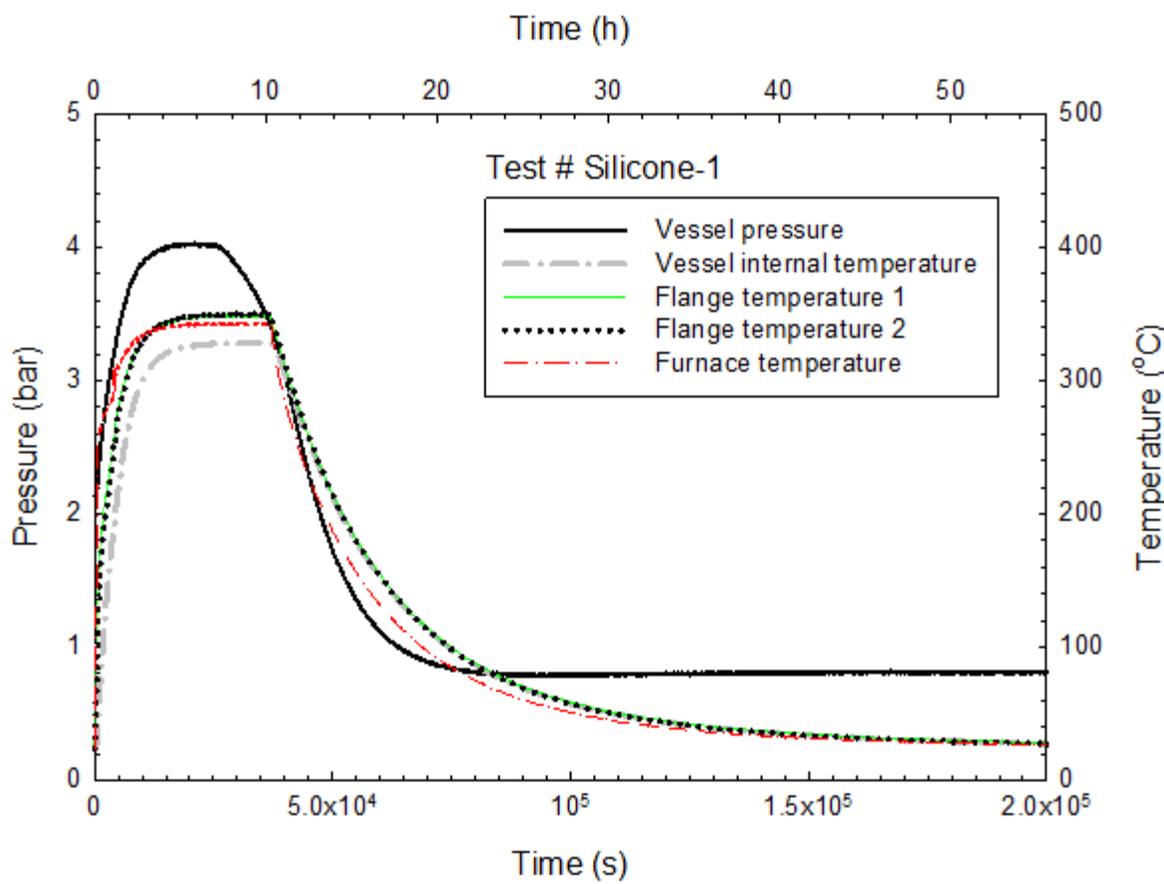
Figure 3-49. Temporal variations of vessel pressure and temperatures in Test # Silicone-1.

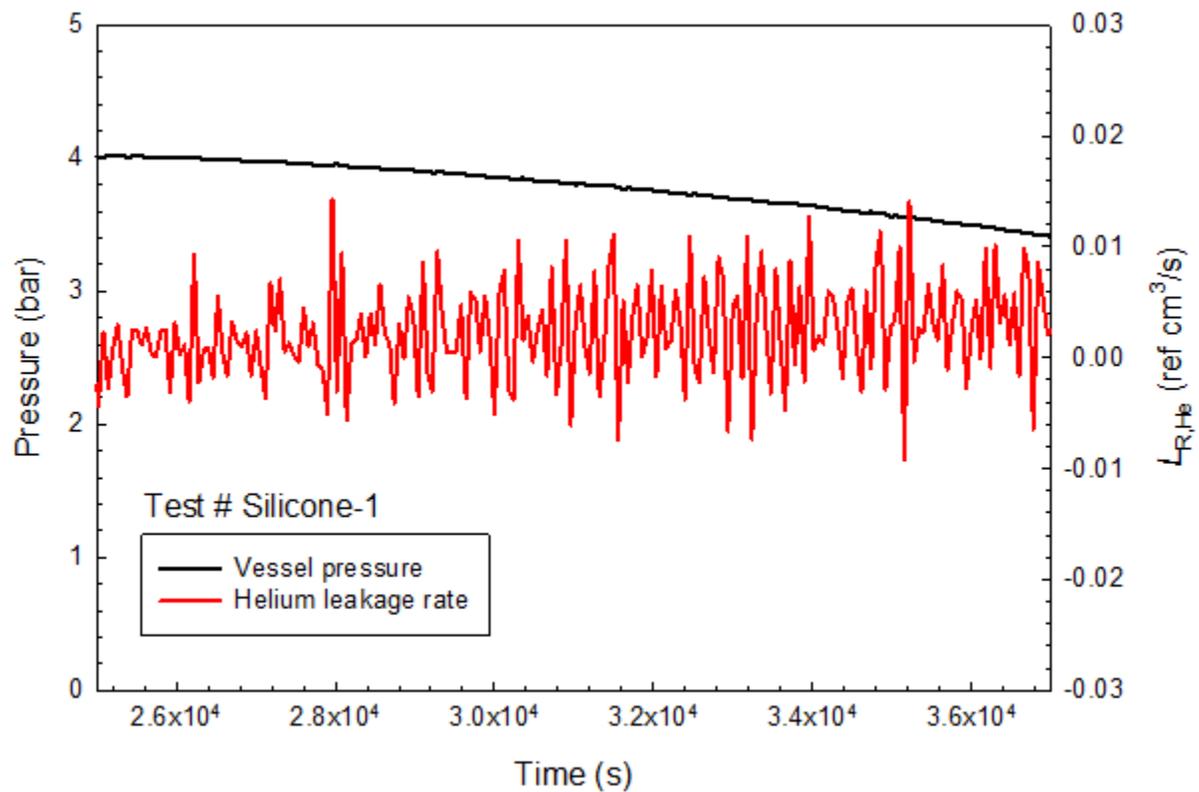
Figure 3-50. Calculated isothermal reference helium leakage rate in Test # Silicone-1.

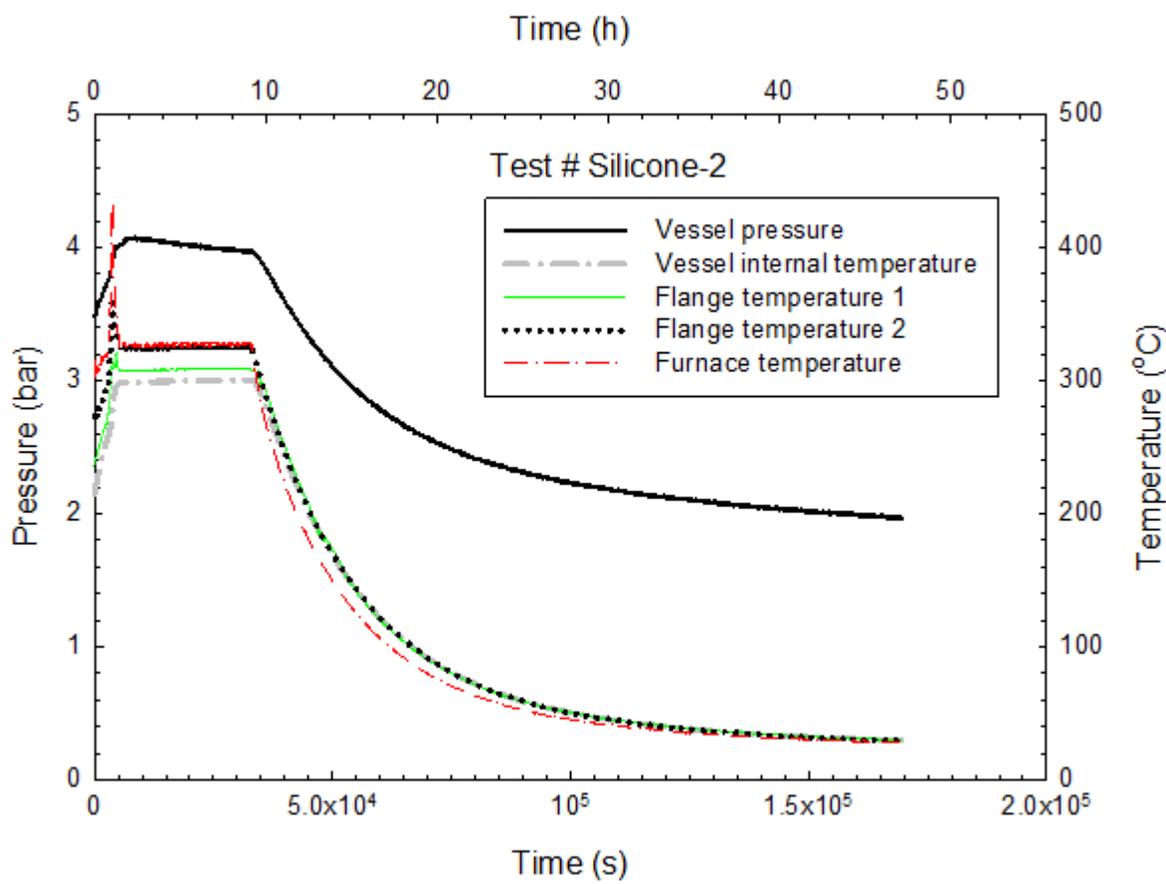
Figure 3-51. Temporal variations of vessel pressure and temperatures in Test # Silicone-2.

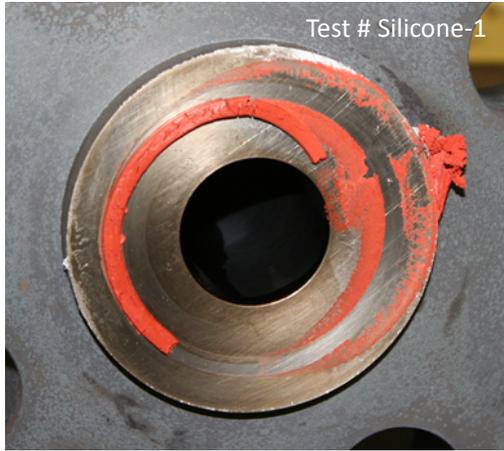
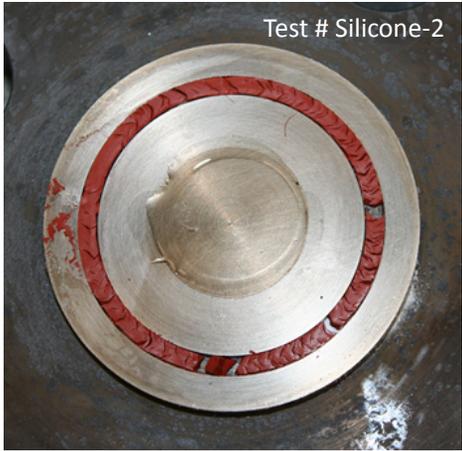
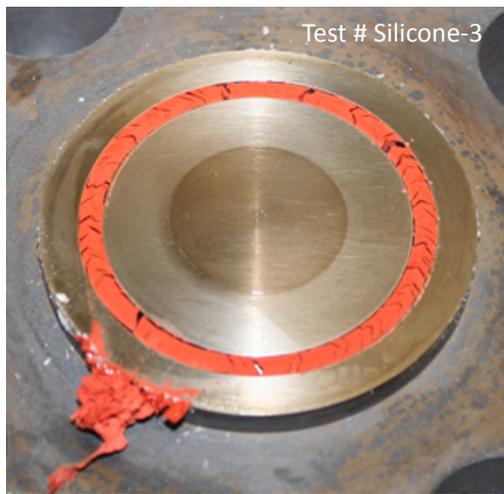
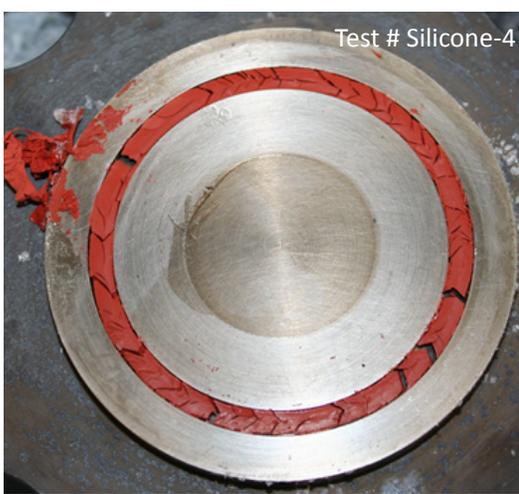
Figure 3-54. Photographs showing the thermally degraded silicone O-ring after 8-h thermal exposure at 316 °C (600 °F) for the four silicone O-ring tests.

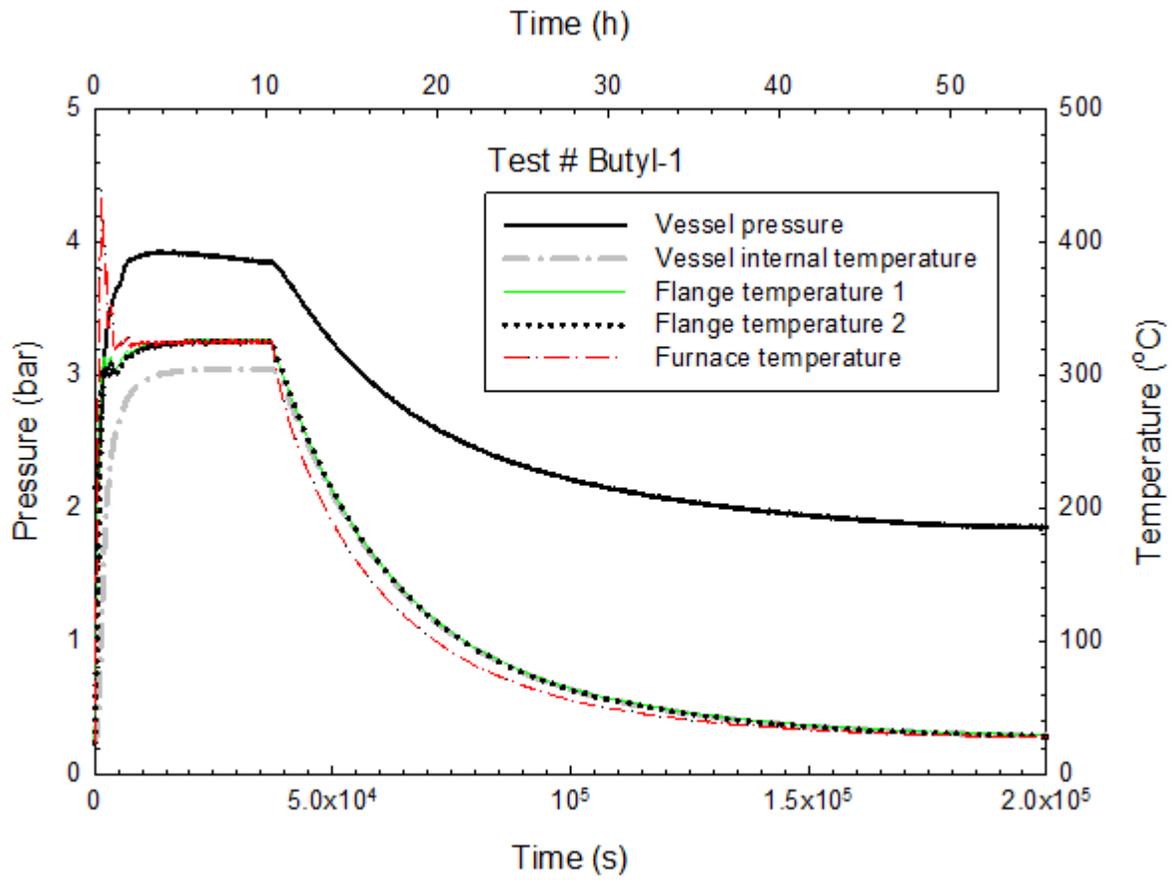
Figure 3-55. Temporal variations of vessel pressure and temperatures in Test # Butyl-1.

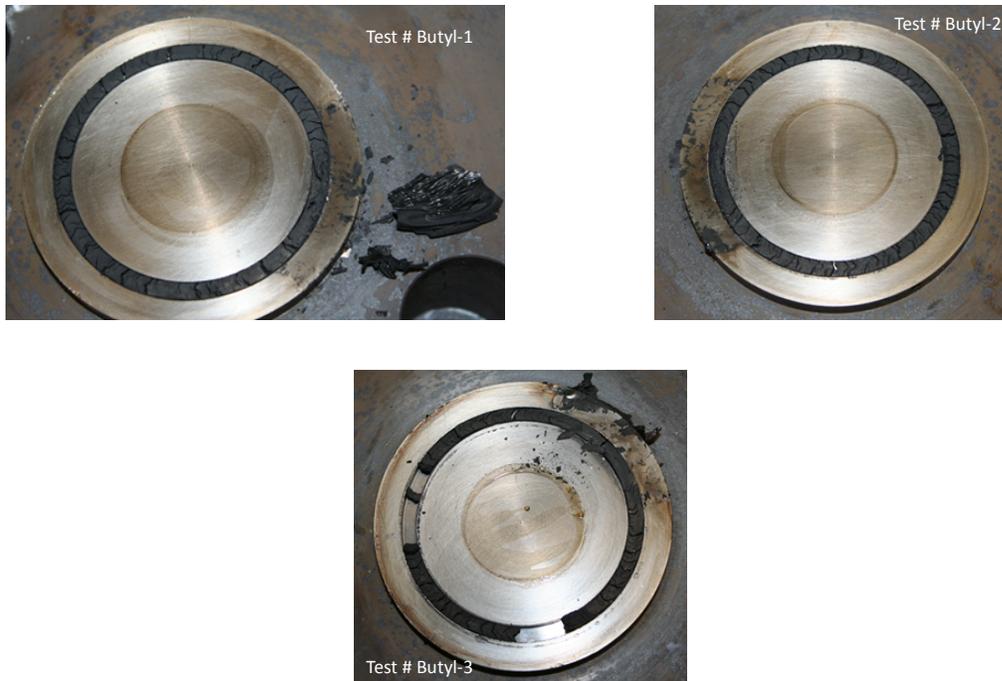
Figure 3-58. Photographs showing the thermally degraded butyl O-ring after 8-h thermal exposure at 316 °C (600 °F) for the three butyl O-ring tests.

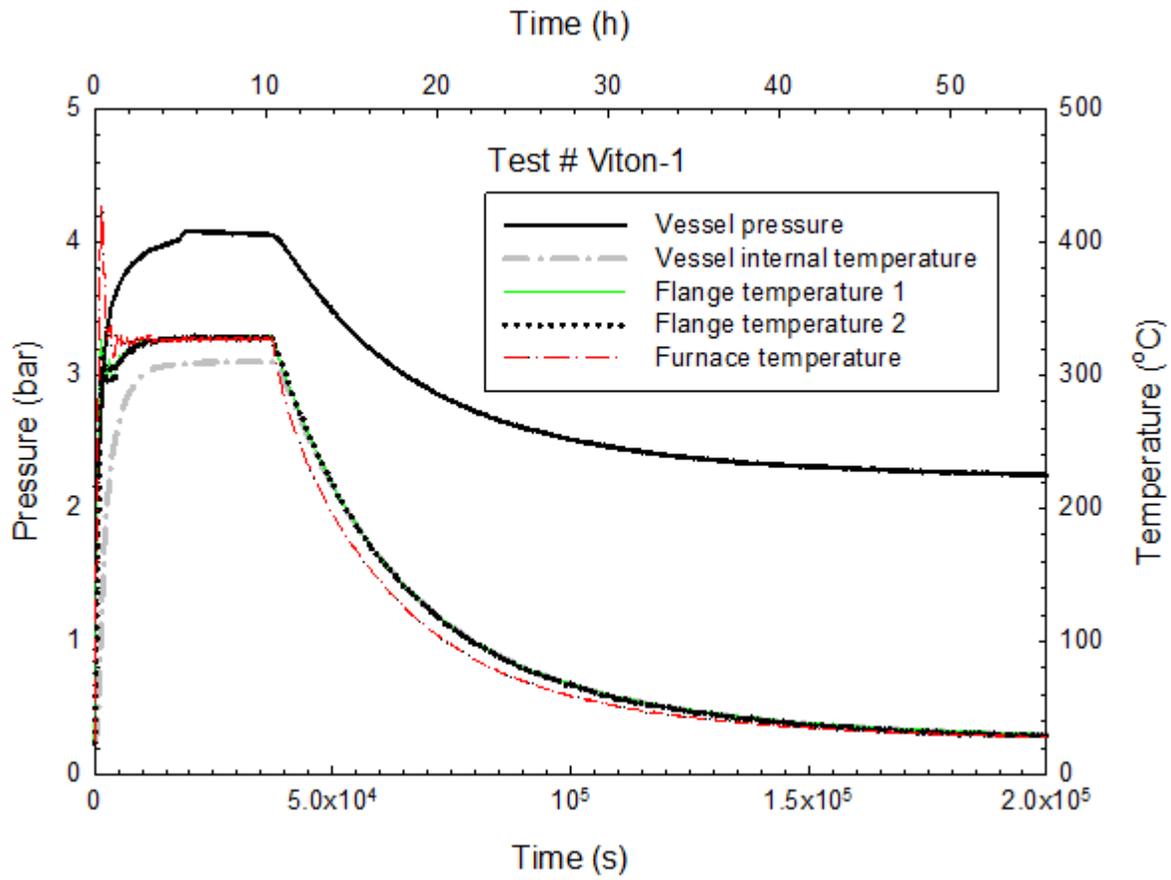
Figure 3-59. Temporal variations of vessel pressure and temperatures in Test # Viton-1.

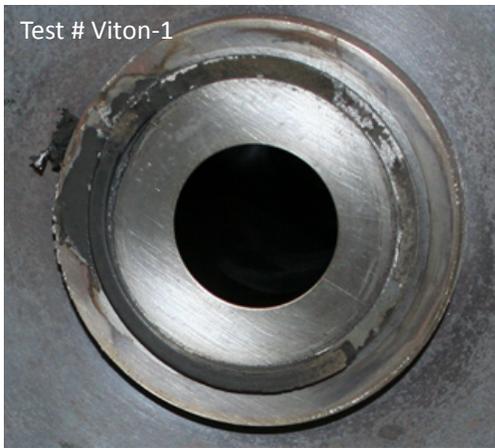
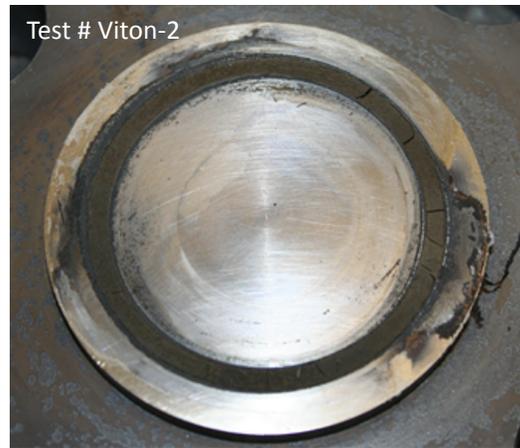
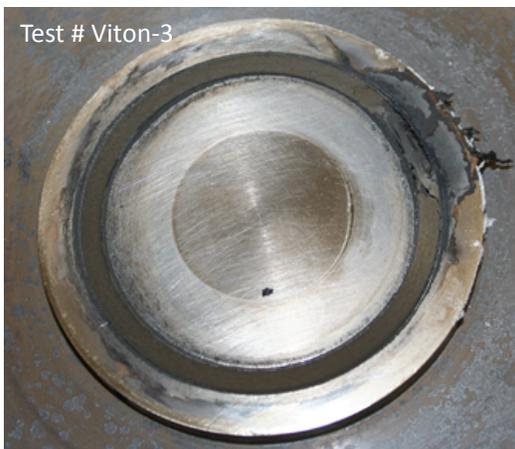
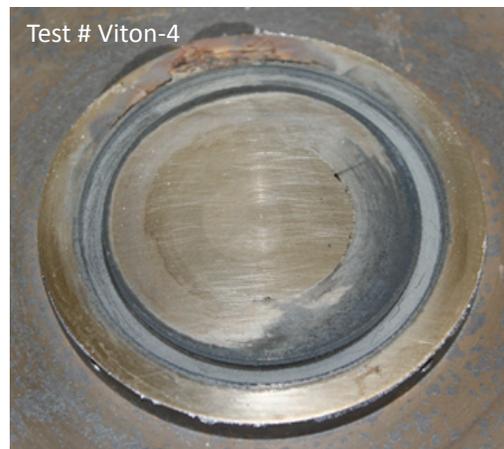
Figure 3-63. Photographs showing the thermally degraded Viton O-ring after 8-h thermal exposure at 316 °C (600 °F) for the four Viton O-ring tests.

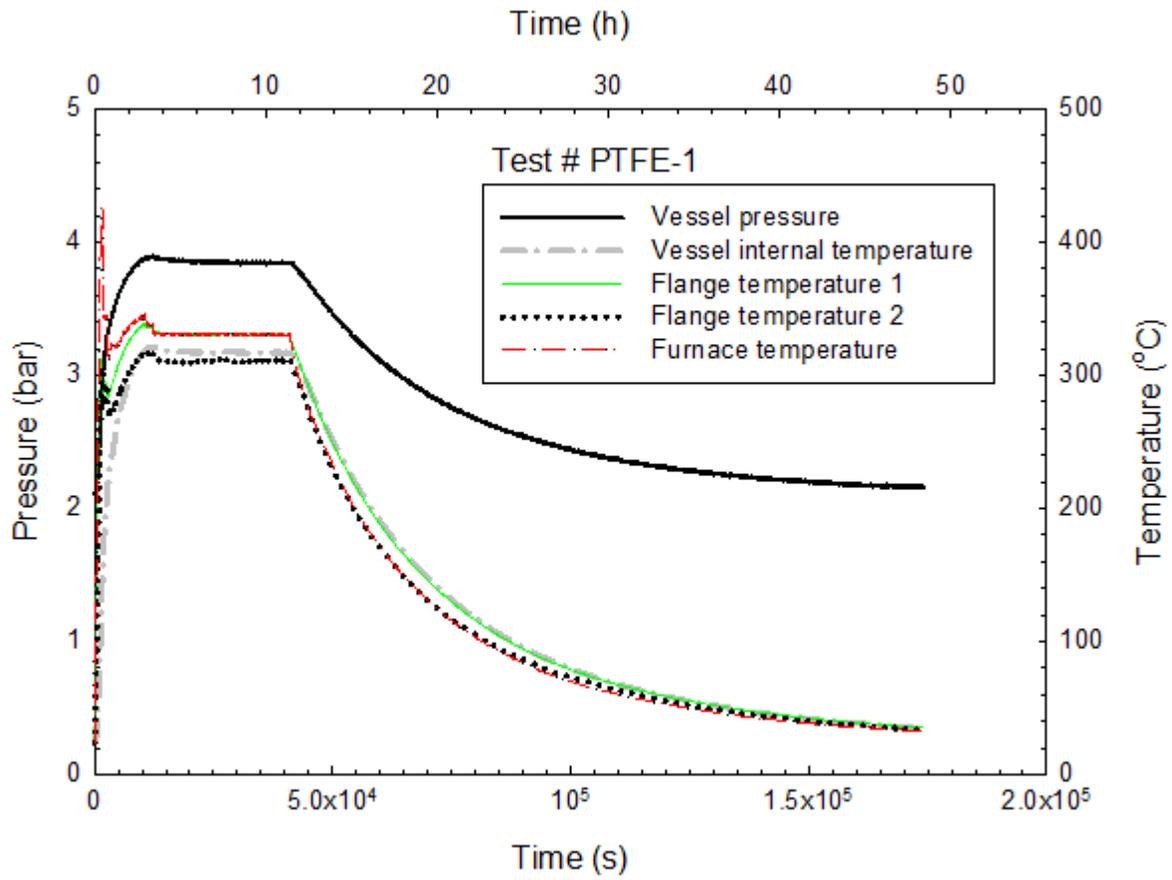
Figure 3-64. Temporal variations of vessel pressure and temperatures in Test # PTFE-1.

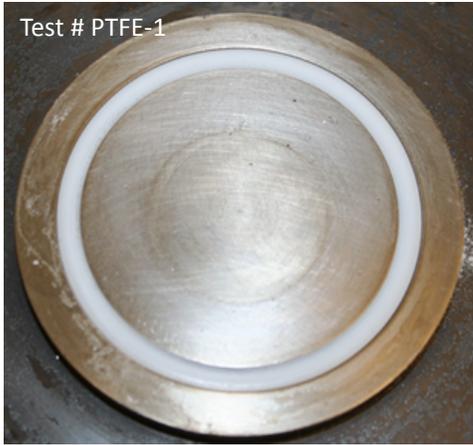
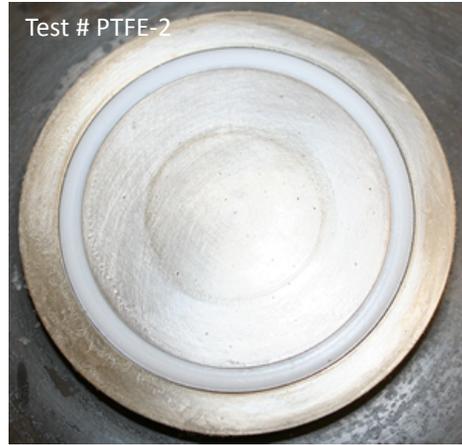
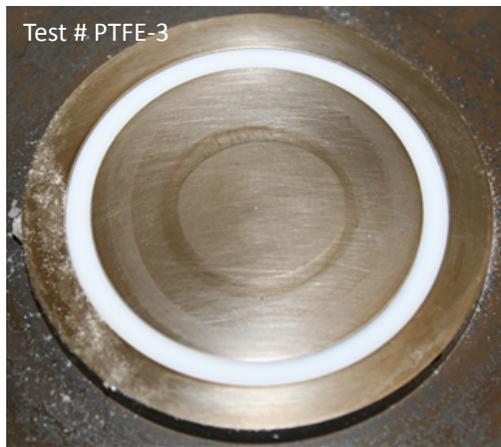
Figure 3-67. Photographs showing the thermally degraded PTFE O-ring after 8-h thermal exposure at 316 °C (600 °F) for the three PTFE O-ring tests.

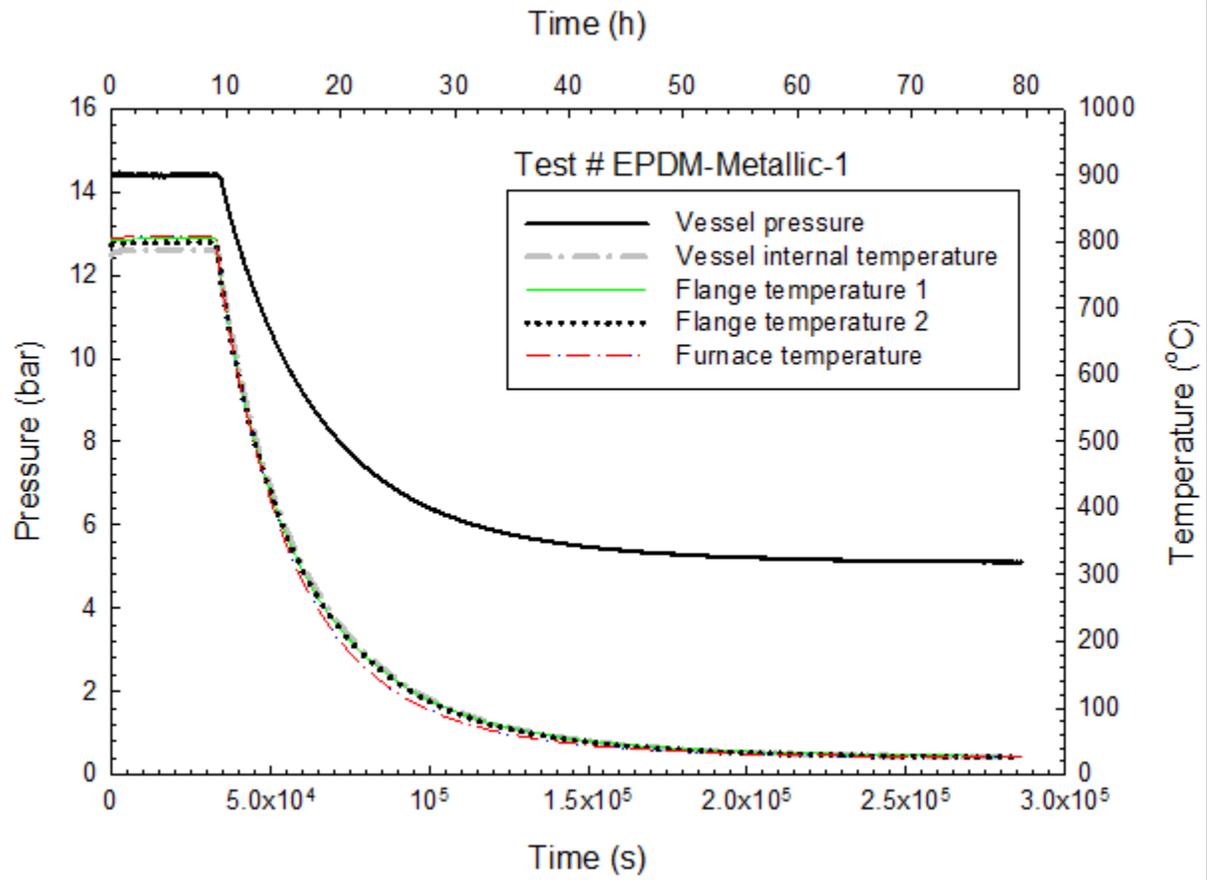
Figure 3-68. Temporal variations of vessel pressure and temperatures in Test # EPDM-Metallic-1 (Vessel #10).

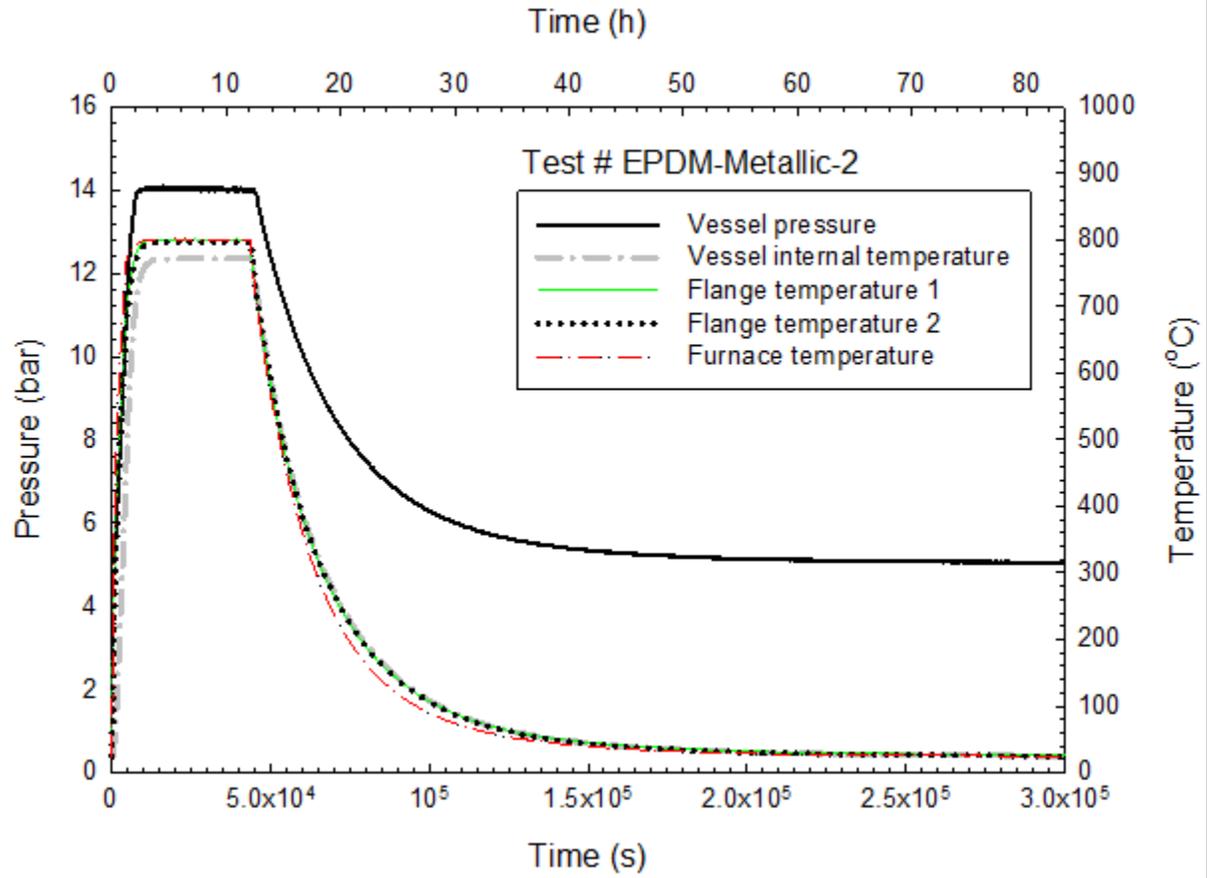
Figure 3-69. Temporal variations of vessel pressure and temperatures in Test # EPDM-Metallic-2 (Vessel #11).

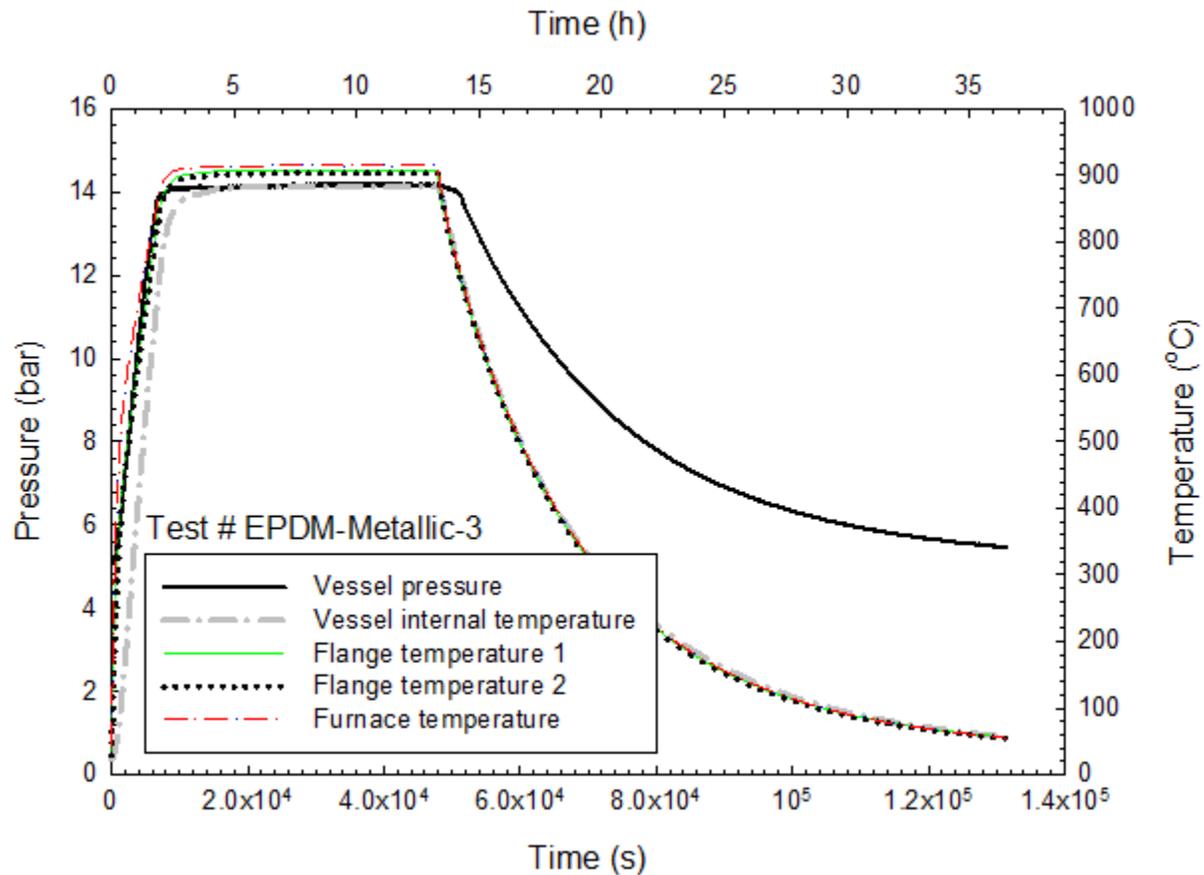
Figure 3-70. Temporal variations of vessel pressure and temperatures in Test # EPDM-Metallic-3 using the cap of Vessel #12 and the body (with boss re-surfaced) of Vessel #10.

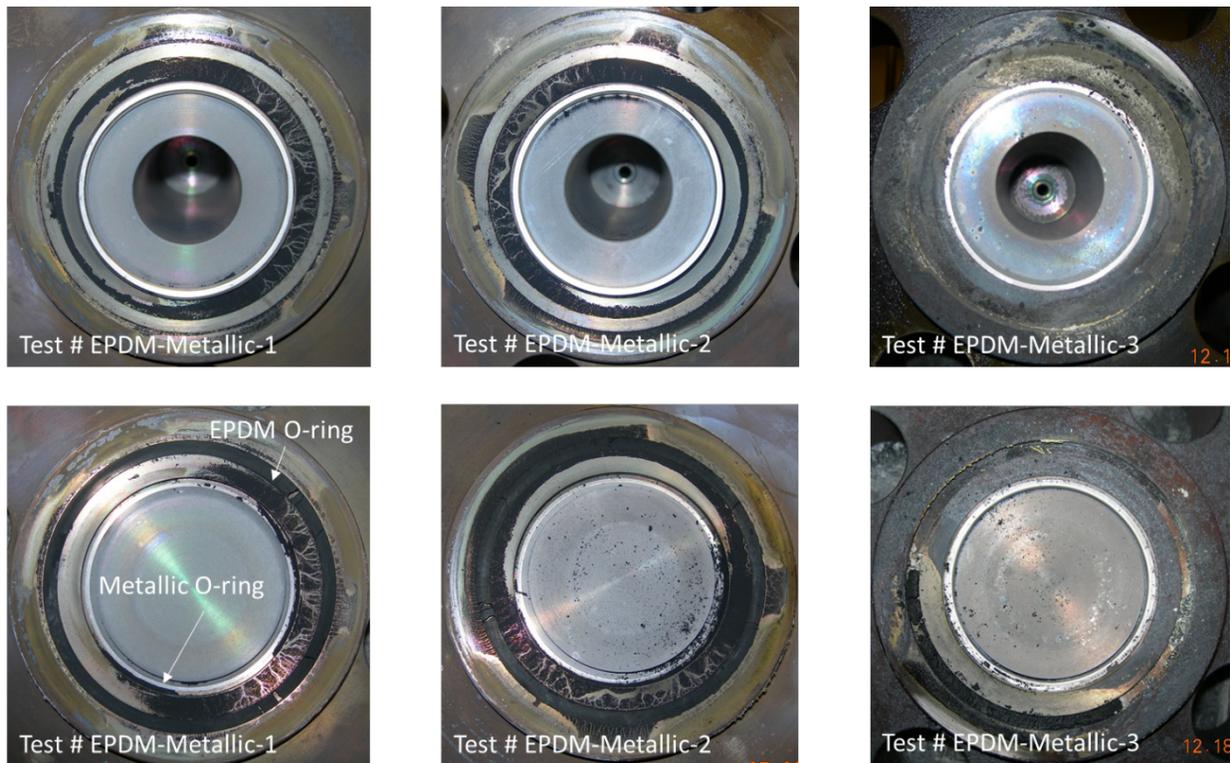
Figure 3-71. Photographs showing the thermally degraded EPDM-Metallic O-rings after 9-h thermal exposure at 800 °C (1472 °F) for the two EPDM-Metallic O-ring tests.

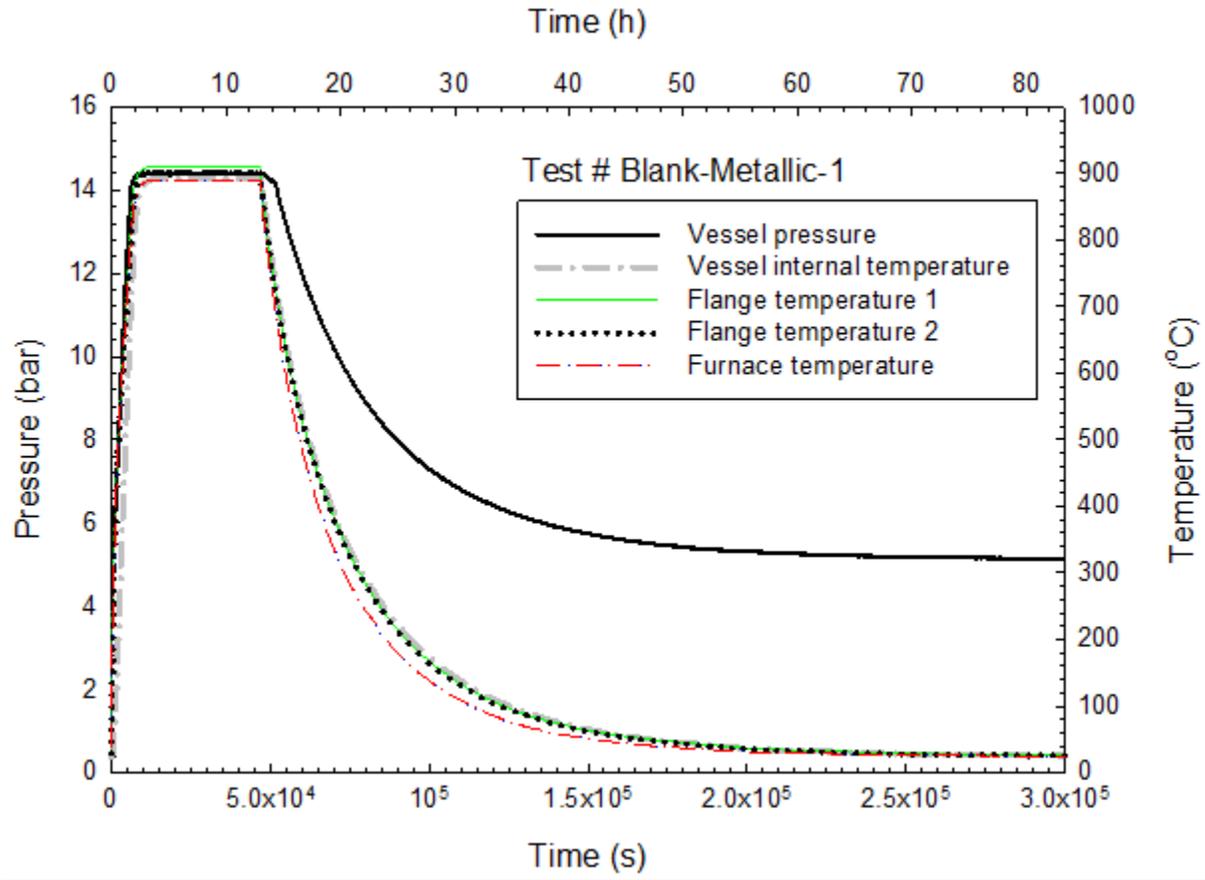
Figure 3-72. Temporal variations of vessel pressure and temperatures in Test # Blank-Metallic-1 using the cap of Vessel #13 and the body (with boss re-surfaced) of Vessel #11.
