Performance of Metal and Polymeric O-Ring Seals in Beyond-Design-Basis Temperature Excursions

This report documents the beyond-design-basis thermal exposure test results of the performance of metallic and polymeric seals typically used in radioactive material transportation packages. The overall objective of the project is to provide test data and insights regarding the performance of these O-ring seals (metallic or polymeric) when exposed to beyond-design-basis temperature conditions that could result due to a severe fire. Tests were conducted using a small-scale test package (pressure vessel) made of stainless steel SS 304 filled with helium initially pressurized at either 5 bar or 2 bar at room temperature. The test package was then exposed in an electric furnace to temperatures equal to, or above the specified maximum operating temperatures of these seals (up to 900 °C) for a pre-determined period (typically 8 h to 9 h). These O-ring temperatures and test periods are more severe than the 800°C for 30 minutes hypothetical accident conditions described in 10 CFR Part 71. In addition, the 800°C and 900°C seal temperatures are much higher than would be expected in real world condi

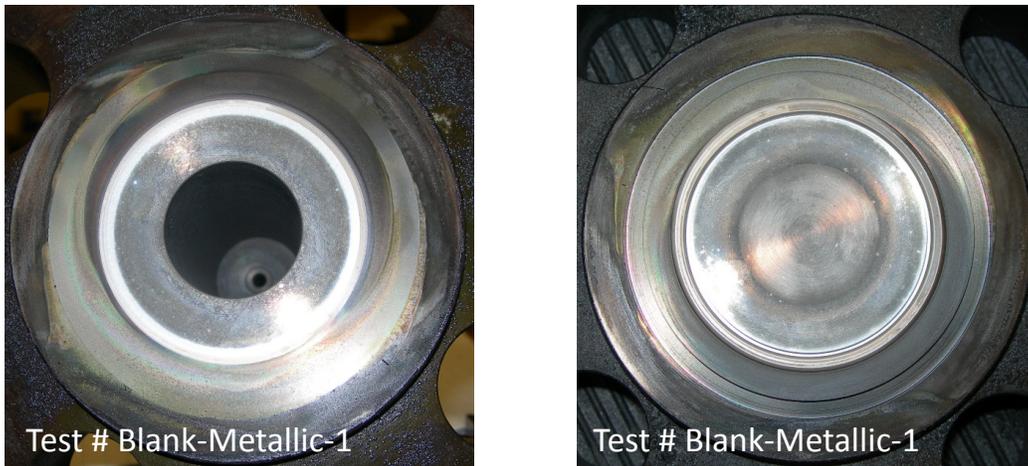
Figure 3-73. Photographs showing the thermally degraded Metallic O-ring after 9-h thermal exposure at 900 °C (1652 °F) for the Blank-Metallic O-ring test.

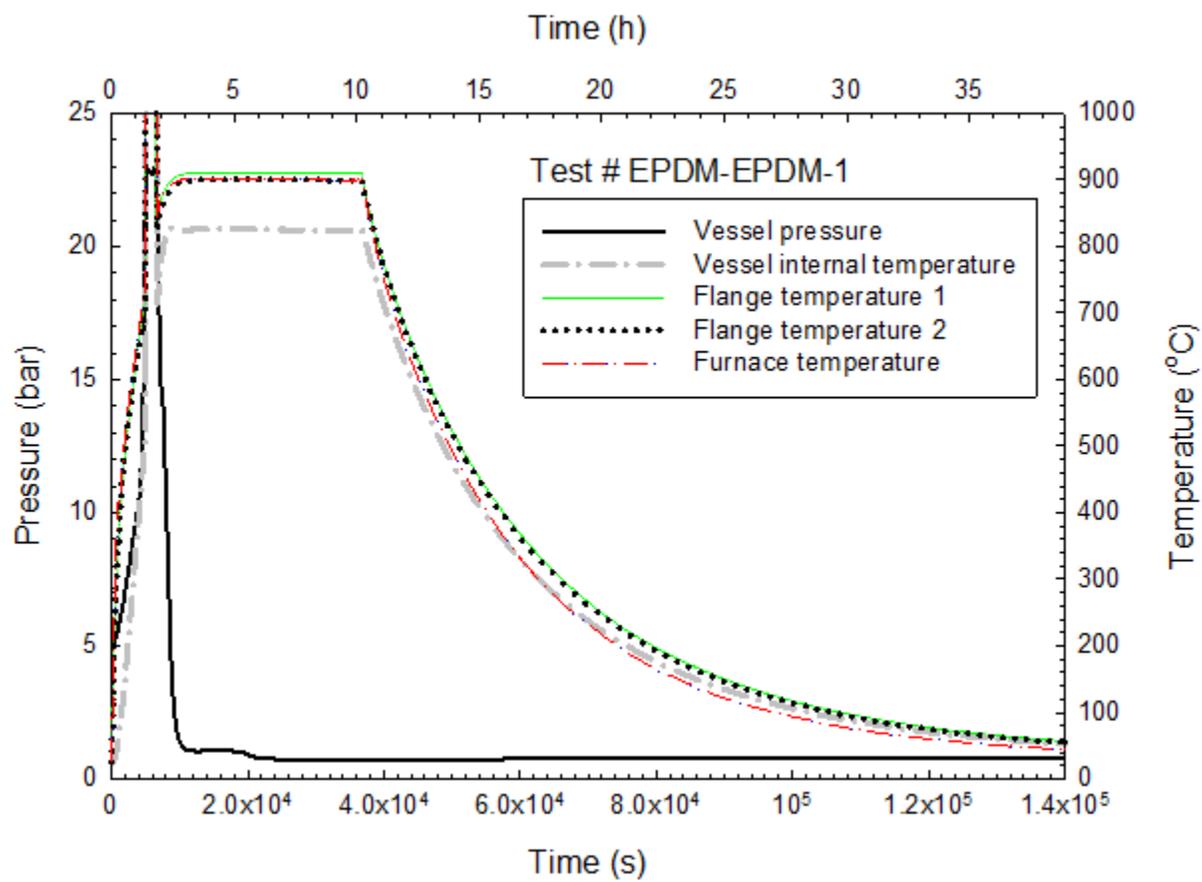
Figure 3-74. Temporal variations of vessel pressure and temperatures in Test # EPDM-EPDM-1 using Vessel #16.

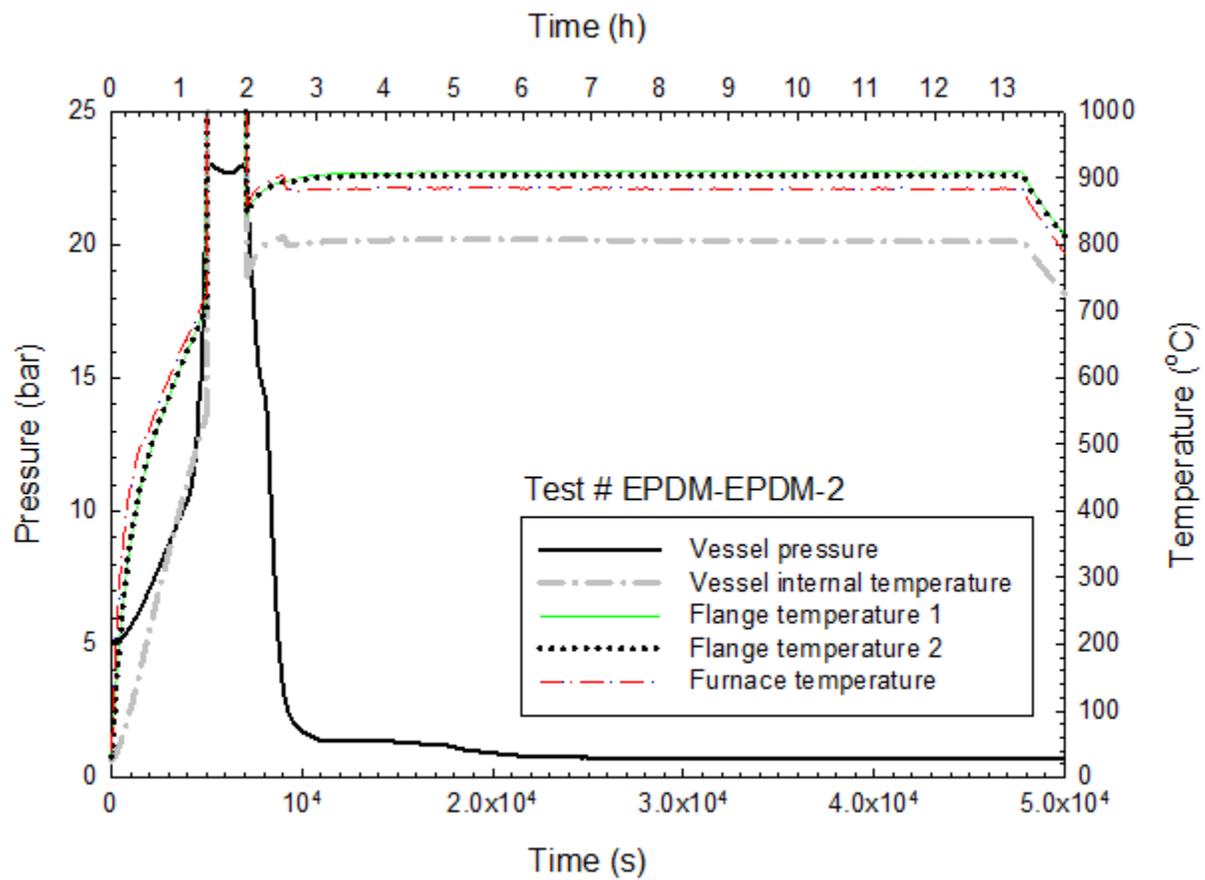
Figure 3-75. Temporal variations of vessel pressure and temperatures in Test # EPDM-EPDM-2 using Vessel #17.

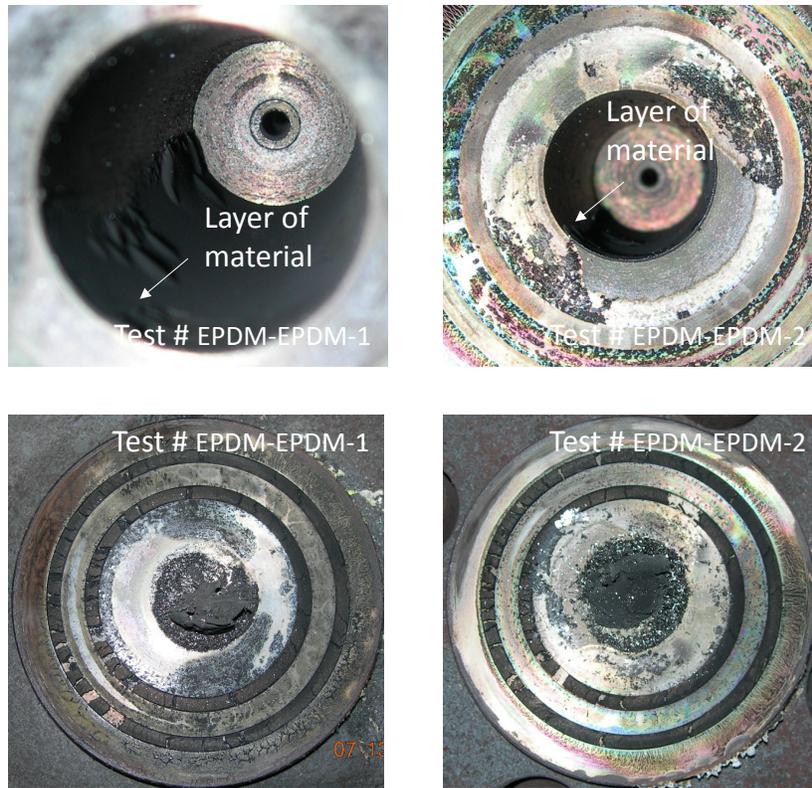
Figure 3-76. Photographs showing the thermally degraded EPDM O-rings after 9-h thermal exposure at 900 °C (1652 °F) for the EPDM-EPDM O-ring test.

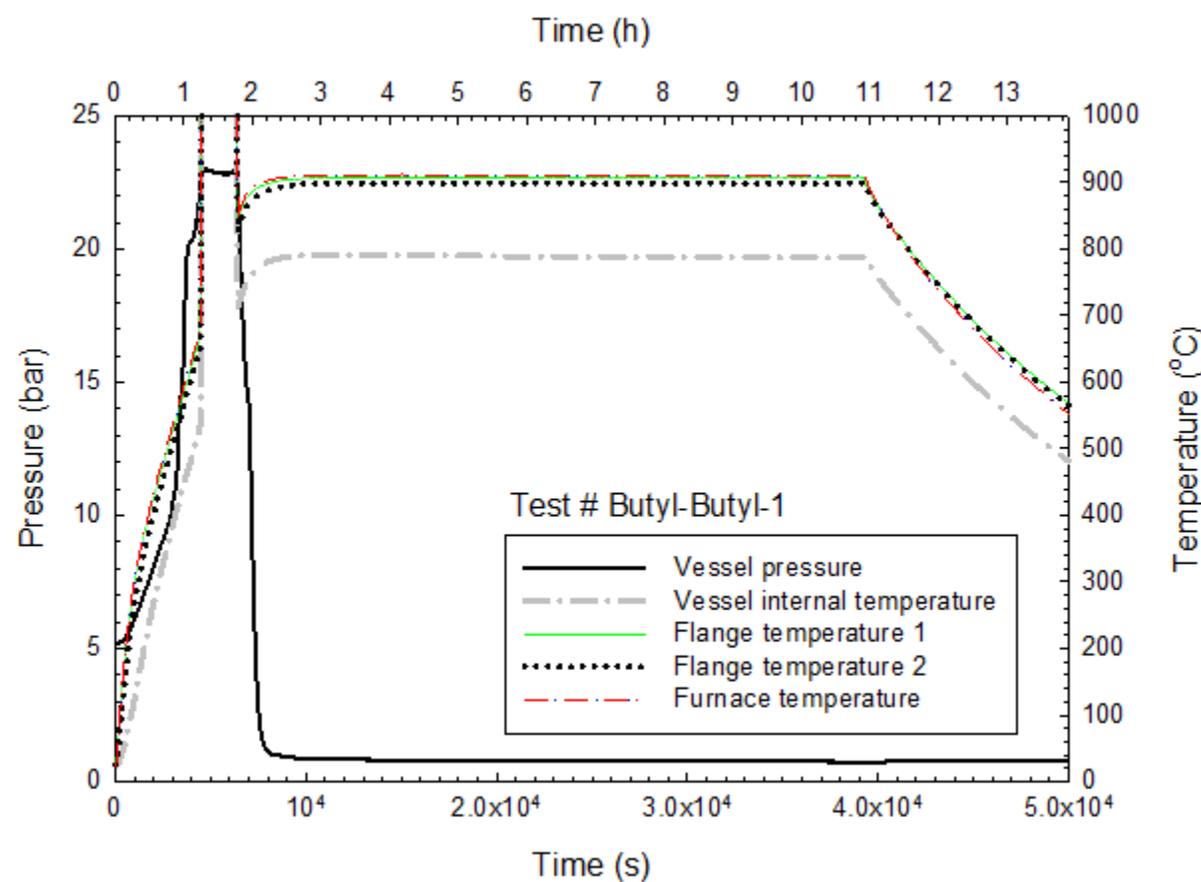
Figure 3-77. Temporal variations of vessel pressure and temperatures in Test # Butyl-Butyl-1 using Vessel #16.

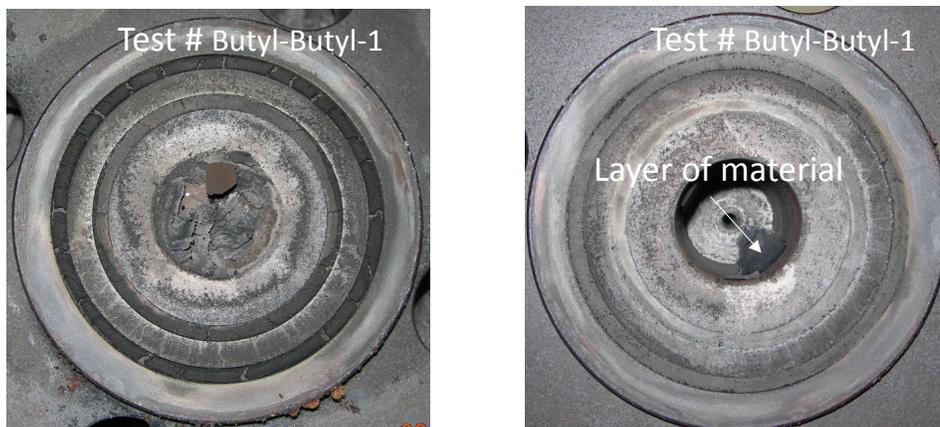
Figure 3-78. Photograph showing the thermally degraded butyl O-rings after 9-h thermal exposure at 900 °C (1652 °F) for the butyl-butyl O-ring test.

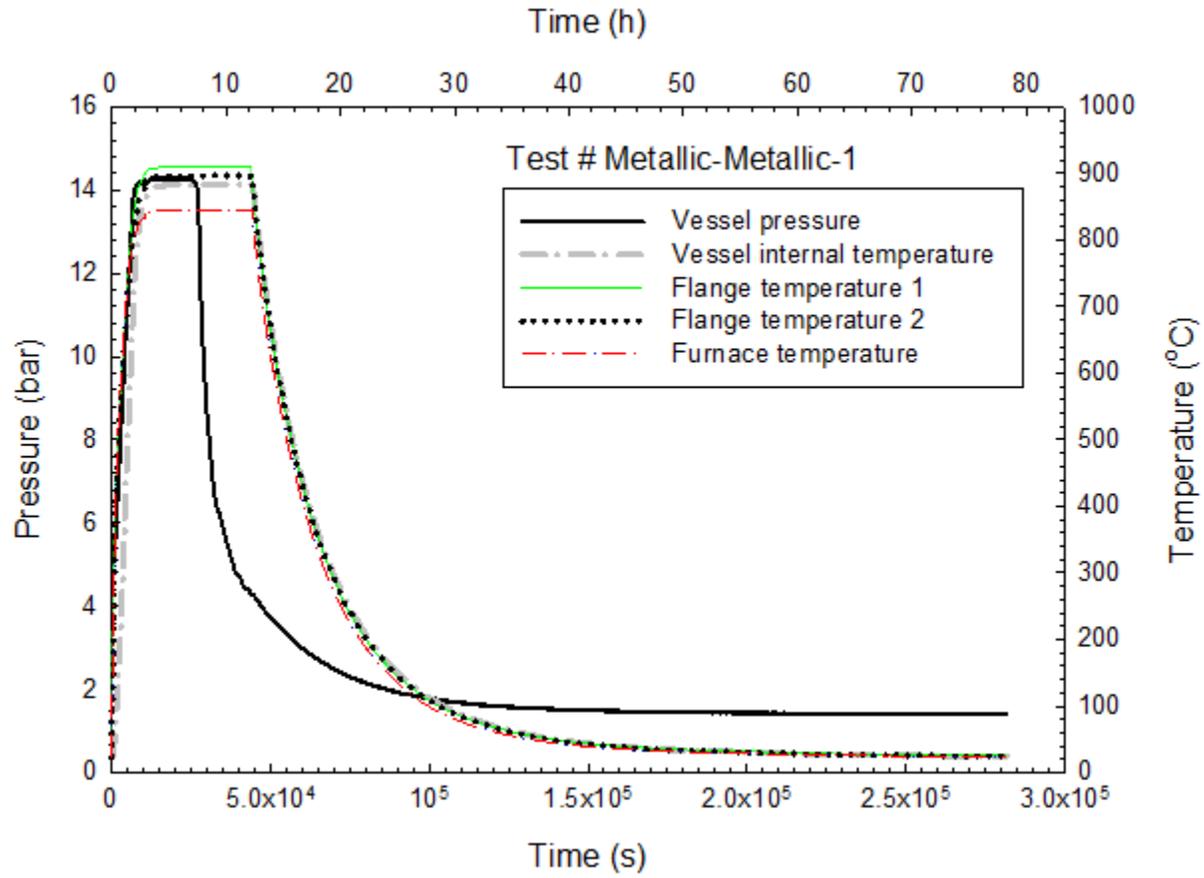
Figure 3-79. Temporal variations of vessel pressure and temperatures in Test # Metallic-Metallic-1 using the cap of Vessel #14 and the body of Vessel #12.

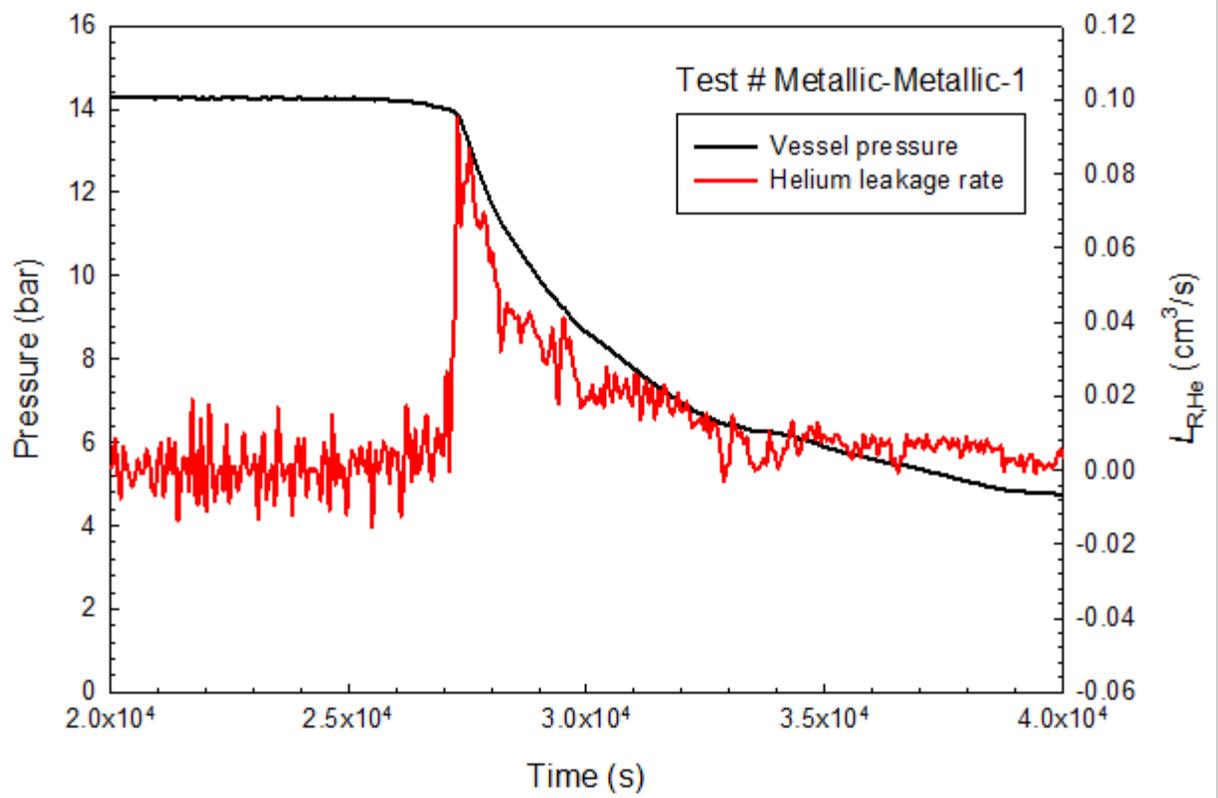
Figure 3-80. Isothermal reference helium leakage rate during the 9 h heating in Test # Metallic-Metallic-1 using the cap of Vessel #14 and the body of Vessel #12.

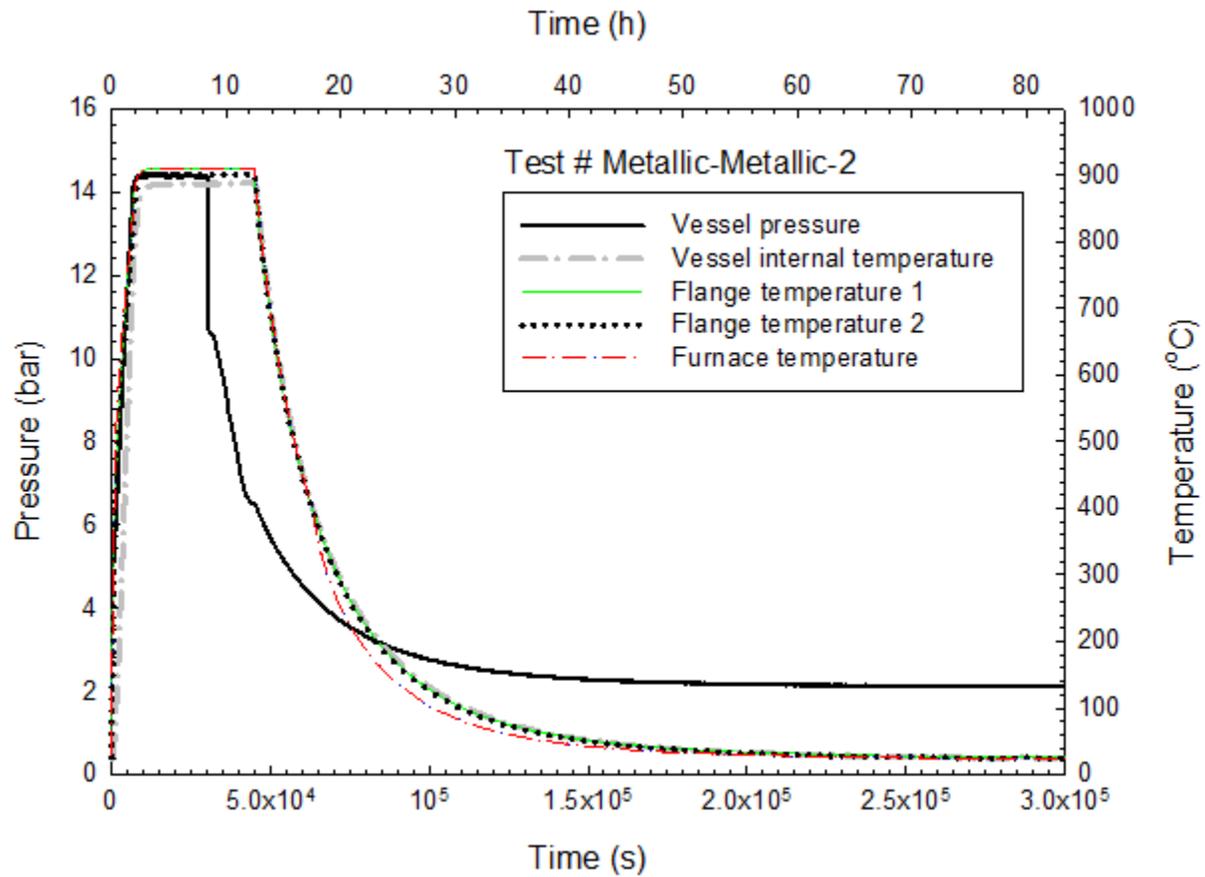
Figure 3-81. Temporal variations of vessel pressure and temperatures in Test # Metallic-Metallic-2 using the cap of Vessel #15 and the body of Vessel #13.

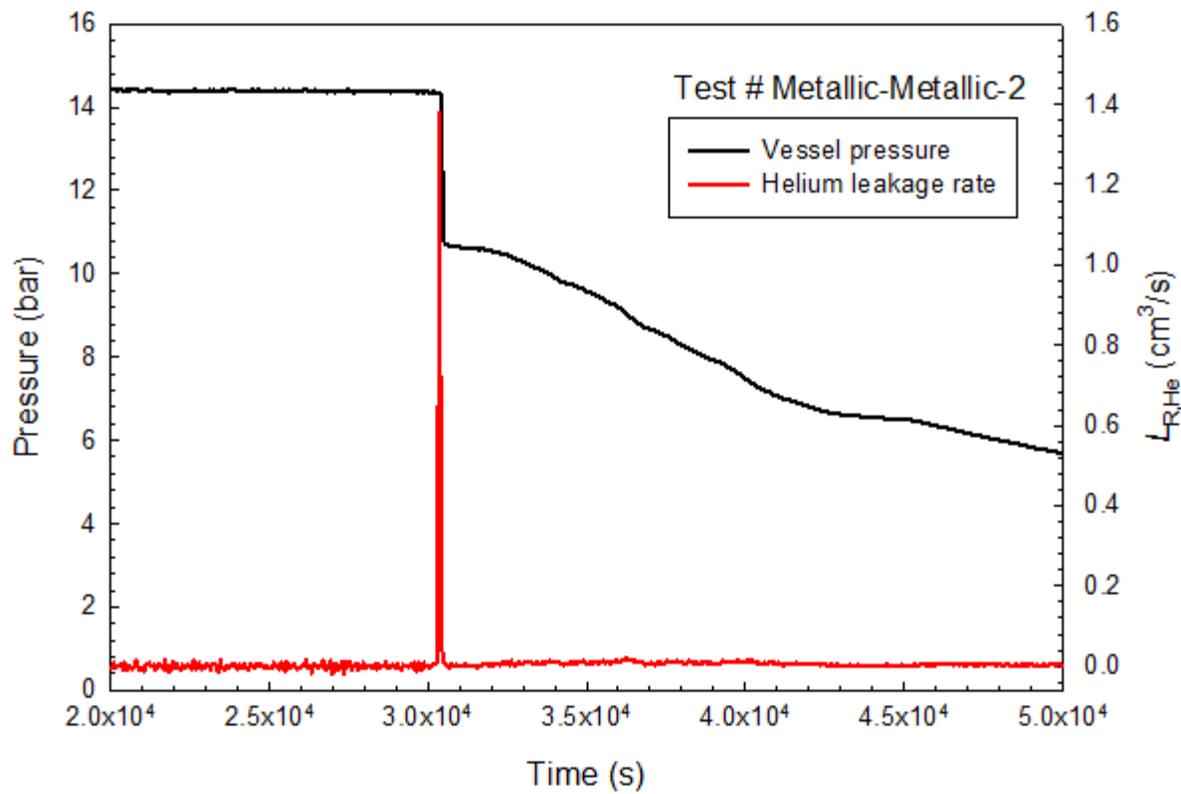
Figure 3-82. Isothermal reference helium leakage rate during the 9 h heating in Test # Metallic-Metallic-2 using the cap of Vessel #15 and the body of Vessel #13.

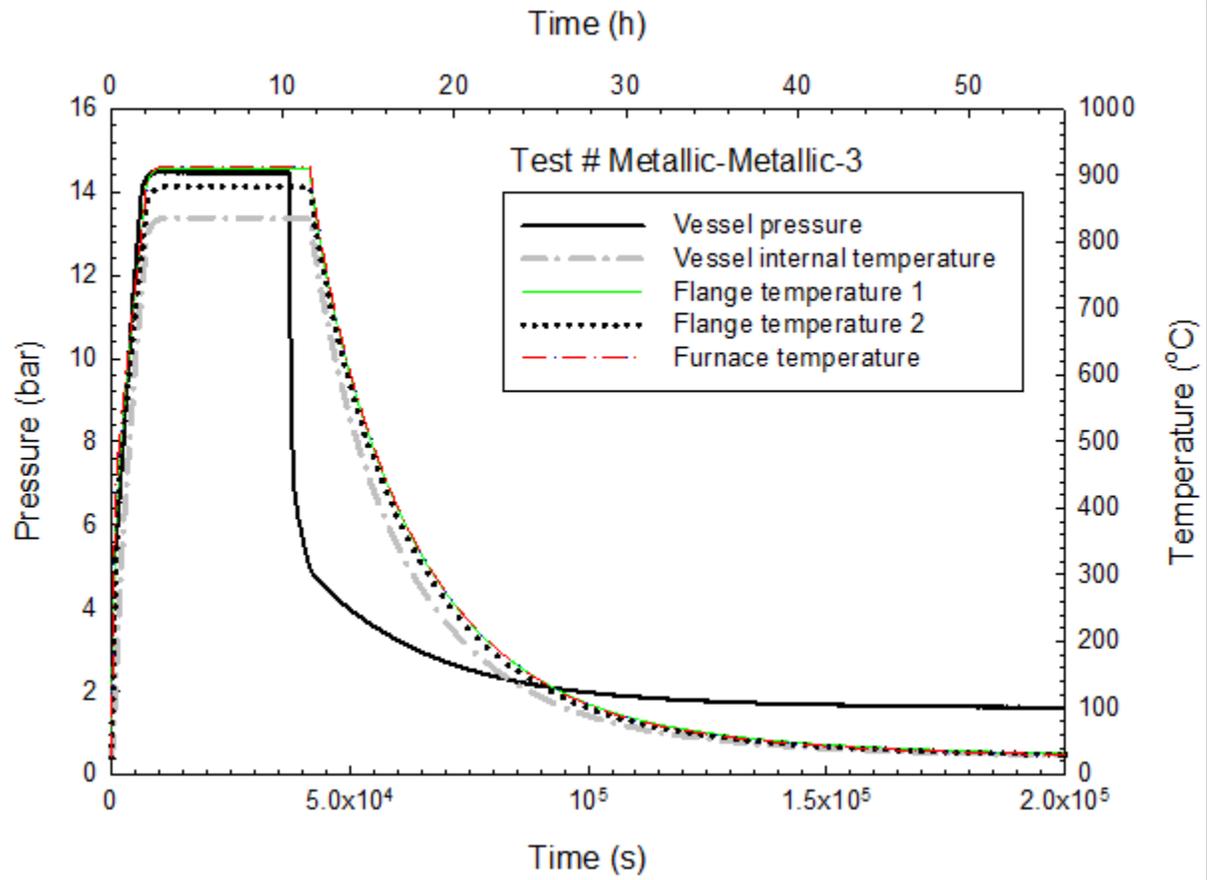
Figure 3-83. Temporal variations of vessel pressure and temperatures in Test # Metallic-Metallic-3 using Vessel #18.

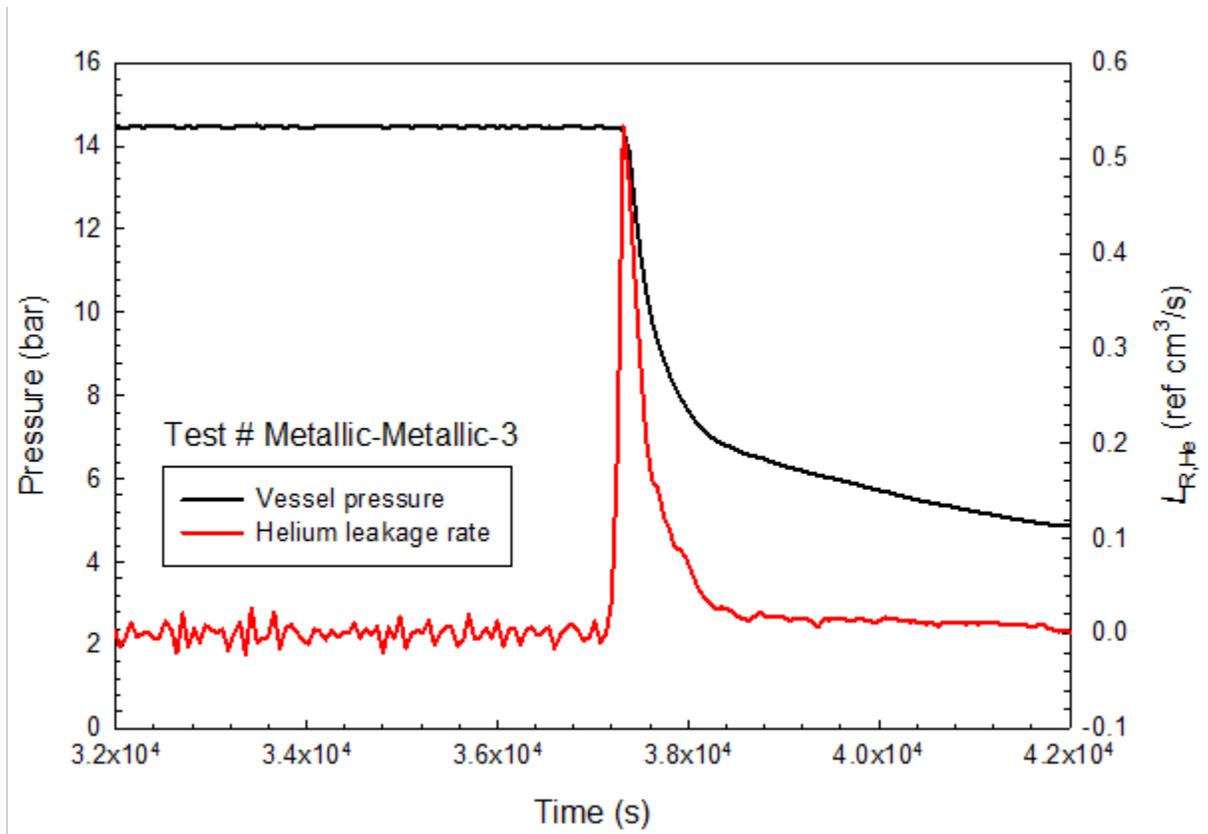
Figure 3-84. Isothermal reference helium leakage rate during the 9 h heating in Test # Metallic-Metallic-3 using the cap of Vessel #18.

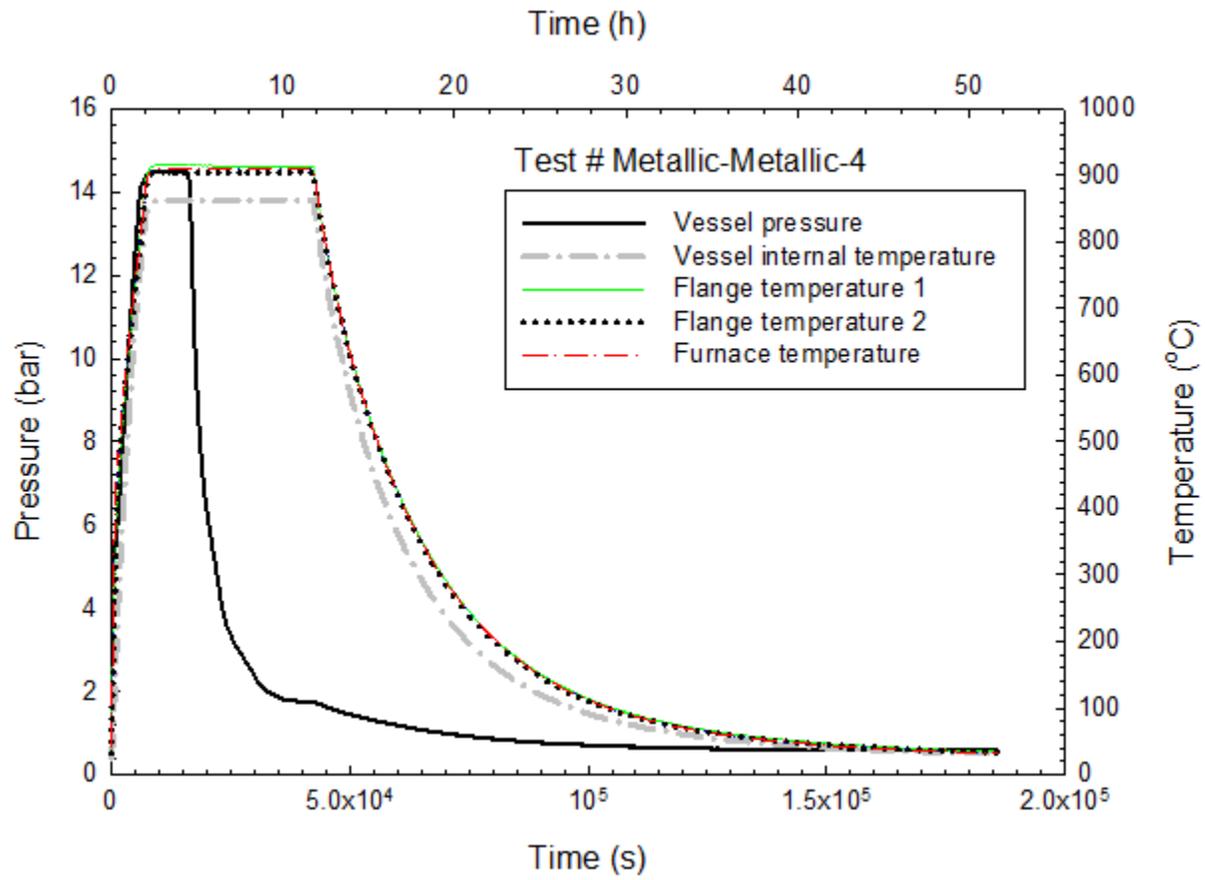
Figure 3-85. Temporal variations of vessel pressure and temperatures in Test # Metallic-Metallic-4 using Vessel #19.

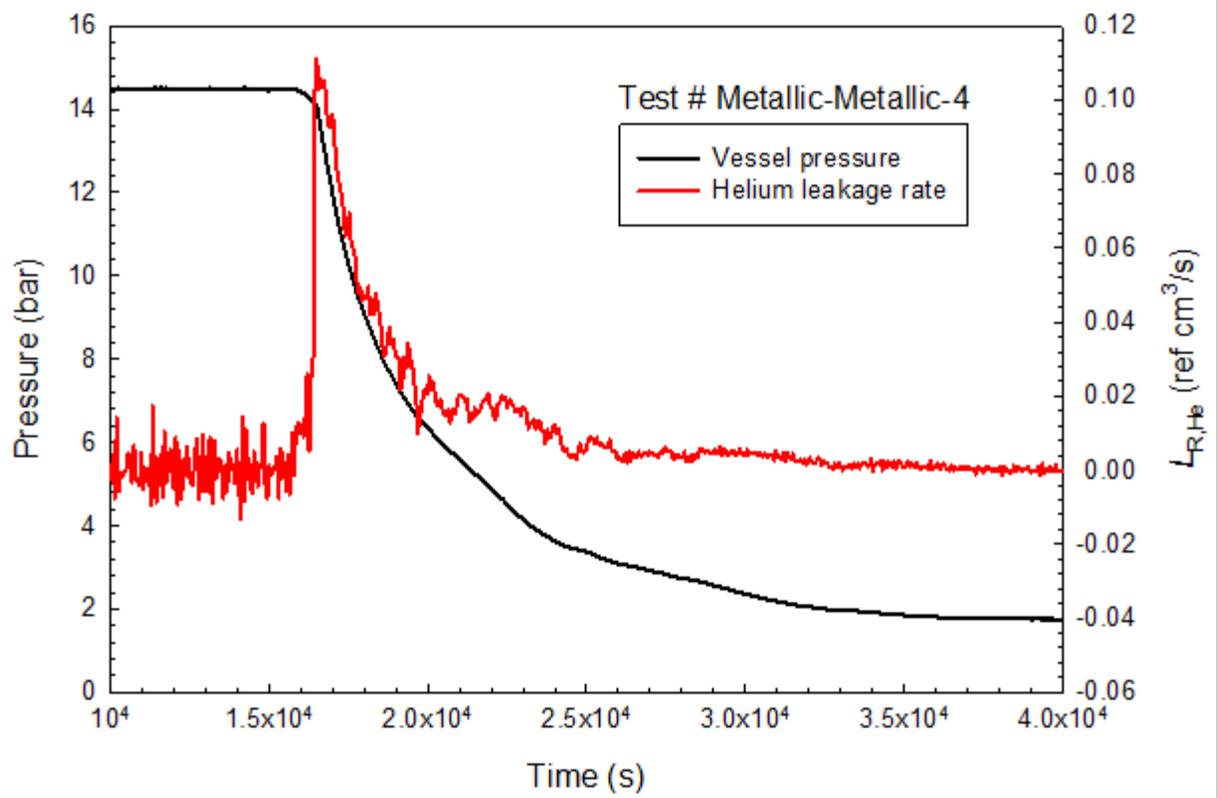
Figure 3-86. Isothermal reference helium leakage rate during the 9 h heating in Test # Metallic-Metallic-4 using Vessel #19.

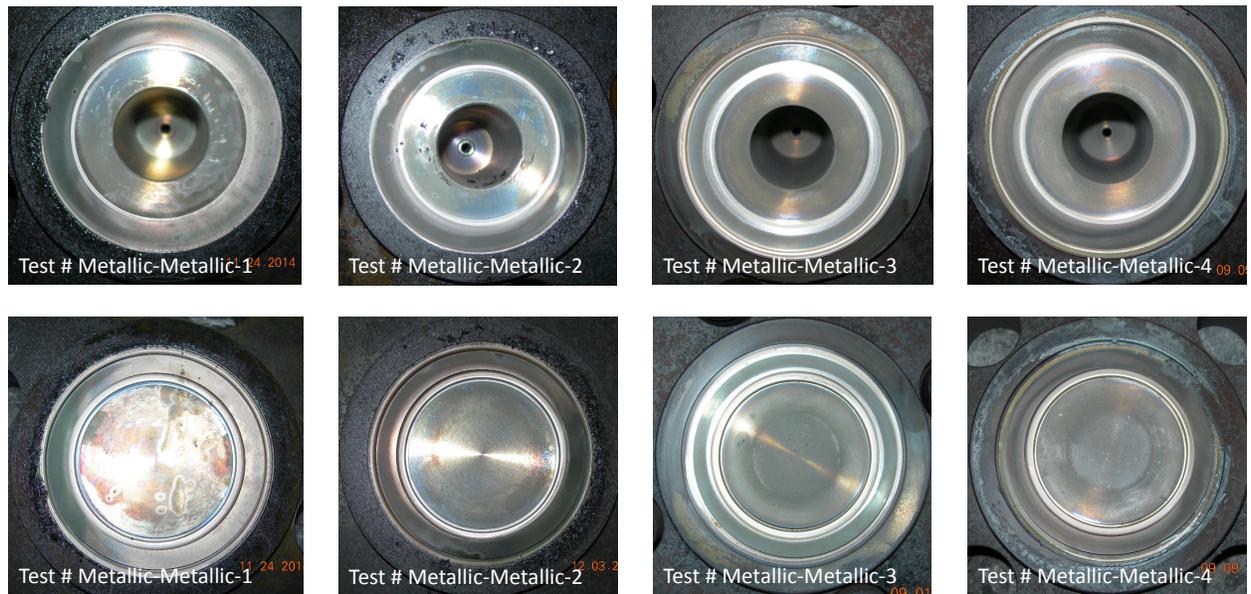
Figure 3-87. Photographs showing the thermally degraded Metallic-Metallic O-rings after 9-h thermal exposure at 900 °C (1652 °F) for the two Metallic-Metallic O-ring tests.

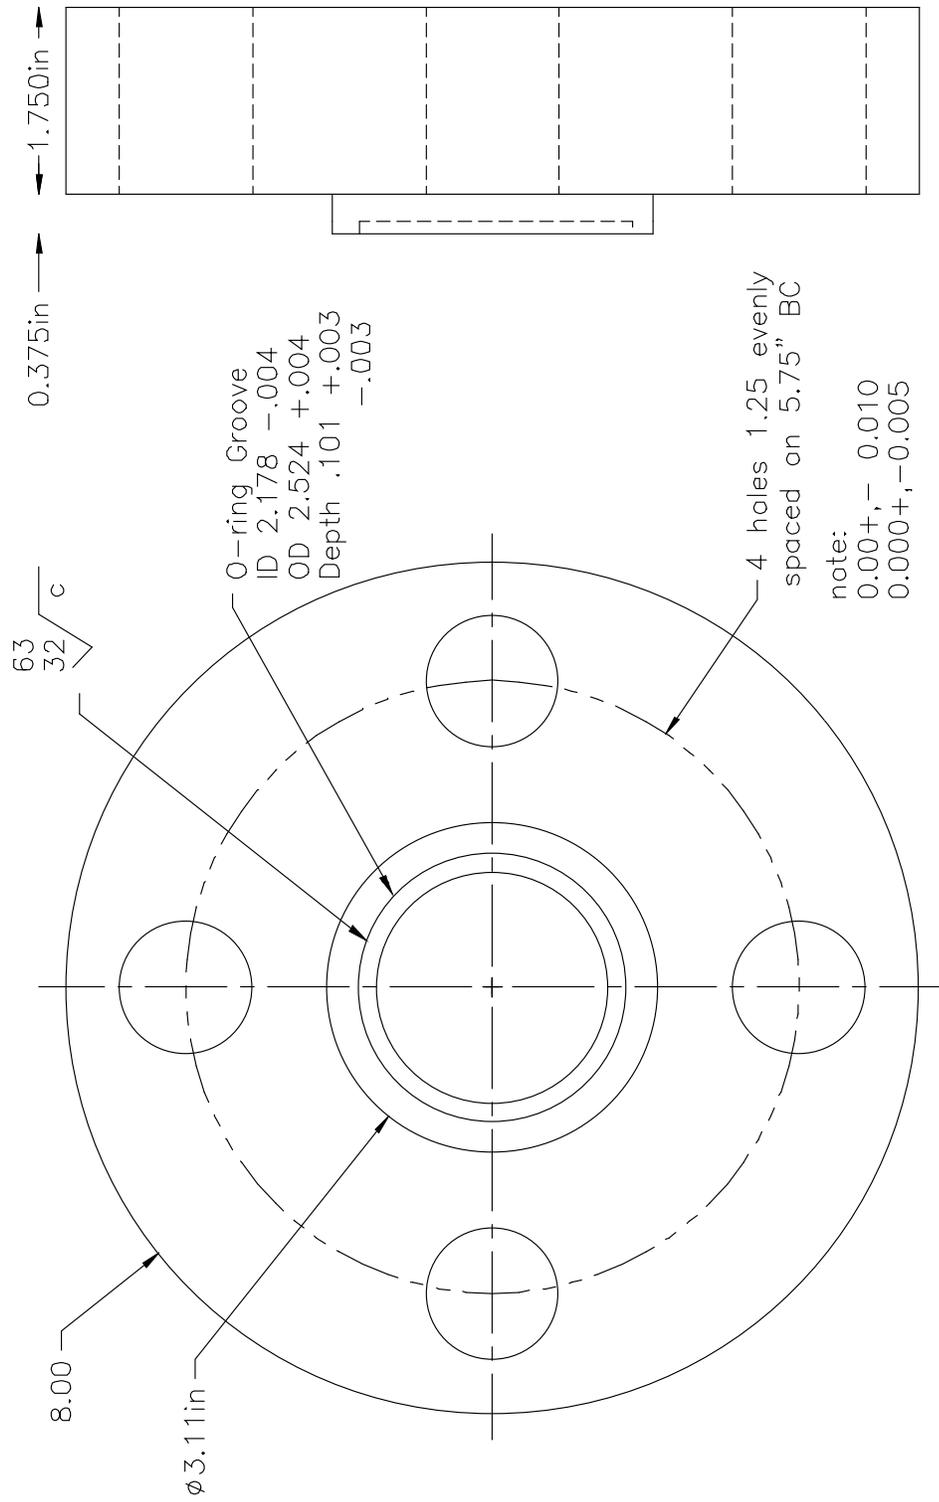
Figure A-2. Design drawing of removable flange for single metallic seal (vessel cap).

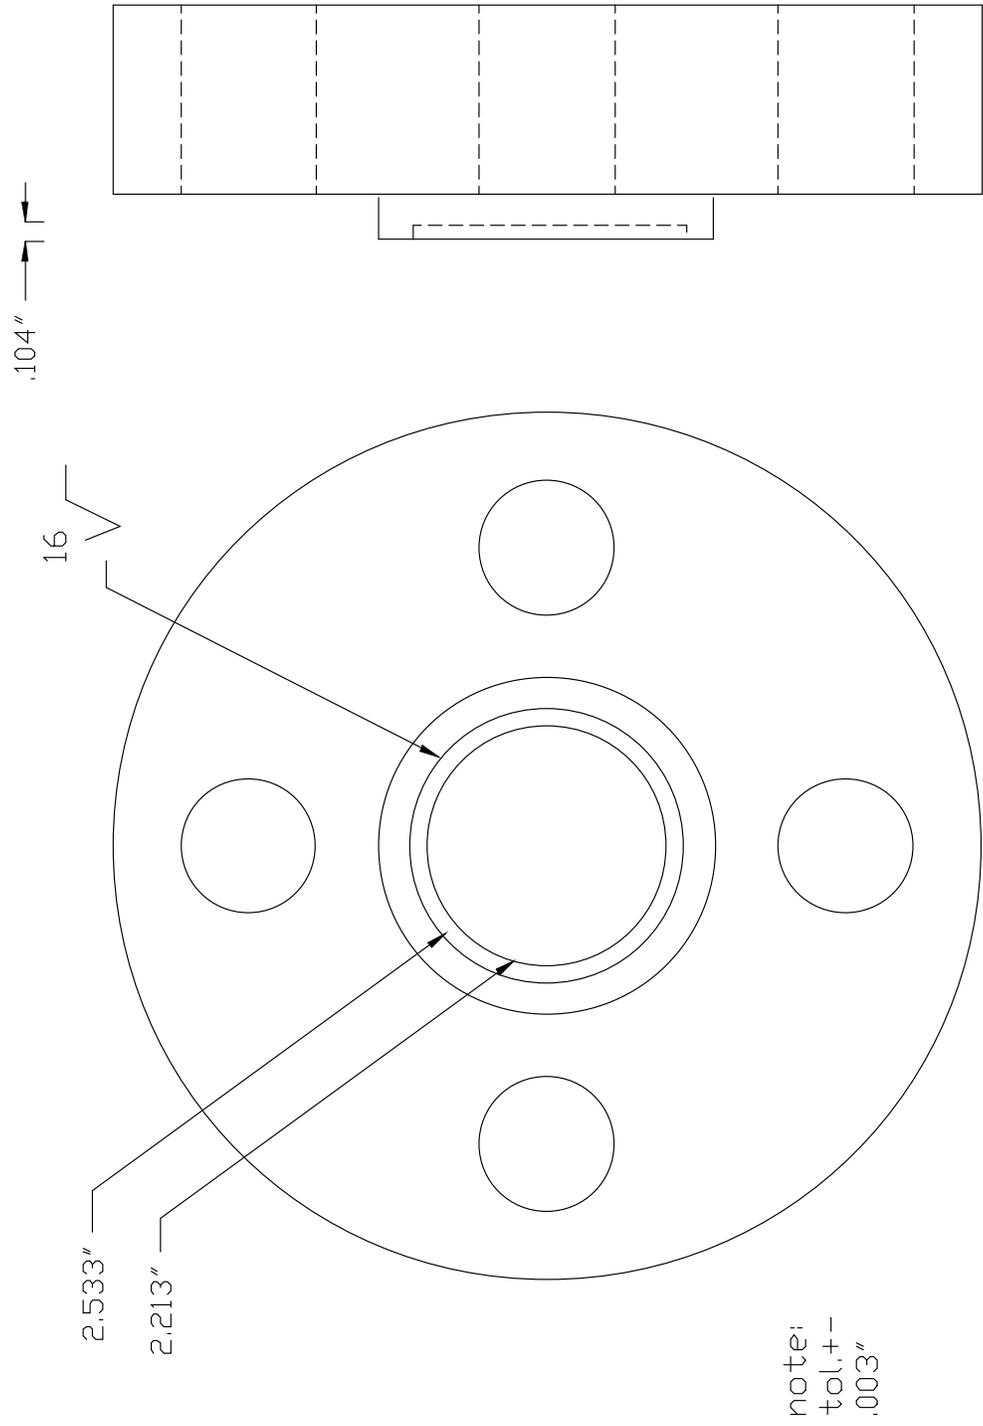
Figure A-3. Design drawing of removable flange for single polymeric seal (vessel cap).

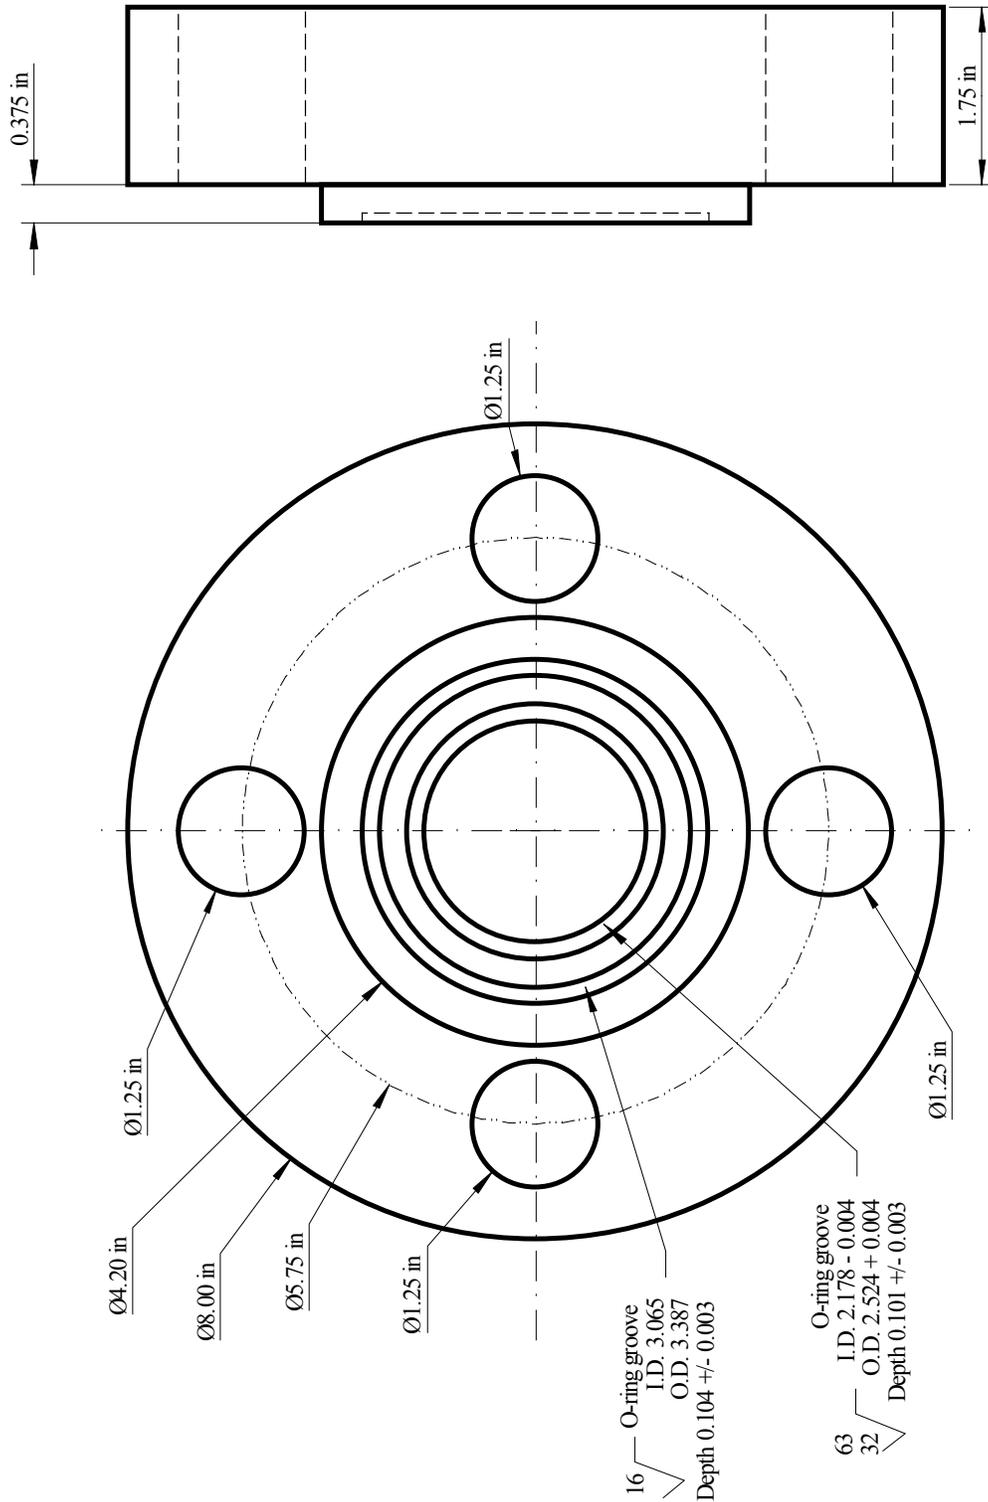
Figure A-5. Design drawing of removable flange for double O-ring (outer EPDM-inner metallic) seal (vessel cap).

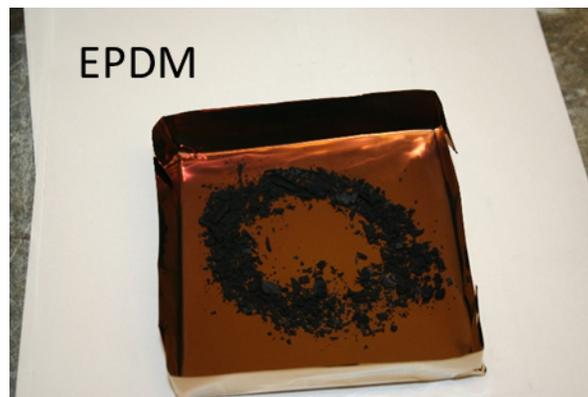
Figure E-2. Photograph showing an EPDM O-ring after thermal exposure at 450 °C (842 °F) for 8 h.

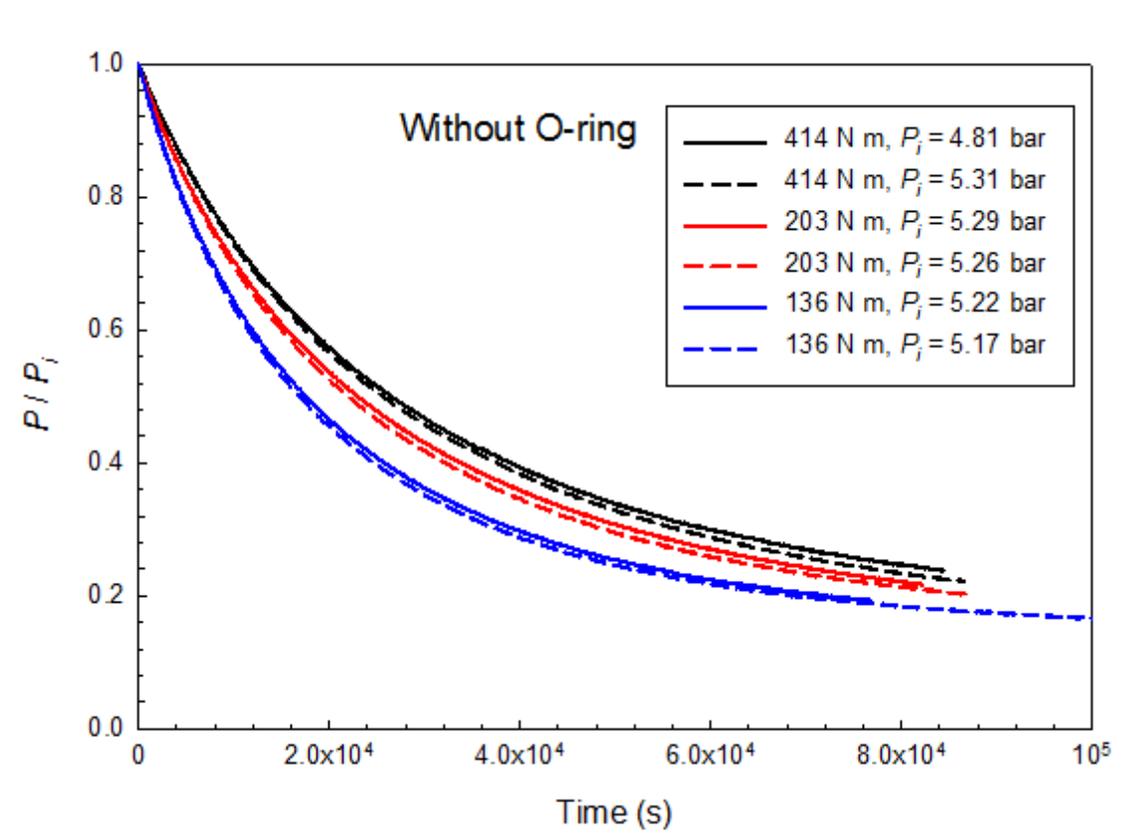
Figure F-1. Temporal variation of normalized vessel pressure at 24 °C without O-ring at different torques used to tighten the vessel flanges.
