SUBJECT: TRIP REPORT

On November 4 and 5, 2015, staff from the Low Level Waste and Performance Assessment Branches within the Division of Decommissioning, Uranium Recovery, and Waste Management participated in a site visit to the Beatty, Nevada Disposal site. The purpose of the visit was to provide guidance to the State of Nevada on the final cover system after the October 18, 2015, event at the facility. A trip report documenting the staff's observations is enclosed.

**BEATTY, NEVADA SITE VISIT
NOVEMBER 4-5, 2015
TRIP REPORT**

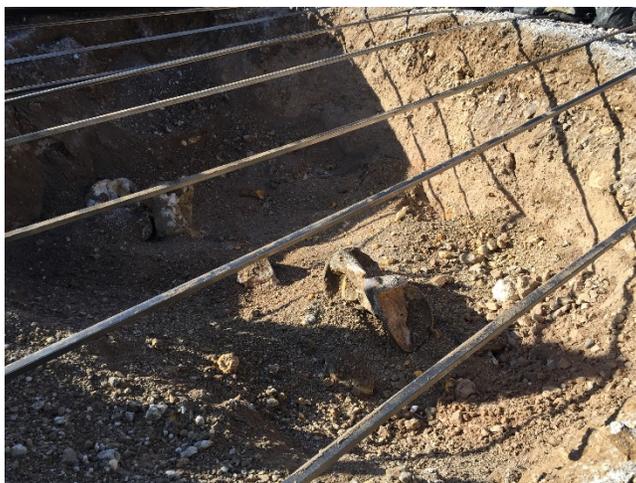
NRC staff spent the days of November 4th and 5th making observations at the site and damage to the Beatty site cover. The crater in Trench 14 was visible near the boundary of the site and, although no measurements were taken by NRC staff, was approximately 20 ft in diameter and several feet deep. It was created in the shallower portion of the trench and eleven drums were ejected from the crater. Some drums were ripped apart while others were crushed, but intact. The crater was created by a sequence of events on October 18th the consisted of white smoke, flames, violent expelling of material, material collapsing back into the crater, and subsequent cycle beginning again. The results of several surveys and samples taken at the site indicated that no radioactive material was exposed in or around the crater.

Crater in Trench 14 with remains of drums

At the close-out meeting, participants discussed various types of engineered surface covers that should replace the current one. NRC staff recommended that the State of Nevada should consider temporary repairs to the existing cracks, subsidence areas, and crater. These areas could be backfilled with soil and graded to promote runoff and minimize the potential for water to penetrate the existing cover. NRC staff had observed that the polyethylene sheets had been spread over the crater and the larger subsidence depressions in and near Trenches 14 and 20 to shield them from the weather and potential new rainfall. NRC staff recommended incorporating the polyethylene sheets with a temporary cover, i.e., backfilling the depressions and holes and leaving the sheets in place to provide additional protection from water intrusion if another significant rainfall event were to occur and minimizing the potential of additional precipitation from reaching inside trenches. In addition, NRC staff recommended that the sodium hydroxide be removed from the surface of Trench 14 as soon as possible. Dissolution of sodium hydroxide is highly exothermic, and the resulting heat may cause heat burns or ignite flammables. Removal would reduce the chance of exposure at the ground surface and also avert sodium from seeping back down into the trench with waste.

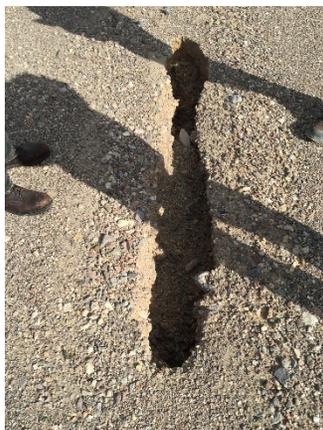
Aside from the crater at the end of Trench 14, NRC staff observed several other issues related to the earthen barrier covering the trenches at the Beatty site including linear cracks near the edge of trenches, sinkhole-type openings, and areas of subsidence. Long linear cracks were observed along what appeared to be the edge of Trench 22. These cracks likely originated along the interface of the trench fill and the non-trench material and then propagated toward the surface.

Various hypotheses were proposed for the existence of the linear cracks: The linear cracks could result from differential settlement between the waste within the trench and native soil adjacent to the trench. It was also hypothesized that different properties of the trench material and the material outside the trench lead to differences in expansion and contraction rates between the two material during periods of desiccation and rewetting. It was also mentioned that the Beatty area suffered from numerous smaller earthquakes with a magnitude range between 2 and 5 which could also contribute to either the cause or size of the cracks.

Linear cracks or fissures

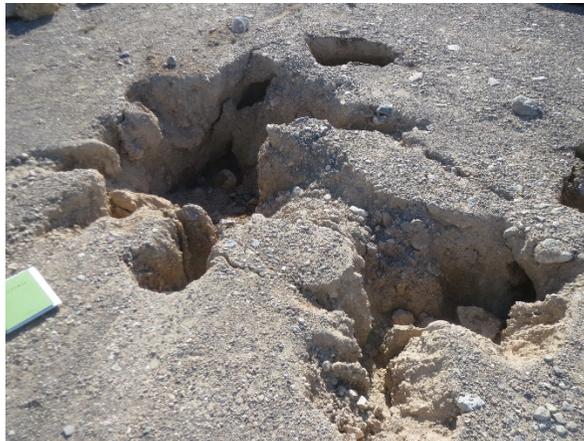
Trench 20 had evidence of subsidence, however the subsidence was more similar to that of a sinkhole-type subsidence, i.e., no visible depression except for the holes on the surface. Subsurface cavities in the trenches may have formed and increased in size so that the cavity roof lost support and cover material near the surface fell downwards into the cavity. None of the small channels that formed during the rain event seemed to flow towards the sinkhole-type subsidence. The holes were deep and the bottom was not visible.

Sinkhole-type subsidence

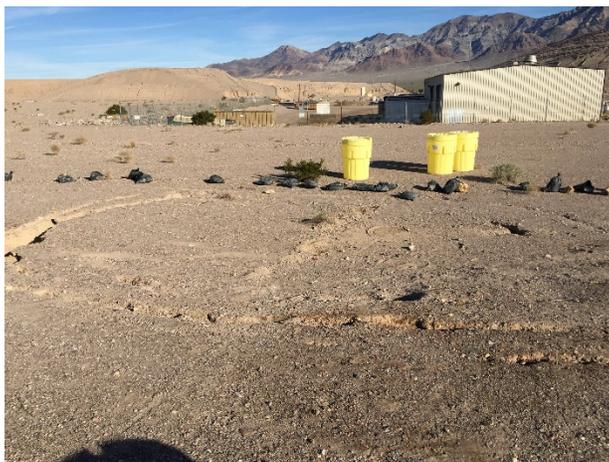
In contrast, the large subsidence depression near the middle of Trench 14 had numerous rivulets from the surrounding cover terminate in it so that much of that water may have flowed into Trench 14 through the cracks that were visible around the depression, or by ponding and infiltration. The crater was downgradient from this depression, so it would have been possible for rainwater that had entered at the depression to have moved downgradient within the trench towards the waste at the end of Trench 14 near the boundary.

Large subsidence or depression
