Entergy Nuclear Operations, Inc.
(Indian Point Nuclear Generating Units 2 and 3)

Recent Materials Inspections of PWR Reactor Internals

Glenn Gardner, Dominion
Chair, Reactor Internals Working Group

NRC RIC Meeting
March 2015

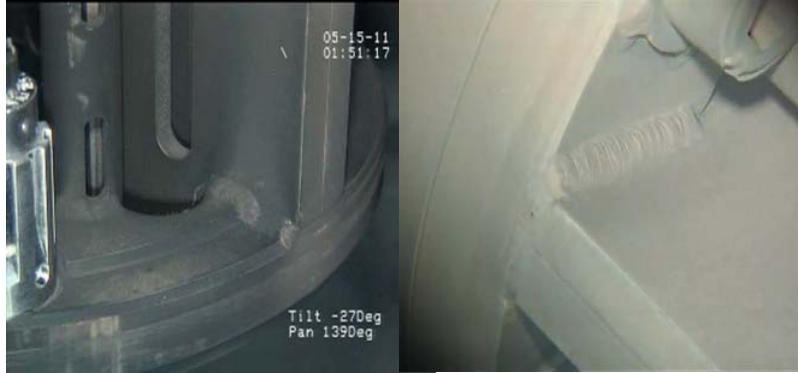
W Lower CRGT Flange Welds

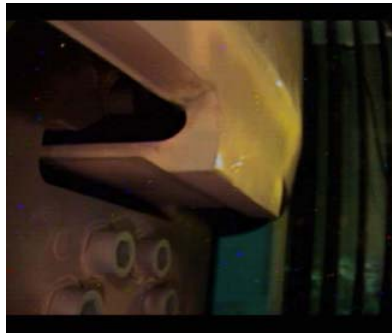
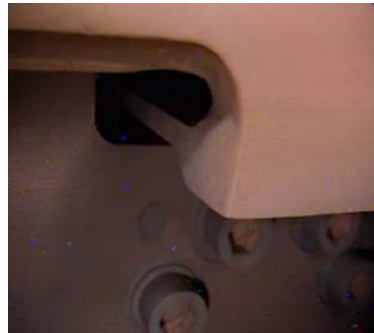
Thermal Shield Flexures (VT-3)

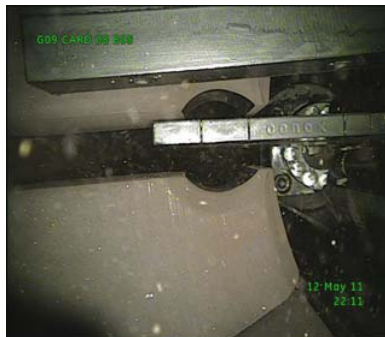
VT-3/Measurement W Control Rod Guide Cards

Acceptable

- No macroscopic effects of void swelling
 - No distortions, cracking, or excessive bolting failure
- High-strength nickel alloy clevis insert bolting failures
 - However, not in safety function load path
- Guide card wear will require monitoring
 - MRP Interim guidance MRP-2014-006 issued

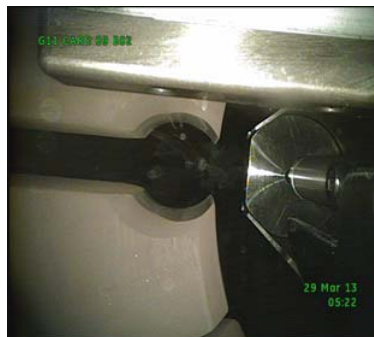
Observed Wear
